Building and Timber Pest Inspection Report

Inspection Date: Sat, 28 Feb 2026

Property Address: 5/510 Butson Ave, South Albury NSW 2640, Australia

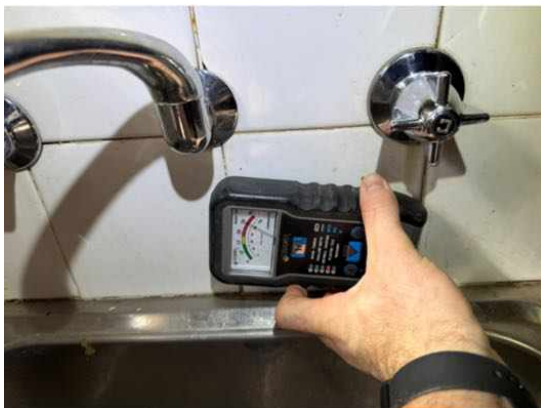
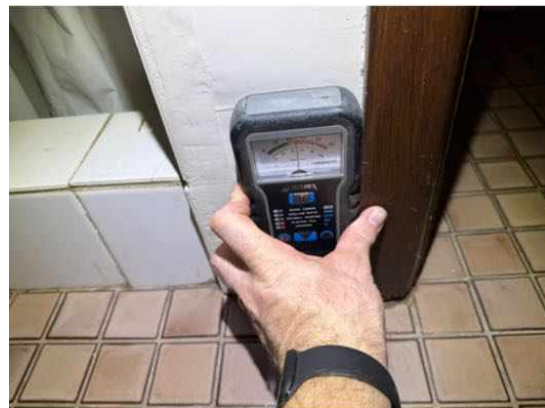
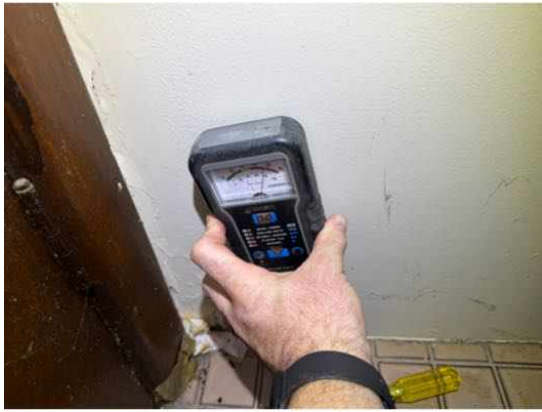
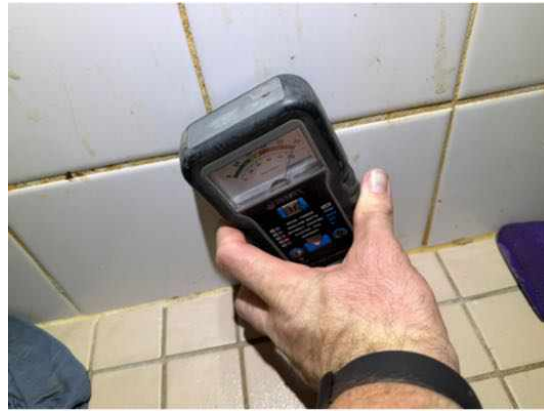
Finding 3.01

Building: Main Building
Location: Shower, Laundry
Finding: Shower & Laundry Tap - High Moisture
Information: It appears that high moisture is present at but not limited to, beneath the laundry tap, behind the shower wall and to the wall adjacent to the shower. Potential causes of leaking include but are not limited to loose or damaged plumbing fittings and fixtures, and/or deteriorated seals or waterproofing.

Evidence of high moisture was identified at, but not limited to beneath the laundry tap, above the DPC in the brickwork (rear elevation), behind the shower wall, and to the adjacent shower wall. Recommend engaging a licensed plumber and/or tiling contractor promptly, to identify the cause of the moisture & provide remedial works where necessary.

Areas of leaking and high moisture create an environment conducive to termite activity and therefore should not be neglected. Recommend engaging a licensed plumber and/or tiling contractor promptly, to provide remedial works where necessary.

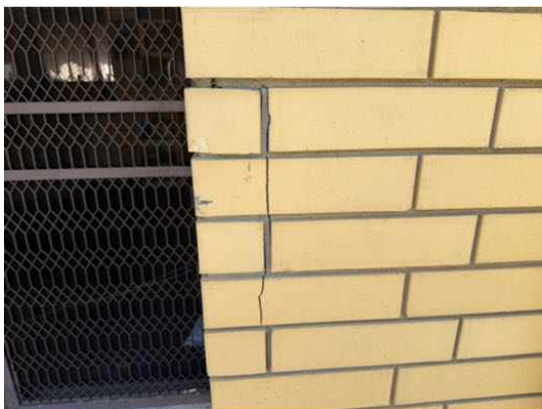
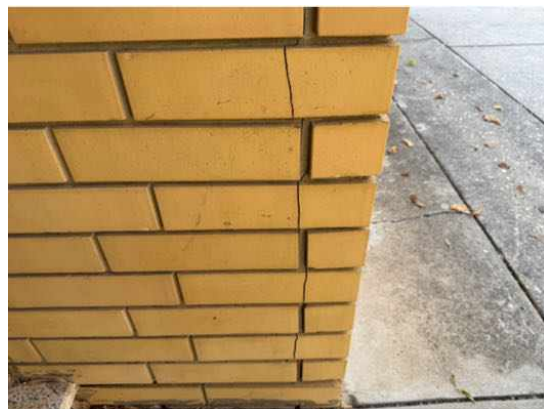
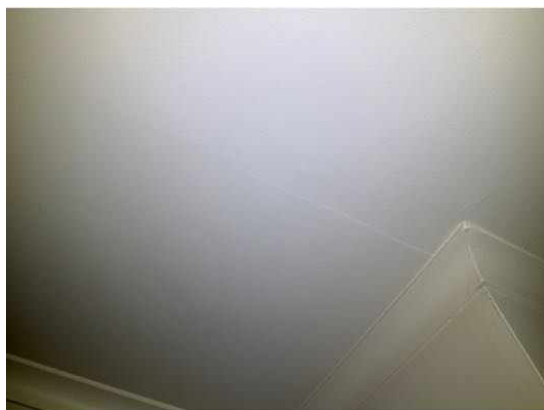
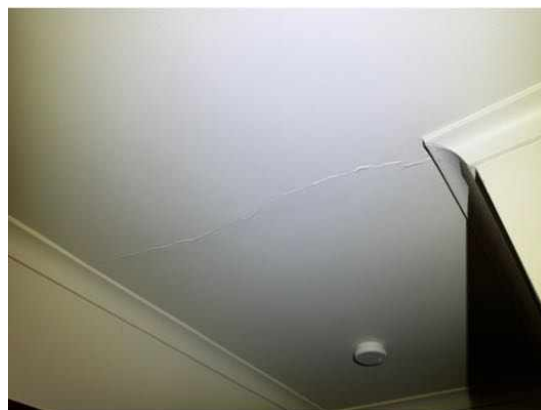
Finding 3.02

Building:	Main Building
Location:	Internal Areas, Brickwork
Finding:	Cracking - External & Internal
Information:	Cracking was identified to some areas of the brickwork and internal linings at the time of inspection. Cracking has a variety of possible causes, however, the most common is general movement of adjacent footings and/or expansion / contraction of building materials.

Cracking is a relatively common defect, and is most likely to occur adjacent to windows, doors and other openings.

The client should monitor the cracking. Should the cracking lengthen, widen or become more numerous, the client should consult with a structural engineer promptly to provide further advice.

All areas of internal and external cracking should be monitored to identify any further movement. Should cracking lengthen, widen, or become more numerous, a structural engineer should be engaged promptly, for further evaluation.

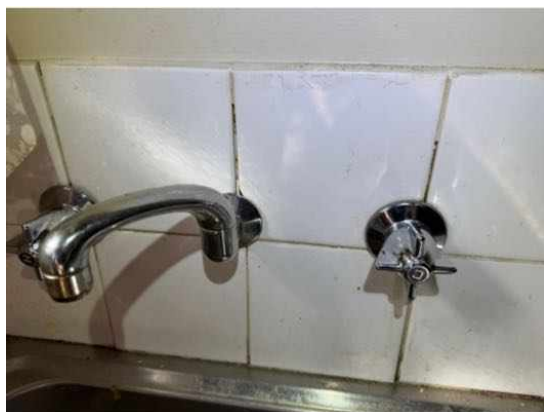
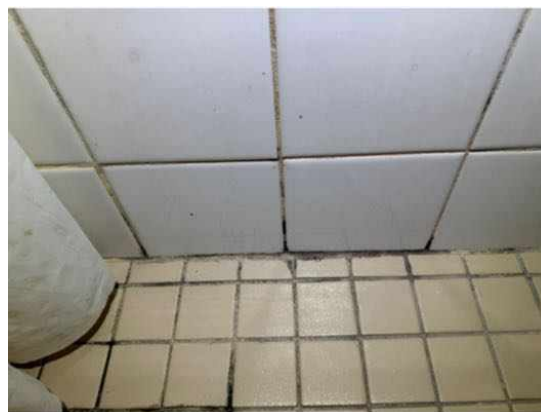
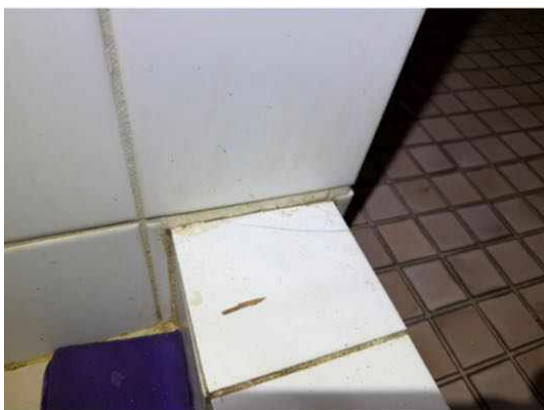
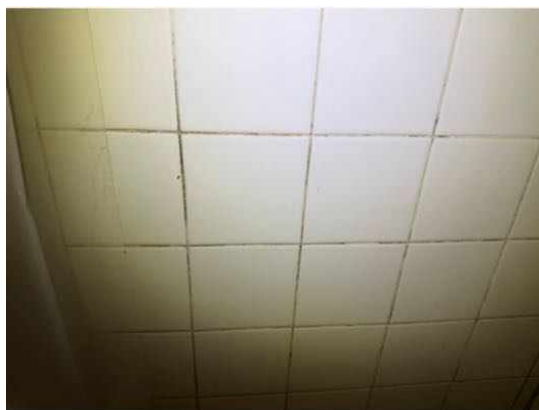
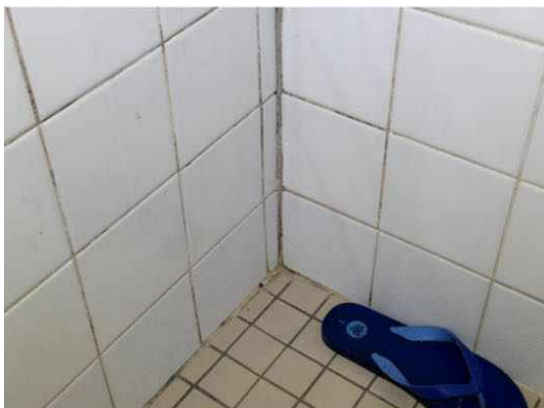
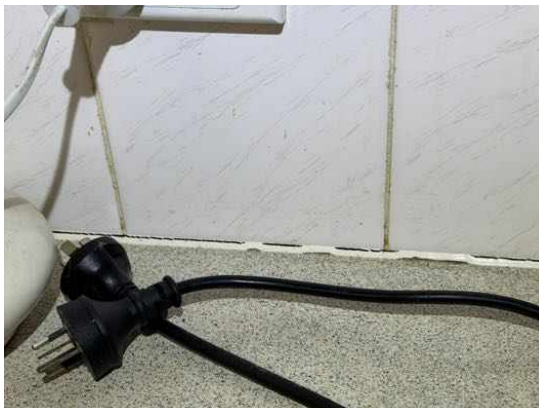
Finding 3.03

Finding: Sealant / grouting - deteriorated or missing & Cracked Tiles

Information: It appears that the sealant and grout has deteriorated in some tiled areas, a common defect in buildings of a similar age. Areas of cracked tiles were also noted, which can allow for moisture ingress behind the tiles, if neglected.

Sealant and grouting in areas that come into regular contact with water should be maintained for the long term care of your property.

Recommend engaging a licensed tiling contractor in the short term, to provide maintenance works where necessary.

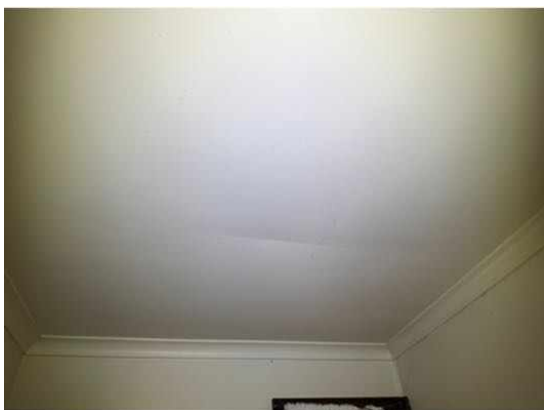
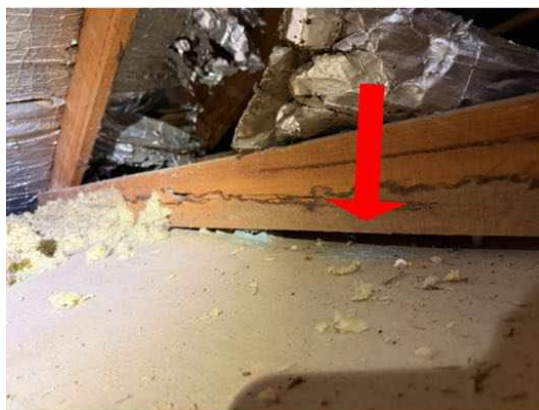
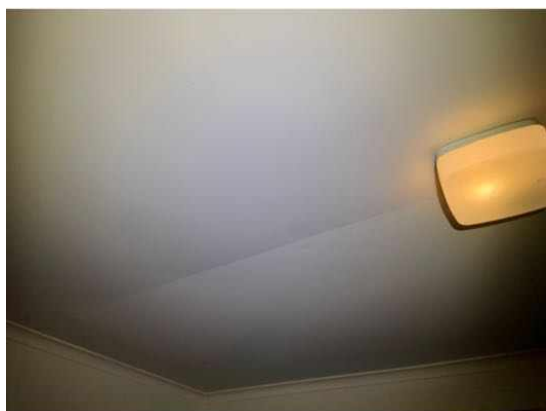
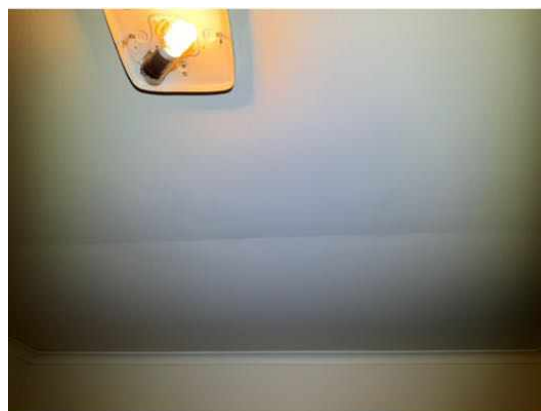
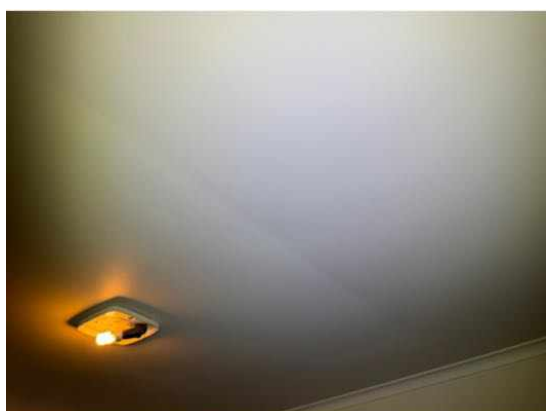
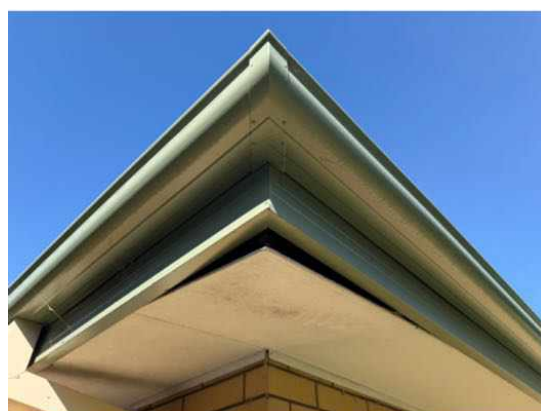
Finding 3.04

Building:	Main Building
Location:	Ceilings, Eaves
Finding:	Ceiling & Eaves - Sagging
Information:	Some areas of the ceilings and eave sheets were found to be sagging at the time of inspection. Causes of ceiling and eaves sagging include fixings (e.g. nails or glue) that have become loose and require re-fixing.

Where minor sagging has occurred, works such as re-gluing of ceiling sheets and installing additional fixings may be required. Such works may be performed by relevant tradespeople, such as plasterers or licensed carpenters, at clients discretion.

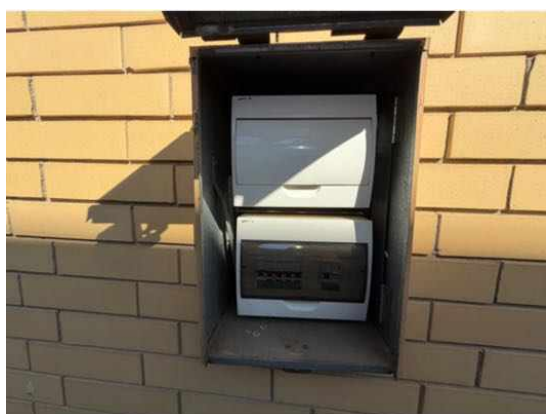
Finding 6.01

Building: Main Building
 Location: Switchboard
 Finding: Termite Management System - no evidence of a chemical installation
 Information: The application of a termite barrier is strongly recommended, as it appears no termite management system has been installed, with no evidence or durable notice to suggest works taking place. Generally, a durable notice is placed in the meter box to indicate current termite barriers.

Such barriers are highly effective in preventing termite attack on the building and therefore should be installed.

Recommend seeking further advice from a licensed pest controller.

Installation of a termite barrier is recommended as there was no evidence of installation of a previous termite management system. 12 monthly termite inspections, conducted by a qualified termite inspector are also advised. Recommend engaging a licensed pest controller, to provide further advice.

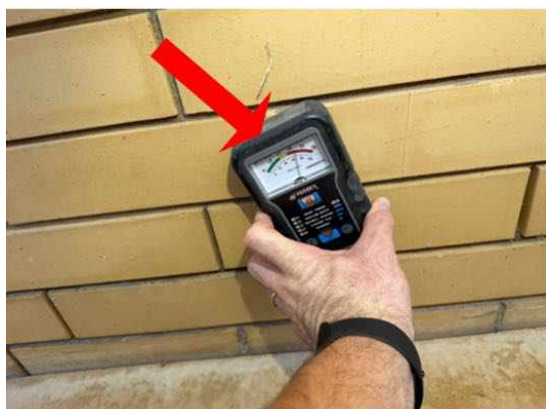
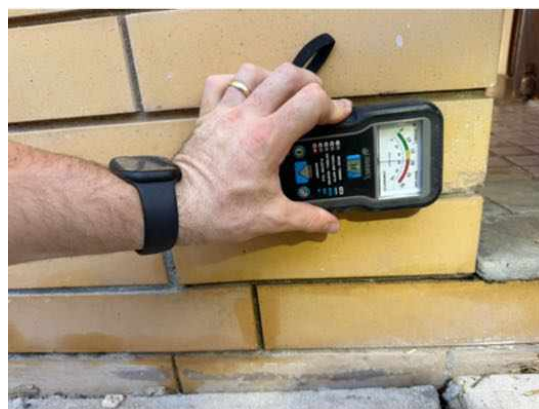
Finding 6.02

Building: Main Building
 Location: Rear Elevation
 Finding: High Moisture - Brickwork
 Information: It appears moist conditions are present above the damp proof course at, but not limited to the rear elevation of the unit. Potential causes of moisture above the DPC include associated leaking from pipework and/or deterioration of the DPC and water pooling against the building allowing for rising damp.

Recommend consulting with a licensed plumber in the short term to provide further advice & remedial works where necessary.

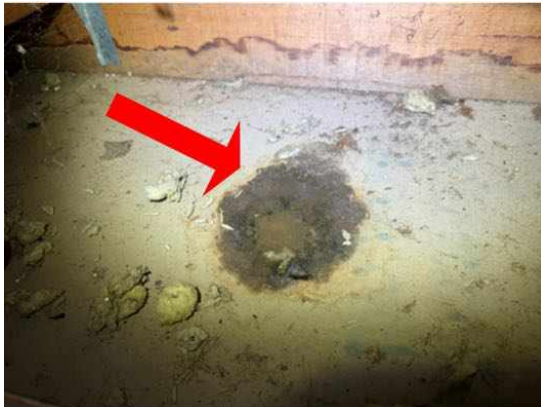
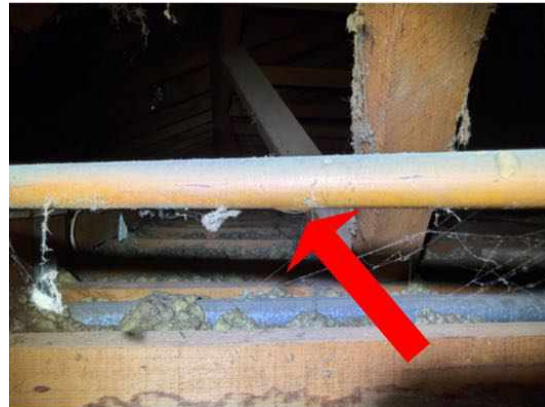
Finding 6.03

Building: Main Building
 Location: All Areas
 Finding: Pipe Leak - Roof Void
 Information: It appears that a pipe in the roof void was leaking at the time of inspection, and has resulted in water pooling on the bathroom ceiling. This creates an environment conducive to termite activity.

Recommend engaging a licensed plumber promptly to provide remedial works where necessary, to avoid further water damage.

It appears that a pipe in the roof void was leaking at the time of inspection. Recommend engaging a licensed plumber promptly to provide remedial works where necessary.

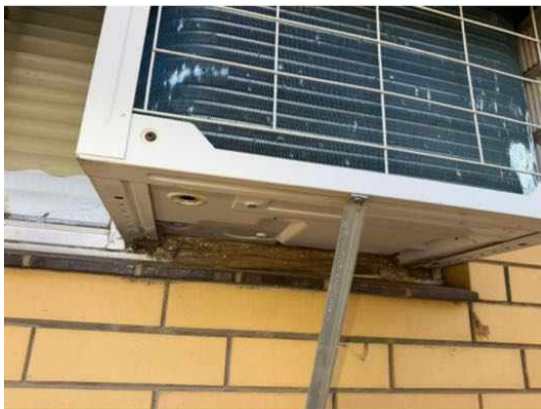
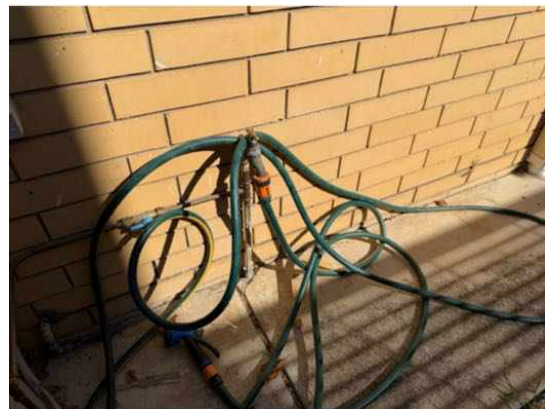
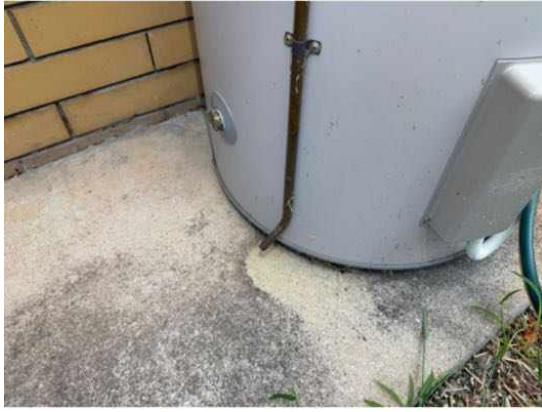
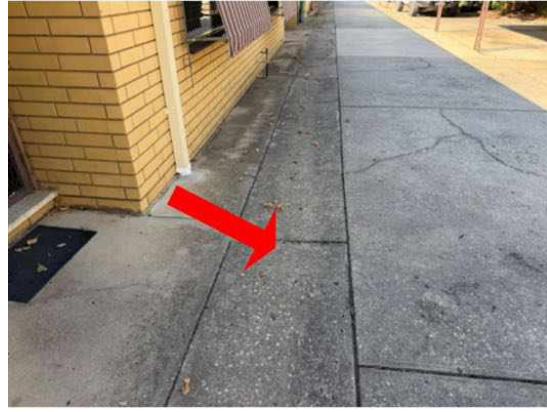
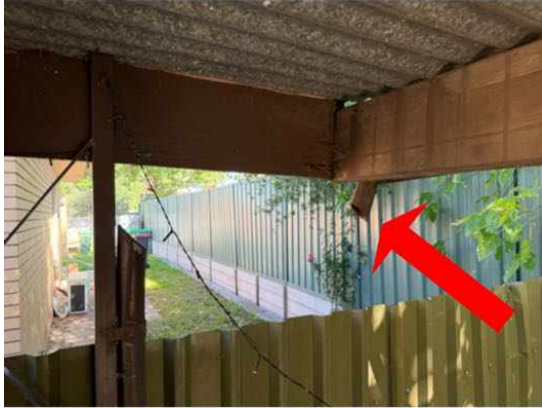
Finding 6.04

Building:	Main Building
Location:	All external areas, Carport Down-pipe
Finding:	Potential Water pooling - against property
Information:	Potential areas of water pooling around the perimeter of the property were identified. Where insufficient drainage of taps, hot water system & aircon overflows are present water pooling is likely to occur, and can create areas conducive to timber pests. The carport down-pipe was also found to be disconnected and there appears to be insufficient stormwater drainage to the front of the unit.

Recommend consulting with a licensed plumber, specialising in drainage, to provide further advice & remedial works where necessary.

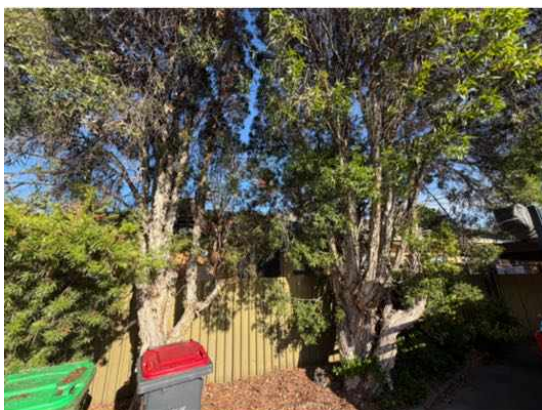
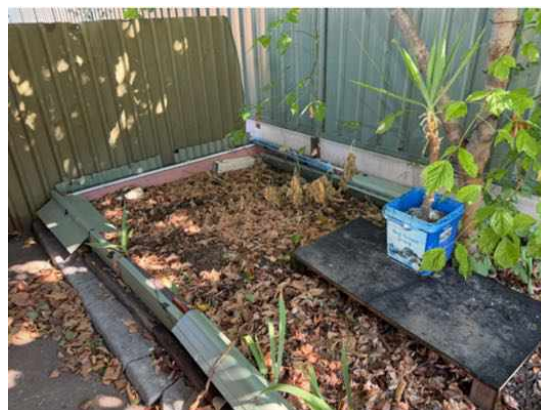
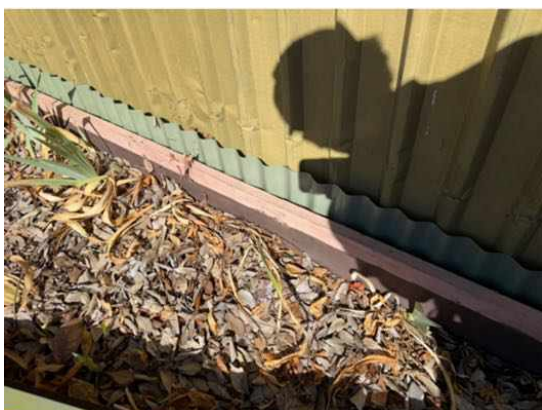
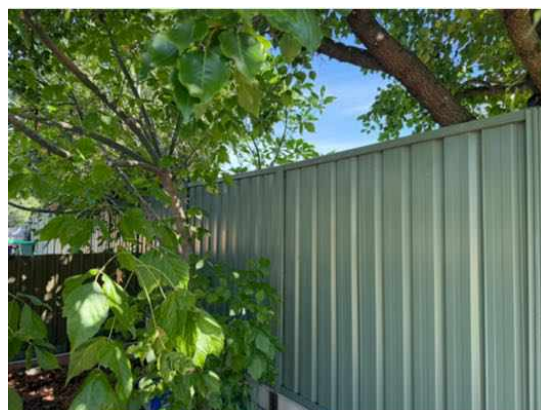
Finding 6.05

Building:	Main Building
Location:	All External Areas
Finding:	Timber in direct ground contact & trees - conducive to termites
Information:	Where timber materials are in direct contact with the ground and consequently moisture, they become conducive to termite activity. The landscaping timbers and trees surrounding the building create an environment conducive to termite activity.

Where feasible, any timbers in direct contact with the ground should be removed and any trees in close proximity to the building should be removed or test drilled (inspected) at least annually to reduce the risk of termite infestation & detect any early signs of termite activity.

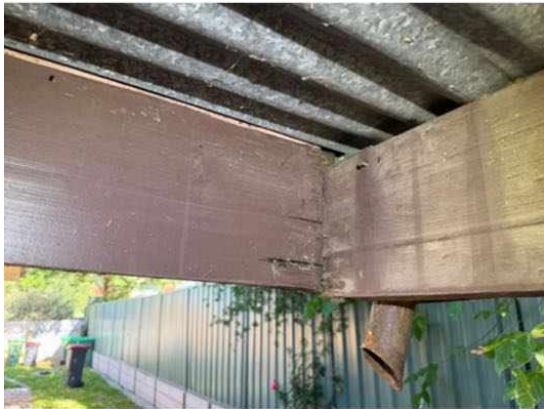
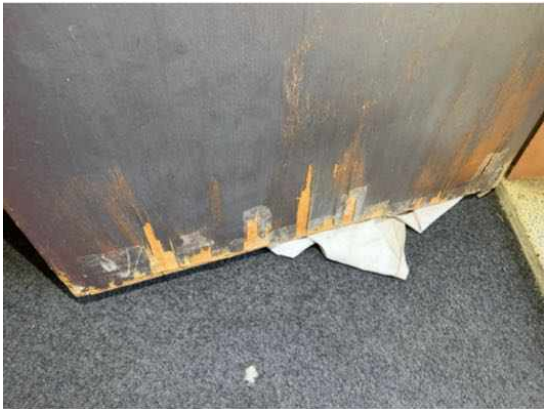
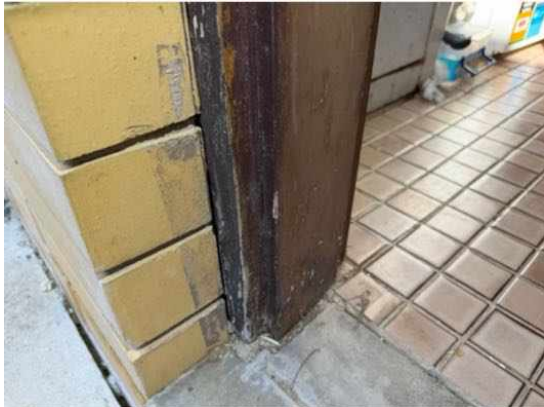
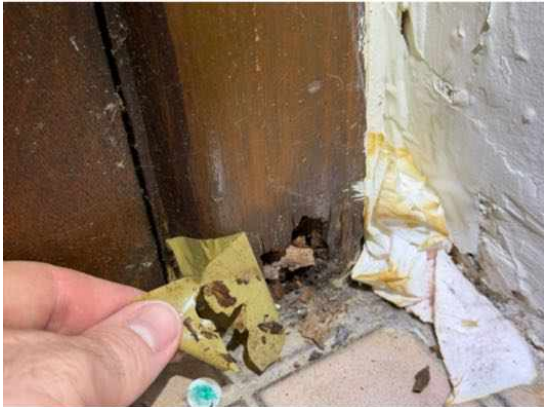
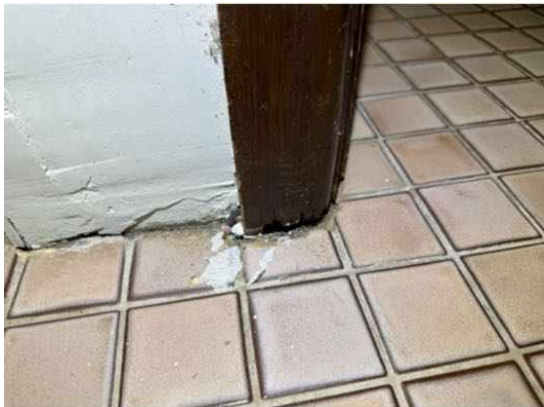
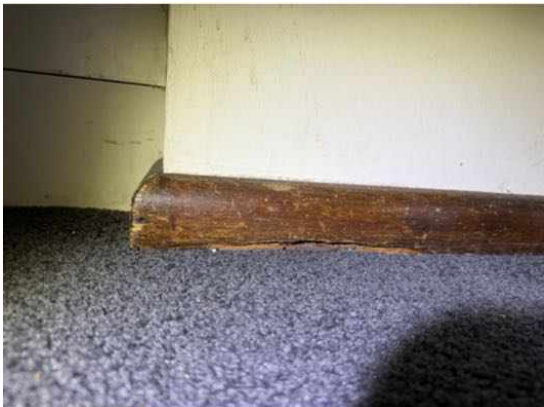
Finding 7.01

Building:	Main Building
Location:	Carport Framing, Bathroom Architraves, Front Door, Skirting
Finding:	Fungal decay & weathering
Information:	Areas of fungal decay (wood rot) & weathering were identified at but not limited to areas of the carport framing, bathroom architraves, the front door, and skirting boards.

For areas of fungal decay, the client can engage a licensed carpenter at their discretion to replace affected materials. For areas of general weathering, it is advised the client engage a licensed painter to apply protective sealant or coating to areas of weathered external timbers.

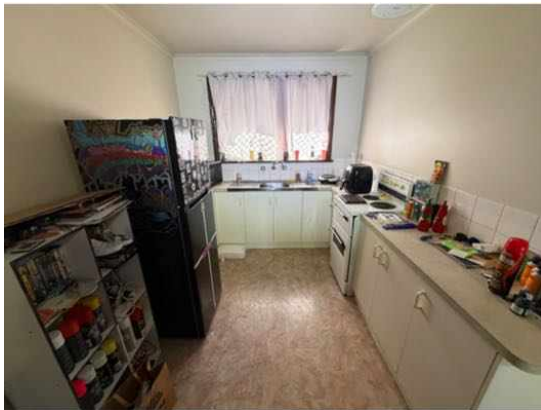
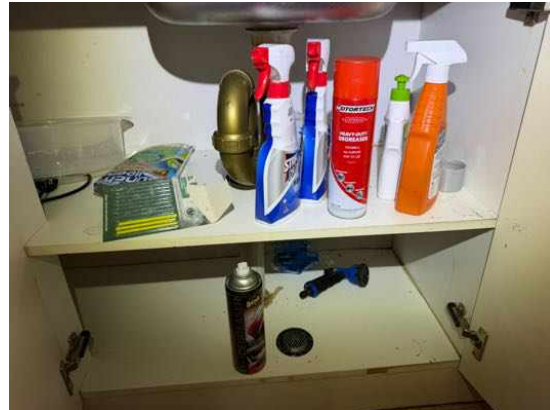
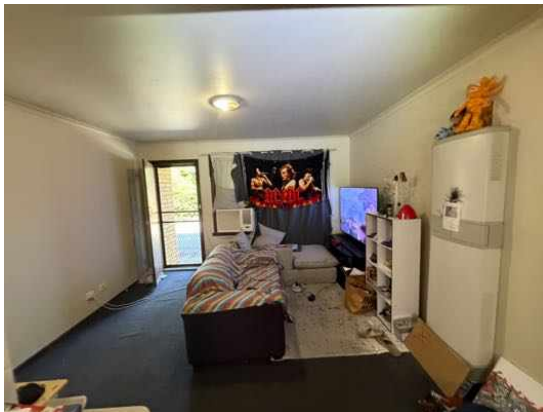
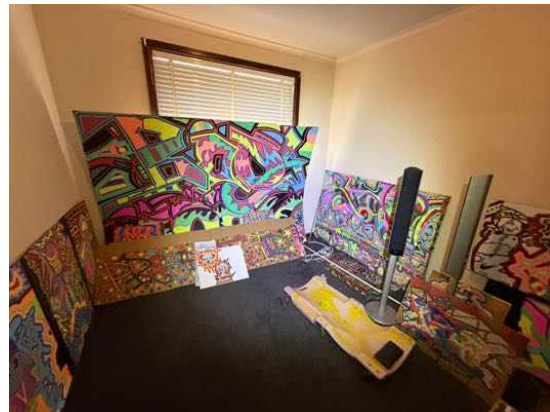
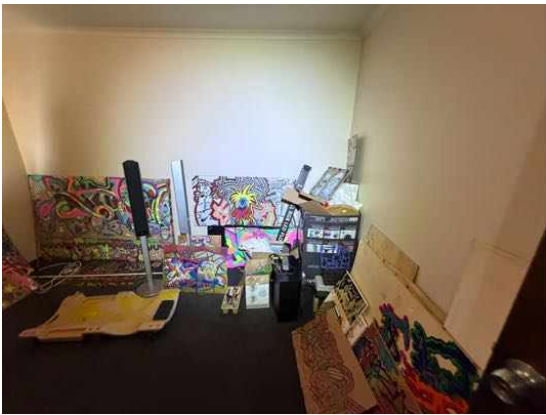
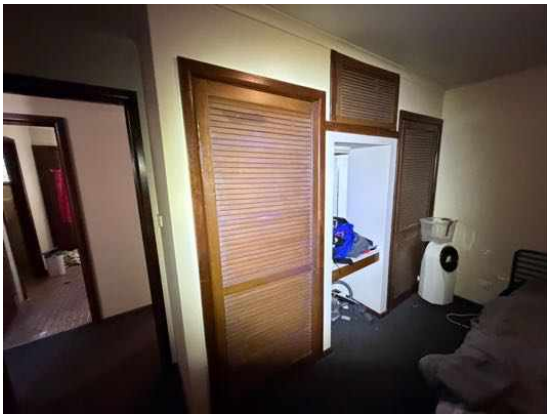
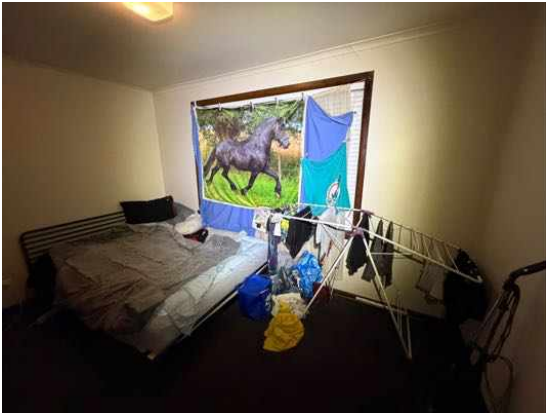
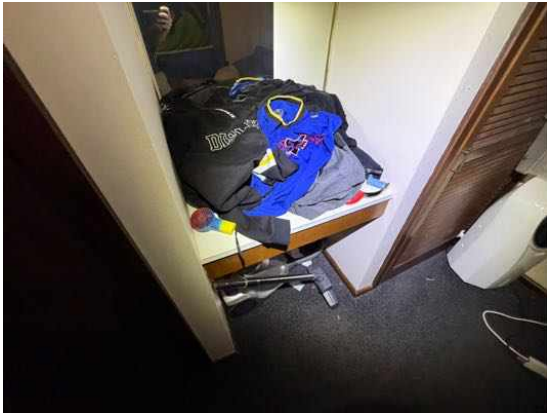
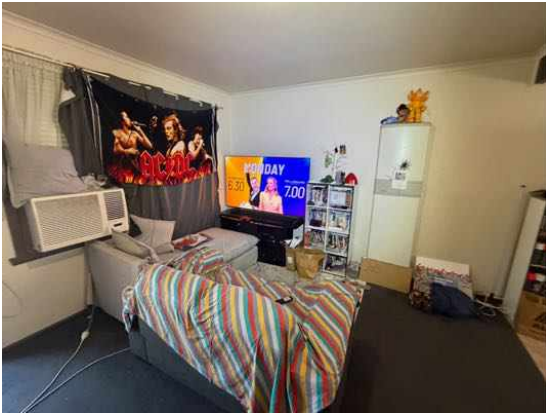
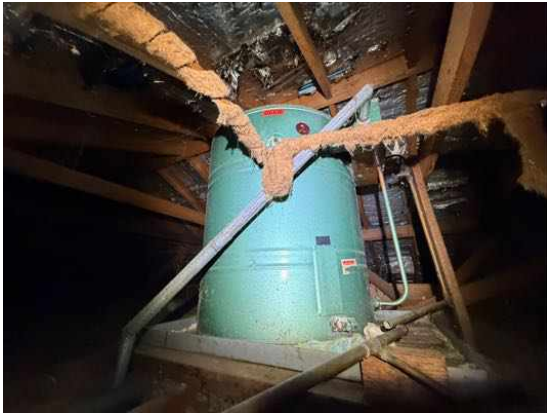
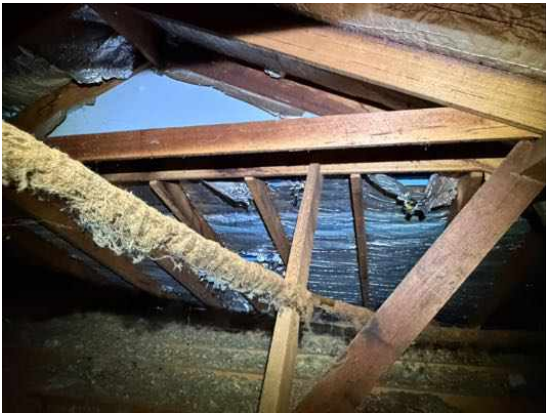
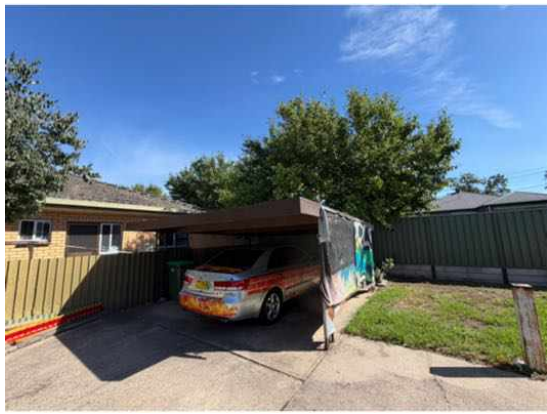
Several limitations and obstructions impeded the inspection and, if feasible, should be removed, and a further inspection should be performed. The roof void was unable to be fully inspected due to areas of low roof pitch, loose fill insulation, and pipework. Indicative images below depict some of the obstructions encountered.

Building: Main Building
Location: All Areas
Finding: Additional Photos - Obstructions and Limitations
Information: These photographs are an indication of the obstructions and limitations which impeded full inspection of the property at the time of inspection. These obstructions can hide an array of defects and should be removed to allow full inspection to be carried out. A re-inspection is recommended once the areas are made accessible.

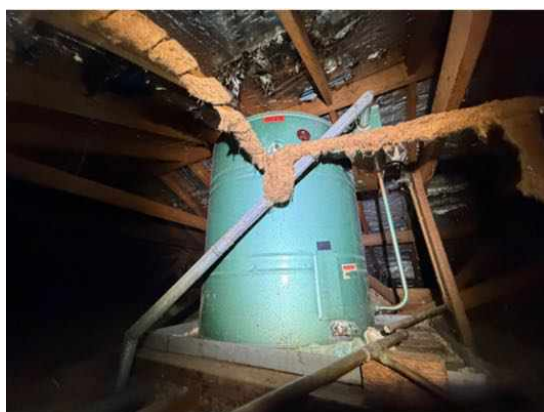
Building: Main Building
Location: Roof Void
Finding: Gravity-Fed HWS - Disconnected
Information: A disconnected gravity-fed hot water system (HWS) remains in the roof void.

Despite this plumbing system being unused, it may contain residual water. If neglected, rust of the system overtime, may lead to residual water leaking.

Recommend that the client either monitor the condition of the system or get the system drained by a licensed plumber to prevent any potential future leaks.

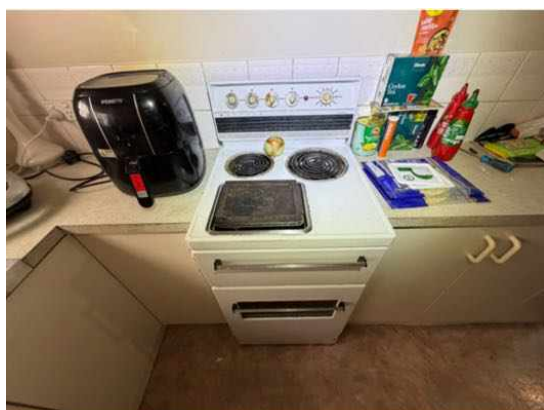
Building: Main Building
Location: Stove
Finding: Stove - Not Operating
Information: It appears that the stove was not operating at the time of inspection. Recommend engaging a licensed electrician at clients discretion, to provide further advice and remedial works where necessary.

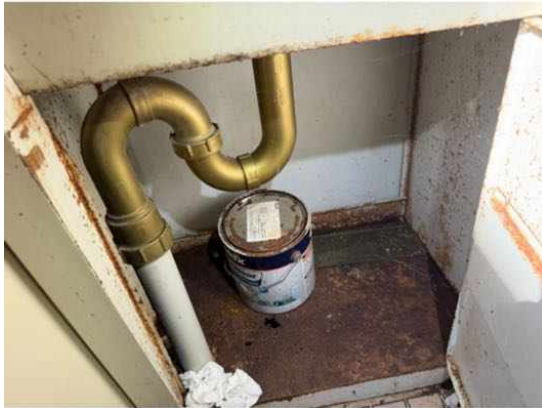
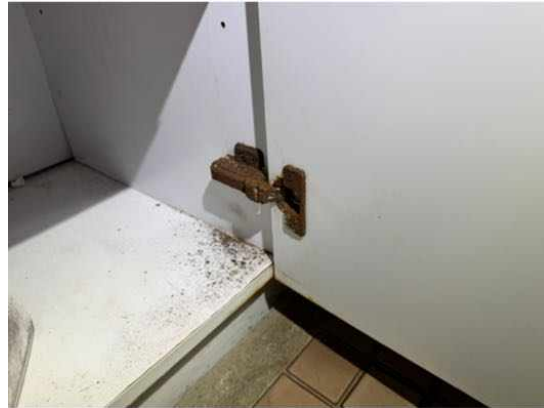
Location: Vanity, Laundry Sink
 Finding: Rust - Laundry Sink Cabinet & Bathroom Vanity
 Information: It appears that the laundry sink cabinet and bathroom vanity have been affected by rust. This could be an indicator of previous leaking in the area.

No evidence of water leaking was found in these areas at the time of inspection.

The client should monitor these areas. Should evidence of moisture become apparent, a licensed plumber should be engaged to provide further advice.

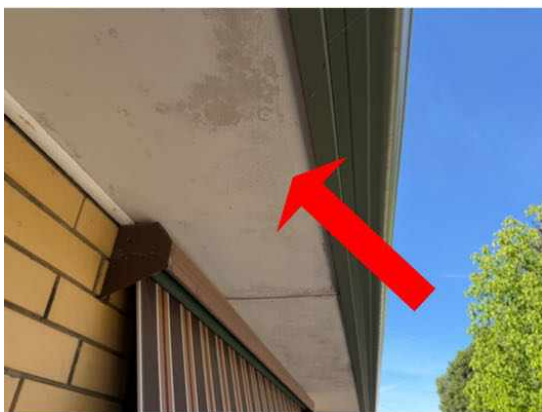
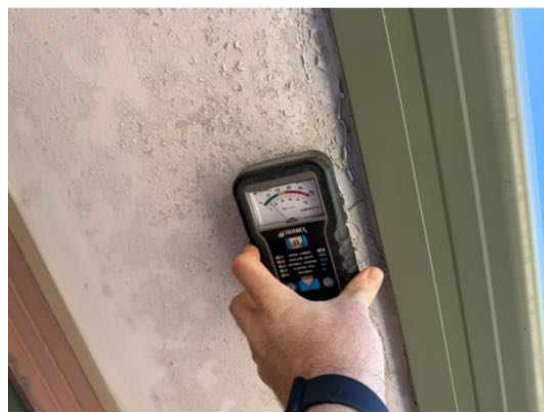
Building: Main Building
 Location: Front Eaves
 Finding: Eaves - Stained / Deterioration
 Information: It appears that areas of the eaves were stained / deteriorated, which may have been an indicator of previous leaking. No high moisture was evident in the area at the time of inspection. Recommend client to monitor the affected area.
