Building and Timber Pest Inspection Report

Inspection Date: Wed, 11 Mar 2026

Property Address: 2-8 Elwood St, Notting Hill VIC 3168,
Australia

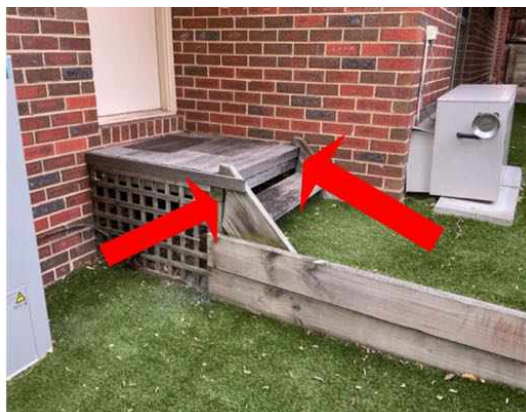
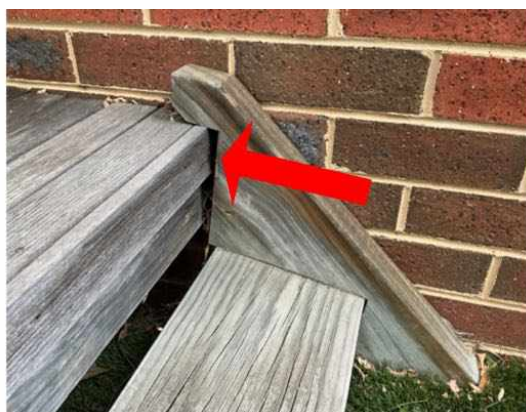
Building: Main Building
Location: Yard - Back
Finding: Rear steps coming loose
Information: On inspection of the rear steps/treads it was noticed that the steps/treads are starting to come loose. Loose steps/treads can create a risk of slips trips and falls for anyone using the stairs. Continued use without repair may result in further loosening or detachment of the treads increasing the likelihood of injury.

It is recommended to engage a carpenter as soon as possible to repair/replace the stairs to reduce the risk of safety hazards and further deterioration.

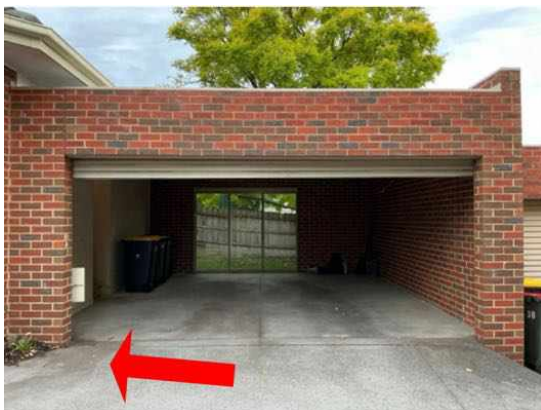
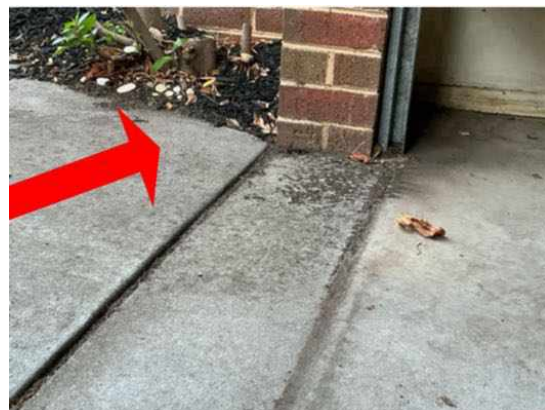
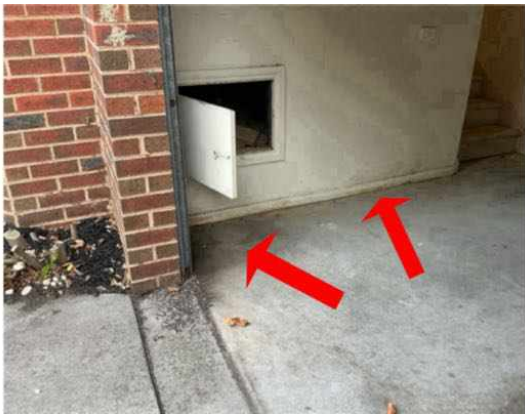
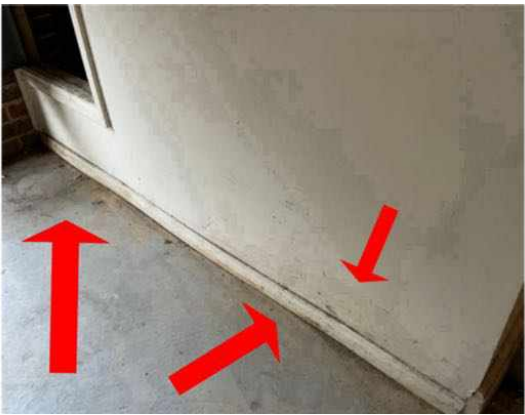
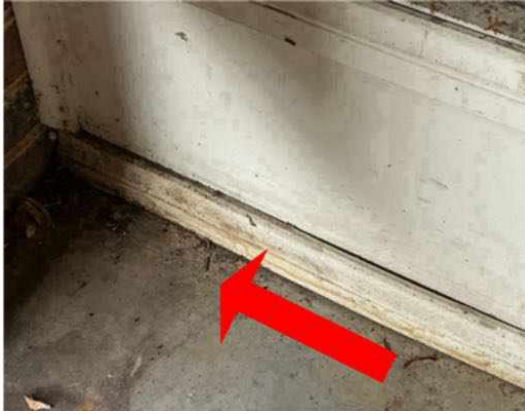
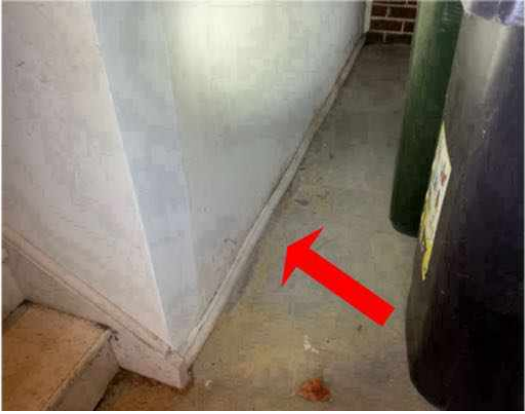
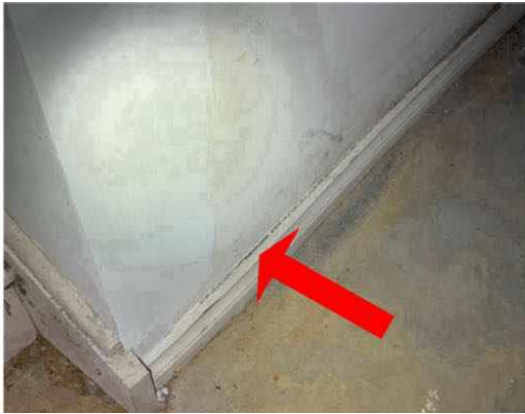
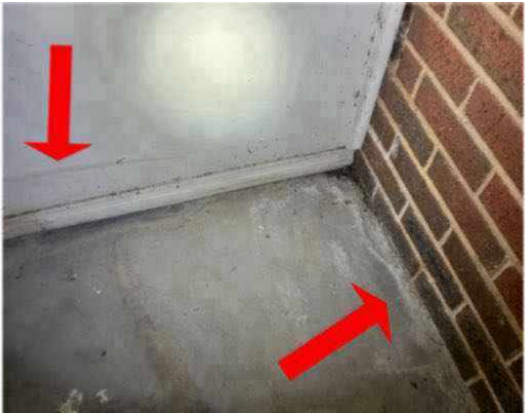
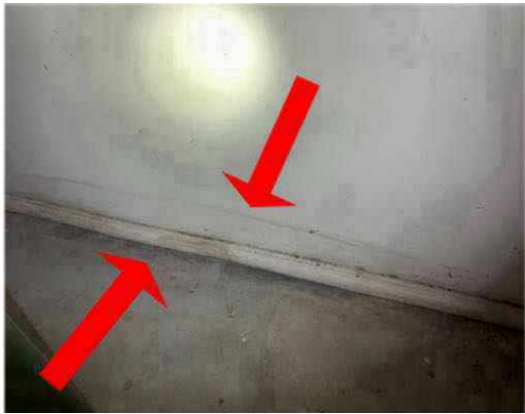
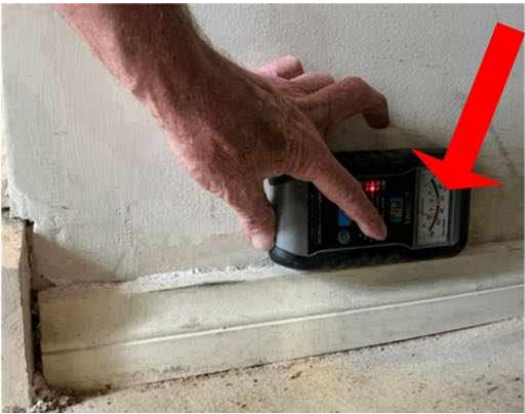
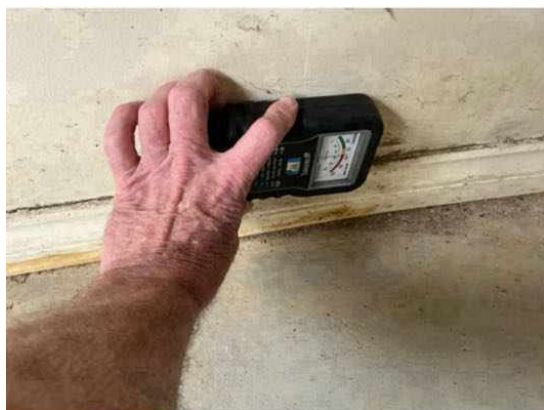
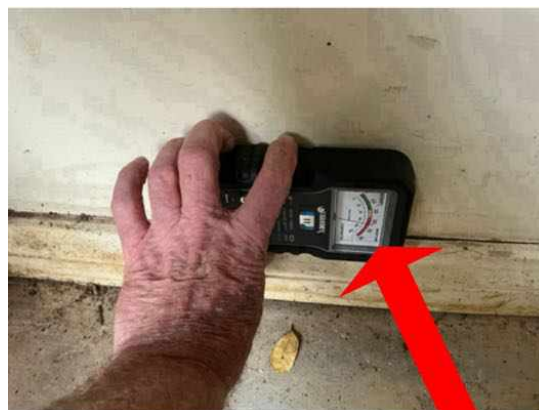
Finding 2.01

Location: Garage
Finding: Moisture ingress at garage roller door
Information: During inspection of the garage water staining was observed to parts of the garage concrete, walls and skirting board areas. Moisture readings were taken using a moisture meter which indicated elevated moisture levels in those areas.

This condition is considered a major defect because it involves active water ingress into the building which has the potential to cause significant structural damage if not rectified.

Further investigation was taken by opening the garage roller door and inspecting the external slab at the entry point. It was observed that the external concrete surface is higher than the internal garage floor level. This condition creates an adverse fall toward the garage allowing rainwater to fall toward and potentially enter the garage during rainfall events.

Evidence of moisture staining suggest that water ingress has occurred previously.

This condition represents an improper drainage/fall configuration at the garage entry.

The presence of ongoing or periodic moisture within the garage creates conditions that may be conducive to timber pest activity and building deterioration.

Repairs may include improving site drainage grading surfaces away from the structure and implementing appropriate drainage measures to prevent further water ingress into the garage.

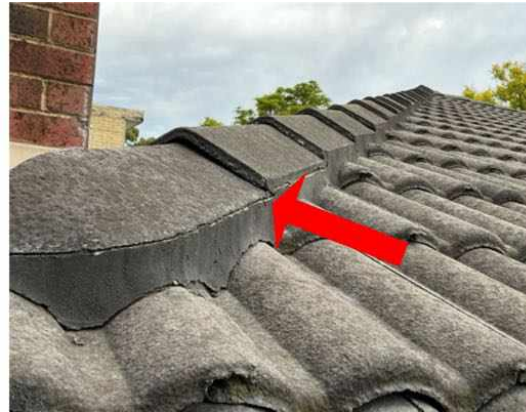
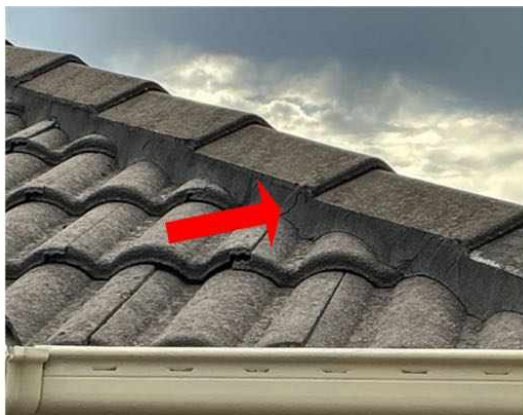
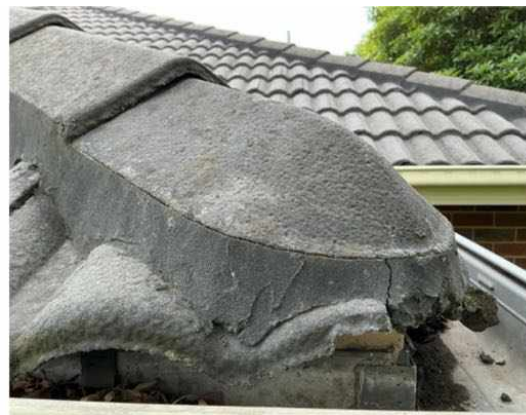
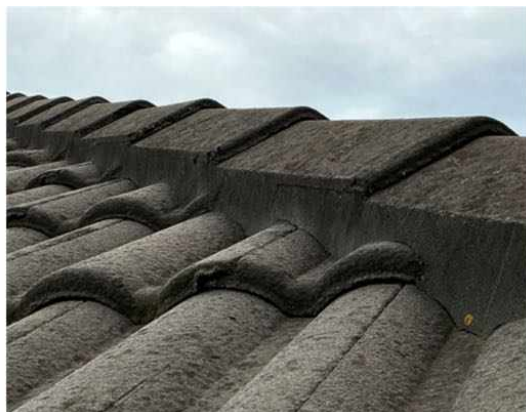
Building: Main Building
Location: Roof Exterior
Finding: Roof tile mortar deterioration and cracking
Information: Cracking and deterioration was observed in the parts of the ridge and hip tile mortar bedding. The mortar has separated in several areas, with visible gaps forming between ridge tiles and the underlying bedding. This condition indicates age-related degradation and exposure to the elements, which has caused the mortar to become brittle and lose its bonding integrity.

Compromised mortar may lead to further deterioration, potentially allowing water ingress and structural damage to the roof structure below.

Recommend engaging a qualified roofing contractor to carry out repointing or full re-bedding of affected ridge and hip tiles as necessary. All deteriorated mortar should be removed and replaced with new flexible roof bedding compound in accordance with current Australian Standards (AS 2050).

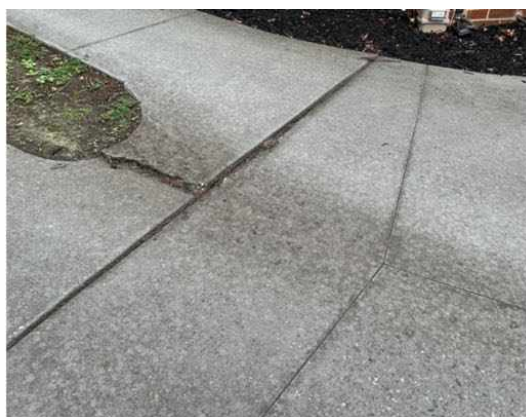
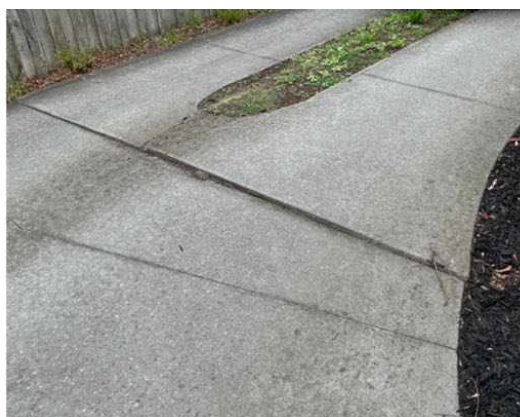
Finding 3.03

Building:	Main Building
Location:	Driveway
Finding:	Paving - Cracked Uneven
Information:	Sections of the driveway external paved area are cracked and uneven, creating a potential trip hazard. It appears as though the area has been subject to rough installation, or that paving sections have lifted due to tree roots.

Where paving creates a trip hazard, personal injury may ensue if due caution is not taken by all persons within this area.

Re-paving of the area is required as soon as possible to remedy this situation. Further consultation with a specialist concreter is advised.

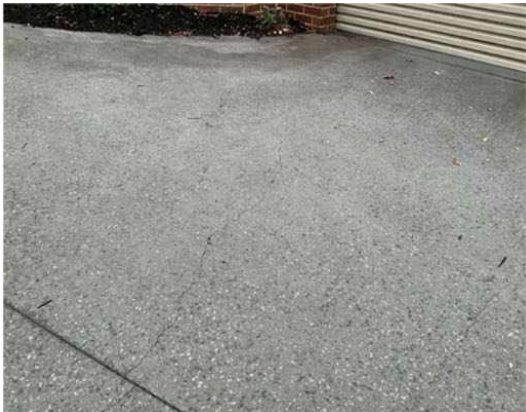
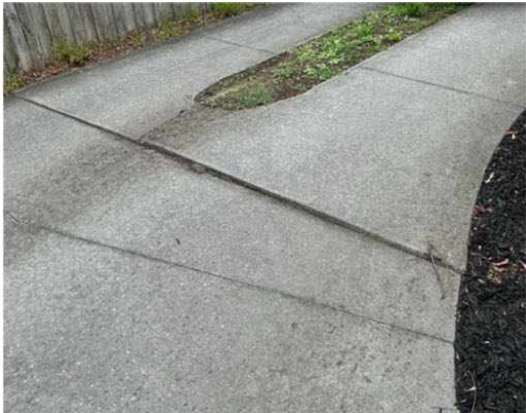
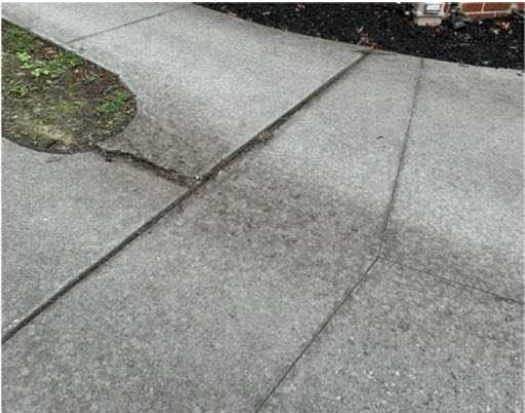
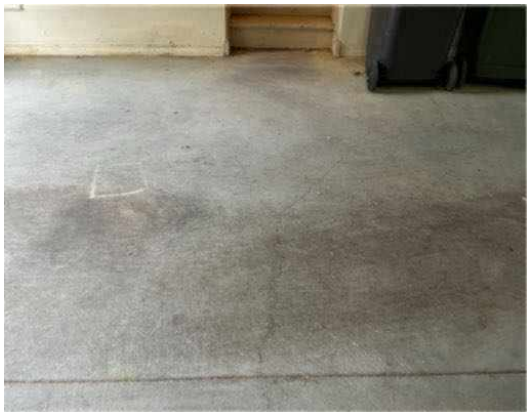
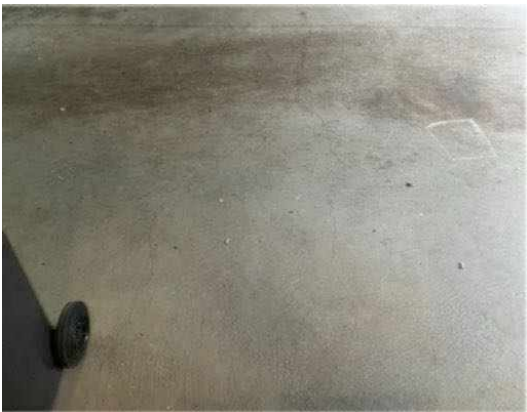
Finding 3.04

Building:	Main Building
Location:	Driveway/garage
Finding:	Driveway/garage Cracking
Information:	Cracks were identified in the driveway and garage concrete paving. Although cracks are quite noticeable, they are often only considered to be an appearance defect, and usually do not indicate any structural damage.

Generally the cause of the cracks in existing concrete paving such as driveways and pathways is indicative of the expansion and contraction of the concrete. Such causes are generally due to environmental factors, such as moisture levels, weather conditions, root systems of nearby trees or the soil types on which they are laid.

Cracks may also be due to poor original installation of the concrete. Factors such as poor compaction of the sub surface and/or inadequate reinforcing of the slab may create cracking and other secondary defects.

Monitoring of all cracking should be conducted frequently. Always contact a building inspector should cracks widen, lengthen, or become more numerous.

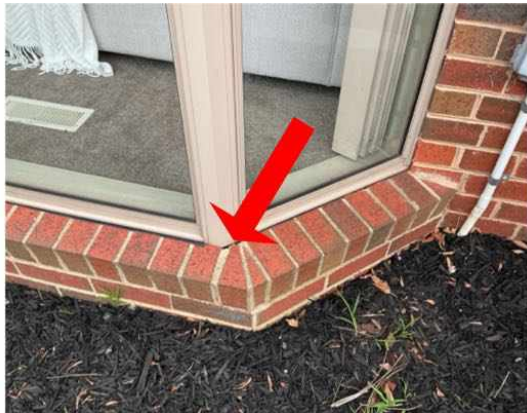
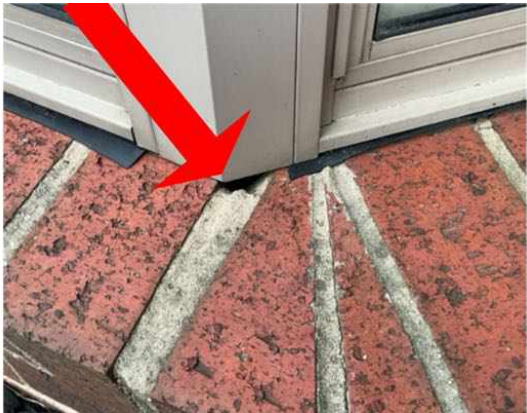
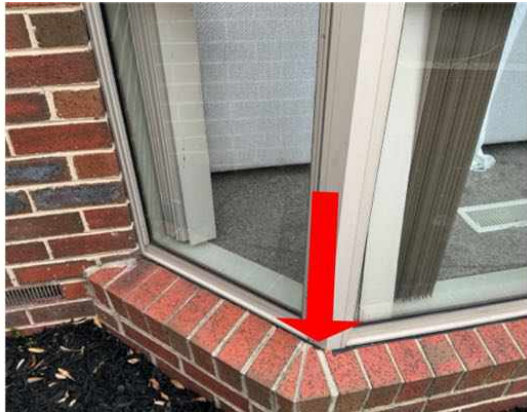
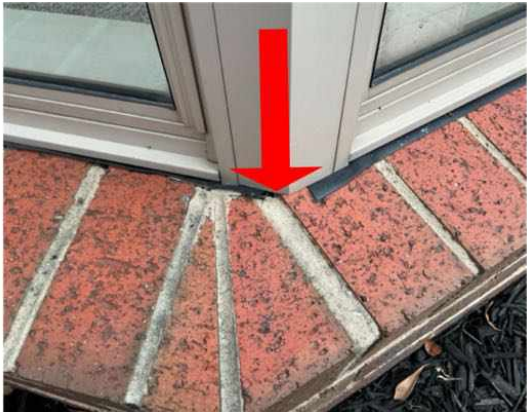
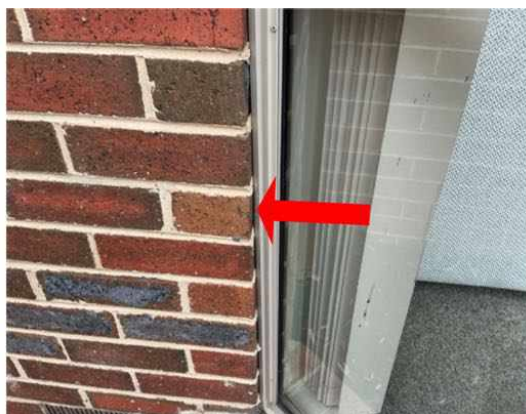
Finding 3.05

Building: Main Building
Location: Exterior walls - front
Finding: A few gaps to the exterior walls/windows
Information: A few gaps were noticed around the bay window. These gaps can let in water, drafts, and pests. Overtime moisture ingress may cause damage to internal walls, mould growth, or structural issues. Gaps also reduce the energy efficiency of the property. Recommend engaging a caulker to seal gaps with an exterior grade flexible sealant that is UV and weather resistant to reduce the risk of pest/water penetration to the building as soon as possible.

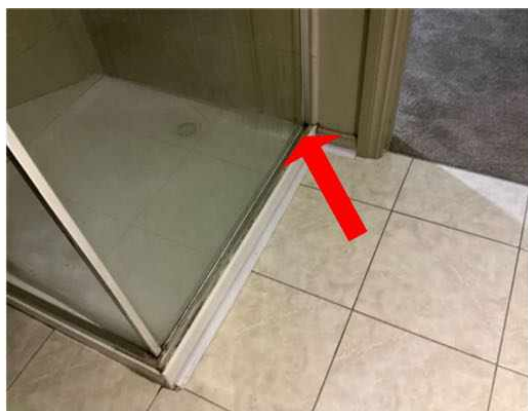
Building:	Main Building
Location:	Bathroom
Finding:	Shower screen - Leaking bathroom
Information:	Leaking was evident to the shower screen in the bathroom at the time of inspection. It is suspected that the leaking has occurred as a result of deteriorated or missing caulking to the shower or general ageing of the building elements.

Leaking from the shower where left unattended, is likely to lead to water damage to adjoining flooring and walls. Such damage can lead to water damage and necessitate extensive remedial works being required. Active water leaks may also create an environment that is susceptible to the formation and development of mould.

Appointment of a caulking contractor is required to repair or replace the caulking to the shower area. Such works should be performed as soon as possible to ensure that no further damage occurs.

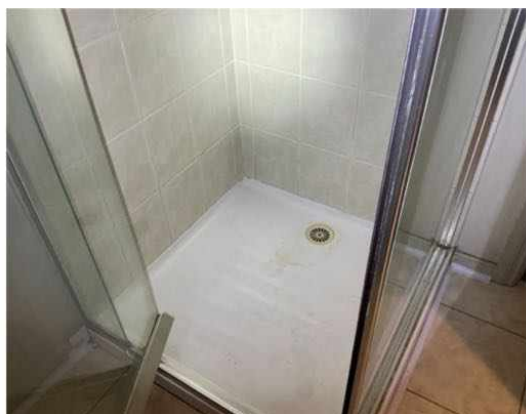
Finding 3.08

Building:	Main Building
Location:	Bathroom
Finding:	Bathroom Sealant and grouting - Missing or damaged
Information:	It was noted on inspection that sealant or grout is degraded to the tiled shower alcove and or other areas of the bathroom.

Different materials and floor areas move at different rates, generally causing cracking to grout or sealant at this point. A flexible sealant is required to allow for expected expansion and contraction, while keeping the joint water tight and protective of all associated building materials.

Flexible and mould resistant materials should be applied to affected areas to prevent any subsequent water damage that is likely to occur. Regular maintenance and replacement of damage or missing or damaged sealant and grout is highly recommended to the wet areas, as this is a regular wear and tear defect. Sealant and grouting in areas that come into regular contact with water should be maintained for the long term care of your property.

A sealant specialist or tiling contractor should be appointed to complete these works as soon as possible

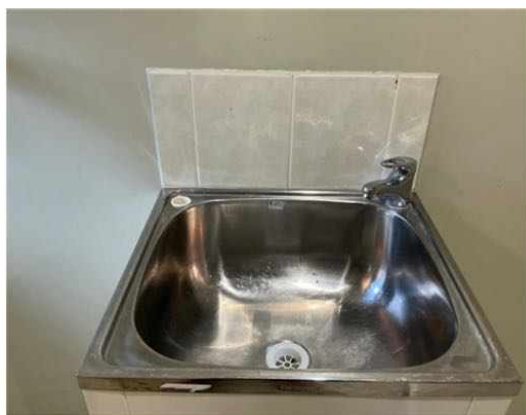
Finding 3.09

Building:	Main Building
Location:	Laundry
Finding:	Laundry- Sealant and grouting - Missing or damaged
Information:	It was noted on inspection that sealant or grout is degraded to the laundry splash back and or other areas of the laundry.

Different materials and floor areas move at different rates, generally causing cracking to grout or sealant at this point. A flexible sealant is required to allow for expected expansion and contraction, while keeping the joint water tight and protective of all associated building materials.

There appears to be excessive mould to the sealant and grout which will likely require scraping out and replacement.

Flexible and mould resistant materials should be applied to affected areas to prevent any subsequent water damage that is likely to occur. Regular maintenance and replacement of damage or missing or damaged sealant and grout is highly recommended to the wet areas, as this is a regular wear and tear defect. Sealant and grouting in areas that come into regular contact with water should be maintained for the long term care of your property.

A sealant specialist or tiling contractor should be appointed to complete these works

as soon as possible

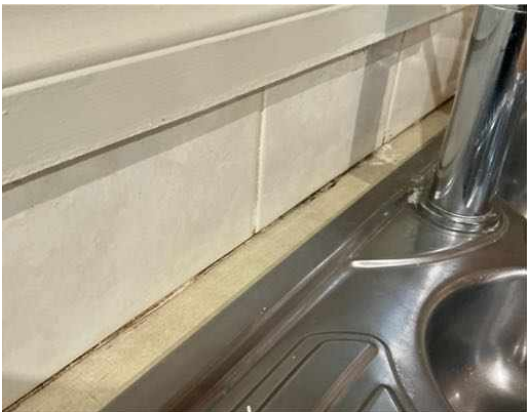
Finding 3.10

Building:	Main Building
Location:	Kitchen
Finding:	Kitchen Sealant and grouting - Missing or damaged
Information:	It was noted on inspection that sealant or grout is degraded to the kitchen splash back and or other areas of the kitchen.

Different materials and floor areas move at different rates, generally causing cracking to grout or sealant at this point. A flexible sealant is required to allow for expected expansion and contraction, while keeping the joint water tight and protective of all associated building materials.

There appears to be excessive mould to the sealant and grout which will likely require scraping out and replacement.

Flexible and mould resistant materials should be applied to affected areas to prevent any subsequent water damage that is likely to occur. Regular maintenance and replacement of damage or missing or damaged sealant and grout is highly recommended to the wet areas, as this is a regular wear and tear defect. Sealant and grouting in areas that come into regular contact with water should be maintained for the long term care of your property.

A sealant specialist or tiling contractor should be appointed to complete these works as soon as possible

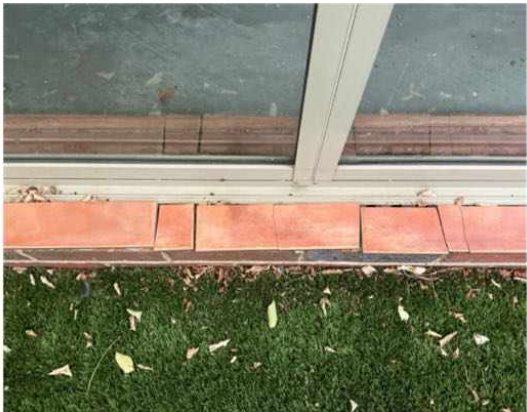
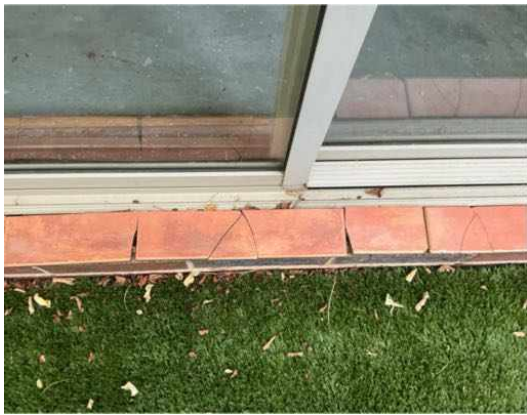
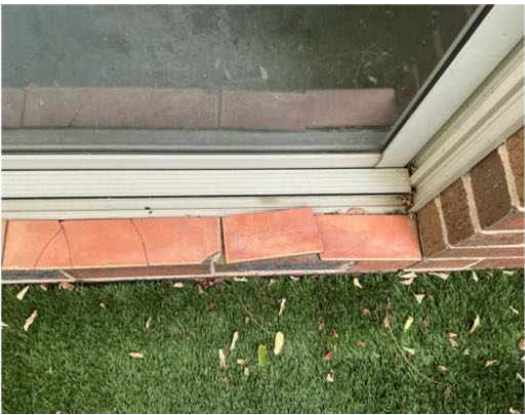
Finding 3.11

Building: Main Building
Location: Garage
Finding: Cracked tiles
Information: Cracked tiles was evident to the garage at the time of inspection. It is suspected that this cracking has occurred as a result of minor settlement of the building or poor workmanship.

Cracked tiles to the household detract from the overall appearance of the affected areas however it is unlikely to create or lead to any secondary defects.

While not considered a matter of urgency, replacement of cracked tiles is recommended at the clients discretion. A tiling contractor may be appointed to perform these works. Where cracks become more numerous, contact a licensed building inspector for further investigation.

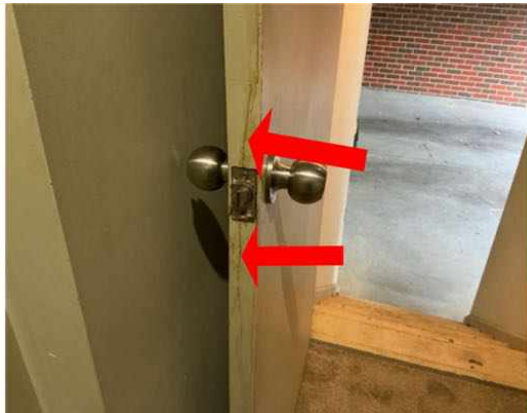
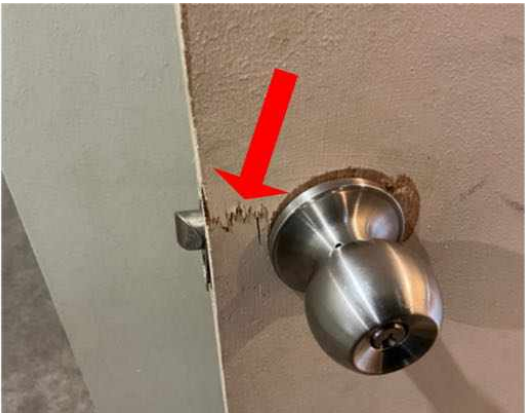
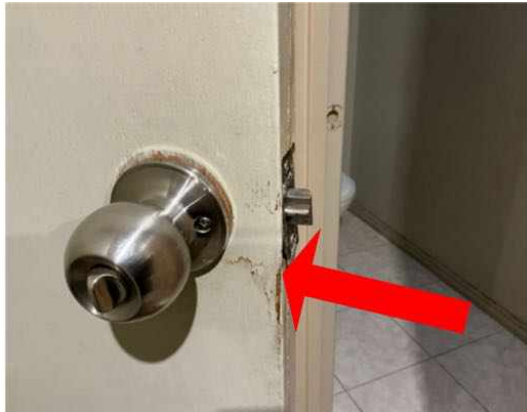
Finding 3.12

Building: Main Building
Location: Garage
Finding: Garage door damaged
Information: On inspection of the garage door, it was noted that it has been damaged to parts through accidental or deliberate damage.

Is recommended to engage a carpenter and painter to repair/replace the door to reduce the risk of further deterioration.

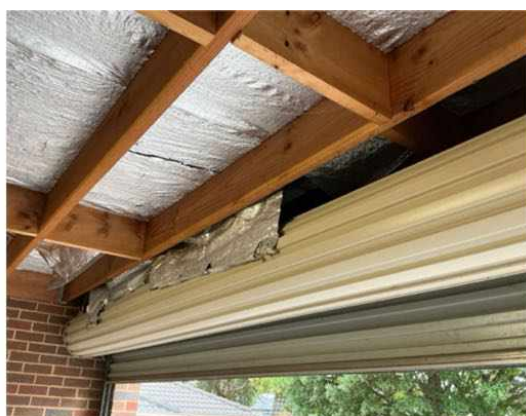
Finding 3.13

Building:	Main Building
Location:	Garage
Finding:	Sarking deteriorated
Information:	The garage roof sarking is showing signs of deterioration near the roller door. The material appears aged and weakened, with sections beginning to break down. This reduces its effectiveness as a secondary barrier against water ingress, dust, and wind-driven rain.

Reduced protection of the roof cavity from moisture, which may lead to water ingress during heavy rainfall.

Increased risk of condensation forming in the roof space, potentially contributing to timber decay and mould growth.

Replace deteriorated sections where necessary to restore full functionality.

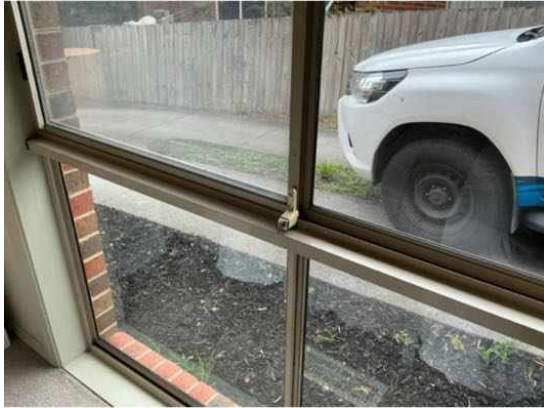
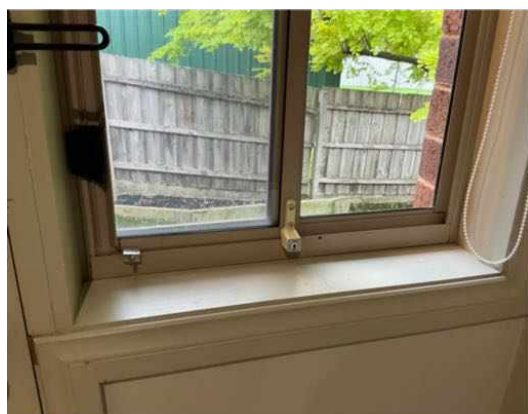
Building: Main Building
Location: Various parts of the building
Finding: Window locks stiff to operate
Information: The window locks to the building are stiff to operate. This can happen overtime in harsh weather conditions or through lack of maintenance. Recommend engaging a carpenter to repair/maintain to make more operational at the owners discretion.

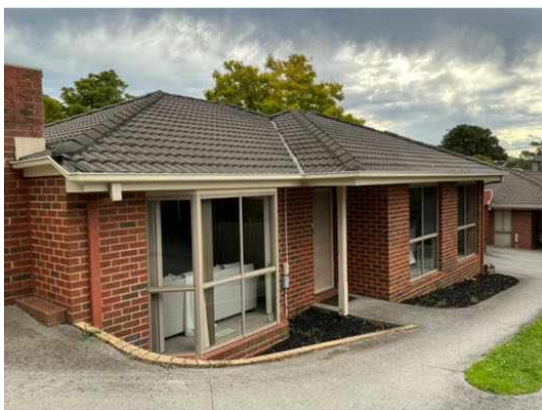
Building:	Main Building
Location:	All External Areas
Finding:	No Termite Management System - no evidence of a chemical installation
Information:	The application of a post-construction chemical termite barrier is highly recommended for all properties, particularly if live termite activity has been found on the site previously. Such barriers are highly effective in preventing termite attack on any timber building elements throughout the property.

The client may consider gaining further advice from a pest controller as to the costs and procedures involved with this application. It is recommended that obtaining such advice be a short-term priority.

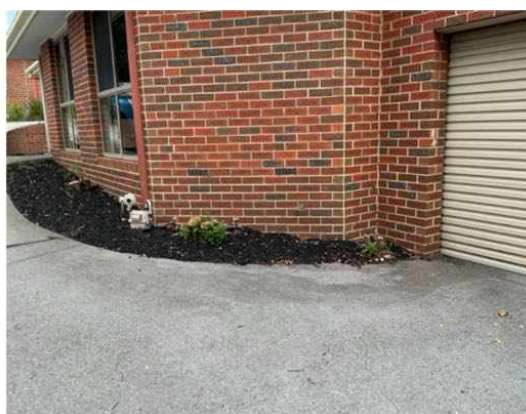
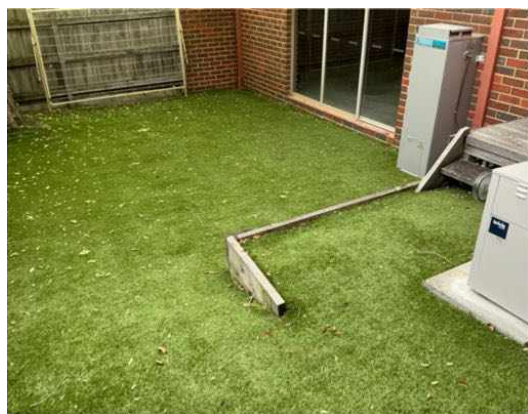
Finding 6.02

Building:	Main Building
Location:	Yards
Finding:	Site drainage - poor/inadequate
Information:	The site drainage to parts of the yards was found to be inadequate at the time of inspection, creating potential for subsequent water damage to associated building elements. Excessive moisture will attract termites.

Where site drainage is inadequate, installation of an Agricultural (Aggie) Drain may be required. A qualified plumber should be appointed to further inspect the property and perform any remedial works as necessary. Water damage and secondary defects are likely to occur if left unmanaged.

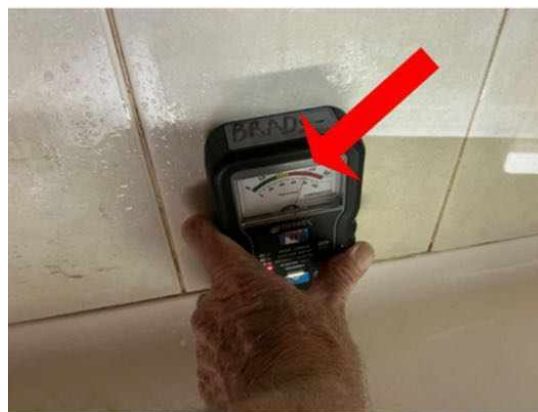
Finding 6.03

Building:	Main Building
Location:	Bathroom
Finding:	Shower - Damp
Information:	Damp is evident to parts of the bathroom shower alcove found using using a moisture meter. This defect is quite common, and is suspected to have been caused by moisture permeating through the grouting in this area, which shows evidence of deterioration creating moist conditions. Leaking pipes within the adjoining wall is also a possible cause. Excessive moisture can attract termites.

Damp (or structural damp) refers to the presence of unwanted moisture in the structure of a building, either as the result of intrusion from outside, or condensation from within the structure. In the shower area, internal water leaks or other sources of excessive moisture are generally the cause of damp.

Unmanaged damp in the shower recess is likely to facilitate the formation and development of mould and fungi growth, decaying associated building materials and compromising their structural integrity. It is important to address damp conditions, as the World Health Organisation notes that excess moisture leads - on almost all indoor materials - to growth of microbes such as moulds, fungi and bacteria, which subsequently emit spores and other matter into the indoor air. Exposure to these contaminants is associated with a wide range of respiratory and other health-related problems.

Consultation with a qualified plumber or bathroom specialist is advised immediately to identify the cause of damp and to perform remedial works as required. Where excessive mould growth is present, further inspection by a specialist environmental health inspector should also be considered.

Always ensure that sealant and grout is in good condition to prevent any moisture issues occurring in the future.

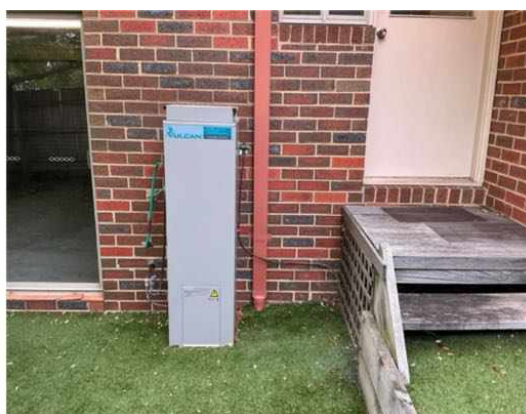
Finding 6.04

Building: Main Building
 Location: Yard - Back
 Finding: HWS Overflow - Not Connected
 Information: The Hot Water System (HWS) overflow was found to be disconnected from storm water drainage and is creating excessive moisture in the surrounding area.

These damp conditions can lead to secondary defects such as rot, rust or corrosion of associated building elements, the formation of fungal decay, or even the creation of potential slip hazards. When coupled with poor site drainage, pooling of water may also attract termite activity to this area.

It is highly recommended that a licensed plumber be appointed to connect the HWS overflow in order to prevent such an environment from being created. These minor works should be carried out as soon as possible.

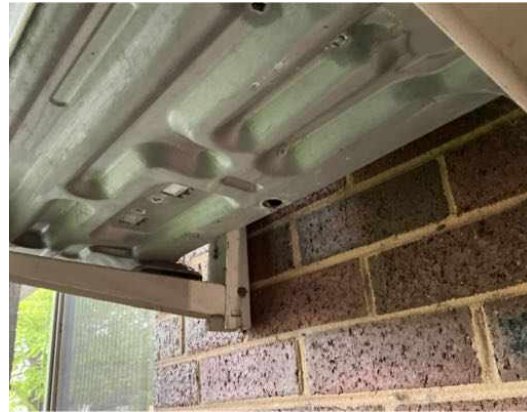
Finding 6.05

Building: Main Building
 Location: Yard - Back
 Finding: Air conditioning unit overflow -Not plumbed for drainage
 Information: The overflow to the air conditioning unit is not plumbed or connected to suitable

drainage, which has resulted in the surrounding area becoming excessively damp. These damp conditions can lead to secondary defects such as rot, rust or corrosion of associated building elements, the formation of fungal decay, or even the creation of potential slip hazards. When coupled with poor site drainage, pooling of water may also attract termite activity to this area. It is highly recommended that a qualified plumber be appointed to install adequate drainage to the overflow. These works will ensure that the area remains dry and free of any secondary defects.

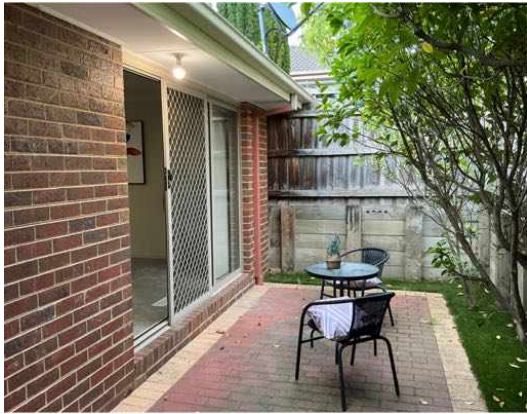
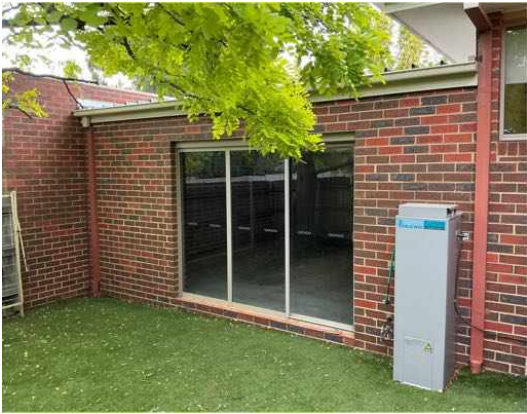
Finding 6.06

Building:	Main Building
Location:	Various parts of the building
Finding:	Bridging attachments to buildings
Information:	Bridging occurs when items against a building provide a concealed entry point for termites into the building or by passing around a termite management system.

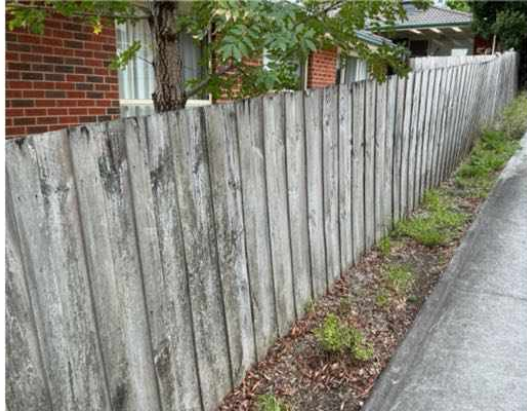
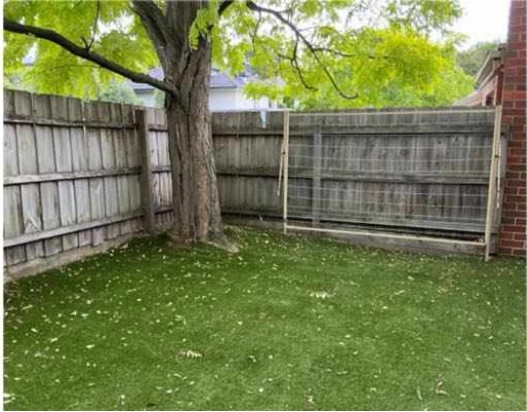
Finding 6.07

Building: Main Building
Location: Various parts of the building
Finding: In ground contact
Information: Any timbers in direct ground contact provide opportunity for concealed termite entry and are likely to be subject to premature rot and decay as the soil retains moisture or damp conditions against the timbers.

Remove untreated timber that is in direct contact with external grounds. Consider replacement with more durable materials i.e. treated timber or non timber elements. Frequent pest inspections are advised to readily identify any termite activity in these areas.

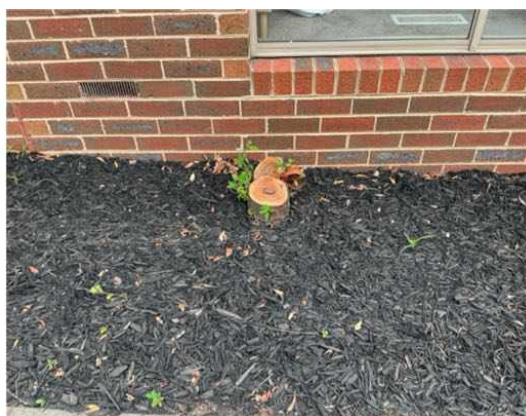
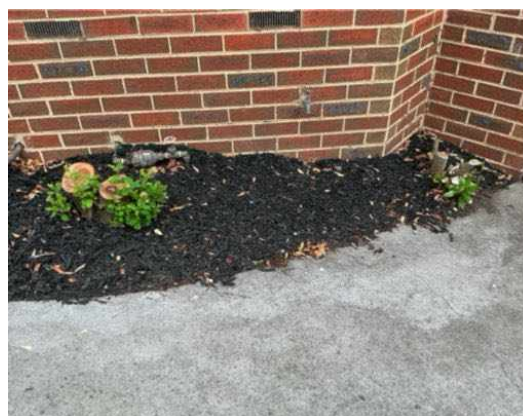
Finding 6.08

Building:	Main Building
Location:	Yard - Front
Finding:	Tree roots/stumps - external area
Information:	Tree roots/stumps to the external property increases the risk of termite activity being present. As they are likely to come into contact with weather conditions or excessive moisture, wood rot is likely to develop on timbers that are not treated.

It is highly recommended that any stored timbers or stumps be immediately removed from areas in which they may attract any termite / timber pest attack. Minimisation of risk / prevention of termite attack is far more adequate than dealing with the presence of termite activity.

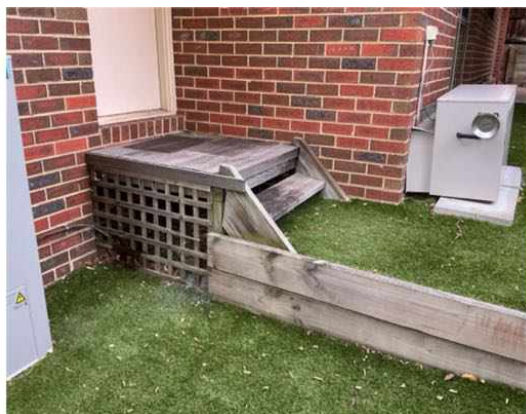
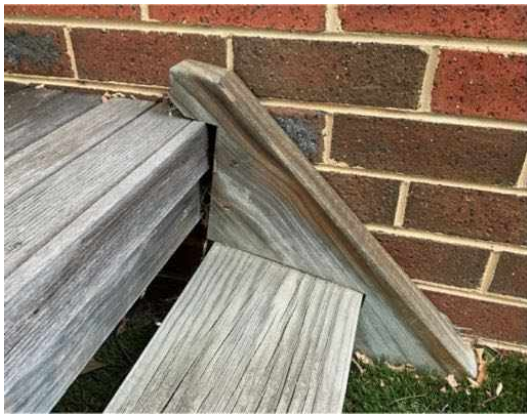
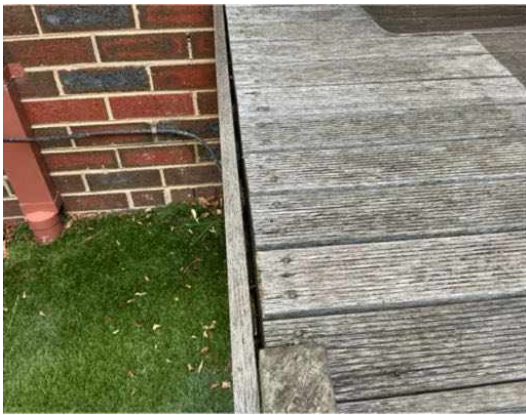
Finding 7.02

Building:	Main Building
Location:	Yard - Back
Finding:	Wood rot rear steps
Information:	The rear steps shows evidence of wood rot and deterioration with parts coming loose. Wood rot, also known as Fungal Decay, occurs when timbers and other cellulose building materials are exposed to damp conditions on an ongoing basis. This could be the result of exposure to weathering over a prolonged period of time, or the attraction of excessive moisture from other abutting building materials. Contributing factors also include poor air ventilation in the area.

A qualified plumber may be appointed to assess the cause of excessive moisture and to provide advice on any remedial works as required. A qualified carpenter or registered builder may also be required to replace affected building materials.

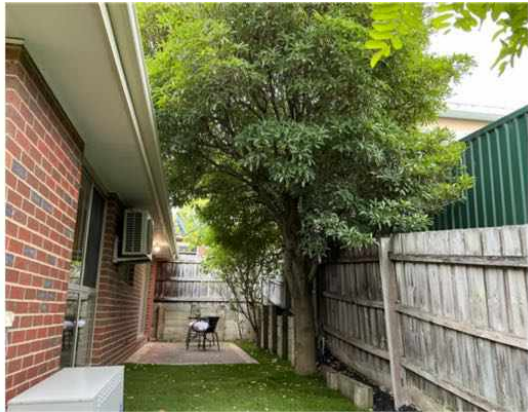
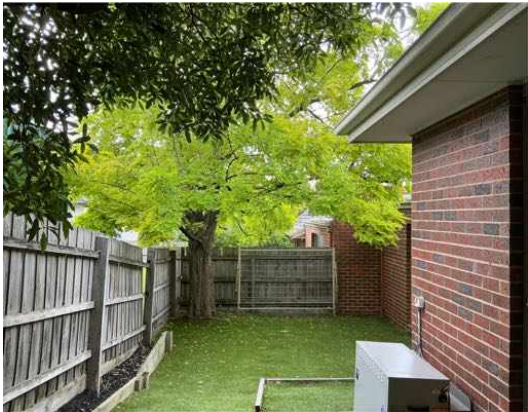
Building: Main Building
Location: Yard - Back
Finding: large trees near property
Information: Some large trees are growing near the structure. Tree roots can cause major foundation and plumbing related issues. Recomend engaging an arborist to further investigate and advise on the severity of the root systems and any rectification works that may be required to reduce the risk of property damage and deterioration.
