# Building and Timber Pest Inspection Report

Inspection Date: Fri, 9 Jan 2026

Property Address: 43 Ngungun Cr, Glass House Mountains  
QLD 4518, Australia

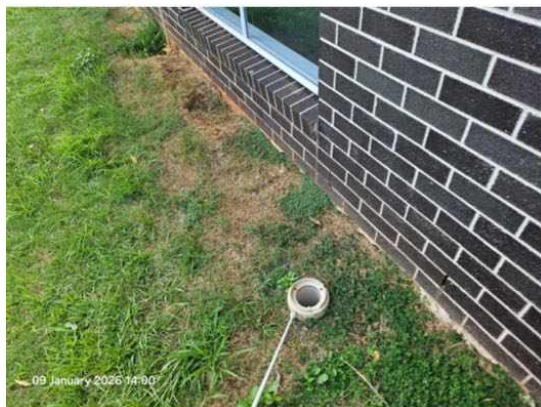
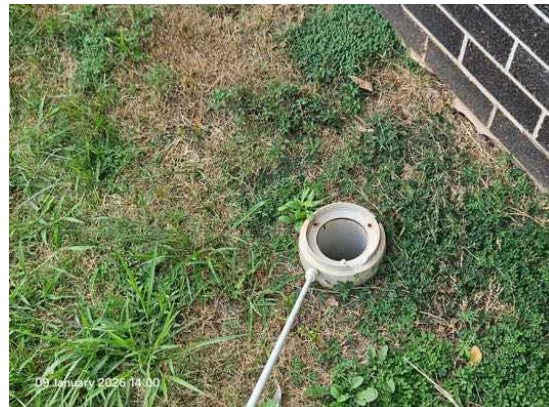
#### Finding 3.01

Building: Yard  
 Location: Left side  
 Finding: Sewer access cap - Broken  
 Information: During the inspection it was noted that the cap to the sewer clear out in the rear yard was broken.

A licensed plumber could be engaged to exchange it.

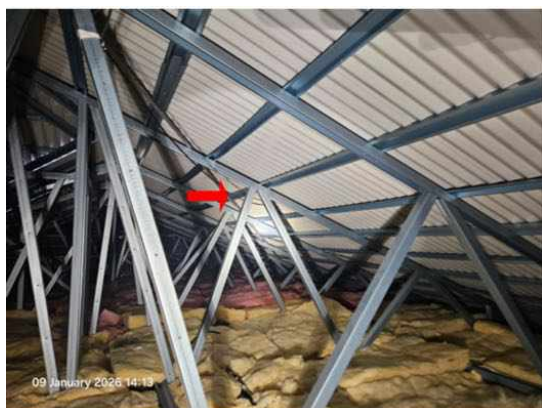
#### Finding 3.02

Building: Main Building  
 Location: As shown  
 Finding: TV antenna seal  
 Information: It was noted during the inspection of the roof space that the TV antenna coaxial cable access point through the roof sheet may require resealing to prevent water entry.

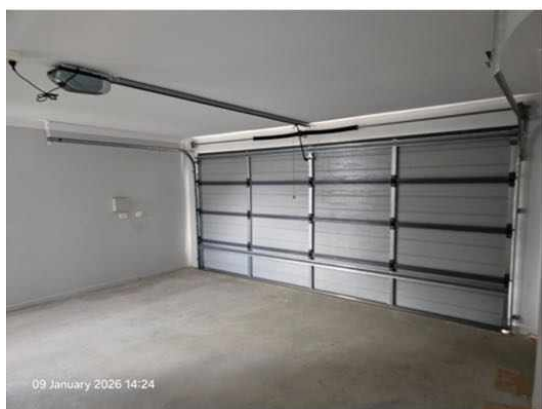
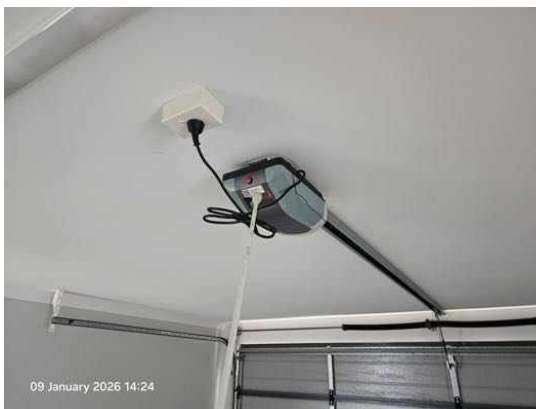
### Finding 3.03

Building:	Main Building
Location:	Garage
Finding:	Garage door motor
Information:	On the day of inspection the garage door could not be operated. The motor requires resetting.

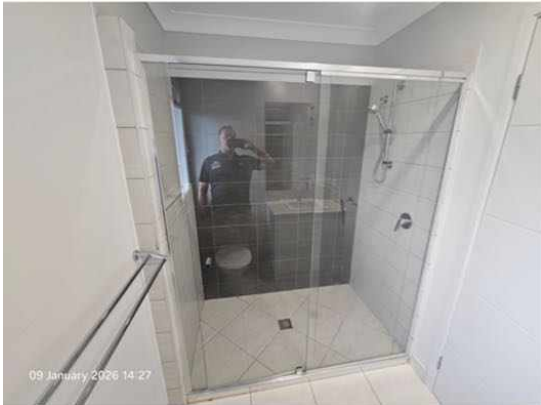
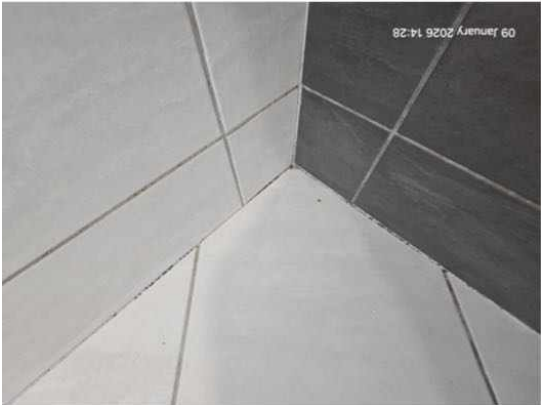
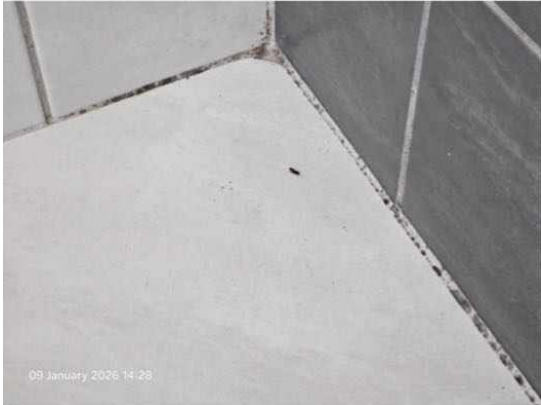
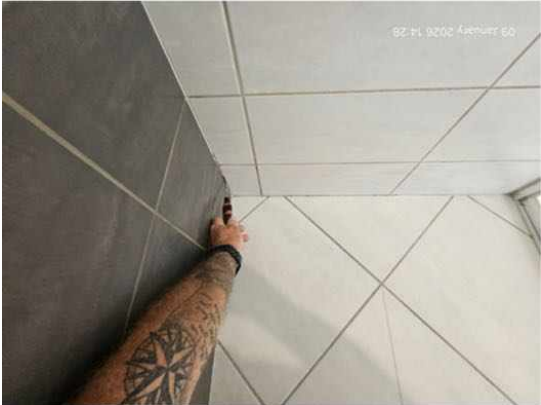
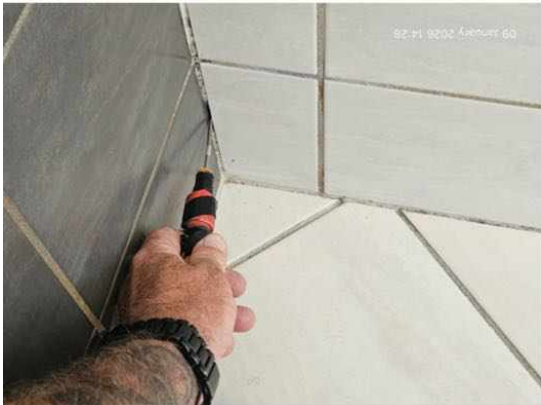
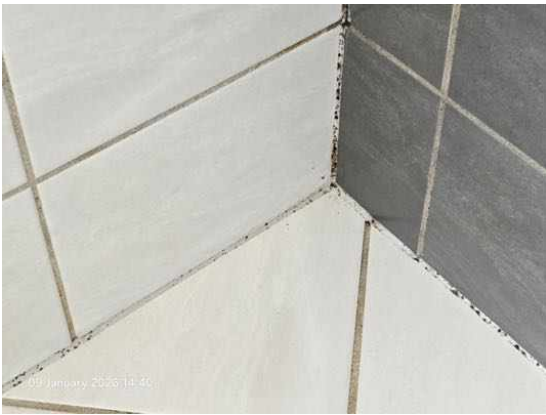
### Finding 3.04

Building:	Main Building
Location:	Bathroom, ensuite
Finding:	Sealant - requires renewal, showers
Information:	<p>The silicone sealant around the edges of the shower recesses require renewal as it has become deteriorated and some places delaminated from the floor / wall junction.</p> <p>It is recommended that the existing silicone sealant be removed and new sealant be applied.</p> <p>A licensed tiler or suitably qualified handy person could be engaged to carry out this work.</p>

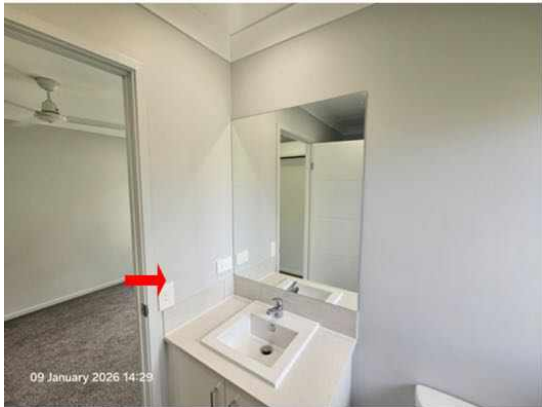
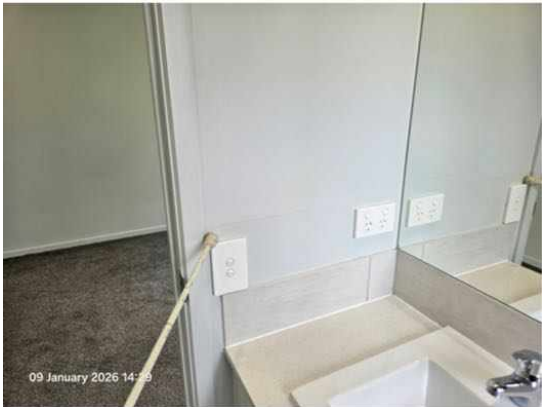
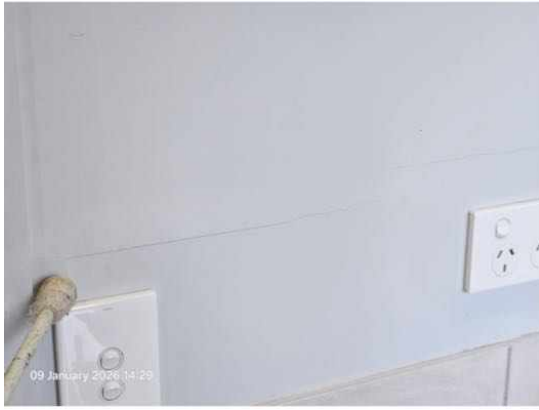
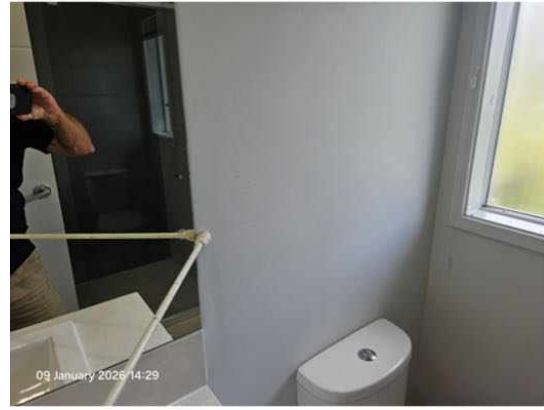
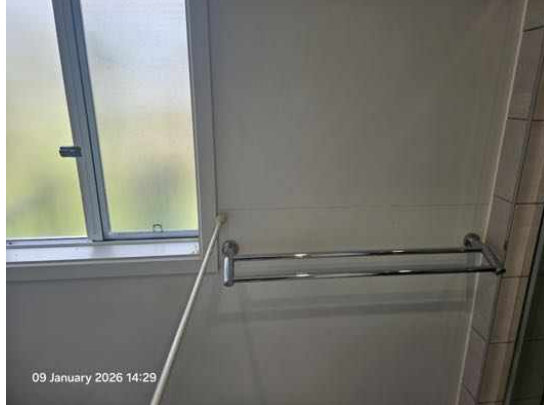
**Finding 3.05**

Building: Main Building  
Location: Ensuite - Master  
Finding: Cracking to internal wall sheets  
Information: On the day of inspection cracking was noted to the joints of the ensuite walls. These may possibly be attributed to settlement and movement of the building.

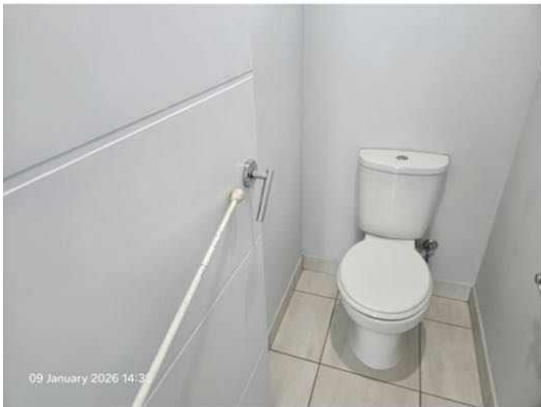
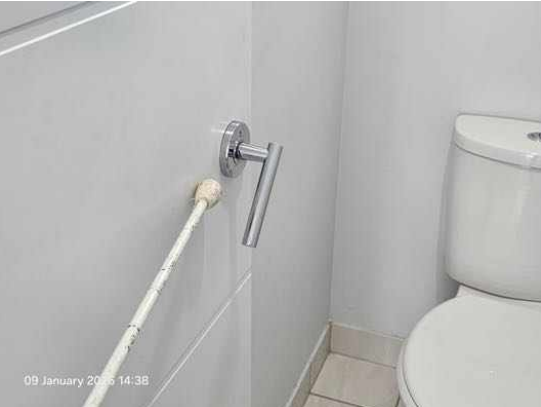
**Finding 3.07**

Building: Main Building  
 Location: Toilet (WC)  
 Finding: Door hardware faulty  
 Information: At the time of inspection the door hardware to the main entry door to the toilet was faulty and requires tightening / adjusting.

A licensed carpenter or general handyman could be engaged to repair the door lock.

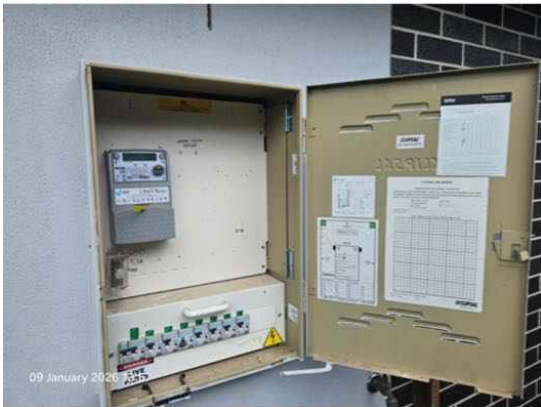
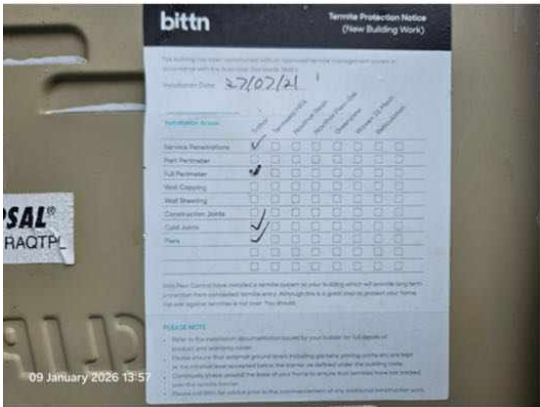
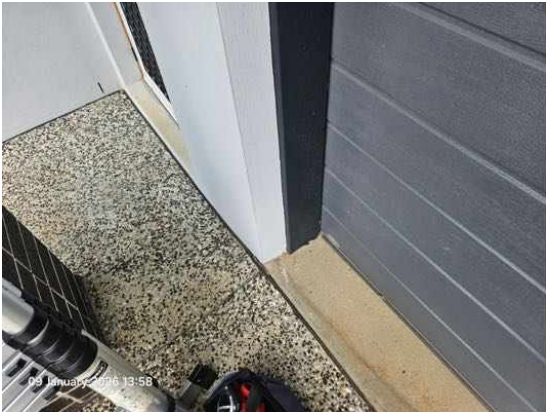
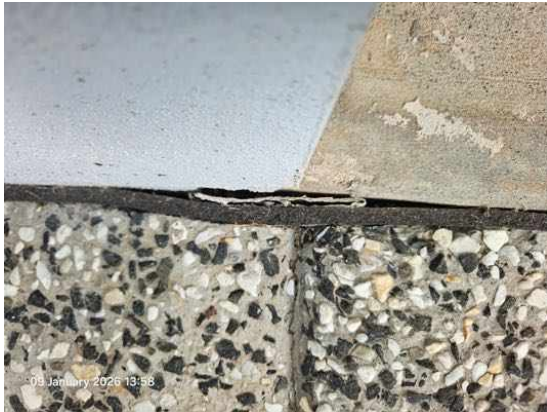
The building employs a physical barrier system to the perimeter and slab penetrations. In order for a barrier system to be effective, the property must have regular inspections at intervals of not greater than 12 months. Depending on the risk profile attributed to the property, these inspections may be recommended at lesser time periods.
