Building and Timber Pest Inspection Report

Inspection Date: Mon, 12 Jan 2026

Property Address: 48 Church St, Beaumaris VIC 3193, Australia

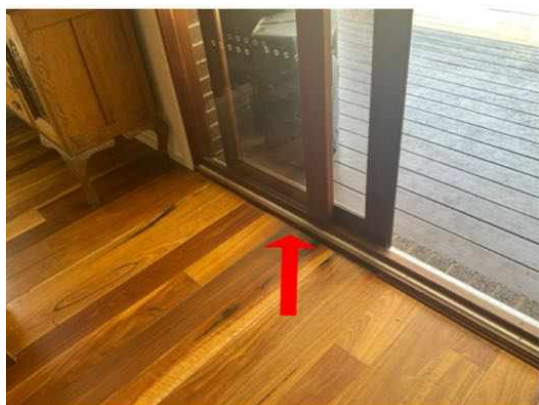
Location: Dining Room
 Finding: Flooring - slight gaps to ends of boards
 Information: At the time of inspection, it was noted there were slight gaps to the ends of some floor boards.

It is suspected that this may have been caused by either poor installation of the boards or the boards have shifted over time.

Monitoring of the flooring is recommended to look for any changes. Should no changes occur, a flooring specialist may be engaged to inspect the floor and advise of ways to repair the flooring.

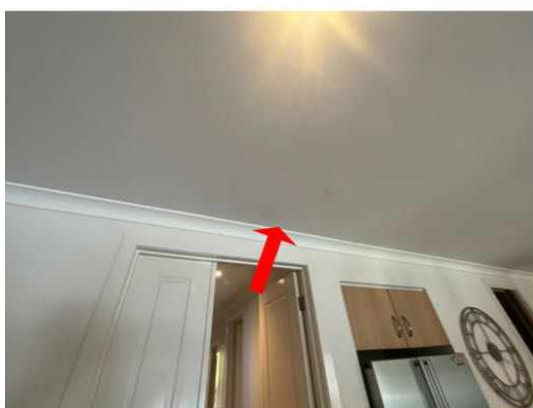
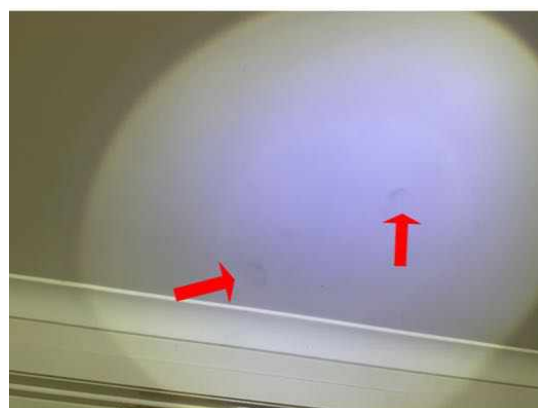
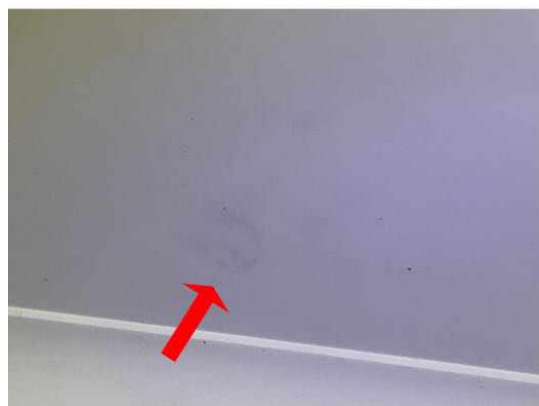
Finding: Ceiling stained - no current moisture noted

Information: At the time of inspection, there appeared to be some staining to the ceiling in this area. It is unclear how the staining has occurred.

At the time of the inspection, there was no moisture within the stained area of the ceiling when tested with a moisture meter.

It is recommended that the area be monitored for any changes or increase in staining. Should this occur, consultation with a plumber should be undertaken to determine the source of the leak and make necessary repairs.

Should no changes occur, the area may be repainted at the discretion of the homeowner.

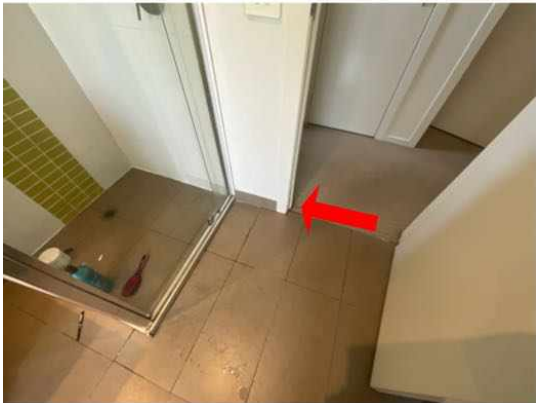
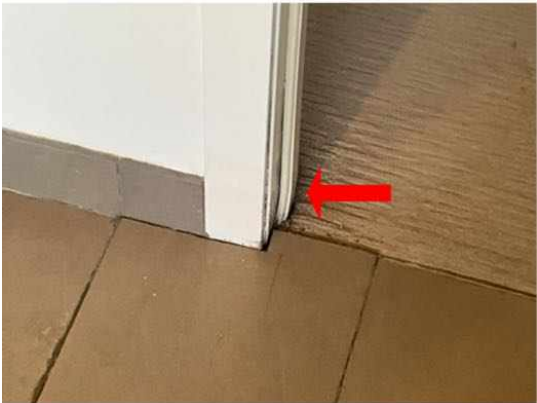
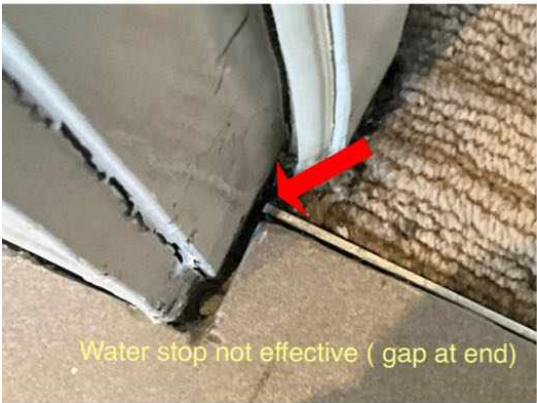
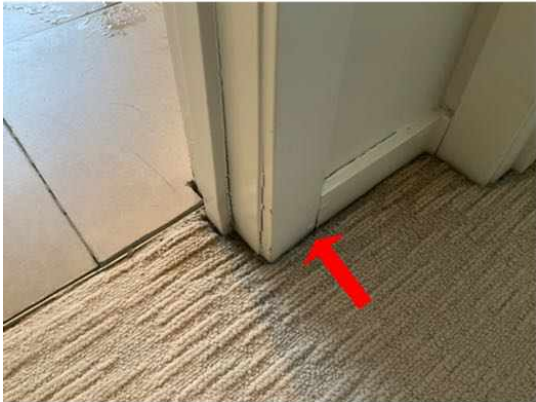
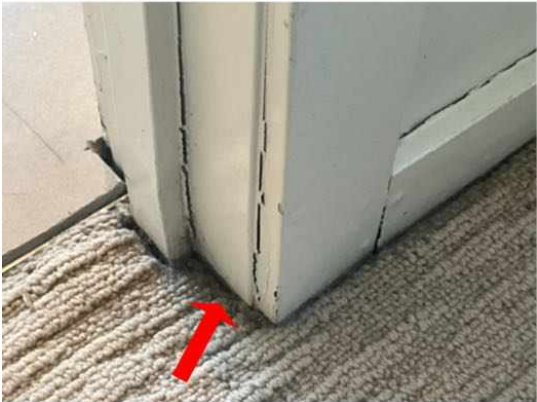
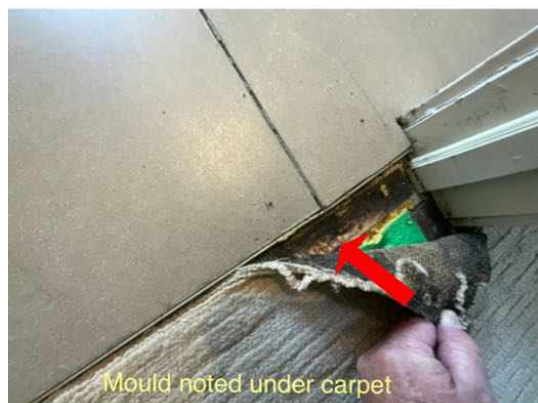
Building:	
Location:	Bathroom > Upstairs,Rear
Finding:	Moisture damage to door frame and possible lack of an effective water stop.
Information:	Evidence of moisture damage was identified to the door frame in the bathroom. It is suspected that this has occurred as a result of excess moisture from internal spills or from water seeping under the tiles.

A water stop is a barrier which prevents moisture that may have seeped under the floor tiles to move out of the wet area into the hallway. This barrier forms part of the waterproofing system in the bathroom. Having gaps at either end means the water stop is not complying with current standards. Standards have changed however over the years and bathrooms only needed to meet the standards that were applicable at the time of installation.

Please note: staining was noted to the ceiling of the dining area immediately

underneath this bathroom. It is suspected this staining was caused by leaking in the bathroom. No current moisture was noted in the ceiling at the time of inspection when tested with a moisture meter.

It is highly recommended that a Tiler be engaged to inspect the area to improve the water tightness of the bathroom and prevent moisture exiting. This could involve sealing the ends of the water stop, through to installing new stops. Regrouting and ref sealing of the bathroom is also required.

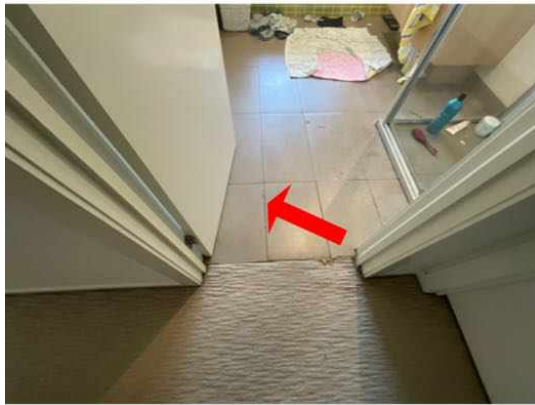
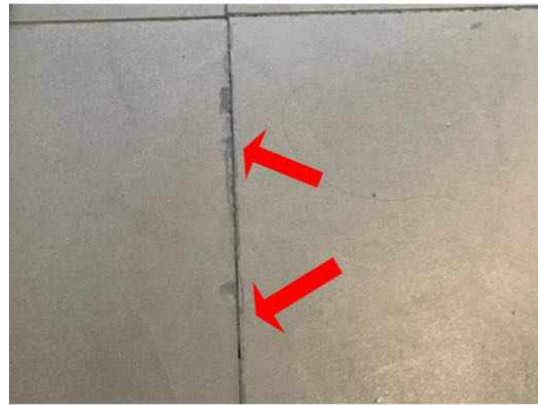
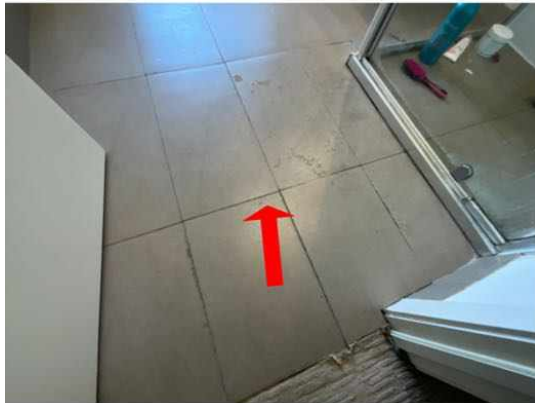
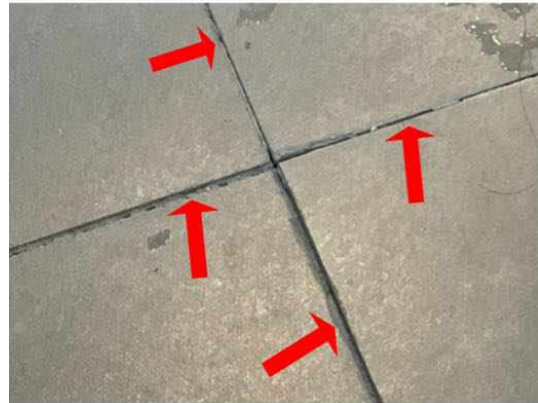
Finding 3.13

Finding: Grout - Missing or degraded within the floor of the bathroom area

Information: It was noted on inspection that grout is missing or degraded to the floor within the bathroom.

Different materials move at different rates, generally causing cracking to grout at this point. Build up of moisture in the bathroom can also cause grout to degrade.

Any damaged or degraded materials should be scraped out and flexible and mould resistant materials should be applied to affected areas to prevent any subsequent water damage that may occur. Regular maintenance and replacement of damaged or missing grout/ sealant is highly recommended to the wet areas, as this is a regular wear and tear defect. Both grout and sealant in areas that come into regular contact with water should be maintained for the long term care of your property.

A bathroom specialist or tiling contractor should be appointed to complete these works as soon as possible.

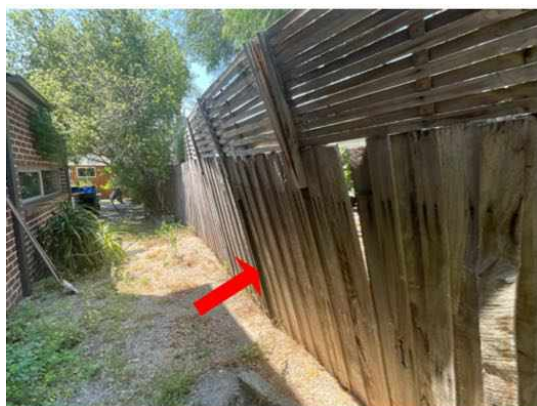
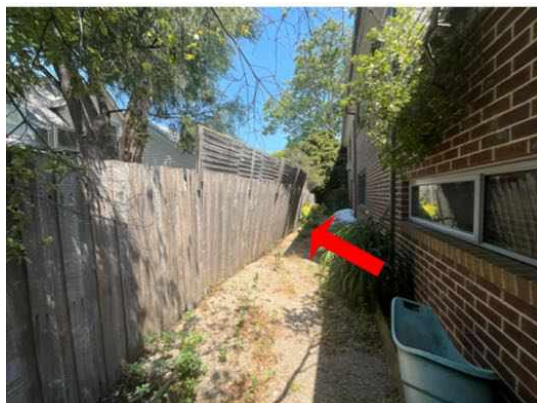
Finding 3.14

Finding: Fencing - leaning and deteriorated

Information: It was noted at the time of inspection that a section of the fencing at the side of the property was leaning quite substantially. Other sections of the fence were also deteriorated.

Typically fencing deteriorates due to age and or wear, rot and or rust which is generally expected for a structure of this age, due to prolonged exposure to weather conditions. Sometimes inadequate installation or maintenance can be to blame.

Repair of several elements of the fencing will be required. Replacement may also be a consideration.

A licensed fencing contractor should be appointed to provide further advice and perform rectification works as necessary.

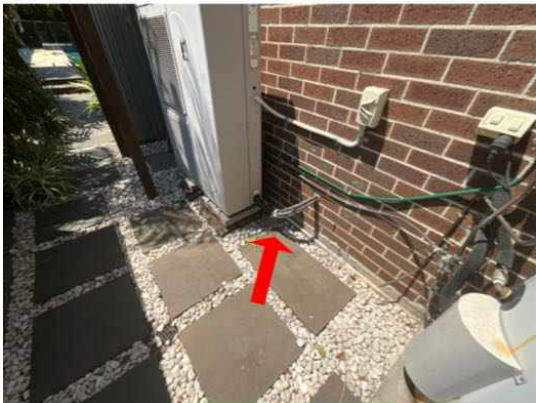
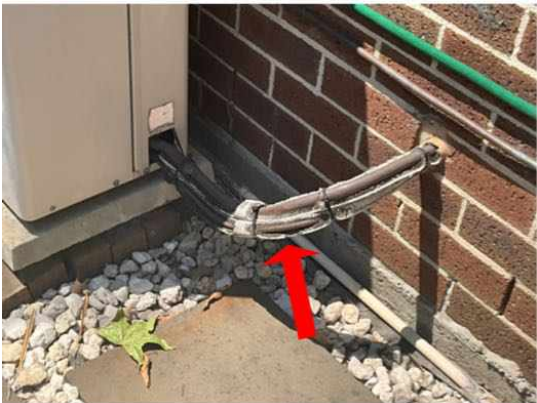
Finding 3.15

Finding: Pipework - Insulation deteriorated

Information: Sections of the pipe insulation show evidence of damage and deterioration. It is suspected that this deterioration has developed as a result of excessive exposure to weather, including UV exposure in daylight. Deteriorated insulation reduces the effectiveness of the material in helping to maintain the desired temperature and work most efficiently.

If left in an exposed position, it is likely that the deterioration will continue and worsen over time, potentially resulting in secondary building defects as well as a further loss in insulating properties.

Some areas of replacement of pipe insulation is likely to be required. Further preventative measures to remove or protect the material from future exposure are also advisable. Consultation with a licensed plumber is advised to gain quotes for the repair and/or replacement of deteriorated insulation.

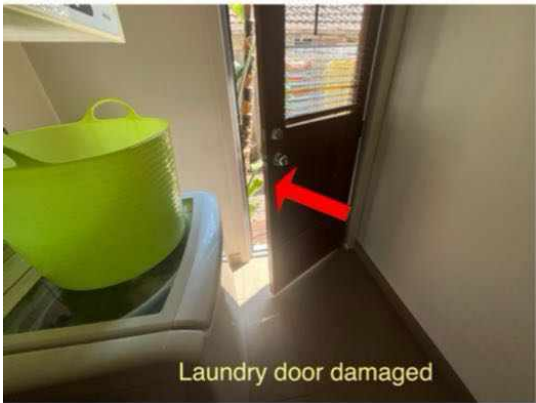
Laundry door damaged

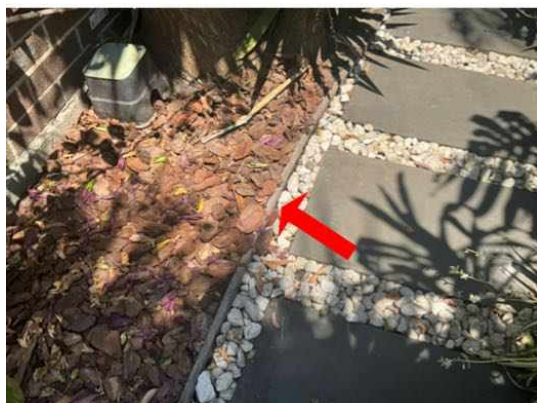
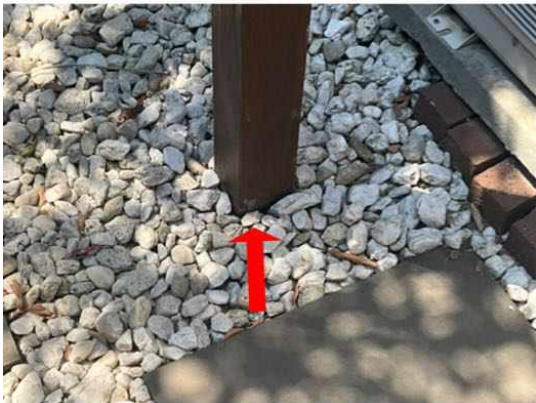
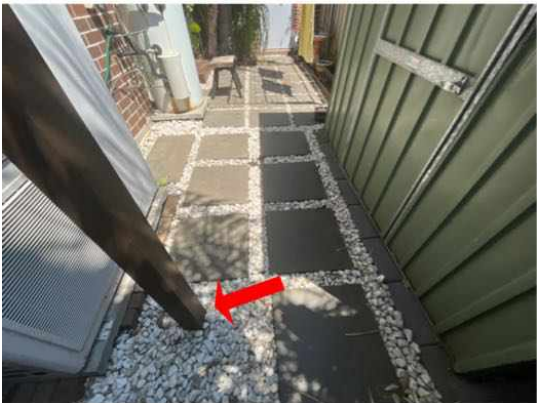
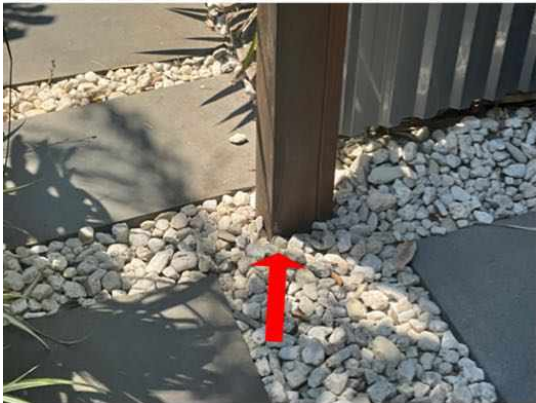
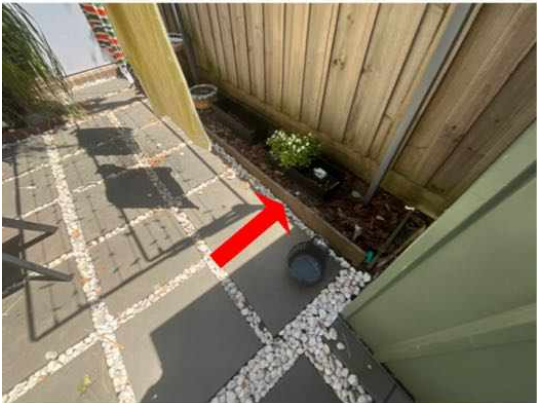
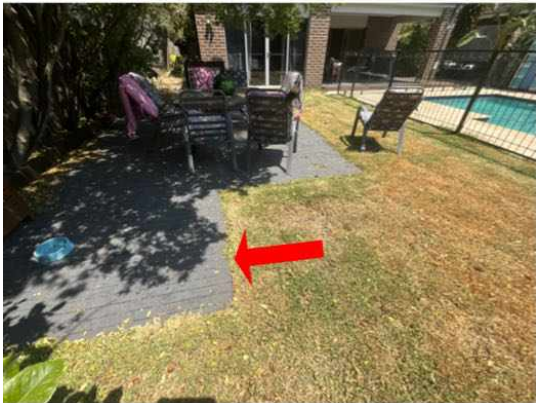
Information: Where timber elements are in direct contact with the ground and consequently moisture or dampness, they become conducive to termite activity. Whether timber is used as a building element, part of a fencing structure or stored as an unused item, they can provide an environment that is attractive to termite infestation.

When met with excessive moisture, timber begins to decay and develop wood rot. Any timbers that are in direct contact with external grounds especially if left untreated or non-durable also provide ingress for subterranean termites into that particular element.

Where possible, the removal of any such materials that may be conducive to termite activity should be carried out as soon as possible to minimise the risk of termite attack. Where not possible or practical, regular monitoring of timber elements is recommended. Replacement of any damaged materials should be carried out where necessary.

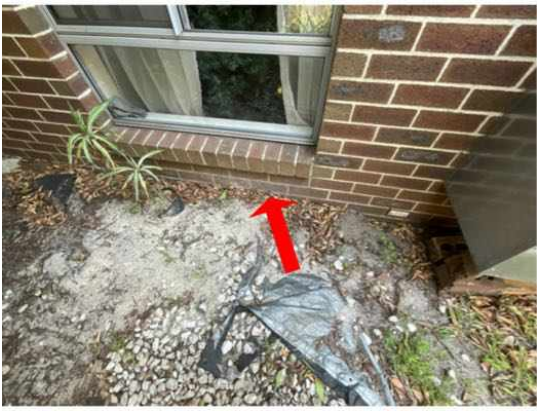
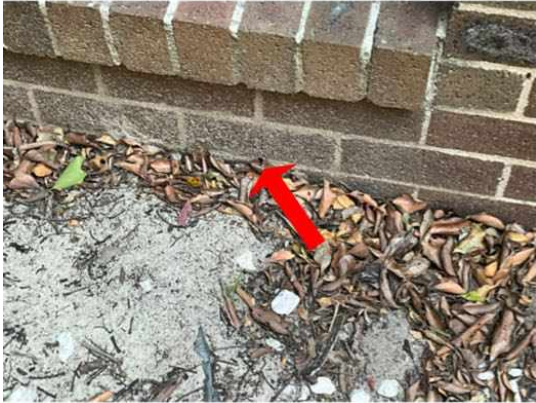
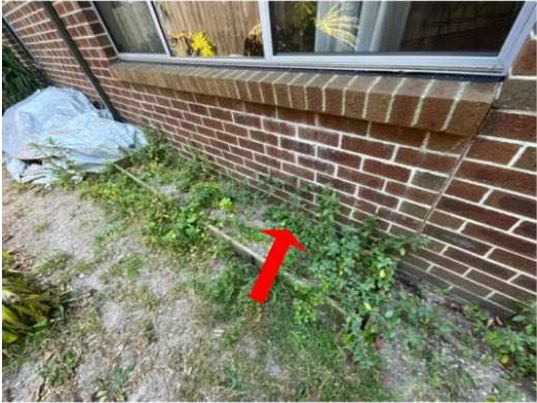
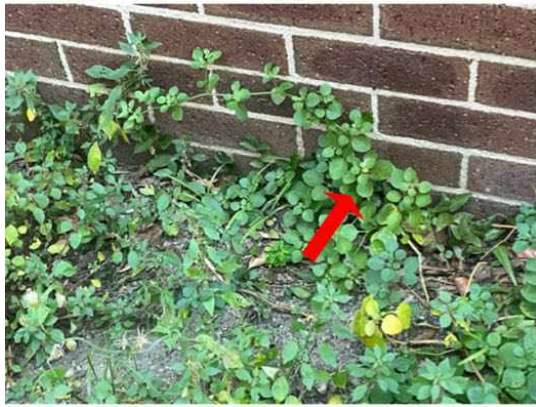
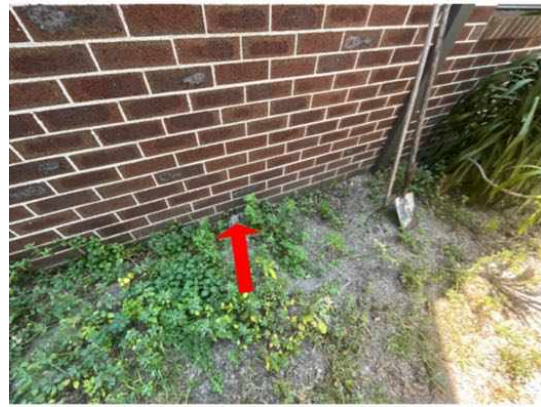
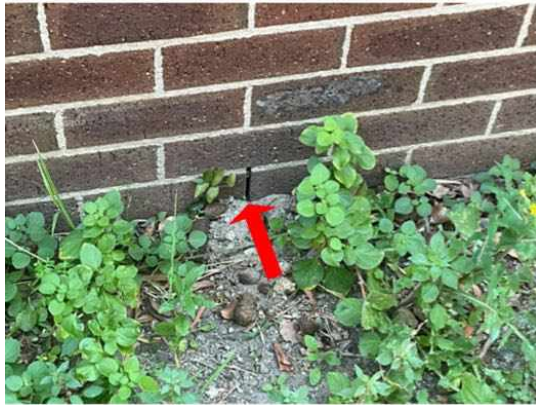
Information: It was noted during the time of inspection that some of the weep holes to the brickwork were blocked. Weep holes are designed to allow water from leaks or seepages in brickwork to be directed to the external environment, prior to entering the wall cavity or associated building materials. Weep holes should therefore be kept clean and free of debris or blockages.

Blocked weep holes are likely to result in the presence of excessive moisture within the brickwork and associated structures, creating potential for water damage and

moisture problems.

Depending on the nature of the blockage, the homeowner may be able to undertake remedial works to remove blockages. Alternatively, appointment of a registered builder may be required to remove blockages. Preventative works are necessary in ensuring the structural integrity of the affected brickwork and should be performed as soon as possible.
