# Building and Timber Pest Inspection Report

Inspection Date: Sat, 14 Mar 2026

Property Address: 16 Airdsley Ln, Bradbury NSW 2560,  
Australia

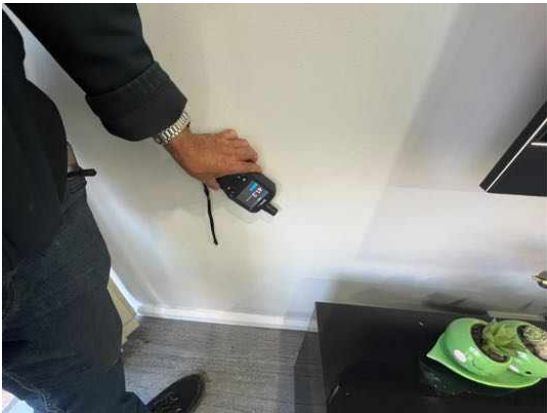
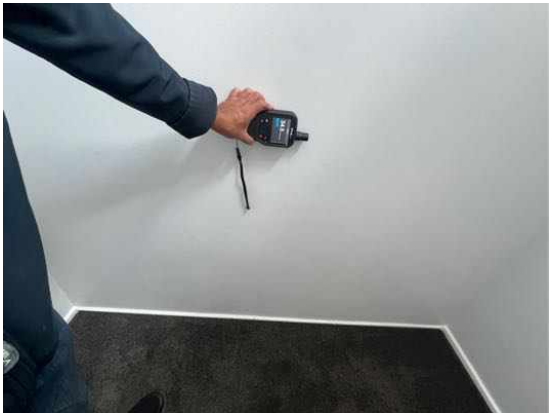
### Finding 3.02

Building:	Main Building
Location:	Lounge Room Right wall
Finding:	Elevated Moisture – Further Investigation Recommended
Information:	Elevated moisture readings were detected in several locations, with some areas also showing signs of dampness while others did not present visible surface issues, although no significant structural damage was evident at the time of inspection, dampness can contribute to deterioration if left unaddressed. Inspector was not able to inspect the external wall due to space constraints. A further investigation by a licensed plumber or waterproofing specialist is recommended to confirm the source and ensure no concealed issues are developing.

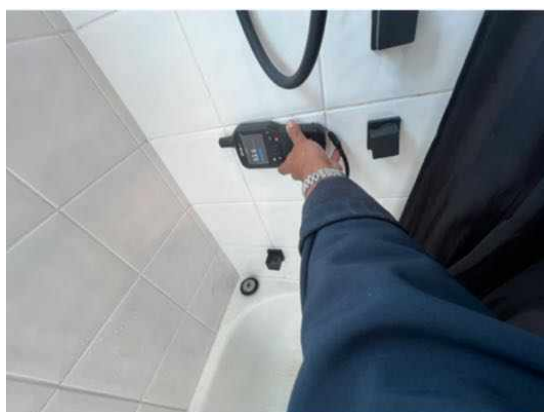
**Finding 3.03**

Building: Main Building  
Location: Bathroom  
Finding: Elevated Moisture Bathroom (No visible deterioration noted)  
Information: Elevated moisture levels were detected to tiled surfaces in bathroom/shower areas. Persistent moisture ingress can lead to concealed damage, including timber rot and mould growth.

Elevated moisture readings in tiled wet areas can occur from normal shower use, age/deterioration of waterproofing membranes, plumbing leaks or moisture absorption

through grout lines. While no damage was visible, elevated readings may indicate moisture retention behind tiles, which can be a conducive condition for future deterioration if not monitored.

Monitor the area over time for signs of drumming, efflorescence, tile movement, or grout deterioration. Recommend a licensed waterproofing specialist to perform further investigation (e.g., pressure testing, membrane assessment).

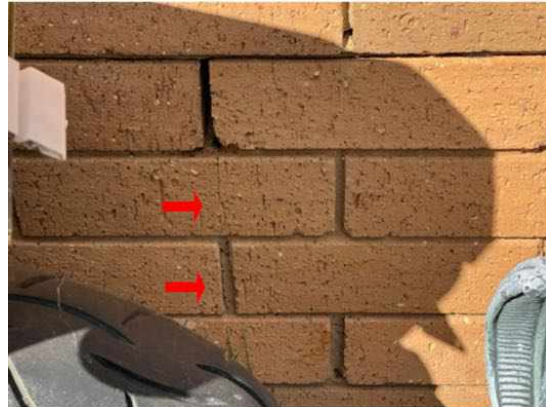
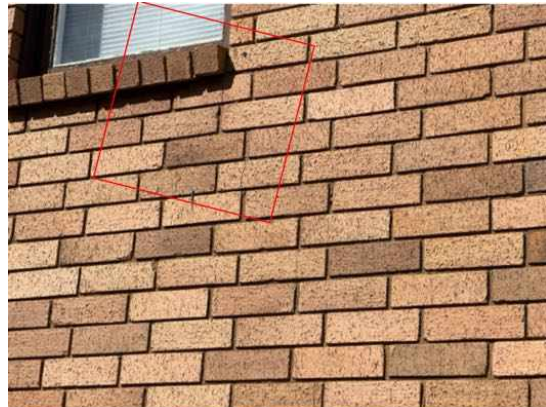
Building:	Main Building
Location:	All External Areas , carport , main building
Finding:	Brickwork - Cracking noticeable to some areas
Information:	There were several cracks and or crack repairs evident to external brickwork.

Noticeable cracks are a common occurrence in external brickwork and are a likely result of age expected building movement, general expansion, and/or contraction of building materials in different weather conditions. Noticeable cracks in brickwork may develop if left unattended, with potential for necessitating major remedial works or replacement of the brickwork.

It is highly advised that a qualified bricklayer be appointed to provide necessary works to cracked brickwork to prevent any further damage. Such works should be conducted as soon as possible.

Always monitor these cracks and contact a building inspector should cracks widen, lengthen, or become more numerous.

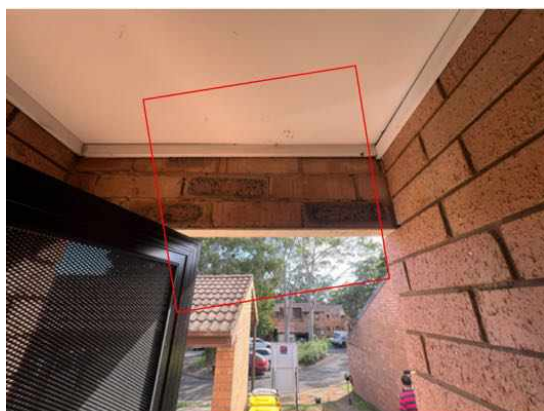
Mortar may deteriorate as a result of age of building materials, minor movement of bricks, or frequent exposure to weathering. Mortar should be replaced to ensure that bricks remain in their intended location and to prevent gaps, which would allow water or moisture ingress and secondary damage as a result.

Mortar deterioration can be addressed by a bricklayer where areas of deterioration are localised and easily accessible. Alternatively, appointment of a registered builder is advised, to repoint large areas of decaying mortar. Where secondary structural defects have become evident, consultation with a structural engineer may be required.

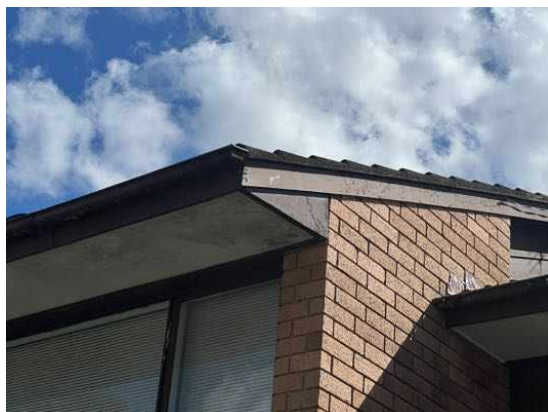
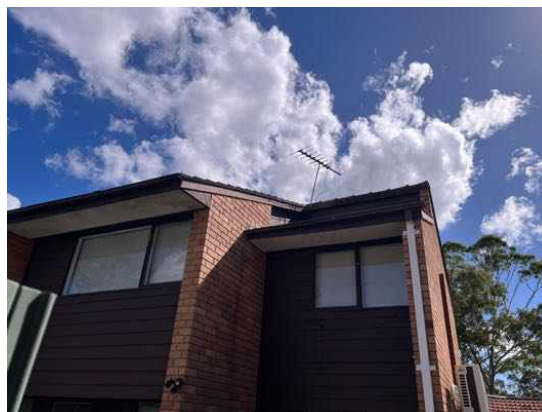
### Finding 3.08

Building:	Main Building
Location:	All External Areas
Finding:	Fascias - Wood rot to some areas
Information:	Wood rot was found to be affecting fascias and barges in this area, evidenced by the presence of mould on the surface in some areas. Wood rot, also known as Fungal Decay, occurs when timbers and other cellulose building materials are exposed to damp conditions on an ongoing basis.

It is advised that a roof plumber be appointed to inspect all roof plumbing and subsequently identify the cause of the wood rot. Replacement of affected fascias and barges may then be a necessary step in protecting surrounding building elements from such deterioration.

A qualified plumber may be appointed to assess the cause of excessive moisture and to provide advice on any remedial works as required. A qualified carpenter or registered builder may also be required to replace affected building materials.

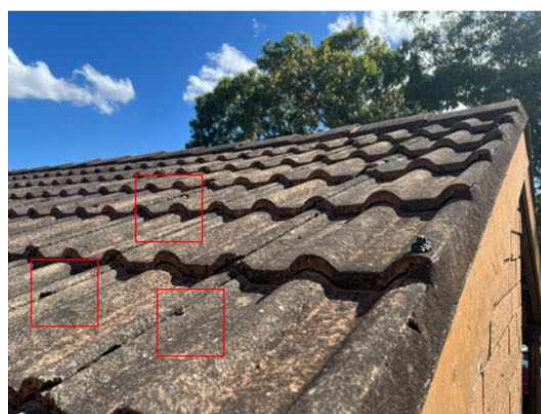
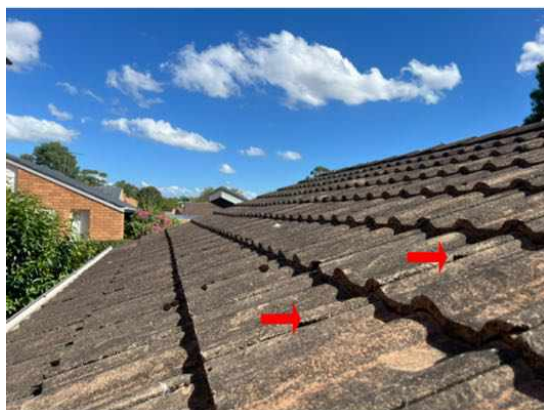
Finding: Tiles - Cracked or damaged

Some tiles were also chipping and out of alignment at the time of inspection and should be replaced and aligned.

Mortar deterioration can be attended to by a handyman where areas of deterioration are localised and easily accessible. Otherwise, consultation with a roofing contractor is advised where greater works are required.

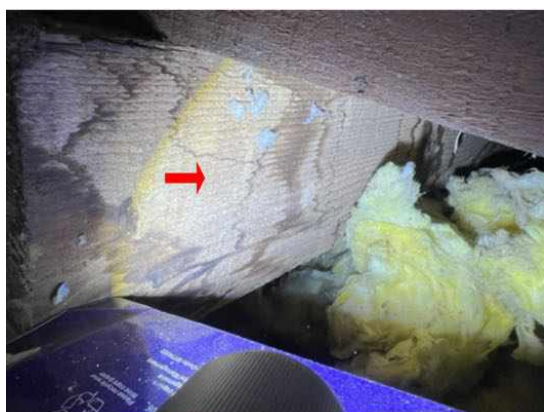
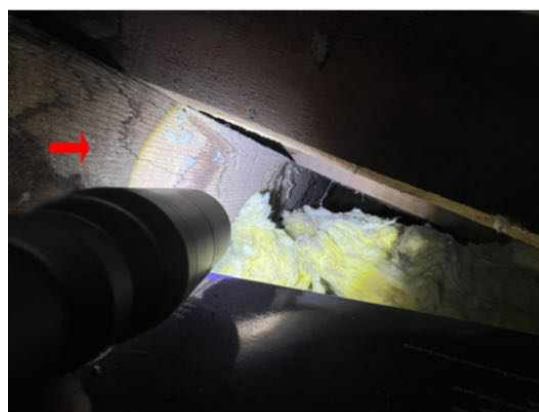
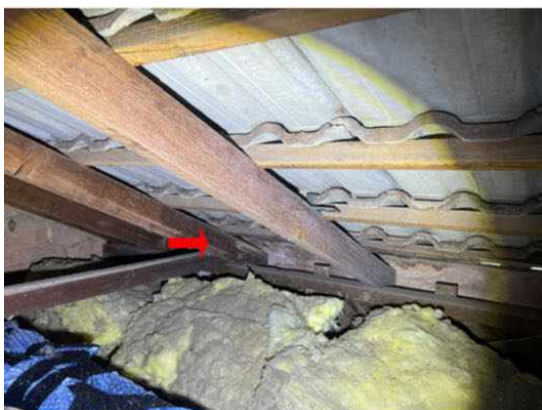
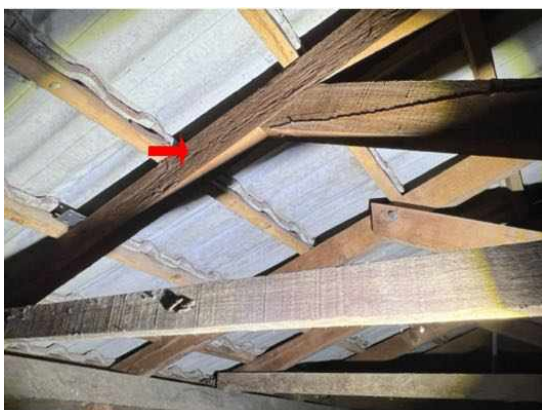
### Finding 3.31

Building:	Main Building
Location:	Roof Void
Finding:	Aged Timber and moisture staining – Roof Void
Information:	Visible decay was noted to some areas , consistent with age-related shrinkage and general weathering. The affected areas also exhibited localised surface darkening and moisture stains, which may indicate past moisture exposure. No evidence of structural compromise was observed at the time of inspection. These conditions appear typical for a dwelling of this age and construction, but ongoing monitoring is recommended. A licensed builder or licensed carpenter should be consulted if there is further deterioration or leaks. A further invasive inspection by a licensed timber pest technician is recommended for any concealed termite activity

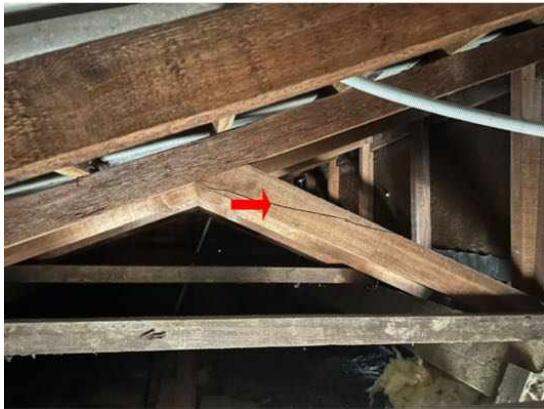
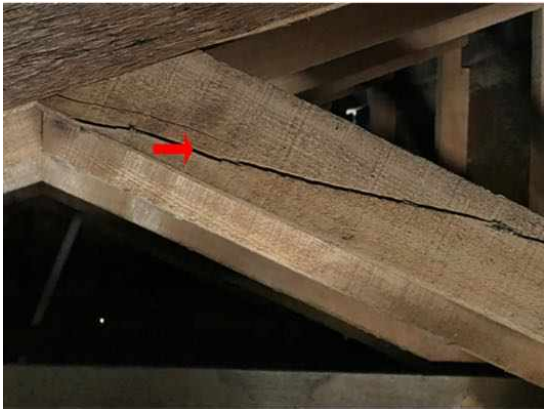
### Finding 3.32

Building:	Main Building
Location:	Roof Void
Finding:	Building element - Damaged - Timber splitting
Information:	Breakage occurs generally when the building materials have either aged and decayed, or as a result of damage (accidental or deliberate).

Repair and/or replacement of broken elements is advised to ensure that additional secondary defects do not arise as a consequence. Such works are necessary, as all building elements play a key role in the operation and function of the overall structure and its performance.

A licensed carpenter should be appointed to repair or replace the affected building element prior to any subsequent damage being caused.

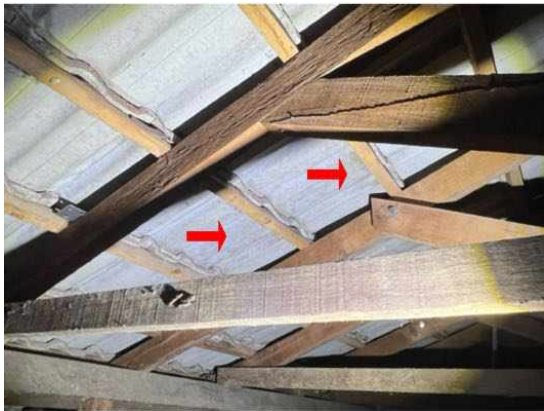
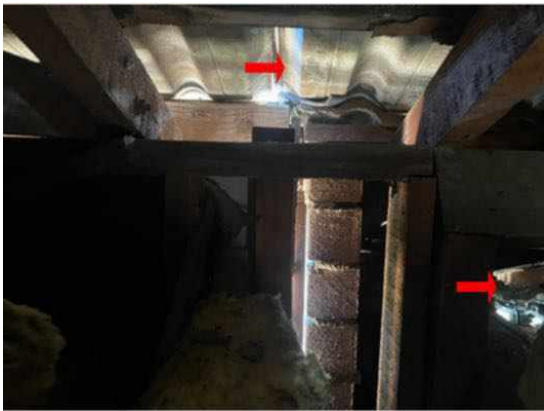
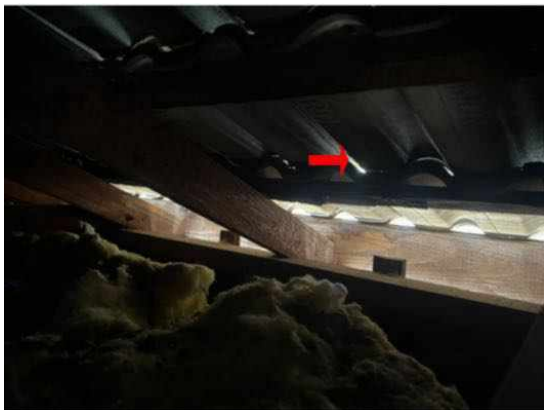
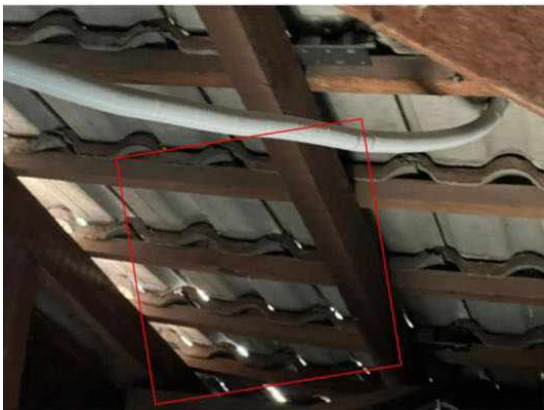
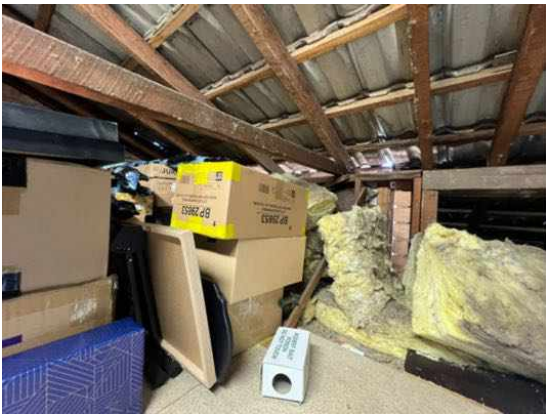
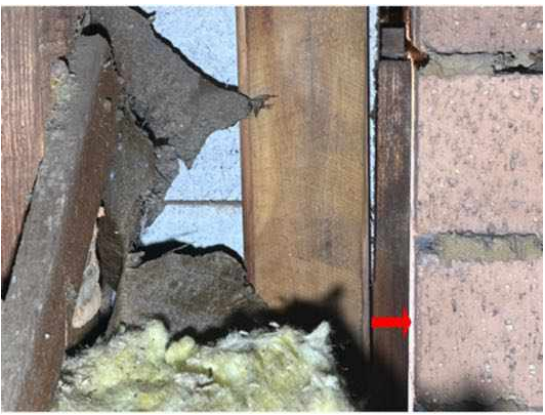
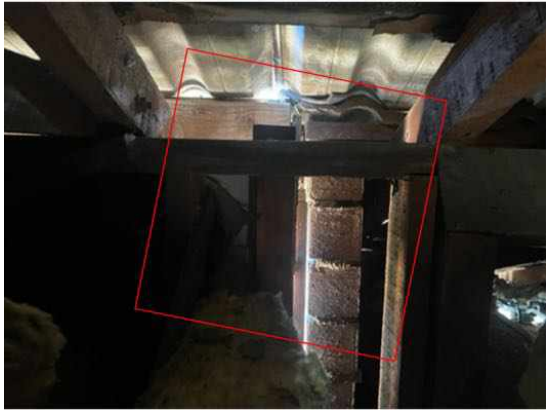
**Finding 3.33**

Building: Main Building  
Location: Roof Void  
Finding: Roof Void – No Sarking & Light Ingress  
Information: Light ingress is visible through multiple roof tile laps, which is typical of older tile roofs without sarking and may allow minor wind-driven moisture or dust into the space, though no active leaks were observed.

Consider retrofitting sarking or roof wrap in the future to improve thermal and moisture performance.

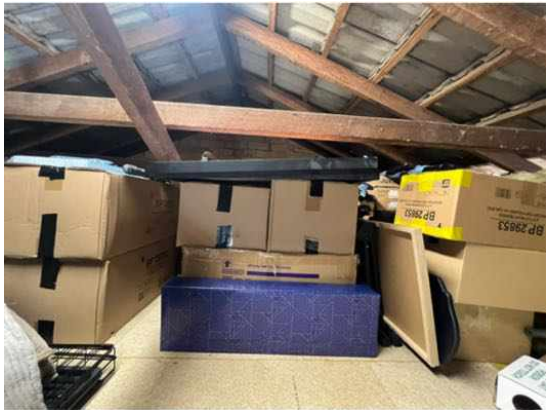
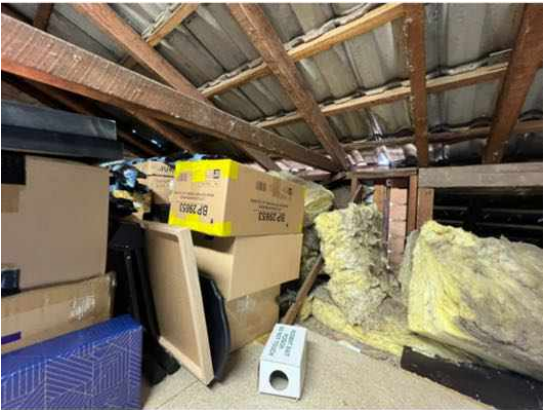
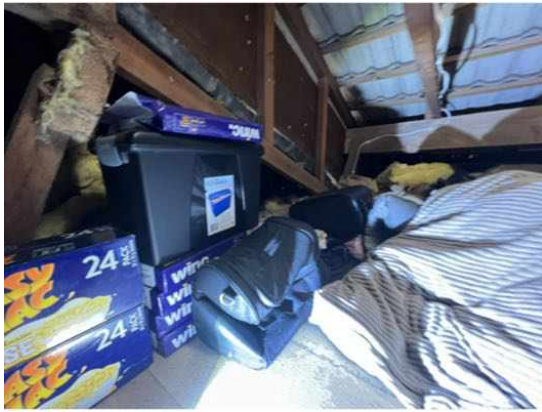
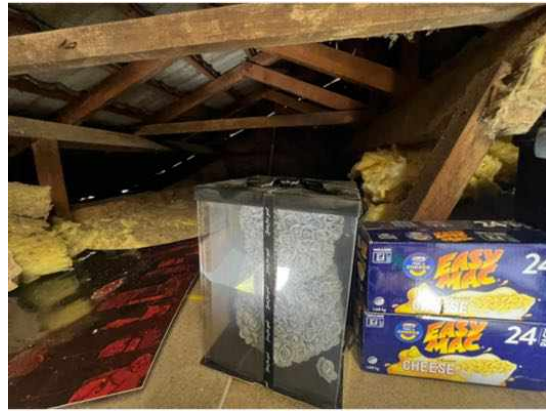
**Finding 3.34**

Building: Main Building  
Location: Roof Void  
Finding: Stored Items - Roof Void  
Information: Stored goods were noted in the roof void.. Roof spaces are not designed for storage and excessive weight can damage ceiling structures. All stored items should be removed.

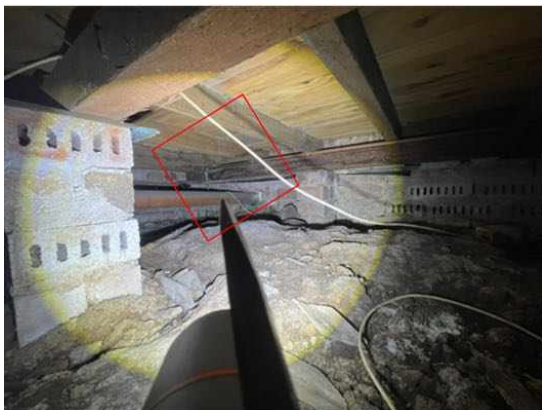
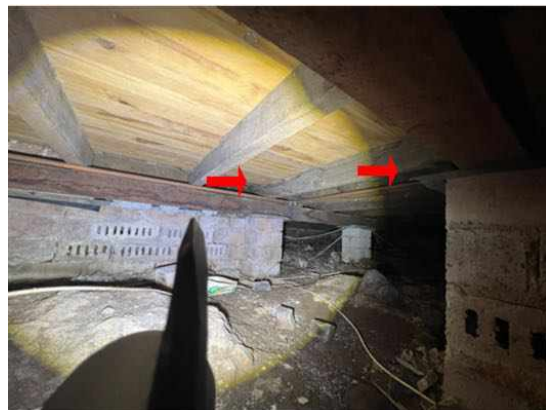
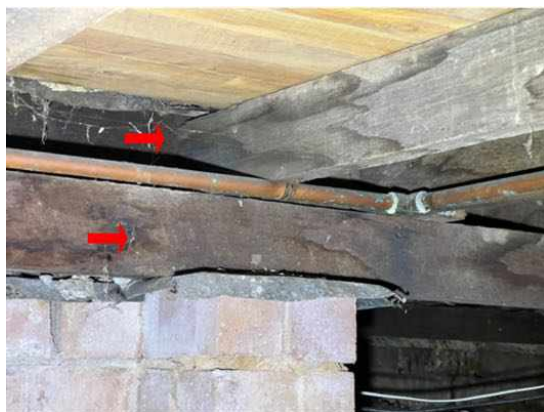
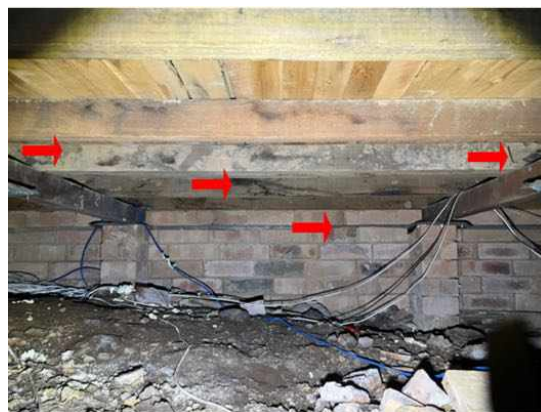
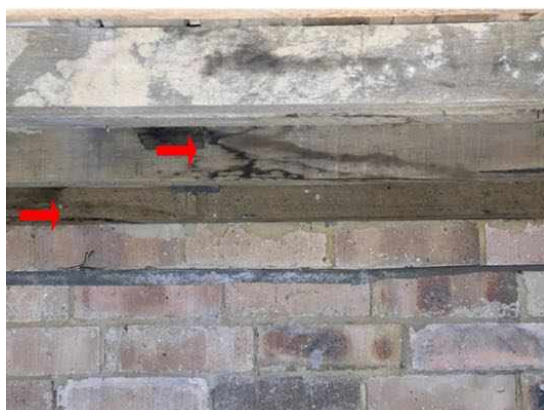
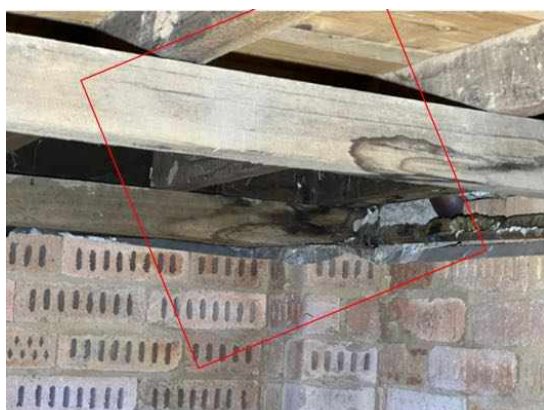
### Finding 3.35

Building:	Main Building
Location:	Subfloor
Finding:	Subfloor Timber Staining – Moderate Condition
Information:	Discolouration and surface fungal growth were noted on several subfloor timbers likely due to historic moisture exposure. While the visual signs suggest past damp conditions, the timbers felt solid to touch during the inspection and showed no immediate evidence of structural failure or active decay. Ventilation appears limited in some areas, which may contribute to moisture retention. Although not classified as a major defect, ongoing monitoring is recommended, and a licensed plumber should be engaged to check for any slow leaks or past water ingress contributing to staining. Although no visible signs of termites was evident at the time of inspection however Due to presence of conducive conditions a further invasive inspection by a licensed termite specialist is recommended in the areas where access was limited due to obstructions and limited crawl space.

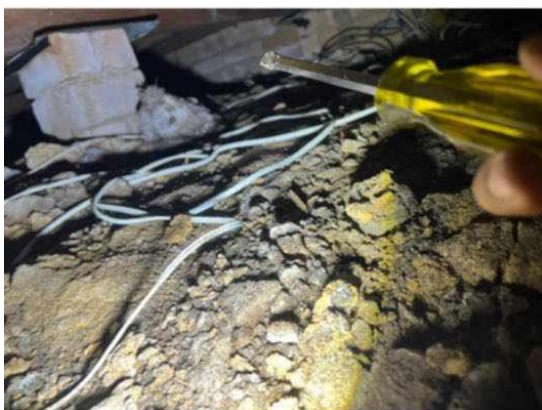
Building:	Main Building
Location:	Subfloor
Finding:	Subfloor ventilation - Inadequate
Information:	Adequate subfloor ventilation aids in preventing excessive moisture wood rot and termite activity by ensuring a dry subfloor environment.

Loose cables and debris was also present , debris should be cleared and cables should be secured for safety and access by a licensed electrician.

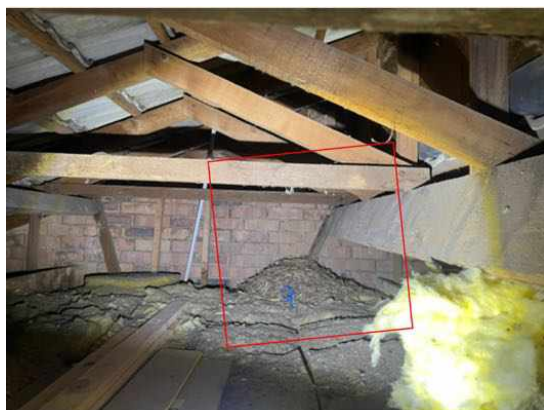
Finding 3.38

Building:	Main Building
Location:	Roof Void
Finding:	Bird Nesting & Debris – Roof Void
Information:	A substantial bird nest and associated organic debris were identified in the roof space near the wall. This presents a potential fire hazard, can attract pests or vermin, and may contribute to poor air quality or odour transfer into the living areas. The presence of nesting material also indicates a possible entry point or ventilation gap in the roof cladding or eaves. Recommend safe removal by a pest controller or roofer and sealing of any potential entry paths to prevent recurrence.

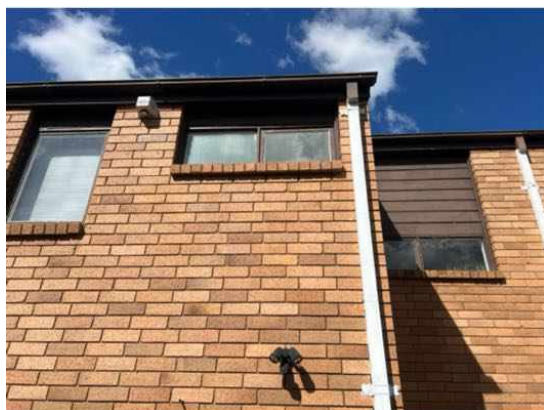
### Finding 3.39

Building:	Main Building
Location:	All External Areas
Finding:	Installation - substandard or incomplete - Unsealed gap
Information:	The installation of this building element appears to have been completed to a substandard level of workmanship or is incomplete. Generally substandard repairs or installation are related to poor workmanship, the use of inappropriate materials, or a failure to complete installation to a suitable standard.

Where installation is substandard and/or incomplete, the client should contact the responsible trade to undertake rectification. Unfinished and substandard building works are likely to degrade more quickly and may create potential for secondary defects to associated building elements.

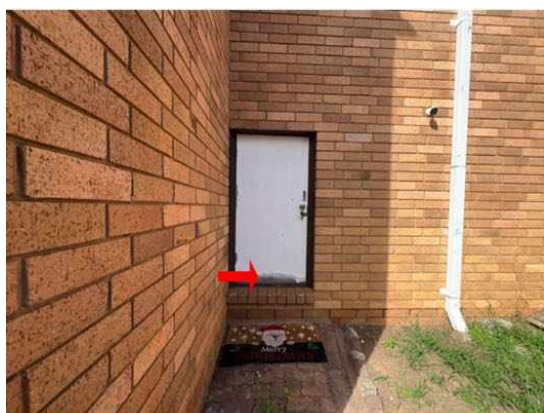
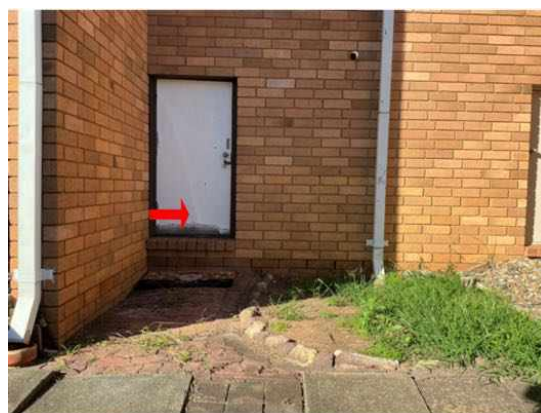
### Finding 3.40

Building:	Main Building
Location:	All External Areas - Front
Finding:	Delamination of timbers
Information:	Localised delamination and surface deterioration were observed to sections of laminated joinery panels. This condition commonly occurs where moisture exposure or wear causes separation of laminate finishes from the underlying substrate. The defect is generally cosmetic in nature but may worsen over time if moisture exposure continues. Repair or replacement of affected joinery components may be considered as part of routine maintenance.

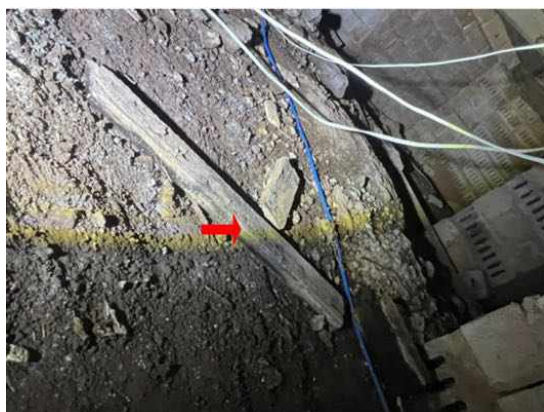
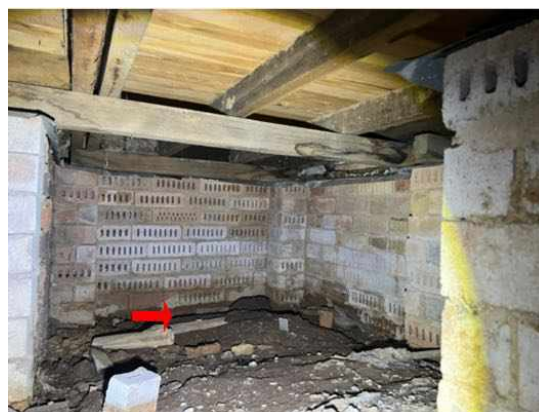
Building:	Main Building
Location:	All External Areas & subfloor
Finding:	In ground contact - Timber to some areas
Information:	Any timbers in direct ground contact provide opportunity for concealed termite entry and are likely to be subject to premature rot and decay as the soil retains moisture or damp conditions against the timbers.

Remove untreated timber that is in direct contact with external grounds. Consider replacement with more durable materials i.e. treated timber or non timber elements. Frequent pest inspections are advised to readily identify any termite activity in these areas.

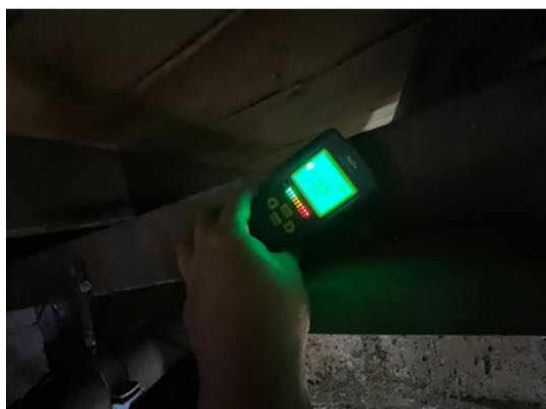
If mould growth has been found there may be environmental biological or health issues involved. In these cases an appropriately qualified inspector should also be contacted.

Prior to any remedial works being performed a qualified plumber should be appointed to further inspect the property and to identify the cause of the excessive moisture. Works to remove affected building elements may then be necessary and should be performed by an appropriate tradesperson.

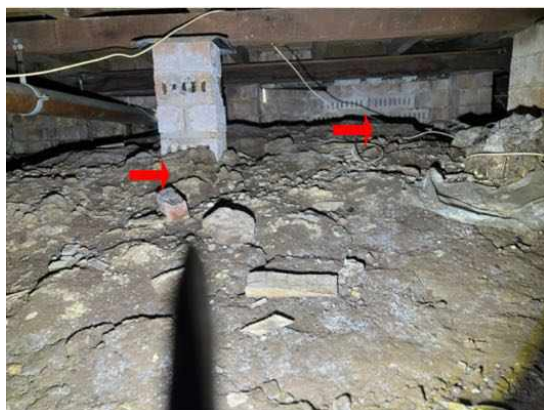
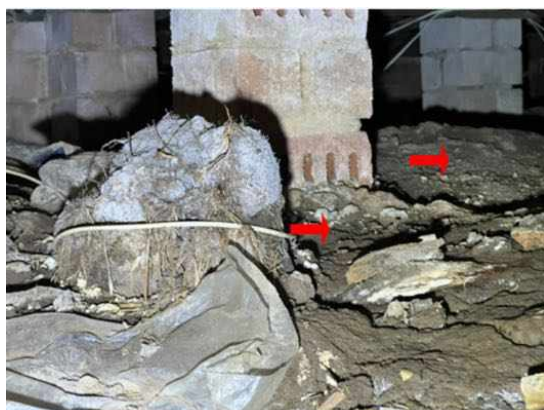
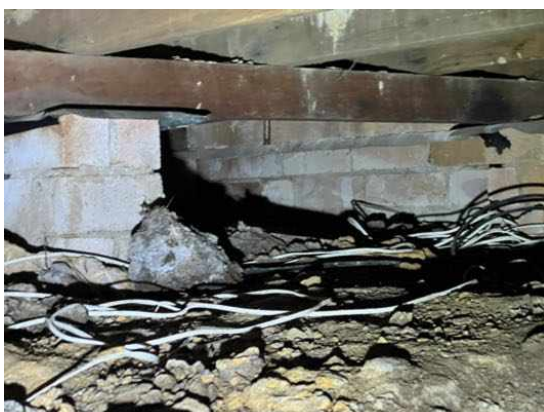
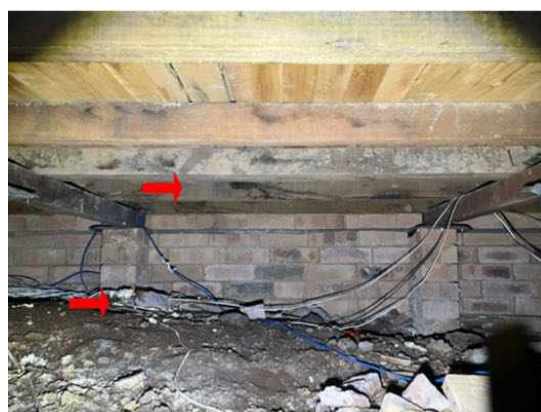
### Finding 6.08

Building:	Main Building
Location:	Subfloor
Finding:	Subfloor ventilation - Inadequate
Information:	Adequate subfloor ventilation aids in preventing excessive moisture wood rot and termite activity by ensuring a dry subfloor environment.

Subfloor ventilation can be improved in most cases by addressing the causes such as exposing subfloor vents installing additional new vents installing mechanical (forced airflow) ventilation and removing debris from the subfloor.

A registered builder should be appointed as soon as possible to perform these works as necessary.
