# Building Inspection Report

Inspection Date: Fri, 27 Mar 2026

Property Address: 39 Dawn St, Highett VIC 3190, Australia

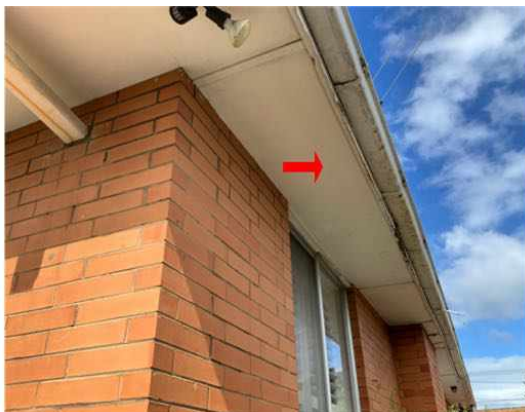
### Defects 1.03

Building:	Main Building
Location:	Eaves
Finding:	Asbestos - Suspected ACM Identified on Site
Information:	Reporting on Asbestos is outside the Scope of this Report. This suspected defect is highlighted as a caution only. We suspect, based on our experience in the building industry, that there is a higher risk of the identified building element containing asbestos.

As Asbestos Reporting is outside the scope of this report, we advise that you consider a separate Asbestos Inspection and Condition Audit, which can include the taking of samples for definitive confirmation of the presence of Asbestos.

In the interim, the client is advised to act with caution, especially when considering any damage to building materials general wear and tear renovations extensions demolition and general maintenance activities due to the suspected presence of Asbestos.

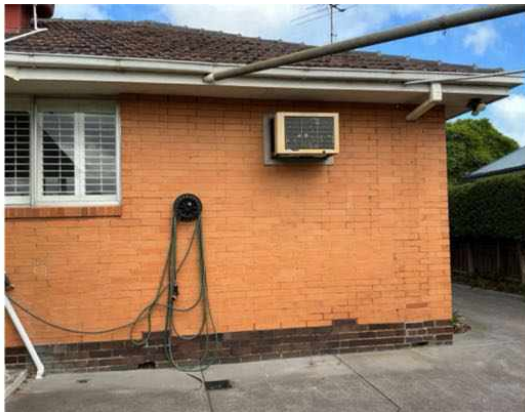
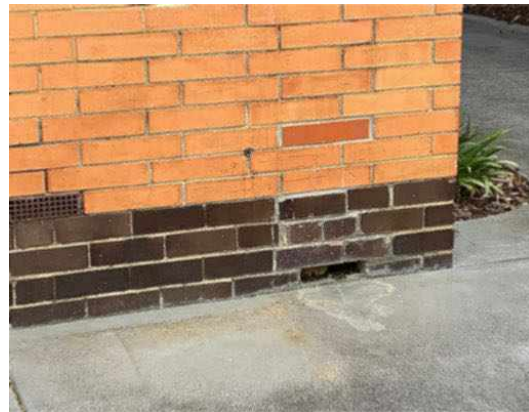
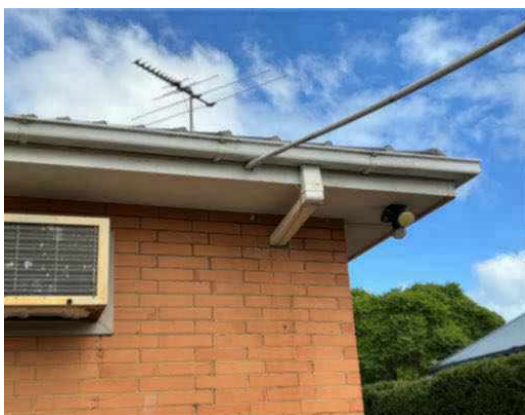
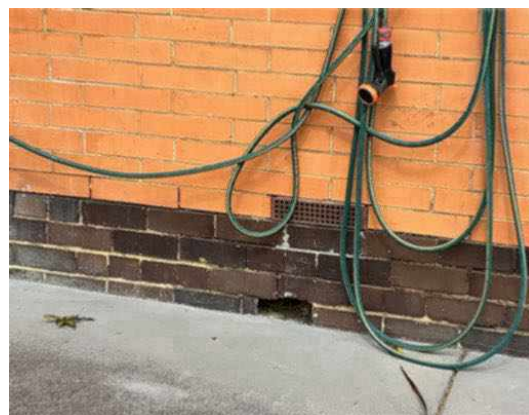
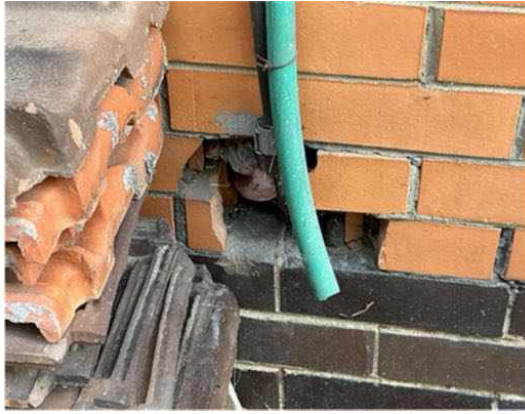
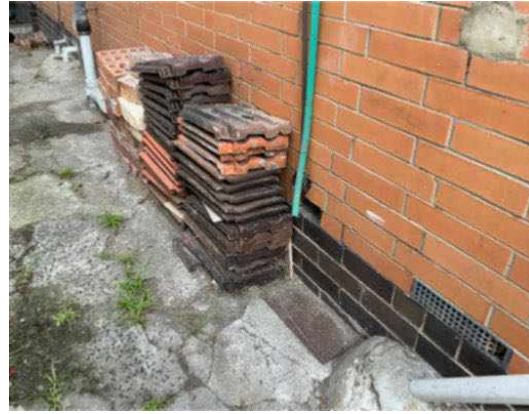
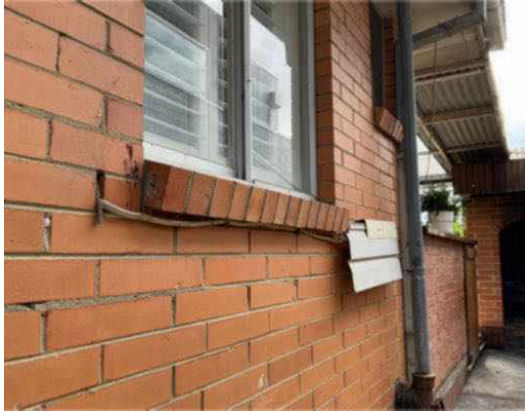
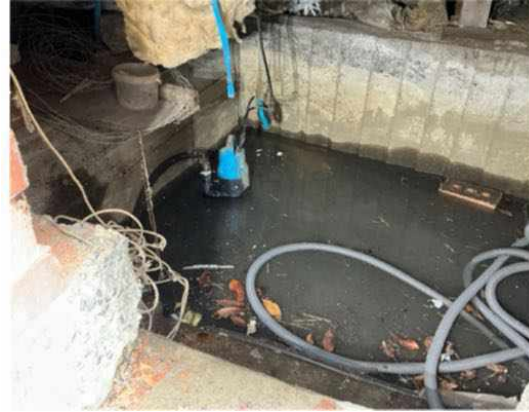
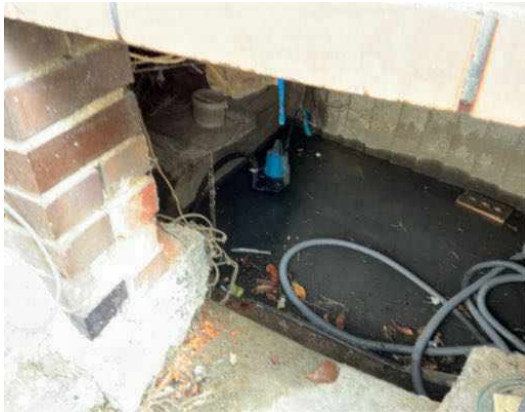
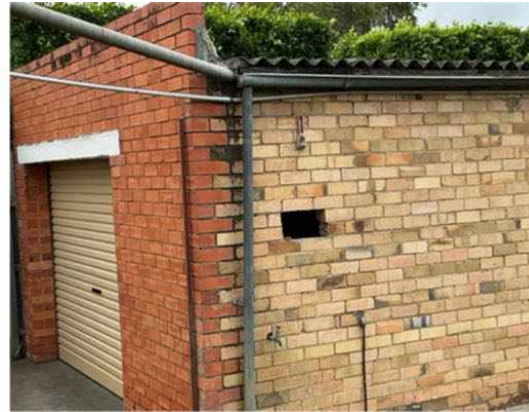
## Defects 1.04

Building:	Main Building
Location:	All areas
Finding:	Unconventional handyman plumbing, electrical and brickwork
Information:	This handyman work appears to have been completed to a substandard level and does not comply with regular building practices. Where handyman work is not completed satisfactorily, accelerated deterioration of the associated building elements is likely to occur and secondary defects to surrounding structures may develop.

It is highly recommended that the substandard work be rectified by professional services. Works to improve this area are likely to increase the safety and the operation of the associated building elements.

The client should exercise care when coming into the immediate vicinity of the substandard works. Rectification works are advised as soon as possible by the appropriate trades.

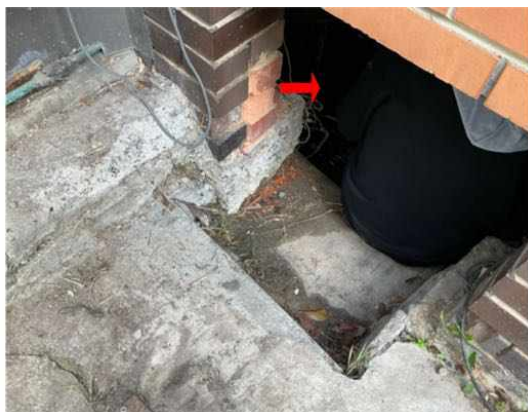
## Defects 1.05

Building:	Main Building
Location:	Subfloor debris
Finding:	Asbestos suspected
Information:	Many areas of suspected asbestos containing material were found throughout the property as shown in photos. Reporting on Asbestos is outside the Scope of this Report. This suspected defect is highlighted as a caution only. We suspect, based on our experience in the building industry, that there is a higher risk of the identified building elements containing asbestos.

In the interim, the client is advised to act with caution, especially when considering any damage to building materials, general wear and tear, renovations, extensions,

demolition and general maintenance activities due to the suspected presence of Asbestos.

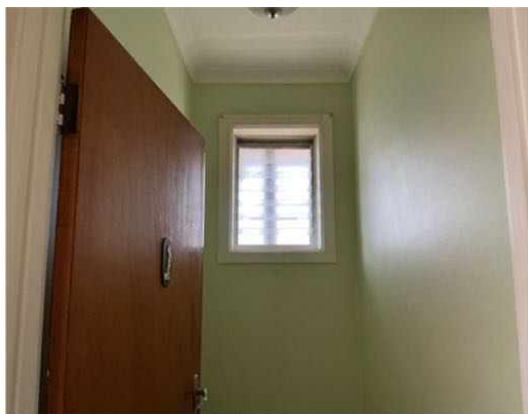
### Defects 1.06

Information: Many areas of suspected asbestos containing material were found throughout the property as shown in photos. Reporting on Asbestos is outside the Scope of this Report. This suspected defect is highlighted as a caution only. We suspect, based on our experience in the building industry, that there is a higher risk of the identified building elements containing asbestos.

In the interim, the client is advised to act with caution, especially when considering any damage to building materials, general wear and tear, renovations, extensions, demolition and general maintenance activities due to the suspected presence of Asbestos.

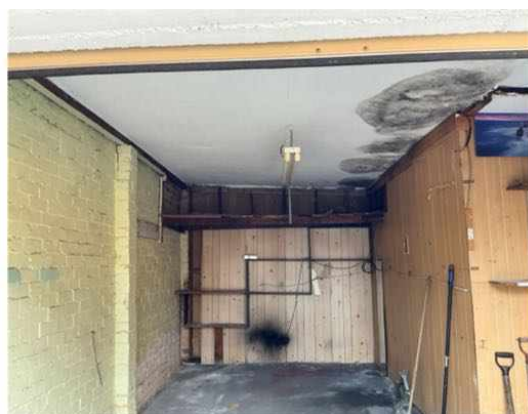
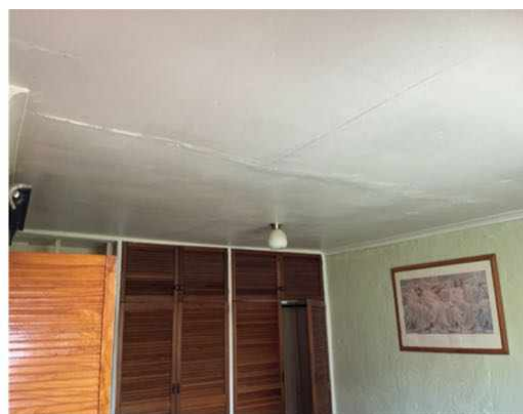
### Defects 2.01

Building:	Main Building
Location:	Garage and bungalow
Finding:	Exterior roof - Leaking
Information:	Active roof leaks were evident at the time of inspection. Roof leaks can have a number of causes, including damage to roof coverings, deterioration of roof fixtures and fittings, or loosely associated materials (fascias etc.).

Where water leaks are active, rain penetration is likely to cause water damage to associated structures and building elements in this area, which can have a range of implications. If left unmanaged, the development of major structural damage to the roofing and associated structures may occur.

A roof plumber should be appointed as soon as possible to primarily identify the cause of the leak, and to provide subsequent repair works as necessary. Depending on the extent of the damage, replacement of sections of the roof covering and/or roofing structures may be required, and may be performed by a registered builder or qualified carpenter.

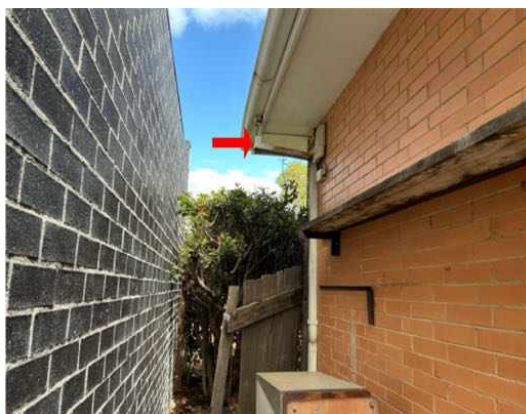
## Defects 2.02

Building:	Main Building
Location:	Exterior walls - right side
Finding:	Stormwater drain - Not connected
Information:	The roof plumbing is not adequately connected to stormwater drainage on the site. This disconnection negatively impacts the functional capacity of the roof plumbing.

Where roof plumbing doesn't drain adequately, the area at the base perimeter can become excessively damp, potentially creating an environment that is susceptible to rust and corrosion of surrounding building elements, as well as attracting termites and other pests.

It is highly recommended that a plumber be appointed to further inspect the area and to install adequate drainage equipment where necessary.

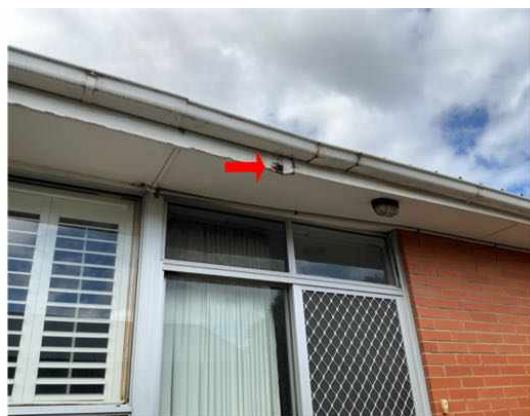
### Defects 3.01

Building:	Main Building
Location:	Roof Exterior
Finding:	Fascias - Wood rot
Information:	Wood rot was found to be affecting fascias and barges in this area, evidenced by the presence of mould on the surface in some areas. Wood rot, also known as Fungal Decay, occurs when timbers and other cellulose building materials are exposed to damp conditions on an ongoing basis.

It is likely that this wood rot has developed as a result of faults in the roof plumbing, creating excessive moisture in this areas. Frequent exposure to rain and other weather conditions also make fascias and barges susceptible to accelerated deterioration.

Early intervention and regular maintenance will prolong the useful life of these building elements. Prior to any works being performed, the cause of the moisture that has created the visible wood rot should be identified and addressed in a suitable manner.

It is advised that a roof plumber be appointed to inspect all roof plumbing and subsequently identify the cause of the wood rot. Replacement of affected fascias and barges may then be a necessary step in protecting surrounding building elements from such deterioration.

A qualified plumber may be appointed to assess the cause of excessive moisture and to provide advice on any remedial works as required. A qualified carpenter or registered builder may also be required to replace affected building materials.

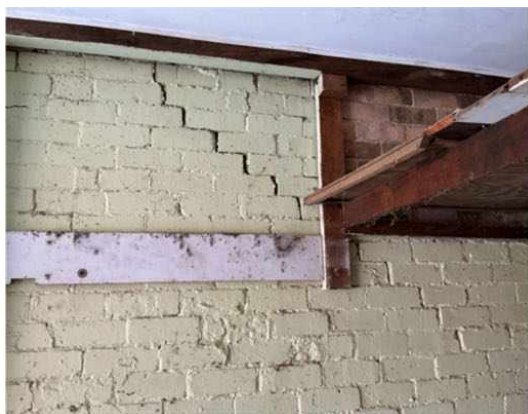
### Defects 3.02

Building:	Main Building
Location:	Garage and bungalow
Finding:	Brickwork - Step cracking
Information:	Step cracking was identified to the brickwork in this area at the time of inspection. Step cracking, which is similar to other forms of cracking, has a variety of possible causes. However, the most common is the subsidence of adjacent footings.

Step cracking is a relatively common defect, and is most likely to occur adjacent to windows, doors and other openings. Mortar failure in the gaps between affected bricks indicates the stresses and tensions affecting the wall.

Where step cracking is extensive or severe, the client is advised to consult a structural engineer. Minor step cracking can be used as a warning sign to address factors causing stress to the wall, which can include the effect of surrounding trees, water leaks, soil erosion, or even the presence of reactive soils in the surrounding area.

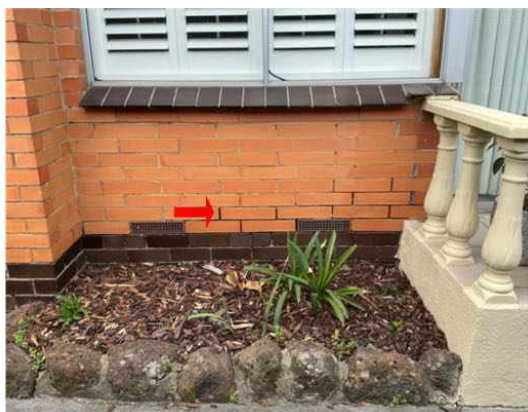
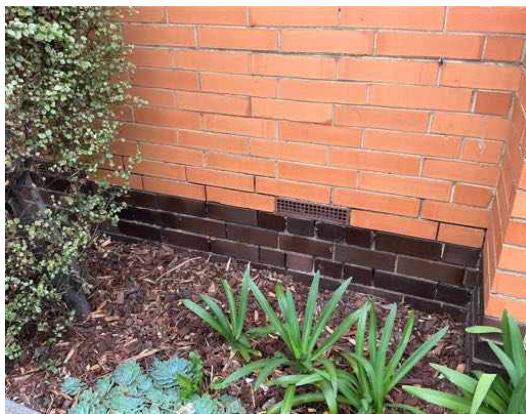
### Defects 3.03

Building:	Main Building
Location:	All areas
Finding:	Brickwork - Deteriorated mortar
Information:	Mortar, or 'bedding', is the material which fills joins and intersections between bricks in masonry walls and structures. Sections of mortar in this brickwork were identified as having deteriorated, which is generally expected for a property of this age and condition.

Mortar may deteriorate as a result of age of building materials, minor movement of bricks, or frequent exposure to weathering. Mortar should be replaced to ensure that bricks remain in their intended location and to prevent gaps, which would allow water or moisture ingress and secondary damage as a result.

Mortar deterioration can be addressed by a bricklayer where areas of deterioration are localised and easily accessible. Alternatively, appointment of a registered builder is advised, to repoint large areas of decaying mortar. Where secondary structural defects have become evident, consultation with a structural engineer may be required.

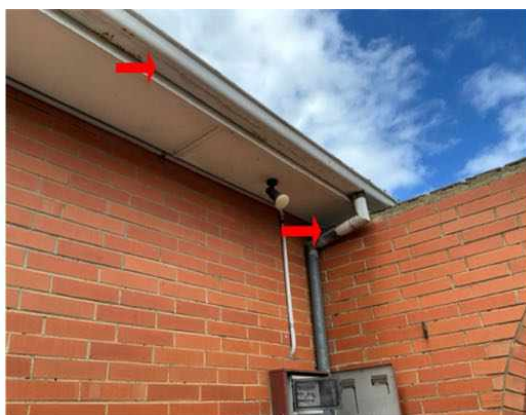
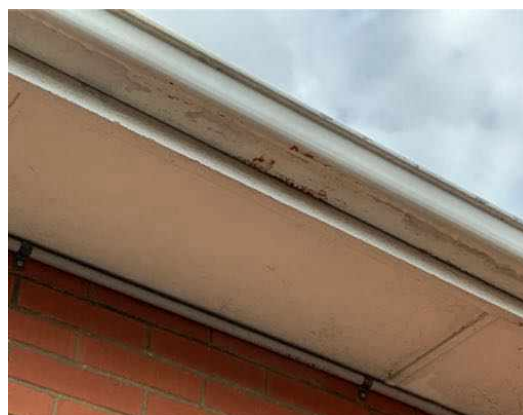
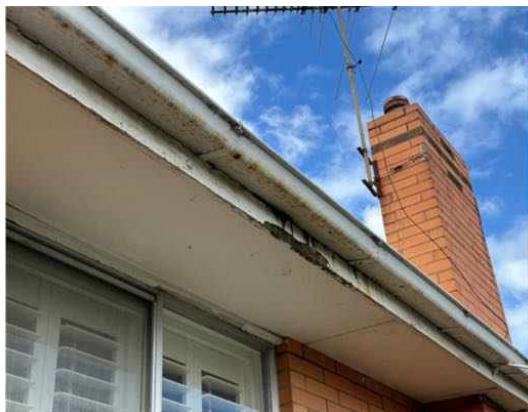
### Defects 3.04

Building:	Main Building
Location:	Roof Exterior
Finding:	Roof plumbing - Rusted or corroded
Information:	The roof plumbing has areas of rust and corrosion. It is suspected that this has been caused by blockages, resulting in pooling or standing water, that have prematurely rusted elements of the roof plumbing.

Rusted roof plumbing will generally develop holes and leaks that can affect other building elements with poor drainage of storm water. Poorly drained roof areas will also lead to damp conditions surrounding the base perimeter of the building which, if left unmanaged, can lead to a range of secondary building defects.

Repair and/or replacement of rusted roof plumbing is highly required in order to reinstate the roof drainage system to a fully operational level. To further maintain these areas, gutters should be cleaned frequently, allowing the avoidance of any partial blockages.

A licensed plumber or specialist roof restoration company should be appointed to undertake these works. It is advised that such works be completed as soon as possible to prevent any further damage and deterioration.

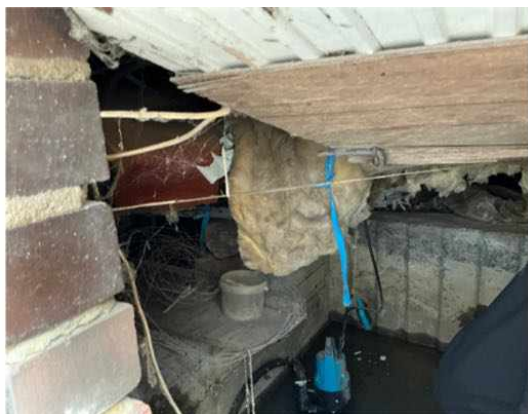
### Defects 3.05

Building:	Main Building
Location:	Subfloor
Finding:	Heating / Cooling Ducts - damaged
Information:	The heating/cooling ducts were found to be damaged and not at a fully operational level. Generally, damage to ducts occurs as a result of aging and material deterioration, but impact damage or pest damage may also be the underlying cause.

The damage sustained by the ducts detracts from the energy efficiency of the property. The airflow within the property is likely to be restricted, particularly in areas where ducting shows signs of major damage.

A heating/cooling specialist should be appointed to provide further advice on remedial work options and to perform any works deemed necessary.

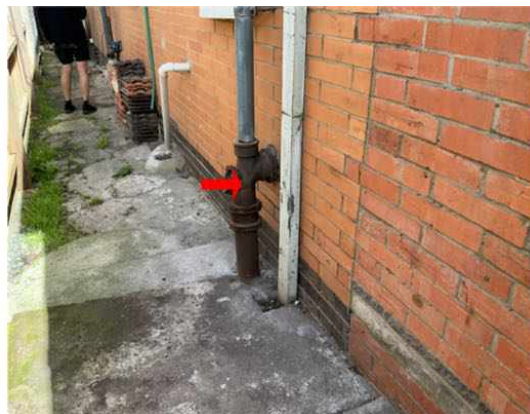
### Defects 3.06

Building:	Main Building
Location:	Exterior walls - left side
Finding:	Building element - Rusted or corroded
Information:	This building element shows evidence of rusting and corrosion, which is likely to have developed as a result of excessive exposure to moisture and or inadequate coatings.

As surface rust provides no protection to the underlying iron, the deteriorating condition is likely to worsen if not addressed in the short-term future.

Where possible, the use of galvanized (treated) metals or aluminium coated metals aid in rust prevention, as does regular general maintenance. Rust formation can be controlled with coatings, such as paint, that isolate the iron from the environment.

Rusting and corrosion should be managed by ideally removing or limiting the affected surface from exposure to moisture. A registered builder may be appointed to replace any building elements that have been severely affected by rust or water damage.

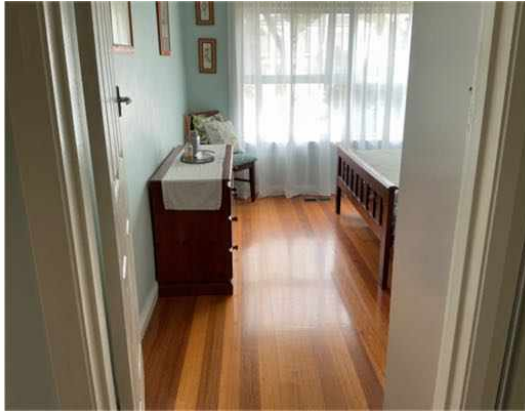
### Defects 3.07

Building:	Main Building
Location:	Bedroom - Master
Finding:	Floors - bouncy
Information:	The internal flooring in this area was identified as being bouncy at the time of inspection. A bouncy floor surface generally presents as a discernible change in level as they are walked across, in noisy or creaking flooring, or in consequent movement of surrounding furniture and fixtures.

Bouncy floors generally indicate that the floorboards or the subfloor structures are coming loose from the joists that they are installed on. Bouncy flooring may also be the result of gaps between flooring and stumps or joist structures, which require packing.

The client is advised to seek quotations for required repairs from a Registered Builder specialising in re-stumping. The potential resolution may range from packing gaps in subfloor structures through to replacement of subfloors stumps and refixing of flooring.

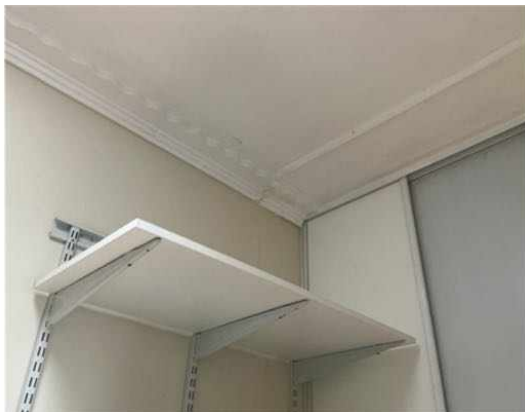
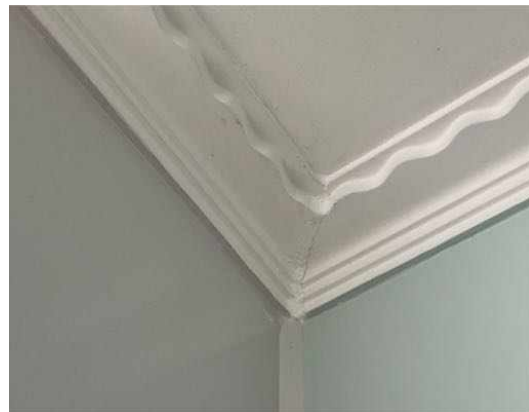
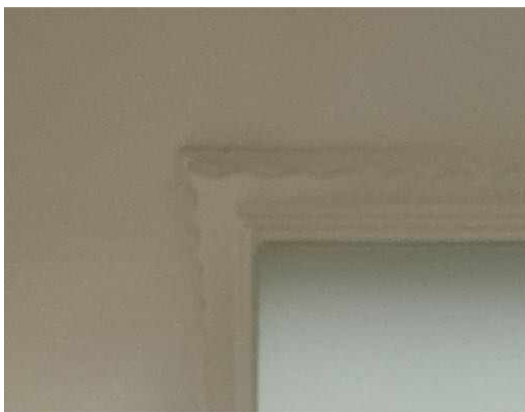
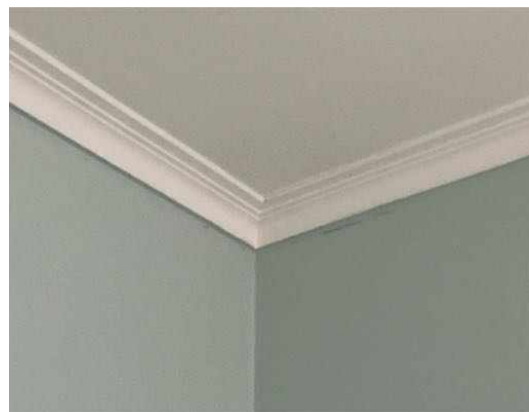
### Defects 3.08

Building: Main Building  
Location: All Areas  
Finding: Cornice - Cracking  
Information: The cornice has separated and cracking is apparent in this area.

This area should be carefully monitored to identify any further damage.

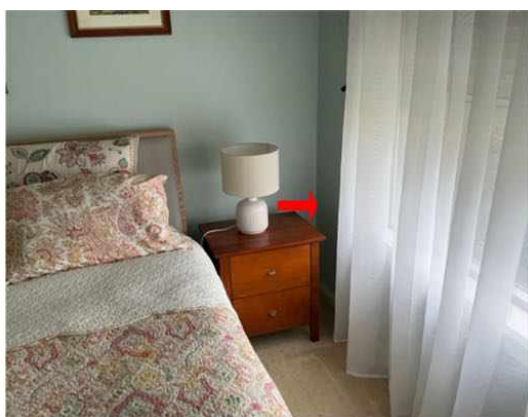
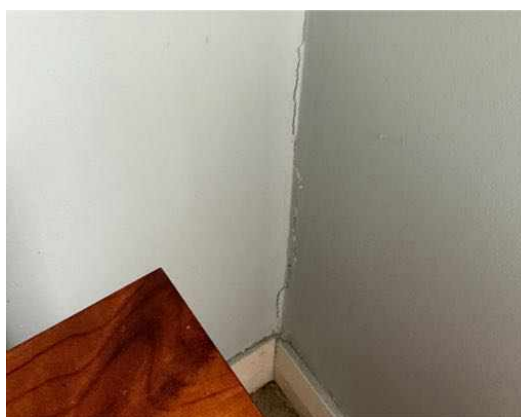
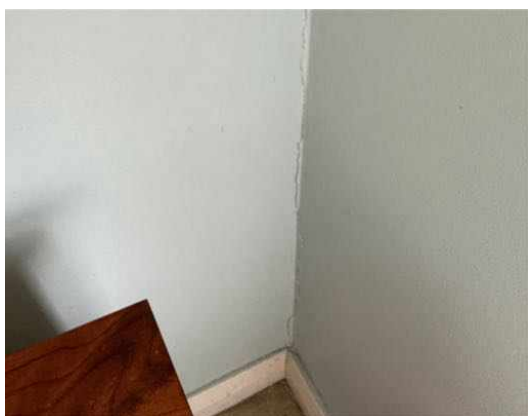
### Defects 3.09

Location: Bedroom -  
 Finding: Cracking - Damage Category 1 - Fine (up to 1mm)  
 Information: Although fine cracks are quite noticeable, they are often only considered to be an appearance defect, and usually do not indicate any structural damage. Generally, the cause of a fine crack is indicative of a separation between building materials and finishes (e.g. paint, plaster, etc.) along joins.

Cracking of this nature can generally be repaired with minor sanding, filling and/or repainting. Such works should be performed by a qualified painter or a general handyman.

Monitoring of all cracking should be conducted frequently. Always contact a building inspector should cracks widen, lengthen, or become more numerous.

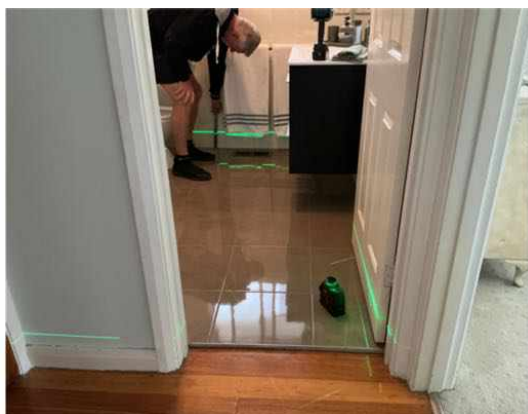
### Defects 3.10

Building: Main Building  
 Location: Bathroom  
 Finding: Flooring - Uneven  
 Information: The internal flooring in this area is out of level and uneven. Uneven flooring is likely to indicate minor defects such as expected movement of the foundations of the property, but may also indicate subsidence of the associated subfloor stumps.

Flooring in other areas was found to be within tolerance although not perfectly level in all areas

It is advised that the flooring be closely monitored to identify any further movement. Where flooring remains relatively unchanged for an extended period of time (i.e. several months), it is likely that this defect has been caused by expected movement of the foundations of the property.

However, where flooring is uneven further, potentially invasive inspection of the subfloor structures and stumps in this area is required. In this case, works to repair are likely to be required, and would be carried out by a registered builder specialising in re-stumping.

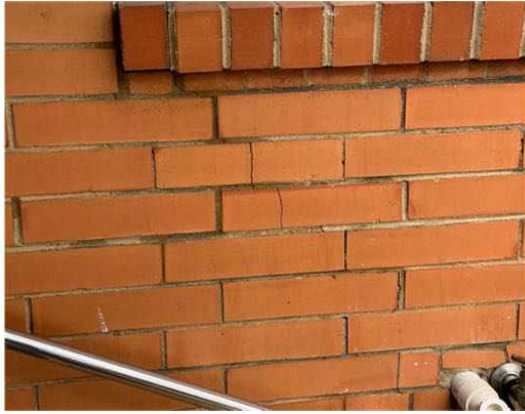
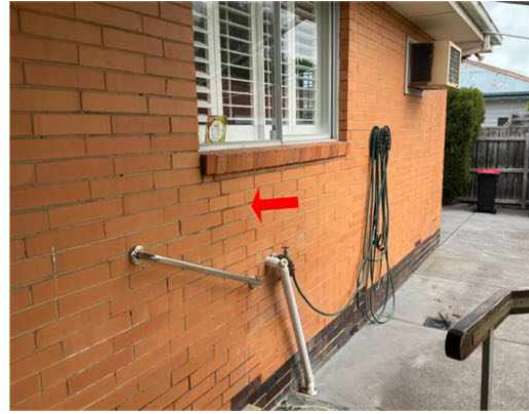
### Defects 3.11

Building:	Main Building
Location:	Exterior walls - rear
Finding:	Brickwork - Step cracking
Information:	Step cracking was identified to the brickwork in this area at the time of inspection. Step cracking, which is similar to other forms of cracking, has a variety of possible causes. However, the most common is the subsidence of adjacent footings.

Step cracking is a relatively common defect, and is most likely to occur adjacent to windows, doors and other openings. Mortar failure in the gaps between affected bricks indicates the stresses and tensions affecting the wall.

Where step cracking is extensive or severe, the client is advised to consult a structural engineer. Minor step cracking can be used as a warning sign to address factors causing stress to the wall, which can include the effect of surrounding trees, water leaks, soil erosion, or even the presence of reactive soils in the surrounding area.

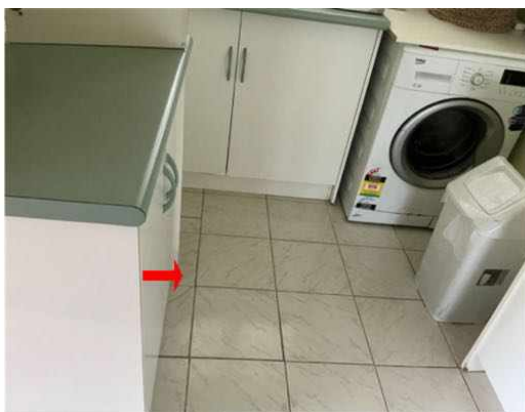
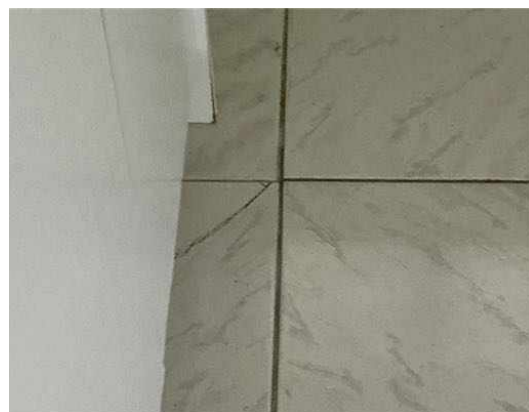
### Defects 3.12

Finding: Floor tiles - Cracked

Information: Cracking in the floor tiles was evident in this area at the time of inspection. It is suspected that this cracking has occurred as a result of the floor being uneven and lacking a solid or suitable foundation for the tiles to be laid on. Settlement in the floor foundations may also have caused movement and resulted in the cracking of tiles in this area.

Cracked tiles throughout the household detract from the overall appearance of the affected areas, as well as creating potential for water penetration to adjoining building elements. If left unmanaged, water damage may occur as a result of constant water penetration over a prolonged period of time.

While not considered a matter of urgency, replacement of cracked floor tiles is advised as a solution. A tiling contractor or general handyperson may be appointed to perform these works at client discretion. Where cracks become more numerous, consultation with a registered builder specialising in re-stumping may be required.

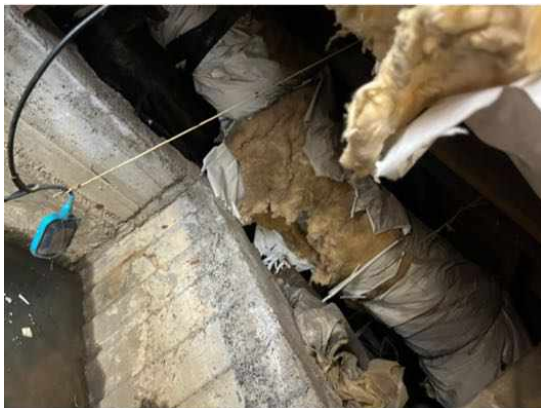
### Defects 3.13

Finding: Heating / Cooling Ducts - damaged

Information: The heating/cooling ducts were found to be damaged and not at a fully operational level. Generally, damage to ducts occurs as a result of aging and material deterioration, but impact damage or pest damage may also be the underlying cause.

A heating/cooling specialist should be appointed to provide further advice on remedial work options and to perform any works deemed necessary.

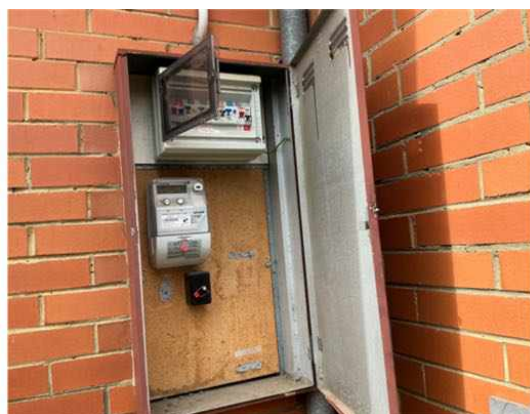
Building:	Main Building
Location:	Electrical Switchboard
Finding:	Termite Management System - no evidence of a chemical installation
Information:	The application of a post-construction chemical termite barrier is highly recommended for all properties, particularly if live termite activity has been found on the site previously. Such barriers are highly effective in preventing termite attack on any timber building elements throughout the property.

The client may consider gaining further advice from a pest controller as to the costs and procedures involved with this application. It is recommended that obtaining such advice be a short-term priority.

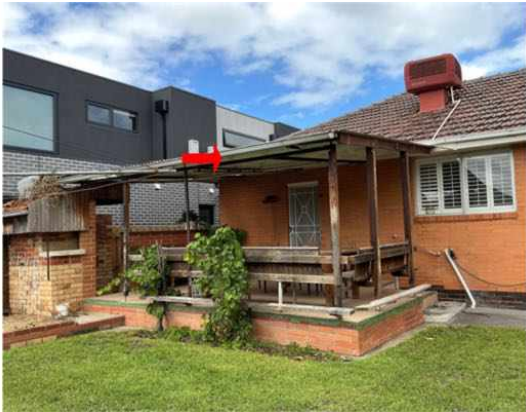
Building:	Main Building
Location:	Alfresco
Finding:	Additional structure - Non-compliant
Information:	The additional structure that has been affixed to this area of the dwelling does not appear to comply with contemporary building practices and current Australian Standards. While the structure does not currently appear to be unsafe, compliance with such standards ensures the structural integrity of the main dwelling and abutting addition.

carried out by registered builders. Such works may be necessary in the short-term future to ensure the safety and functionality of the area.

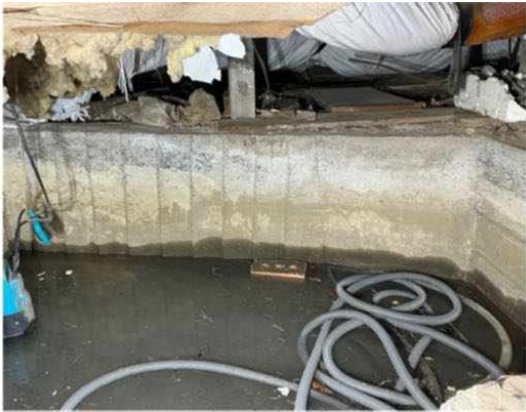
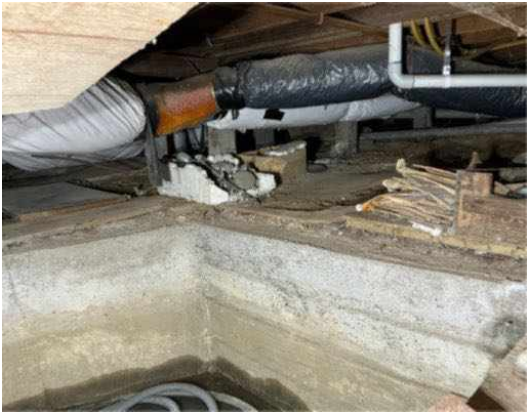
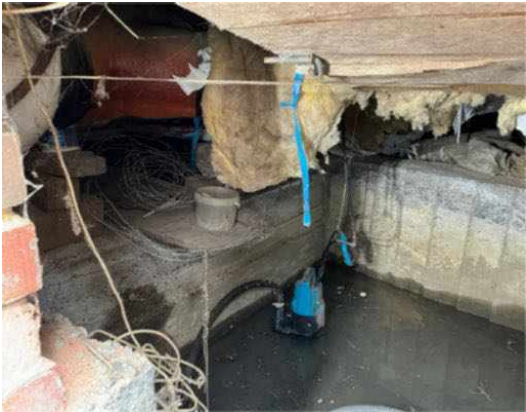
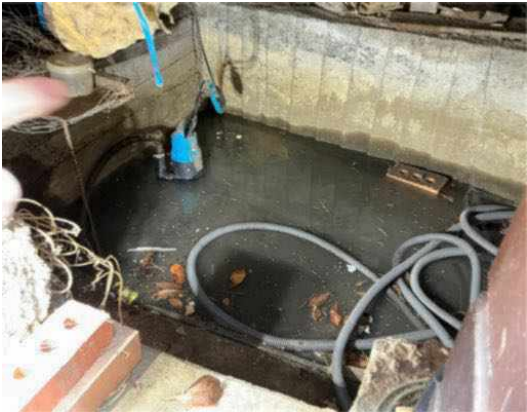
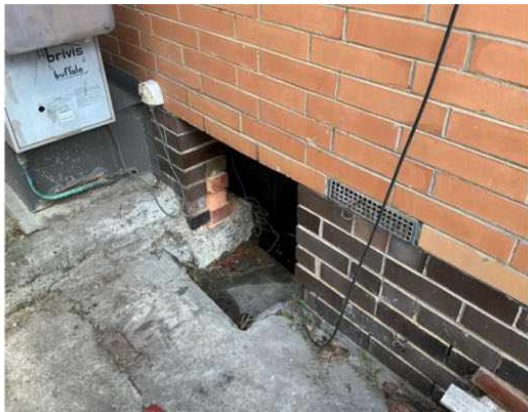
Building: Main Building  
Location: Subfloor  
Finding: Subfloor access limitations  
Information: Limited access to the subfloor was present due to facts including but not limited to access hatch size or placement, for this reason access to the subfloor was minimal.

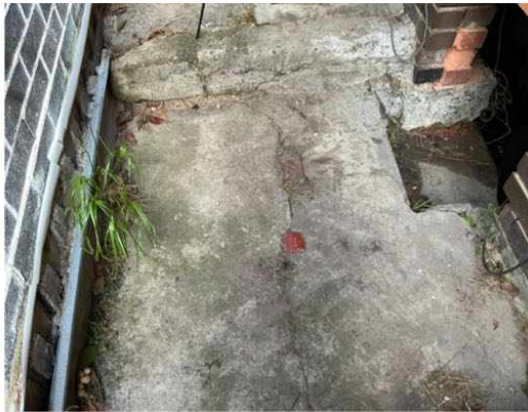
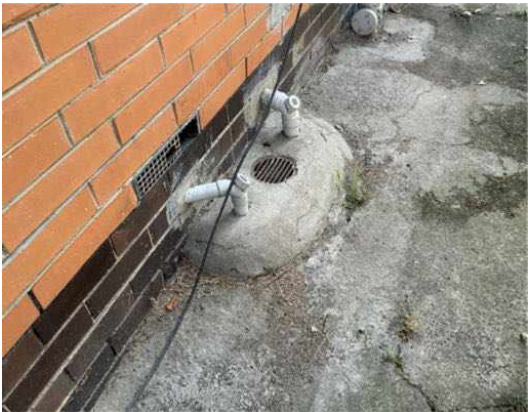
Building: Main Building  
 Location: All Areas  
 Finding: Terracotta pipes  
 Information: Terracotta drainage pipes (sometimes referred to as clay or vitrified clay pipes) have been used for many many years. The use of clay drainage pipes dates back to the Romans, who used the clay pipe system as it was easy to manufacture, straightforward to lay and, for the most part, reliable. However, due to the rigid and

The average lifespan of a clay pipe sewer system is 60 years — which means an upgrade is decades overdue for many homes. For your peace of mind you may wish to have your sewer pipes inspected and replaced before a major problem occurs
