Building and Timber Pest Inspection Report

Inspection Date: Thu, 19 Mar 2026

Property Address: 3B Kungar Rd, Caringbah South NSW 2229,
Australia

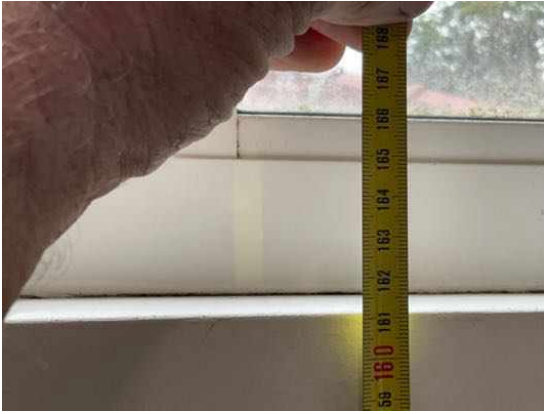
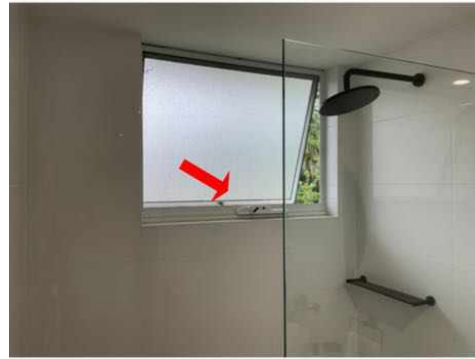
Building: Building 1
 Location: Bathrooms, master bedroom,
 Finding: Window opening restrictors missing.
 Information: These pictured windows are missing window restrictors. The Building Code of Australia rules require all openable windows (where the internal floor is more than 2m above the ground outside) in residential rooms to be fitted with a suitable screen or restrictor. Windows located 1.7m above the floor level do not require protection. These windows are approx 1.65 metres from the floor and 1.07 metres from the top of the bath.

These need to be added urgently for the safety of all persons.

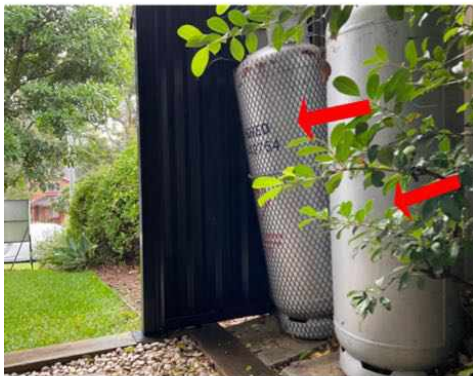
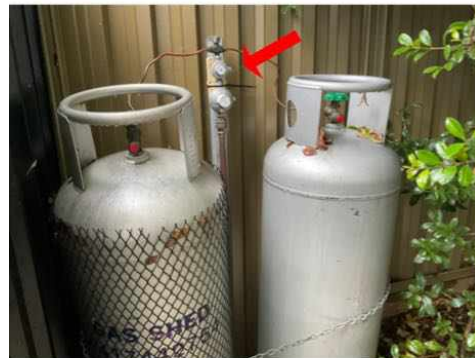
Finding 1.02

Building:	Building 1
Location:	Front left path
Finding:	Gas Bottle - Non-compliant
Information:	In the opinion of the inspector, the gas bottle is non compliant. However, in relation to gas and related gas plumbing, you should always consult a licensed plumber/gas fitter for further advice. The compliance plate could not be found and although a safety chain has been installed, the bottles are on a significant lean.

The client should contact the responsible trade (gas plumber) to undertake rectification before these bottles fall and cause injury or fence damage.

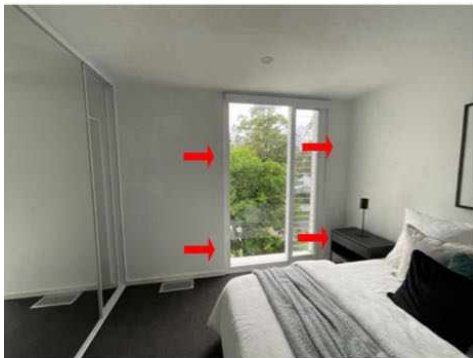
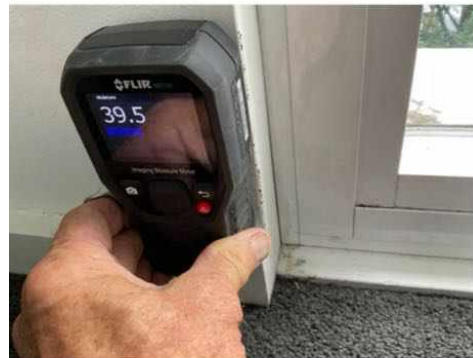
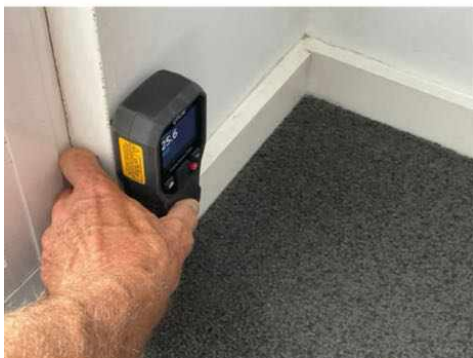
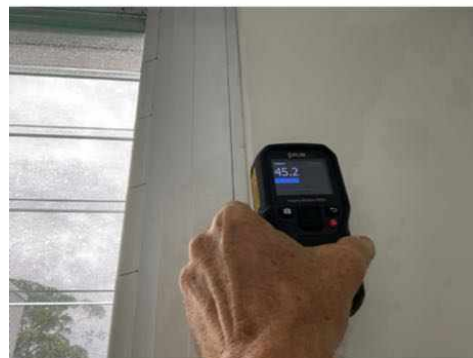
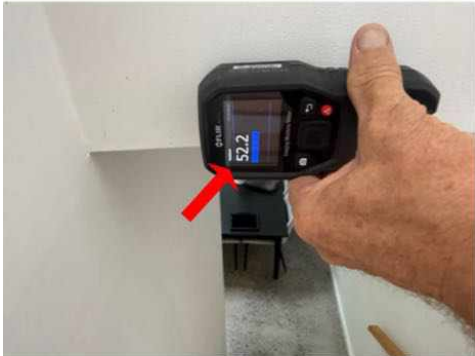
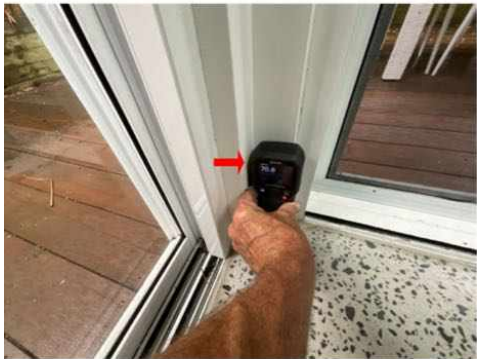
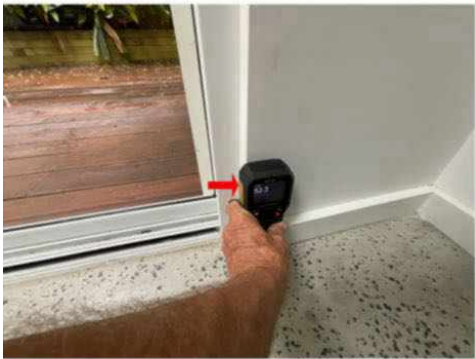
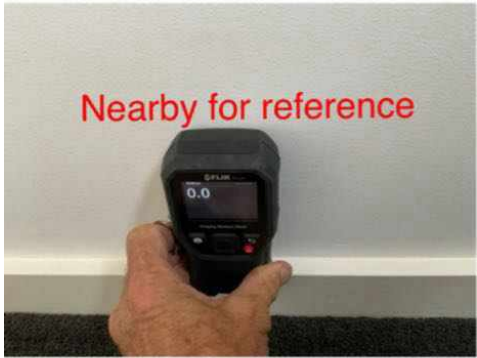
Location: Most windows, some doors and skylights
 Finding: Evidence of excessive moisture was present at the time of inspection
 Information: Excessive moisture was found around most of the house windows, some doors and all rear skylights.

Moisture readings of up to 52.2 were found in front window areas, 70.8 in rear window areas and 34.4 in skylight areas.

Minor mould and rust was found in the front bedroom window which will develop if not addressed.

Excessive moisture in these areas is suspected to be caused by incorrectly installed or missing flashings or damaged sealant.

The exact cause of the moisture ingress could not be determined at the time of the inspection.

Further investigation is required by a sealant expert.

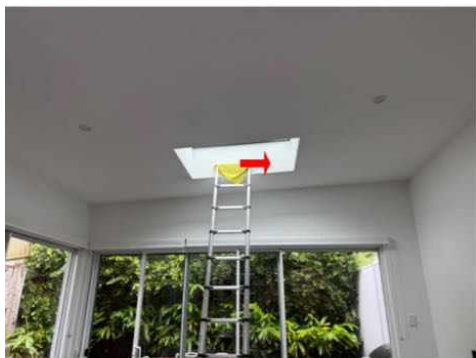
Finding 3.02

Building: Building 1
Location: Skylights
Finding: Evidence of excessive moisture around skylights
Information:

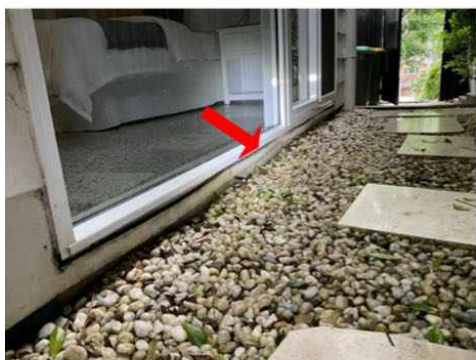
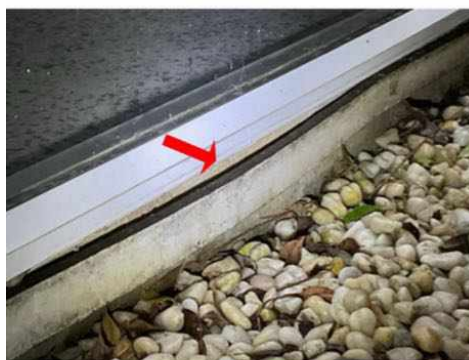
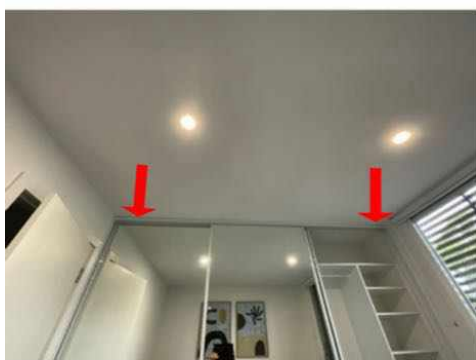
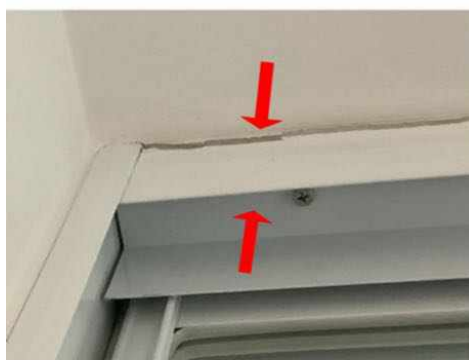
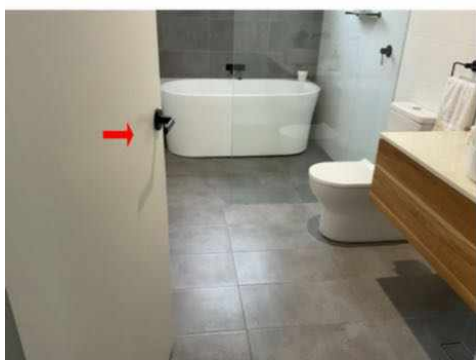
Finding 3.03

Building:	Building 1
Location:	Pictured areas
Finding:	Building elements - Damaged or missing
Information:	Evidence of minor missing or damaged areas was identified at the time of the inspection. These include -

1. A small section of the left side cladding under the bedroom sliding door is bowing not affecting the house as it's covering the slab.
2. The master bedroom sliding door track requires additional fixings to join to the ceiling timbers.
3. The bathroom has no lock.
4. The ensuite spout sometimes sprays water in different directions and needs a service.

A carpenter and plumber would be the trades responsible for rectification of these areas when convenient.

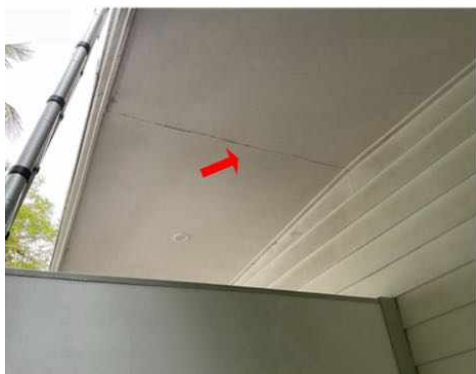
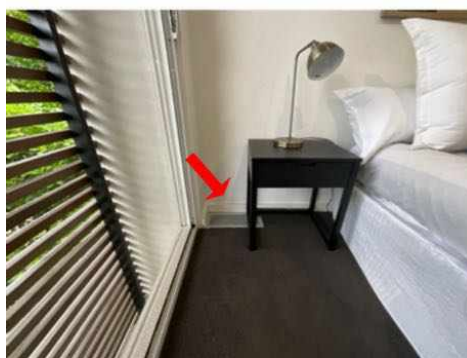
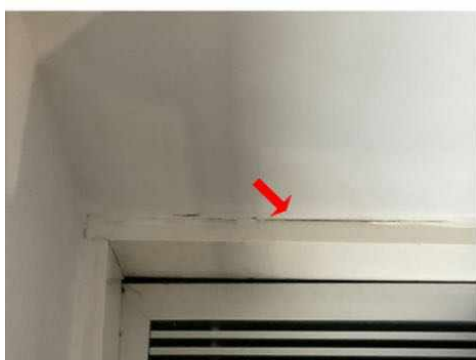
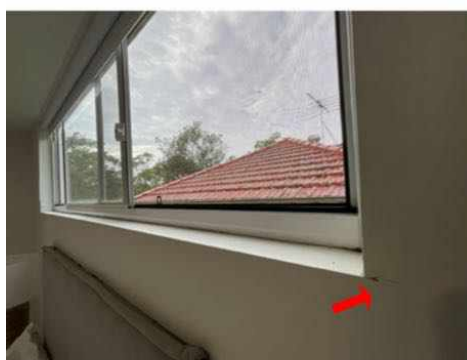
Finding 3.04

Building:	Building 1
Location:	Rear eave and bedrooms
Finding:	Cracking - Damage Category 1 - Fine (up to 1mm)
Information:	Although fine cracks are quite noticeable, they are often only considered to be an appearance defect, and usually do not indicate any structural damage. Generally, the cause of a fine crack is indicative of a separation between building materials and finishes (e.g. paint, plaster, etc.) along joins.

Cracking of this nature can generally be repaired with minor sanding, filling and/or repainting. Such works should be performed by a qualified painter or a general handyman.

Monitoring of all cracking should be conducted frequently. Always contact a building inspector should cracks widen, lengthen, or become more numerous.

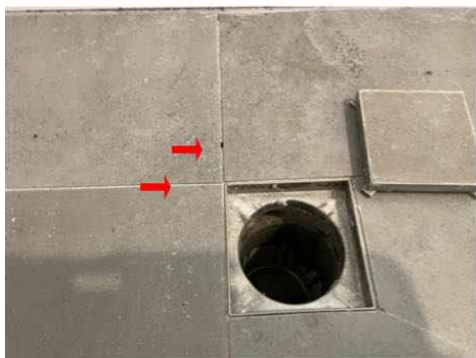
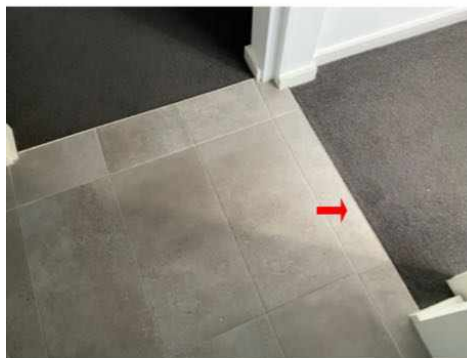
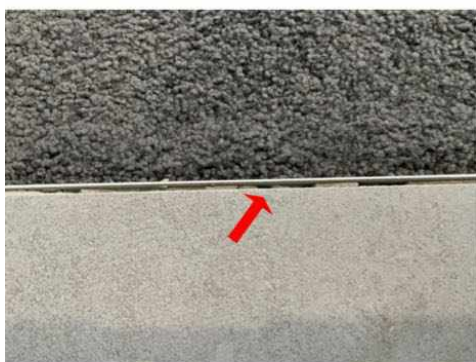
Finding 3.05

Building:	Building 1
Location:	Bathrooms
Finding:	Sealant and grouting - Missing or damaged
Information:	It was noted on inspection that sealant or grout is degraded to these pictured areas.

Different materials and floor areas move at different rates, generally causing cracking to grout or sealant at this point. A flexible sealant is required to allow for expected expansion and contraction, while keeping the joint water tight and protective of all associated building materials.

Flexible and mould resistant materials should be applied to affected areas to prevent any subsequent water damage that is likely to occur. Regular maintenance and replacement of damage or missing or damaged sealant and grout is highly recommended to the wet areas, as this is a regular wear and tear defect. Sealant and grouting in areas that come into regular contact with water should be maintained for the long term care of your property.

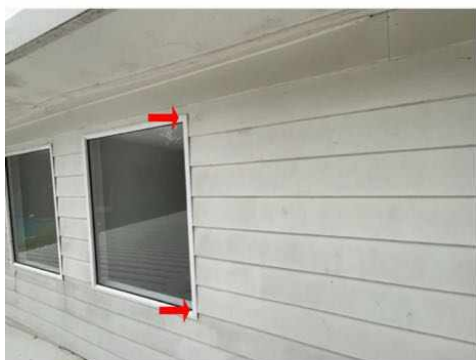
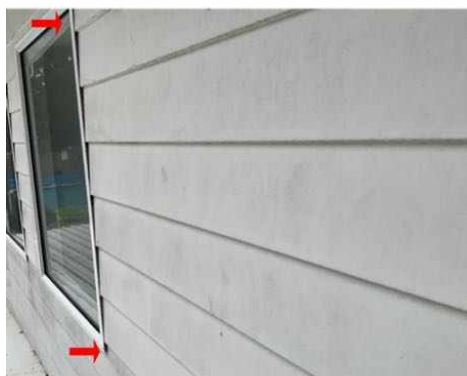
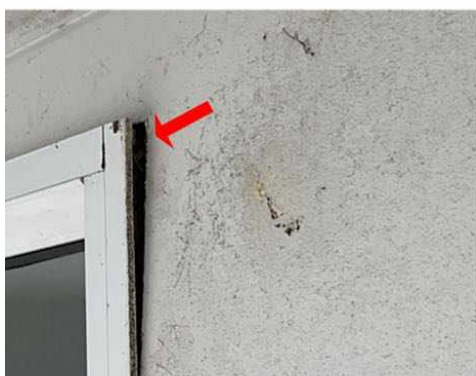
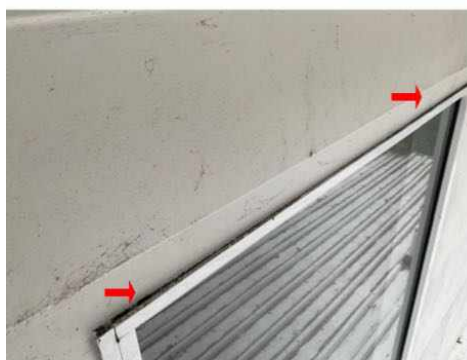
Finding 3.06

Building:	Building 1
Location:	Exterior rear window
Finding:	Sealant (external) - missing
Information:	It was noted on inspection that areas of external sealant was missing to these pictured rear window area. All other upper windows had no safe access.

Flexible sealants should be applied to these affected areas to prevent any subsequent water damage that is likely to occur.

A sealant specialist should be appointed immediately to seal all windows.

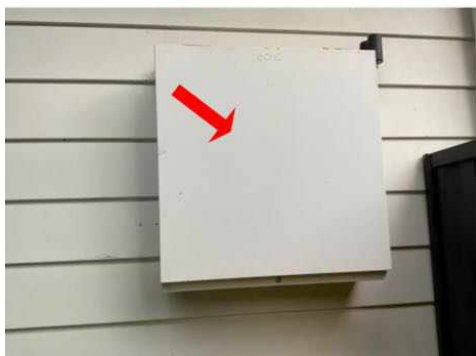
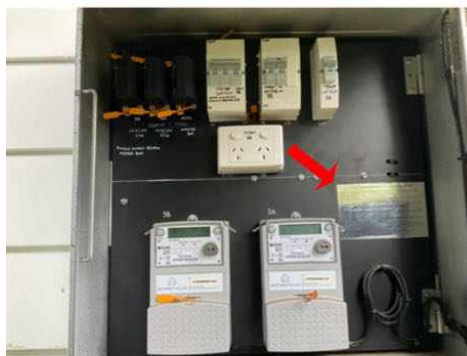
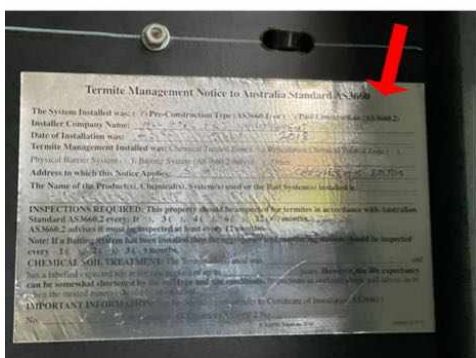
Building: Building 1
 Location: Meter Box
 Finding: Termite Management System - no evidence of a chemical installation
 Information: The application of a post-construction chemical termite barrier is highly recommended for all properties. Such barriers are highly effective in preventing termite attack on any timber building elements throughout the property.

to suggest preventative works taking place since the property was built.

The client may consider gaining further advice from a pest controller as to the costs and procedures involved with a 'chemical' application. It is recommended that obtaining such advice be a short-term priority due to the conditions conducive to termite activity found.

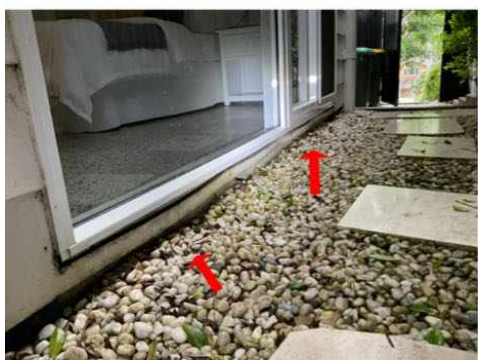
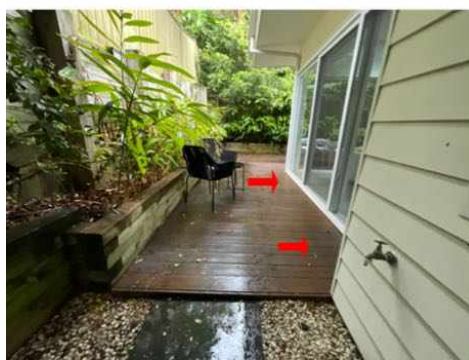
Finding 6.02

Building: Building 1
 Location: Wall areas
 Finding: Bridging - Vegetation and landscaping
 Information: Where any material obstructs inspection of building elements, also known as bridging as it provides a bridging point for the access of termites,

full inspection can not be achieved. Consequently moisture or dampness may be present and the areas become conducive to termite activity. Plants, paths, vegetation or decks against or very close to building slabs provide cover, shade and can provide an environment that is attractive to termite infestation.

If the slab edge is not properly exposed there is a high risk of termite attack. Sometimes, in order to determine the type of slab, a suitably qualified person such as an architect or builder may be required to consult the construction plans.

Where the slab edge cannot be properly inspected, it is highly recommended that termite or timber pest inspections be carried out every 6-12 months to aid protection of the property against infestation.
