Building and Timber Pest Inspection Report

Inspection Date: Wed, 18 Feb 2026

Property Address: 12 Steenson St, Edmondson Park NSW
2174, Australia

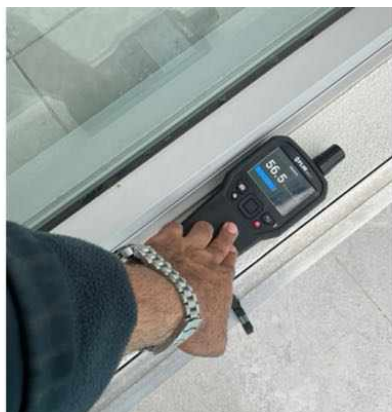
Finding 3.01

Building:	Main Building
Location:	All Internal Areas
Finding:	Elevated Moisture – Further Investigation Recommended
Information:	Elevated moisture readings were detected in several locations externally and tiles in the lounge area adjacent to pool, although no significant structural damage was evident at the time of inspection, dampness can contribute to deterioration if left unaddressed. Elevated moisture ingress these locations may indicate drainage , waterproofing or plumbing related issues. A further investigation by a licensed plumber or waterproofing specialist is recommended to confirm the source and ensure no concealed issues are developing. Failure to investigate this defect can be constitute significant costs in the future.

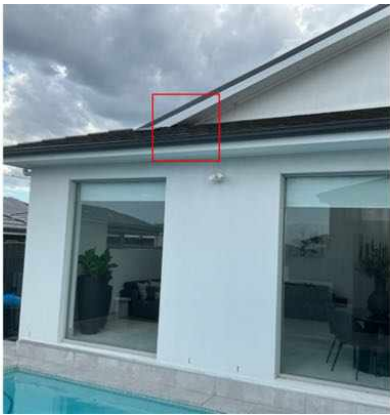
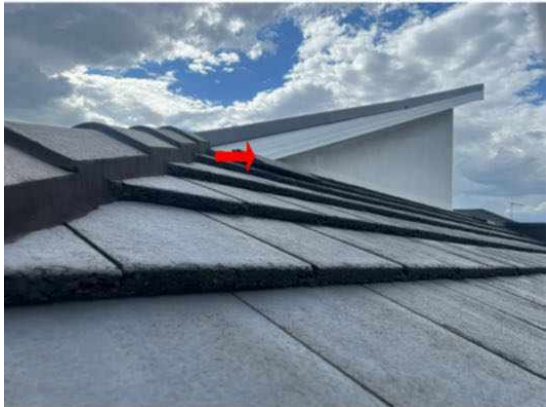
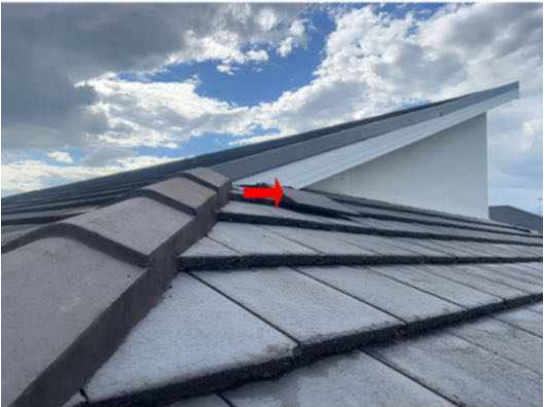
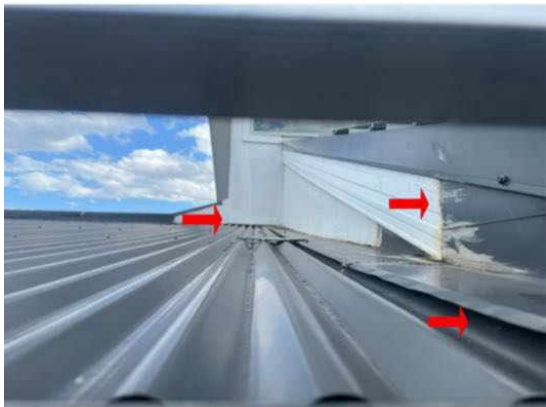
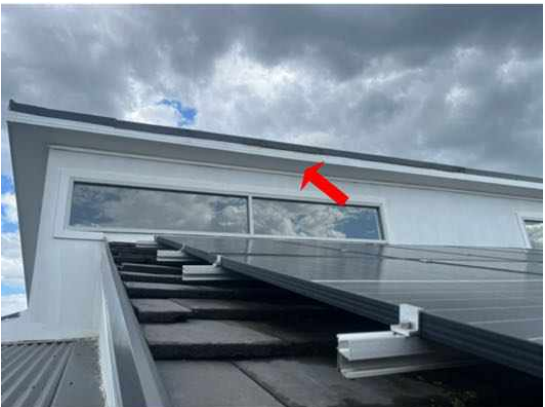
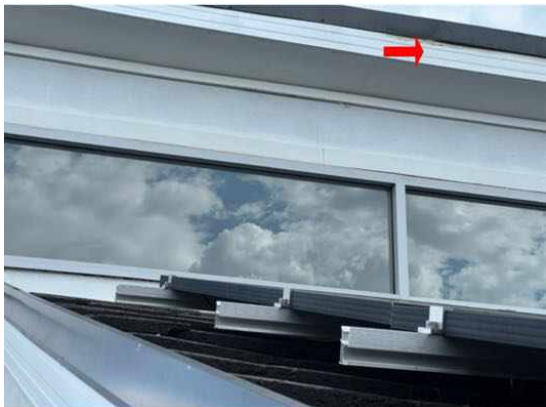
Building:	Main Building
Location:	Roof Exterior
Finding:	Installation - substandard or incomplete - Gap not sealed (Possible moisture ingress)/flashing to some areas
Information:	Visible gaps are present between the flashing and roof sheeting, and the end of the wall cladding/fascia trim does not appear fully sealed. The flashing edge appears loosely fitted in sections, with no evident continuous sealant bead or foam infill closure at the corrugation profiles. These gaps create a potential pathway for wind-driven rain to enter beneath the flashing and into the roof space or wall cavity. The detailing appears incomplete and may not provide adequate weatherproofing.

Further full roof inspection and rectification by a licensed roofer is recommended to properly secure, seal, and weatherproof the junction to prevent moisture ingress and possible concealed damage. Failure to perform these works can cause significant moisture related damage to the ceilings.

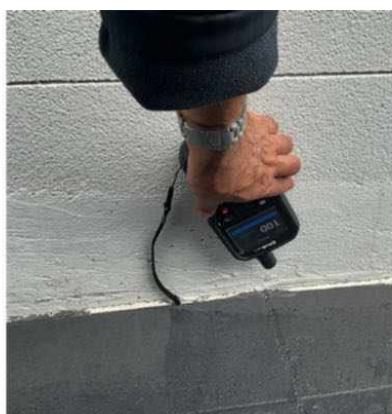
Finding 3.03

Building: Main Building
Location: All External Areas - Left , Rear
Finding: Damp (Elevated Moisture) and minor cracking
Information: The moisture profile and staining pattern are consistent with rising damp, capillary action, moisture bridging, or water accumulation at the wall-slab interface. The adjacent tiled surface and drainage configuration may be allowing water to pond or track toward the wall base. The cracking observed at the lower corner may be associated with shrinkage or minor movement, however, sustained moisture exposure can accelerate render deterioration and potentially impact internal linings if moisture ingress persists. Elevated readings of this magnitude warrant further investigation to determine whether the damp-proof course (DPC) has been bridged or compromised.

Further assessment is recommended to determine the source of moisture, including inspection of drainage falls, slab levels relative to the DPC, and waterproofing detailing at the wall-floor junction. Rectification may involve improving surface drainage, sealing cracks, and ensuring the DPC is not bridged by finishes. Monitoring of moisture levels and internal wall surfaces is advised to confirm whether the condition is active and ongoing.

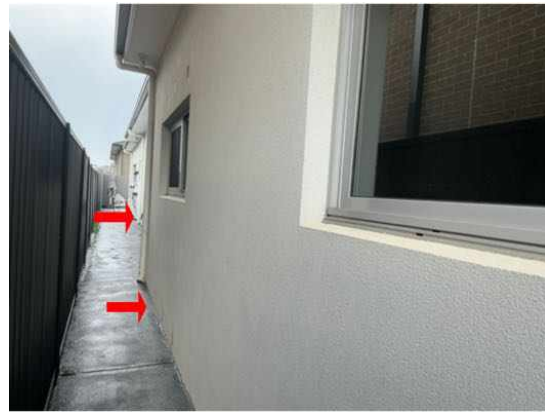
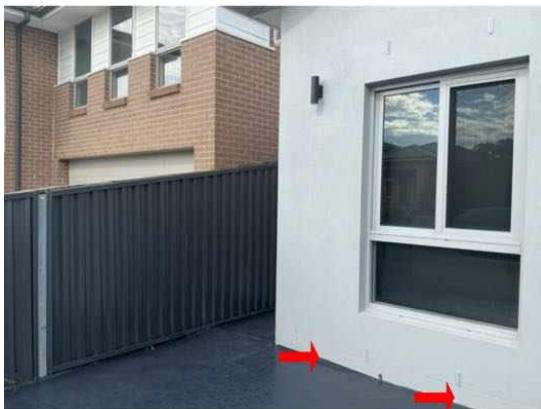
Finding 3.04

Building:	Main Building
Location:	All External Areas
Finding:	Render Finish Covering Damp Membrane
Information:	During the inspection, it was noted that the applied render finish is covering the damp-proof membrane. This is affecting the membrane's ability to prevent moisture movement above it, leading to moisture-related issues over time. It is recommended to consult a qualified builder to ensure the damp-proof membrane is properly exposed, maintaining its effectiveness in preventing moisture ingress.

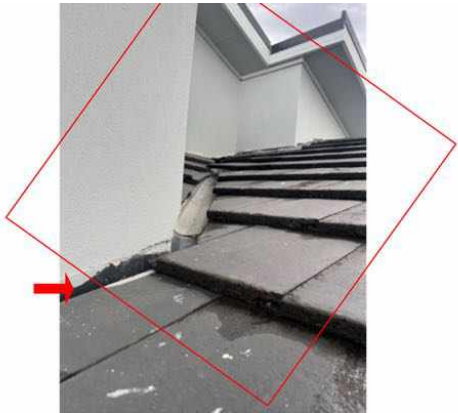
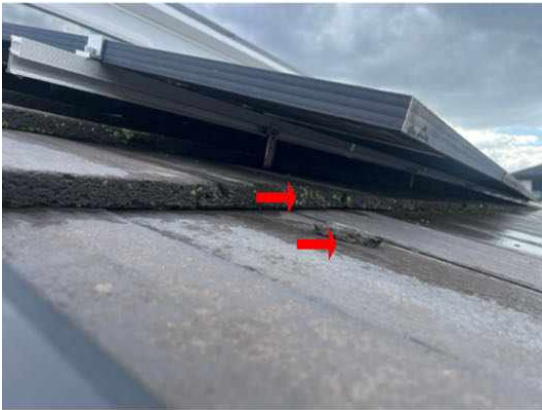
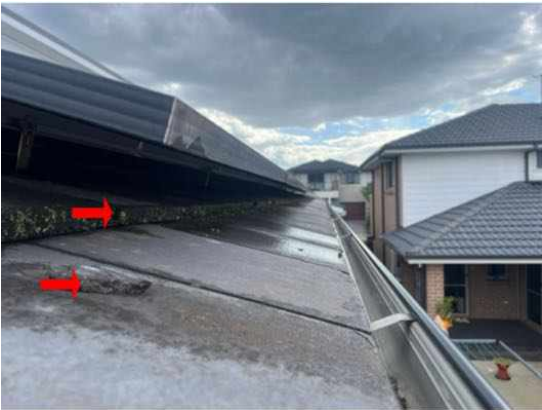
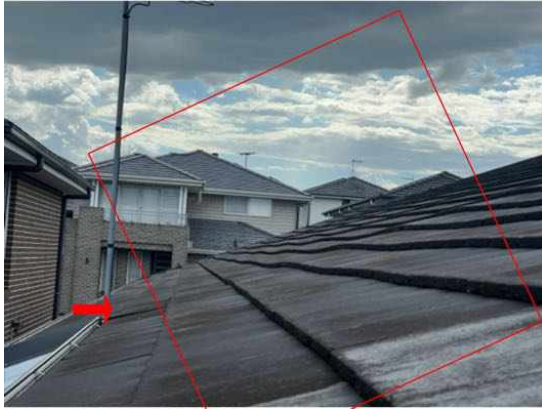
Finding 3.05

Building:	Main Building
Location:	Roof Exterior
Finding:	Roof tiles condition - Observation
Information:	The concrete roof tiles display general surface weathering, minor edge erosion and biological growth (moss/algae) along laps and lower edges, consistent with age and environmental exposure. Some tiles appear slightly uneven, likely due to minor settlement or past foot traffic, though no obvious broken tiles are evident. Routine maintenance including cleaning of biological growth, replacing damaged tiles and checking that tiles are properly seated is recommended to maintain effective drainage and long-term weatherproof performance.

A further thorough inspection of roof is highly recommended by a licensed roofing contractor to confirm there are no further concealed issues are present.

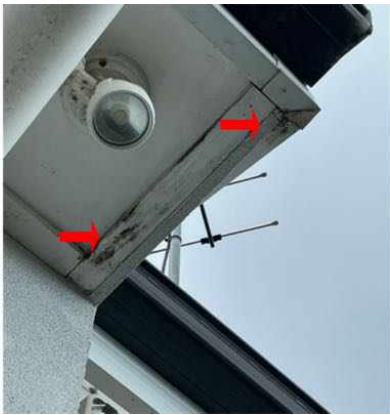
Finding: Water staining to some areas - Eaves

Information: Water staining was evident in this area at the time of inspection. Water staining indicates that surfaces have been exposed to excessive moisture over time. The minerals and other elements in the water lead to staining, which may graduate to corrosion and deterioration if left unmanaged.

While mostly an appearance defect, water staining can be indicative of more serious defects, which may be currently concealed by other building elements.

Where water staining is active, a licensed plumber must be consulted to identify the cause of the staining and to provide advice on any reparation works that may be required. Replacement of any broken or damaged structures is advised.

Conversely, where water staining is old and inactive, affected building materials may be repaired or replaced at client discretion. A qualified carpenter or registered builder may be appointed to perform these works.

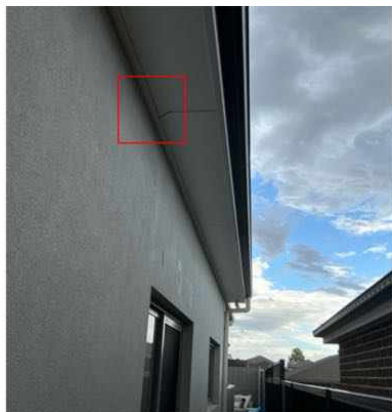
Building:	Main Building
Location:	All External Areas
Finding:	Building element - Damaged - Eave Cracked
Information:	Breakage occurs generally when the building materials have either aged and decayed, or as a result of damage (accidental or deliberate).

Repair and/or replacement of broken elements is advised to ensure that additional secondary defects do not arise as a consequence. Such works are necessary, as all building elements play a key role in the operation and function of the overall structure and its performance.

A relevant tradesperson should be appointed to repair or replace the affected building element prior to any subsequent damage being caused.

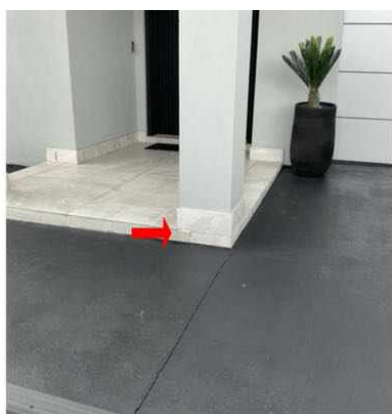
Finding: Tiles - Cracked or damaged/drummy

Information: Cracking was evident to the tiling in this area at the time of inspection. While the cracking appears to be minor, this area is frequently exposed to water, allowing potential for water penetration into adjoining sections of walls or flooring.

If left unmanaged, water penetration to these areas may lead to subsequent water damage, which is likely necessitate repair work to affected building elements.

A tiling contractor should be appointed to ensure that no further water damage occurs. The re-application of silicone and grouting throughout remaining tile work is also advised, to further protect the area against water penetration.

Where water penetration has led to water damage, appointment of a relevant tradesperson may be required to repair damaged building elements.

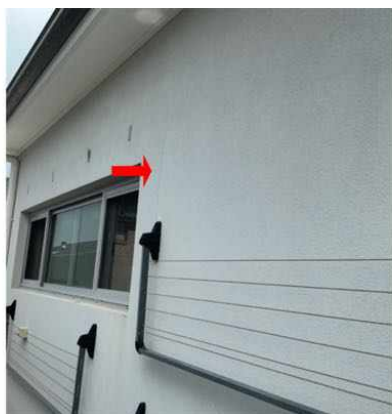
Finding 3.11

Building: Main Building
Location: All External Areas
Finding: Cracks to render - Category 1 to some areas
Information: It has been observed that cracking to rendered surfaces has occurred. The degree of damage falls within Category 1, described as fine cracks that do not need repair and which are less than 1.0mm in width limit.

Damage of this category is not considered a defect for rectification. Always contact your building inspector should cracks widen, lengthen, or become more numerous.

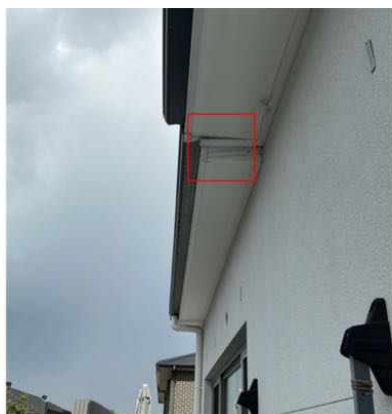
Building:	Main Building
Location:	All External Areas
Finding:	Eave Trim Separation
Information:	The external timber trim at the eaves corner displays a visible separation crack, likely due to minor building movement or timber shrinkage over time. While not structurally

significant on its own, the gap may allow moisture ingress and should be sealed with a flexible exterior-grade sealant to prevent further deterioration.

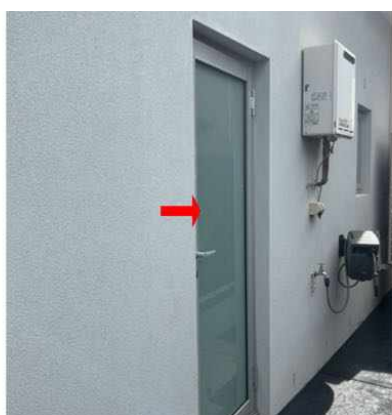
Finding 3.16

Building:	Main Building
Location:	All External Areas - Bathroom external
Finding:	Door - Binding/jamming
Information:	Binding and/or jamming of this door is evident during standard operation. This defect inhibits the functionality of the affected door as well as creating potential for secondary defects to associated building elements, such as damage to the floor covering.

A door that binds to flooring or to the associated door frame may have several causes, ranging from minor defects, such as poor installation of the door or deteriorated hinges, through to major structural issues, such as damage to subfloor structures.

Where door binding/jamming appears to indicate major structural issues, a registered builder specialising in re-stumping should be appointed to provide an estimate on the cost of rectification.

For minor causes, a qualified carpenter or general handyperson should be appointed to perform minor rectification works at client discretion.

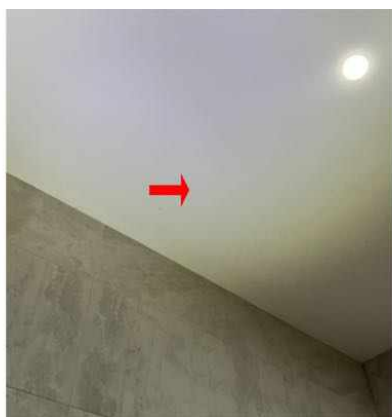
Finding 3.17

Building:	Main Building
Location:	Bathroom
Finding:	Water Staining - Humidity or Ventilation
Information:	The ceiling surface shows faint darkened spotting or shadowing, commonly consistent with surface mould or humidity-related staining, often found in bathroom or wet area ceilings with insufficient ventilation. While there is no visible sagging or major water damage, the pattern suggests prolonged moisture exposure, possibly due to steam accumulation or minor condensation issues. According to AS 4349.1–2007 (Appendix C), this would be classified as a minor defect unless further deterioration or active leaks are found. Recommend improving mechanical or natural ventilation, cleaning the surface with mould treatment, and monitoring for recurrence.

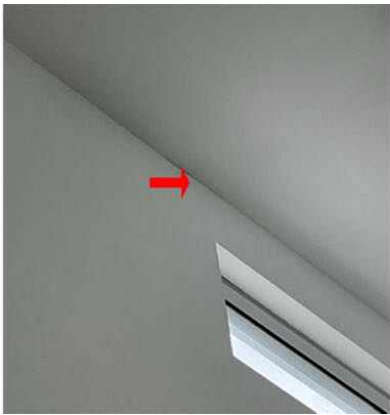
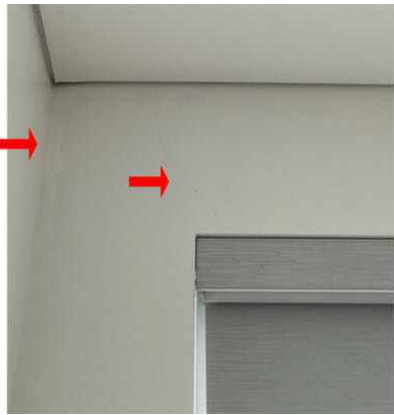
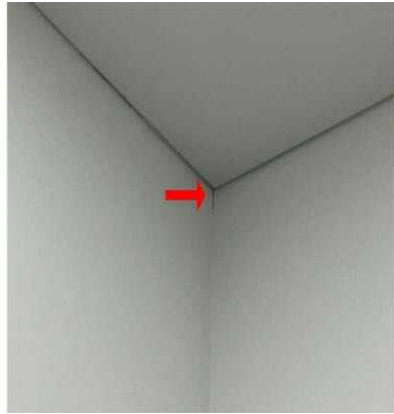
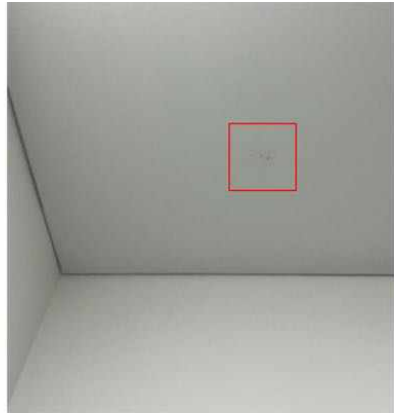
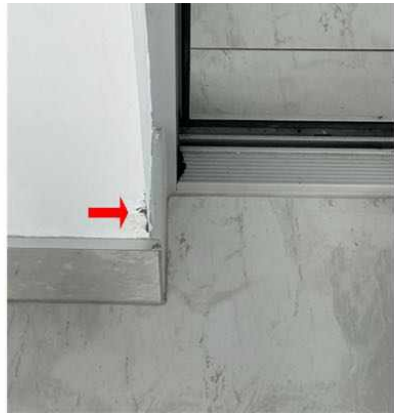
Finding 3.18

Building:	Main Building
Location:	All Internal Areas
Finding:	Paint Finish & Hairline Cracking - To some areas
Information:	The paint finish in this area was identified as being incomplete or substandard at the time of inspection including some hairline minor cracking/separation. Monitoring is recommended where cracking and separation is evident.

Whilst incomplete or missing paint finish is generally an appearance defect, it can also lead to the development of secondary building defects over time. Incomplete areas of paint finish expose the area to moisture, potentially accelerating the deterioration of underlying building materials.

works to aid the appearance of the affected area and to ensure the area is protected against further deterioration. Alternatively, the homeowner following manufacturer instructions may perform these works.

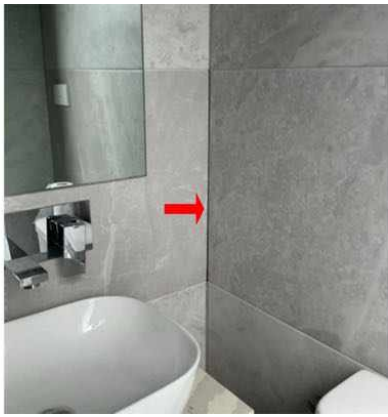
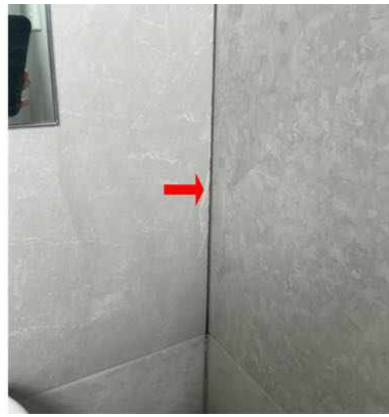
Finding 3.19

Building: Main Building
Location: All Internal Areas , porch , bathroom outside
Finding: Sealant and grouting - Missing or degraded to some areas
Information: It was noted on inspection that sealant or grout is degraded.

Excessive mould to the sealant and grout may require scraping out and replacement.

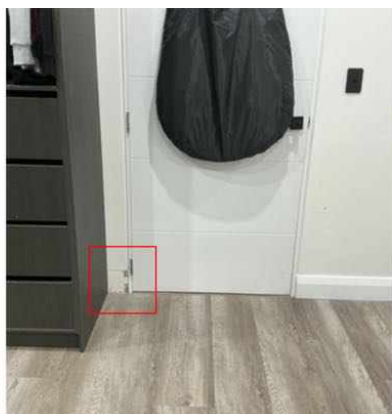
Finding 3.20

Building:	Main Building
Location:	All Internal Areas
Finding:	Building element - Damaged - Plaster damaged master bedroom , kids room
Information:	Breakage occurs generally when the building materials have either aged and decayed, or as a result of damage (accidental or deliberate).

Repair and/or replacement of broken elements is advised to ensure that additional secondary defects do not arise as a consequence. Such works are necessary, as all building elements play a key role in the operation and function of the overall structure and its performance.

A relevant tradesperson should be appointed to repair or replace the affected building element prior to any subsequent damage being caused.

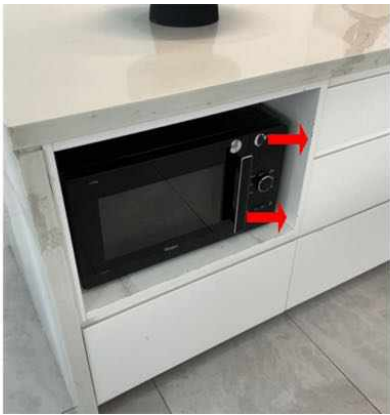
Finding 3.21

Building:	Main Building
Location:	All Internal Areas
Finding:	Building element - Damaged , kitchen cupboard minor scratches
Information:	Breakage occurs generally when the building materials have either aged and decayed, or as a result of damage (accidental or deliberate).

Repair and/or replacement of broken elements is advised to ensure that additional secondary defects do not arise as a consequence. Such works are necessary, as all building elements play a key role in the operation and function of the overall structure and its performance.

A relevant tradesperson should be appointed to repair or replace the affected building element prior to any subsequent damage being caused.

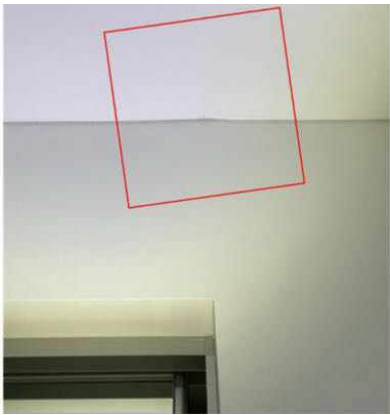
Finding 3.22

Building: Main Building
Location: Bedroom Kids right
Finding: Installation - substandard or incomplete - Uneven ceiling and wall junction
Information: The installation of this building element appears to have been completed to a substandard level of workmanship or is incomplete. Generally substandard repairs or installation are related to poor workmanship, the use of inappropriate materials, or a failure to complete installation to a suitable standard.

Where installation is substandard and/or incomplete, the client should contact the responsible trade to undertake rectification. Unfinished and substandard building works are likely to degrade more quickly and may create potential for secondary defects to associated building elements.

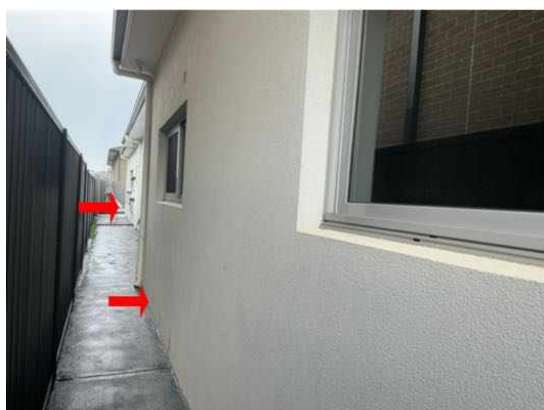
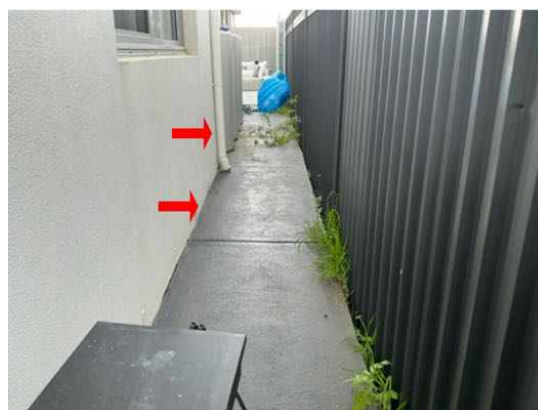
If the slab edge is not properly exposed there is a high risk of termite attack. Sometimes, in order to determine the type of slab, a suitably qualified person such as an architect or builder may be required to consult the construction plans.

Where the slab edge cannot be properly inspected, it is highly recommended that termite or timber pest inspections be carried out every 6-12 months to aid protection of the property against infestation.

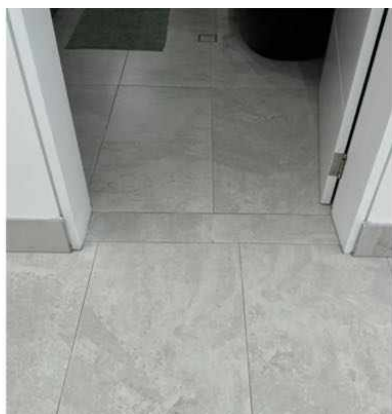
Building: Main Building
Location: Bathroom
Finding: Bathroom & external floor threshold
Information: The bathroom floor is at the same level as the adjoining timber flooring. This configuration is typical in modern dwellings and is permitted where compliant waterproofing and floor falls are provided. No evidence of moisture damage was observed at the time of inspection; however, waterproofing performance cannot be confirmed without invasive inspection.

Care should be taken to avoid excessive water migration beyond the bathroom during use.
