Building and Timber Pest Inspection Report

Inspection Date: Thu, 22 Jan 2026

Property Address: 81/48 Berkshire Pl, Heathwood QLD 4110,
Australia

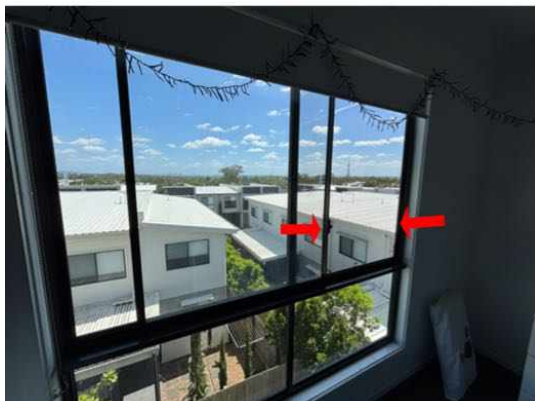
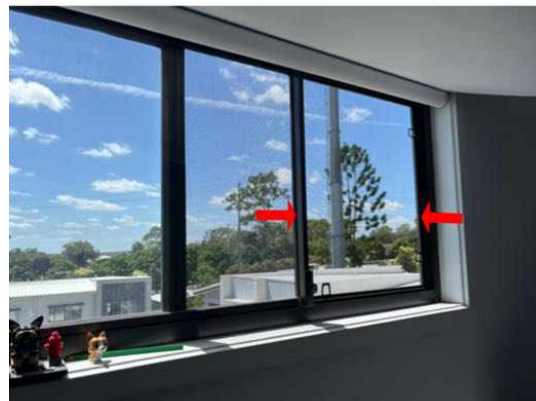
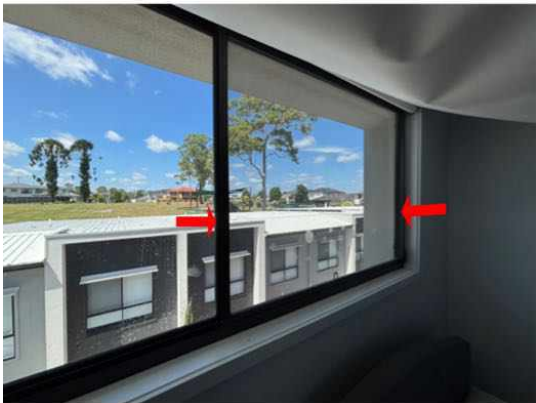
Finding 1.01

Building:	Main Building
Location:	Upstairs bedrooms
Finding:	Windows in the upstairs bedrooms - opening not restricted to 125mm
Information:	At the time of the inspection, it was noted that the windows in the upstairs bedrooms were not restricted to opening to 125mm or less. The windows can be opened to the full extent of the opening as the windows restrictors have been removed.

As of March 2018, windows that open, have a 2 metre or greater fall on the outside and are 1.7m or less from the internal floor level, are required to be restricted to an opening of no more than 125mm.

On 13th March 2018, an amendment to the Strata Schemes Management Act 2015 made it mandatory for residential strata schemes to fit suitable safety devices on applicable windows in the common area of strata buildings. As a result, the Building code of Australia was amended, affecting newly constructed buildings. A later amendment to the Strata Schemes Management Act was also made meaning existing buildings need to meet these same requirements which came into effect on 13th March 2018. Affected windows are any windows that can be accessed from the residence.

A building maintenance professional should be engaged to attach window restrictors to the affected windows. Alternatively, a secure security screen such as Crimsafe can be installed to allow the window to be fully opened. This needs to be done as a matter of urgency.

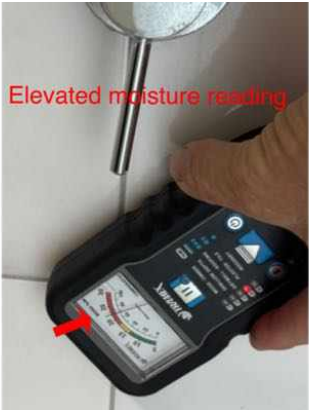
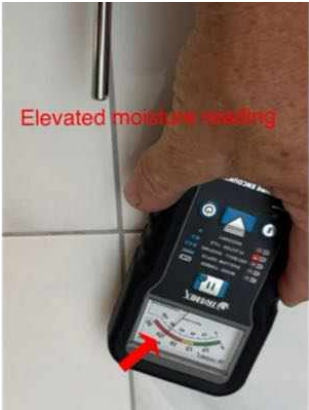
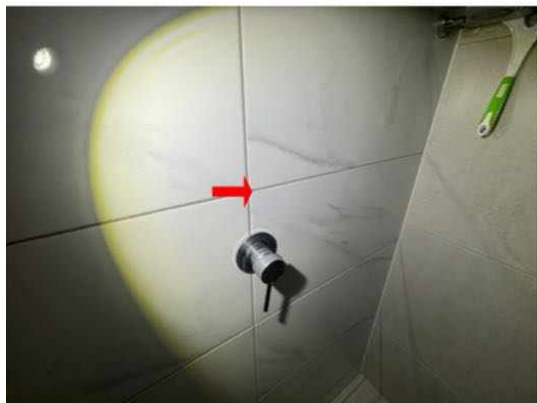
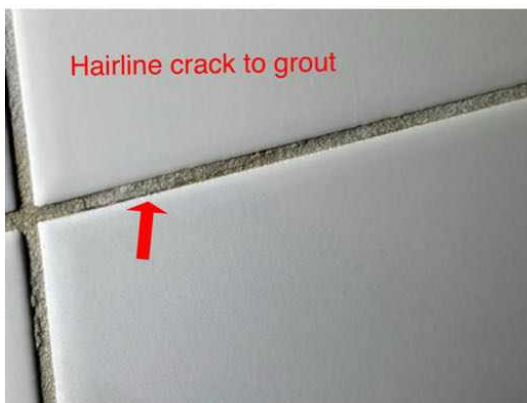
Finding 3.01

Building: Main Building
 Location: Ensuite
 Finding: Ensuite - elevated moisture reading
 Information: At the time of the inspection, it was noted that an elevated moisture reading was recorded below the mixer tap in the shower. A hairline crack was found in the grout in this area which may be allowing moisture to penetrate behind the tiles. Sustained moisture behind the tiles may affect the longevity of the tile adhesive.

Elevated moisture levels were recorded in the ensuite shower. Moisture damage was found on the left hand side of the window in bedroom 3.

A bathroom specialist could be engaged to replace the grout and apply a sealer to the shower floor and wall tiles. This should be done as a short term priority.

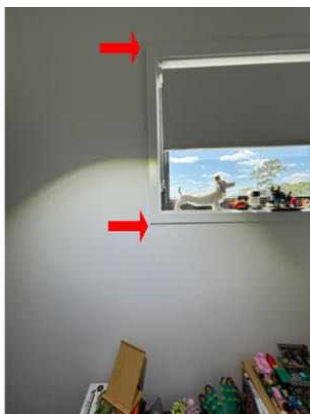
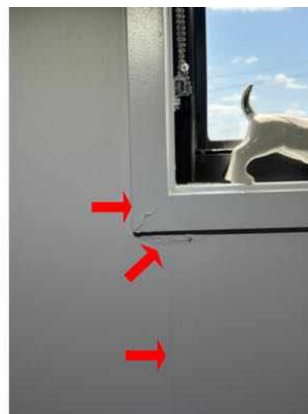
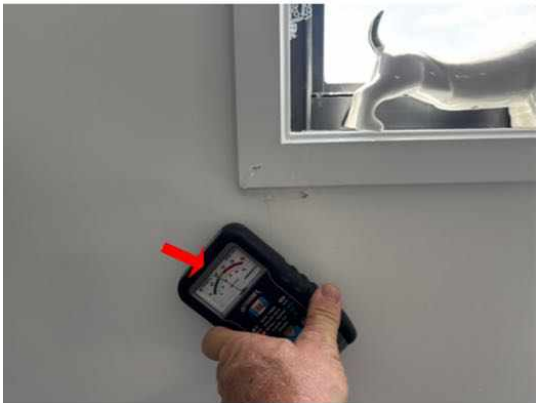
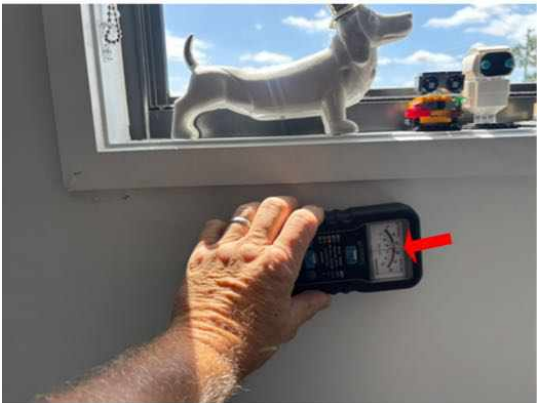
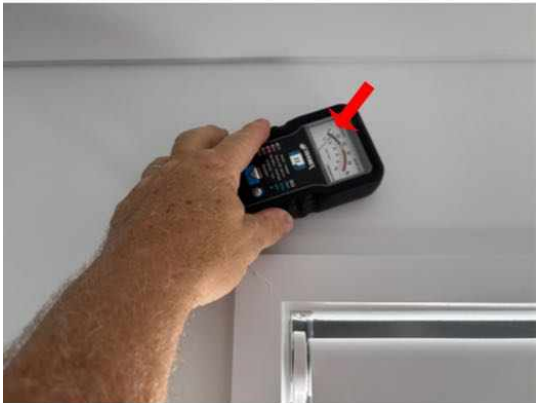
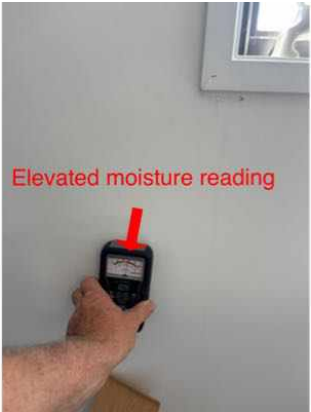
Finding 3.02

Building: Main Building

Location: Bedroom 3

Finding: Bedroom 3 - evidence of moisture damage

Information: At the time of the inspection, it was noted that there was evidence of moisture damage on the left hand side of the window in bedroom 3. Moisture staining can be seen on the wall below the window. It is understood that the body corporate is aware of the leak and has taken steps to rectify this issue by sealing the exterior around the window.

This has been noted as a minor defect due to the body corporate carrying out the necessary repairs. The client should ensure that the repairs are completed to avoid this from becoming a major defect.

Moisture in wall cavities creates a conducive environment for termite activity and can cause undetected damage to the associated building materials.

The client should monitor the area for any further re-occurrence of the water leak.

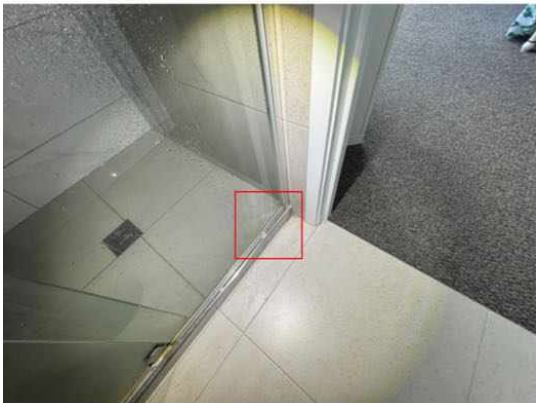
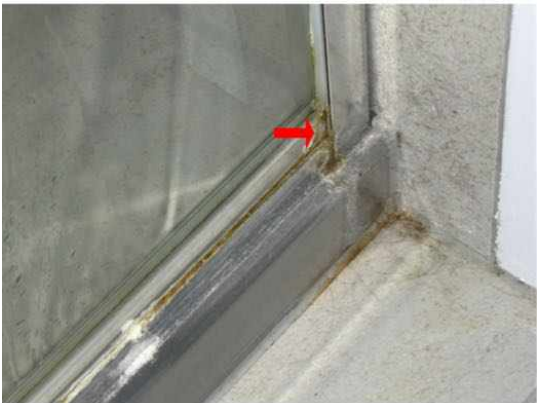
Finding 3.03

Building: Main Building
 Location: Ensuite
 Finding: Ensuite - shower screen leaking
 Information: At the time of the inspection, it was noted that the shower screen in the ensuite has a minor leak. This should be addressed to avoid the leak getting worse and potentially affecting the timber door frame.

A building maintenance professional should be engaged to apply sealant to the shower screen. This should be done as a short term priority.

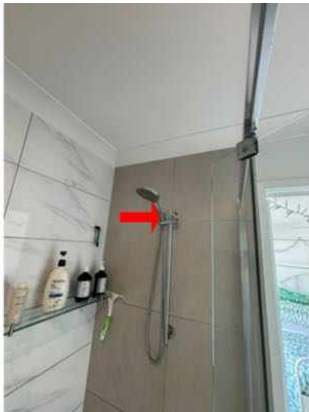
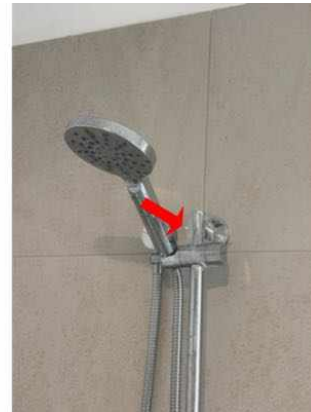
Finding 3.04

Building: Main Building
 Location: Ensuite
 Finding: Ensuite - shower rail locking mechanism not functional
 Information: At the time of the inspection, it was noted that the adjustable fitting for the shower rose was being held in place with tape. This suggests that the locking mechanism is no longer functional. This may be due to general wear and tear.

A building maintenance professional could be engaged to replace this fitting. This can be done at the clients discretion.

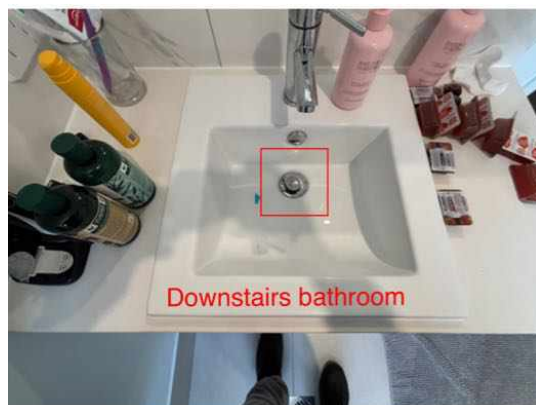
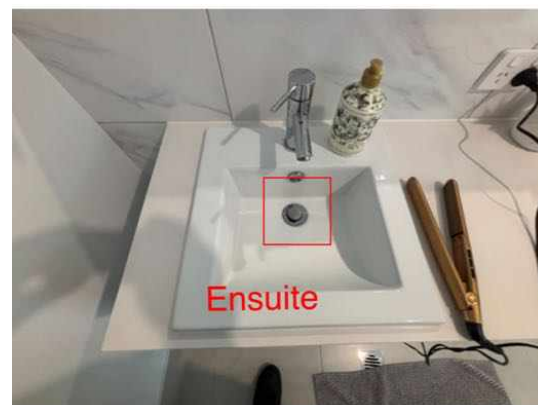
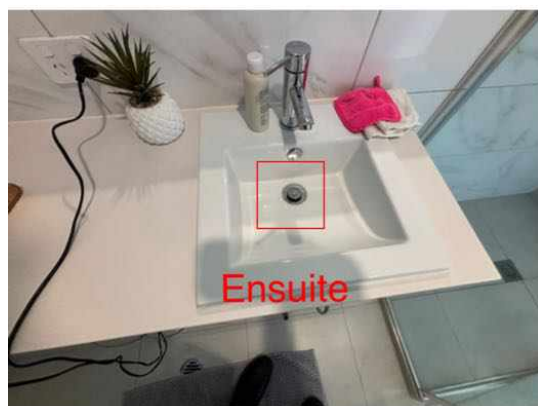
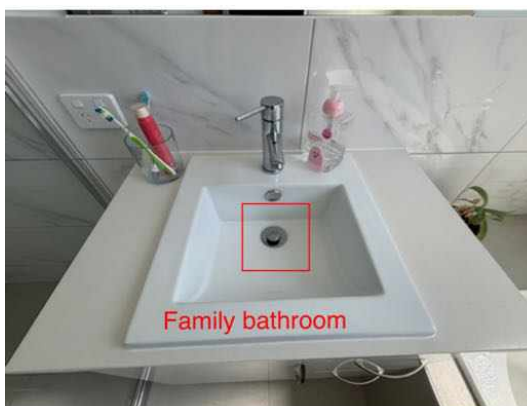
Finding 3.05

Building: Main Building
 Location: All bathrooms
 Finding: Pop up waste - stuck in the open position
 Information: At the time of the inspection, it was noted that the pop up plug waste to the vanities in all of the bathrooms were stuck in the open position. The basins cannot be filled.

A licensed plumber should be engaged to replace the pop up plug wastes. This can be done at the clients discretion.

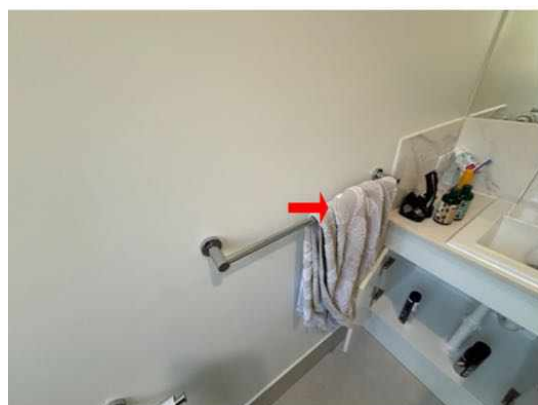
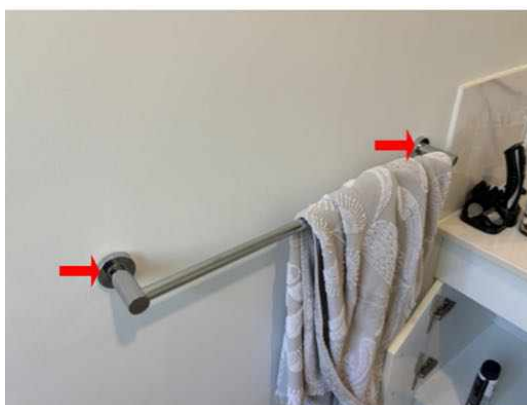
Finding 3.06

Building:	Main Building
Location:	Downstairs bathroom
Finding:	Downstairs bathroom - towel rail loose
Information:	At the time of the inspection, it was noted that the towel rail in the downstairs bathroom was loose. This appears to be from general wear and tear. If not addressed, the towel rail may come away from the wall.

This may require simple adjustment of the fasteners attaching the towel rail. A building maintenance professional could be engaged to carry out this minor repair. This can be done at the clients discretion.

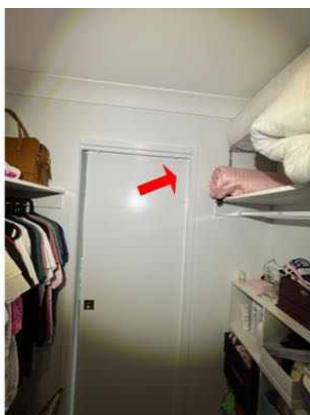
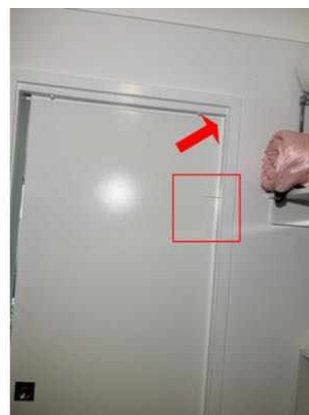
Finding 3.07

Building:	Main Building
Location:	Walk in robe
Finding:	Walk in robe - sliding door binding
Information:	At the time of the inspection, it was noted that the sliding door to the walk in robe in the master bedroom was binding at the top of the door frame. This affects the functionality of this door. Damage from a nail can be seen on the inside of the door.

A building maintenance professional could be engaged to carry out the necessary

repairs to the sliding door. This can be done at the clients discretion.

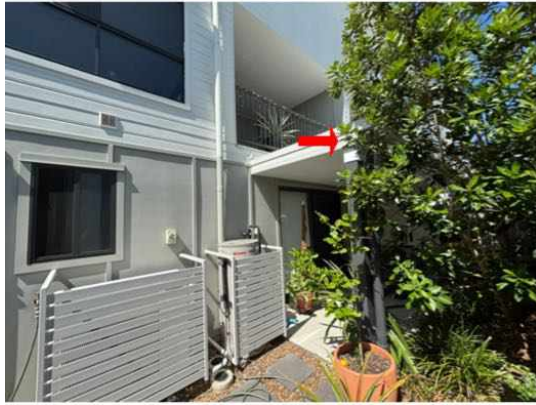
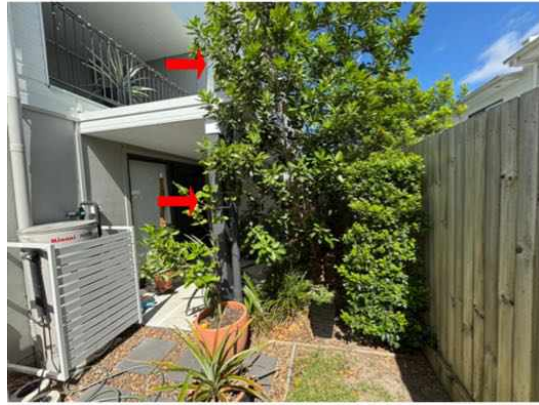
Finding 6.01

Building:	Main Building
Location:	Rear yard
Finding:	Vegetation touching the building
Information:	At the time of the inspection, it was noted that there was vegetation touching the building in the rear yard. This creates a potential access point for termites to enter the building undetected. This is a conducive condition for termite activity.

The client is to ensure that the vegetation is trimmed back to prevent undetected termite entry to the building and to provide a clear inspection area between the vegetation and the dwelling. This should be done as a matter of urgency.

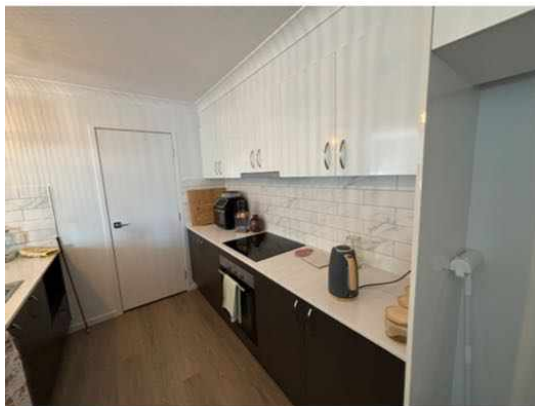
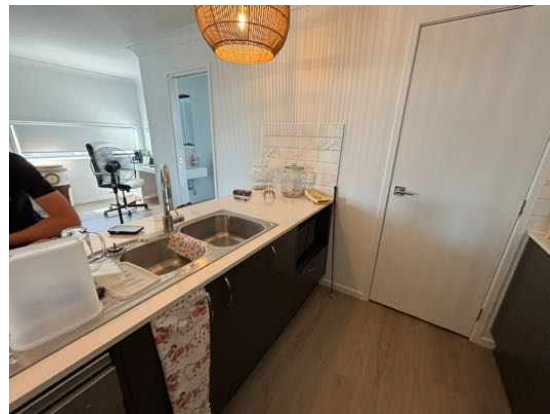
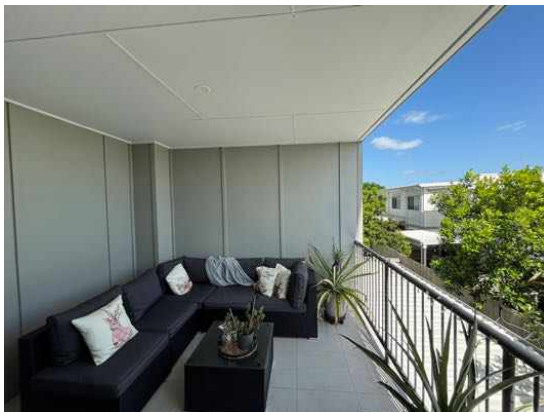
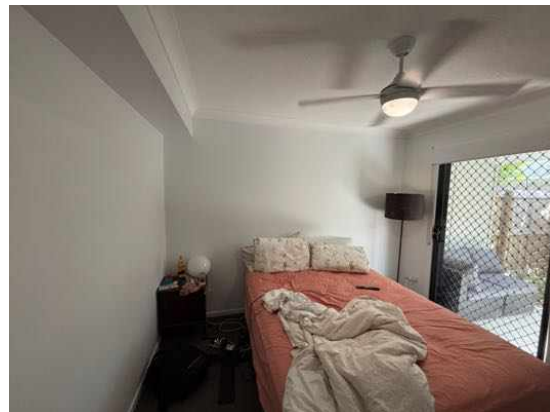
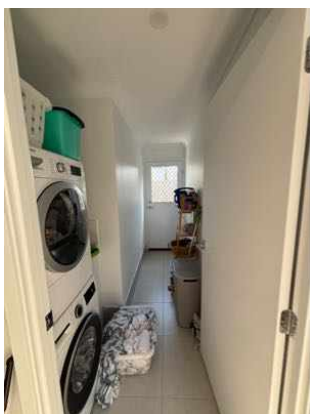
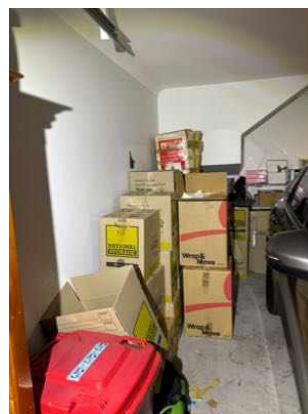
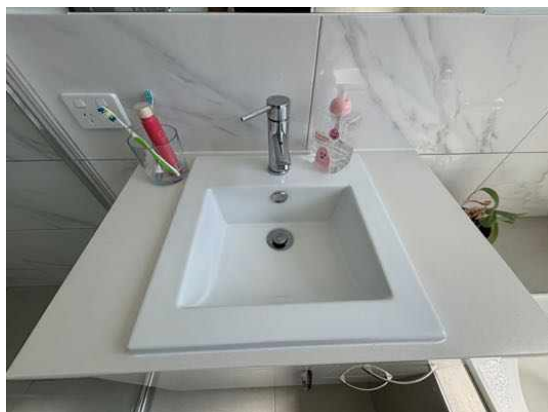
Building: Main Building
Location: All Internal Areas
Finding: Obstructions and Limitations - Internal areas
Information: These photographs are an indication of the obstructions and limitations which impeded full inspection of the property of the internal areas at the time of inspection. These obstructions can hide an array of defects and should be removed to allow full inspection to be carried out. A re-inspection is recommended once the areas are made accessible.

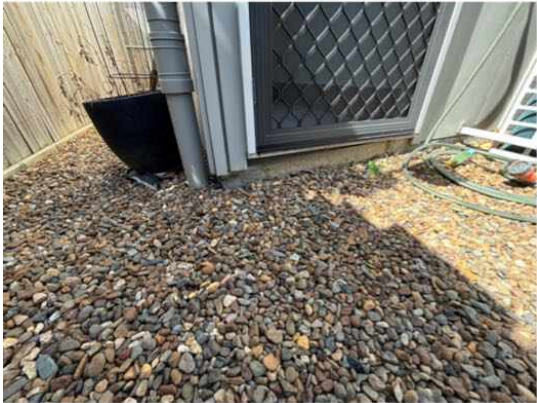
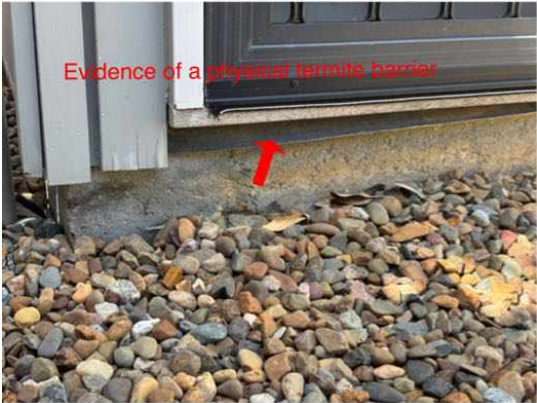
Evidence of a physical termite treatment system was found under the external laundry door. A physical termite barrier would have been installed during construction. No durable notice was found and as such the full details and date of the installation could not be determined.

Building:	Main Building
Location:	All External Areas
Finding:	Evidence of a physical termite management system was identified.
Information:	At the time of the inspection, evidence of a physical termite barrier can be seen under the external laundry door. A physical termite barrier would have been installed during construction. A durable notice was not found and as such the full details and date of the barrier installation could not be determined.

The client may wish to enquire of the body corporate as to the nature of the termite management plan for the complex and the individual townhouses. Also, are annual termite inspections being carried out and are they up to date.

A termite and timber pest technician should be engaged to carry out annual termite inspections as per AS 3660 in order to further protect the dwelling. Annual termite inspections must be carried out in partnership with any termite treatment system, physical or chemical, as no termite treatment system can be expected to be 100% effective.
