Building and Timber Pest Inspection Report

Inspection Date: Tue, 27 Jan 2026

Property Address: 12 Bean Ct, Whittington VIC 3219,
Australia

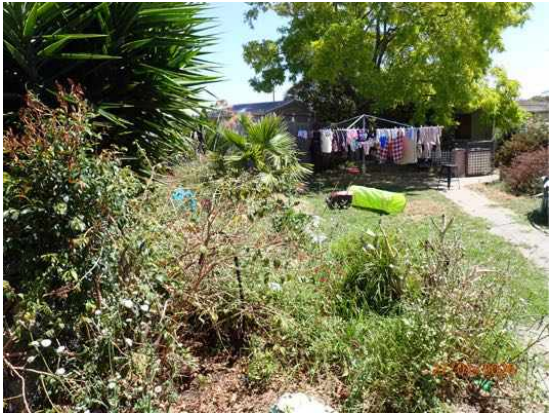
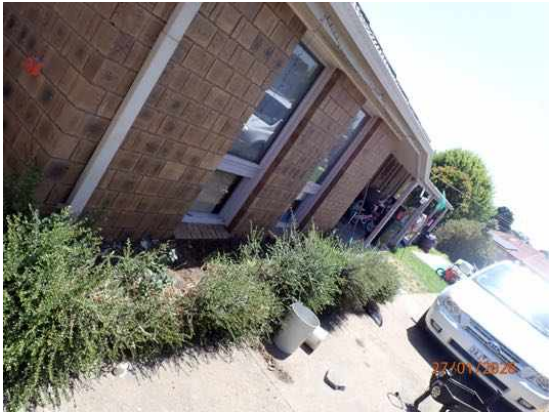
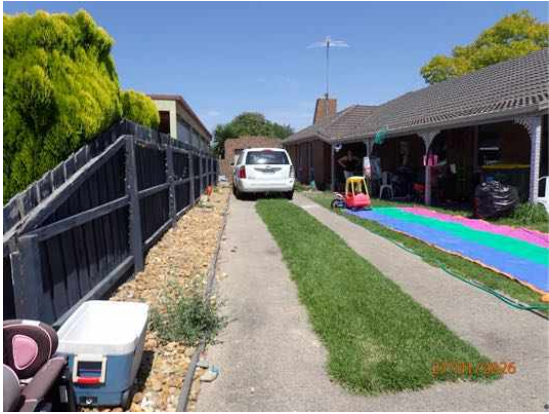
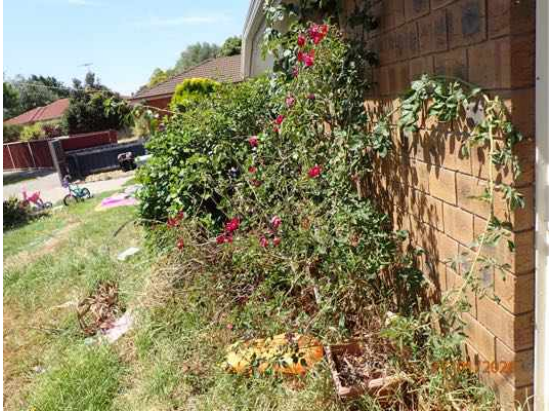
Finding 6.02

Building: Main Building
Location: All External Areas
Finding: Excessive Moisture - Identified
Information: Excessive moisture can attract termites and produce conditions that promote fungal growth and wood decay.

This is advised to be carried out as soon as possible.

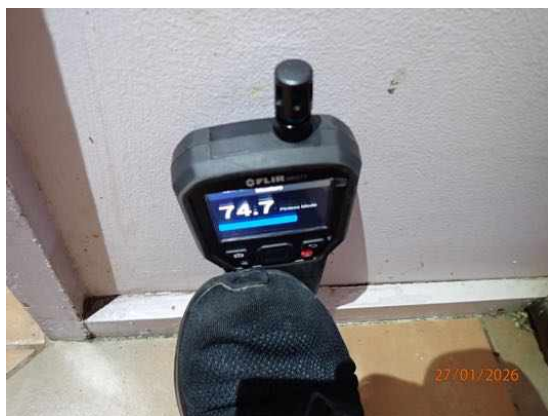
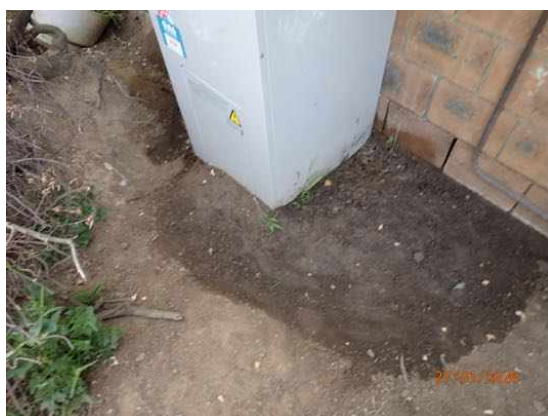
Finding 6.03

Building:	Main Building
Location:	All Internal Areas
Finding:	Wet Areas - Termite Techniques - Moisture Detected
Information:	Moisture readings was found in the walls of the wet areas which warrants further invasive investigation.

If left unattended excessive moisture can attract termites and produce conditions that promote termite attack fungal growth, wood decay.

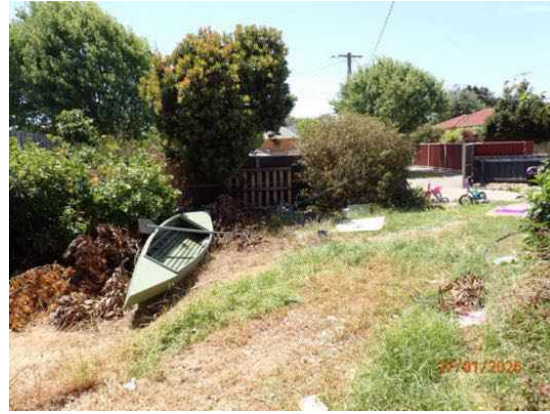
Finding 6.05

Building:	Main Building
Location:	All External Areas
Finding:	Building Materials in Direct Ground Contact - Conducive to Termites
Information:	Where timber elements are in direct contact with the ground and consequently moisture or dampness they become conducive to termite activity. Whether timber is used as a building element part of a fencing structure or stored as an unused item they can provide an environment that is attractive to termite infestation.

The removal of any such materials that may be conducive to termite activity should be removed as soon as possible to minimise the risk of termite attack. All susceptible timbers should be removed and replaced with non susceptible timber.

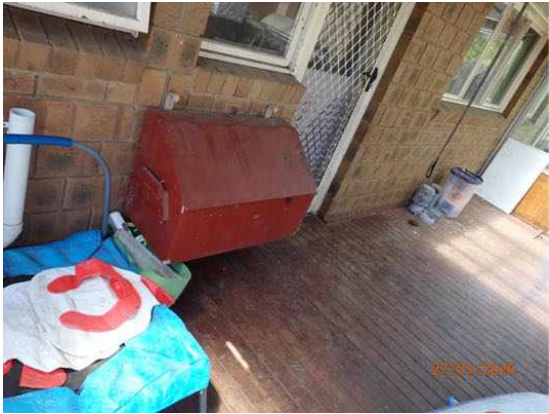
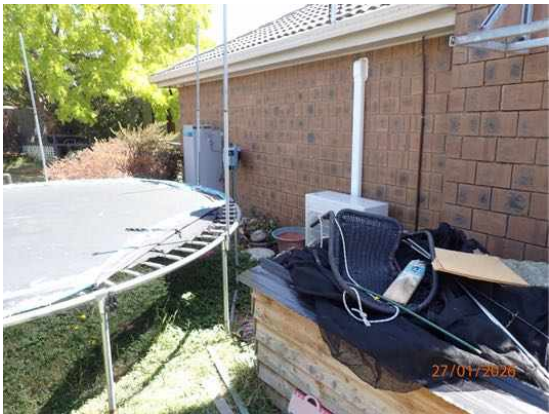
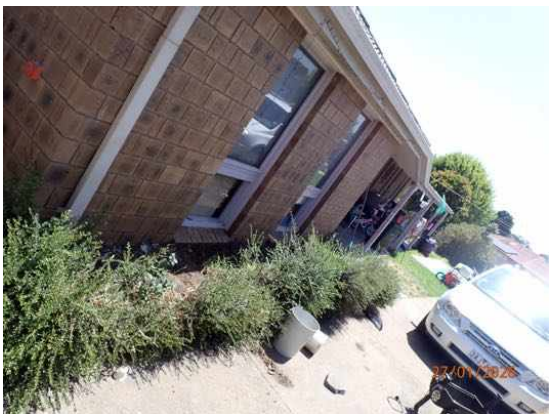
Finding 6.08

Building:	Main Building
Location:	All External Areas
Finding:	Bridging of Termite Barriers - Weep Holes
Information:	Bridging is the spanning of a termite barrier or inspection zone so that subterranean termites are provided with undetected passage over or around that barrier.

Additionally build-up of moisture is likely to occur if weep holes are covered further attracting termite activity to these areas.

It is highly recommended that weep holes are left exposed in all areas throughout the external property. Therefore if any termite activity leading into weep holes becomes easily detectable during frequent pest inspections.

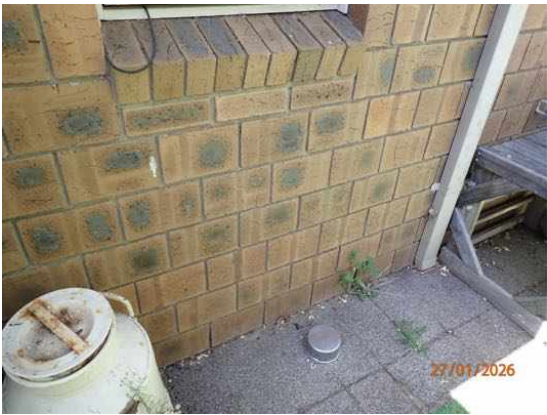
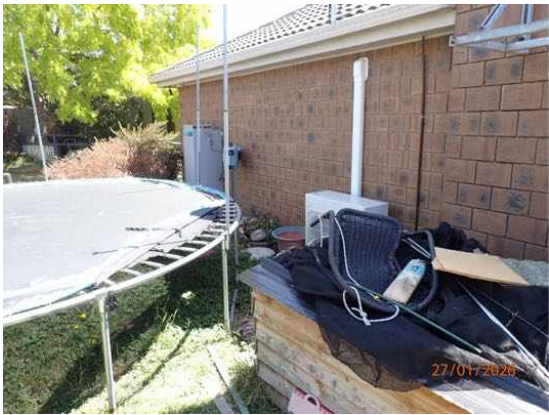
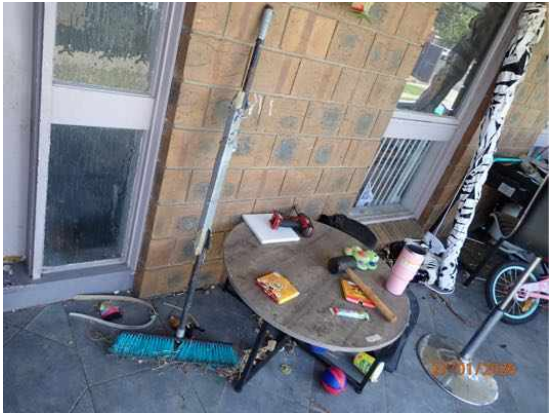
Finding 6.09

Building: Main Building
 Location: All External Areas
 Finding: Bridging - Vegetation
 Information: Where vegetation obstructs inspection of building elements, also known as bridging as it provides a bridging point for the access of termites, full inspection can not be achieved. Consequently moisture or dampness may be present and the areas becomes conducive to termite activity. Plants against or very close to buildings provide cover, shade and can provide an environment that is attractive to termite infestation.
