Building and Timber Pest Inspection Report

Inspection Date: Tue, 10 Feb 2026

Property Address: 30 Murrumba Dr, Ashmore QLD 4214,
Australia

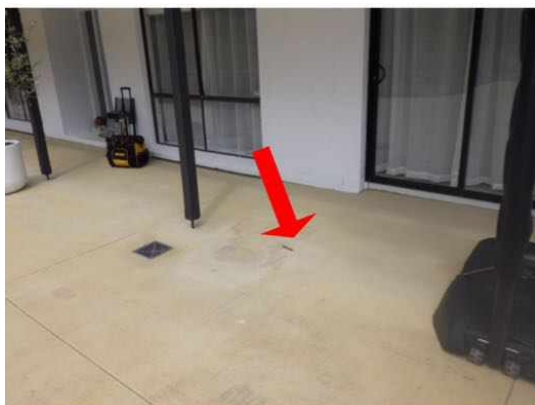
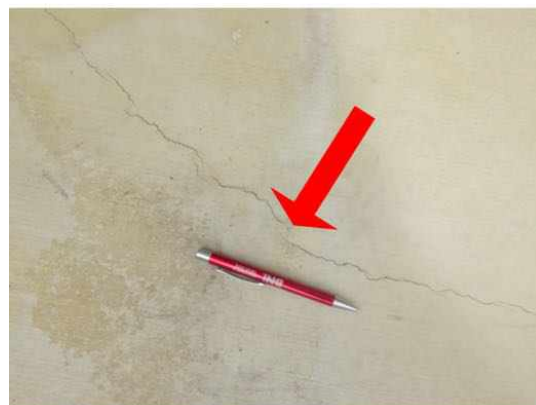
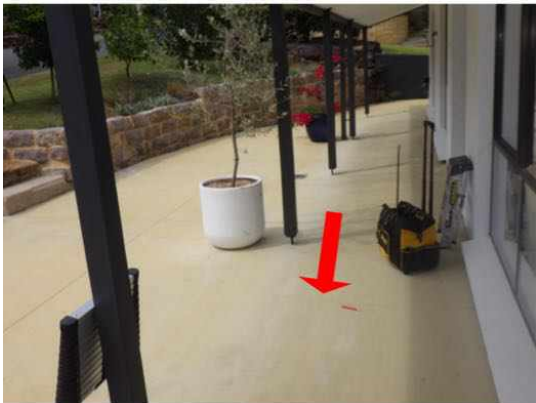
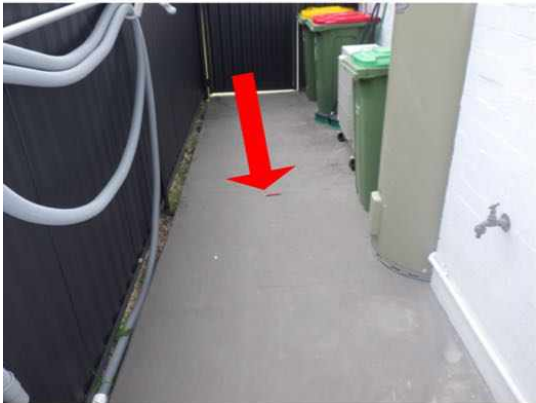
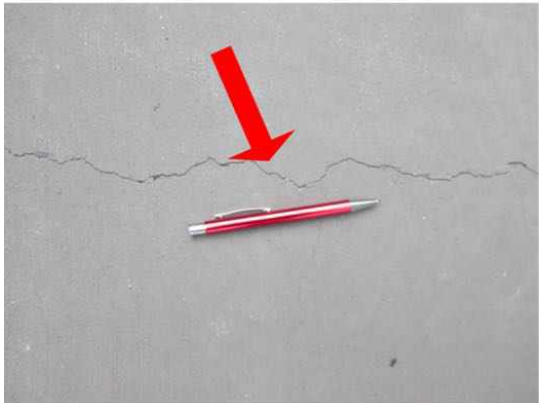
Finding 3.01

Building: Main Building
Location: Driveway > Ground Level
Finding: Cracking in concrete slab - Category 1
Information: Minor cracking coded as Category 1 was identified in the driveway and footpaths concrete slabs (as per example photos). A Category 1 crack is described as a fine but noticeable crack, with the slab at an otherwise reasonable level.

To be considered Category 1, the approximate width of the crack is less than 1.0mm, or a less than 10mm change in offset when a 3m straight edge is placed over the defect.

Category 1 cracks should be monitored for a period of 12 months. At the end of the monitoring period, identified cracks that are rated greater than Category 2 are considered defects, and require rectification.

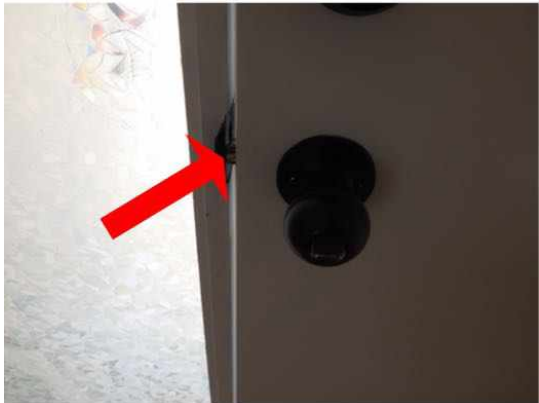
Finding 3.02

Building: Main Building
Location: Entry > Front
Finding: Door - Not latching
Information: The entry door was found to be difficult to latch at the time of inspection. Breakage occurs generally when the building materials have aged and decayed.

A qualified carpenter or general handyman could be appointed to adjust the door handle striker plate at the client's discretion.

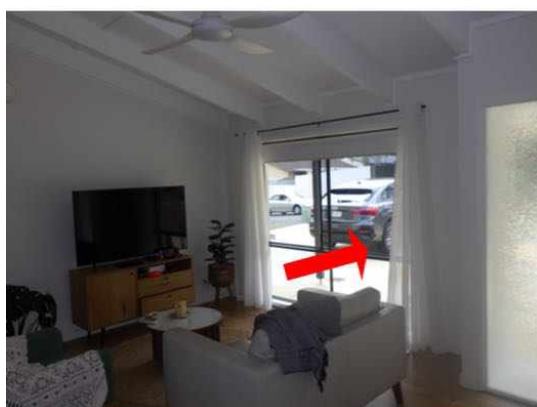
Finding 3.03

Building: Main Building
 Location: Living Room > Front Right
 Finding: Window - Stiff to Slide
 Information: The aluminium sliding window in the living room area was stiff to operate at the time of the inspection. Windows provide ventilation to the adjoining area and should be at a fully operational level to ensure user comfort. Restricted function of the window may also pose as a potential safety hazard if required for emergency egress from the building.

Generally, factors such as general age of the building element and a lack of maintenance are the usual causes for this type of defect.

An aluminium window service agent will be required to repair the affected windows.

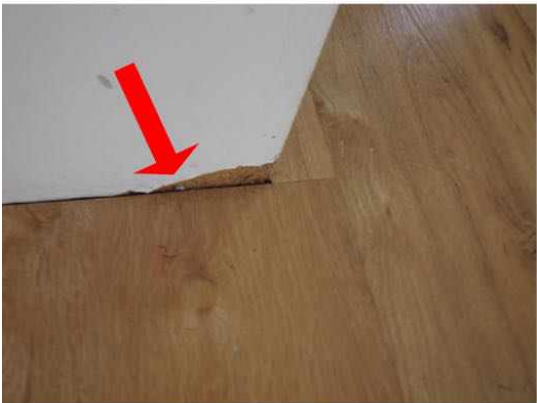
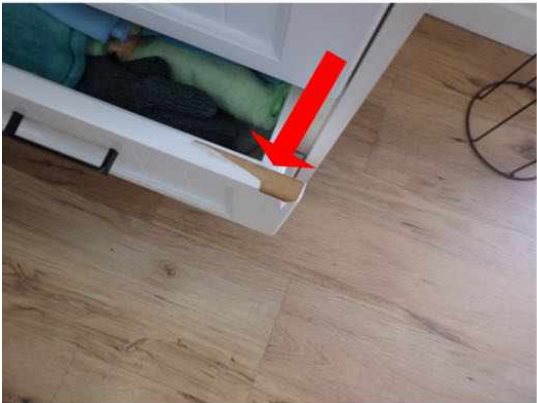
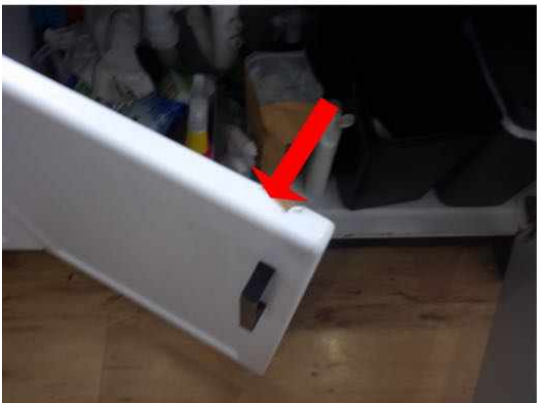
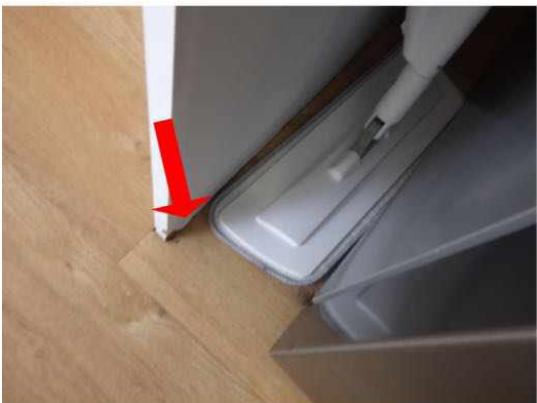
Finding 3.04

Building: Main Building
 Location: Kitchen > Existing
 Finding: Cabinetry - Deterioration
 Information: At the time of inspection the kitchen cabinetry showed signs of minor deterioration (as per example photos). The level of damage appears consistent with exposure to moisture or general wear and tear.

A qualified cabinet maker or general handyman could be engaged to undertake repair works at the clients discretion.

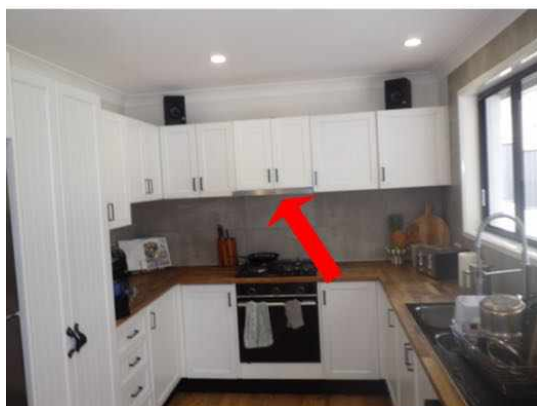
Finding 3.05

Building:	Main Building
Location:	Kitchen > Centre,Rear
Finding:	Rangehood - Light
Information:	The range hood light was not working at the time of inspection. It is advised to replace the bulb first - if still not functioning, a licensed electrician could be appointed to repair or replace the range hood to restore it to a fully operational state.

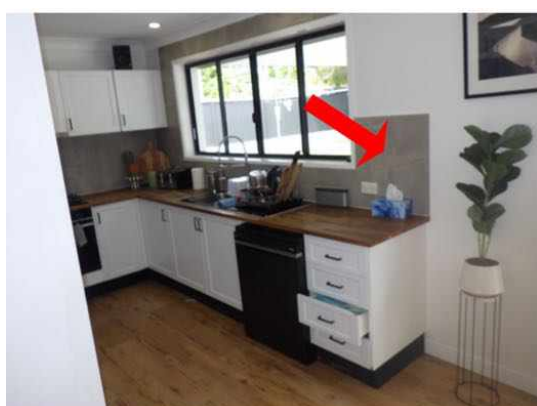
Finding 3.06

Building:	Main Building
Location:	Kitchen > Front Right
Finding:	Grout - Missing
Information:	A small section of grout is missing from the wall splash back tiles in the kitchen. Grout is used to protect gaps and crevices in building materials to ensure that they are water-tight and prevent water penetration to the associated structures.

Where grout is missing, a tiling contractor or general handyman could be appointed to undertake repair works.

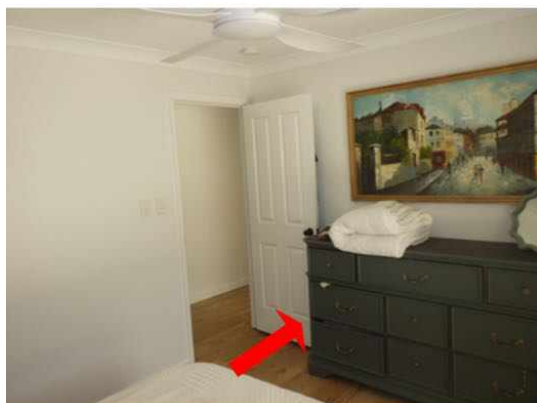
Finding 3.07

Building:	Main Building
Location:	Bedroom - Master > Front

Finding: Door stop - Missing
 Information: The main bedroom door stop is missing or is inadequate to stop the door handle from damaging the wall.

Re-installation or replacement of the door stop is advised to prevent any subsequent damage to the wall linings or associated structures.

A general handyman may be appointed to perform these works at client discretion.

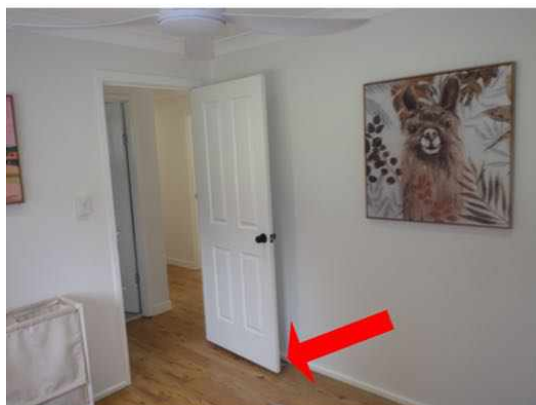
Finding 3.09

Building: Main Building
 Location: Bedroom 3 > Front Left
 Finding: Door stop -
 Information: The bedroom 3 door stop is loose or is inadequate to stop the door handle from damaging the wall.

Re-installation or replacement of the door stop is advised to prevent any subsequent damage to the wall linings or associated structures.

A general handyman may be appointed to perform these works at client discretion.

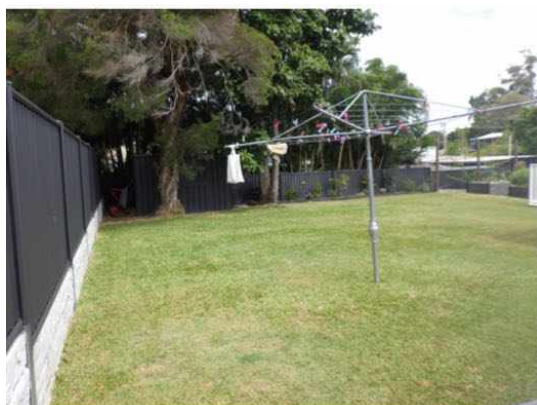
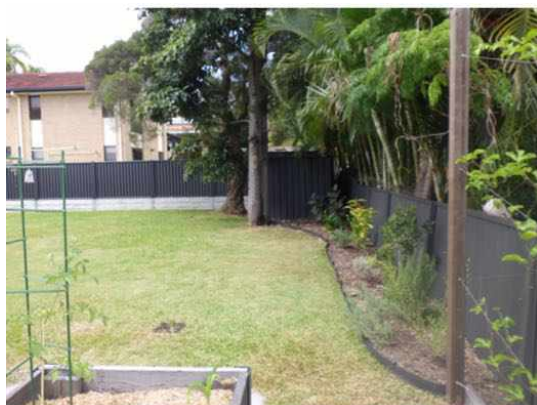
Finding 6.01

Building:	Main Building
Location:	Yard - Back > Ground Level
Finding:	Garden Beds - Conditions Conducive to Termites
Information:	Garden beds and external landscape areas were found to contain debris and garden waste at the time of inspection (as per example photos). These garden beds can include untreated timber, and with a combination of moisture from watering hosing can make conditions conducive to termite activity and termite ingress. Removal of any garden debris is highly advised. Frequent pest inspections are advised to readily identify any termite activity in these areas.

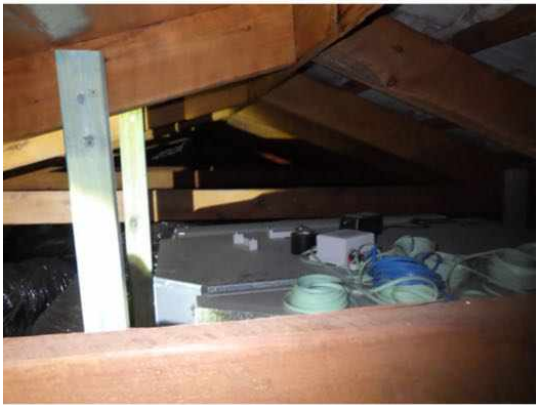
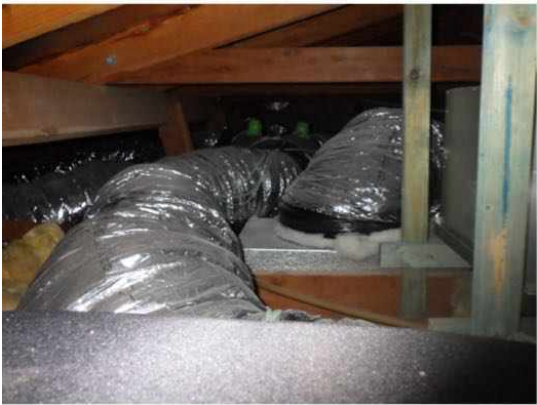
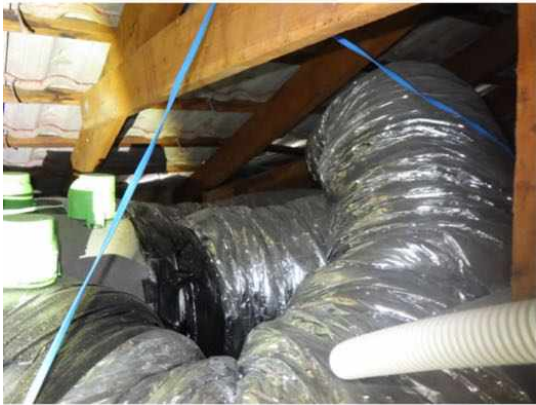
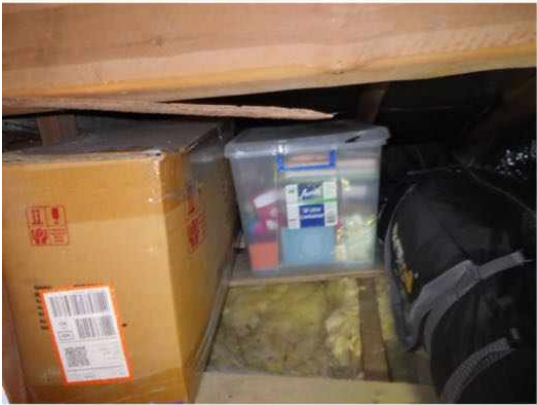
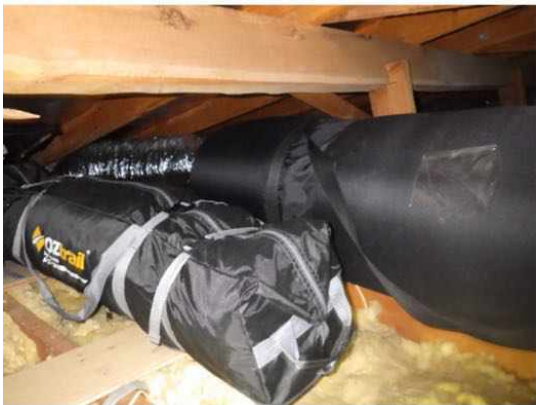
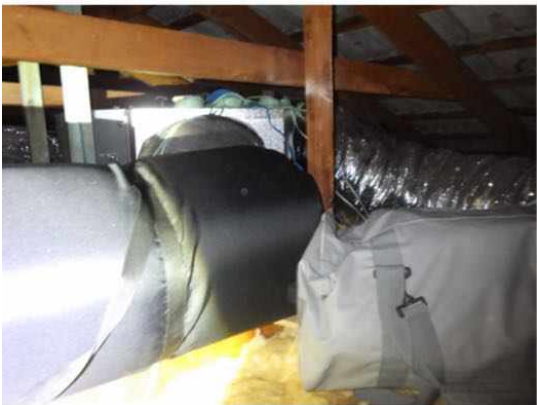
Building: Main Building
Location: Attic > Existing
Finding: Obstructions and Limitations Roof Space
Information: These photographs are an indication of the obstructions and limitations which impeded full inspection of the Roof Space at the time of inspection. These obstructions can hide an array of defects.

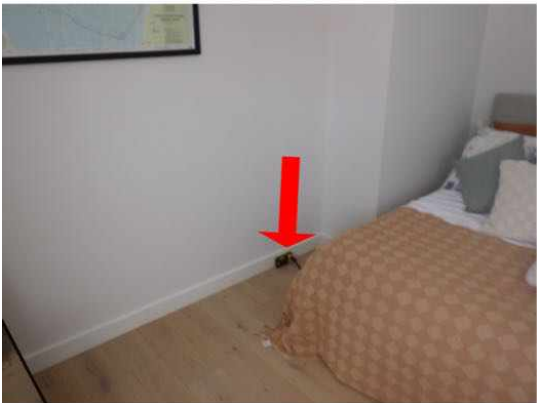
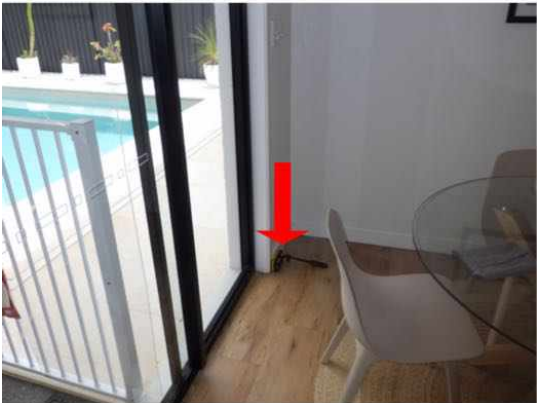
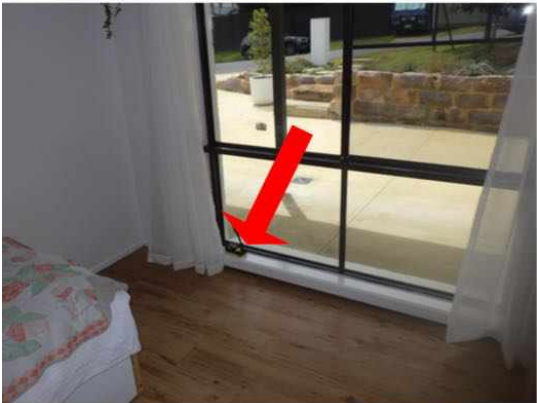
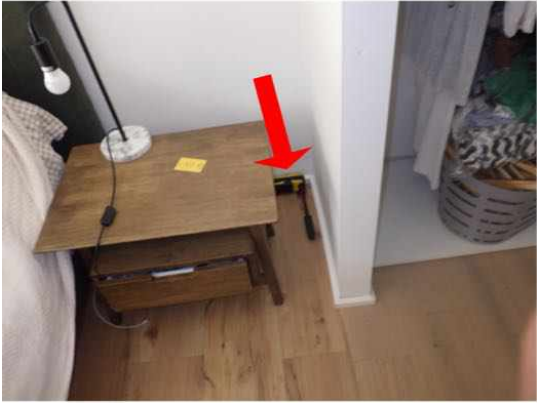
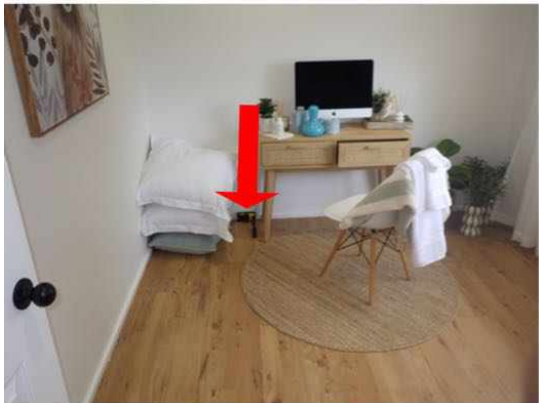
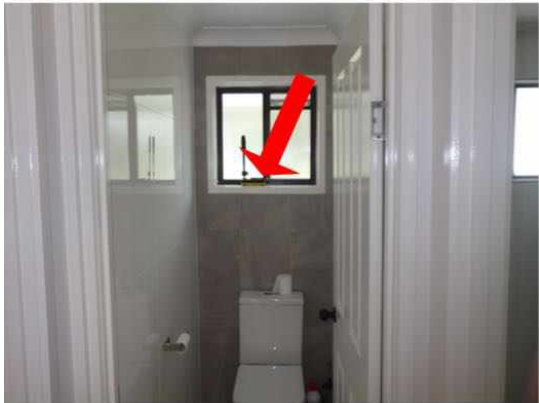
Building: Main Building
Location: Internal Areas > Existing
Finding: Termitracker
Information: The termitracker itracker was positioned randomly to internal wall, timber skirting and window frame areas checking for signs of termite activity.

No activity was recorded at the time of inspection.

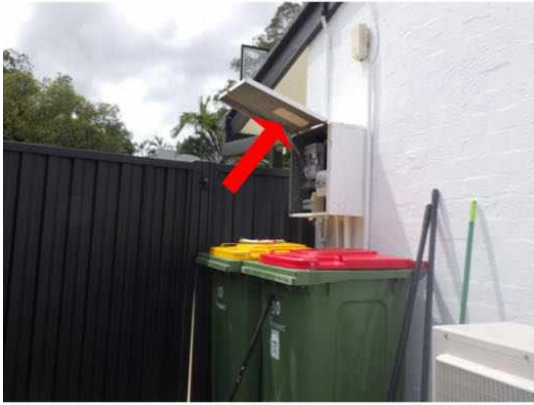
Building:	Main Building
Location:	Exterior walls - right side > Front Right
Finding:	Evidence of a previous termite management system was identified
Information:	There are a number of factors which indicate the presence of a previously installed or applied termite barrier. The most common are a durable notice (to the inside of your meter box) observable physical barriers installed to building perimeter and in ground reticulation systems.

In this instance evidence of a previously installed chemical barrier was observed, with a durable notice (expiry 8/9/2026) observed inside the electrical meter box. This system requires regular annual inspections.

NOTE - No evidence of plugged holes to the building perimeter ground area concrete slabs, generally associated with post construction chemical treatments, or regular annual inspections was found.

Where a Termite Management System has been identified you should refer to the type of barrier date of installation warranty conditions and any documentation provided by a builder or past owner.
