Building Inspection Report

Inspection Date: Tue, 27 Jan 2026

Property Address: 22 Coral Cl, Rosebud VIC 3939, Australia

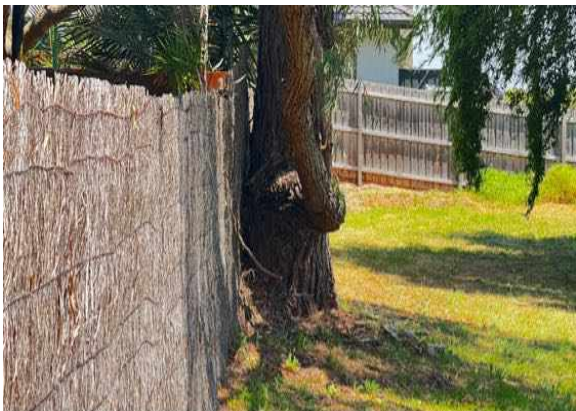
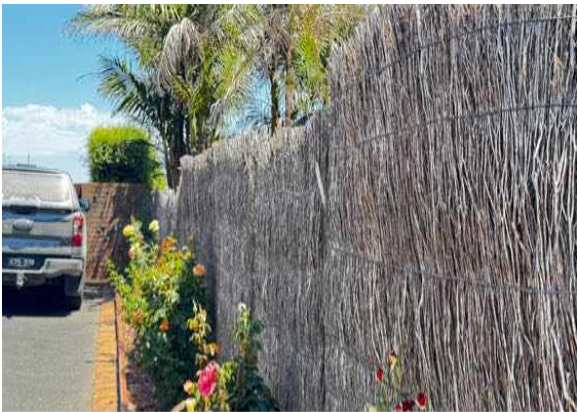
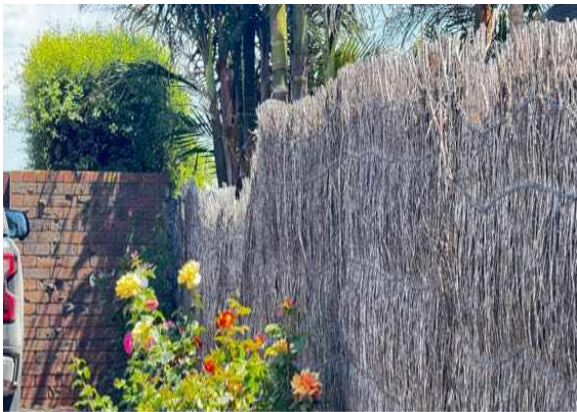
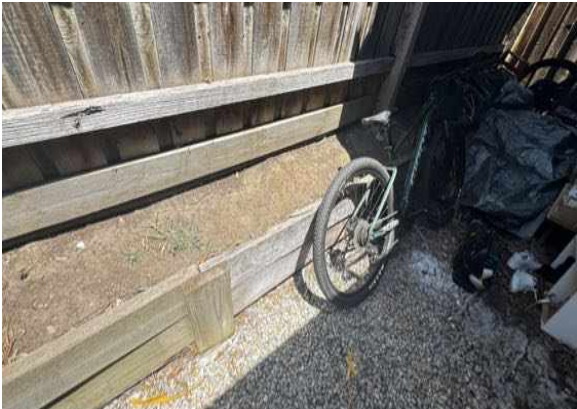
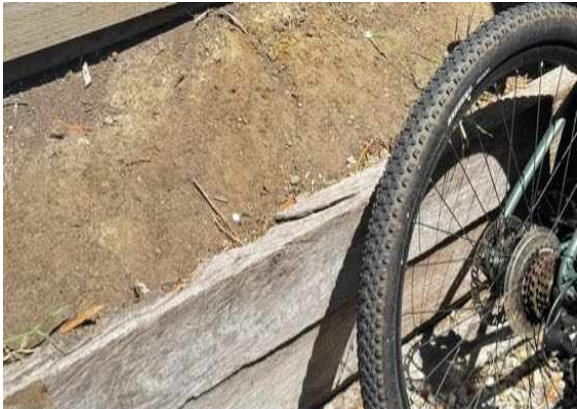
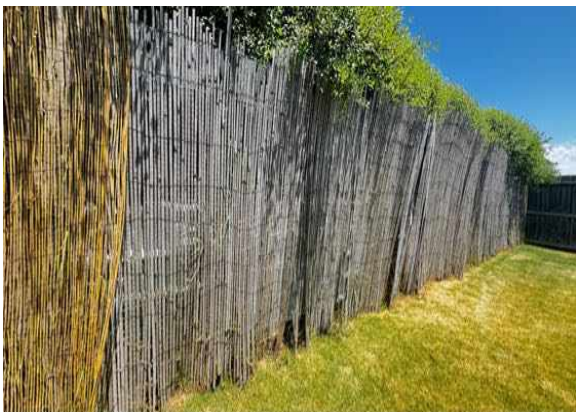
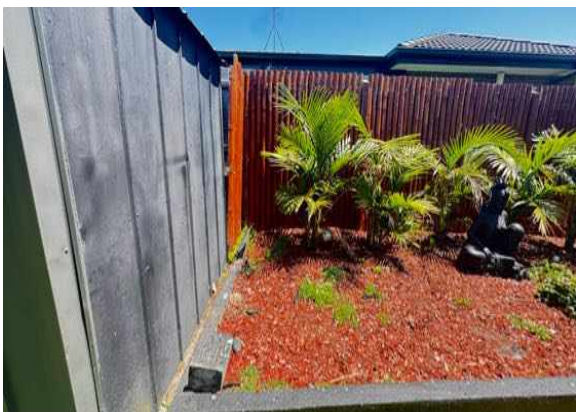
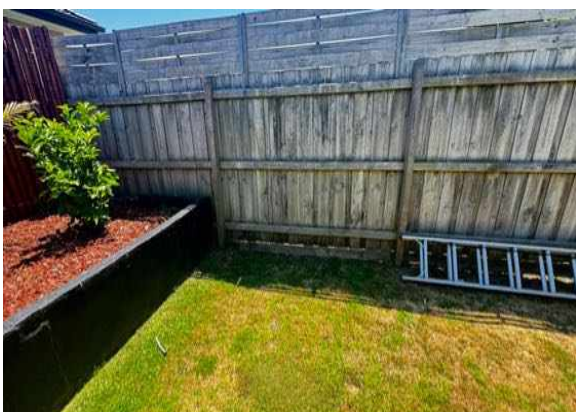
Defects 3.13

Building: Main Building
Location: Fencing All Areas
Finding: Fencing - Deteriated
Information: Timber fencing was inspected and deterioration was observed in this area. Deteriorated fencing can compromise structural stability, reduce privacy, and may allow pest ingress or accelerated decay if left unaddressed.

Possible causes include age-related timber decay, prolonged exposure to moisture or sunlight, poor maintenance, or impact damage.

When practical, a qualified carpenter or fencing specialist should be engaged to repair or replace affected sections, and a qualified painter should be engaged to restore protective finishes. Prompt rectification will maintain structural performance, improve appearance, and extend the lifespan of the fencing.

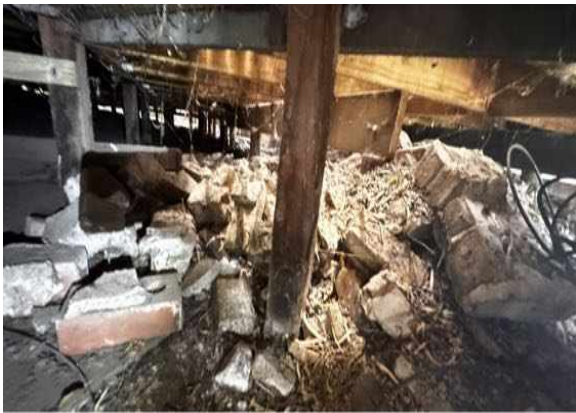
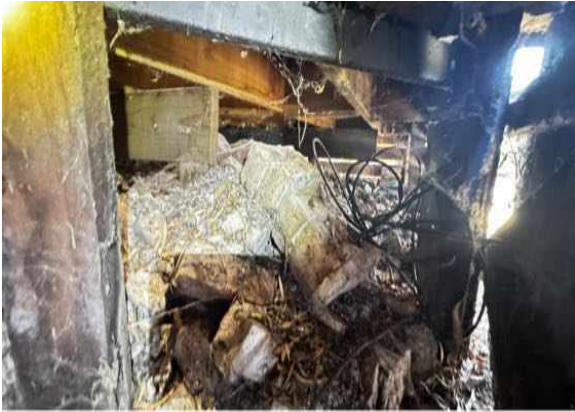
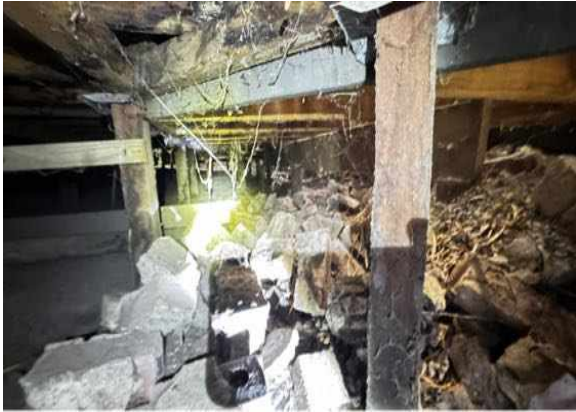
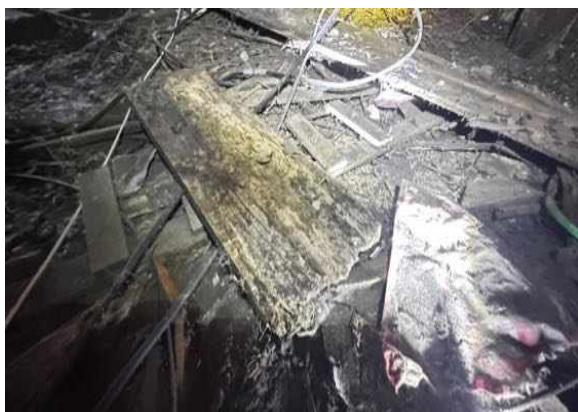
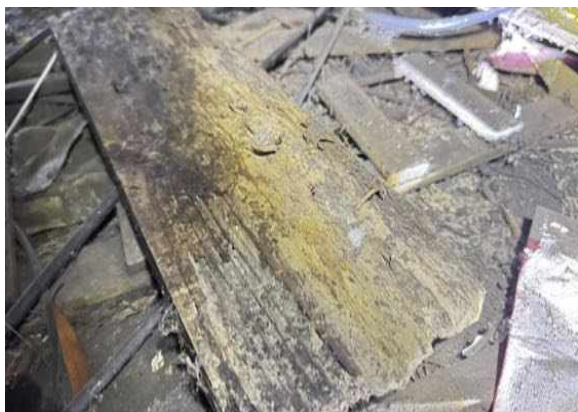
Defects 3.16

Building: Main Building
Location: Subfloor
Finding: Sub - Floor - Stored Items, Rubbish & Debris
Information: The subfloor was observed to contain stored items, rubbish, and debris. The issue is present where clutter restricts access and covers surfaces beneath the building.

This has likely occurred due to accumulation of materials over time or inadequate cleaning. Excess items can conceal defects, restrict inspections and maintenance, increase pest activity, and create fire or safety hazards.

This observation is provided for information only. When practical, a competent handyman should be engaged to remove all rubbish and clear access to ensure safe inspection, maintenance, and ongoing monitoring of the subfloor.

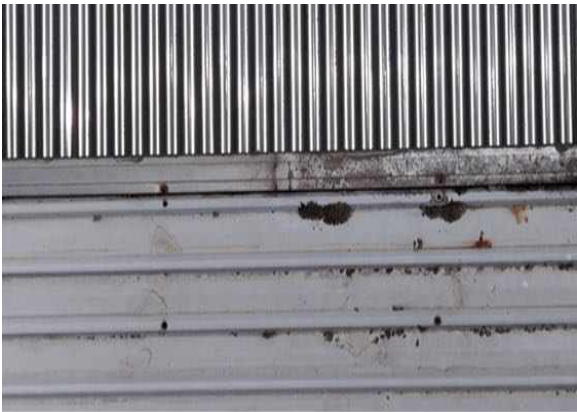
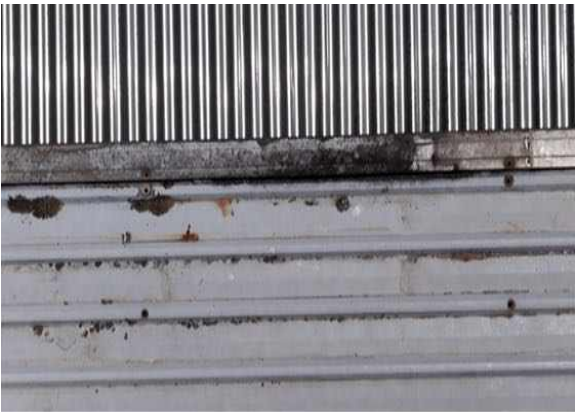
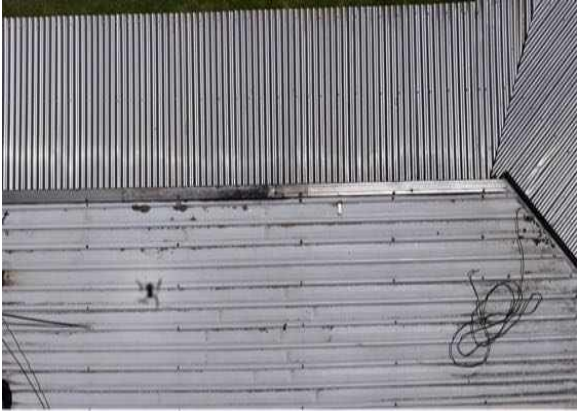
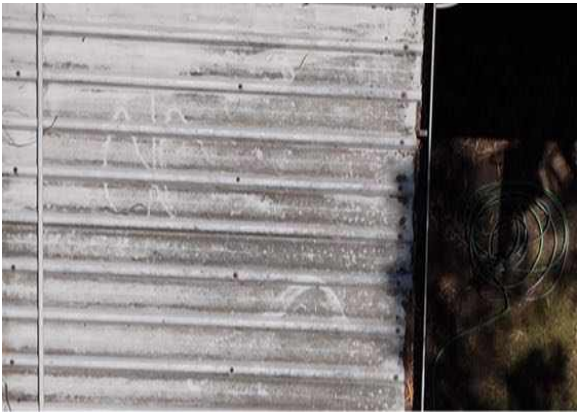
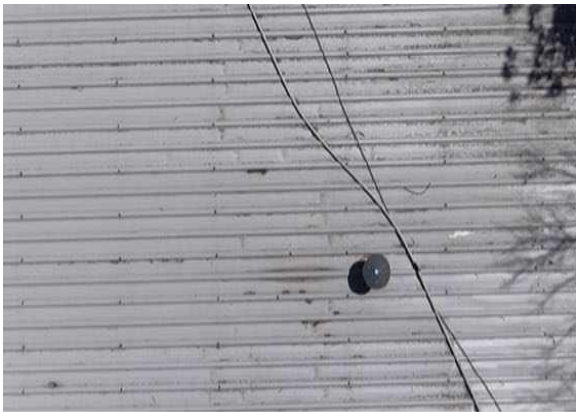
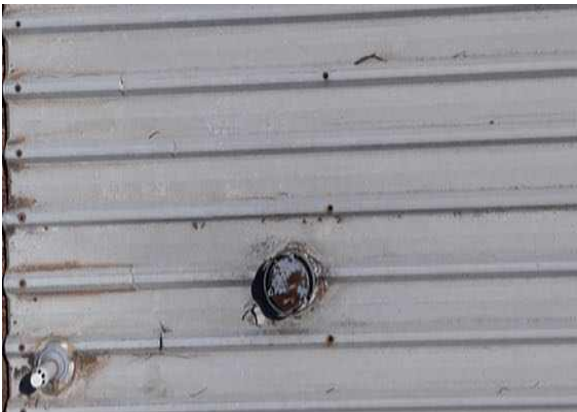
Defects 3.17

Building:	Main Building
Location:	Roof Exterior
Finding:	Roof Plumbing - Rusted & Corroded
Information:	The roof plumbing has areas of rust and corrosion. It is suspected that this has been caused by blockages, resulting in pooling or standing water, that have prematurely rusted elements of the roof plumbing.

Rusted roof plumbing will generally develop holes and leaks that can affect other building elements with poor drainage of storm water. Poorly drained roof areas will also lead to damp conditions surrounding the base perimeter of the building which, if left unmanaged, can lead to a range of secondary building defects.

Repair and/or replacement of rusted roof plumbing is required in order to reinstate the roof drainage system to a fully operational level. To further maintain these areas, gutters should be cleaned frequently, allowing the avoidance of any partial blockages.

A licensed plumber or specialist roof restoration company should be appointed to undertake these works. It is advised that such works be completed as soon as possible to prevent any further damage and deterioration.

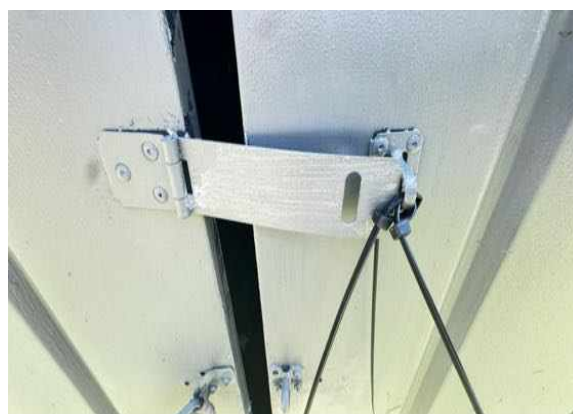
Noted Item

The shed does not appear to compromise the primary dwelling structure but may reduce usability, weatherproofing, and amenity. This deterioration is likely due to age, exposure to weather, and a lack of regular maintenance.

When practical, a competent hand man should be engaged to repair or replace damaged, missing, or weathered components. Rectification will restore functionality, durability, and weatherproofing of the shed.

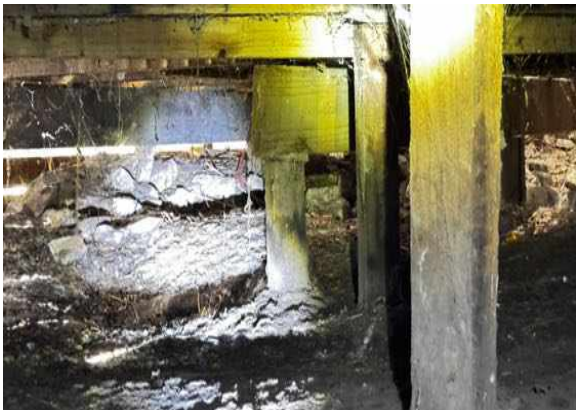
Noted Item

Building: Main Building
 Location: Subfloor
 Finding: Sub Floor - Limited Access
 Information: The subfloor area was observed to have restricted, limited and difficult access. The issue is present where limited space and obstacles prevent safe entry and movement beneath the building.

A registered builder is required to assess and improve subfloor access. This should be addressed as soon as possible to ensure safe entry, proper inspection, and maintenance of the subfloor.

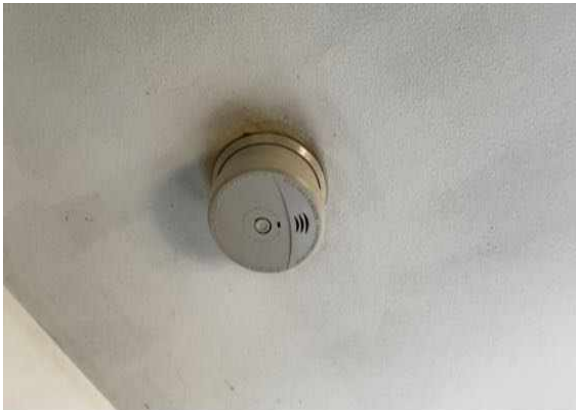
Noted Item

Building: Main Building
Location: All Internal Areas
Finding: Smoke Detectors - Advisory

Smoke detectors are critical life-safety devices, and non-compliant, outdated, or non-operational units may not provide adequate warning in the event of a fire.

It is recommended that a licensed electrician be engaged immediately to test, service, and upgrade smoke detectors as required to ensure correct operation and compliance with current safety requirements.
