# Building and Timber Pest Inspection Report

Inspection Date: Fri, 27 Mar 2026

Property Address: 49 Klicitat Ln, Lima VIC 3673, Australia

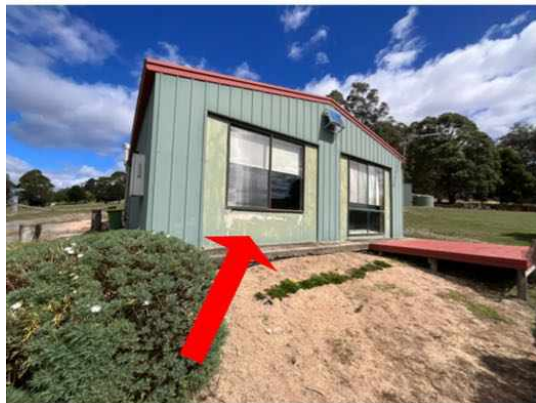
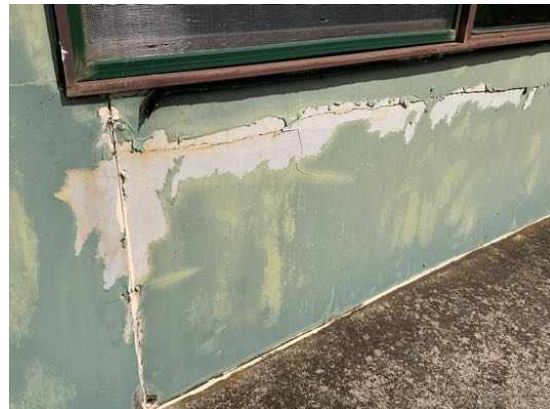
#### Finding 3.01

Building: Building 1  
 Location: Shed  
 Finding: Cladding- deteriorated  
 Information: The external cladding shows signs of damage in several areas. Although not serious at this point, monitoring should be undertaken at intervals to ensure no further damage occurs.

A cladding specialist or handyman could be contacted as needed to patch any damage to prevent further deterioration.

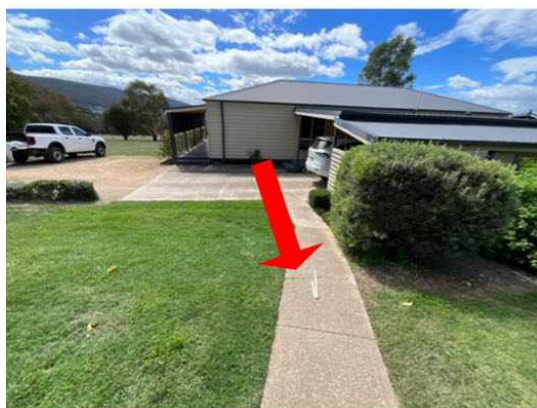
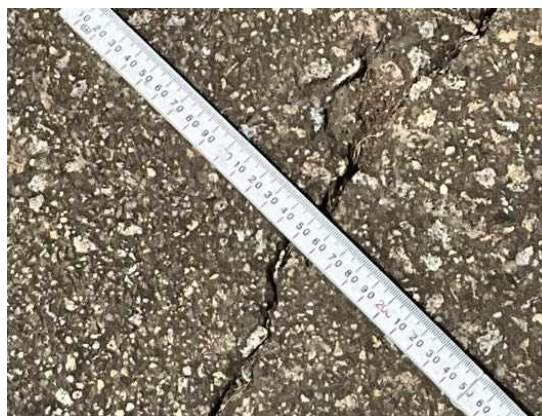
#### Finding 3.02

Building: Building 1  
 Location: Yard - Back  
 Finding: Cracking - External Concrete Paving Damage Category 3 - Wide Cracks (2mm - 4mm)  
 Information: Wide cracks were identified in external concrete paving. Wide cracks are significant and are likely to lead to the development of safety hazards and secondary defects if left unmanaged.

General age and expected deterioration of the paved areas is a common cause of this

type of cracking. However, expansion and contraction of the slab may also have occurred due to environmental factors. Such factors include variable moisture and weather conditions, the presence of trees and their roots having a settling or lifting affect on the soil, or the effect of load bearing, e.g. heavy vehicles over a sustained period of time.

Cracking to this degree may also be due to poor original installation of the concrete. Factors such as poor compaction of the sub surface and/or inadequate reinforcing of the slab may create cracking and other secondary defects. Wide cracks may also have a more significant structural cause, such as subsidence of soils.

Where the crack is located adjacent to structural elements of the building, the advice of a Structural Engineer is advisable before undertaking repairs. Significant repair and likely replacement of the concrete paving is probable.

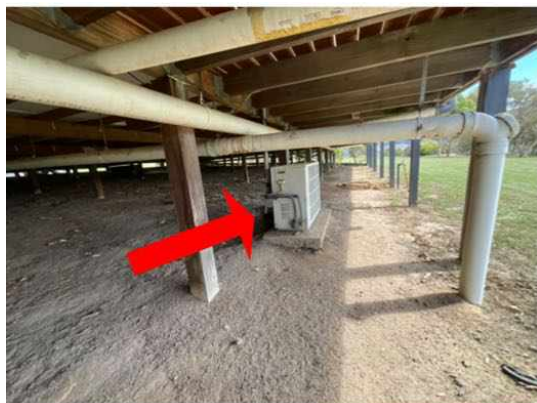
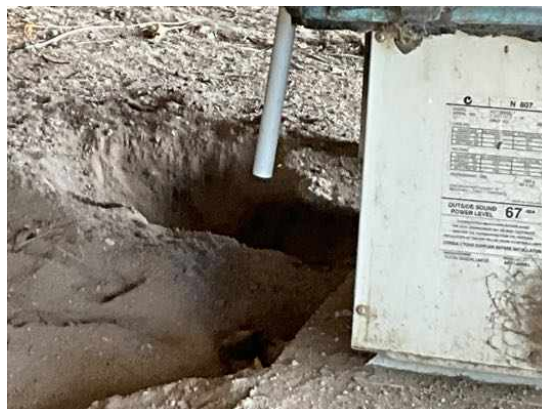
### Finding 6.01

| Building: | Building 1 |
| Location: | Subfloor |
| Finding: | Air conditioner - Disconnected overflow |
| Information: | The Air Conditioner (A/C) overflow was found to be disconnected from storm water drainage and is creating excessive moisture in the surrounding area. |

Such leaking creates an environment which is conducive to an array of defects, including water damage to associated building elements and the attraction of termite or timber pest infestation.

It is highly recommended that a licensed plumber be appointed to connect the A/C overflow in order to prevent such an environment from being created. These minor works should be carried out as soon as possible.

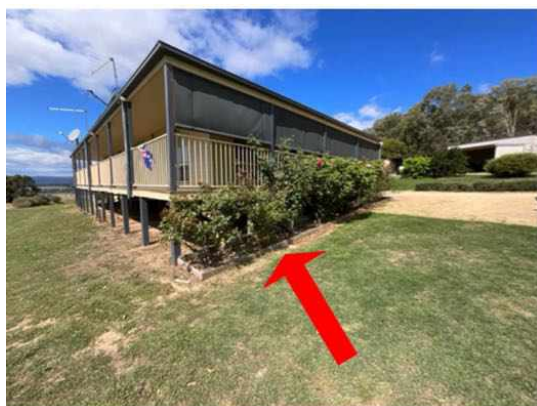
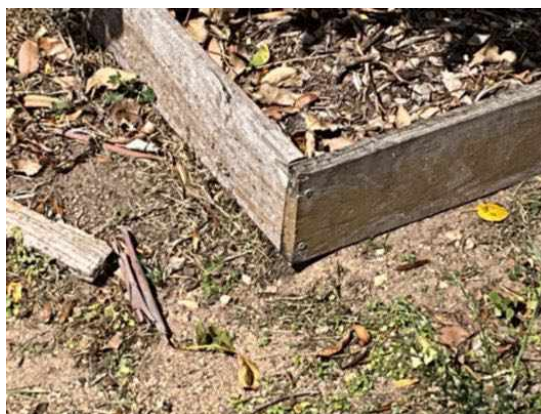
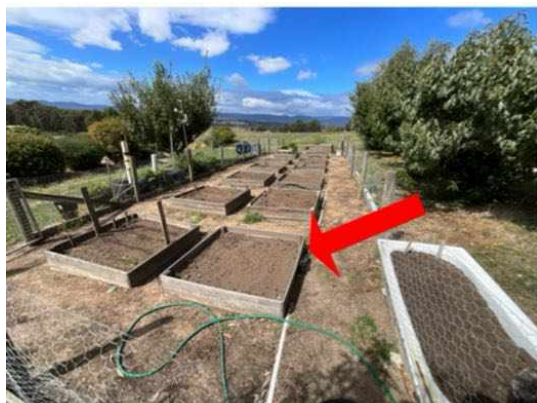
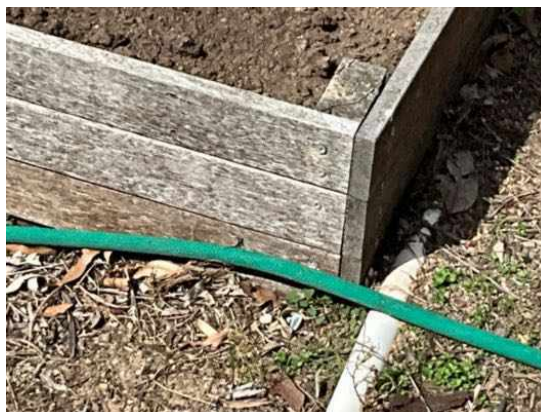
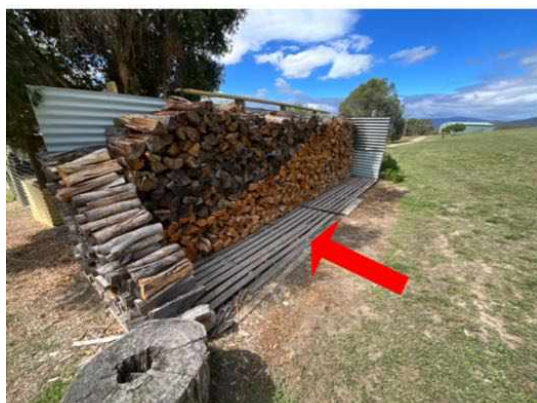
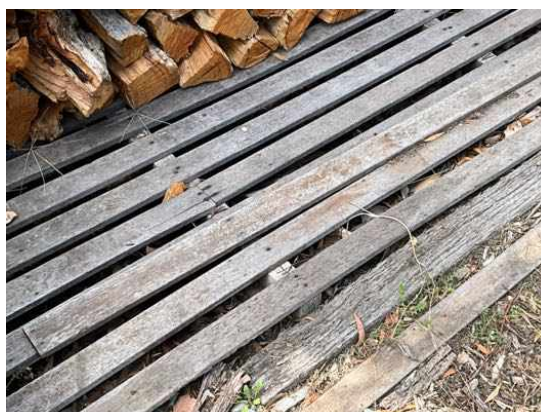
## Finding 6.02

| Building: | Building 1 |
| Location: | Yard - Side, back |
| Finding: | Untreated or non-durable timbers in a hazardous environment |
| Information: | To reduce the risk of timber pest attack it is essential that timber used in a hazardous environment (e.g. in direct contact with the ground or frequently exposed to damp conditions) is of sufficient durability and/or is adequately preservative treated. |

Untreated timbers in direct contact with the ground are likely to develop severe wood rot and/or fungal decay if left unattended creating attraction for subterranean termites to infest the timbers from surrounding areas.

If untreated or non-durable timbers are found to be in a hazardous environment it is highly advised that replacement of these building elements be performed as soon as possible to aid the protection of the property against termite / timber pest attack.

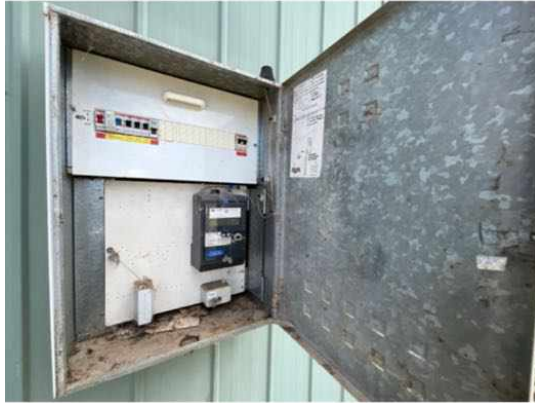
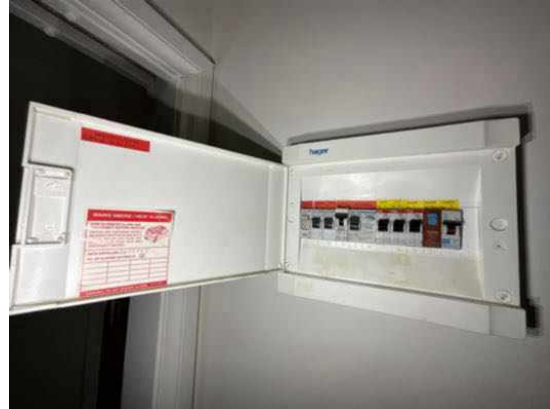
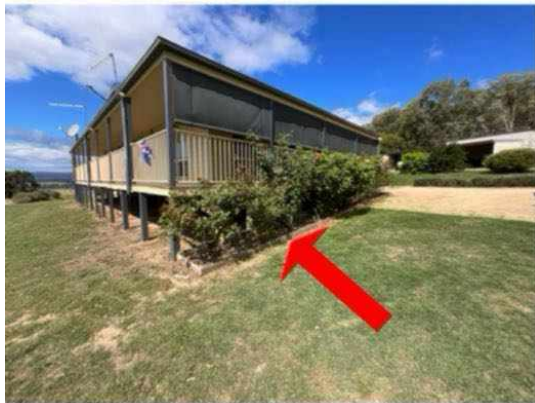
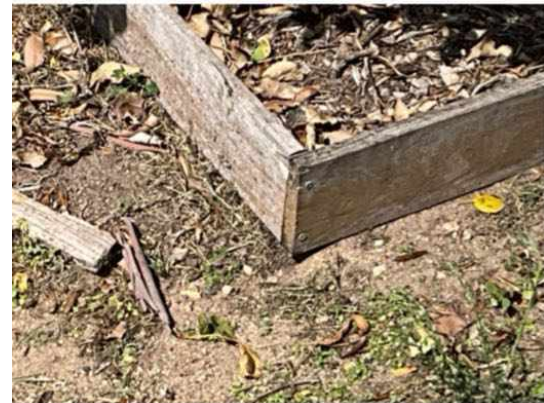
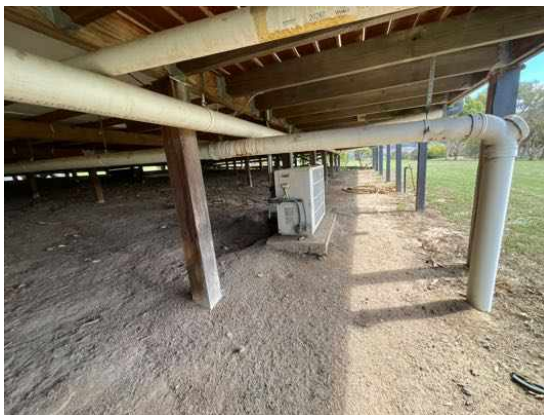
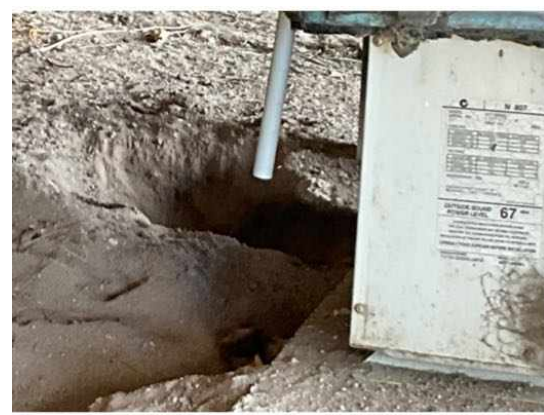
### Finding 6.03

| Building: | Building 1 |
| Location: | All External Areas |
| Finding: | Termite Management System - no evidence of a chemical installation |
| Information: | The application of a post-construction chemical termite barrier is highly recommended for all properties, particularly if live termite activity has been found on the site previously. Such barriers are highly effective in preventing termite attack on any timber building elements throughout the property. |

A durable notice should be placed in the switchboard unit to indicate current termite barriers. At the time of inspection, it appeared as though no termite management system has been installed, with no evidence to suggest preventative works taking

place.

The client may consider gaining further advice from a pest controller as to the costs and procedures involved with this application. It is recommended that obtaining such advice be a short-term priority.

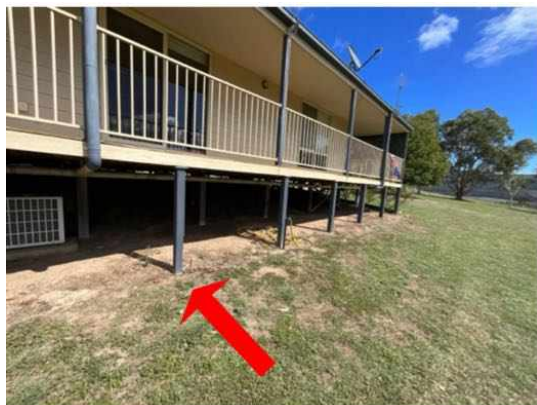
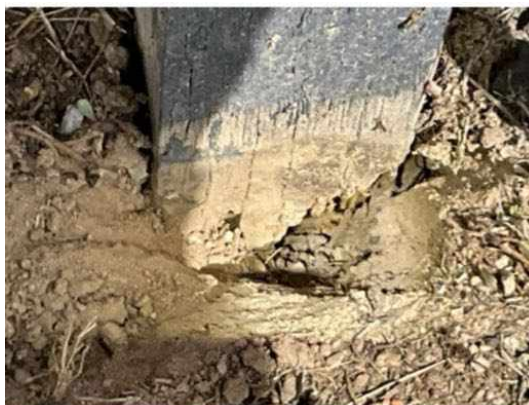
### Finding 7.01

Building: Building 1

Location: Verandah  
Finding: Fungal decay - present (localised)  
Information: Fungal decay also known as wood decay or wood rot generally refers to the deterioration of timber elements when in contact with excessive levels of moisture for a prolonged period of time.

The development of fungal decay is accelerated by temperatures in the range of 5degreeC to 40degreeC as well as the presence of oxygen. Generally fungal decay develops on timber elements that are in use in an external environment which are exposed to rain penetration.

In this case although the affected timber element is in a decaying state the extent of any visible damage appears to be localised to a specific area and is yet to spread to other parts of the building element or affect adjoining structures. The fungal decay is therefore likely to be of a relatively superficial nature with minimal impact on the structural integrity or tensile strength of the timber element.

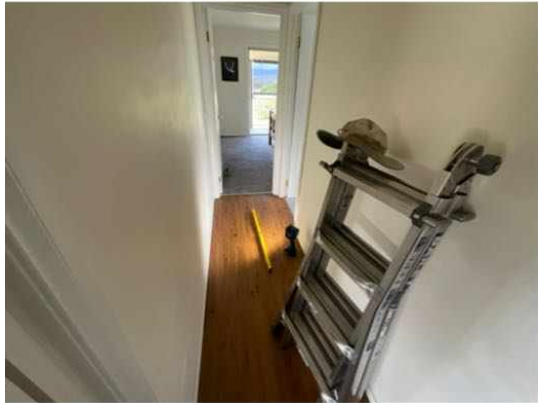
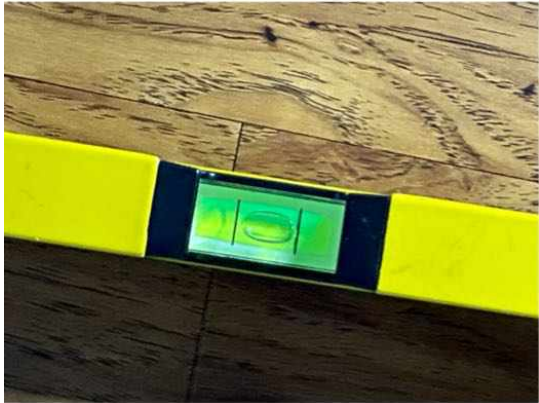
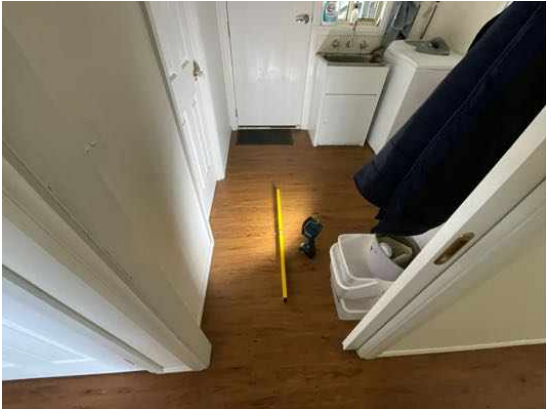
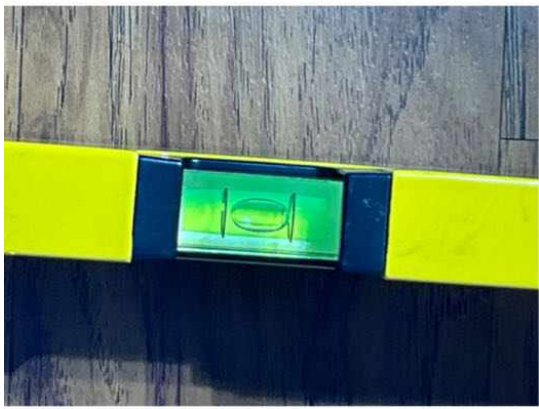
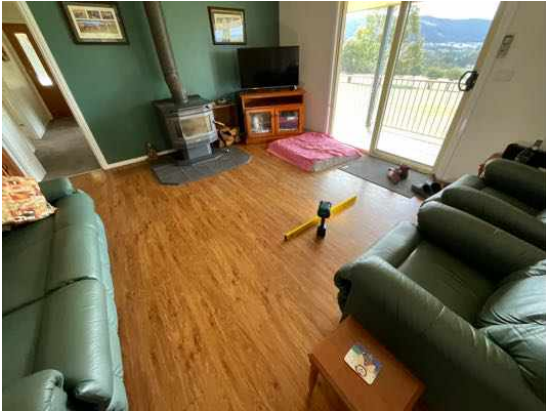
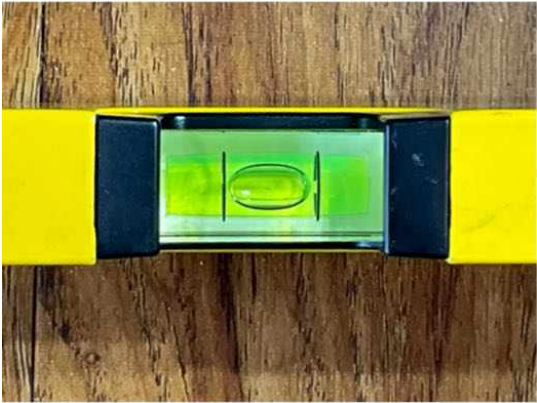
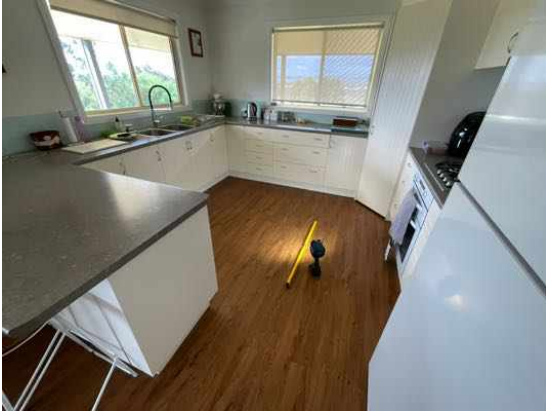
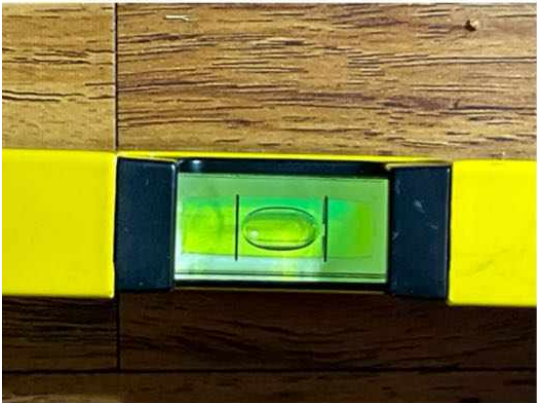
#### Noted Item

Building: Building 1  
Location: All Internal Areas  
Finding: Flooring- generally level  
Information: The internal flooring in this area is generally level and even. Where slightly uneven flooring is present it is likely to indicate minor defects such as expected movement of the foundations of the property.

No immediate action is needed.

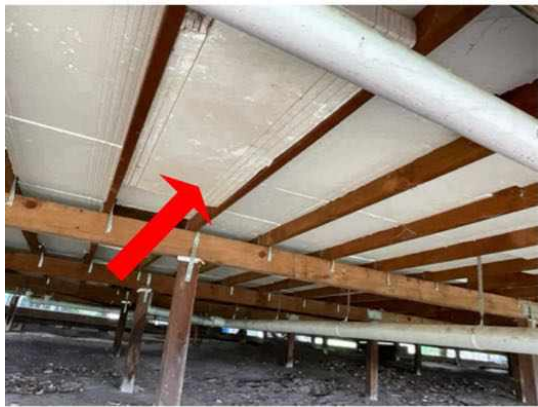
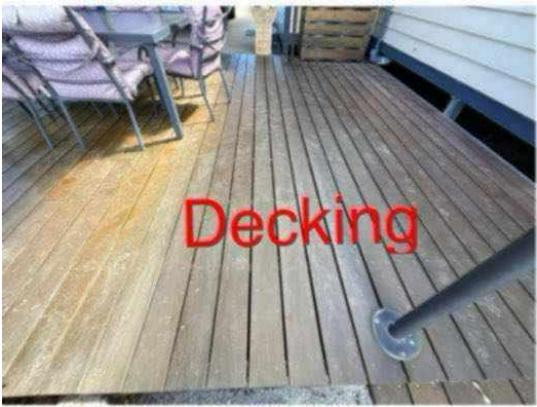
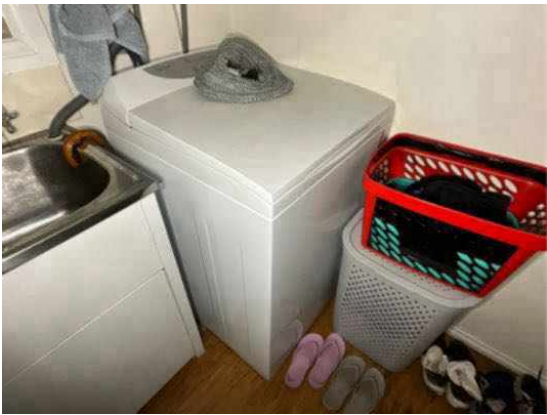
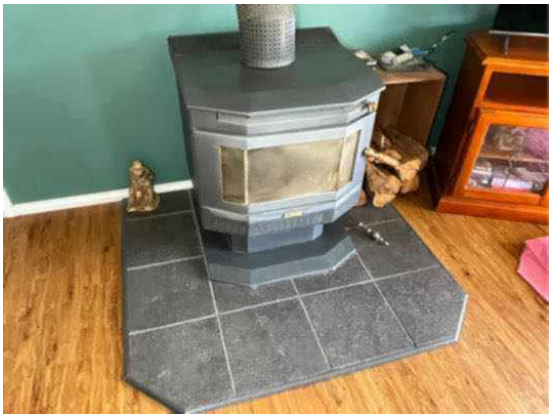
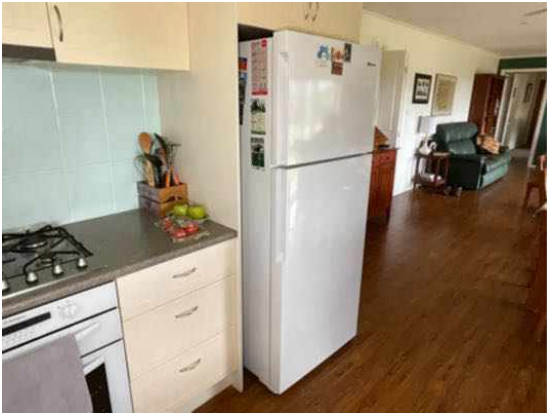
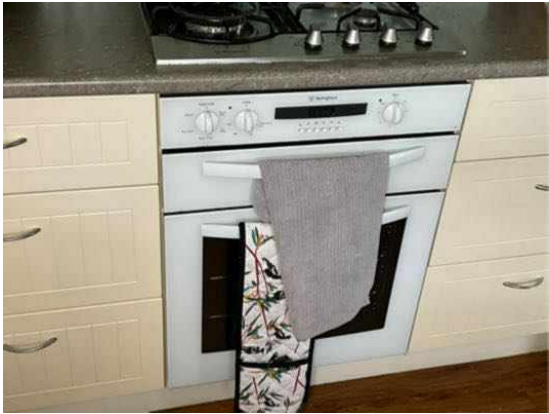
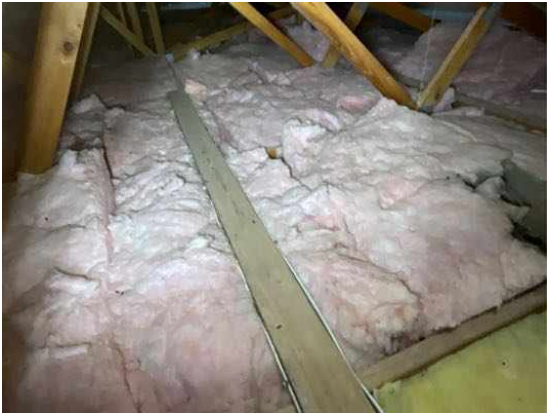
**Noted Item**

Building: Building 1  
Location: All Areas  
Finding: Additional Photos - Obstructions and Limitations  
Information: These photographs are an indication of the obstructions and limitations which impeded full inspection of the property at the time of inspection. These obstructions can hide an array of defects and should be removed to allow full inspection to be carried out. A re-inspection is recommended once the areas are made accessible.
