Building and Timber Pest Inspection Report

Inspection Date: Mon, 9 Mar 2026

Property Address: 16 Glen Lorne Cct, Gilead NSW 2560,
Australia

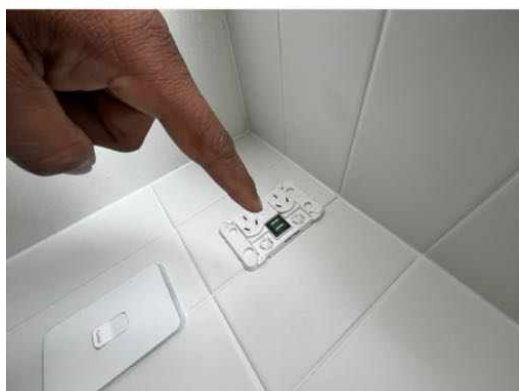
Building:	Main Building
Location:	Electrical switches
Finding:	Electrical switch- cover missing
Information:	The electrical switch cover in this area was found to be missing at the time of inspection.

Left unmanaged, the fitting is unlikely to cause further damage to surrounding building elements. However, the fitting does expose electrical works, and may create a safety hazard if there is potential contact with persons in the area.

Repair and/or replacement of the fitting is advised. A Licensed electrician should be appointed to repair/replace the fitting immediately.

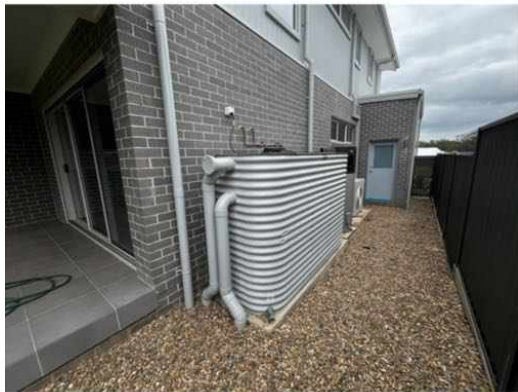
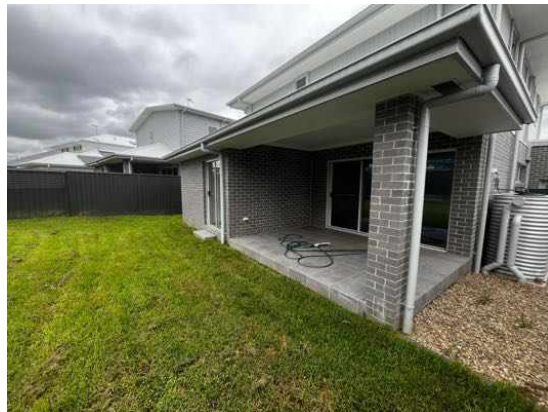
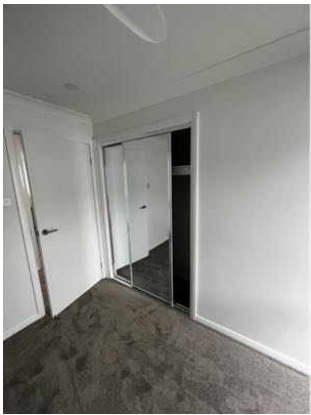
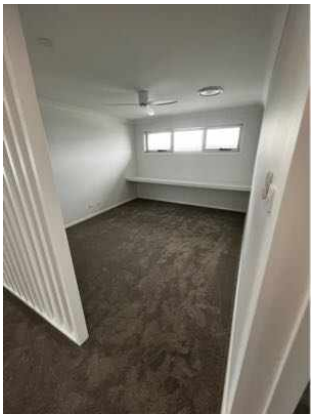
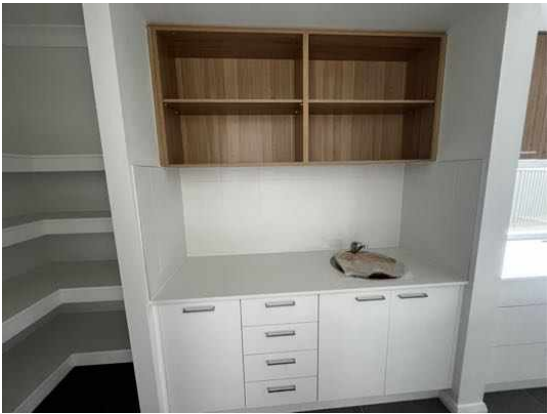
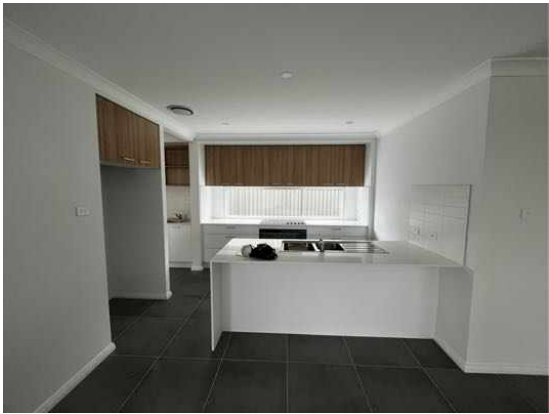
Finding: Additional Photos - Obstructions and Limitations

Information: These photographs are an indication of the obstructions and limitations which impeded full inspection of the property at the time of inspection. These obstructions can hide an array of defects and should be removed to allow full inspection to be carried out. A re-inspection is recommended once the areas are made accessible.

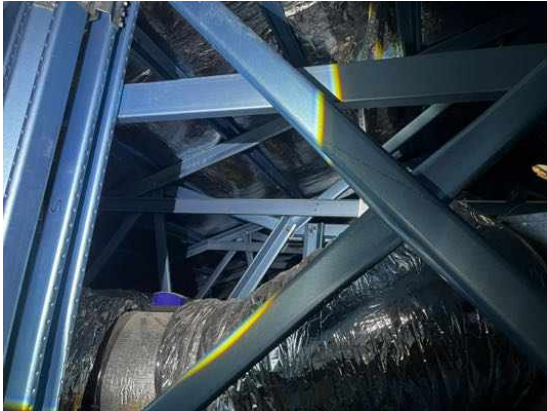
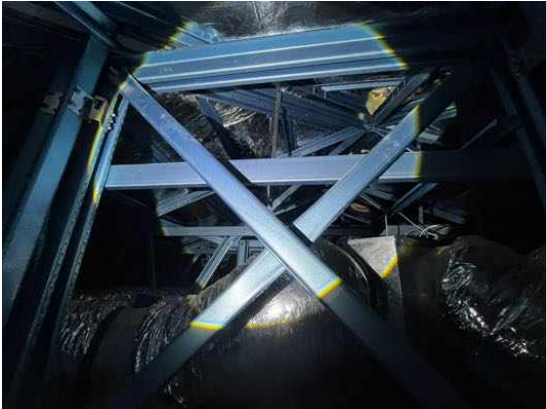
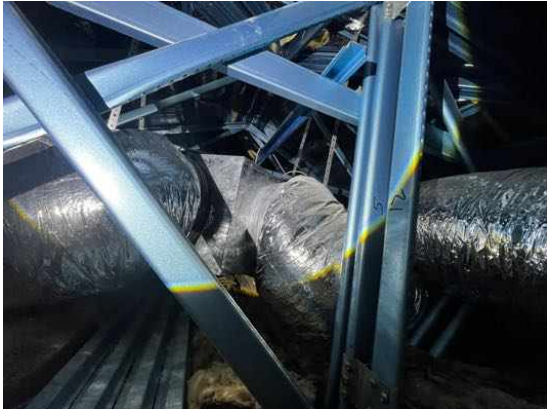
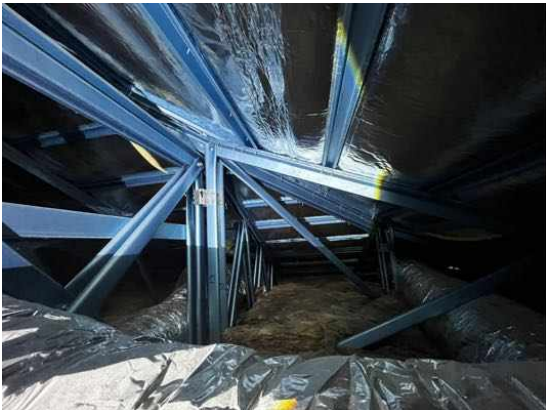
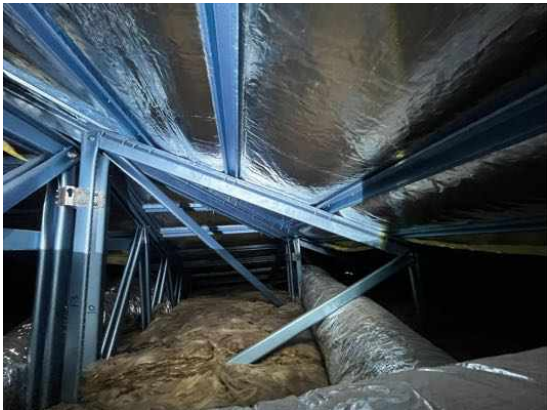
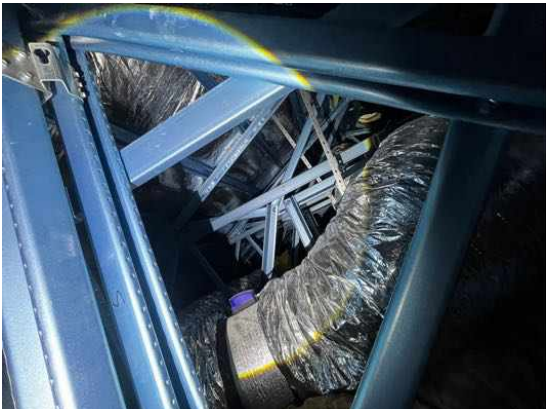
Finding 6.02

Building: Main Building
 Location: Roof Void
 Finding: Obstructions and Limitations - Roof space
 Information: Upon Inspection of the Roof void below mentioned photos have been attached as to the point been reachable to inspect the roof upon safe condition.

These photographs are an indication of the obstructions and limitations which impeded inspection of the Roof Space/Void at the time of inspection such as Stored items, Ducting, Aircon ducting, Skylight tubes, Electrical wires , insulation and cross beams, rafters, low clearance as of the pitch in the roof. These obstructions can hide an array of defects and should be removed to allow full inspection to be carried out.

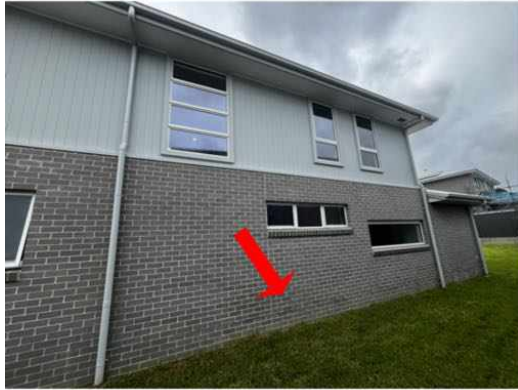
Sometimes, in order to determine the type of slab, a suitably qualified person such as an architect or builder may be required to consult the construction plans.

Where the slab edge cannot be properly inspected, it is highly recommended that termite or timber pest inspections be carried out every 6-12 months to aid protection of the property against infestation.

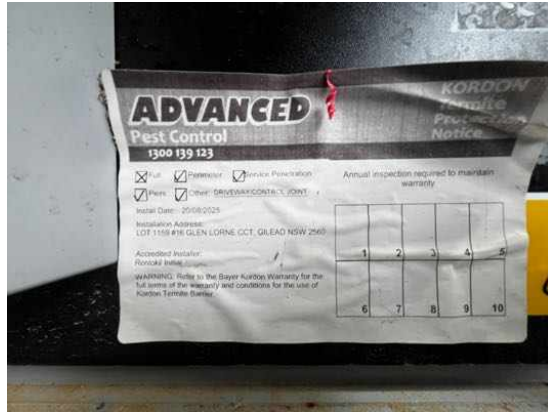
Building: Main Building
 Location: Electrical Meter Box
 Finding: Evidence of a previous termite management system was identified
 Information: Upon Inspection There was a Durable Notice of Termite treatment identified but the date and the information in the notice was not readable/ identifiable - So It is highly recommended to have a termite treatment organised and to follow a termite treatment proposal and keep note of the system every 12 months in duration.

Where a Termite Management System has been identified you should refer to the type of barrier date of installation warranty conditions and any documentation provided by a builder or past owner. Consult the company who installed the barrier to confirm whether the system is still under warranty.

Most chemical termite management systems expire and require replenishment and all physical systems are primarily designed to prevent concealed entry.

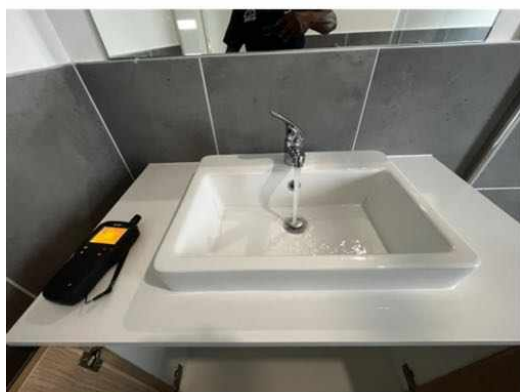
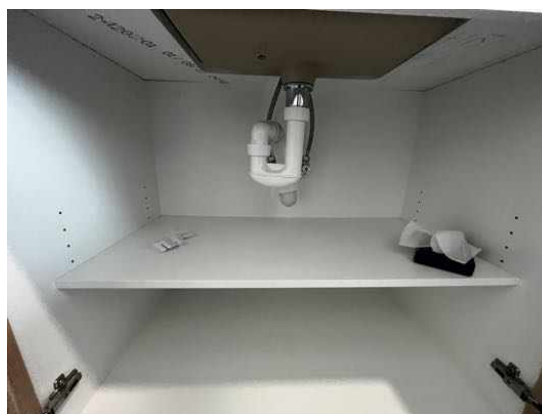
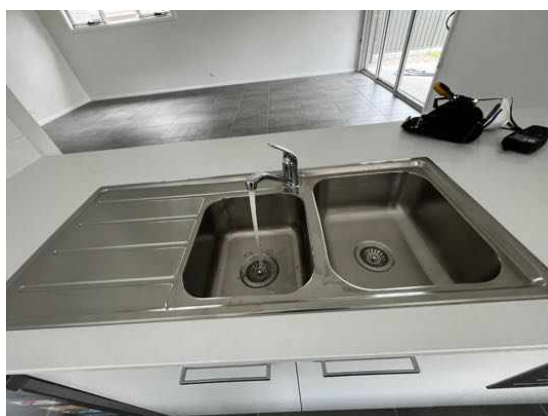
All cupboards where sinks and basins with drainage plumbing were inspected and no evidence of leaks were present at the time of inspection.

For your information only no remedial works are required at the time of inspection.

NOTE: Please be aware that although cupboards have had a thorough inspection, obstructions in cupboards may conceal potential water damage, prevent a full inspection and conditions can change after the initial inspection was carried out, therefore damage may be found after obstructions are removed.

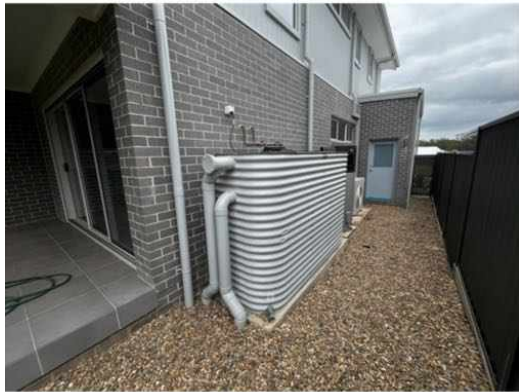
Building: Main Building
Location: Yard - Side
Finding: Storm Water Tank
Information: Storm Water Tank photos taken at the time of inspection.

Please consult a licensed Plumber to check the Connections/ pressure/ pumps/ flow of water and functionality accordingly.

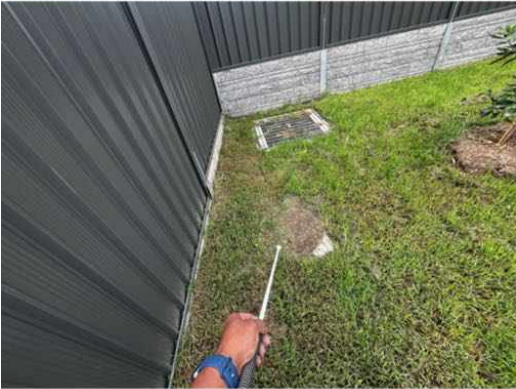
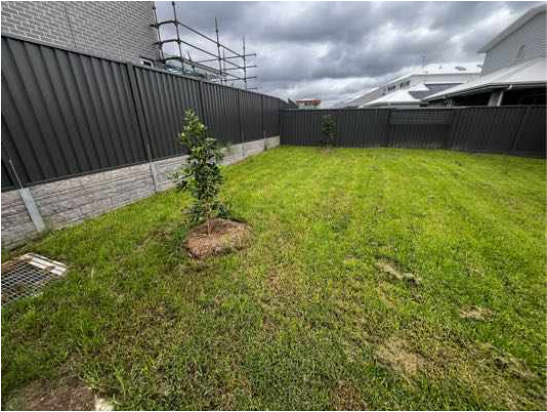
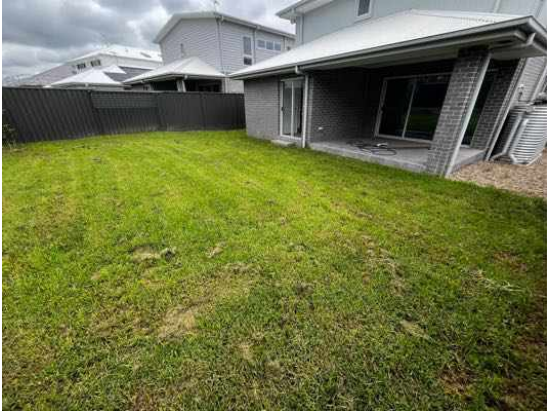
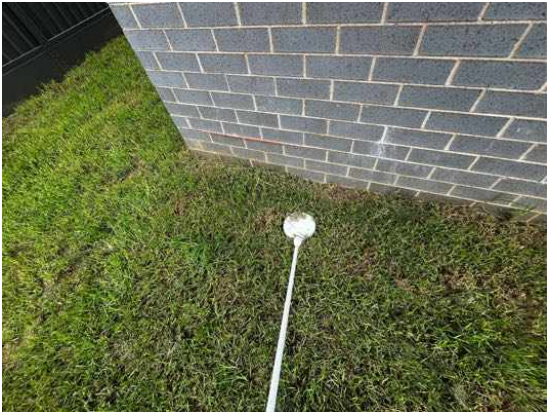
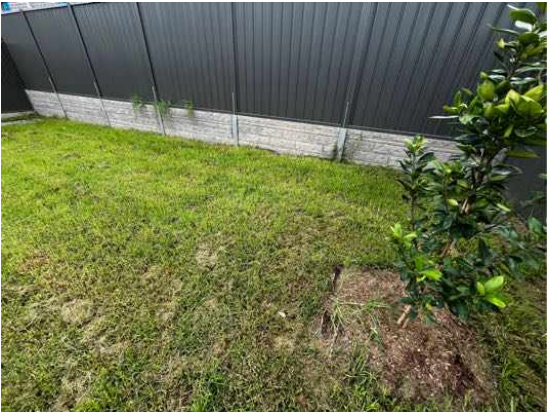
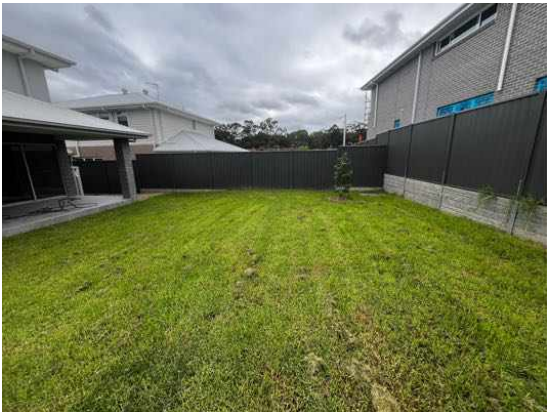
The general adequacy of site drainage is not included in the standard property inspection report. Comments on surface water drainage are limited as where there may have been either little or no rainfall for the period of time, Surface water drainage may appear to be adequate during the inspection but then during periods of heavy rain, may be found to be inadequate.

Any comments made in the section are relevant only in light of the conditions present at the time of inspection. It is recommended that a smoke test be obtained to determine any illegal connections, blocked or broken drains.

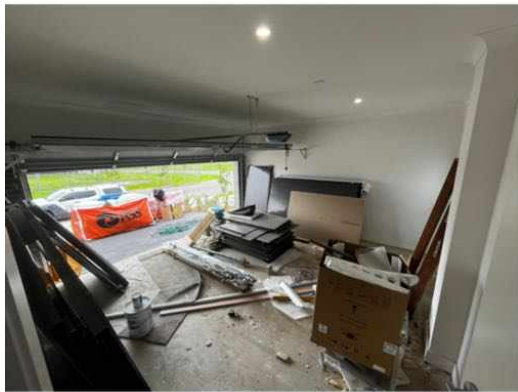
Building: Main Building
Location: Garage
Finding: Obstructions and Limitations - Internal Areas
Information: These photographs are an indication of the obstructions and limitations which impeded full inspection of the property at the time of inspection.

The Garage had stored items and other items during inspection. These obstructions can hide an array of defects and should be removed to allow full inspection to be carried out.

A re-inspection is recommended once the areas are made accessible.
