## Building Inspection Report

Inspection Date: Tue, 17 Mar 2026

Property Address: 35/728-730 Pacific Hwy, Gosford NSW  
2250, Australia

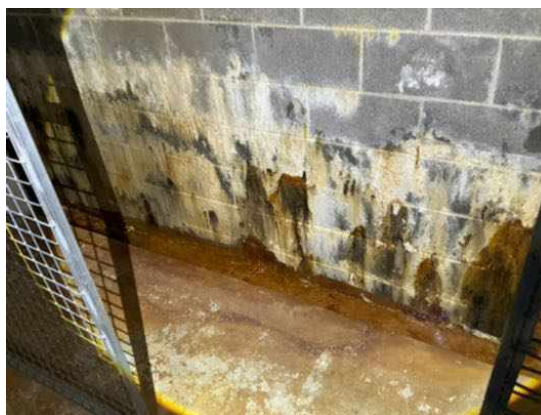
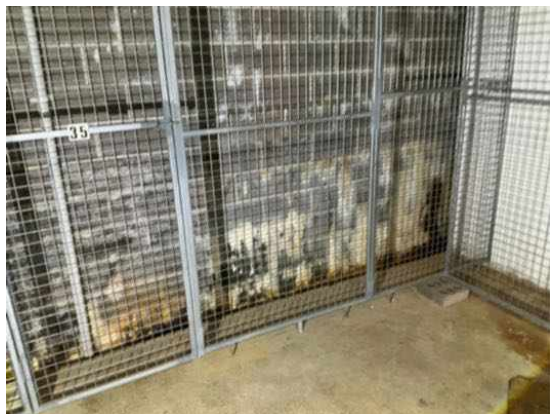
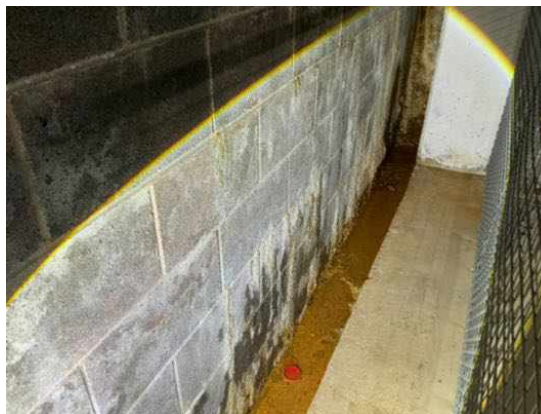
#### Defects 2.01

Building: Main Building  
Location: Garage  
Finding: Major Defect – Water Ingress and Moisture Penetration to Basement Walls  
Information: At the time of inspection, significant water ingress and moisture penetration were observed to the basement walls and slab areas. Evidence included widespread damp staining, efflorescence, mineral deposits, and active water seepage along the base of the masonry walls. Rust staining and prolonged moisture exposure were also noted, indicating that this is an ongoing and long-term issue rather than a recent occurrence.

The observed conditions are consistent with inadequate or overwhelmed stormwater drainage systems, resulting in water accumulation and migration through the retaining/basement walls. Prolonged exposure to moisture can contribute to deterioration of building materials, corrosion of embedded elements, potential mould growth, and may impact the durability and serviceability of the structure over time.

It is noted that the Owners Corporation has already engaged contractors to undertake major stormwater remediation works to address these issues, including upgrades to the drainage system, installation of new stormwater pumps, and improvements to overall water management within the basement area. These works are intended to reduce water ponding and improve stormwater discharge capacity. The remediation project is substantial in nature (noted to be in excess of \$400,000) and is scheduled over several weeks.

- Ongoing dampness or water ingress
  - New staining or efflorescence
  - Surface deterioration or mould growth
- If moisture ingress persists after completion of the remedial works, further investigation by a hydraulic engineer or waterproofing specialist may be required.

- It is also recommended that the client confirm whether there are any ongoing special levies, defects liabilities, or future capital works associated with this issue through the strata records.

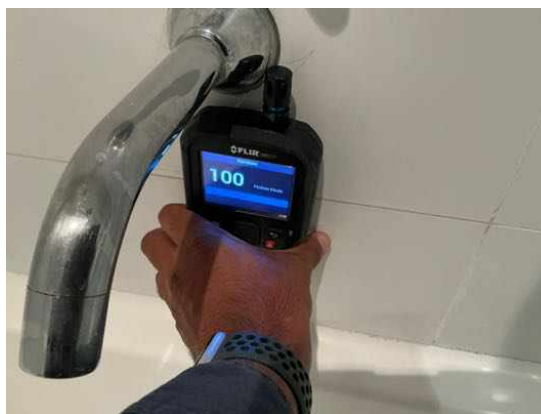
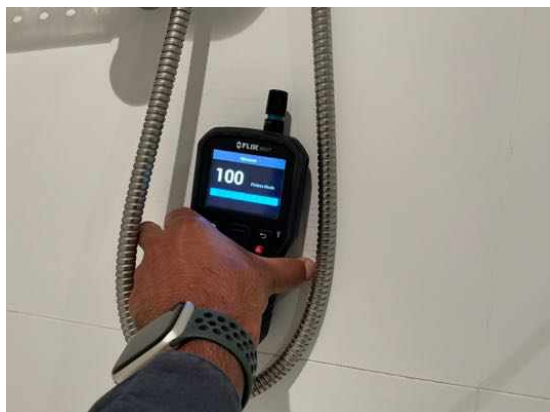
### Defects 3.01

Building:	Main Building
Location:	Bathroom
Finding:	Excessive Moisture - Shower Damp
Information:	At the time of inspection, excessive moisture was noted within the shower area, which is a common issue in wet areas due to the continual exposure to water. This condition is typically caused by moisture seeping through grout lines and settling behind tiles, resulting in localised high-moisture zones. Provided there is no evidence of water staining or elevated moisture readings on the opposite side of the wall, this is considered a minor defect.

However, persistently damp conditions may act as conducive conditions for termite activity, as termites are strongly attracted to moisture-rich environments. It is recommended that the client ensures regular use of the exhaust fan and maintains adequate ventilation after shower use to promote drying and reduce long-term moisture build-up, thereby also reducing the risk of attracting termites.

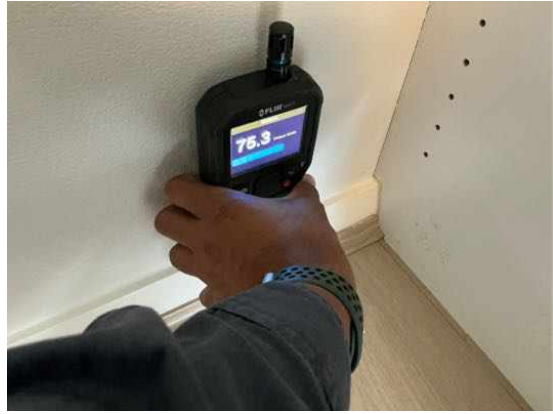
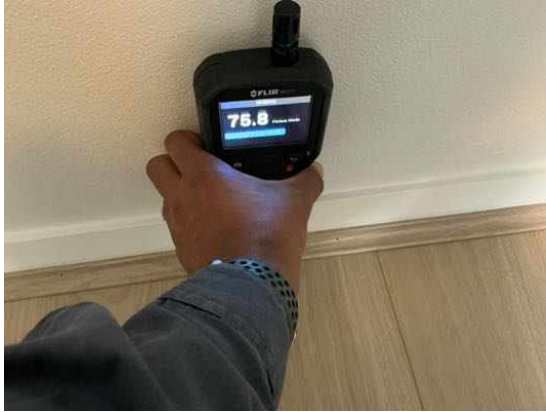
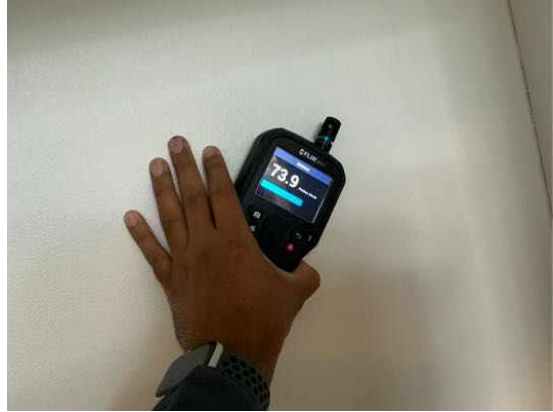
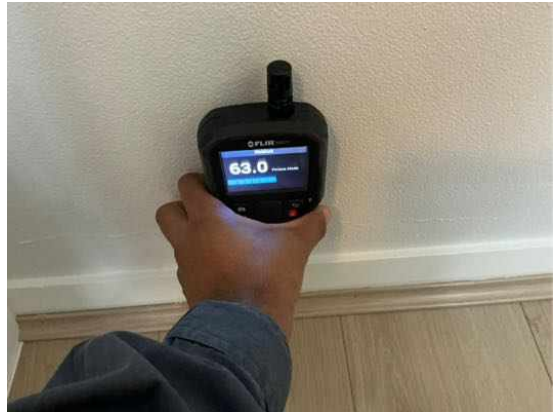
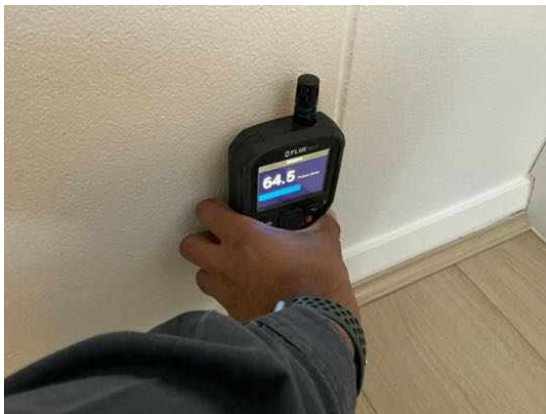
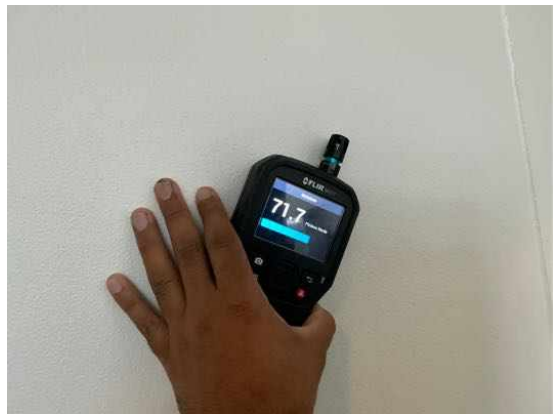
### Defects 3.02

Building:	Main Building
Location:	Living Room
Finding:	Shower Damp - Adjacent Bathroom (Monitoring)
Information:	At the time of inspection, elevated moisture levels were detected on the wall adjacent to the shower area. While no visible water damage or deterioration was noted, the presence of moisture suggests possible seepage or condensation associated with regular shower use.

At this stage, no immediate action is required. However, the area should be monitored over the next 12 months for any signs of deterioration such as staining, bubbling paint, or mould growth. It should be noted that moisture ingress of this nature does not generally resolve without intervention, and at some point remedial works are likely to be required. Should conditions worsen, the client is advised to engage services of a licensed plumber or waterproofing specialist to rectify the issue of moisture before this minor defect turns into major defect.

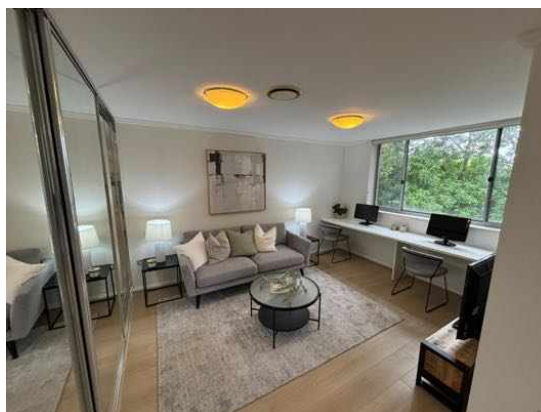
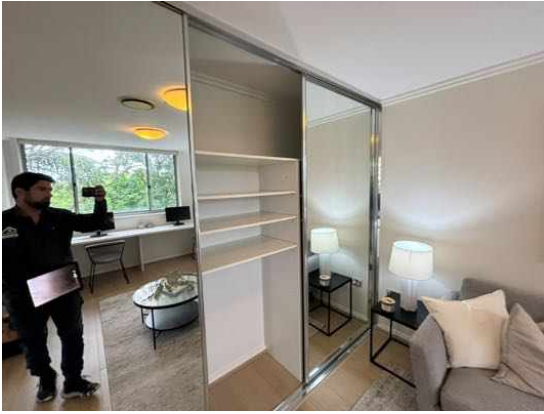
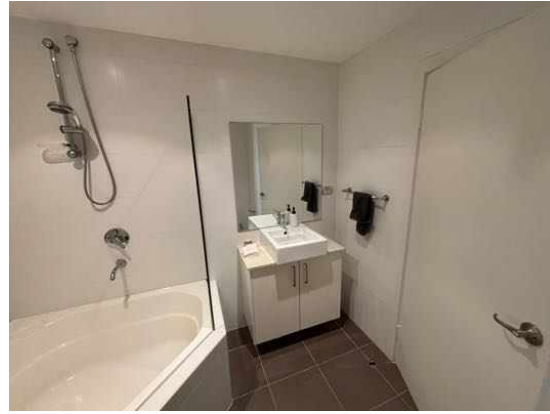
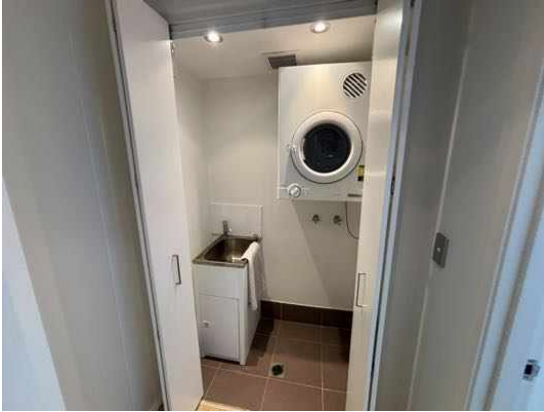
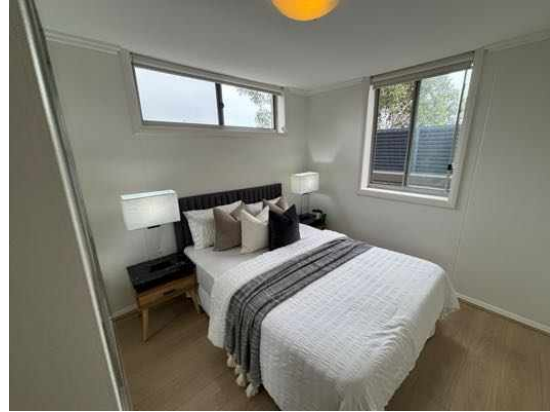
Information: The accompanying photographs provide clear evidence of the obstructions and limitations that restricted a comprehensive inspection of the internal areas of the property at the time of assessment. These obstructions, which may include furniture, personal belongings, stored items, or structural elements such as wall coverings and built-ins, significantly hindered the ability to thoroughly evaluate these areas. It is important to note that such obstructions can potentially conceal a wide array of defects, ranging from hidden structural damage, water leaks, pest infestations, or electrical issues, to deteriorating materials that may not be visible during the initial inspection.

The presence of these impediments means that critical areas of the property were not accessible, and therefore, any underlying defects that may affect the integrity and safety of the property could remain undetected. These hidden defects, if left unaddressed, could worsen over time and may result in costly repairs or pose potential safety hazards to the occupants.

It is highly recommended that all obstructions be cleared to facilitate a complete and thorough inspection of the internal areas. Once the obstructions have been removed and full access is available, a re-inspection should be carried out to ensure that any previously concealed issues can be properly identified and rectified. This follow-up inspection will provide a more accurate assessment of the property's internal condition and help the client make informed decisions about any necessary repairs or maintenance.

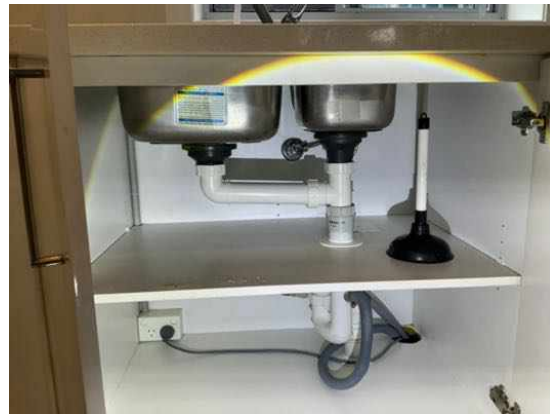
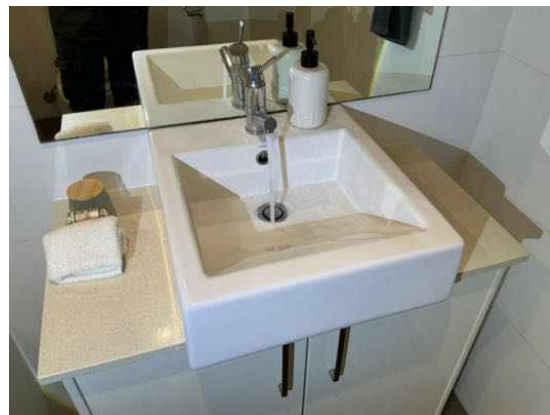
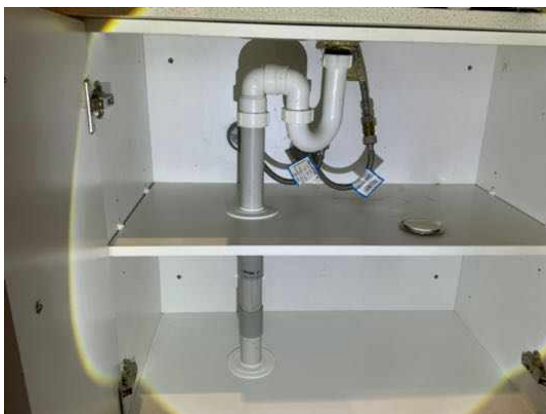
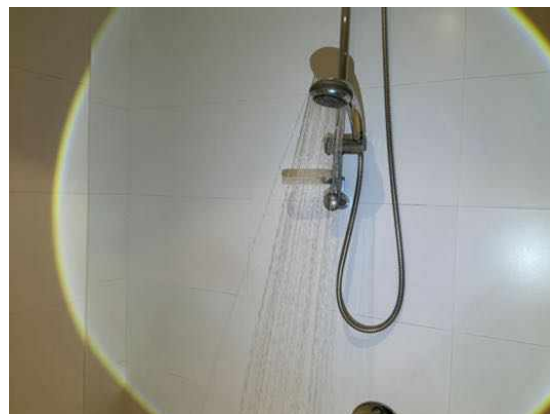
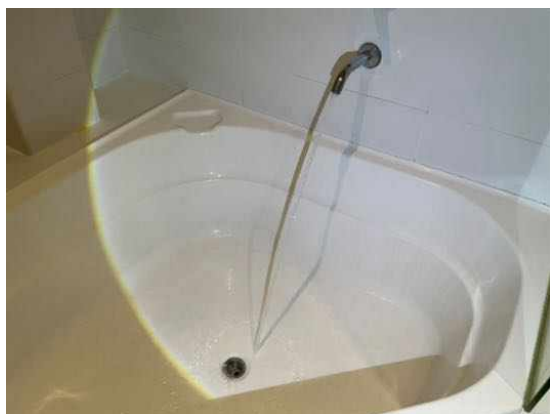
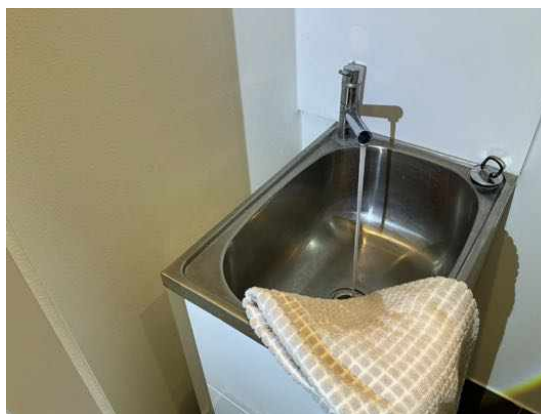
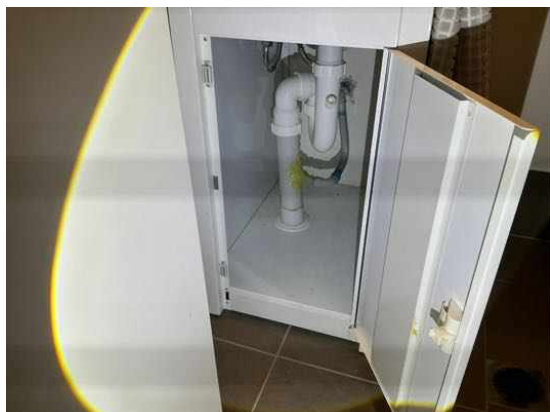
**Building:** Main Building  
**Location:** All Areas  
**Finding:** FYI - Taps, Drainage & Toilets Tested and Cabinetry Obstructions  
**Information:** During the inspection, all accessible taps, drainage systems, and toilets were tested for water flow and drainage efficiency, and checked for any visible signs of leakage. At the time of the inspection, no issues were noted in these areas. Unless highlighted in a separate defect statement, no immediate remedial work appears necessary. Supporting images may be found in the additional photos section for reference.

beneath sinks and vanities was undertaken, stored personal items and fixtures presented obstructions that limited full visibility of the internal areas. As per standard inspection practices, inspectors are not permitted to move or disturb personal belongings during the inspection process. Therefore, only visible and accessible sections were inspected, and concealed water damage or plumbing defects may not have been detected.

Given this, a re-inspection is recommended after all obstructions have been cleared to allow for a comprehensive assessment of these areas. Regular maintenance and monitoring of plumbing and drainage systems is also advised to ensure ongoing functionality and early detection of potential issues.
