Building and Timber Pest Inspection Report

Inspection Date: Fri, 13 Feb 2026

Property Address: 2 -31 Tennyson Ave, Clayton South VIC
3169, Australia

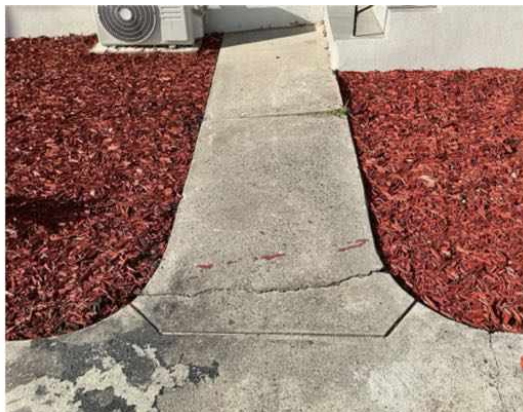
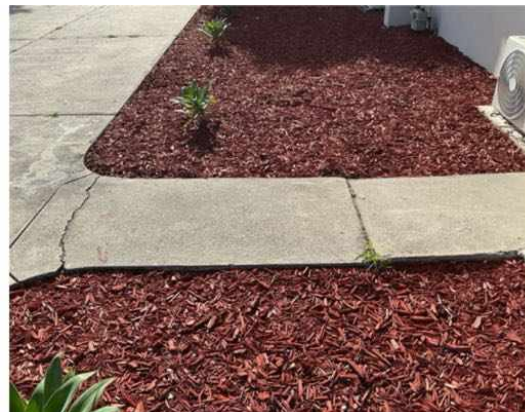
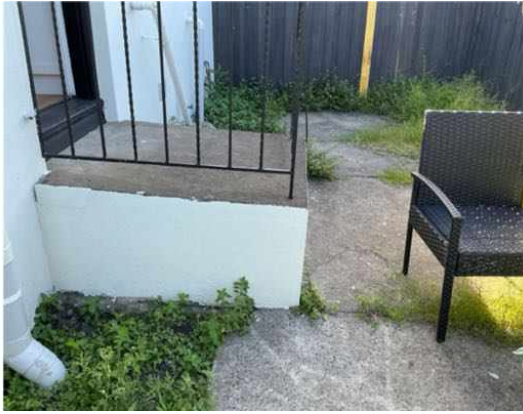
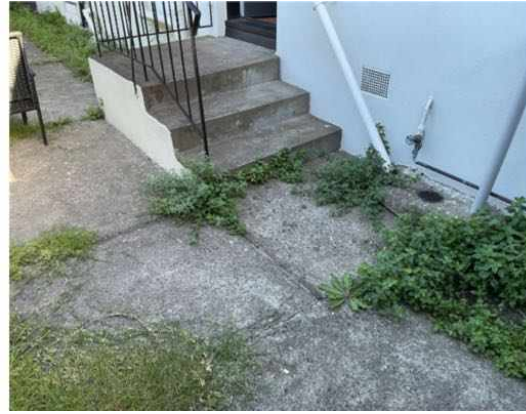
Finding 3.01

Building: Main Building
Location: Pathways
Finding: Paved areas and steps - Cracked/Uneven
Information: Sections of the external paved areas and steps are cracked or uneven, creating a potential trip hazard. It appears as though the area has been subject to rough installation, or that paving sections have lifted due to movements in the foundation of the property.

Where paving creates a trip hazard, personal injury may ensue if due caution is not taken by all persons within this area.

Re-paving of the area is required as soon as possible to remedy this situation. Further consultation with a specialist concreter is advised.

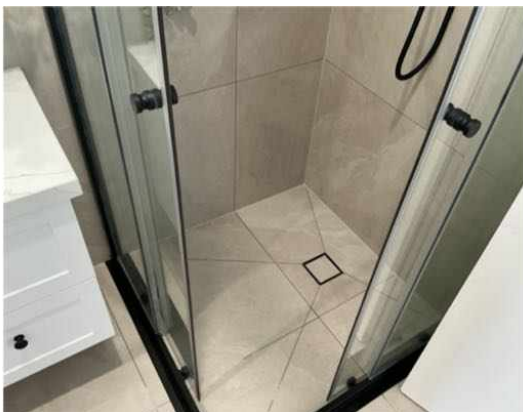
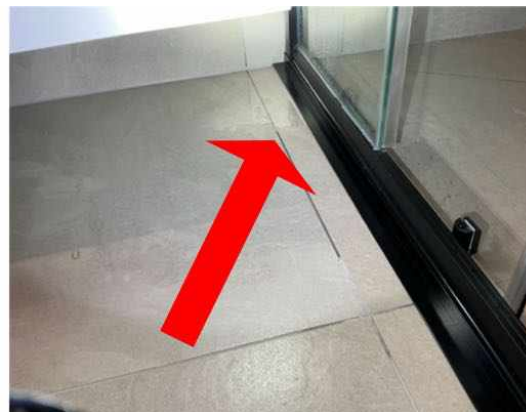
Finding 3.02

Building: Main Building

Location: Bathroom

Finding: Bathroom-Shower screen leaking

Information: Leaking was evident to the shower screen at the time of inspection. It is suspected that the leaking has occurred as a result of deteriorated or missing caulking to the shower or general ageing of the building elements.

Leaking from the shower where left unattended, is likely to lead to water damage to adjoining flooring and walls. Such damage can lead to water damage and necessitate extensive remedial works being required. Active water leaks may also create an environment that is susceptible to the formation and development of mould.

Appointment of a caulking contractor is required to repair or replace the caulking to the shower area. Such works should be performed as soon as possible to ensure that no further damage occurs.

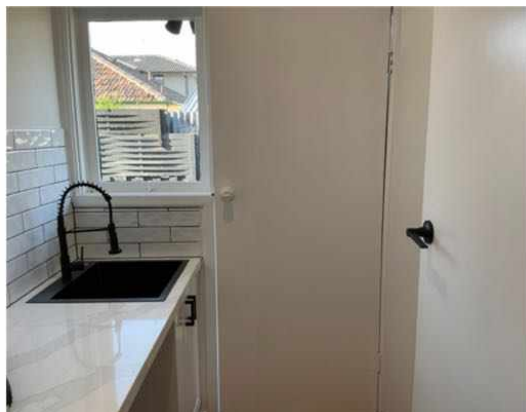
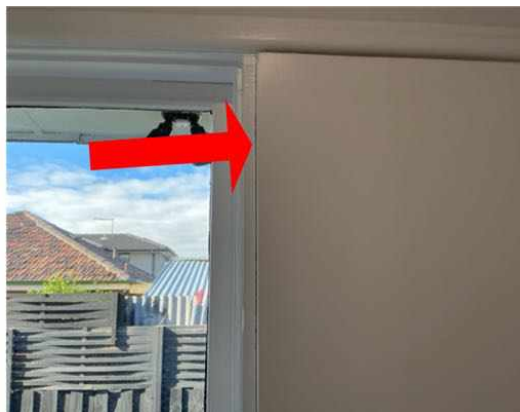
Finding 3.03

Building: Main Building

Location: Laundry

Finding: Door - Binding/jamming laundry

Information: Binding and/or jamming of the laundry door is evident during standard operation. This defect inhibits the functionality of the affected door as well as creating potential for secondary defects.

A door that binds to flooring or to the associated door frame may have several causes, ranging from minor defects, such as poor installation of the door or deteriorated hinges.

For minor causes, a qualified carpenter or general handyperson should be appointed to perform minor rectification works at client discretion.

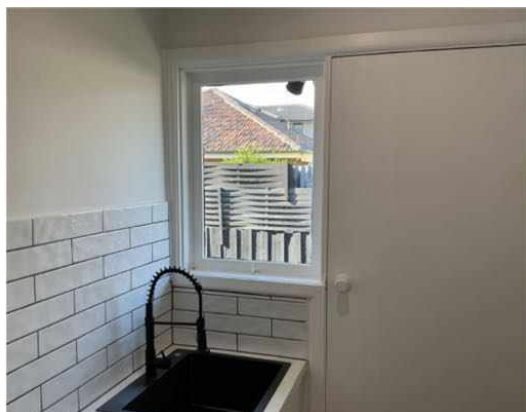
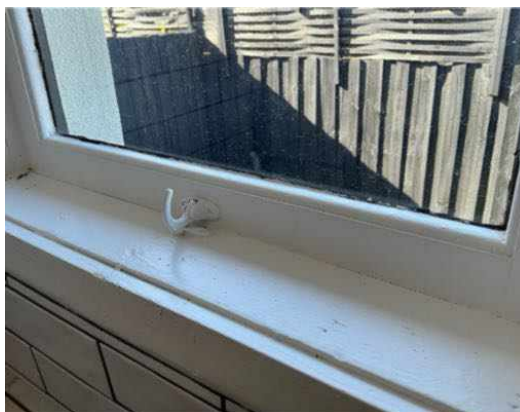
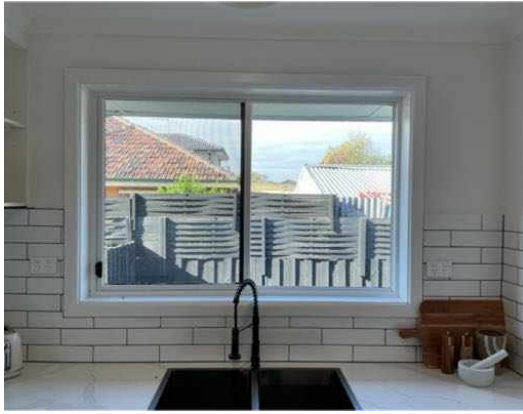
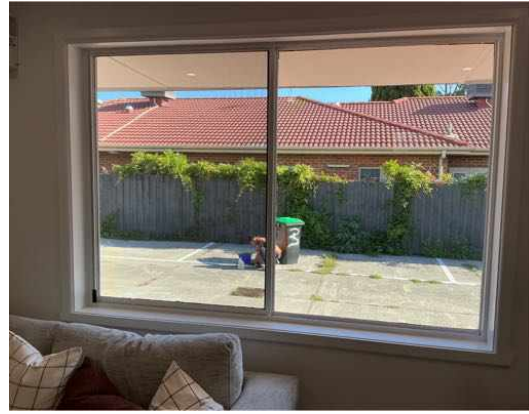
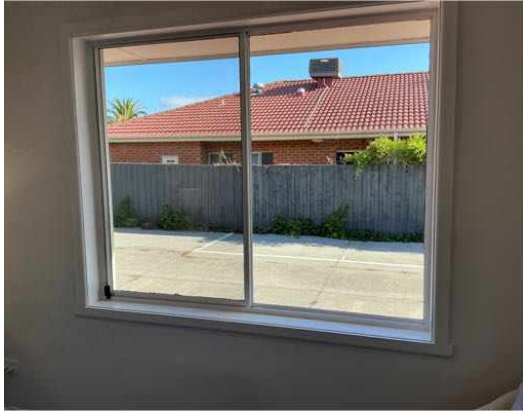
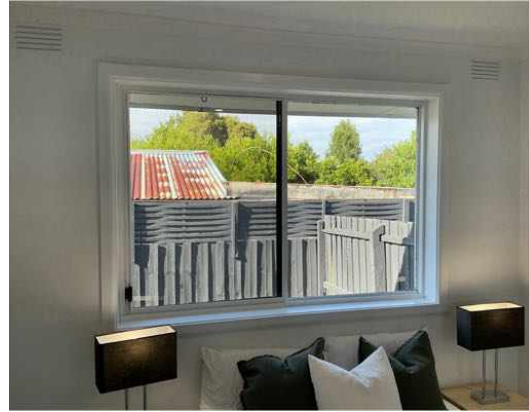
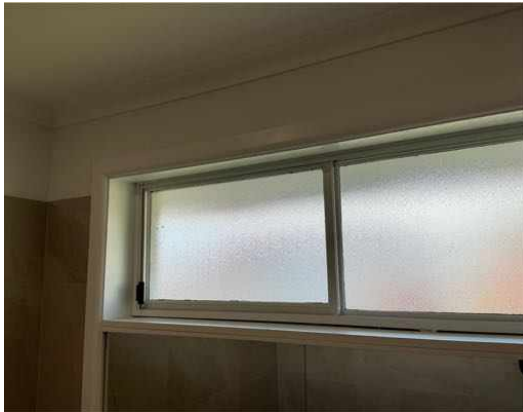
Finding 3.04

Building: Main Building

Location: Windows

Finding: Windows jammed or painted shut or needing adjustment

Information: The windows to the building are jammed shut or stiff to operate. Recommend engaging a carpenter to adjust windows to make more operational at the owners discretion.

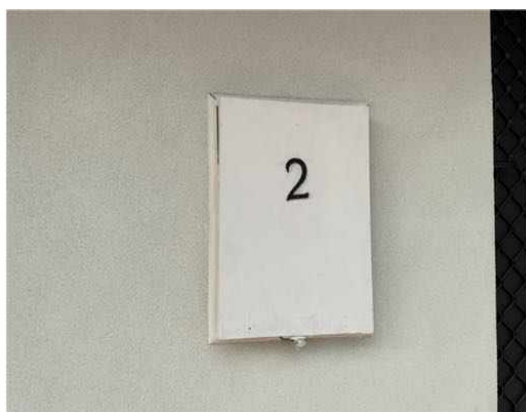
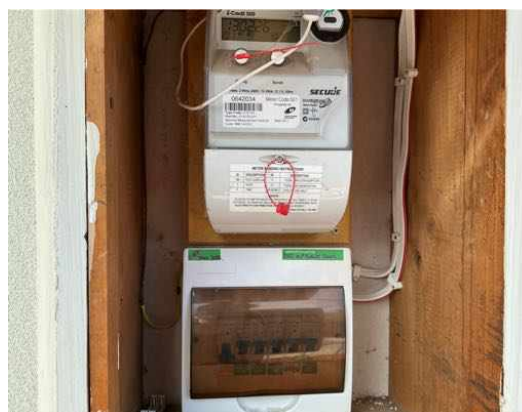
Finding 6.01

Building:	Main Building
Location:	All External Areas
Finding:	No Termite Management System - no evidence of a chemical installation
Information:	The application of a post-construction chemical termite barrier is highly recommended for all properties, particularly if live termite activity has been found on the site previously. Such barriers are highly effective in preventing termite attack on any timber building elements throughout the property.

A durable notice should be placed in the switchboard unit to indicate current termite barriers. At the time of inspection, it appeared as though no termite management system has been installed, with no evidence to suggest preventative works taking place.

The client may consider gaining further advice from a pest controller as to the costs and procedures involved with this application. It is recommended that obtaining such advice be a short-term priority.

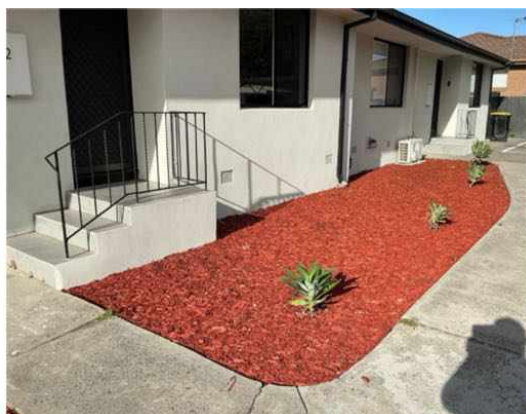
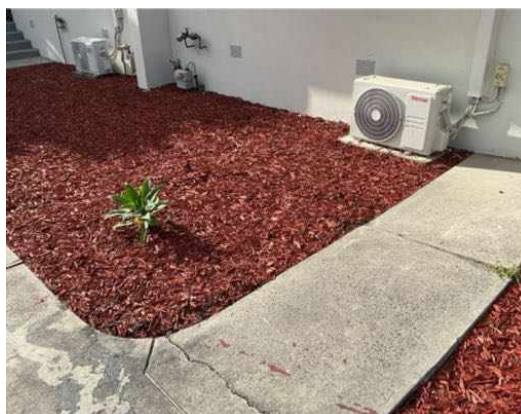
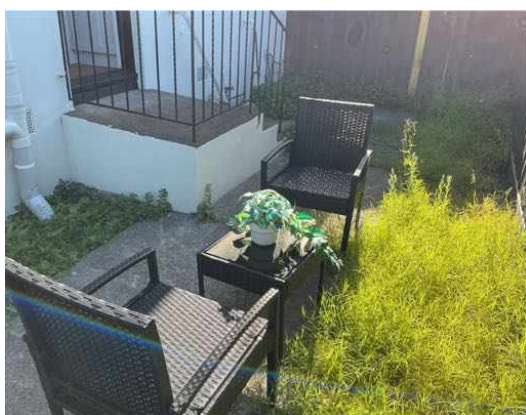
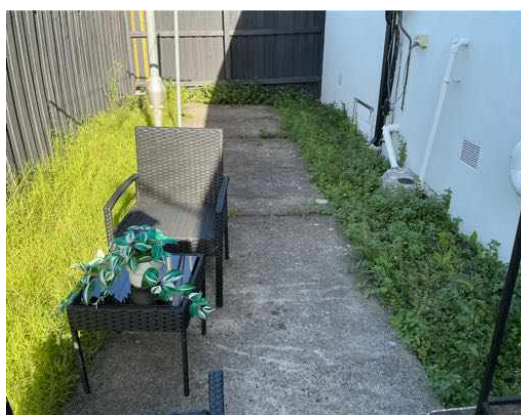
Finding 6.02

Building:	Main Building
Location:	Yards
Finding:	Site drainage - poor/inadequate
Information:	The site drainage to parts of the yards was found to be inadequate at the time of inspection, creating potential for subsequent water damage to associated building elements. Excessive moisture will attract termites.

It is important that water does not lie against the base of walls; surrounding paths and ground levels should be sloped to drain water away from walls. Downpipes should not discharge stormwater onto lower walls or plinths. Stormwater should be carried away by large, regularly cleaned drains. Ground levels may need to be lowered to expose a buried DPC.

Where site drainage is inadequate, installation of an Agricultural (Aggie) Drain may be required. A qualified plumber should be appointed to further inspect the property and

perform any remedial works as necessary. Water damage and secondary defects are likely to occur if left unmanaged.

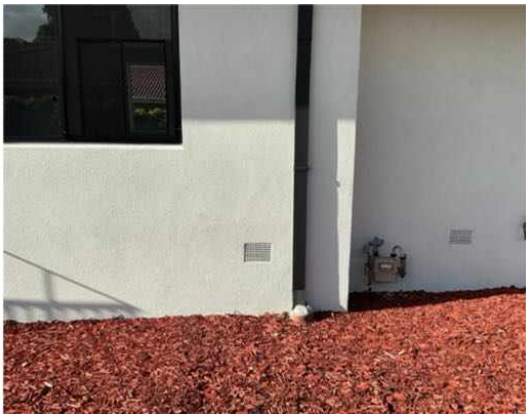
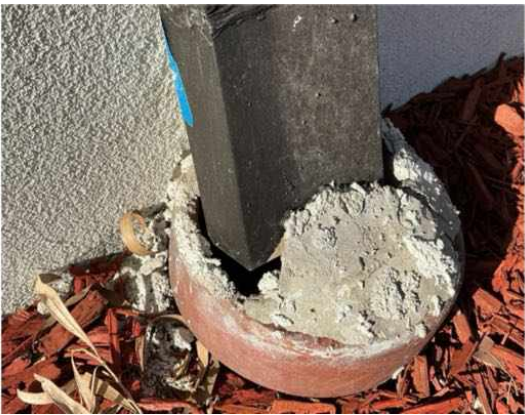
Finding 6.03

Building:	Main Building
Location:	Exterior walls - front
Finding:	Downpipe not properly connected to stormwater
Information:	The front downpipe is not properly connected to stormwater with cracking to the concrete allowing water to escape when raining. This disconnection negatively impacts the functional capacity of the plumbing.

Where plumbing doesn't drain adequately, the area at the base perimeter can become excessively damp, potentially creating an environment that is susceptible to rust and corrosion of surrounding building elements, as well as attracting termites and other pests.

It is highly recommended that a plumber be appointed to further inspect the area and to install adequate drainage equipment immediately where necessary.

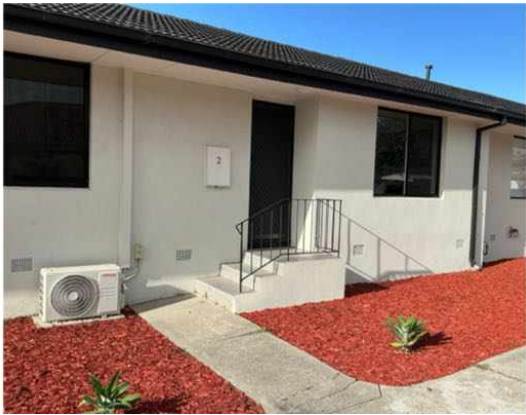
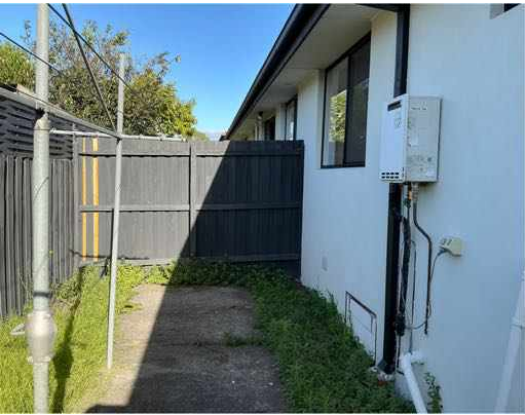
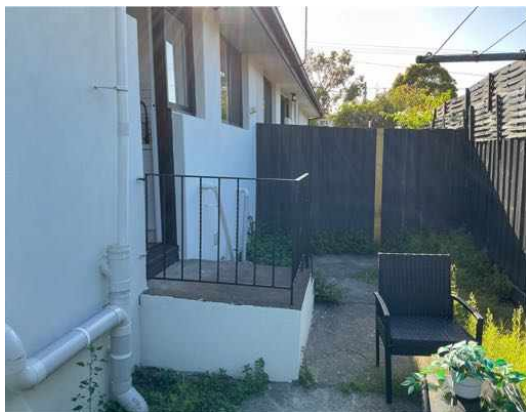
Finding 6.04

Building: Main Building
 Location: Various parts of the building
 Finding: Bridging attachments to buildings
 Information: Bridging occurs when items against a building provide a concealed entry point for termites into the building or by passing around a termite management system.

Where any part of an attachment to a building is not isolated and is not provided with a clear gap of not less than 25mm from building, bridging occurs. Attachments to buildings such as hot water services, downpipes, verandahs, decks, steps, fences, service conduits and the like provide the opportunity for concealed entry.

Building attachments of this nature need to be frequently inspected for termite activity by a qualified inspector.

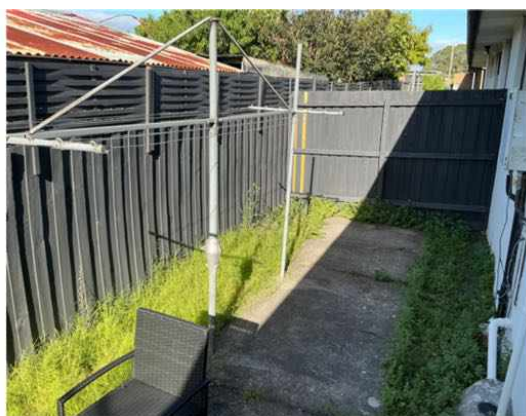
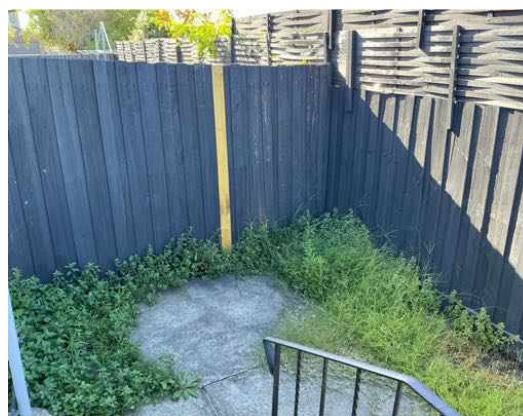
Finding 6.05

Building:	Main Building
Location:	Various parts of the building
Finding:	In ground contact
Information:	Any timbers in direct ground contact provide opportunity for concealed termite entry and are likely to be subject to premature rot and decay as the soil retains moisture or damp conditions against the timbers.

Remove untreated timber that is in direct contact with external grounds. Consider replacement with more durable materials i.e. treated timber or non timber elements. Frequent pest inspections are advised to readily identify any termite activity in these areas.

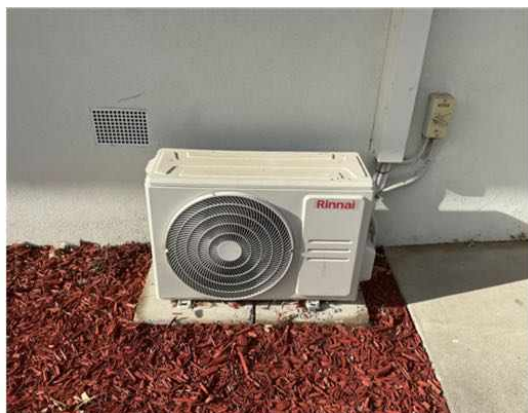
Finding 6.06

Building:	Main Building
Location:	Yards
Finding:	Air conditioning unit overflow -Not plumbed for drainage
Information:	The overflow to the air conditioning unit is not plumbed or connected to suitable drainage, which has resulted in the surrounding area becoming excessively damp. These damp conditions can lead to secondary defects such as rot, rust or corrosion of associated building elements, the formation of fungal decay, or even the

creation of potential slip hazards. When coupled with poor site drainage, pooling of water may also attract termite activity to this area. It is highly recommended that a qualified plumber be appointed to install adequate drainage to the overflow. These works will ensure that the area remains dry and free of any secondary defects.

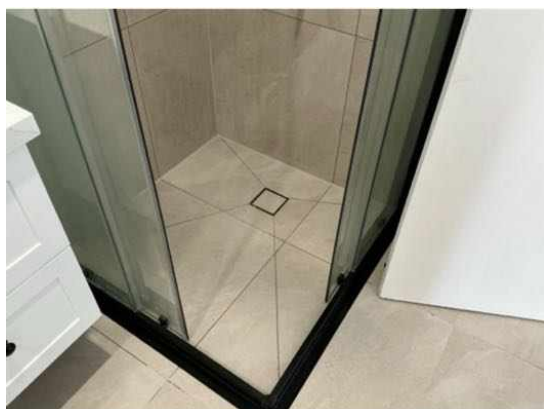
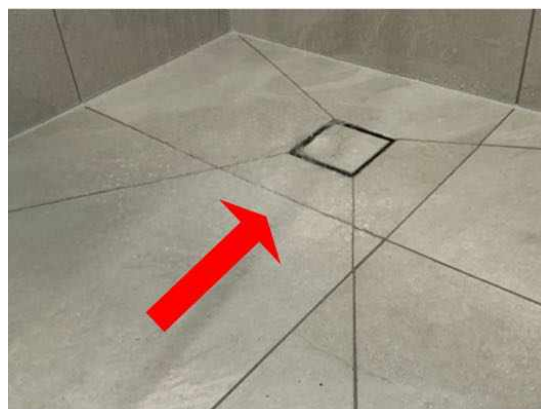
Finding 6.07

Building: Main Building
 Location: Bathroom
 Finding: Shower base - Water pooling
 Information: Evidence of water pooling around the floor waste in the shower recess was noticed at the time of inspection. It is suspected that this excessive moisture is attributed to insufficient fall in the shower floor tiles.

This pooling is minor overall but is still considered unsatisfactory, as standard practices would not permit this situation to occur. Pooling water around floor wastes can create a slip hazard in extreme cases and create conditions that are conducive to mould growth over time. Where left unmanaged, the degradation of sealant and grouting is also likely to occur, possibly necessitating further repair works. Recommend engaging a plumber to rectify to reduce the risk of further deterioration as soon as possible.

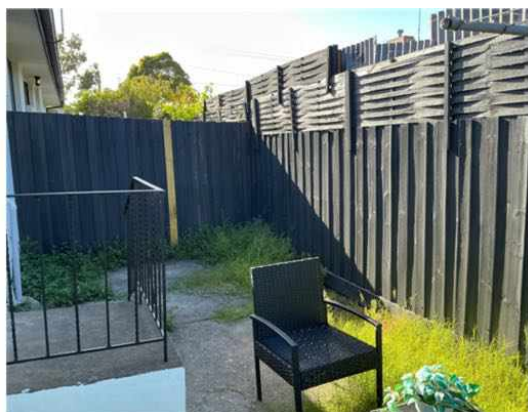
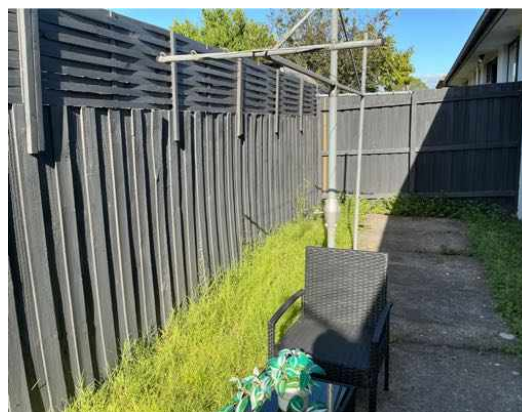
Finding 7.01

Building:	Main Building
Location:	Yard - Back
Finding:	Fencing - wood rot-fungal decay
Information:	It was noted at the time of inspection that sections of the fencing to the property have deteriorated and have fungal decay/wood rot present. Typically fencing deteriorates due to age and or wear, rot and or rust which is generally expected for a structure of this age, due to prolonged exposure to weather conditions. Sometimes inadequate installation or maintenance can be to blame.

If left unattended, it is likely that further damage will occur. It is suspected that repair of several elements of the fencing may be required however replacement may be a consideration of the client also.

A licensed fencing contractor should be appointed to provide further advice and perform rectification works as necessary.

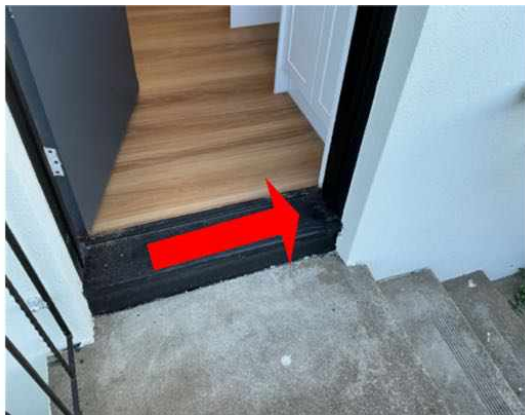
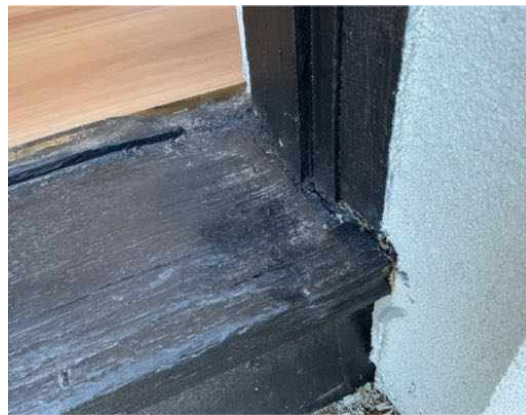
Finding 7.02

Building:	Main Building
Location:	Laundry
Finding:	Wood rot laundry door jamb
Information:	The laundry door jamb shows evidence of wood rot. Wood rot, also known as Fungal Decay, occurs when timbers and other cellulose building materials are exposed to damp conditions on an ongoing basis. This could be the result of exposure to weathering over a prolonged period of time, or the attraction of excessive moisture from other abutting building materials. Contributing factors also include poor air ventilation in the area.

Wood rot is often associated with general damp problems and is evidenced by a 'musty' smell or mould and mildew occurring on surfaces. If left unmanaged, damp

conditions can lead to further health problems and the decay of timbers will continue.

Early intervention and regular maintenance, particularly of exterior timbers, will prolong the useful life of these building elements. Prior to any works being performed, the cause of the moisture that has created the visible wood rot should be identified and addressed in a suitable manner. Replacement of affected timbers may then be a necessary step in protecting surrounding building elements from such deterioration.

A qualified plumber may be appointed to assess the cause of excessive moisture and to provide advice on any remedial works as required. A qualified carpenter or registered builder may also be required to replace affected building materials.

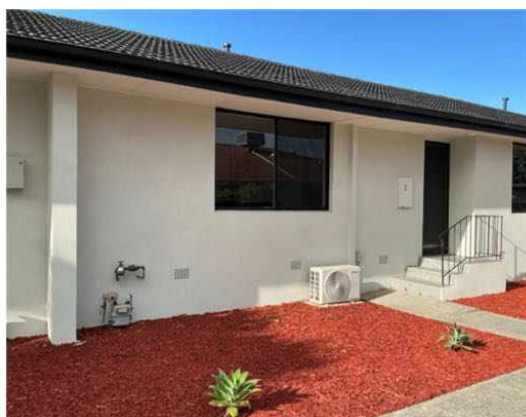
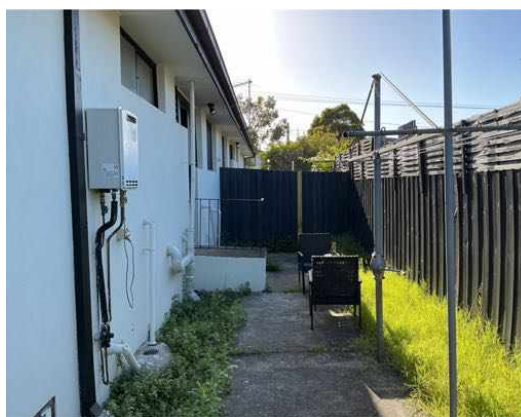
Building: Main Building
Location: All External Areas
Finding: Additional Photos - Obstructions and Limitations
Information: These photographs are an indication of the obstructions and limitations which impeded full inspection of the property at the time of inspection. These obstructions can hide an array of defects and should be removed to allow full inspection to be carried out. A re-inspection is recommended once the areas are made accessible.

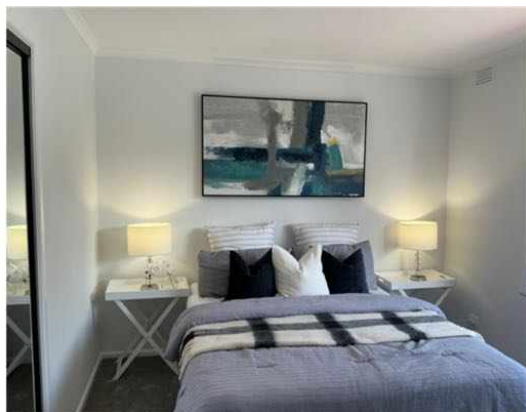
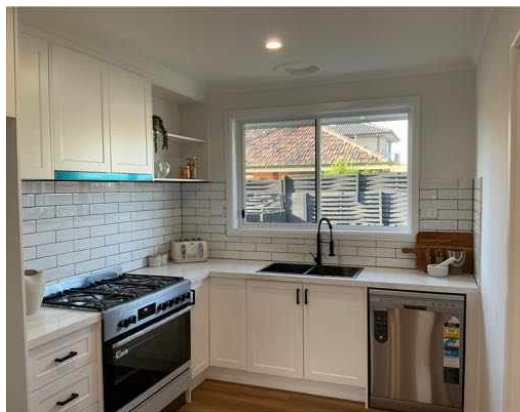
Building: Main Building
Location: All Internal Areas
Finding: Additional Photos - Obstructions and Limitations
Information: These photographs are an indication of the obstructions and limitations which impeded full inspection of the property at the time of inspection. These obstructions can hide an array of defects and should be removed to allow full inspection to be carried out. A re-inspection is recommended once the areas are made accessible.

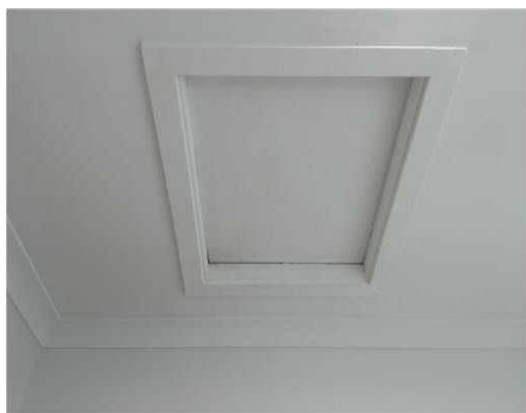
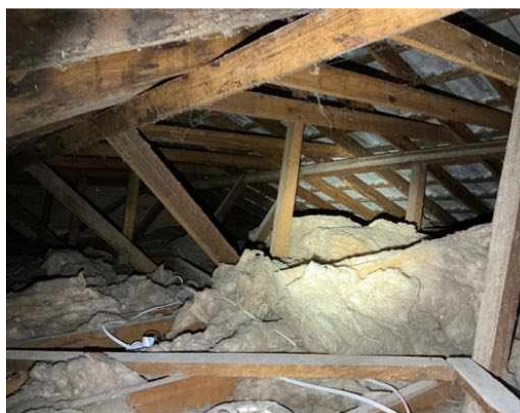
Building:	Main Building
Location:	Roof Void
Finding:	Roof space undersized manhole -Obstructions and Limitations
Information:	The roof space was inaccessible at the time of inspection, and inspected from the manhole only, due to an undersized man hole which impeded the inspection of the roof space of the main building. These obstructions can hide an array of defects and it is highly recommended that an access hatch be constructed to Australian standards to allow full inspection to be carried out. A re inspection is recommended once the area is made accessible.

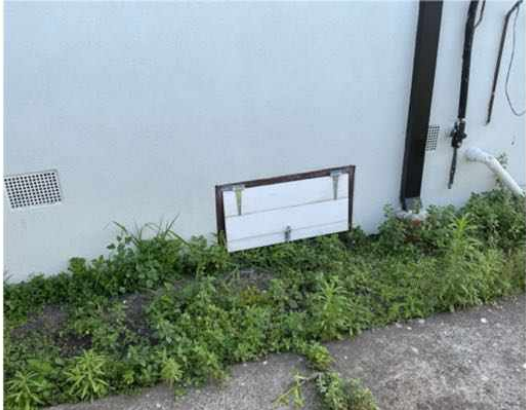
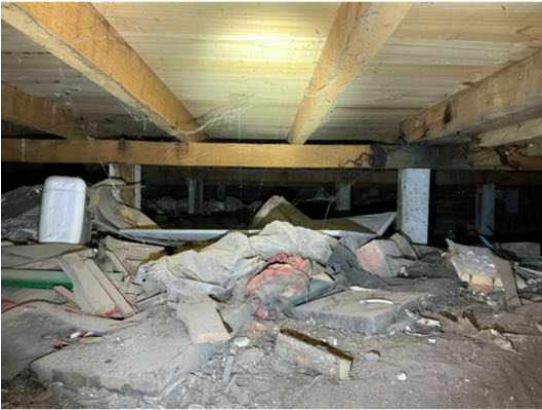
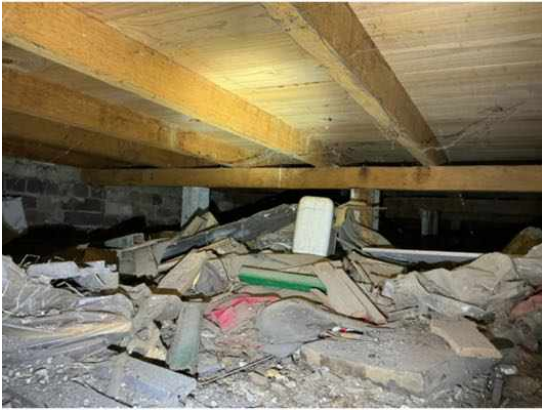
Building:	Main Building
Location:	Subfloor
Finding:	Subfloor- undersized manhole -Obstructions and Limitations
Information:	The subfloor was inaccessible at the time of inspection, and inspected from the manhole only, due to an undersized man hole which impeded the inspection of the subfloor of the main building. These obstructions can hide an array of defects and it is highly recommended that an access hatch be constructed to Australian standards to allow full inspection to be carried out. A re inspection is recommended once the area is made accessible.
