Building Inspection Report

Inspection Date: Mon, 16 Feb 2026

Property Address: 131 Greens Rd, Wyndham Vale VIC 3024,
Australia

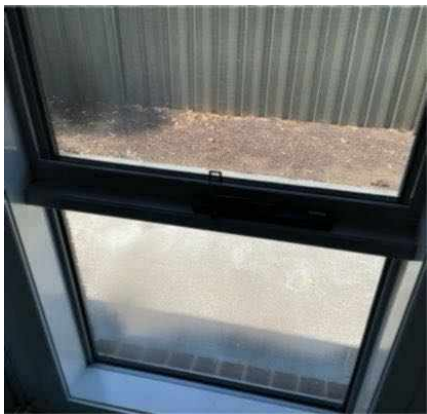
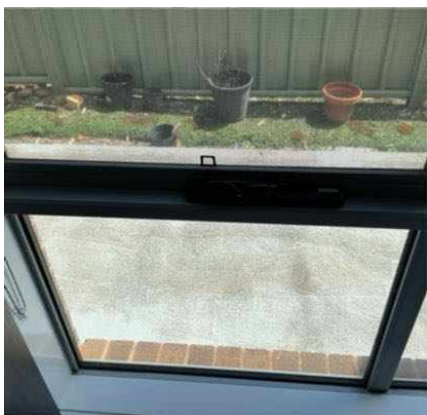
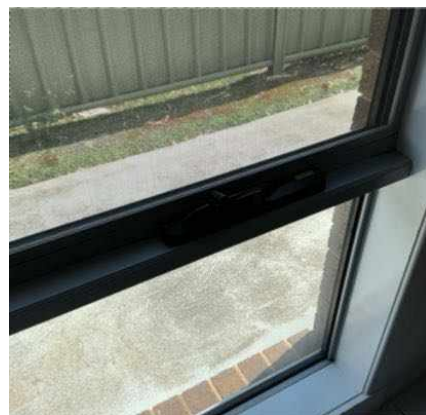
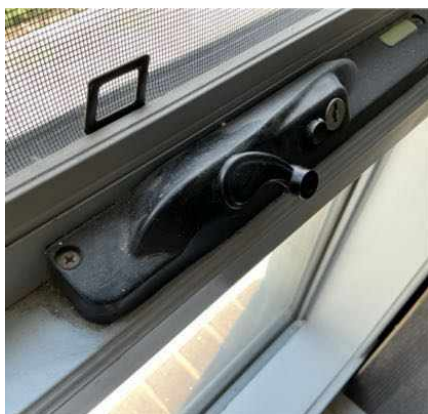
Defects 3.01

| Finding: | Defective and Inconsistent Window Winder Operation |
| Information: | During the inspection, several window winders were observed to be defective or inconsistent in operation. Issues noted include missing plastic operating handles to some winders, difficulty opening or closing certain windows, some winders found to be locked or seized, and others producing grinding noises during operation. These conditions indicate wear, damage, or incorrect adjustment of the window winder mechanisms. |

- Difficult or inoperable window winders can restrict ventilation and normal use of the windows
- Missing handles and grinding noises indicate deterioration or damage that may worsen over time
- Locked or seized winders may prevent windows from being opened in an emergency, posing a potential safety concern
- Continued use of defective winders may lead to complete mechanism failure or damage to window frames

- Missing handles should be replaced, and winders that are difficult to operate, locked, or noisy should be repaired or replaced as required
- Following rectification, all windows should be tested to confirm smooth operation and safe opening and closing

In summary, multiple window winders are defective or compromised, and rectification is recommended to restore safe, functional, and consistent window operation throughout the dwelling.

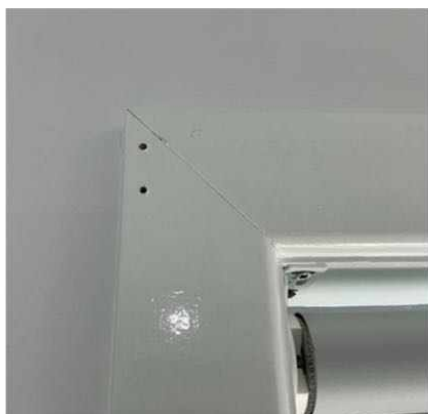
Defects 3.02

| Finding: | Cracking to Painted Architraves and Skirting Boards |
| Information: | Cracks were observed opening up in various sections of the painted architraves and skirting boards. These cracks may be associated with minor building movement, timber shrinkage, or inadequate surface preparation prior to painting. |

- Aesthetic presentation is compromised by visible cracking.
- Potential ongoing movement may lead to further deterioration or require repeated maintenance.
- May indicate underlying workmanship or preparation issues.

- Engage a qualified painter or builder to assess the extent of cracking and undertake necessary repairs, which may include filling, sanding, and repainting affected areas.
- Monitor for any signs of worsening or recurring movement over time.

This condition is not uncommon following recent painting, particularly in timber joinery, and is typically considered a maintenance item unless associated with significant structural movement.

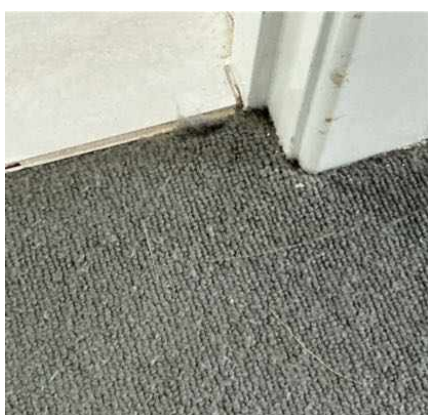
Defects 3.03

| Finding: | Early Wear to Carpeted Flooring |
| Information: | During the inspection, the carpet in areas was observed to be showing early signs of wear. This includes visible flattening of the pile, localised tracking along the main traffic path, and minor surface irregularities. These conditions are commonly associated with regular foot traffic, furniture movement, and general use over time, particularly in high-use circulation areas. |

- Progressive wear may lead to further deterioration of the carpet fibres, reducing overall service life.
- Worn areas can detract from the cosmetic presentation of internal spaces.
- If deterioration continues, localised repairs may become impractical, requiring partial or full replacement.

- Continue routine cleaning and maintenance to slow further wear, including professional carpet cleaning as required.
- Consider the use of runners or protective mats in high-traffic areas to reduce ongoing deterioration.
- If wear becomes more pronounced or unacceptable, seek advice from a flooring specialist regarding repair or replacement options.

The observed carpet wear appears consistent with normal use and is not unusual for trafficked areas. Ongoing maintenance and monitoring will assist in managing presentation and extending the remaining lifespan of the flooring.

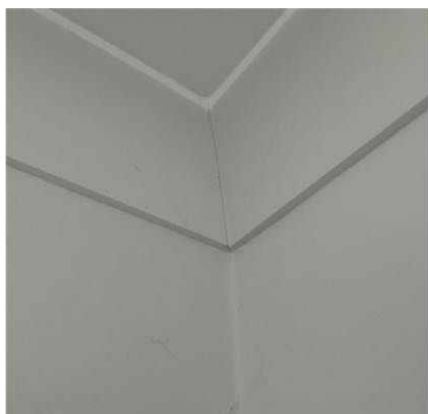
Defects 3.05

| Finding: | Cracking to Internal Wall Linings |
| Information: | Cracking was observed to internal wall linings during the inspection. These types of cracks are generally considered common and are typically the result of natural building movement, age-related wear, thermal expansion and contraction, or minor installation-related issues in plasterboard or supporting framing members. |

- Engage a qualified plasterer to repair cracks and consider installing expansion joints if necessary to accommodate ongoing building movement.
- Arrange for repainting by a qualified painter following any plaster repairs.
- Monitor cracks over time for signs of progression (e.g. widening, lengthening, or new cracks forming).
- If deterioration continues or operational issues with doors/windows arise, seek further assessment from a building inspector or structural engineer.

The cracking noted is typical of minor building movement and does not currently present as structural. Regular monitoring and cosmetic repair will assist in preserving the internal presentation and allow early intervention if future issues arise.

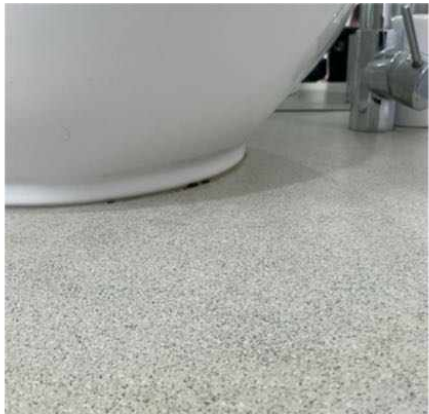
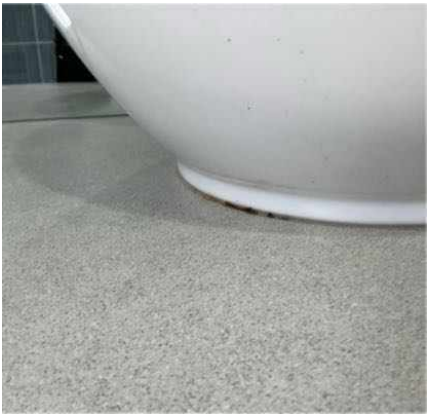
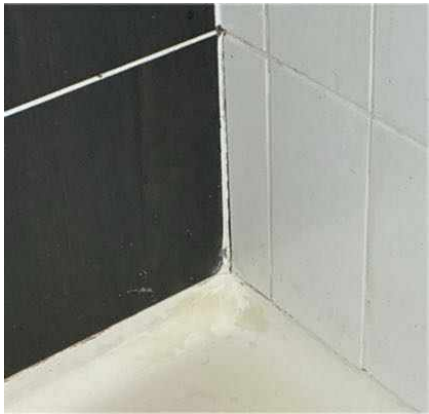
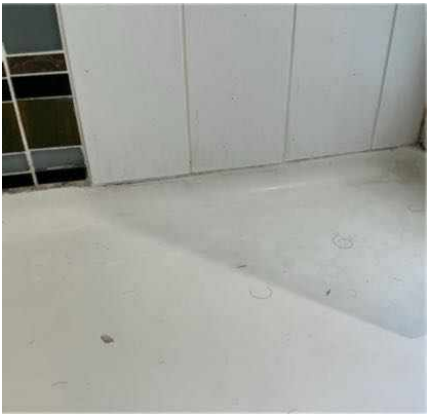
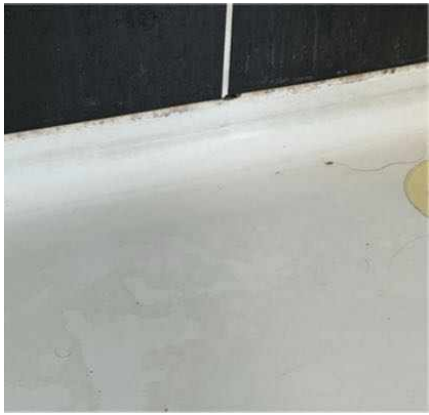
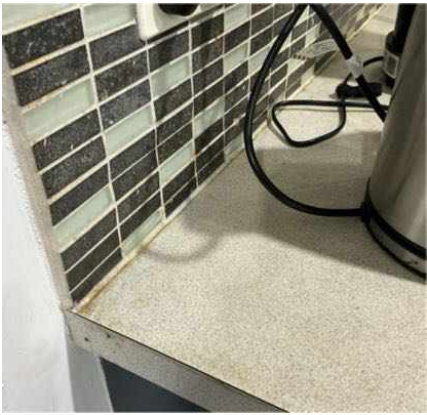
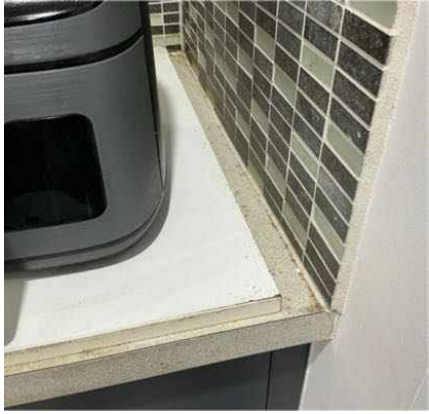
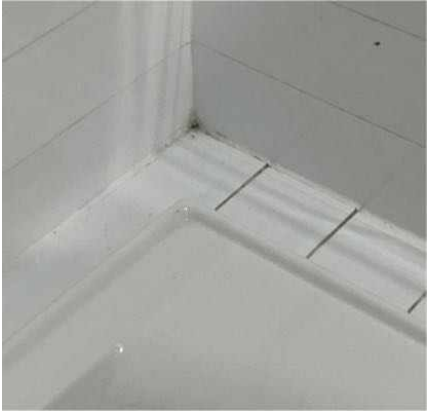
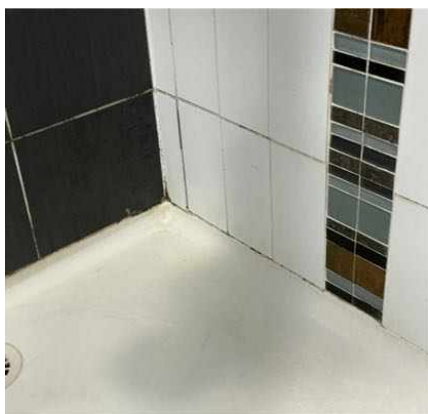
Defects 3.06

| Finding: | Deteriorated Sealant and Caulking – Ensuite, Bathroom, Laundry and Kitchen |
| Information: | During the inspection, the sealant to tiled junctions in the ensuite, bathroom, laundry and kitchen was found to be significantly deteriorated, with visible cracking, separation, and areas of missing caulking. This condition is typically caused by general ageing, exposure to moisture, and differential movement between adjacent surfaces such as wall tiles, vanity units, benchtops, and skirting boards. The failure of these joints compromises the waterproofing integrity of the wet areas. |

- Potential for water ingress into wall cavities, subfloor spaces, and adjacent joinery.
- Moisture-related damage to skirting boards, cabinetry, flooring, and wall linings.
- Increased risk of mould and mildew growth, potentially affecting occupant health.
- Reduced visual appeal and presentation of wet area finishes.

- Engage a qualified trade to remove failed sealant and reapply with mould-resistant, flexible waterproof caulking.
- Inspect adjacent grout lines for similar deterioration and re-grout as required.
- Repair or replace any skirting boards or fixtures already affected by water damage.
- Ensure wet areas are adequately ventilated to prevent premature sealant degradation.

The condition of the sealant and caulking requires attention to prevent further deterioration and to maintain waterproofing performance in all wet areas.

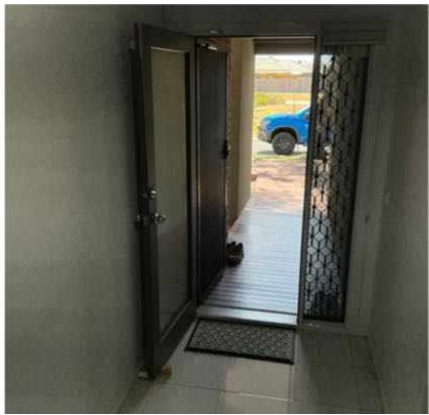
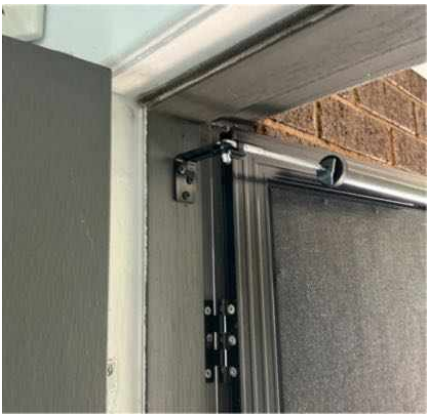
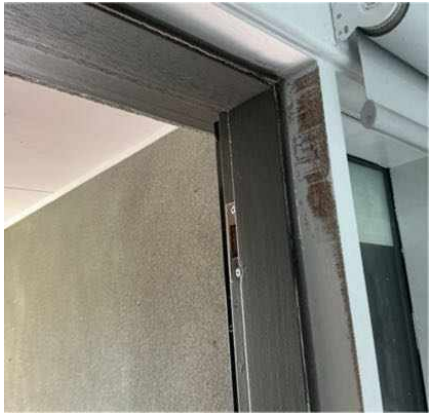
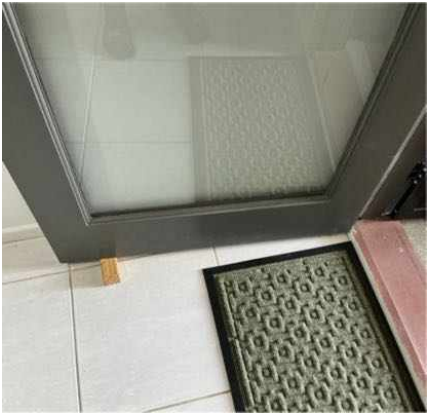
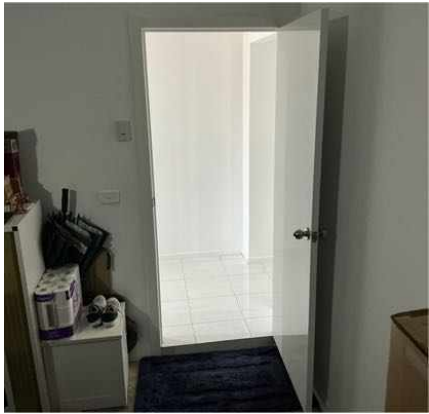
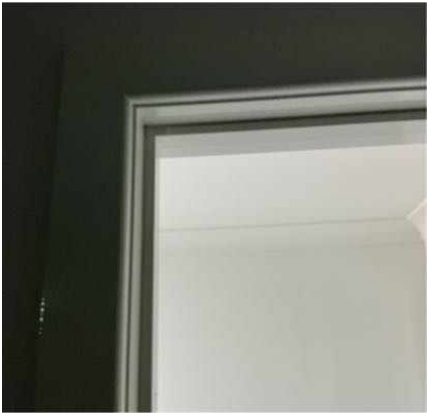
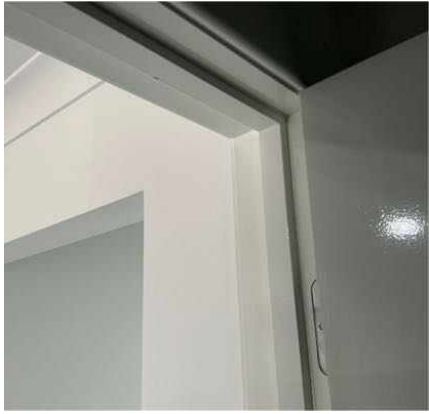
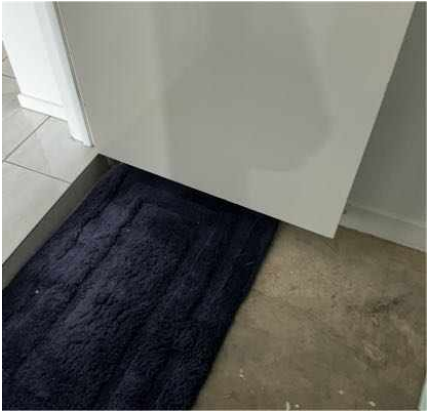
Defects 3.07

| Information: | External perimeter door seals and bottom Raven door seals are essential components of a home's weatherproofing system. These seals serve as a protective barrier against external weather conditions, preventing rain, wind, dust, and pests from entering the home. Additionally, they play a critical role in maintaining indoor temperatures, improving energy efficiency, and reducing heating and cooling costs. |

During the inspection, it was observed that these seals were missing from all the external doors of the property. The absence of door seals leaves the home vulnerable to several issues, including:

- Without proper seals, rain and wind can easily penetrate through gaps around the doors, potentially causing water damage, drafts, and discomfort for occupants.

- It is highly recommended to engage a skilled handyperson or tradesperson to install external perimeter door seals and bottom Raven door seals on all external doors. These seals should be selected and installed based on the specific needs of the homeowner and the property's design.

By installing and maintaining high-quality door seals, homeowners can protect their property from external elements, improve energy efficiency, and enhance the overall comfort and safety of their living spaces. Prompt action is recommended to prevent potential damage and unnecessary energy costs.

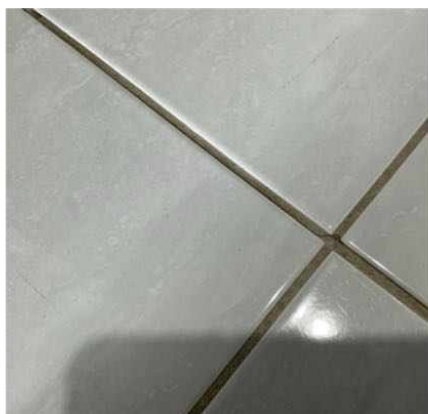
Defects 3.09

| Finding: | Cracked and Previously Repaired Floor Grout – Entry Area |

In summary, the cracked and previously repaired grout in the entry area indicates unresolved movement or installation-related issues, and remedial works should be undertaken to restore durability and prevent further deterioration.

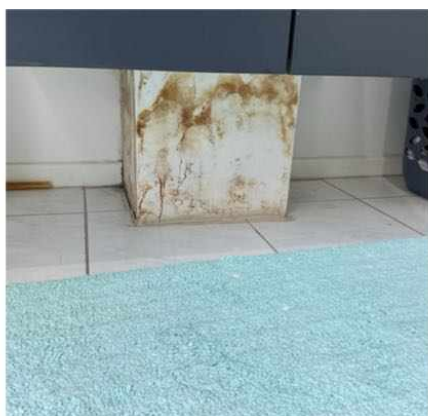
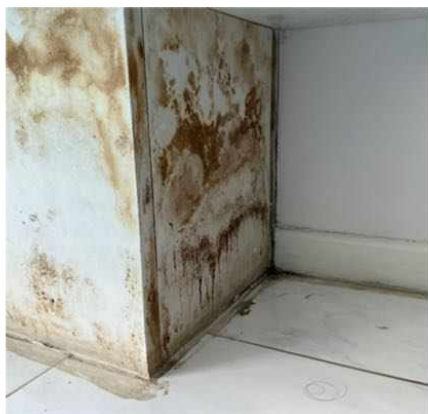
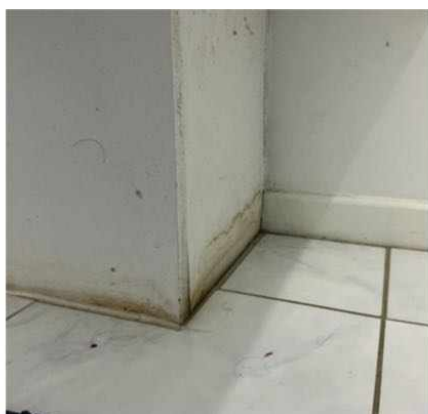
Defects 3.12

In summary, staining to the vanity kick panels in both the bathroom and ensuite is consistent with past moisture exposure. Further investigation and appropriate rectification are recommended to prevent continued deterioration and restore the finish of the cabinetry.

- The vanities and surrounding areas should be checked to confirm there is no active plumbing leak or ongoing moisture source
- If no active moisture source is identified, the staining can be treated as historical and affected kick panels repaired or replaced as required
- Any identified plumbing or moisture-related issues should be rectified prior to undertaking cosmetic repairs

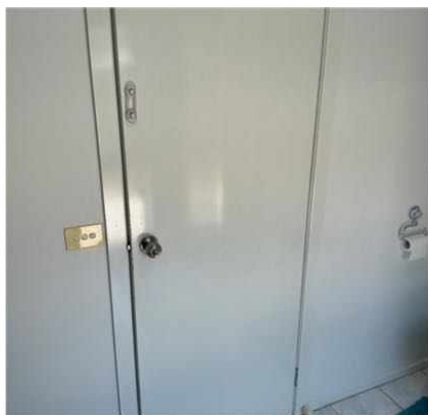
Defects 3.13

Building: Main Building
Location: Ensuite
Finding: Door Binding on Striker Plate
Information: One or more internal doors were noted to bind or fail to latch smoothly due to misaligned striker plates. This condition commonly occurs where minor frame movement has taken place, or where striker plates were not set correctly during installation.

In summary, misaligned striker plates were observed to one or more internal doors. Minor adjustment and maintenance are recommended to restore proper functionality.

- Adjust door hardware and hinges where necessary to ensure smooth and secure operation.
- Monitor for any signs of further frame movement that may cause recurrence.

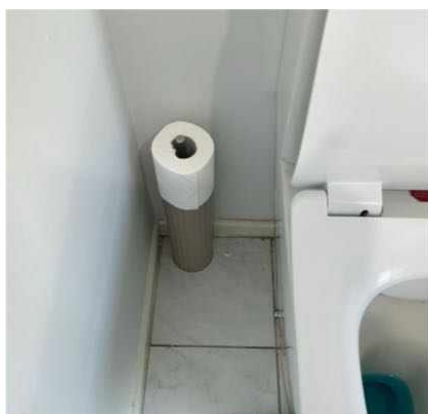
Defects 3.14

In summary, cracking at the skirting and wall junction behind the toilet appears consistent with historical moisture exposure, with no active moisture detected by thermal imaging at the time of inspection; however, repairs and ongoing monitoring are recommended to prevent future issues.

- If no ongoing moisture source is identified, affected skirting boards and junctions should be repaired, resealed, and refinished
- If changes are observed in the future, further investigation by a suitably qualified tradesperson is recommended

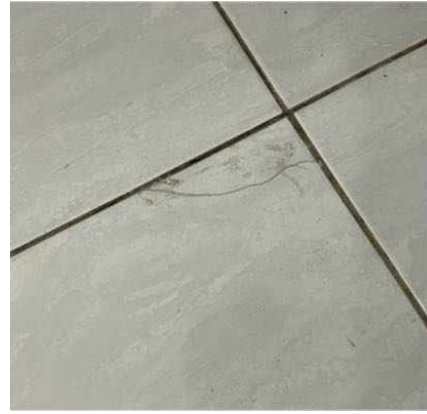
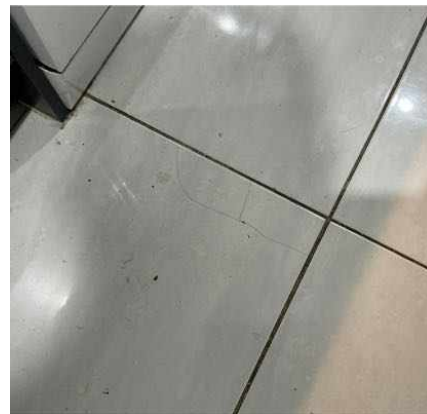
Defects 3.15

Cracked tiles are a relatively common occurrence and typically considered a maintenance or cosmetic issue unless accompanied by other signs of structural movement.

- If cracking becomes more extensive, consult a registered builder or building inspector for further evaluation.

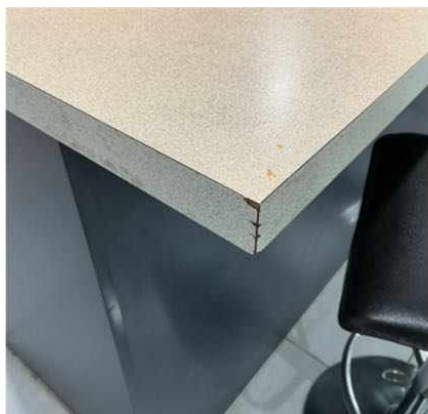
Defects 3.16

Building: Main Building
Location: Kitchen
Finding: Damaged and Chipped Laminate Edging to Kitchen Benchtop

In summary, the laminate edging to the kitchen benchtop is damaged beyond minor delamination, with exposed substrate evident. Remedial works or replacement are recommended to prevent further deterioration and restore functionality and appearance.

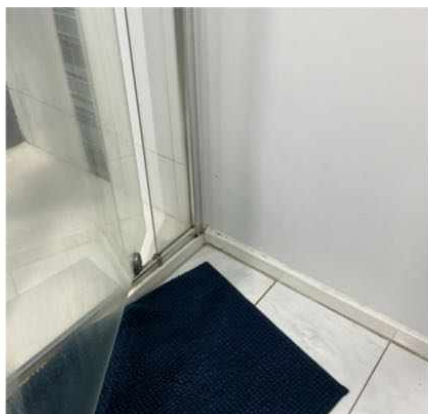
Defects 3.17

The water damage noted adjacent to the shower suggests a failure to adequately contain water within the wet area. Although the visible damage may be manageable with minor repair works, it also raises concerns about possible concealed defects. Further investigation is recommended to ensure the issue is not ongoing and to determine the appropriate scope of rectification.

- Where active leaks are present, necessary rectification should be prioritised to prevent further internal damage

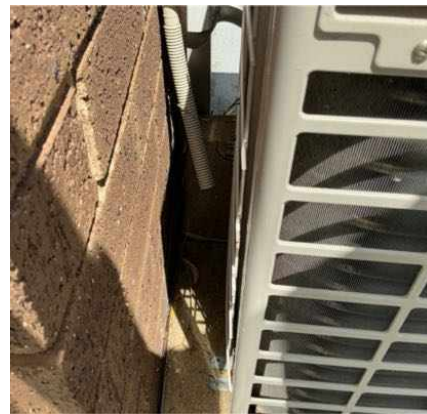
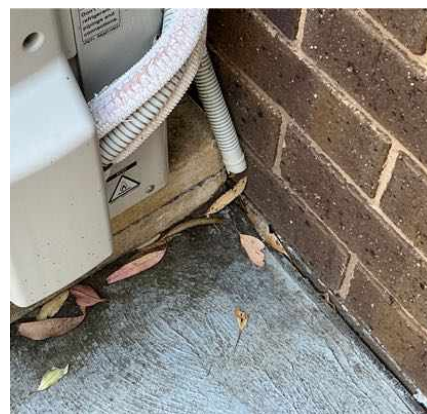
Defects 3.18

Although this is a relatively minor plumbing oversight, it presents an ongoing risk to nearby building elements and termite management. Correction is typically straightforward and should be planned as part of post-settlement maintenance to preserve building durability and reduce pest-related risks.

- Engage a licensed plumber to assess and reroute the overflow pipe into a compliant drainage system, ensuring water is directed safely away from the property.
- Monitor adjacent building elements for signs of moisture damage, corrosion, or fungal growth.
- Ensure that landscaping, garden beds, or other features around the area do not trap moisture against the building.
- Incorporate this item into ongoing property maintenance schedules to reduce the risk of long-term damage or pest attraction.

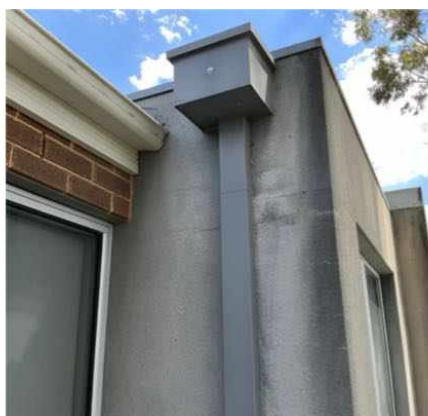
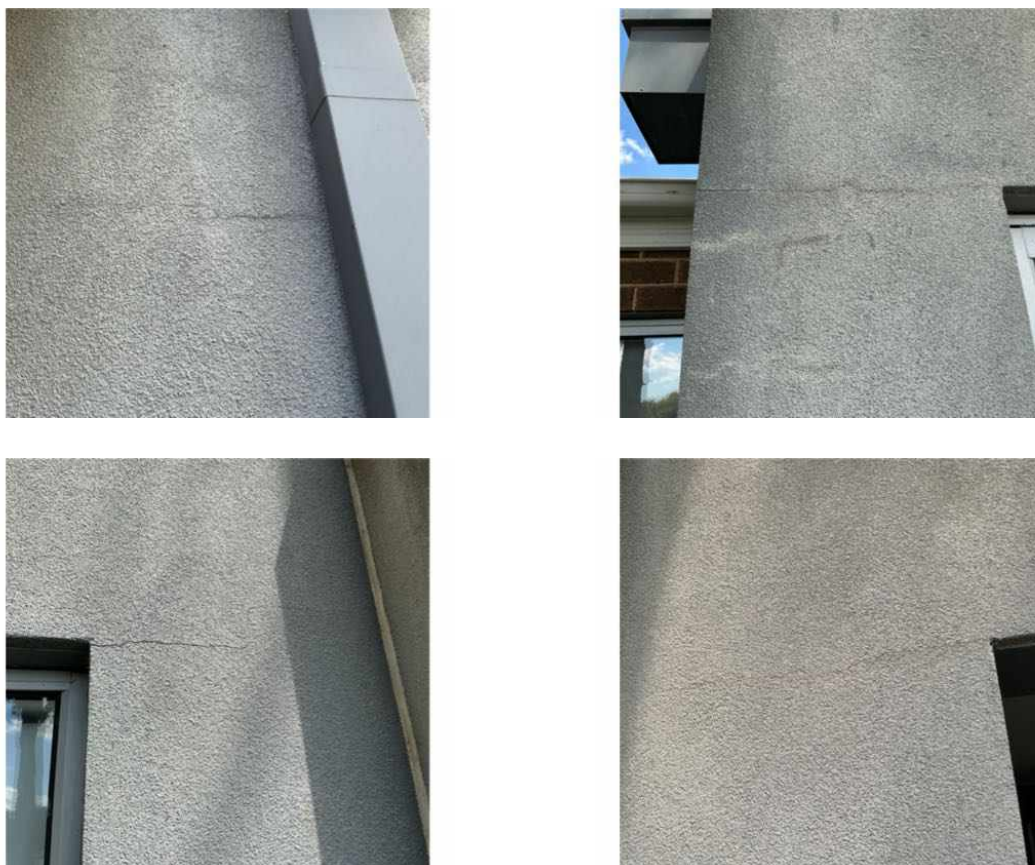
Defects 3.19

In summary, fine cracking to the external render is present and, while currently considered minor, requires maintenance to prevent moisture ingress and ongoing deterioration of the rendered wall system.

- The affected render cracking should be monitored and sealed using an appropriate flexible, paintable exterior sealant
- Following sealing, the areas should be repainted to maintain weather resistance and uniform appearance
- Any increase in cracking width, length, or pattern should be further investigated by a suitably qualified professional

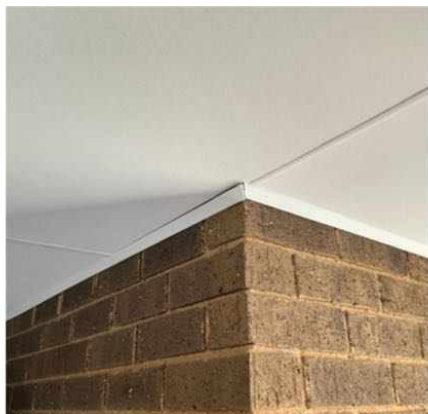
Defects 3.20

The separation observed is consistent with typical age-related wear and environmental exposure, and is considered a maintenance item rather than a structural concern. Prompt attention will help prevent moisture-related deterioration and preserve the external appearance of the property.

- Repaint affected areas with a high-quality, weatherproof coating to protect from further weathering.
- Monitor repaired areas as part of routine exterior maintenance, particularly following seasonal changes or heavy rain events.

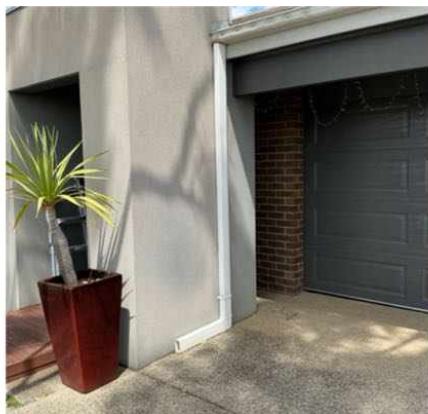
Defects 3.22

In summary, roof water discharge directly to the ground near the building is a non-compliant practice that poses moisture and structural risks. Rectification is required to ensure compliance with standard stormwater drainage provisions and to protect the building's foundation integrity.

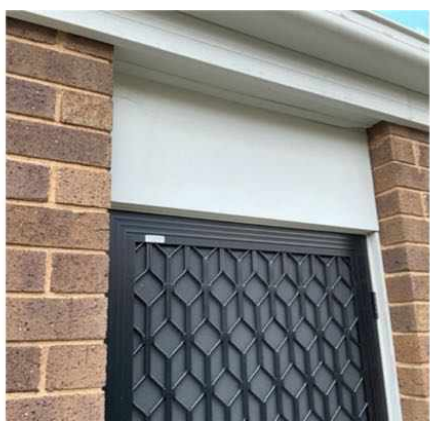
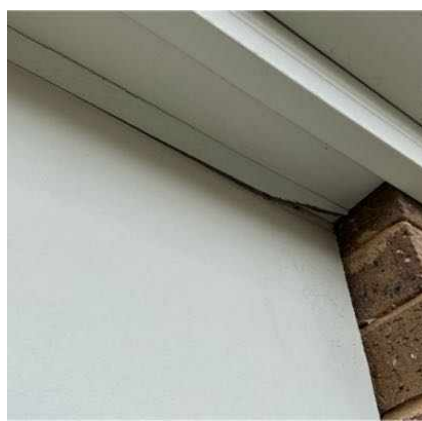
Defects 3.23

In summary, the broken quad moulding above the external garage access door requires repair or replacement to restore an appropriate finish and reduce the risk of moisture ingress and further deterioration.

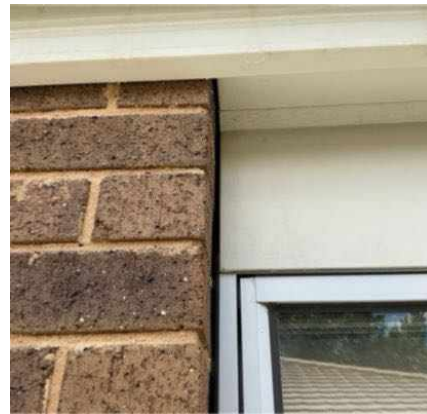
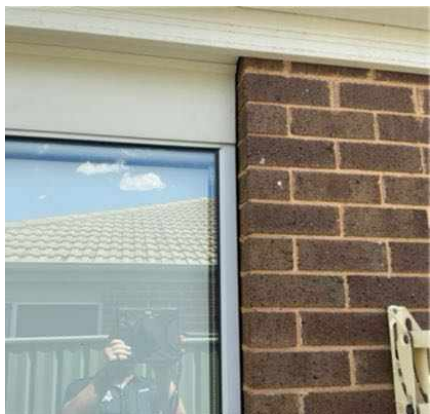
Defects 3.24

In summary, the gaps observed to multiple infill panels above windows represent a weatherproofing and finish deficiency and should be rectified to improve durability, performance, and protection of the building envelope.

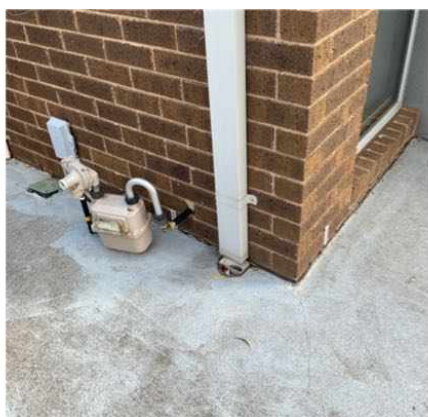
Defects 3.25

In summary, the downpipe is not correctly connected to the stormwater system and requires rectification to ensure roof water is effectively managed and discharged away from the base of the dwelling.

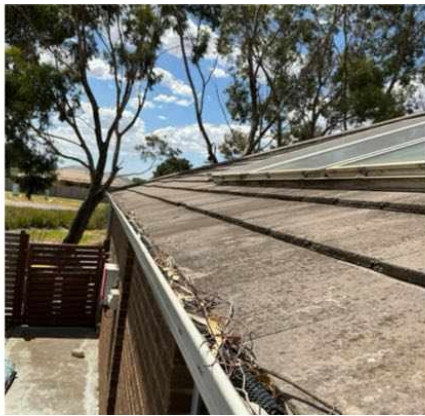
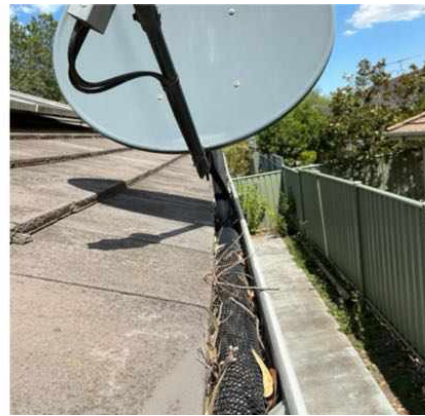
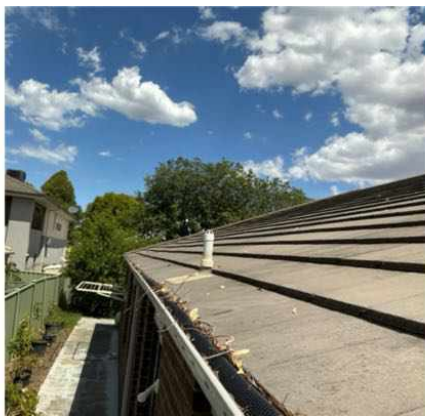
Defects 3.26

Routine gutter maintenance is a simple but important measure to protect the home from water ingress, deterioration, and potential fire hazards.

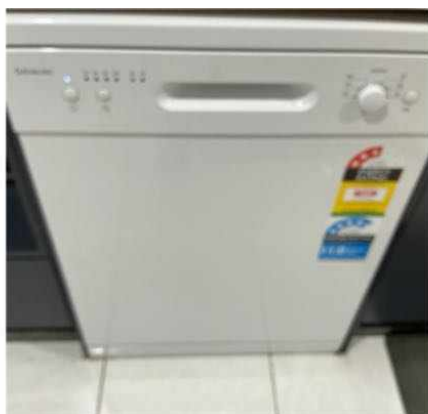
Building: Main Building
Location: All Internal Areas
Finding: Condition of Installed Appliances and Air Conditioner - Operational
Information: the time of inspection, the installed appliances—including the oven, cooktop, rangehood, dishwasher, and reverse cycle air conditioner—were checked for basic operational function. All appliances powered on and responded as expected to standard user inputs, indicating they are in working condition.

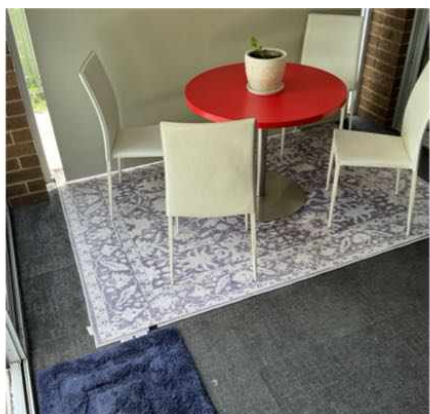
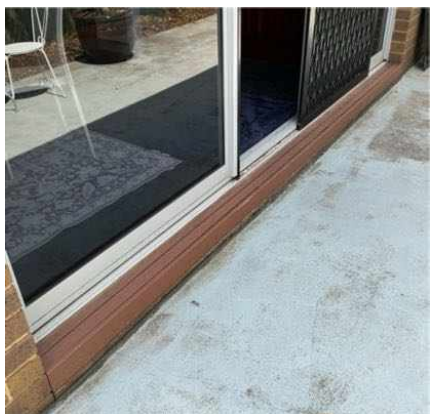
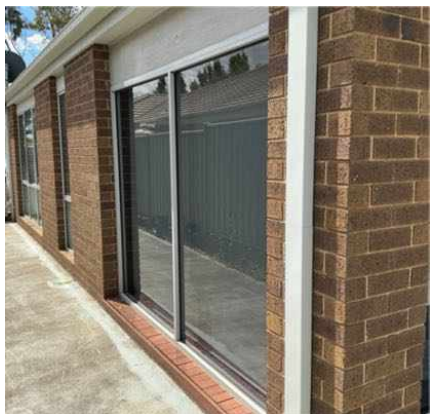
In summary, the enclosure of the decked alfresco area represents a change to the original use of the space, and confirmation of appropriate approvals and compliance should be obtained prior to purchase.

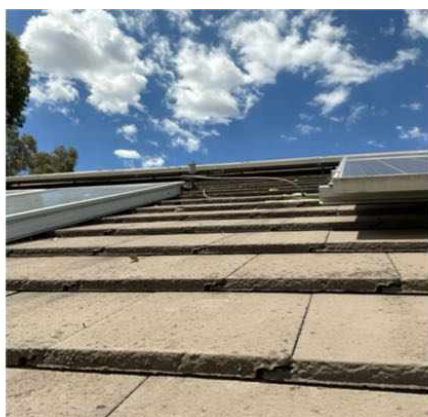
Building: Main Building
 Location: Roof Exterior
 Finding: Aged Roof Covering – General Weathering
 Information: The tiled roof covering was observed to be in fair condition, with signs of general wear and weathering consistent with the age of the property. The roof appears to have performed adequately over time, offering effective protection against the elements.

The current condition of the roof suggests it has generally performed well, but proactive upkeep will be required to extend its service life and prevent the development of secondary defects.

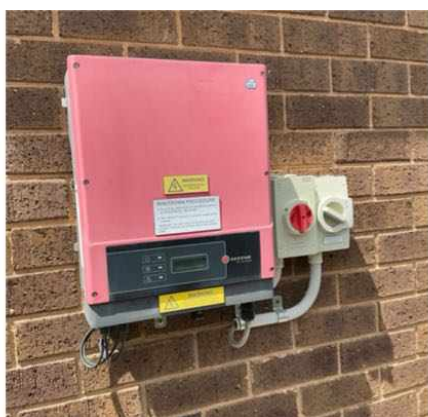
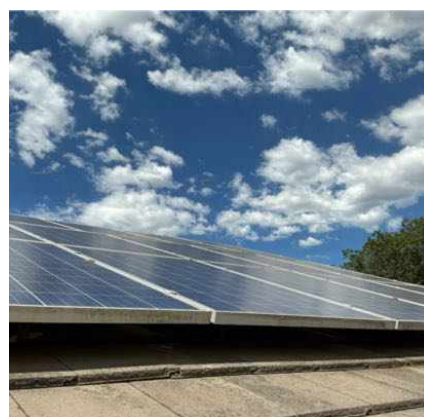
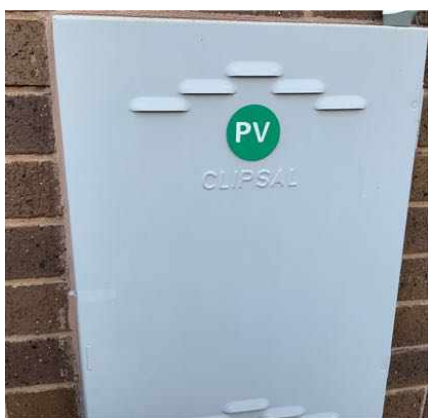
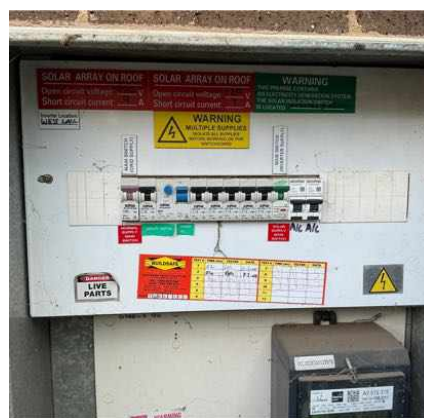
As the inspection of solar power systems is beyond the scope of this report, no assurance is provided regarding the operational status or safety compliance of the system.

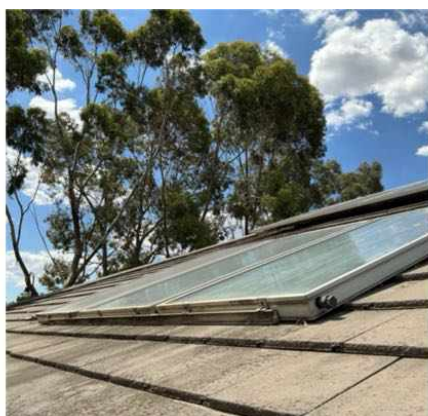
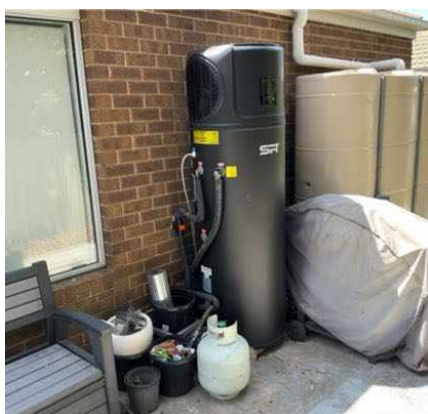
In summary, the solar hot water panels are no longer in use following installation of the heat pump system and should be removed, with the roof fully reinstated, to reduce ongoing maintenance risks and potential water ingress issues.
