Building and Timber Pest Inspection Report

Inspection Date: Fri, 27 Mar 2026

Property Address: 109 Coxs Rd, North Ryde NSW 2113,
Australia

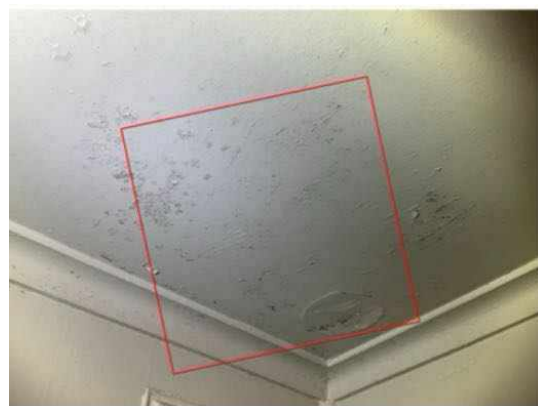
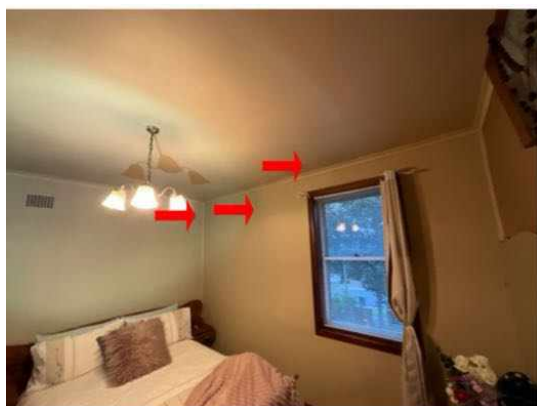
Building:	Main Building
Location:	Multiple areas
Finding:	Mould present - Ventilation
Information:	Evidence of mould growth was noted, which is believed to have grown due to lack of ventilation to the area.

Generally, the client is advised to ensure that the general environment is free of moisture and humidity to aid in the prevention of mould formation and development. Any mould found during the inspection should be cleaned immediately by a cleaning contractor or the homeowner as applicable.

Although the exhaust fan was found to be working at the time of inspection, however a licensed electrician May be appointed to ensure the full exhaust fan operation.

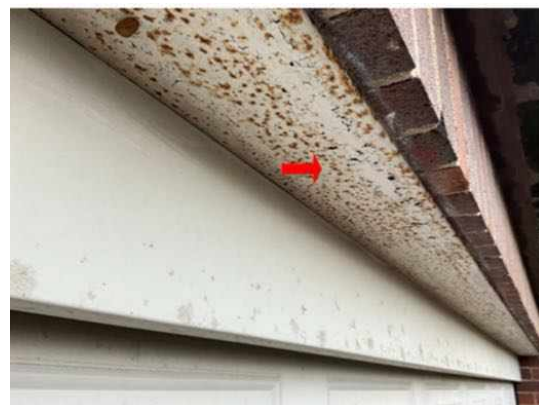
Building:	Main Building
Location:	Garage
Finding:	Building element - Rusted or corroded
Information:	This building element shows evidence of rusting and corrosion, which is likely to have developed as a result of excessive exposure to moisture and or inadequate coatings.

As surface rust provides no protection to the underlying iron, the deteriorating condition is likely to worsen if not addressed in the short-term future.

Where possible, the use of galvanized (treated) metals or aluminium coated metals aid in rust prevention, as does regular general maintenance. Rust formation can be controlled with coatings, such as paint, that isolate the iron from the environment.

Rusting and corrosion should be managed by ideally removing or limiting the affected surface from exposure to moisture. A licensed painter must be appointed for an adequate paint coating system. A licensed builder may be appointed to replace any building elements that have been severely affected by rust or water damage.

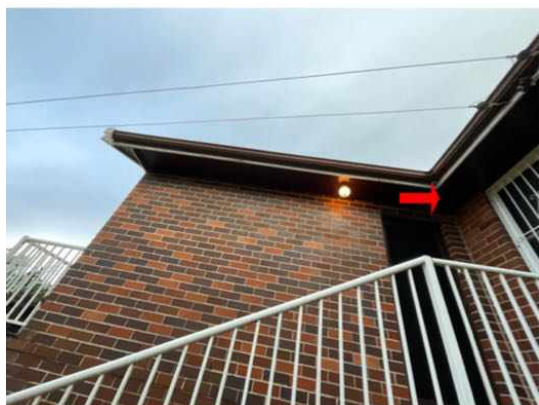
Building:	Main Building
Location:	Porch
Finding:	Painted surface - Bubbling
Information:	Sections of paint in this area was found to have bubbled and deteriorated. Paint bubbling is generally an indication of excessive moisture in the area, that is currently hidden by the painted surface.

The presence of excessive moisture can have major implications on associated building elements if left unattended. While only seemingly minor at this stage, the damage cannot be determined due to the paint obstructing any further inspection of the damage.

It is highly advised that the affected paint be cleaned to allow a further, more invasive inspection by a licensed roof plumber. Failure to act on this defect may necessitate

major works in the future.

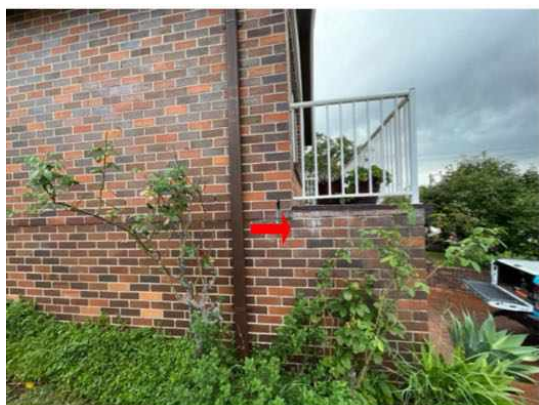
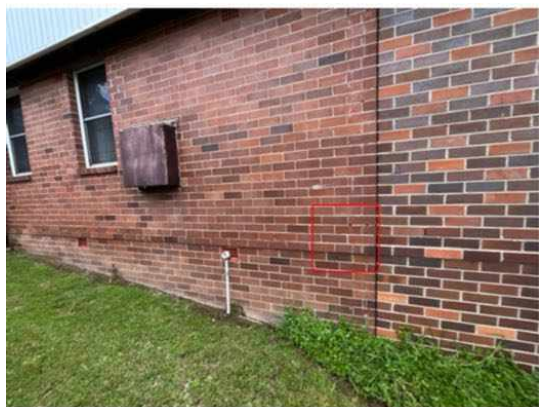
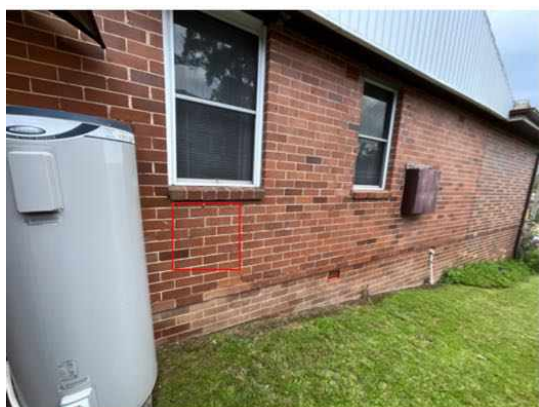
Building:	Main Building
Location:	Multiple areas
Finding:	Brickwork - Step cracking
Information:	Step cracking was identified to the brickwork in this area at the time of inspection. Step cracking, which is similar to other forms of cracking, has a variety of possible causes. However, the most common is the subsidence of adjacent footings.

Step cracking is a relatively common defect, and is most likely to occur adjacent to windows, doors and other openings. Mortar failure in the gaps between affected bricks indicates the stresses and tensions affecting the wall.

Minor step cracking can be used as a warning sign to address factors causing stress to the wall, which can include the effect of surrounding trees, water leaks, soil erosion, or even the presence of reactive soils in the surrounding area. The degree of damage falls within Category 1, described as fine cracks, which are less than 1.0mm in width limit, and that do not need repair.

Damage of this category is not considered a defect for rectification. Always contact your building inspector should cracks widen, lengthen, or become more numerous.

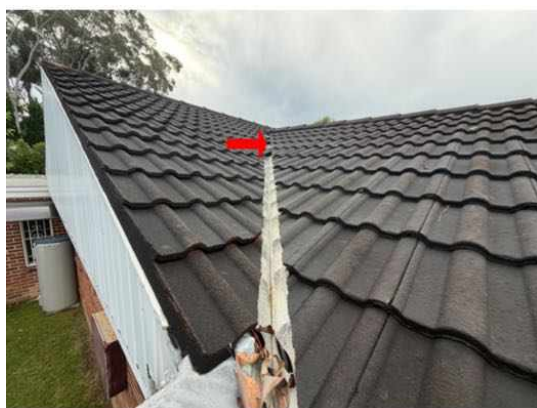
Building:	Main Building
Location:	Roof Exterior
Finding:	Roof tiles - Slippage
Information:	Upon inspection of the exterior roof covering, it was noted that numerous tiles have slipped from their original fixing. Tiles may slip over time due to a number of minor causes, including breakage of tiles, failings in the adjoining battens, or fixings that may have failed.

Roof tiles that have moved from their original position are very likely to allow water penetration into the roof void, exposing roofing structures to excessive moisture. This creates an environment that is conducive to water damage and accelerated deterioration of all associated building elements.

Replacement of loose or missing roofing tiles is recommended immediately to prevent the development of any secondary defects. A roofing restoration specialist should be appointed to complete such works as necessary.

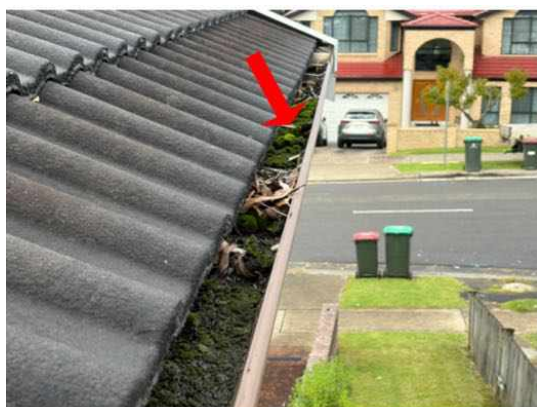
Blocked gutters are likely to lead to high levels of moisture in the affected areas. Such moisture will not only cause rust and decay of the associated building materials, but can also provide conditions that are conducive to termite and timber pest activity. Blockages in gutters should therefore be removed immediately to ensure dry conditions are maintained.

Consult a Licensed Plumber for further specific advice on remedial works that may be required. In the interim, it is highly advised that blocked gutters be removed by the homeowner or a general handyperson as a matter of urgency.

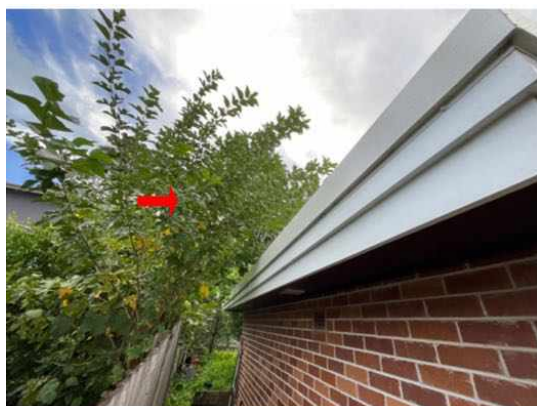
Gutters are a critical part of the building's management of storm water and rain. It is therefore important that they be kept clear to prevent secondary damage to associated building elements, including exterior and interior walls, ceiling linings and any adjoining building elements. Where gutters are blocked, pooling of rainwater is likely to occur, fast-tracking rust and corrosion of the roof plumbing elements.

It is highly advised that all overhanging tree branches be removed as soon as possible to prevent any further damage. Repair and/or replacement of sections of damaged guttering may also be required where the extent of the damage necessitates.

Such works should be performed by the homeowner; however, appointment of a landscape contractor or an arborist may be required. Consultation with a licensed roof plumber is required where guttering has been damaged.

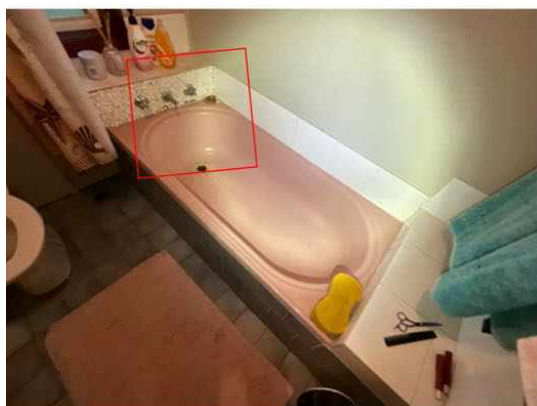
Building: Main Building
 Location: All Wet Areas
 Finding: Sealant and grouting - Missing or damaged
 Information:

It was noted on inspection that sealant or grout is degraded to this area.

Different materials and floor areas move at different rates, generally causing cracking to grout or sealant at this point. A flexible sealant is required to allow for expected expansion and contraction, while keeping the joint water tight and protective of all associated building materials.

Flexible and mould resistant materials should be applied to affected areas to prevent any subsequent water damage that is likely to occur. Regular maintenance and replacement of damage or missing or damaged sealant and grout is highly recommended to the wet areas, as this is a regular wear and tear defect. Sealant and grouting in areas that come into regular contact with water should be maintained for the long term care of your property.

A sealant specialist should be appointed to complete these works as soon as possible.

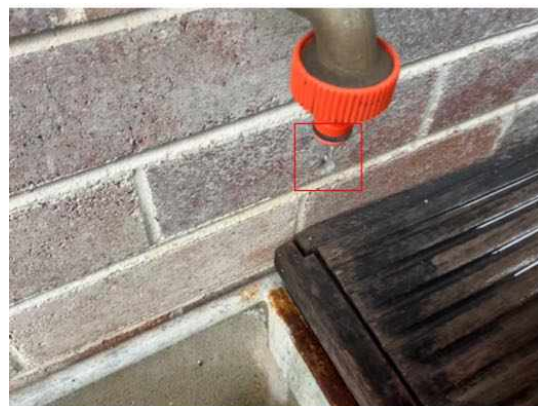
Replacement of washers will ensure that water wastage does not occur and that the persistent water leak does not result in secondary damage to surrounding structures. Such damage may range from rust and corrosion to damage of surfaces, e.g. bench tops, etc.

A qualified plumber should be appointed to replace degraded washers and to further inspect associated plumbing fixtures and fittings. Where water damage has occurred, a carpenter or cabinet maker may be appointed to replace affected building elements.

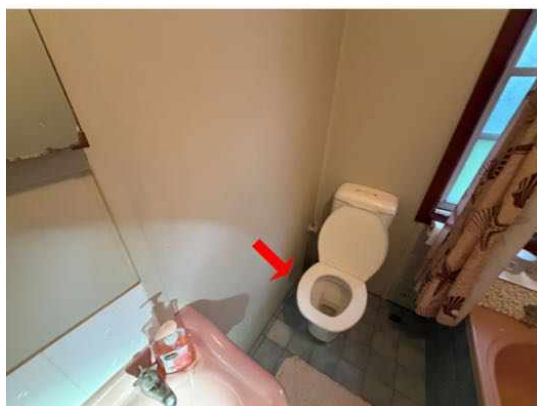
Building:	Main Building
Location:	Bathroom
Finding:	Evidence of excessive moisture was present at the time of inspection
Information:	Excessive moisture can attract termites and produce conditions that promote termite attack, fungal growth and wood decay. Excessive moisture is generally caused by deteriorated, inadequate or missing roof drainage, leaking plumbing pipes or fixtures, poorly plumbed HWS overflows or condenser units and poor site drainage. It is highly recommended that all plumbing and drainage fixtures and fittings be maintained regularly in order to prevent excessive moisture being present in the external / internal property.

A licensed plumber must be appointed urgently for further assessment.

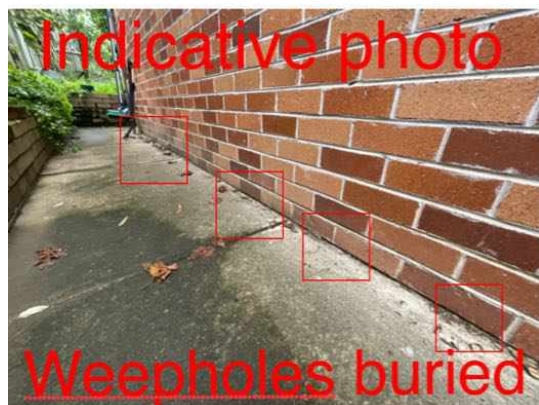
Building:	Main Building
Location:	Rear extension perimeter
Finding:	Bridging or breaching of termite barriers - weep holes
Information:	Bridging is the spanning of a termite barrier or inspection zone so that subterranean termites are provided with passage over or around that barrier.

It is highly recommended that weep holes are left exposed in all areas throughout the

external property. Therefore if any termite activity leading into weep holes becomes easily detectable during frequent pest inspections.

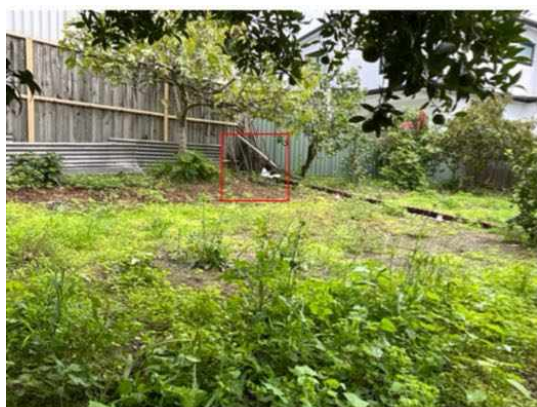
weather conditions or excessive moisture wood rot is likely to develop on timbers that are not treated.

It is highly recommended that any stored timbers be immediately removed from areas in which they may attract any termite / timber pest attack. Minimisation of risk / prevention of termite attack is far more adequate than dealing with the presence of termite activity.

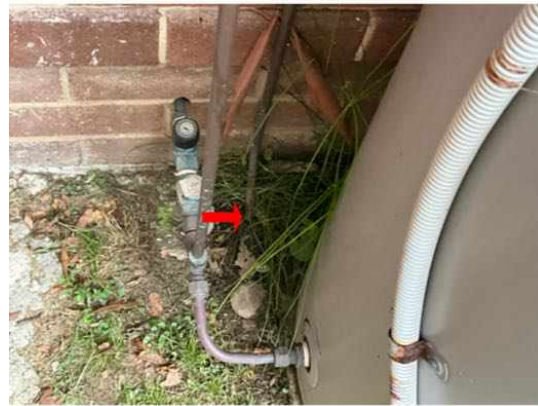
Building:	Main Building
Location:	Yard - Side
Finding:	Overflow - Not plumbed for drainage
Information:	The overflow is not plumbed or connected to suitable drainage, which can result in the surrounding area becoming excessively damp.

It is highly recommended that a licensed plumber be appointed to install adequate drainage to the overflow. These works will ensure that the area remains dry and free of

any secondary defects.

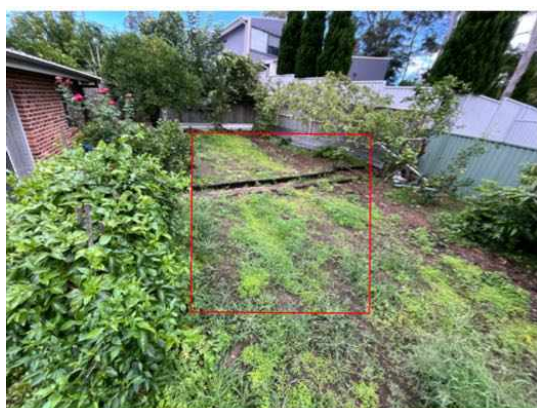
It is important that water does not lie against the base of walls; surrounding paths and ground levels should be sloped to drain water away from walls. Downpipes should not discharge stormwater onto lower walls or plinths. Stormwater should be carried away by large, regularly cleaned drains. Ground levels may need to be lowered to expose a buried DPC.

Where site drainage is inadequate, installation of an Agricultural (Aggie) Drain may be required. A licensed plumber should be appointed to further inspect the property and perform any remedial works as necessary. Water damage and secondary defects are likely to occur if left unmanaged.
