Building Inspection Report

Inspection Date: Wed, 11 Mar 2026

Property Address: 1510/338 Water St, Fortitude Valley QLD
4006, Australia

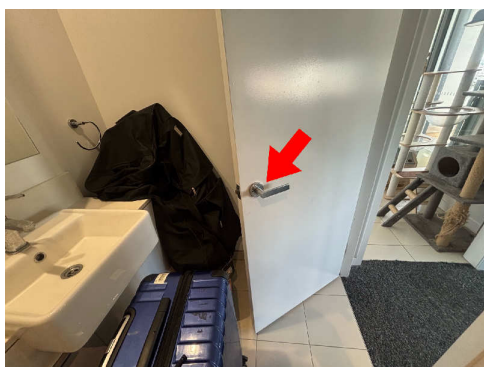
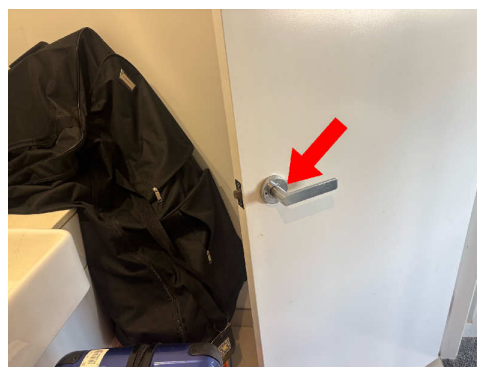
Defects 3.01

Location: Ensuite

Finding: Ensuite - door handle loose

Information: At the time of the inspection, it was noted that the door handle to the ensuite was loose. If left unaddressed, the functionality of the door handle may be affected.

A building maintenance professional could be engaged to repair or replace the door handle. This can be done at the clients discretion.

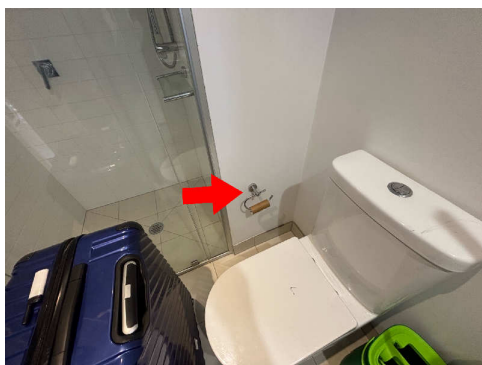
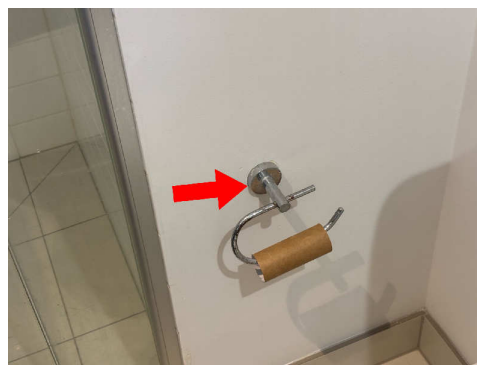
Defects 3.02

Location: Ensuite

Finding: Ensuite - toilet roll holder loose

At the time of the inspection, it was noted that the toilet roll holder in the ensuite was loose. While not a major operational defect, function can deteriorate if the problem is left unmanaged.

It is advised that the homeowner performs remedial works to re-attach the toilet roll holder to its original fixing. A building maintenance professional may be required to perform these works. This can be done at the clients discretion.

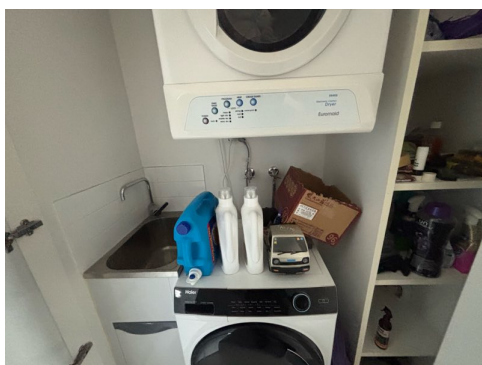
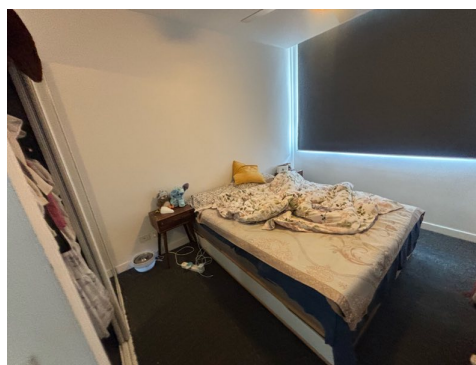
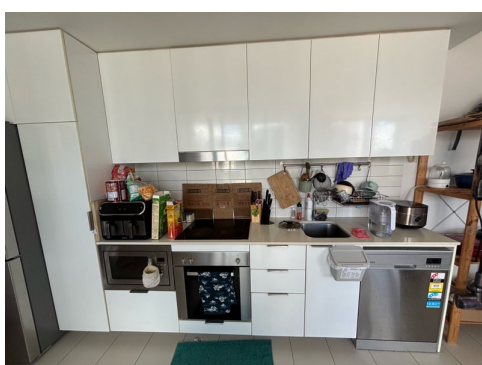
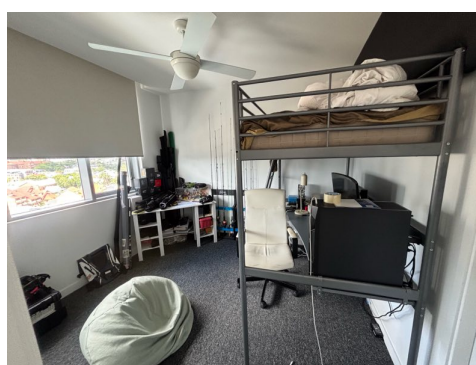
Noted Item

Location: All Internal Areas

Finding: Obstructions and Limitations - Internal areas

Information: These photographs are an indication of the obstructions and limitations which impeded full inspection of the property of the internal areas at the time of inspection. These obstructions can hide an array of defects and should be removed to allow full inspection to be carried out. A re-inspection is recommended once the areas are made accessible.
