# Building and Timber Pest Inspection Report

Inspection Date: Thu, 19 Mar 2026

Property Address: 6 Union St, Williamstown VIC 3016,  
Australia

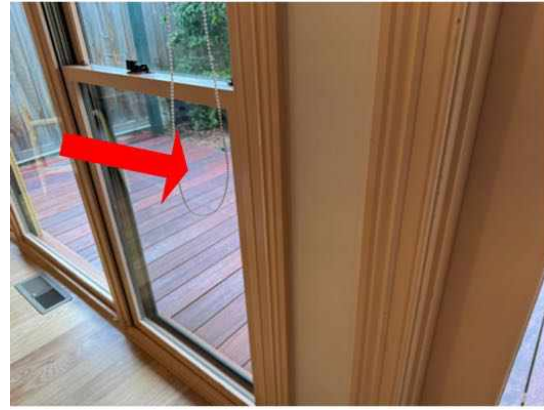
Building: Main Building  
 Location: Lounge Room  
 Finding: Curtain & Blind - Safety Cord  
 Information: Looped curtains and blind cords pose a significant strangulation hazard for children as they can place the loop over their heads and/or get tangled in the loose cords. The mandatory standard for blinds, curtains and window fittings (in place from 30th

December 2010) requires all new window furnishings to come with warning labels and to be installed with tensioning devices. However, as this standard is not retrospective, curtains and blinds installed before 2010 still need to be made safe. Check all the rooms in your house for any blinds or curtains with long, loose or looped cords. This includes any cords within children's reach at floor level or near furniture they can climb on. Secure any loose or looped cords with cleats or tension devices - these can be purchased from your local curtain and blind retailer or hardware store.

When installing new blinds and curtains, ensure you or the installer secures loose or looped cords immediately.

It is recommended that this defect be resolved immediately to avoid harm to occupants.

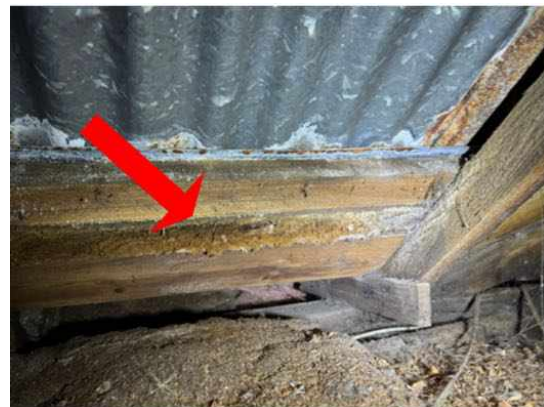
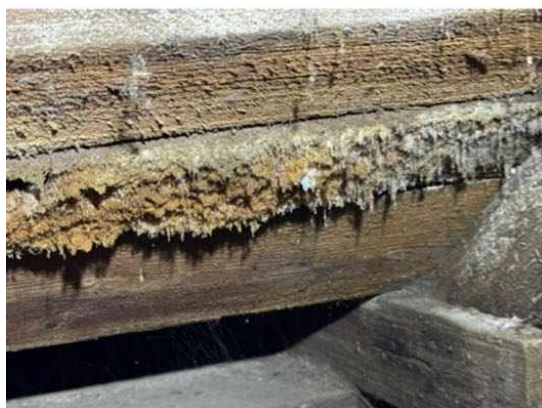
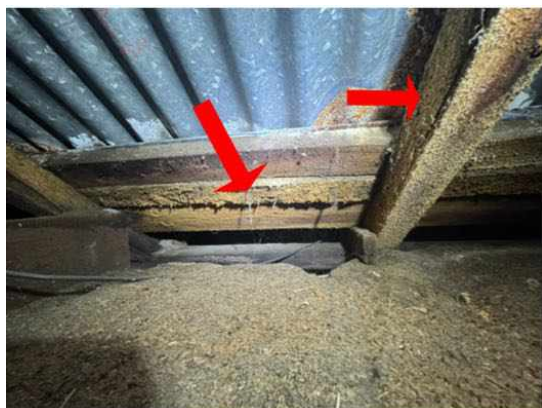
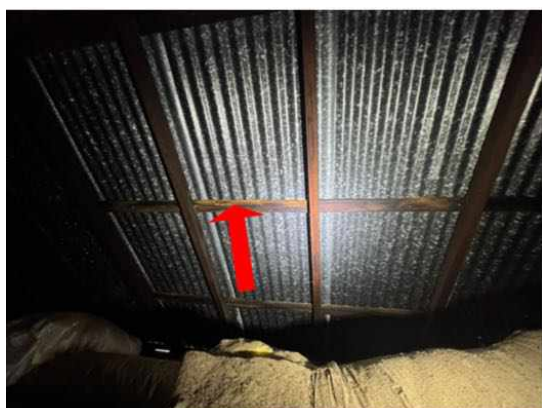
### Finding 2.01

Building:	Main Building
Location:	Roof Void
Finding:	Chemical delignification identified
Information:	Chemical delignification also known as wood defibration refers to the chemical breakdown of timber building elements. This breakdown of the Lignin deteriorates the wood impacting on the structural integrity and tensile strength of the affected building element.

Chemical delignification is most common near marine environments due to the high levels of salt in the air however this deterioration may also occur in other areas where timber elements are frequently exposed to damaging gases chemicals etc.

- Chemical delignification to timber: Structural timber deterioration identified, requiring urgent repair or replacement and investigation of the cause by a qualified builder and/or structural engineer.
- Roof sheets deteriorated: Roof sheeting is rusted, loose, and deteriorated, requiring urgent repair or replacement by a qualified roofing contractor.

Where timber building elements have deteriorated repair and / or replacement is required immediately to ensure the safety of the associated structures. The likely cause of the defibration should also be investigated and dealt with accordingly.

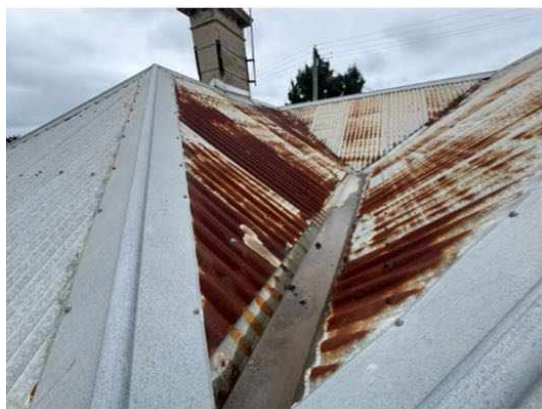
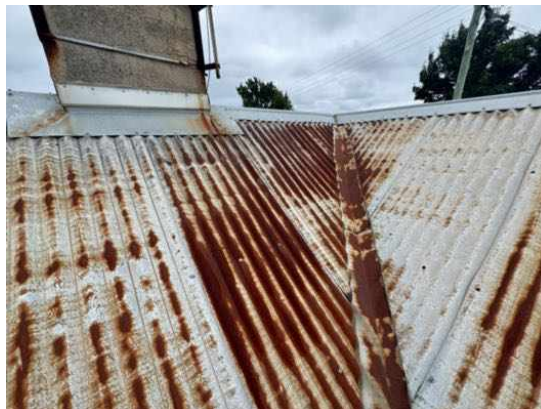
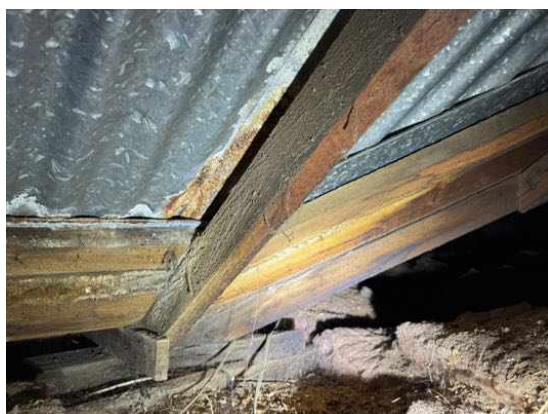
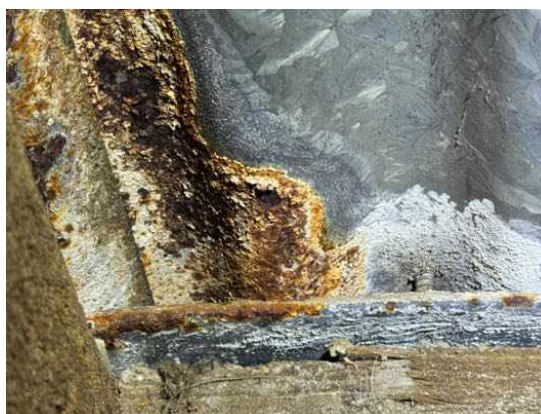
## Finding 2.02

Building:	Main Building
Location:	Roof Exterior
Finding:	Roof sheets - Deteriorated
Information:	Upon inspection of the exterior roofing, it was found that the roof sheets show signs of rust and deterioration, with some sheets having come loose from their original fixing. The roofing has sustained an array of issues due to the age of the materials and a lack of general maintenance over time, including loose sheeting and deterioration of associated building elements.

Loose, deteriorated and damaged roof sheets are susceptible to water penetration, exposing the surrounding associated area to internal roof leaks and water damage.

Re-fixing of all loose roof sheets should be conducted as soon as possible to ensure that no further damage occurs. Depending on the extent of the damage, replacement of sections of roof sheets or associated materials may be required. Engagement of a roofing restoration contractor is highly advised to perform remedial works as necessary.

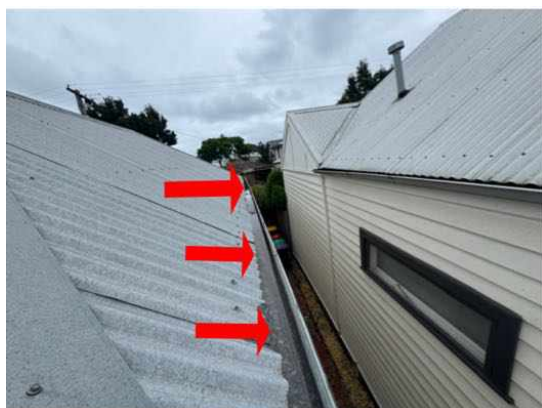
### Finding 2.03

Building:	Main Building
Location:	Roof Exterior
Finding:	Gutters - Water pooling
Information:	Water was found to be pooling in sections of the roof guttering. This is generally a secondary defect caused by blocked or partially blocked gutters. Such blockages and subsequent water pooling are likely to lead to rust and water damage to associated structures if left unattended.

- Gutters water pooling: Water pooling observed in gutters, likely due to blockages, requiring cleaning, repair, and further investigation by a roofing plumber (including CCTV drainage inspection)
- Subsidence: Movement of subfloor foundations identified, requiring assessment by a structural engineer and likely rectification works by a registered builder (re-stumping specialist).
- Bowed walls: Structural bowing to walls noted, requiring urgent assessment by a structural engineer and remedial works by a registered builder.

Any areas of guttering that shows evidence of water pooling should be checked for partial or full blockages and any secondary damage that may have occurred as a result. Depending on the extent of the damage, building elements may require repair and/or replacement to ensure adequate roof drainage and function of exterior plumbing system.

A roofing plumber should be appointed as soon as possible to rectify this issue. It is highly advised that all gutters be maintained on a frequent basis to ensure the condition of roof plumbing.

It is also recommended that a CCTV inspection of the stormwater drainage system be carried out to identify any blockages, damage, or defects that may be contributing to poor site drainage.

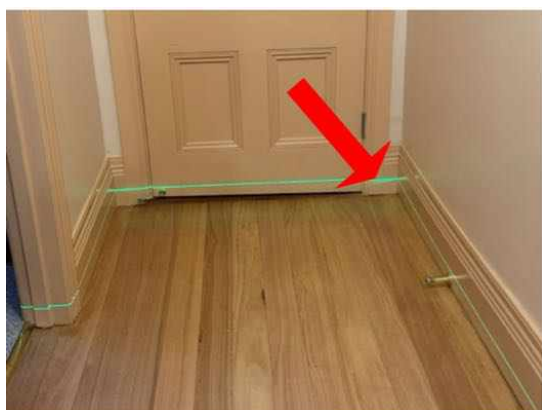
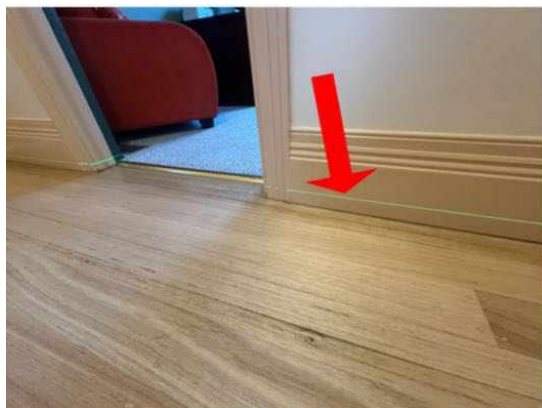
### Finding 2.04

Building: Main Building  
Location: All Internal Areas >  
Finding: Subsidence  
Information:

It appears that the subfloor structure has been affected by movement of the foundations, often referred to as sinking or subsidence. Whilst a degree of movement is expected in subfloors over time, especially as environmental conditions change and buildings 'settle' after construction, this degree of subfloor movement requires attention.

General subsidence is usually initiated by changes in soil moisture content. The most critical factor is identifying the specific causes, and identifying if this is a recurring or ongoing problem, or one that has been resolved by previous works in the past.

Subsidence can have complex and varying causes, which will influence the required remedial works. It is advised to begin by consulting a structural engineer to determine the required scope of works. This generally includes some form of underpinning, as well as addressing the underlying cause. Consultation with a geotechnical engineer may also be necessary where changes to soil moisture content is apparent.

A Registered Builder specialising in re-stumping would then generally carry out works as advised by an Engineer.

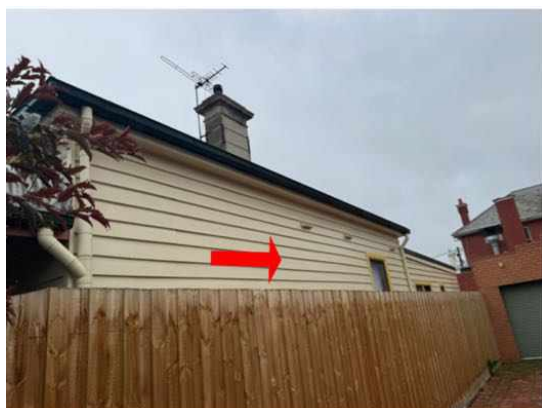
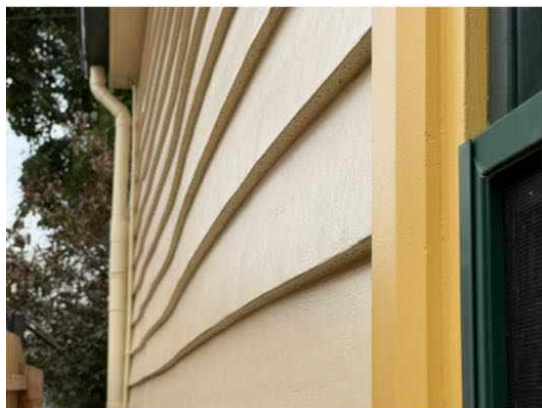
### Finding 2.05

Building:	Main Building
Location:	Exterior walls - right side
Finding:	Walls - Bowed
Information:	Vertical bowing and horizontal bending is caused by lack of resistance to vertical pressures from foundations, upper floors or roofs, or horizontal pressures from a range of causes e.g. environmental conditions.

Quotations for building works required to fix bowing building elements should be sought prior to purchase. It is suspected that extensive works, including works to walls and associated finishes, is likely to be required.

A structural engineer may provide advice prior to seeking quotations on the required scope of works to prevent structural failure. Where bowing is less severe, a registered builder, in association with qualified trades, should be appointed to perform remedial works.

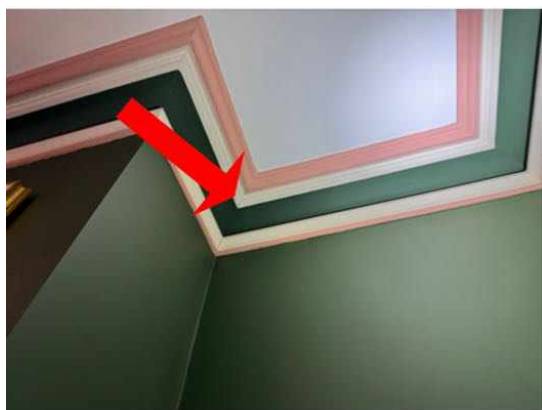
### Finding 3.01

Building:	Main Building
Location:	All Internal Areas
Finding:	Cracking - Damage Category 2 - Noticeable (up to 5mm)
Information:	Noticeable cracks are a common occurrence as a result of many primary defects. Such causes may include age, general wear and tear, expected building movement, general expansion/contraction of building materials in different weather conditions, and/or minor failings in the installation or application of building materials.

Noticeable cracks may result in minor sticking or jamming of associated doors and windows, which require easement. However, noticeable cracks are easily filled and repaired.

Monitoring of all cracking should be conducted frequently. Always contact a building inspector should cracks widen, lengthen, or become more numerous. Additionally, your building inspector should also be contacted if associated building elements such as doors and windows become more difficult to operate over time.

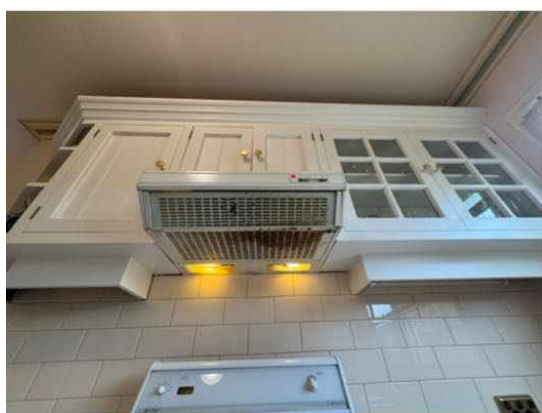
Building:	Main Building
Location:	Kitchen
Finding:	Range hood - Not operating
Information:	The range hood appears to be damaged or blocked and is not operating as intended.

Non-operational items should be addressed to ensure that the full function of the building structure is available. Where some building elements are not operating as intended, it is possible that secondary building defects could arise due to their non-operation.

Repair and/or replacement of the faulty building element is recommended. It is highly recommended that the relevant tradesperson be engaged to perform any necessary works.

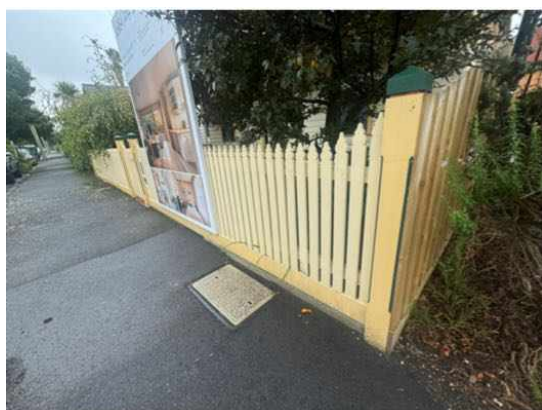
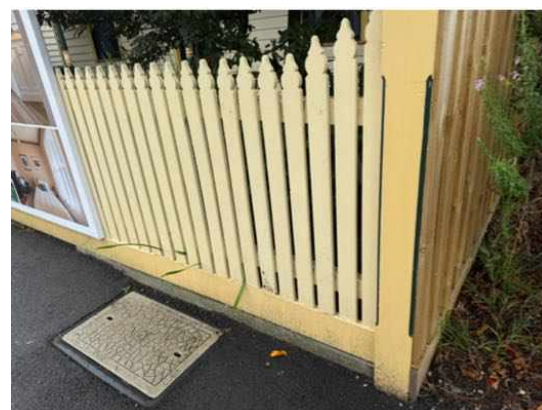
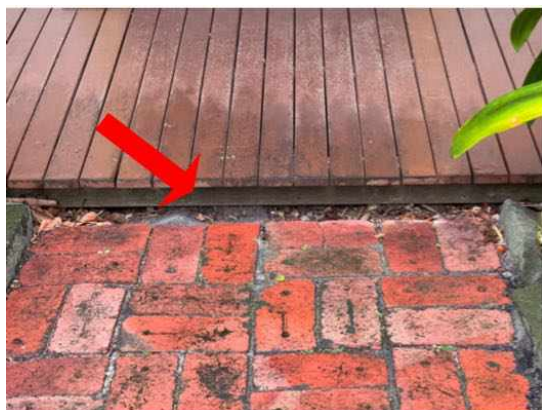
Building: Main Building  
 Location: Yard - Front  
 Finding: Building materials in direct ground contact - conducive to termites  
 Information: Where timber elements are in direct contact with the ground and consequently moisture or dampness they become conducive to termite activity. Whether timber is used as a building element part of a fencing structure or stored as an unused item they can provide an environment that is attractive to termite infestation.

When met with excessive moisture timber begins to decay and develop wood rot. Any timbers that are in direct contact with external grounds especially if left untreated or non-durable also provide ingress for subterranean termites into that particular element. Consider replacement with more durable materials i.e. treated timber or non timber elements.

The removal of any such materials that may be conducive to termite activity should be removed as soon as possible to minimise the risk of termite attack. Where it is not possible frequent inspections of these areas shall be undertaken to provide early detection of infestation

It is highly recommended that termite or timber pest inspections be carried out every 6-12 months to aid protection of the property against infestation.

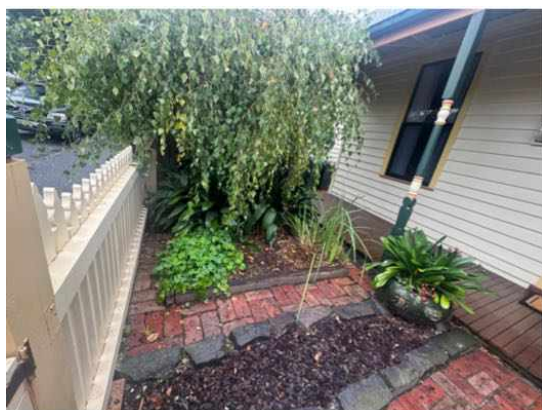
### Finding 6.03

Building:	Main Building
Location:	Yard - Front
Finding:	Garden Beds - Conditions Conducive to Termites
Information:	Garden beds were found at the time of inspection. These garden beds can include untreated timber, and with a combination of moisture from watering hosing can make conditions conducive to termite activity and termite ingress.

The building of gardens or planting of shrubs close to the perimeter of the building may promote termite activity. It is highly recommended that termite or timber pest inspections be carried out every 6-12 months to aid protection of the property against infestation.

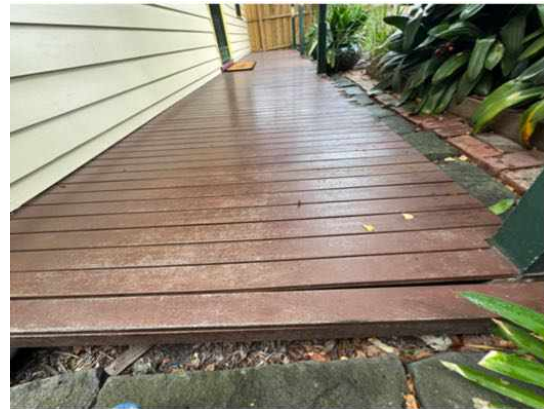
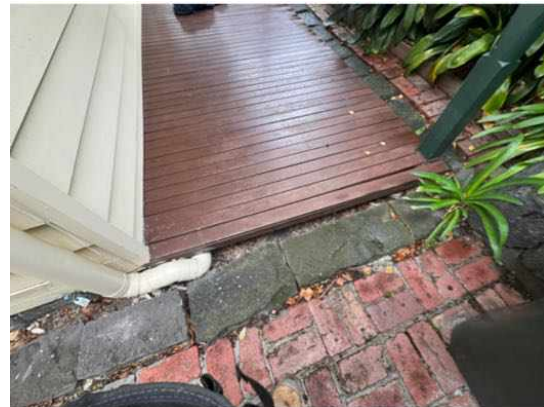
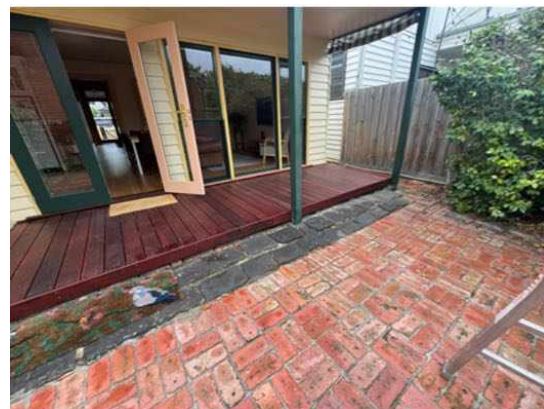
### Finding 6.04

Building:	Main Building
Location:	All External Areas
Finding:	Attachments and items adjacent to buildings
Information:	Attachments to buildings shall have a nominal gap to allow clear and uninterrupted visual inspection across the inspection zone.

porches, access ramps, carports, trellises, decks, hot-water systems, air conditioners, downpipes, service pipes, or similar attachments, shall be separated from the building by a gap of at least 25 mm, to allow clear and uninterrupted visual inspection. Where it is not possible to separate existing attachments from the building, frequent inspections of these areas shall be undertaken to provide early detection of infestation.

When bridging has occurred, full inspection is prevented, and termites may enter a property in a concealed or undetectable manner. It is highly recommended that termite or timber pest inspections be carried out every 6-12 months to aid protection of the property against infestation.

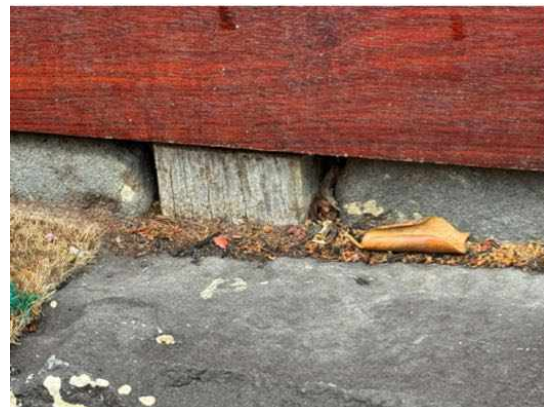
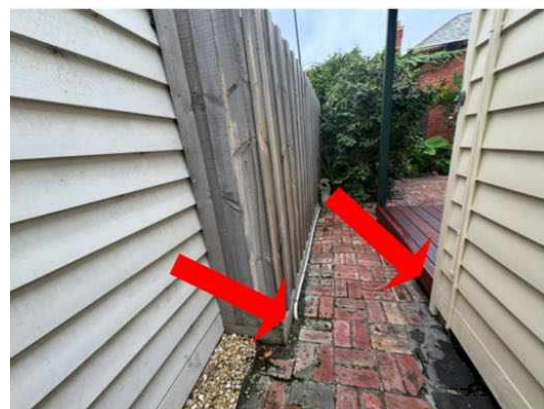
### Finding 6.05

Building:	Main Building
Location:	Yard - Back
Finding:	Building materials in direct ground contact - conducive to termites
Information:	Where timber elements are in direct contact with the ground and consequently moisture or dampness they become conducive to termite activity. Whether timber is used as a building element part of a fencing structure or stored as an unused item they can provide an environment that is attractive to termite infestation.

When met with excessive moisture timber begins to decay and develop wood rot. Any timbers that are in direct contact with external grounds especially if left untreated or non-durable also provide ingress for subterranean termites into that particular element. Consider replacement with more durable materials i.e. treated timber or non timber elements.

The removal of any such materials that may be conducive to termite activity should be removed as soon as possible to minimise the risk of termite attack. Where it is not possible frequent inspections of these areas shall be undertaken to provide early detection of infestation

It is highly recommended that termite or timber pest inspections be carried out every 6-12 months to aid protection of the property against infestation.

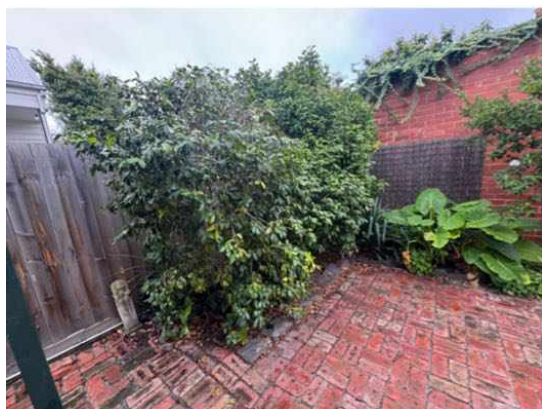
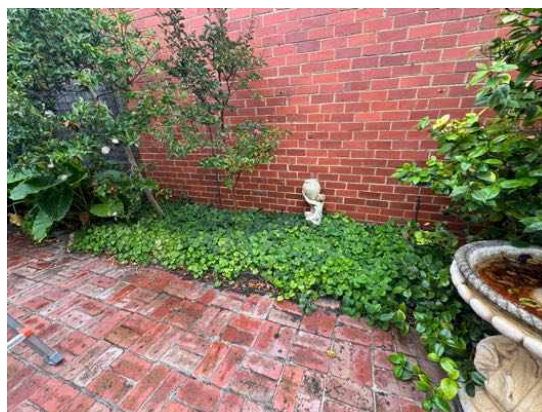
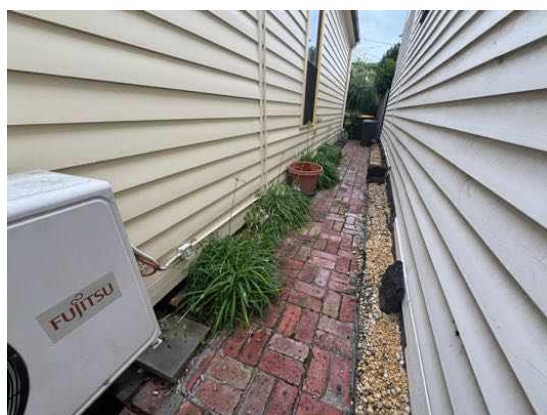
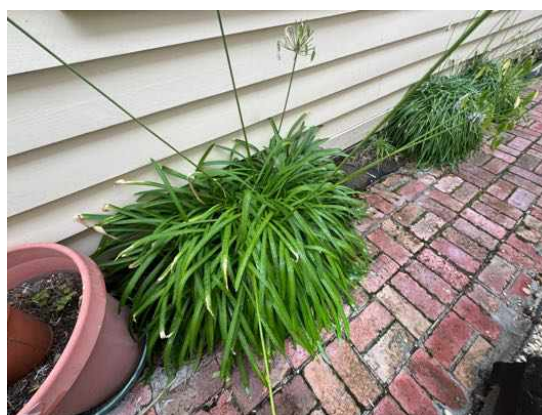
### Finding 6.06

Building: Main Building  
 Location: Yard - Back  
 Finding: Garden Beds - Conditions Conducive to Termites  
 Information: Garden beds were found at the time of inspection. These garden beds can include untreated timber, and with a combination of moisture from watering hosing can make conditions conducive to termite activity and termite ingress.

The building of gardens or planting of shrubs close to the perimeter of the building may promote termite activity. It is highly recommended that termite or timber pest inspections be carried out every 6-12 months to aid protection of the property against infestation.

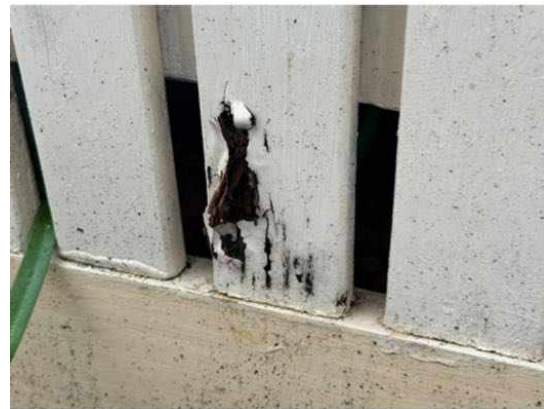
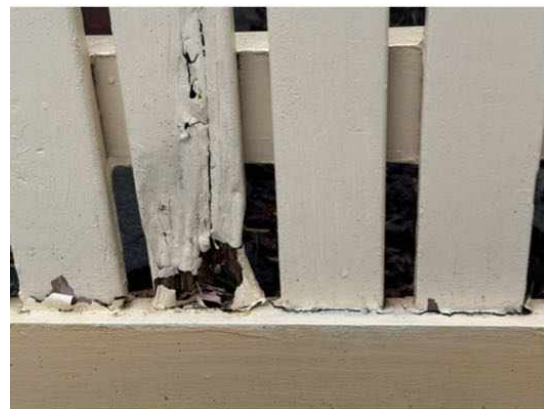
### Finding 7.01

Building: Main Building  
 Location: Fencing  
 Finding: Wood rot- Fencing  
 Information: This building element shows evidence of wood rot. Wood rot, also known as Fungal Decay, occurs when timbers and other cellulose building materials are exposed to damp conditions on an ongoing basis.. In this case although the affected timber

element is in a decaying state the extent of any visible damage appears to be localised to a specific area and is yet to spread to other parts of the building element or affect adjoining structures. The fungal decay is therefore likely to be of a relatively superficial nature with minimal impact on the structural integrity or tensile strength of the timber element.

If left unattended, it is likely that further damage will occur. It is suspected that repair of several elements of the fencing may be required.

A fencing contractor should be appointed to provide further advice and perform rectification works as necessary.

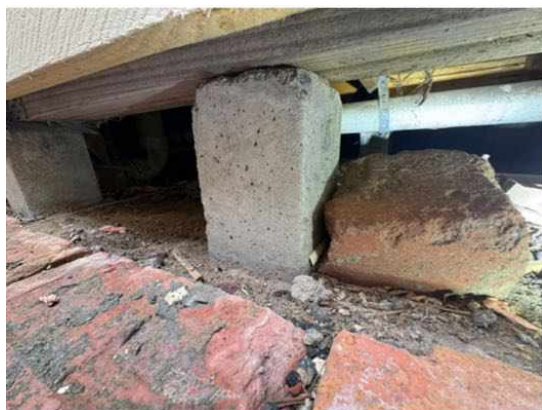
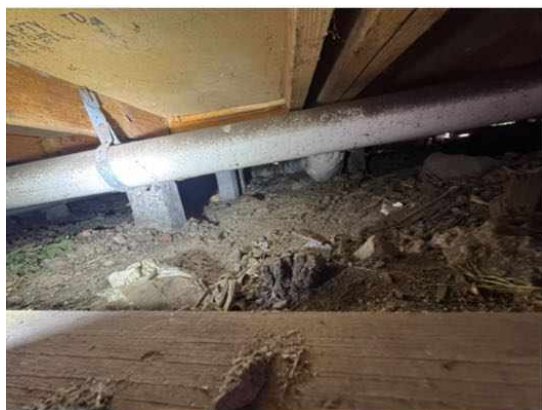
Building: Main Building  
Location: Subfloor  
Finding: Access restricted - subfloor  
Information: There was a problem with gaining access to the sub floor to conduct an inspection of this area at the time of the inspection. Being unable to gain access to a large area of the building increases the risk of undetected termite timber pest activity.

We recommend a reinspection once access can be provided and where possible, any physical barrier should be removed and a manhole installed to allow a full inspection to be carried out.

A re-inspection should be arranged once the areas are made accessible.
