Building Inspection Report

Inspection Date: Wed, 25 Mar 2026

Property Address: 5 Doonhamer Pl, Clyde North VIC 3978,
Australia

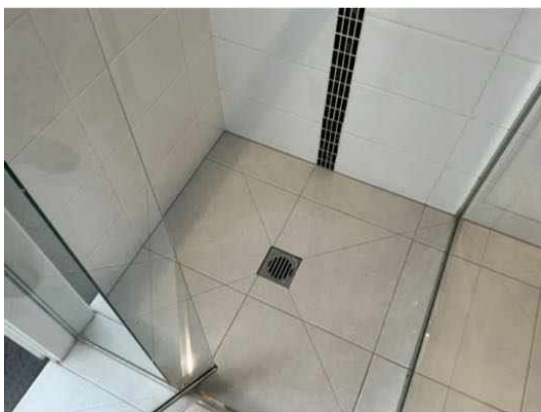
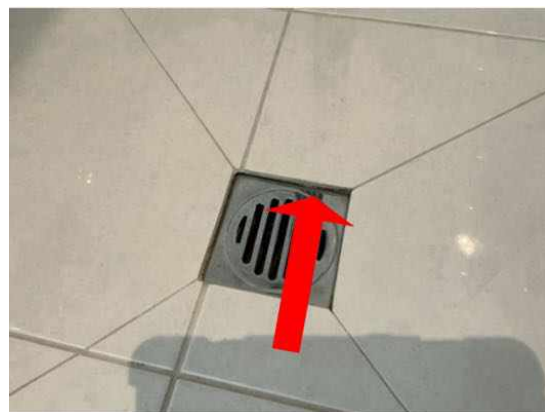
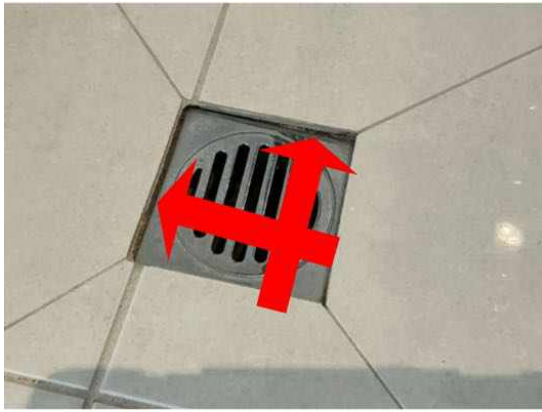
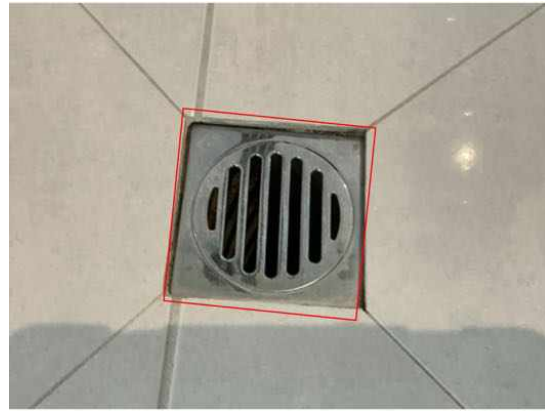
Defects 2.01

Building: Main Building
Location: Ensuite - Master
Finding: Failed Ensuite Shower Drain Installation (Major Defect)
Information: The ensuite shower drain has dropped below the finished tile level, indicating failure or displacement of the drain assembly beneath the tiled surface.

This condition compromises the effectiveness of the drainage system and waterproofing membrane, increasing the likelihood of water ponding within the shower base and potential water ingress into surrounding building elements, which may lead to concealed moisture damage and deterioration over time.

A major defect was identified in the ensuite shower, where the drain has dropped below the finished tile level, indicating failure or displacement of the drain assembly beneath the tiled surface. This condition compromises both the effectiveness of the drainage system and the integrity of the waterproofing membrane, allowing water to pond within the shower base and increasing the risk of water ingress into adjacent building elements. If left unaddressed, this may lead to concealed moisture damage, deterioration of structural components, and potential mould growth. Rectification will require removal of the affected shower floor tiles, reinstatement and proper securing of a new drain assembly at the correct level by a licensed plumber, followed by full re-waterproofing by a qualified waterproofer in accordance with NCC requirements and relevant Australian Standards, and retiling of the shower base.

It is recommended that a licensed plumber and qualified waterproofer remove the affected shower tiles, reinststate and properly secure a new drain assembly at the correct level, undertake full re-waterproofing in accordance with NCC requirements and relevant Australian Standards, and re-tile the shower base to ensure compliant and functional performance.

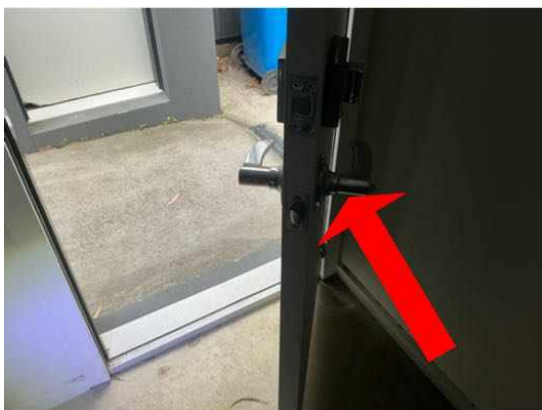
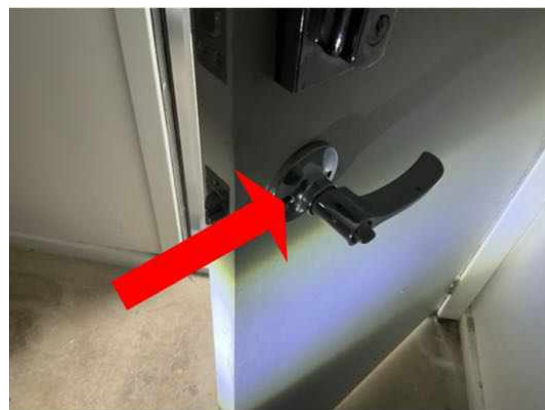
Defects 3.01

Building: Main Building

Location: Garage

Finding: Door handle - Not latching

Information: It was noted that the door in the garage area was not latching during operation at the time of inspection. Whilst detracting from the functionality of this building element, this minor defect may also be a security risk, and may therefore have serious implications if left unattended.

It is suspected that this defect has occurred due to minor issues with the associated hinges. Such damage is identified as general wear and tear, which is expected for building elements of this age.

A qualified carpenter or general handyperson may be appointed to perform rectification works as necessary, at client discretion. If left unattended, further functional impairment is likely to occur.

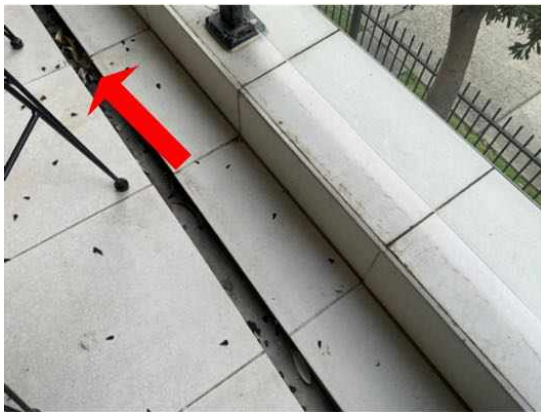
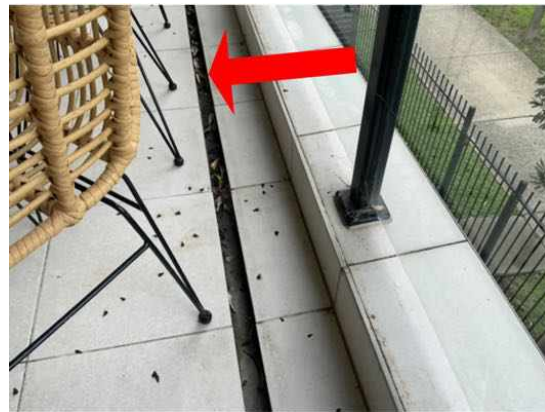
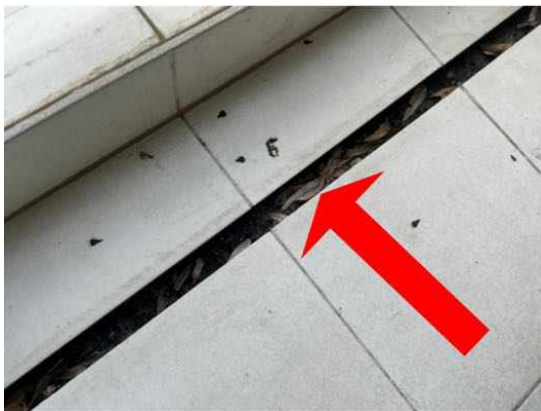
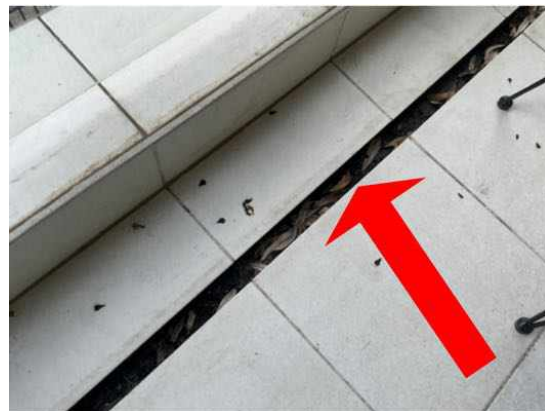
Defects 3.02

Location: Balcony
 Finding: Blocked Balcony Drain
 Information:

The balcony drain was observed to be partially blocked with an accumulation of leaves and debris, restricting the free flow of water.

If not addressed, this obstruction may lead to water ponding during rainfall events, increasing the risk of water ingress into the building and potential damage to adjacent building elements over time.

It is recommended that the balcony drain be cleaned and cleared of all debris immediately by a suitable maintenance person to restore proper drainage and prevent further issues.

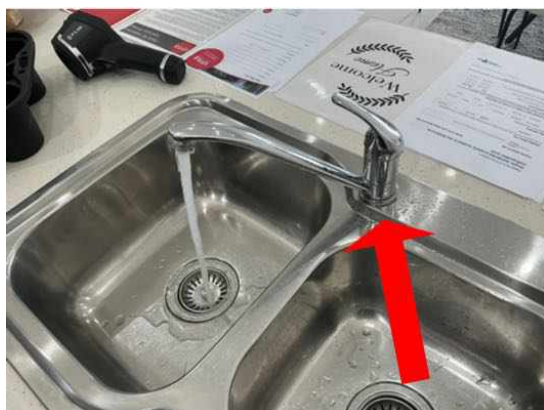
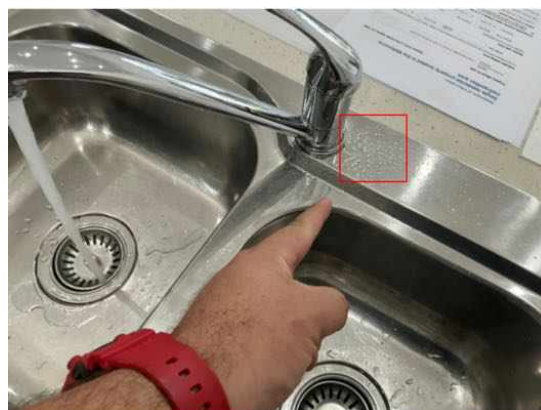
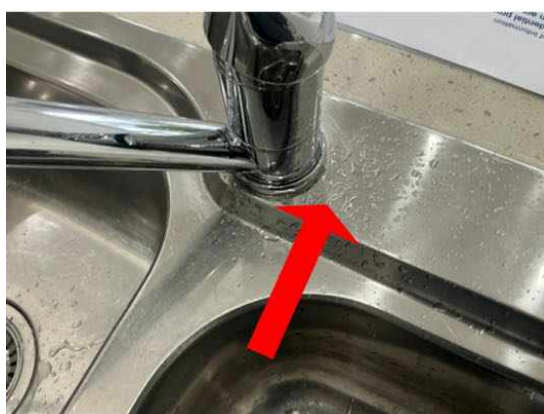
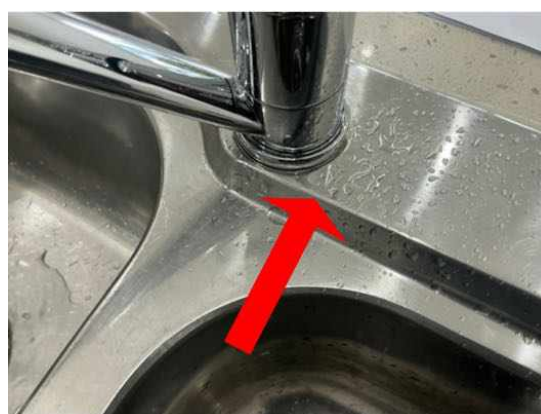
Defects 3.03

Building: Main Building
 Location: Kitchen
 Finding: Tap - Leaking

Information: The tap in the kitchen sink area was found to be leaking at the time of inspection. This is a common defect that is consistent with general ageing of the building element. However, it may be indicative of substandard plumbing workmanship if the tap is relatively new.

While this defect only seems minor, if left unmanaged, it is likely to result in the development of rust, water damage and/or extensive water usage.

It is advised that a handyman or licensed plumber be appointed to perform remedial works on the affected tap. Such works should be performed prior to the development of secondary defects to ensure adequate functionality of all associated building elements.

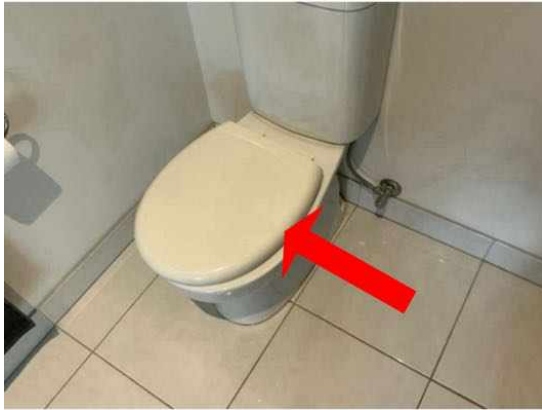
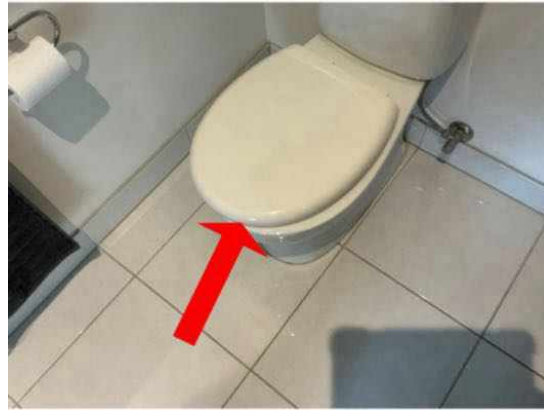
Defects 3.04

Building:	Main Building
Location:	Ensuite - Master
Finding:	Toilet seat - loose
Information:	The toilet seat was found to be loose and shifting during use at the time of inspection. This defect likely developed due to wear and tear of the seat's fixing hardware. However, it may also be the result of improper installation or accidental impact.

If left unaddressed, the loose toilet seat could worsen, leading to potential damage to the mounting points or discomfort for users. In some cases, further instability may lead to minor injuries or increased wear on the toilet bowl.

It is recommended that the toilet seat be properly refastened or replaced by a licensed plumber to ensure safe and stable use.

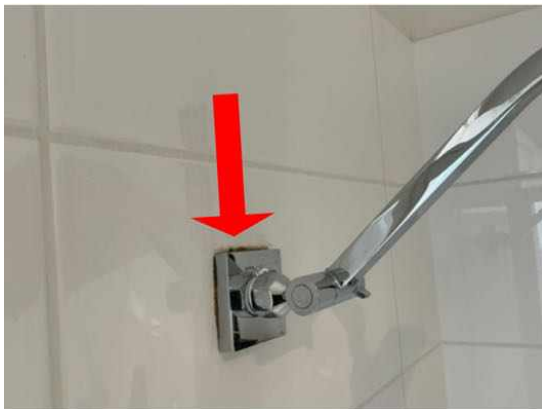
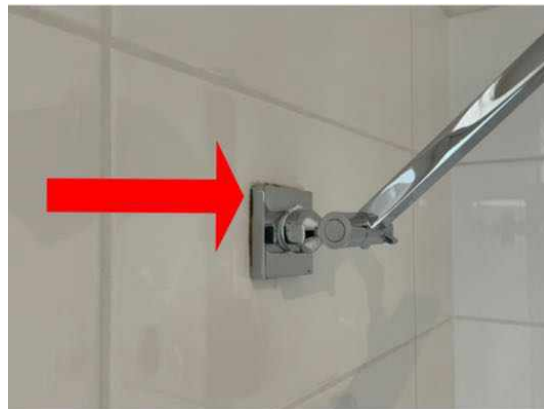
Defects 3.05

Building: Main Building
 Location: Ensuite - Master >
 Finding: Loose Shower Head – Bathroom
 Information: The shower head in the bathroom was found to be loose at its connection point. This looseness is causing minor water drips during and after use.

If left unattended, this could lead to water tracking behind the fitting, potentially contributing to moisture damage within the wall cavity or surrounding finishes over time.

It is recommended that the shower head be properly tightened or refitted using appropriate thread sealant or plumber's tape to ensure a secure and watertight connection.

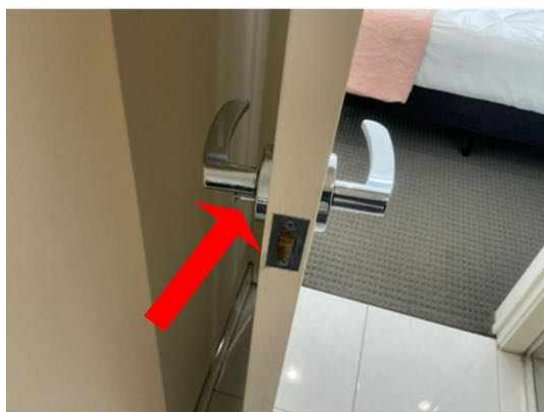
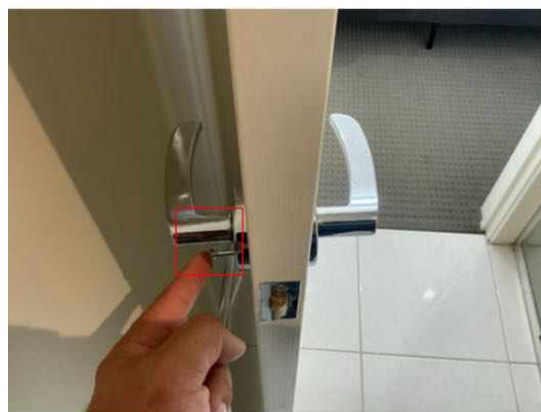
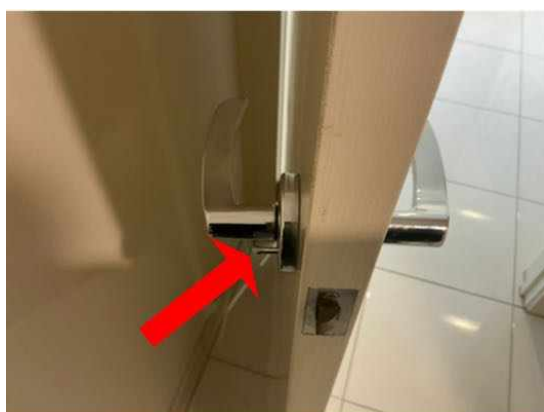
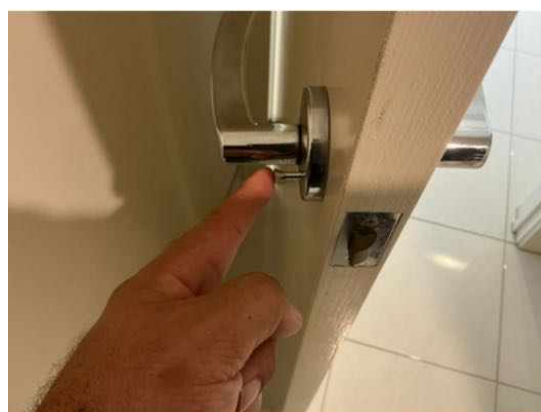
Defects 3.06

Building: Main Building
 Location: Both bathrooms
 Finding: Misaligned Bathroom Door Latches
 Information: The 2 bathroom doors' latches were found not to engage or align correctly with the

strike plates, preventing the doors from latching and closing properly.

This may result in reduced privacy and indicates minor misalignment of the door, latch, or strike plate, which may worsen over time with continued use.

It is recommended that a qualified carpenter or suitable handyman realign the doors, latches, and strike plates to ensure the doors close, engage, and latch correctly.

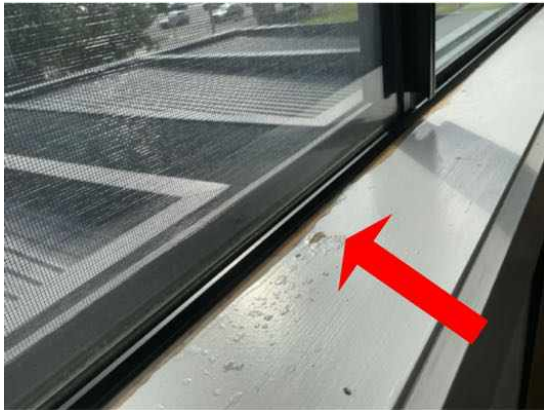
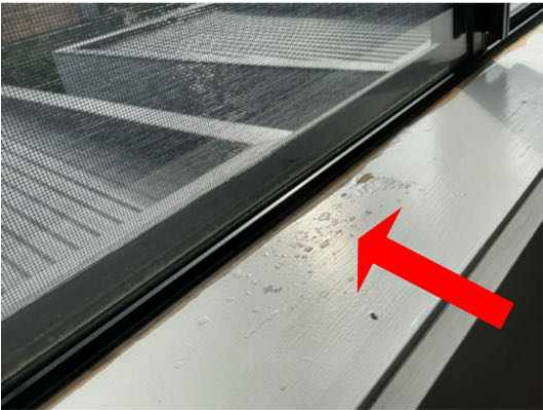
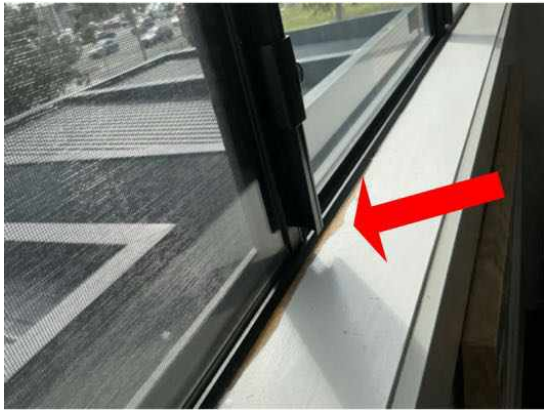
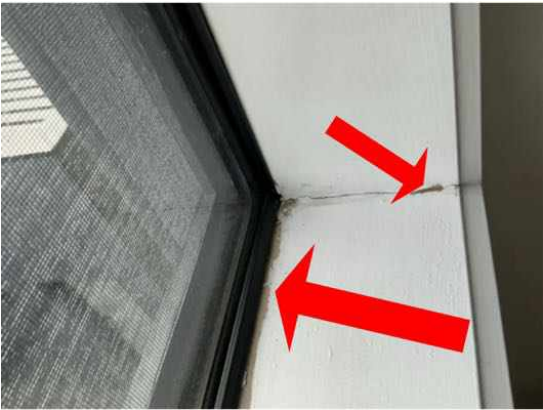
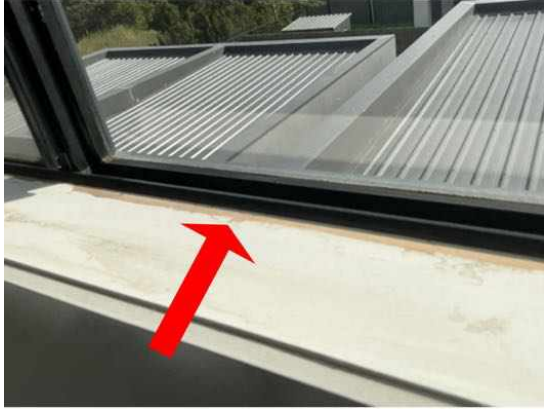
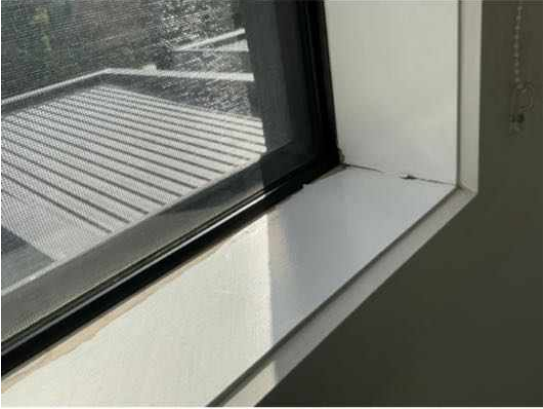
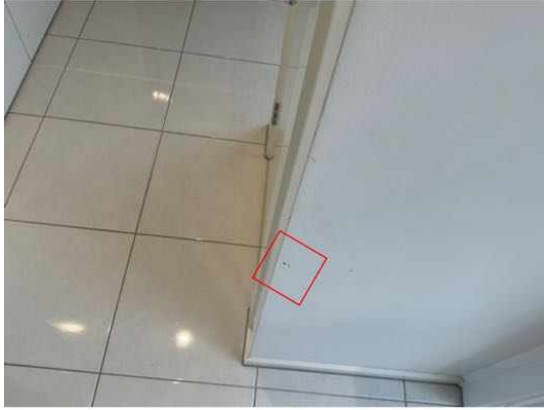
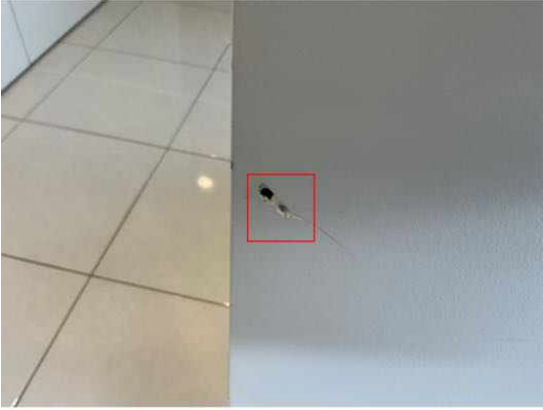
Defects 3.07

Building: Main Building
 Location: All Internal Areas
 Finding: General Wear and Tear to Internal Finishes
 Information:

Multiple observations of general wear and tear were identified at the time of inspection, including deterioration and peeling of paint to internal window sills and frames, areas of paint bubbling, and minor holes to plastered wall surfaces.

These conditions are considered cosmetic in nature and do not impact the structural integrity or functional performance of the building; however, if left unattended, they may continue to deteriorate and affect the overall presentation of the property.

It is recommended that a qualified painter or plasterer carry out minor repairs, including filling, sanding, and repainting of the affected areas, as part of routine

maintenance at the client's discretion.

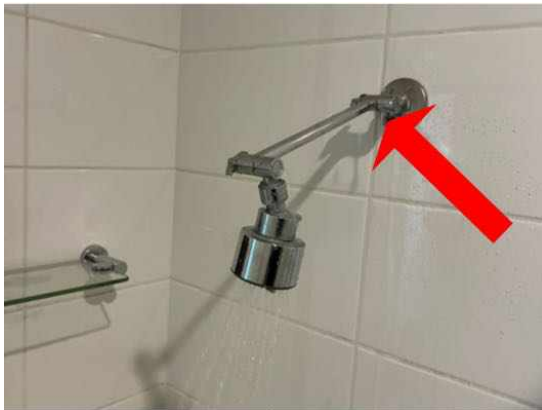
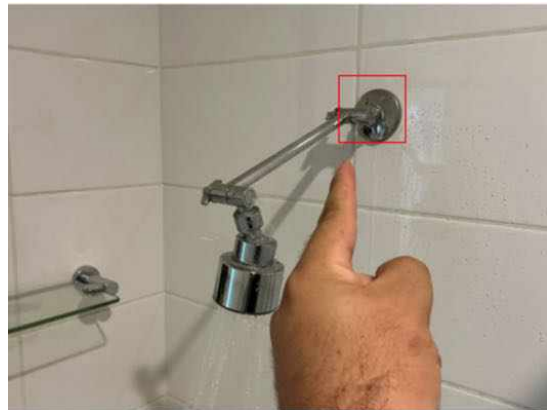
Defects 3.08

Building: Main Building
 Location: Bathroom
 Finding: Defective Shower Head in Bathroom
 Information: Upon visual inspection, it was observed that the shower head in the bathroom is defective. This damage prevents the proper operation of the shower, hindering its functionality.

It is recommended that a licensed plumber be engaged to assess and repair or replace the shower head to restore proper use of the shower.

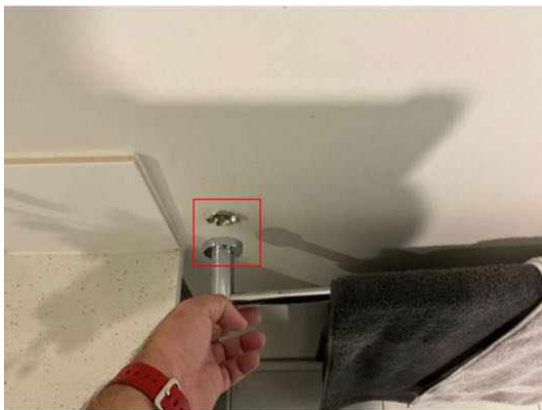
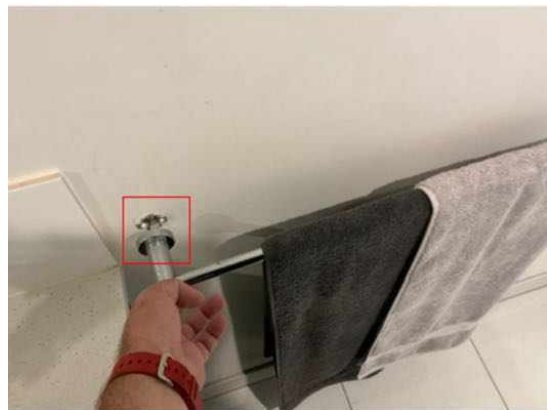
Defects 3.09

Building: Main Building
 Location: Bathroom
 Finding: Towel rail - loose
 Information: The towel rail was found to be loose at the time of inspection. While not a major operational defect, function can deteriorate if the problem is left unmanaged.

It is advised that the homeowner performs remedial works to re-attach the towel rail to its original fixing. A general handyman may be required to perform these works.

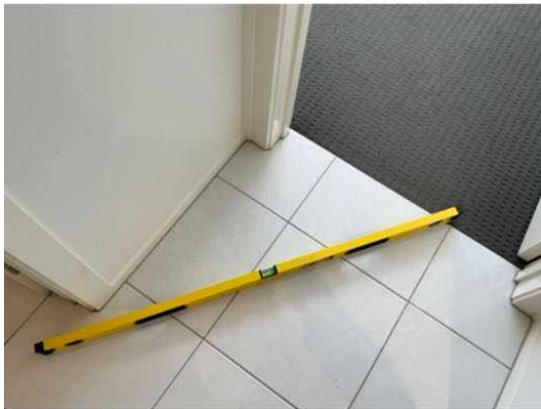
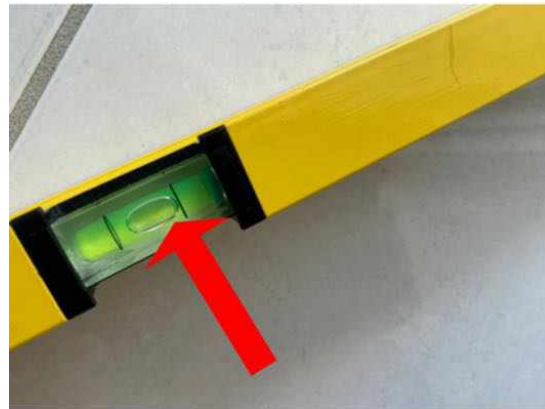
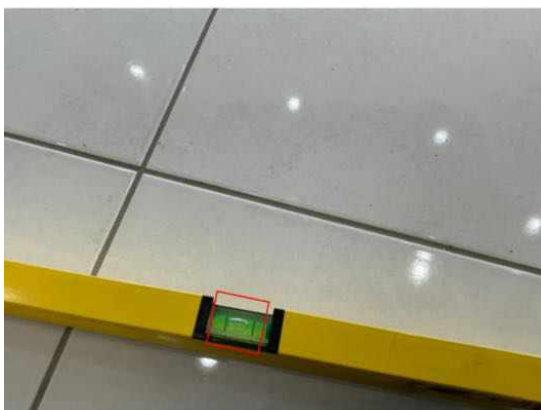
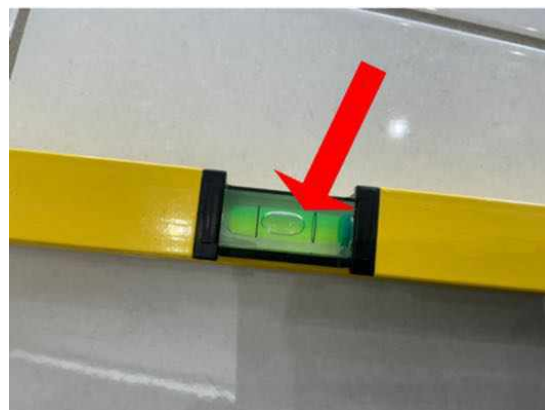
Defects 3.10

Building:	Main Building
Location:	All Internal Areas
Finding:	Floor tiles - Uneven
Information:	The tiled flooring areas appear to be uneven in multiple spots. While this may indicate a failure of the subfloor structure, it is suspected, in this case, that the area has been subjected to poor tiling workmanship at the time of installation.

Where poor workmanship is the cause of uneven tiling, the tiled surface level is unlikely to decrease further. If unevenness does increase over time, this may indicate issues with the associated flooring structure.

Where uneven tiled flooring appears to be a result of poor tiling work, a tiling contractor should be appointed to re-instate the flooring at the discretion of the client. Where flooring remains uneven, further inspection of the flooring structure may be required.

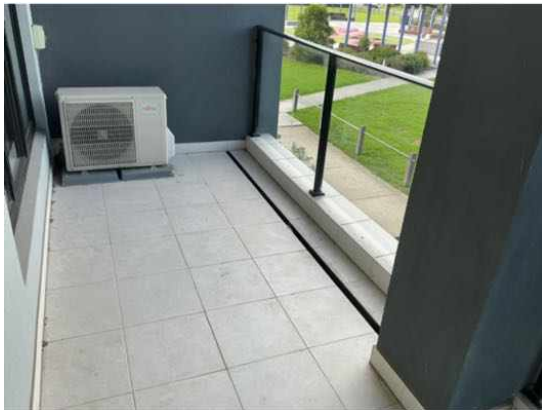
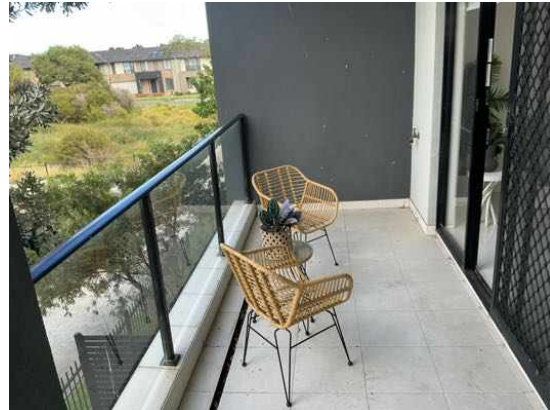
Defects 3.11

Building:	Main Building
Location:	Balcony
Finding:	Absence of Balcony Overflow Provision

Information: The balcony was observed to have no visible overflow provision to manage excess water during heavy rainfall or in the event of a blocked primary drain.

The absence of an overflow increases the risk of water ponding and potential water ingress into the internal areas of the dwelling, which may lead to damage to building elements and finishes over time.

It is recommended that a qualified plumber or builder assess the balcony drainage system and install a compliant overflow provision in accordance with NCC requirements to ensure safe discharge of excess water.

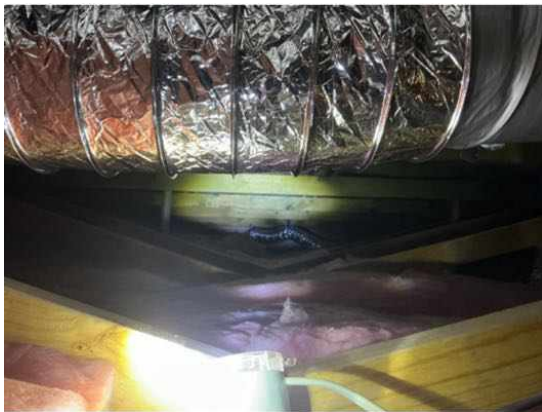
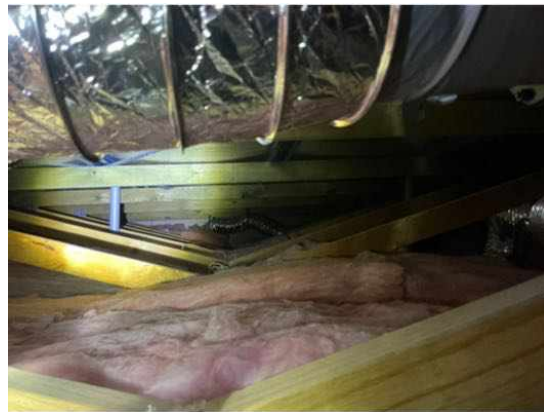
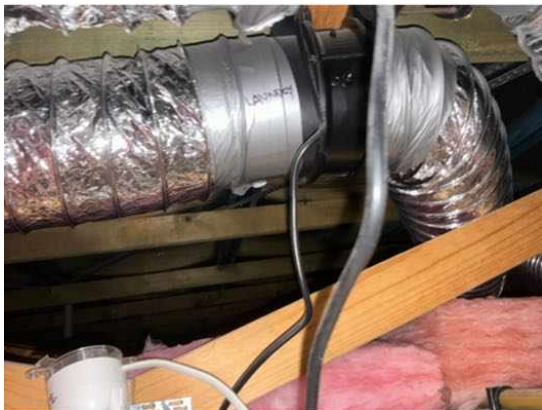
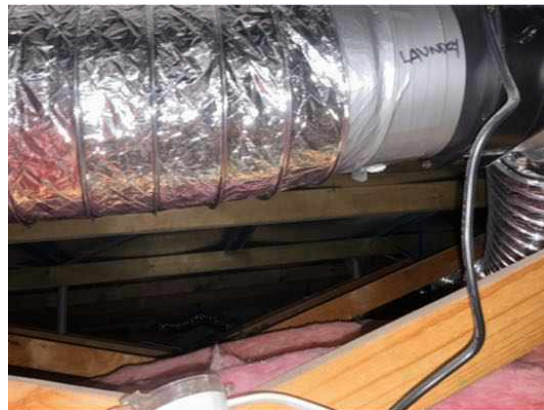
Building: Main Building
 Location: Roof Void
 Finding: Obstructions and Limitations - roof cavity
 Information: These photographs are an indication of the obstructions and limitations which impeded the inspection of the roof cavity area of the property at the time of inspection. These obstructions can hide an array of defects and should be removed to allow full inspection to be carried out. A re-inspection is recommended once the areas are made accessible.

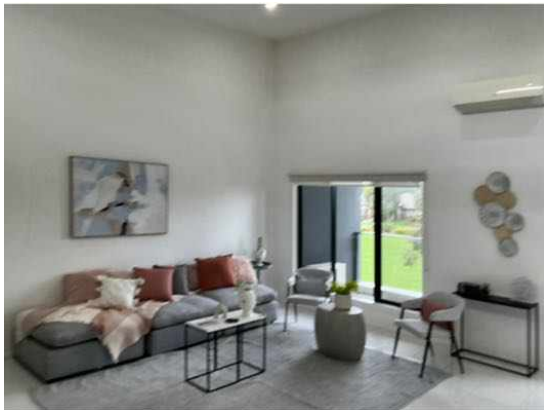
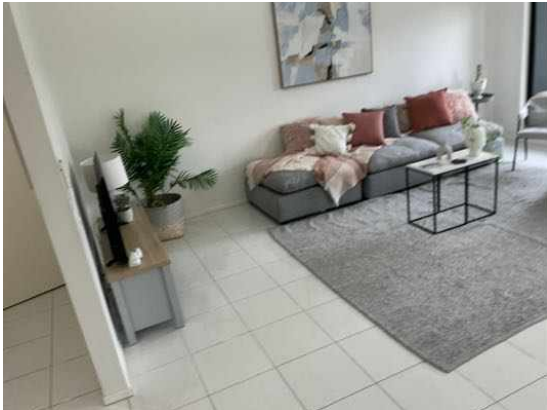
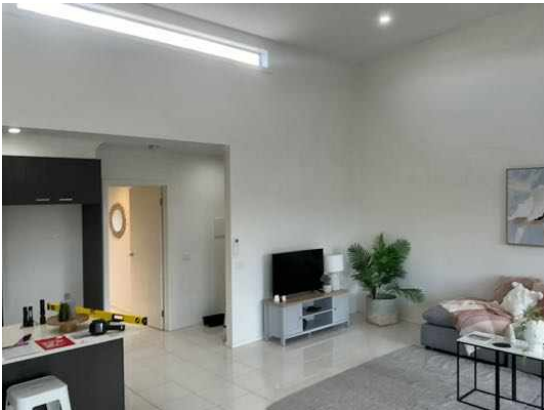
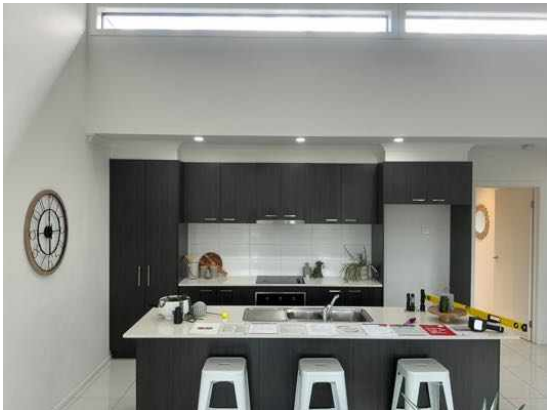
Building: Main Building
 Location: All Internal Areas
 Finding: Obstructions and Limitations - Interior
 Information: These photographs are an indication of the obstructions and limitations which impeded the inspection of the internal areas of the property at the time of inspection.

These obstructions can hide an array of defects and should be removed to allow full inspection to be carried out. A re-inspection is recommended once the areas are made accessible.
