## Building Inspection Report

Inspection Date: Tue, 24 Feb 2026

Property Address: 57 Villa Doria Dr, Clyde North VIC 3978,  
Australia

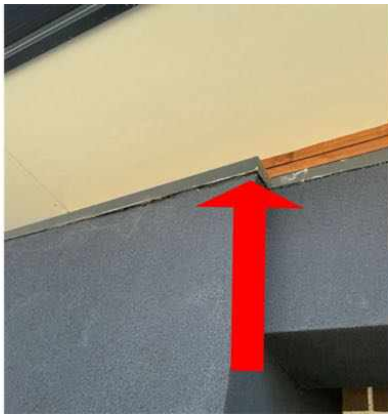
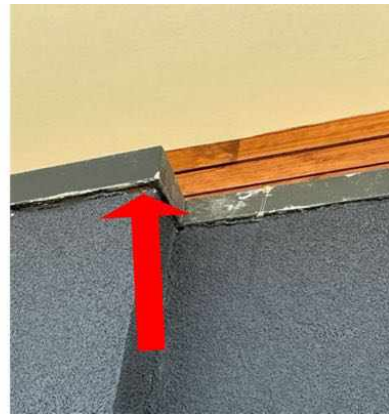
#### Defects 3.01

Building: Main Building  
Location: Front Elevation  
Finding: Defective Installation and Gapping to Front Elevation Capping  
Information:

The front elevation rendered capping/parapet top was observed to have open gaps and incomplete sealing at the junction between the horizontal capping and the adjacent wall surface. There are visible separations at the corner joint and along the top edge, with inconsistent application of sealant and areas where the substrate appears exposed. The finish is irregular and does not present as a properly sealed weatherproof termination.

Open joints and unsealed gaps at capping locations can allow water ingress behind the rendered façade system. Over time, this may lead to moisture penetration into the wall structure, deterioration of the render coating, corrosion of embedded metal components (if present), and potential internal damp-related issues. Given this is a horizontal termination point, it is particularly vulnerable to rainwater entry.

It is recommended that a roofing contractor or registered builder inspect the affected capping and properly seal all joints using an appropriate exterior-grade flexible sealant. Any loose or poorly bonded sections should be rectified, and the capping should be refinished to provide a continuous, weatherproof seal in accordance with good building practice and NCC requirements.

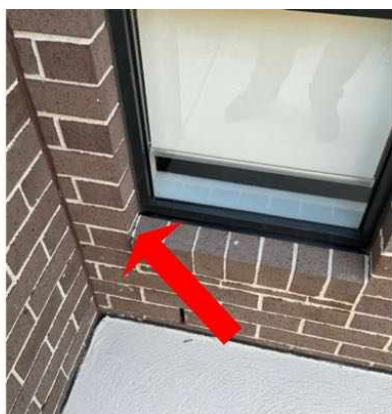
### Defects 3.03

| Finding: | Brickwork - Deteriorated mortar |
| Information: | Mortar, or 'bedding', is the material which fills joints and intersections between bricks in masonry walls and structures. Sections of mortar in this brickwork were identified as having deteriorated, which is generally expected for a property of this age and condition. |

Mortar may deteriorate as a result of age of building materials, minor movement of bricks, or frequent exposure to weathering. Mortar should be replaced to ensure that bricks remain in their intended location and to prevent gaps, which would allow water or moisture ingress and secondary damage as a result.

Mortar deterioration can be addressed by a bricklayer where areas of deterioration are localised and easily accessible. Alternatively, appointment of a registered builder is advised, to repoint large areas of decaying mortar. Where secondary structural defects have become evident, consultation with a structural engineer may be required.

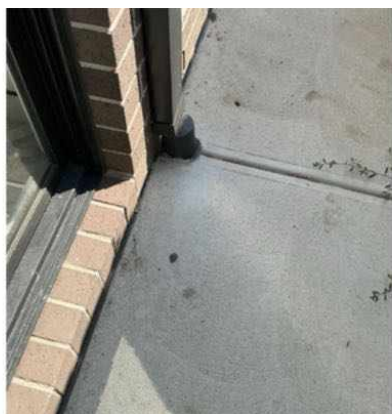
### Defects 3.04

Gaps were observed between the external concrete paving and the adjacent brick veneer wall, as well as voids behind downpipes where they are fixed against the external wall surface. The separations appear unsealed and provide open pathways at the wall-to-ground and wall-to-downpipe junctions.

Open gaps at these locations can allow surface water to track toward and potentially into the wall cavity, particularly during heavy rainfall. Prolonged moisture exposure at the base of external walls may contribute to dampness issues, deterioration of mortar joints, and increased risk of concealed moisture-related defects. Gaps behind downpipes may also allow water splash-back or leakage to enter the wall interface.

It is recommended that a qualified tradesperson seal the affected junctions using an appropriate exterior-grade flexible sealant. The interface between paving and brickwork should be properly sealed while maintaining adequate drainage fall away from the structure, and all gaps behind downpipes should be closed to minimise the risk of water ingress in accordance with good building practice.

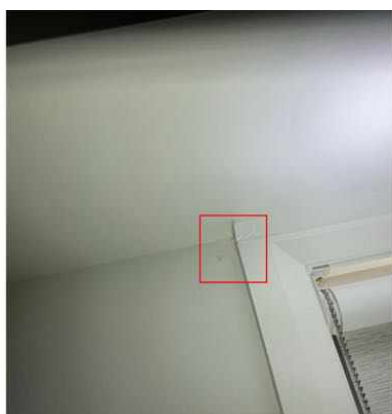
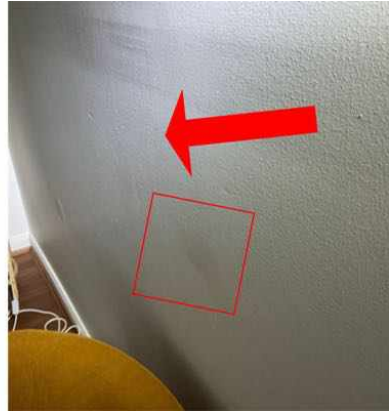
### Defects 3.05

Building: Main Building  
 Location: Lounge  
 Finding: Minor Workmanship Defects to Door Frame Finishes in Lounge Room  
 Information:

Minor workmanship issues were observed in the lounge room, primarily around the door frame finishes. Localised areas exhibit rough finishing and incomplete preparation, with visible surface irregularities that require sanding. In addition, an isolated section of paint inconsistency was noted where the colour and finish do not match the surrounding surfaces.

Although cosmetic in nature, unfinished or poorly prepared surfaces detract from the overall quality of workmanship and presentation. Inconsistent paint application may lead to premature peeling or uneven wear over time if not properly rectified.

It is recommended that a qualified painter sand and prepare the affected door frame areas, apply appropriate undercoat where required, and repaint to achieve a consistent finish that matches the adjoining surfaces in accordance with acceptable trade standards.

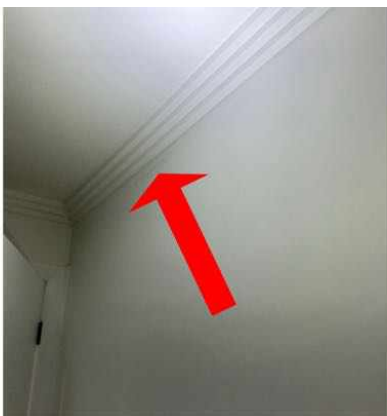
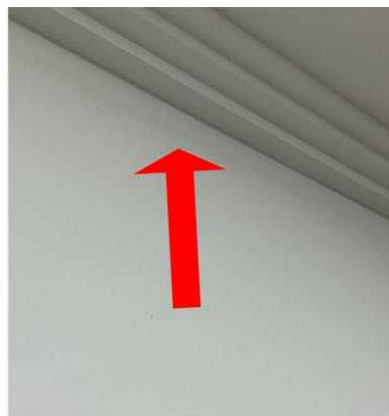
### Defects 3.06

Building: Main Building  
 Location: Garage  
 Finding: Inadequate Paint Finish to Garage Walls  
 Information:

The paint finish within the garage was observed to be of poor workmanship, particularly at the upper sections of the walls and around the garage perimeter. The finish presents as inconsistent, with uneven coverage, visible lap marks and areas lacking uniform appearance. The overall presentation does not reflect an acceptable trade standard.

An inconsistent or poorly applied paint finish detracts from the quality of the build and may result in premature deterioration, patchiness or ongoing aesthetic concerns. While primarily cosmetic, such workmanship issues fall below reasonable expectations for a completed residential project.

It is recommended that a qualified painter return to site to properly prepare the affected surfaces, including sanding and spot priming where required, and reapply paint to achieve an even, consistent and uniform finish throughout the garage in accordance with acceptable painting standards.

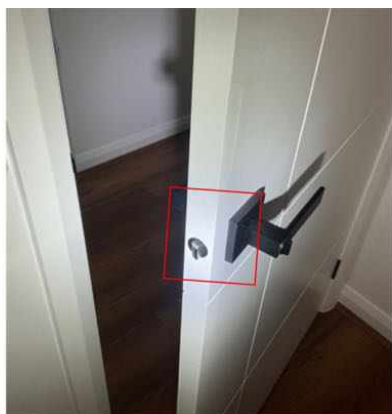
### Defects 3.07

| Information: | It was noted that the door in the master bedroom 1 was not latching during operation at the time of inspection. Whilst detracting from the functionality of this building element, this minor defect may also be a security risk, and may therefore have serious implications if left unattended. |

It is suspected that this defect has occurred due to minor issues with the associated hinges. Such damage is identified as general wear and tear, which is expected for building elements of this age.

A qualified carpenter or general handyperson may be appointed to perform rectification works as necessary, at client discretion. If left unattended, further functional impairment is likely to occur.

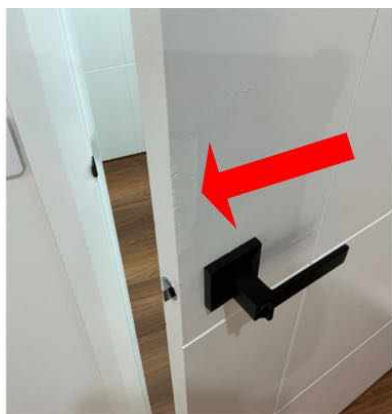
### Defects 3.08

Building: Main Building  
 Location: Bedroom - Master 1  
 Finding: Poor Paint Finish to Master Bedroom 1 Door  
 Information:

The paint finish to the door of Master Bedroom 1 was observed to be of poor workmanship. A localised area has been patched and repainted; however, the finish is inconsistent with the remainder of the door surface. The colour tone and sheen do not match uniformly, and the patched section remains visibly distinguishable.

Inconsistent paint application and colour variation detract from the overall presentation and indicate inadequate surface preparation and finishing. While cosmetic in nature, such defects fall below acceptable trade standards for a completed residential dwelling.

It is recommended that a qualified painter return to properly prepare the affected door surface, including sanding and priming as required, and repaint the entire door (not just the patched section) to ensure a uniform colour, sheen, and consistent finish throughout.

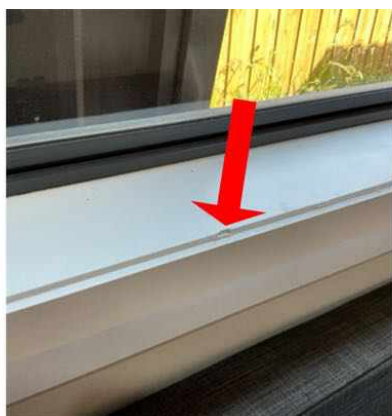
### Defects 3.09

A dented section was identified to the window sill in Master Bedroom 1. The affected area presents as surface damage to the finished element, which is inconsistent with the expected condition of a newly constructed dwelling.

Surface dents and imperfections detract from the overall quality and presentation of the property and indicate incomplete finishing works. In a brand new home, internal elements such as window sills are expected to be delivered free from visible damage and finished to an acceptable trade standard.

It is recommended that a qualified plasterer or painter return to site to properly fill the damaged section, sand the surface smooth, and repaint the entire affected area as required to achieve a consistent and uniform finish in line with new-build expectations.

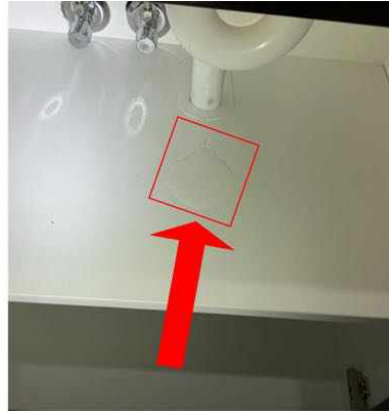
### Defects 3.10

Building: Main Building  
 Location: Ensuite - Master 1  
 Finding: Leaking Plumbing to Sink Tap in Master Ensuite 1  
 Information: Upon visual inspection, it was observed that the plumbing connected to the sink tap in master ensuite 1 is leaking. When the tap was tested, it was evident that the plumbing pipes beneath the sink are leaking into the vanity unit, affecting the cupboards and shelves underneath.

It is strongly recommended that a licensed plumber be engaged immediately to investigate the source of the leak and carry out the necessary repairs. Prompt action is required to prevent further water damage to the vanity and surrounding areas.

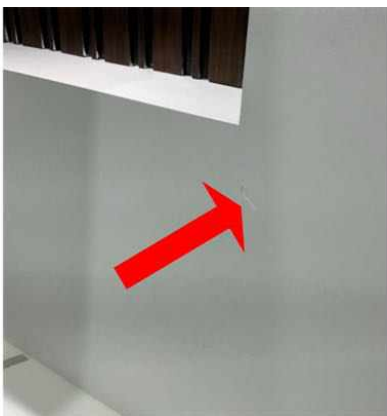
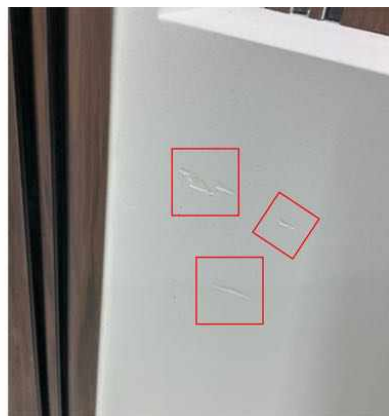
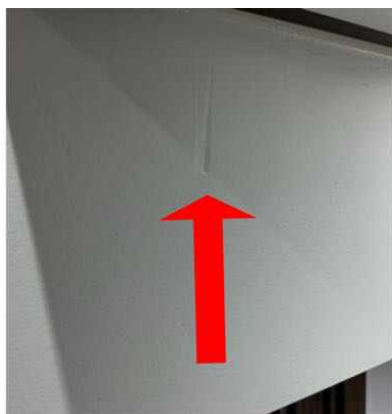
### Defects 3.11

Building: Main Building  
 Location: Nook  
 Finding: Poor Paint and Surface Finish to Nook Area Walls  
 Information:

The paint and surface finish to the nook area walls were observed to be of poor workmanship. Multiple dents and minor surface damages were identified, along with inconsistent paint application and uneven finish across various sections of the wall. The overall presentation does not meet acceptable trade standards for a newly constructed property.

Surface imperfections and inconsistent finishing detract from the quality of the build and indicate inadequate preparation prior to painting. In a new dwelling, internal wall surfaces are expected to be free from visible dents, patch marks, and uneven coating, with a uniform and consistent finish throughout.

It is recommended that a qualified painter properly prepare the affected areas by filling all dents and damaged sections, sanding the surfaces smooth, applying primer where required, and repainting to achieve a uniform, consistent, and professional finish in accordance with acceptable industry standards.

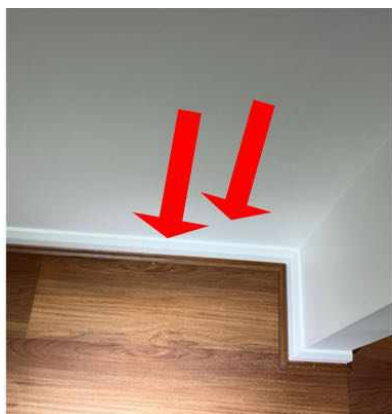
### Defects 3.12

Building: Main Building  
 Location: Walk-In Robe - Master 1  
 Finding: Dented Plaster and Skirting Finishes to Walk-In Robe (Master Bedroom 1)  
 Information:

Dents and minor surface damage were observed to the plasterboard wall linings and skirting boards within the walk-in robe of Master Bedroom 1. The affected areas present as localised indentations and inconsistent surface finishes, which are not consistent with the expected standard of a newly completed dwelling.

Such surface defects detract from the overall presentation and indicate inadequate care during installation or finishing works. In a new property, plaster surfaces and skirting boards are expected to be delivered free from visible dents and damage, with a smooth and uniform finish.

It is recommended that a qualified painter or plasterer return to site to fill all dents and damaged sections, sand the surfaces smooth, prepare the skirting boards appropriately, and repaint to achieve a consistent and professional finish in accordance with acceptable trade standards.

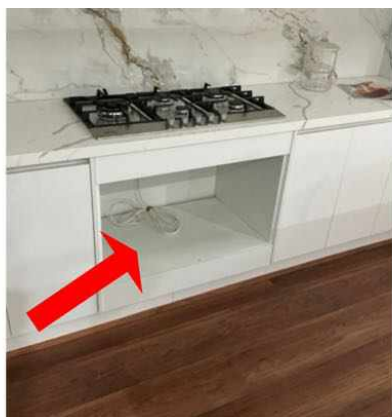
### Defects 3.13

The absence of the oven prevents verification of installation compliance, operational performance, and safe connection to electrical supply in accordance with NCC requirements. In a newly constructed dwelling, all specified fixtures and fittings are expected to be installed and operational prior to handover.

It is recommended that the builder arrange for the oven to be supplied, installed, and fully commissioned by a licensed electrician prior to practical completion and handover. Confirmation of compliance and safe operation should be provided upon installation.

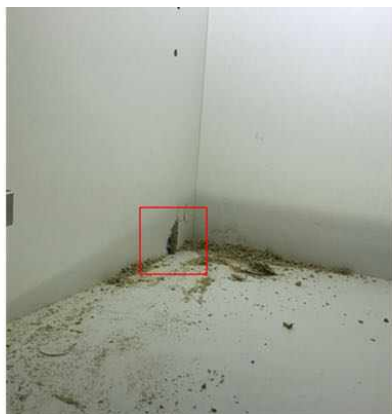
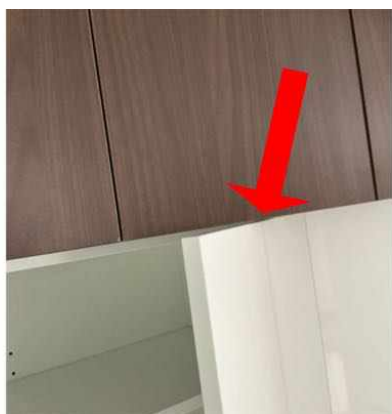
### Defects 3.14

Building: Main Building  
 Location: Kitchen  
 Finding: Poor Workmanship to Kitchen Cabinetry and Joinery  
 Information:

Poor workmanship was observed to the kitchen cabinetry and joinery finishes throughout. Untidy and inconsistent gaps were noted between panels and at junctions, with sections appearing unfinished. Debris and construction residue were present inside multiple cupboards. Exposed electrical wiring was observed within cabinetry cavities, not properly secured or concealed. In addition, several cupboard doors were misaligned and did not open and close smoothly.

Deficient joinery workmanship and incomplete finishing detract from the overall quality of the installation and fall below acceptable trade standards for a newly constructed dwelling. Exposed or unsecured electrical wiring within cupboards presents a potential safety risk and does not reflect compliant installation practice. Misaligned doors and poor clearances may lead to premature wear of hinges and hardware.

It is recommended that the cabinet maker return to site to rectify all identified issues. This should include realignment and adjustment of all cupboard doors and hardware, correction of uneven gaps, proper finishing of all joinery interfaces, removal of debris, and ensuring all electrical wiring within cabinetry is properly secured and safely concealed by a licensed electrician where required. All works should be completed to an acceptable professional standard prior to handover.

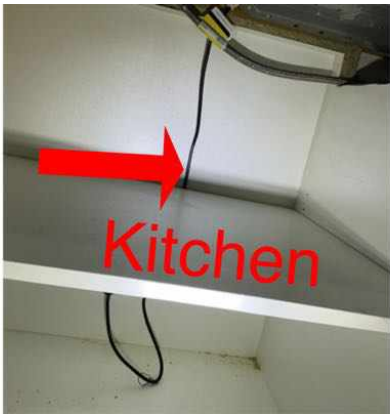
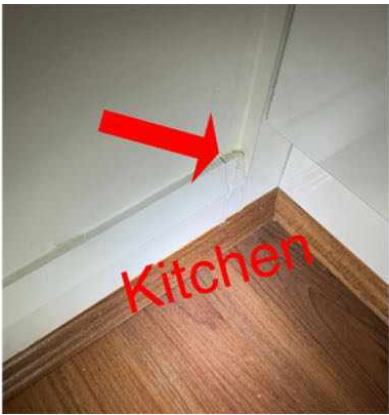
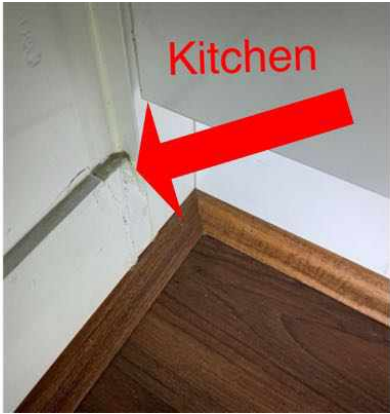
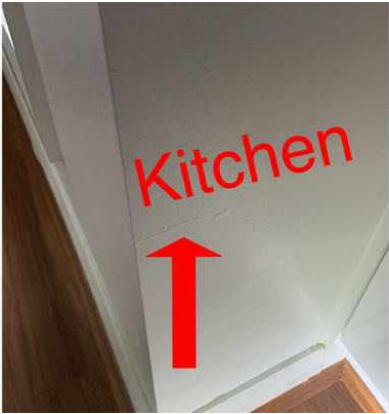
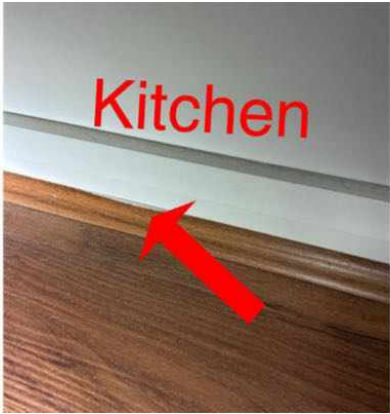
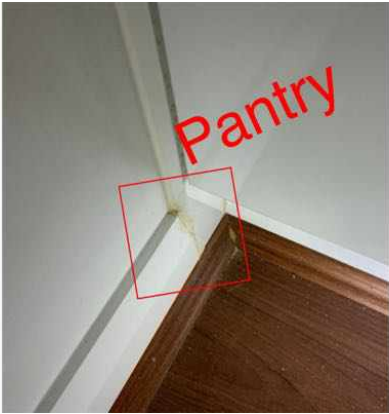
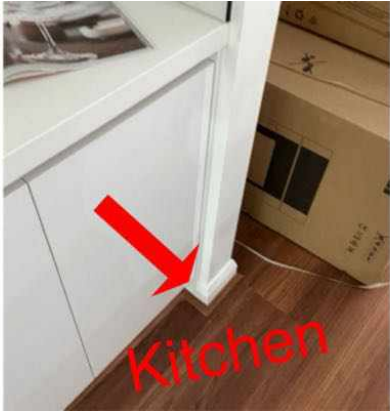
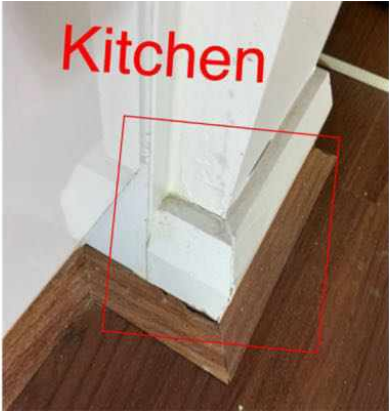
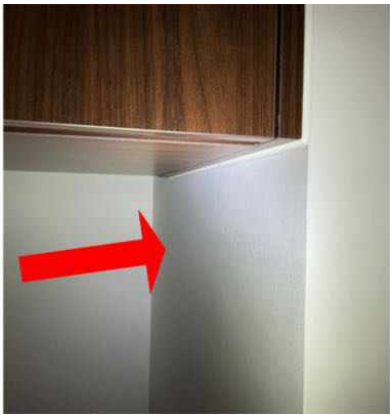
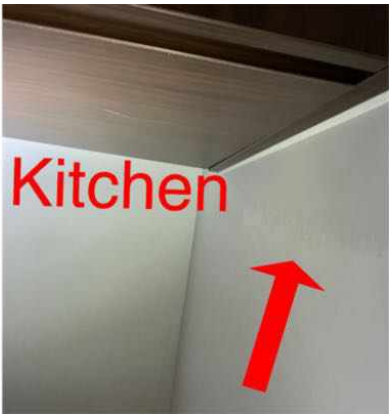
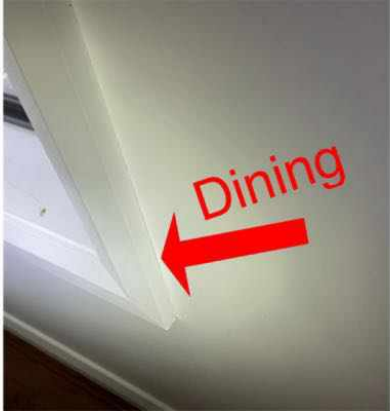
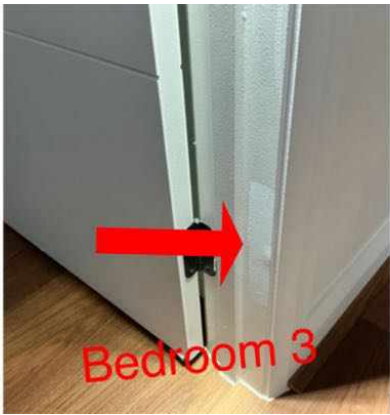
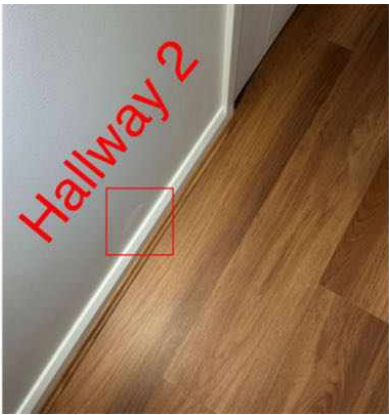
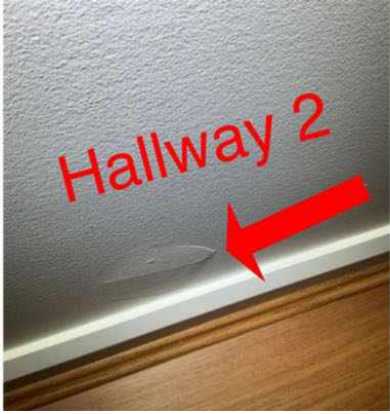
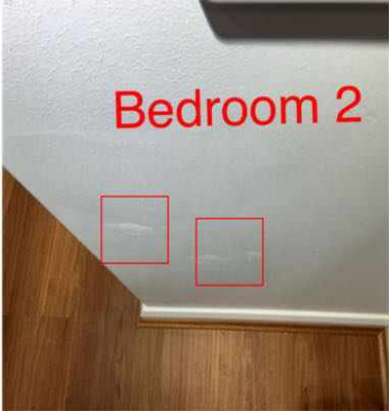
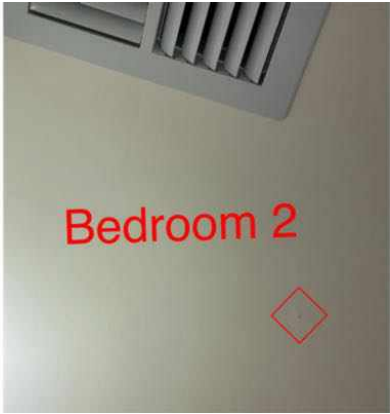
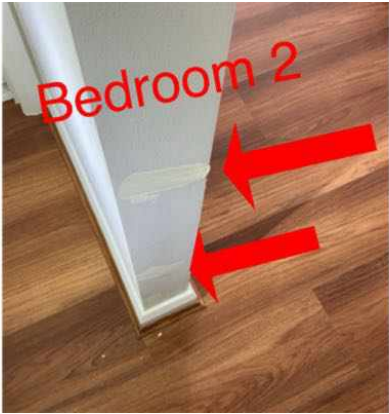
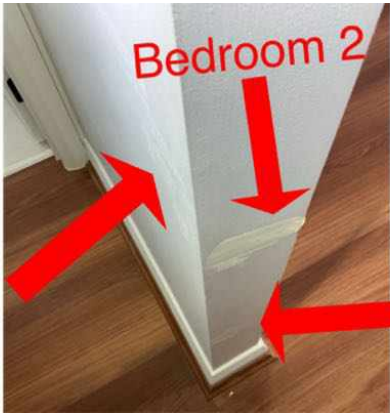
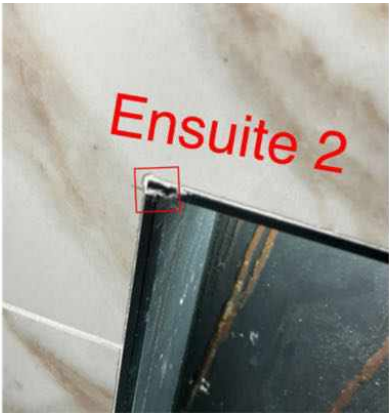
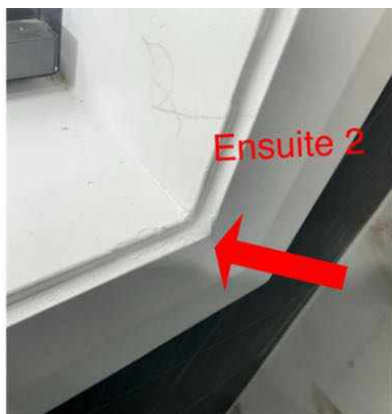
### Defects 3.16

| Finding: | Multiple Workmanship and Finishing Defects Throughout Dwelling |

The photographs below indicate multiple workmanship and finishing defects throughout the dwelling. These include exposed and poorly routed wiring within kitchen cabinetry that has not been properly concealed, untidy and inconsistent finishes to skirting boards, and widespread painting and surface finishing defects across various areas of the home. Several locations exhibit poor plaster finishing, uneven surfaces, and substandard paint application.

The overall standard of finishing observed falls below the reasonable expectations for a newly constructed dwelling at handover stage. Exposed wiring should be properly concealed and secured, and internal finishes including painting, plastering, and trim works are expected to be completed to an acceptable professional standard. Incomplete or poorly executed finishes detract from the presentation and quality of the build.

It is recommended that the builder undertake a comprehensive review of all identified locations prior to handover and arrange for rectification by the relevant qualified trades. This should include proper concealment of wiring by a licensed electrician where required, rectification of plaster defects, correction of skirting finishes, and repainting to achieve a consistent and professional finish throughout the property before practical completion.

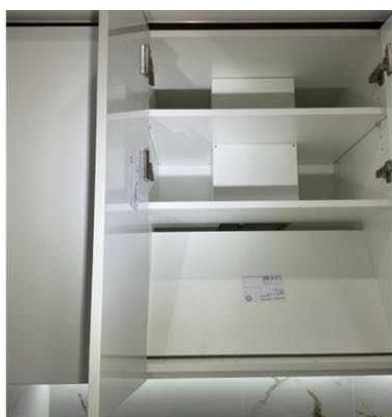
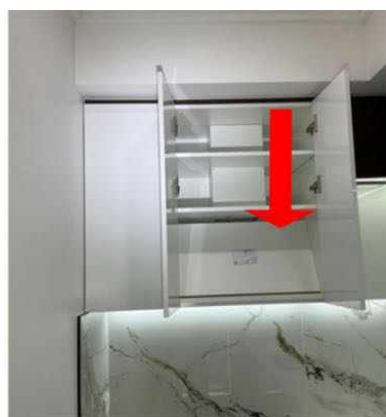
**Defects 3.17**

Building: Main Building  
 Location: Pantry - Walk In  
 Finding: Rangehood to Pantry Area Not Installed  
 Information:

The absence of the installed rangehood means the mechanical ventilation system to this area is incomplete and cannot be assessed for operation or compliance. In a newly constructed dwelling, all specified fixtures and fittings are expected to be installed prior to practical completion and handover.

It is recommended that the builder arrange for the installation and commissioning of the rangehood to the pantry area prior to handover. Installation should be completed in accordance with manufacturer specifications and relevant electrical requirements by a licensed electrician.

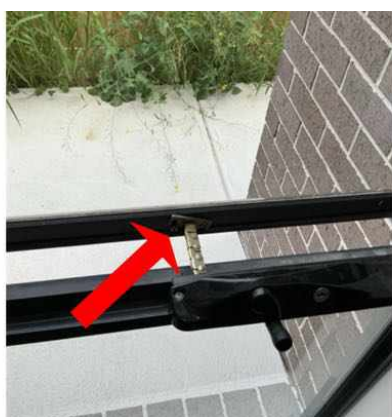
**Defects 3.18**

The window restrictor arm to the aluminium window has not been installed properly. The mechanism appears loosely fitted and not securely fixed to the frame, with poor alignment at the bracket connection.

Improper installation of the restrictor may affect its ability to function correctly as a safety device and may compromise compliance with fall prevention requirements.

It is recommended that the builder arrange for the window restrictor to be properly refixed and installed in accordance with manufacturer specifications to ensure secure and correct operation.

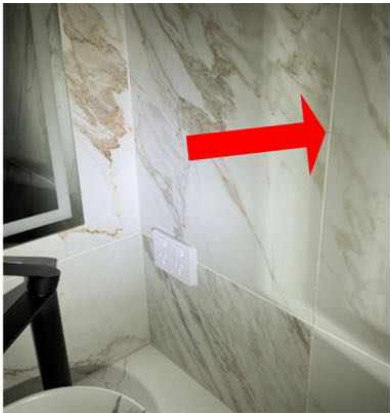
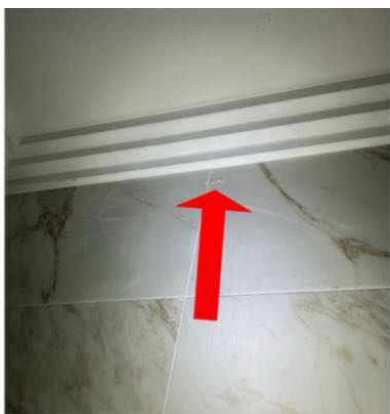
**Defects 3.20**

Poor workmanship was observed to the wall tiling within the powder room. A section of grout was noted to be missing between tiles, and additional grout residue has been left on the tile surfaces. The finish appears incomplete and has not been properly cleaned following installation.

Missing grout can allow moisture penetration behind tiles, while excess grout residue affects the overall presentation and indicates inadequate finishing. In a newly constructed dwelling, tiling works are expected to be neatly finished, fully grouted, and free from visible residue.

It is recommended that a qualified tiler return to site to properly re-grout the affected joints, remove all excess grout residue from tile surfaces, and ensure the finish is completed to an acceptable professional standard.

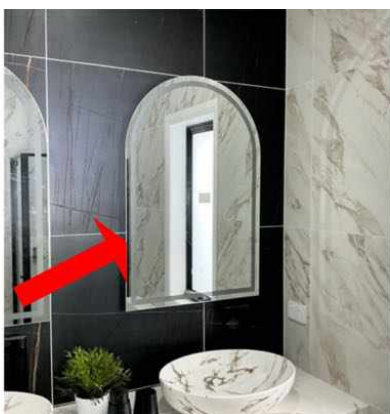
**Defects 3.21**

Building: Main Building  
 Location: Master ensuite 2  
 Finding: Unstable Mirror Installation to Master Ensuite 2  
 Information:

It is recommended that the builder arrange for the mirror to be properly refixed and stabilised. The mounting brackets and fixings should be checked and secured to ensure the mirror is firmly supported and does not move during normal use.

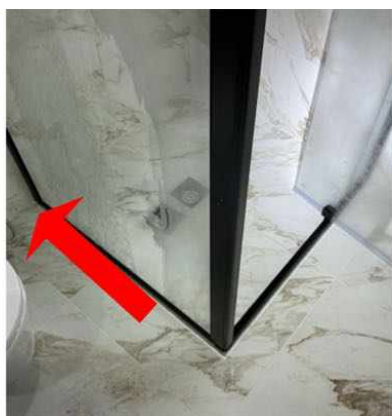
**Defects 3.22**

Building: Main Building  
 Location: Master ensuite 2  
 Finding: Shower screen - Leaking  
 Information: Leaking was evident to the Master ensuite 2's shower screen at the time of

Appointment of a caulking contractor is required to repair or replace the caulking to the shower area. Such works should be performed as soon as possible to ensure that no further damage occurs.

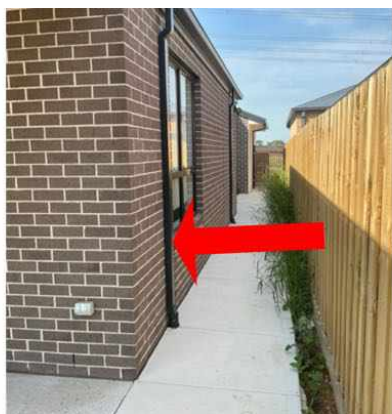
**Defects 3.24**

Building: Main Building  
 Location: All External Areas  
 Finding: Bridging Attachments to the Building  
 Information: Bridging occurs when items fixed or placed against a building create concealed pathways for termites to bypass any existing termite management system and gain access to the structure undetected. Typical bridging elements include attachments such as hot water services, downpipes, verandahs, decks, steps, fences, and service conduits, where insufficient clearance exists between these elements and the building structure.

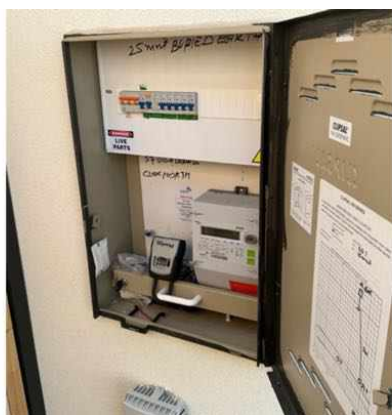
### Defects 3.25

Building: Main Building  
 Location: All external areas  
 Finding: Termite Management System - no evidence of a chemical installation  
 Information: At the time of inspection, there was no evidence to indicate that a previous or current termite management system has been installed at the property. No durable notice was observed within the electrical switchboard or elsewhere on site to confirm the presence of any chemical or physical termite protection measures. Additionally, there were no visible indicators to suggest that preventative termite treatments or barriers have been applied in the past.

It is highly recommended that the client consult with a licensed pest controller regarding the installation of a post-construction chemical termite barrier. Such systems are proven to be effective in preventing termite ingress and should be considered a priority, particularly where no existing protection is in place. A durable notice confirming the installation of any future system should be affixed within the switchboard in accordance with AS 3660.

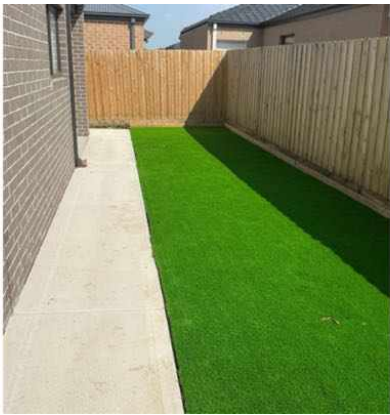
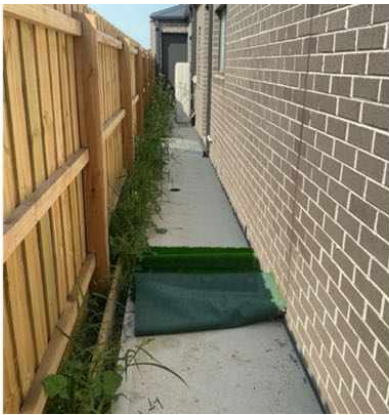
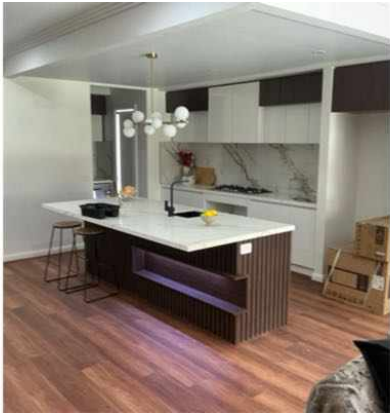
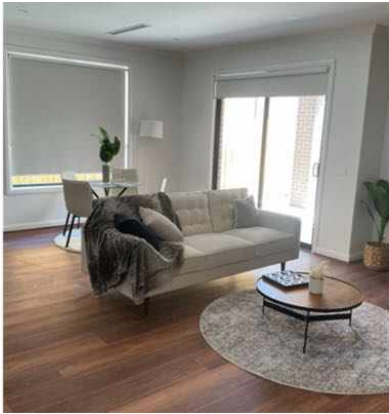
**Noted Item**

Building: Main Building  
Location: All Areas  
Finding: Additional Photos - Obstructions and Limitations  
Information: These photographs are an indication of the obstructions and limitations which impeded full inspection of the property at the time of inspection. These obstructions can hide an array of defects and should be removed to allow full inspection to be carried out. A re-inspection is recommended once the areas are made accessible.

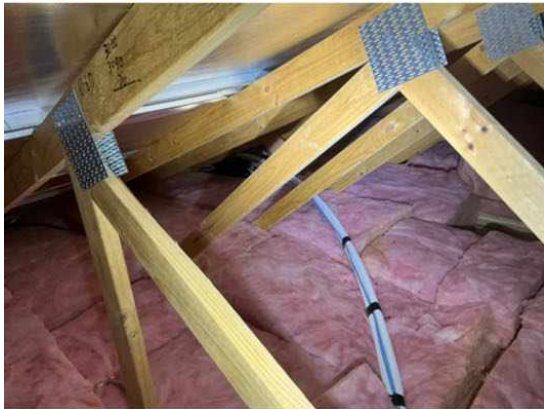
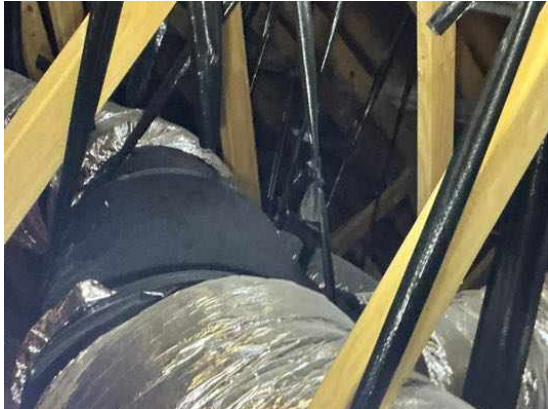
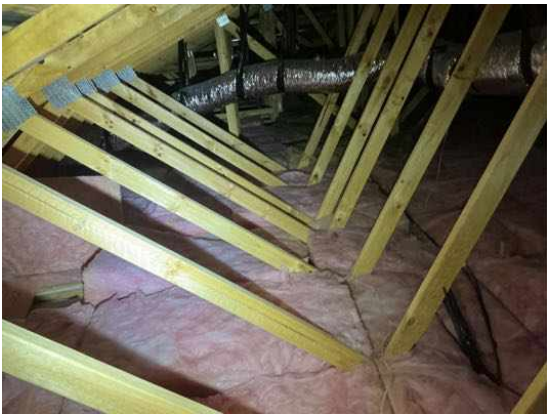
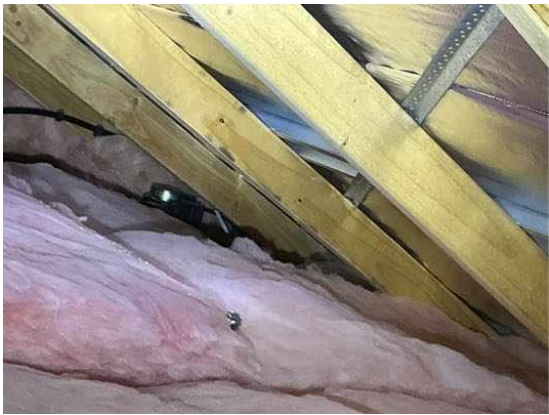
**Noted Item**

Building: Main Building  
Location: Roof Void  
Finding: Obstructions and Limitations - roof cavity  
Information: These photographs are an indication of the obstructions and limitations which impeded the inspection of the roof cavity area of the property at the time of inspection. These obstructions can hide an array of defects and should be removed to allow full inspection to be carried out. A re-inspection is recommended once the areas are made accessible.
