Building and Timber Pest Inspection Report

Inspection Date: Wed, 11 Feb 2026

Property Address: unit 51/2 Crewe Pl, Rosebery NSW 2018,
Australia

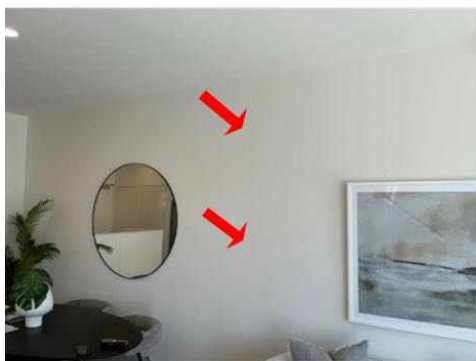
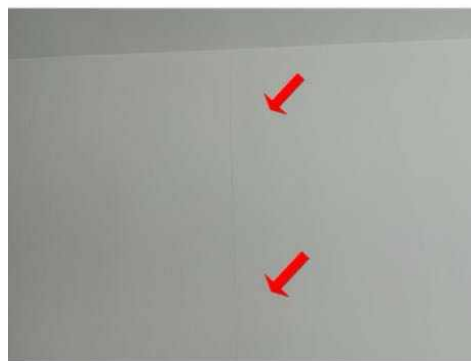
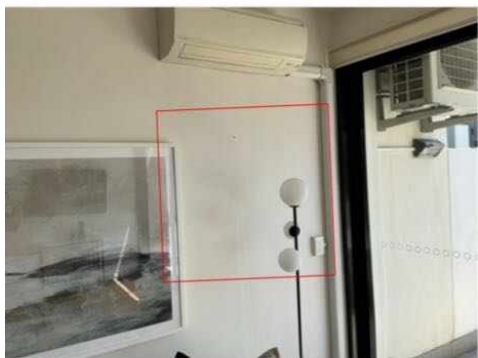
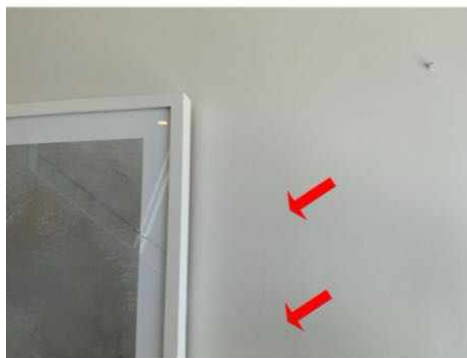
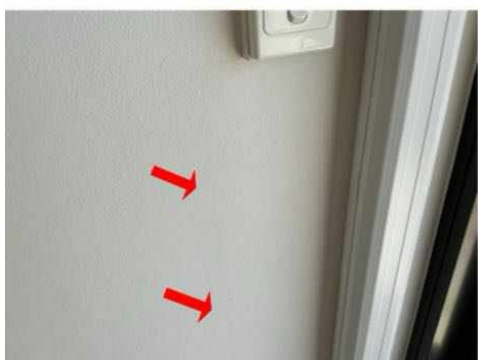
Building: Main Building
Location: Main western wall of living room
Finding: Cracks to internal render - Category 1
Information: It has been observed that cracking to internal rendered surfaces has occurred. The degree of damage falls within Category 1, described as fine cracks that do not need repair and which are less than 1.0mm in width limit.

Damage of this category is not considered a defect for rectification. Always contact your building inspector should cracks widen, lengthen, or become more numerous.

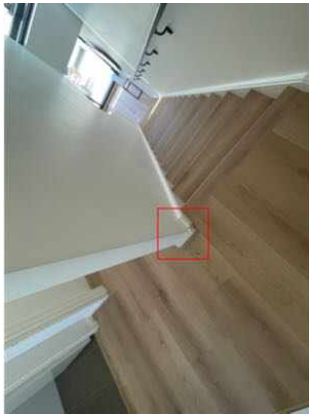
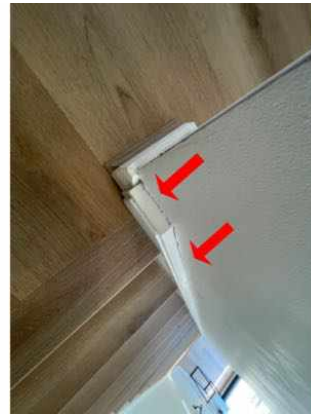
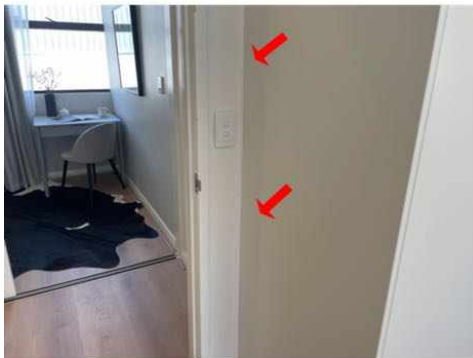
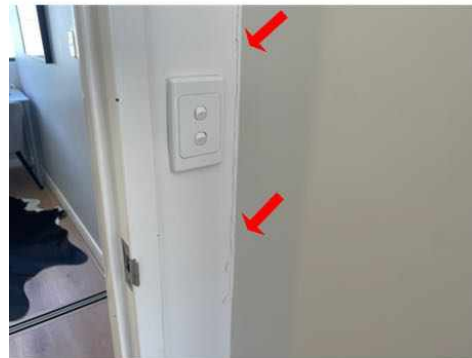
Finding 3.02

Building:	Main Building
Location:	Top of stairs, bedroom entrance
Finding:	Paint finish - Substandard
Information:	The paint finish in this area was found to have been completed to a substandard level. Substandard painting is generally classified as an appearance defect. However, the substandard appearance may also be indicative of poor surface preparation and substandard workmanship.

If this applies, further areas of poor and incomplete finishes could develop over time. Furthermore, substandard paint finishes in areas exposed to moisture, e.g. external areas or wet areas, could lead to deterioration of underlying building materials.

Substandard paint finishes should be sanded back, filled, leveled and repainted, as applicable. Where inadequate paint protection has led to the deterioration of the associated building element, repair and/or replacement of this building element may be required.

A painting contractor should be appointed as soon as possible to perform necessary works to aid the appearance of the affected area and to ensure that the area is protected against further deterioration. Alternatively, the homeowner following manufacturer instructions may be able to provide this service.

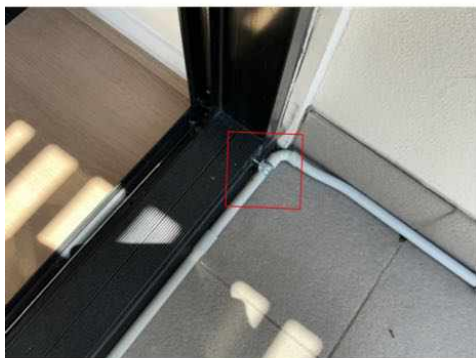
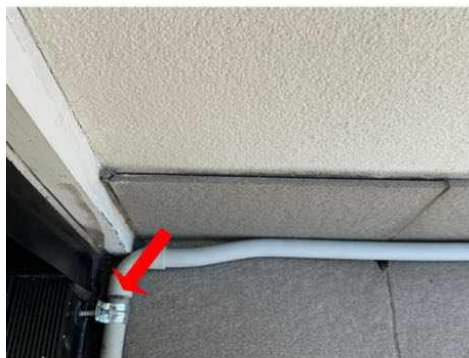
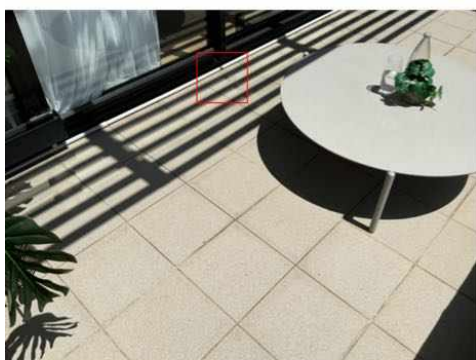
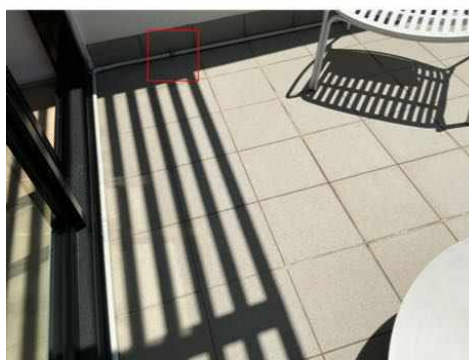
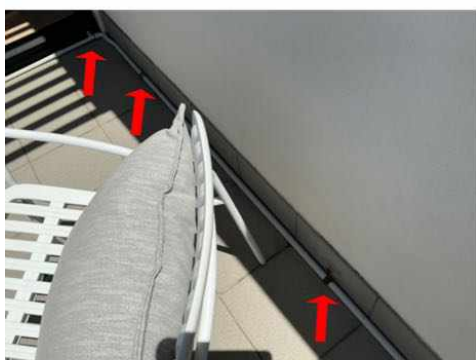
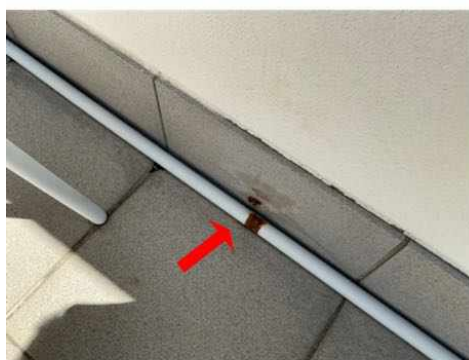
Finding 3.03

Building:	Main Building
Location:	Lower balcony
Finding:	Building element - Broken or Damaged- Brackets damaged or missing
Information:	Breakage occurs generally when the building materials have either aged and decayed, or as a result of damage (accidental or deliberate).

Repair and/or replacement of broken elements is advised to ensure that additional secondary defects do not arise as a consequence. Such works are necessary, as all building elements play a key role in the operation and function of the overall structure and its performance.

A relevant tradesperson should be appointed to repair or replace the affected building element prior to any subsequent damage being caused.

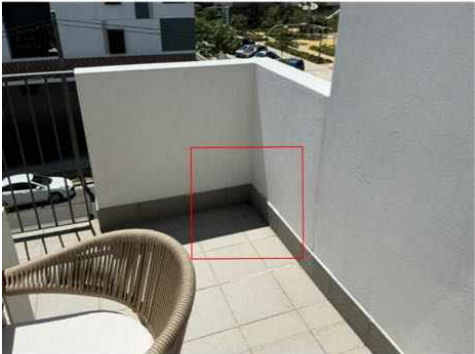
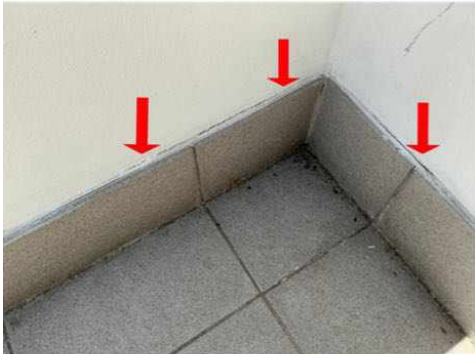
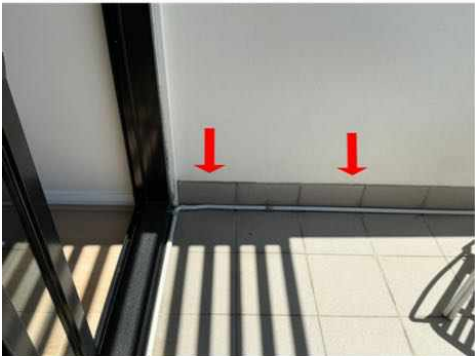
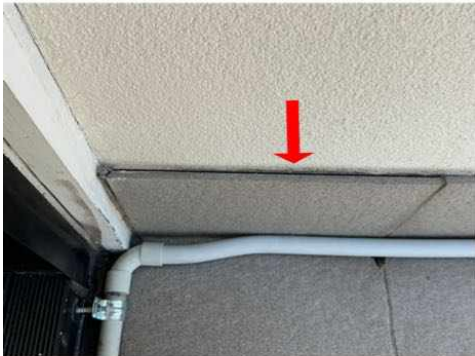
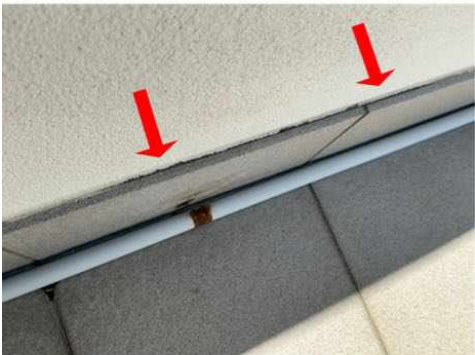
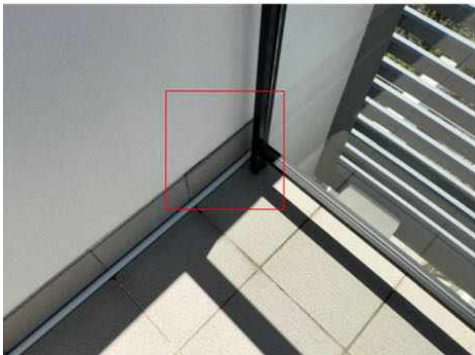
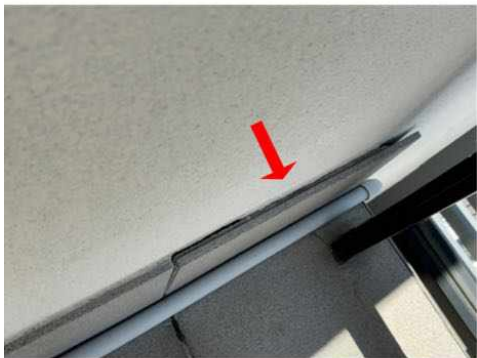
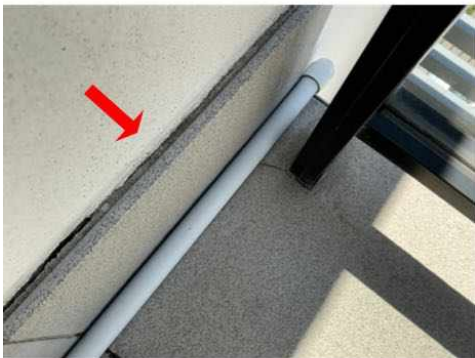
Finding 3.04

Building:	Main Building
Location:	Lower and upper balconies
Finding:	Tiles - Drummy
Information:	Drummy tiled areas were identified at the time of inspection. The term 'drummy' refers to tiles that have become detached from their fixing, despite otherwise being in relatively good condition. Such defects are generally caused by physical or moisture damage to the area. Drummy tiled areas may also be a direct result of poor workmanship during the construction process.

Tiled areas may swell and shrink with changes in air humidity if the area has sustained moisture damage. Any exposure to moisture is capable of causing tiled areas to

become drummy and/or cracked over a prolonged period of time. Drummy tiled areas generally require removal and replacement of affected tiles, with adequate sealant and grouting.

Specialist trades are available for these types of services. A registered builder may be required to undertake works if damage is extensive or if secondary building defects have resulted. Otherwise, it is advised that a tiling contractor be appointed to perform works as necessary. Immediate action is recommended to ensure that no further damage is sustained in the affected area.

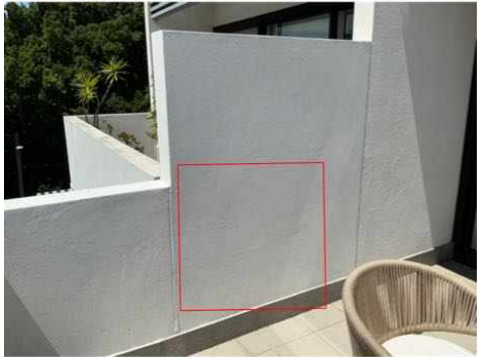
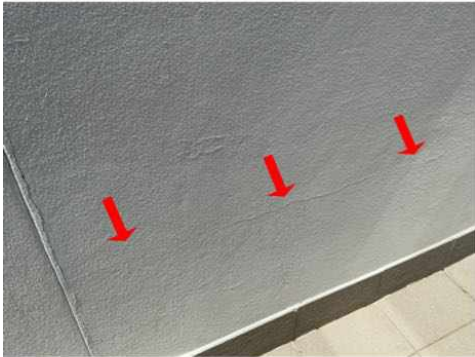
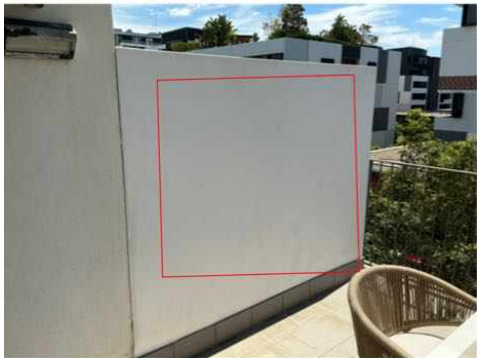
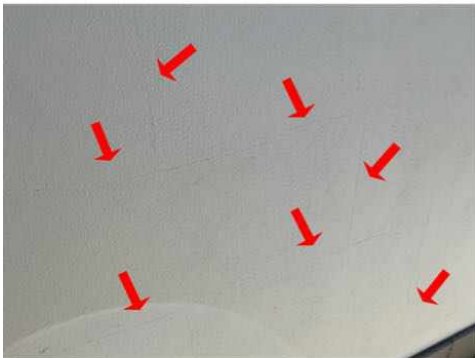
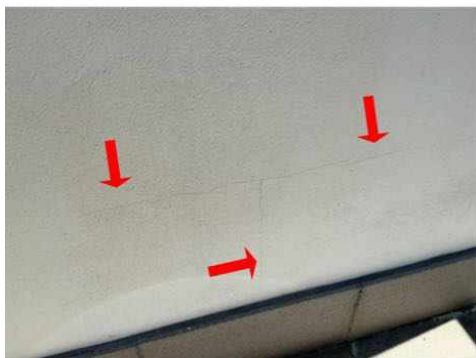
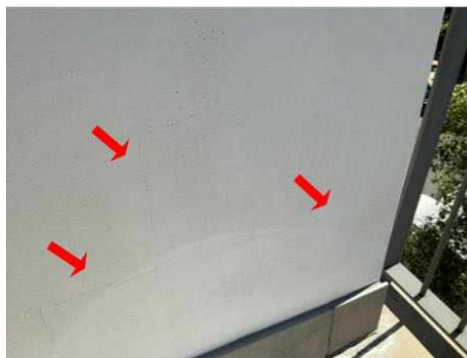
Finding 3.05

Building: Main Building
Location: All Areas
Finding: Cracks to external render - Category 1
Information: It has been observed that cracking to internal rendered surfaces has occurred. The degree of damage falls within Category 1, described as fine cracks that do not need repair and which are less than 1.0mm in width limit.

Damage of this category is not considered a defect for rectification. Always contact your building inspector should cracks widen, lengthen, or become more numerous.

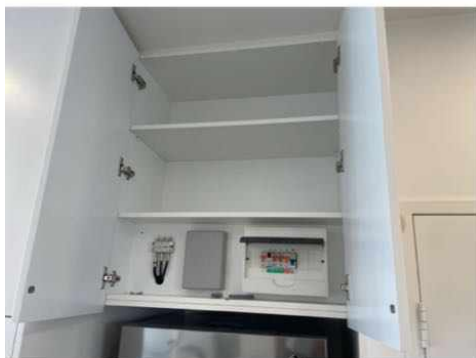
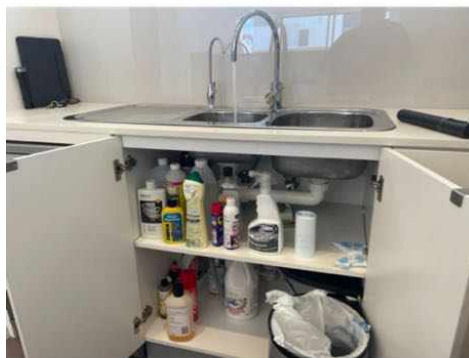
Building:	Main Building
Location:	All Areas
Finding:	Termite Management System - no evidence of a chemical installation- meter box, under kitchen sink
Information:	The application of a post-construction chemical termite barrier is highly recommended for all properties, particularly if live termite activity has been found on the site previously. Such barriers are highly effective in preventing termite attack on any timber building elements throughout the property.

A durable notice should be placed in the switchboard unit to indicate current termite barriers. At the time of inspection, it appeared as though no termite management system has been installed, with no evidence to suggest preventative works taking place.

The client may consider gaining further advice from a pest controller as to the costs and procedures involved with this application. It is recommended that obtaining such advice be a short-term priority.

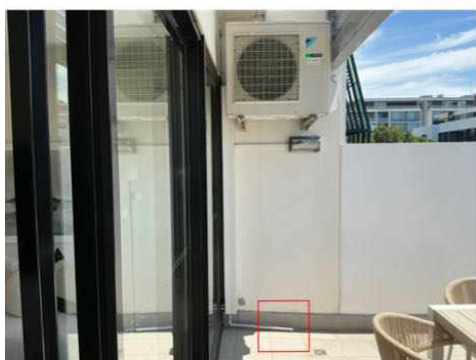
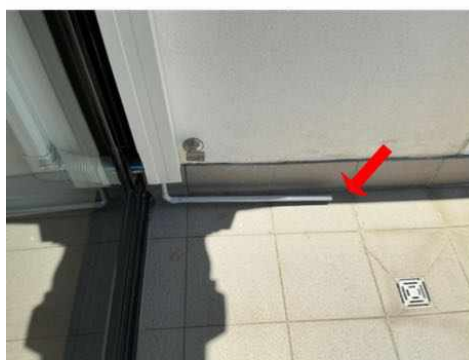
Finding 6.02

Building:	Main Building
Location:	Lower balcony
Finding:	Air conditioner - Disconnected overflow
Information:	The Air Conditioner (A/C) overflow was found to be disconnected from storm water drainage and is creating excessive moisture in the surrounding area.

Such leaking creates an environment which is conducive to an array of defects, including water damage to associated building elements and the attraction of termite or timber pest infestation.

It is highly recommended that a licensed plumber be appointed to connect the A/C overflow in order to prevent such an environment from being created. These minor works should be carried out as soon as possible.
