Building and Timber Pest Inspection Report

Inspection Date: Wed, 11 Feb 2026

Property Address: 2/7 Patterson St, Bonbeach VIC 3196,
Australia

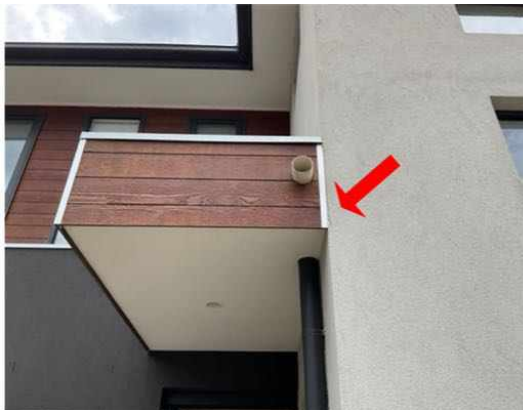
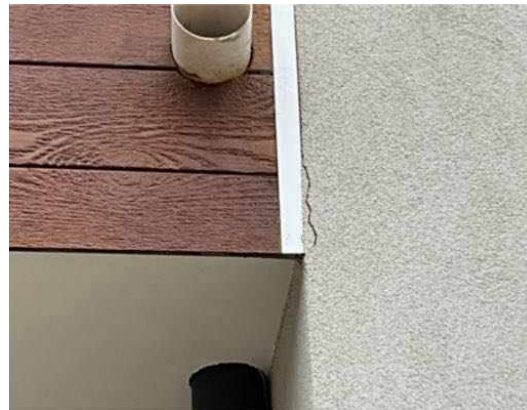
Finding 3.01

Building: Main Building
 Location: Exterior walls - front
 Finding: External rendering - minor crack
 Information: Minor cracks were observed in the exterior rendering of the building in this area during the inspection. This type of crack is typically the result of natural settling of the structure, weather exposure, or thermal expansion and contraction over time. While small in size, even minor cracks in exterior rendering can allow moisture to penetrate the surface, which may cause further damage if left untreated.

A qualified renderer may be engaged to assess the damage and apply appropriate repair materials.

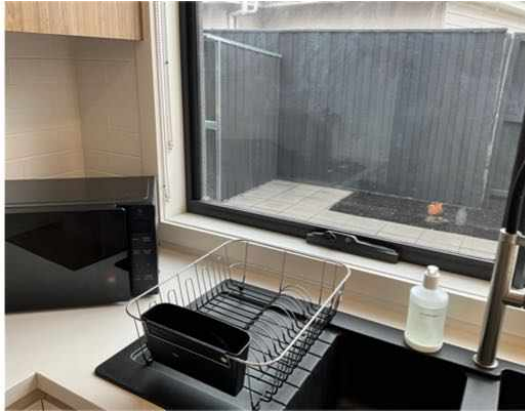
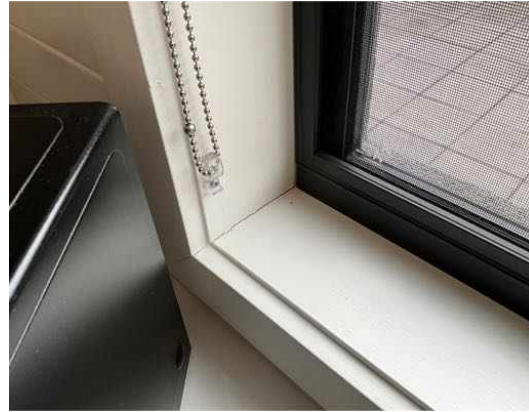
Finding 3.02

Building: Main Building
 Location: All Internal Areas
 Finding: Minor Cracking to Architrave Joints
 Information: Minor cracking was observed to architrave joints at the time of inspection. This type of cracking is commonly associated with normal building movement, material shrinkage, or minor settlement and is typical in many residential properties.

At the time of inspection, the cracking appeared cosmetic in nature and did not indicate significant structural movement.

No immediate action is required. The cracks may be repaired as part of routine maintenance, such as filling and repainting. If cracking becomes more pronounced or widespread in the future, further assessment by a Registered Builder is recommended.

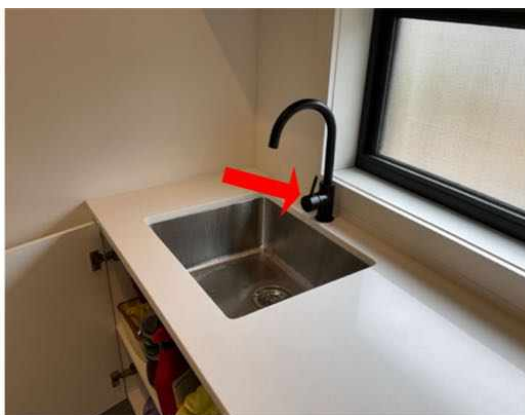
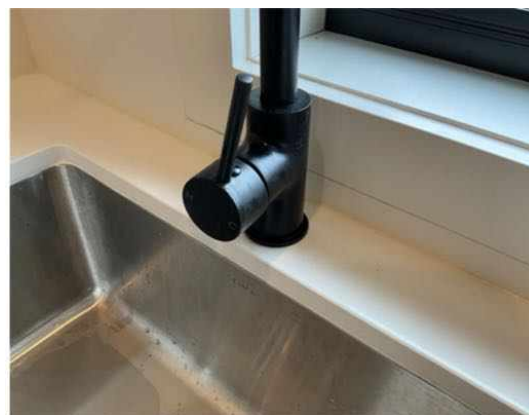
Finding 3.03

Building: Main Building

Location: Laundry

Finding: Loose Sink Tap Fitting

Information: The sink tap was observed to be slightly loose at the time of inspection. This condition may be due to normal wear, minor movement over time, or inadequate fixing of the tap assembly.

If left unaddressed, a loose tap fitting may worsen with regular use and could lead to leakage beneath the sink, potentially causing water damage to cabinetry or surrounding finishes.

It is recommended that the tap be secured and adjusted to ensure it is firmly fixed. If tightening does not resolve the issue or if leakage is identified, a licensed plumber should be engaged to carry out further inspection and repairs as required.

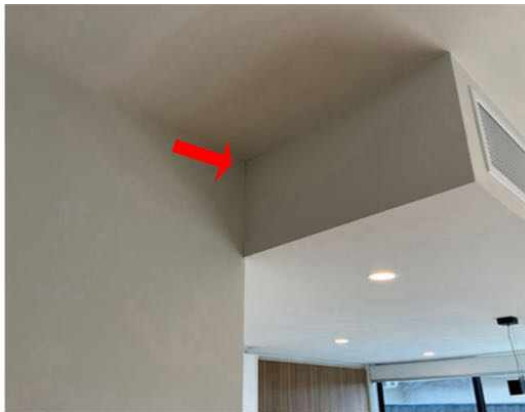
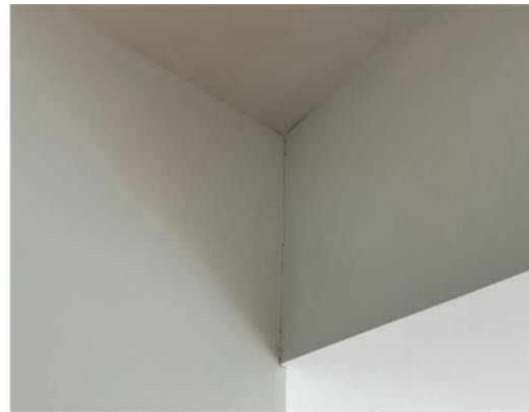
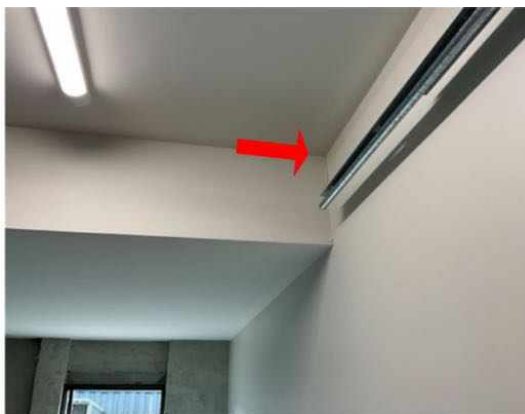
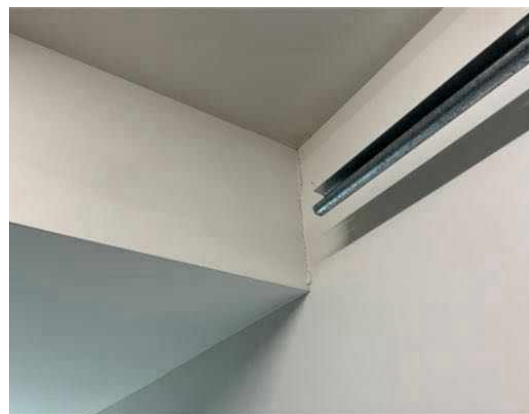
Finding 3.04

Building: Main Building
 Location: Kitchen & Garage
 Finding: Minor Cracking to Plasterboard Walls
 Information: Minor cracking was observed to plasterboard wall surfaces at the time of inspection. The cracking appears consistent with normal building movement, minor settlement, or material shrinkage commonly experienced in residential properties.

At the time of inspection, the cracking appeared cosmetic in nature and did not indicate significant structural movement. Such defects are generally associated with typical wear and tear over time.

No immediate structural action is required. The cracks may be repaired as part of routine maintenance, including filling, sanding, and repainting. Should cracking increase in width, length, or frequency, further assessment by a Registered Builder is recommended.

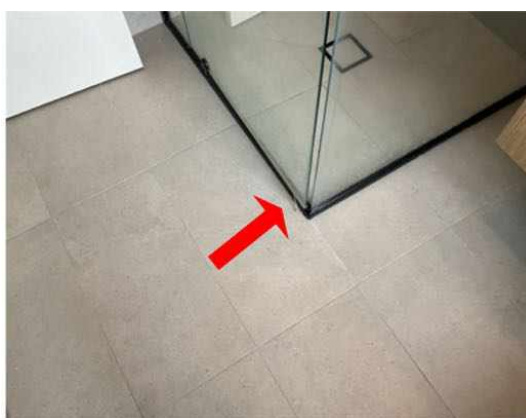
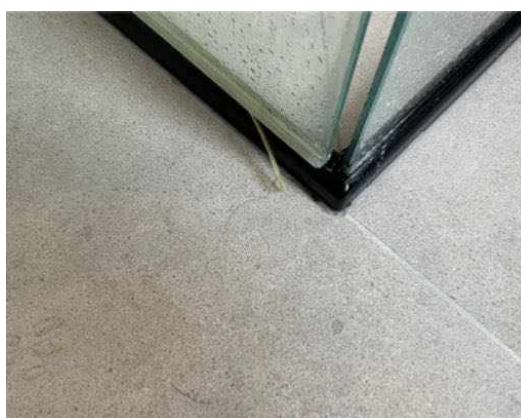
Finding 3.05

Building: Main Building
 Location: Bathroom
 Finding: Inadequate Sealing to Shower Screen Base

Information: An opening and inadequate sealing were observed at the base and corner junction of the shower screen during the inspection. A visible gap was present between the shower screen frame and the floor surface, which may allow water to escape the shower area during use.

If left unaddressed, inadequate sealing at the shower screen base may result in water leakage onto surrounding floor areas, leading to moisture penetration, deterioration of floor finishes, and potential water damage to adjacent building elements over time.

It is recommended that a licensed glazier or suitably qualified contractor be engaged to reseal the shower screen using appropriate waterproof sealant. Prompt rectification will assist in maintaining effective water containment and reducing the risk of ongoing moisture-related damage.

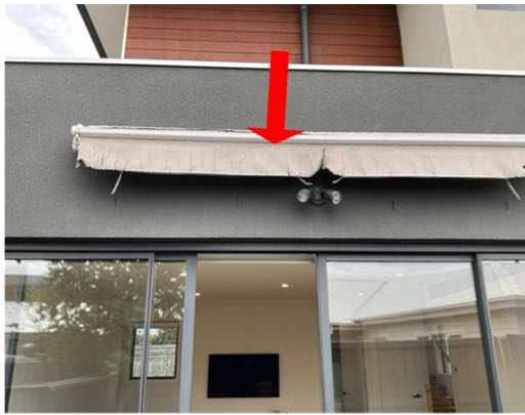
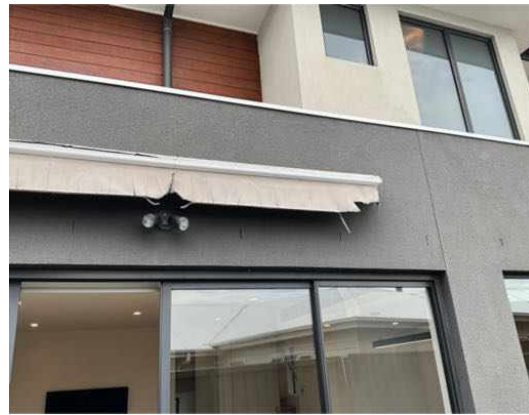
Finding 3.06

Building: Main Building

Location: Exterior walls - rear

Finding: Deteriorated and Damaged Awning Fabric

Information: The external awning fabric was observed to be deteriorated and torn at the time of inspection. Cracking, fraying, and splitting of the fabric were evident along the lower edge, consistent with prolonged exposure to weather conditions, ultraviolet degradation, and general wear and tear over time.

If left unaddressed, the deteriorated awning fabric may continue to degrade, reducing its effectiveness in providing shade and weather protection. Loose or torn sections may also present a risk of further damage during windy conditions and may affect the overall appearance of the property.

It is recommended that a qualified awning installer or suitable contractor be engaged to assess the condition of the awning and carry out necessary repairs or replacement of the fabric. Prompt attention will help restore functionality, improve durability, and prevent further deterioration.

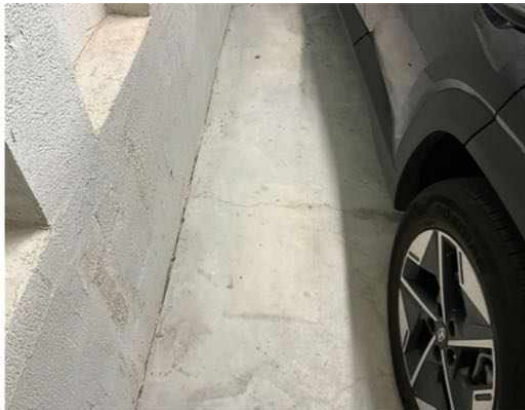
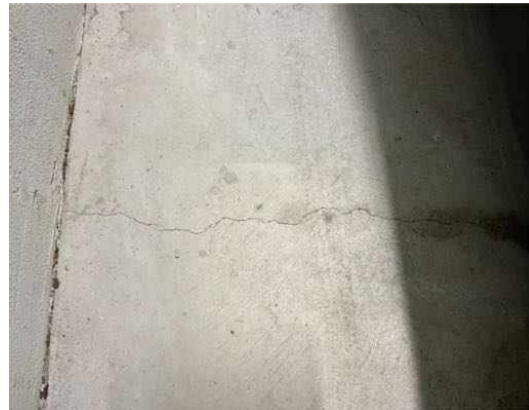
Finding 3.07

Building: Main Building
 Location: Garage
 Finding: Minor Cracks in Garage Slab
 Information: Minor cracks were observed in the concrete slab in the garage area during the inspection. These appear to be superficial and are commonly caused by concrete shrinkage, curing, or minor settlement.

Such cracks can allow moisture to enter the slab and may worsen if movement continues. Progressive cracking may indicate developing movement in the slab.

It is recommended to monitor the cracks for any widening or new cracking. If further deterioration occurs, a qualified building inspector should be engaged to assess the extent of movement and advise on appropriate next steps.

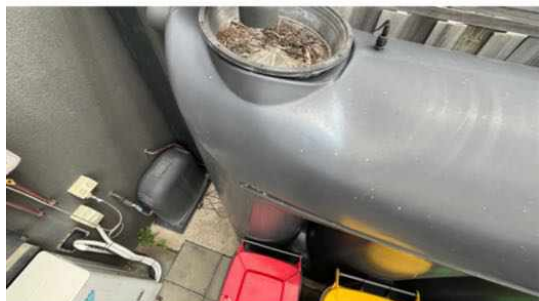
Finding 3.08

Building: Main Building
 Location: Exterior walls - rear
 Finding: Water tank inlet - partially blocked
 Information: The water tank inlet was found partially blocked with debris like leaves, twigs, and dirt during the inspection.

This is a common problem that reduces the efficiency of rainwater harvesting.

The filter needs to be cleaned regularly to ensure proper water flow and prevent the tank from becoming contaminated.

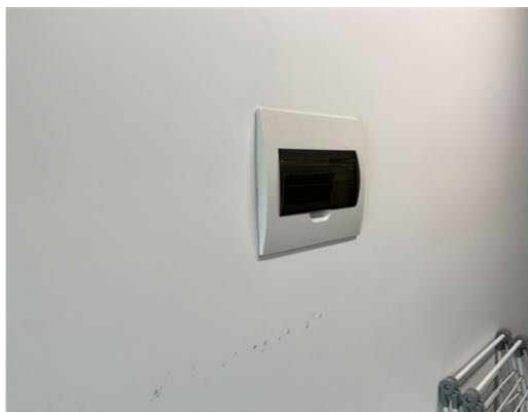
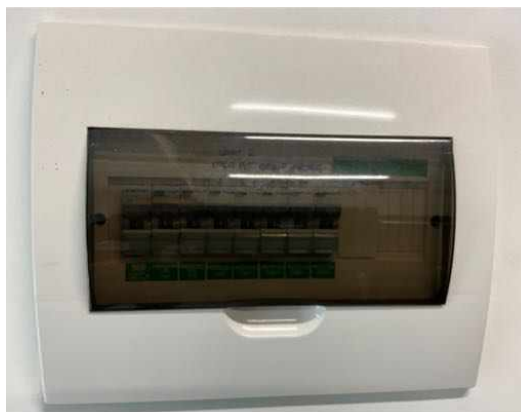
Finding 6.01

Building:	Main Building
Location:	Meter Box
Finding:	Termite Management System - no evidence of a chemical installation
Information:	The application of a post-construction chemical termite barrier is highly recommended for all properties, particularly if live termite activity has been found on the site previously. Such barriers are highly effective in preventing termite attack on any timber building elements throughout the property.

A durable notice should be placed in the switchboard unit to indicate current termite barriers. At the time of inspection, it appeared as though no termite management system has been installed, with no evidence to suggest preventative works taking place.

The client may consider gaining further advice from a pest controller as to the costs and procedures involved with this application. It is recommended that obtaining such advice be a short-term priority.

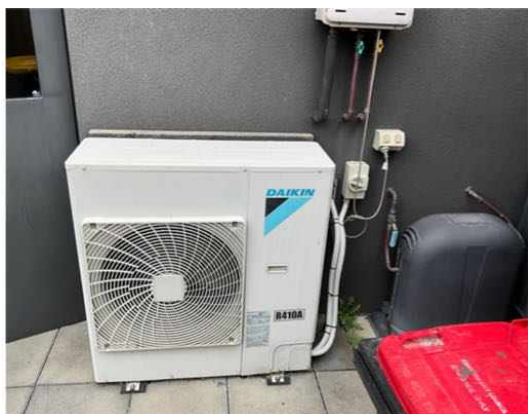
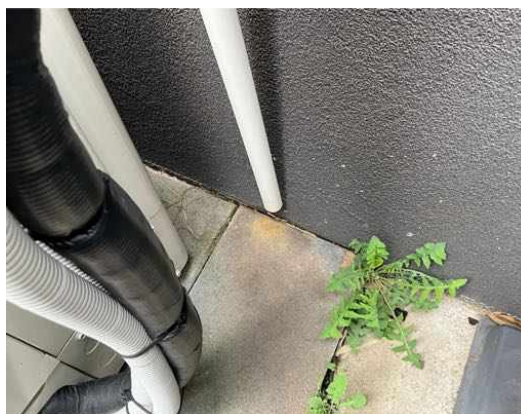
Finding 6.02

Building:	Main Building
Location:	All External Areas
Finding:	Air conditioner - Disconnected overflow
Information:	The Air Conditioner (A/C) overflow was found to be disconnected from storm water drainage and is creating excessive moisture in the surrounding area.

Such leaking creates an environment which is conducive to an array of defects, including water damage to associated building elements and the attraction of termite or timber pest infestation.

It is highly recommended that a licensed plumber be appointed to connect the A/C overflow in order to prevent such an environment from being created. These minor works should be carried out as soon as possible.

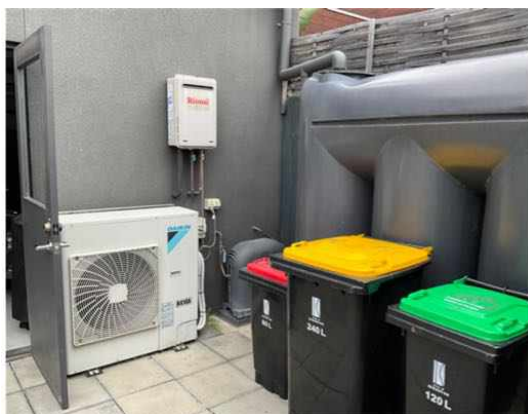
Finding 6.03

Building:	Main Building
Location:	All External Areas
Finding:	Bridging - Attachments to Buildings
Information:	Bridging occurs when items against a building provide a concealed entry point for

termites into the building or by passing around a termite management system.

Where any part of an attachment to a building is not isolated and is not provided with a clear gap of not less than 25mm from the building, bridging occurs. Attachments to buildings such as hot water services, downpipes, verandahs, decks, steps, fences, service conduits are the like provide the opportunity for concealed entry.

Building attachments of this nature need to be frequently inspected for termite activity by a qualified inspector.

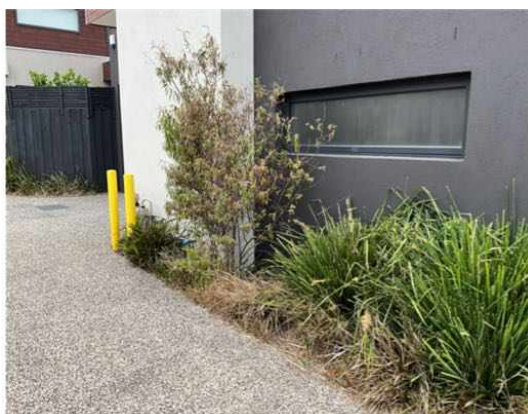
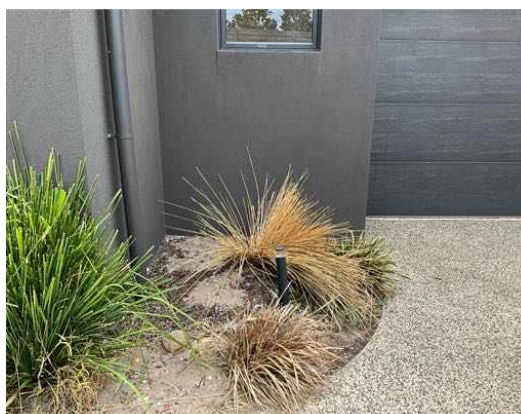
Finding 6.04

Building:	Main Building
Location:	All External Areas
Finding:	Garden Beds - Conditions Conducive to Termites
Information:	Garden beds were found to be evident in the garden area. These garden beds can include untreated timber, and with a combination of moisture from watering hosing can make conditions conducive to termite activity and termite ingress.

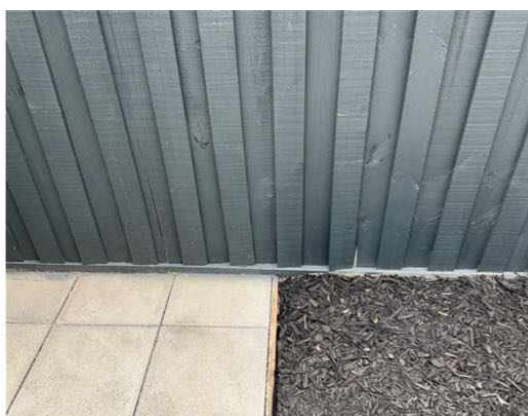
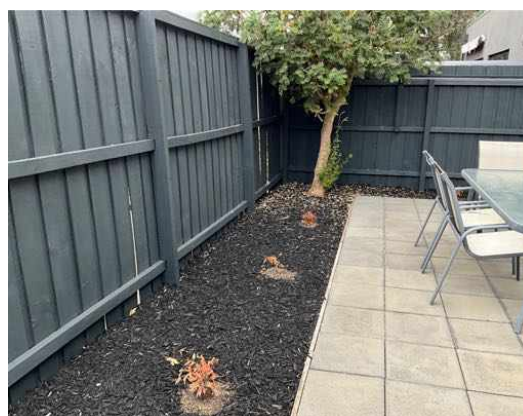
Finding 6.05

Building:	Main Building
Location:	All External Areas

Finding: Building materials in direct ground contact - conducive to termites

Information: Where timber elements are in direct contact with the ground and consequently moisture or dampness they become conducive to termite activity. Whether timber is used as a building element part of a fencing structure or stored as an unused item they can provide an environment that is attractive to termite infestation.

When met with excessive moisture timber begins to decay and develop wood rot. Any timbers that are in direct contact with external grounds especially if left untreated or non-durable also provide ingress for subterranean termites into that particular element.

The removal of any such materials that may be conducive to termite activity should be removed as soon as possible to minimise the risk of termite attack.

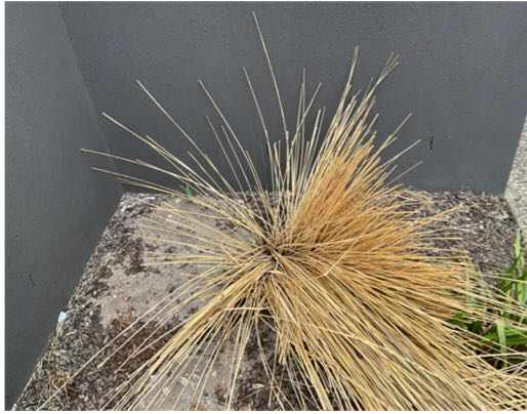
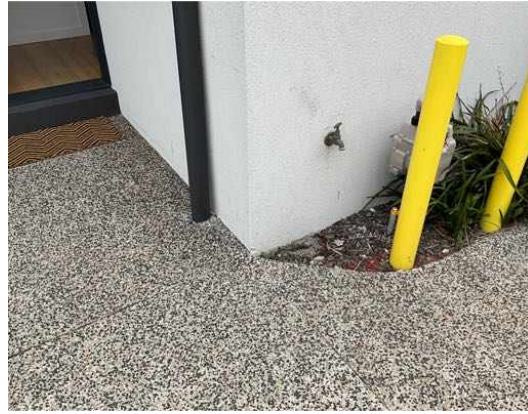
Finding 6.06

Building: Main Building

Location: All External Areas

Finding: Slab Edge - Exposure

Information: An inspection zone of at least 75mm in relation to the exposed slab edge, between the bottom brick and the perimeter pavement, is required. This inspection zone should be maintained in order to force termites into the open where they can be detected more readily during regular inspections. The slab edge should not be concealed by anything that may prevent inspection of the area, including render, landscaping, soil, turf, paving, concrete cladding or other structures.

If the slab edge is not properly exposed there is a high risk of termite attack. Sometimes, in order to determine the type of slab, a suitably qualified person such as an architect or builder may be required to consult the construction plans.

Where the slab edge cannot be properly inspected, it is highly recommended that termite or timber pest inspections be carried out every 6-12 months to aid protection of the property against infestation.

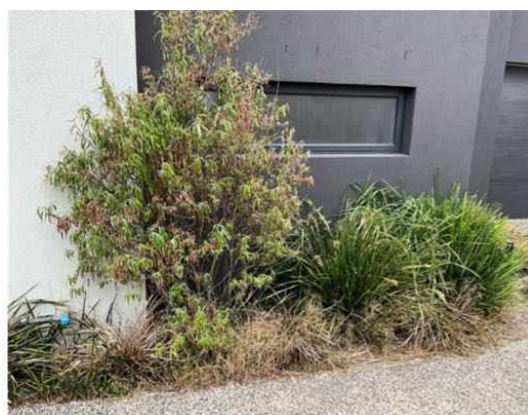
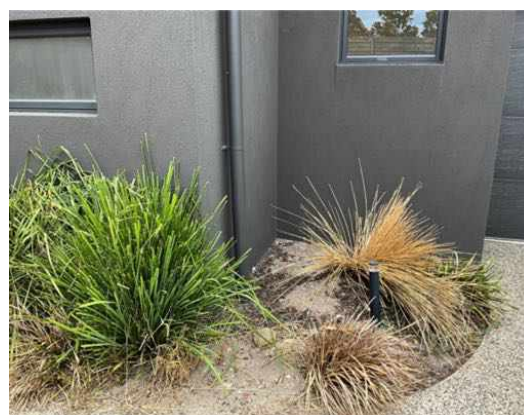
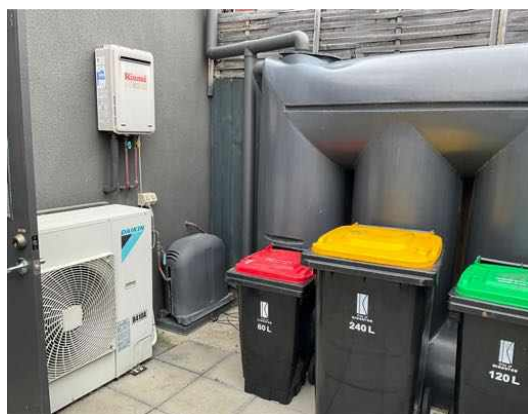
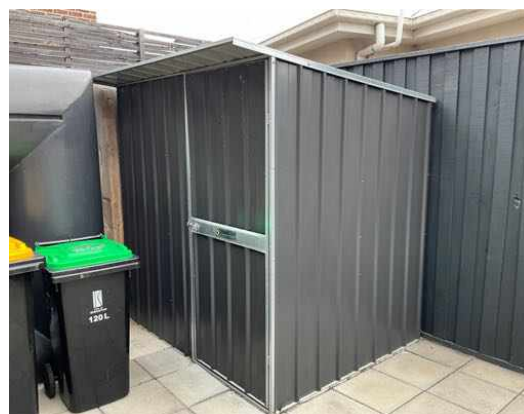
Building:	Main Building
Location:	All External Areas
Finding:	Obstructions and Limitations - External areas
Information:	These photographs are an indication of the obstructions and limitations which impeded full inspection of the external areas of the property at the time of inspection. These obstructions can hide an array of defects and should be removed to allow full inspection to be carried out. A re-inspection is recommended once the areas are made accessible.

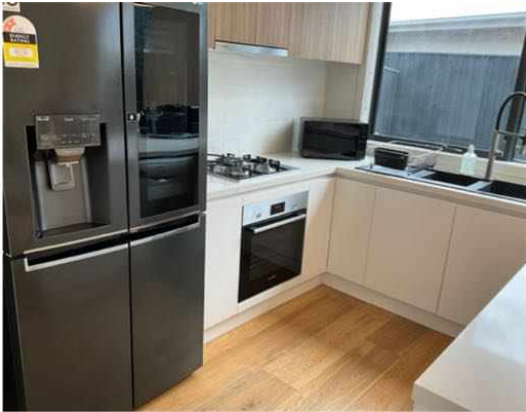
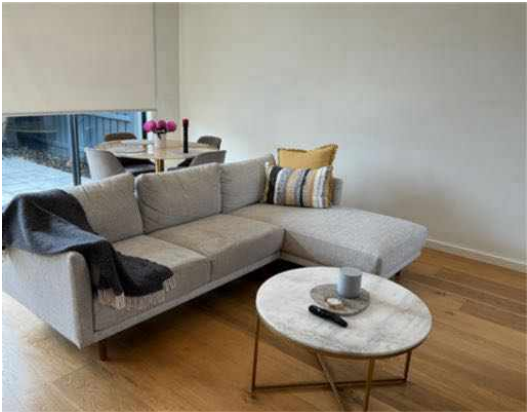
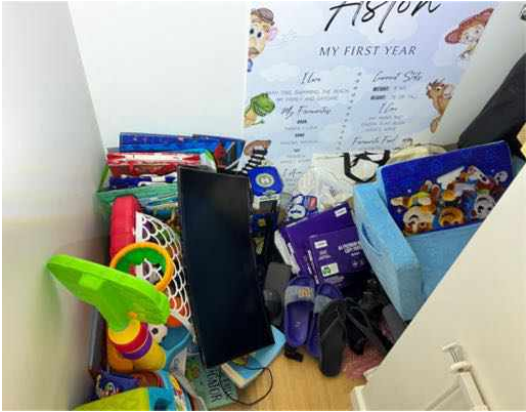
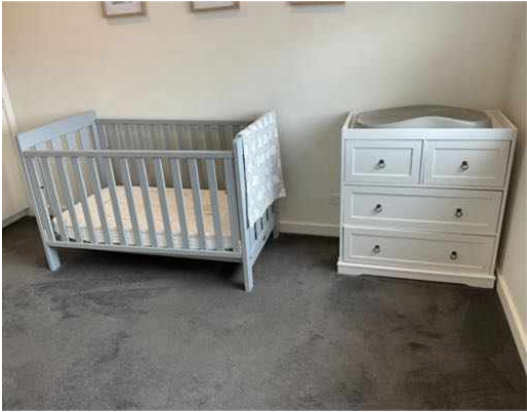
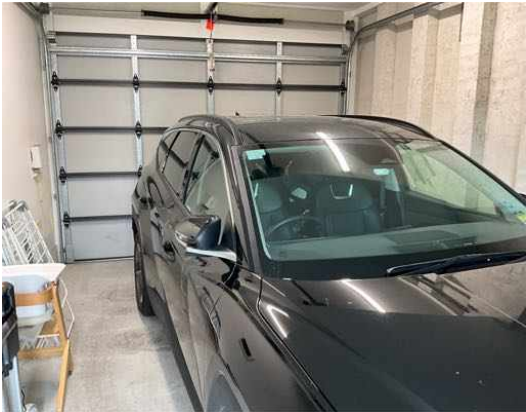
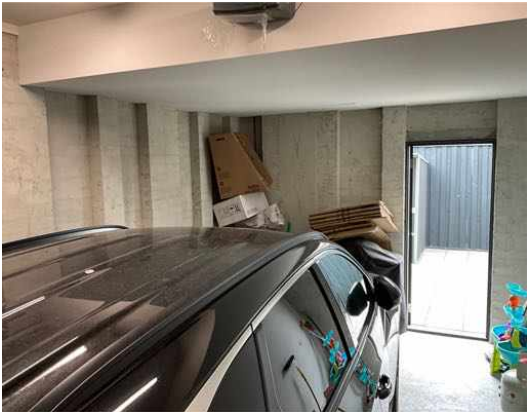
Building:	Main Building
Location:	All Internal Areas
Finding:	Obstructions and Limitations - Internal areas
Information:	These photographs are an indication of the obstructions and limitations which impeded full inspection of the internal areas of the property at the time of inspection.

These obstructions can hide an array of defects and should be removed to allow full inspection to be carried out. A re-inspection is recommended once the areas are made accessible.
