Building Inspection Report

Inspection Date: Wed, 21 Jan 2026

Property Address: 13/19 Drusilla Glade, Riverstone NSW 2765,
Australia

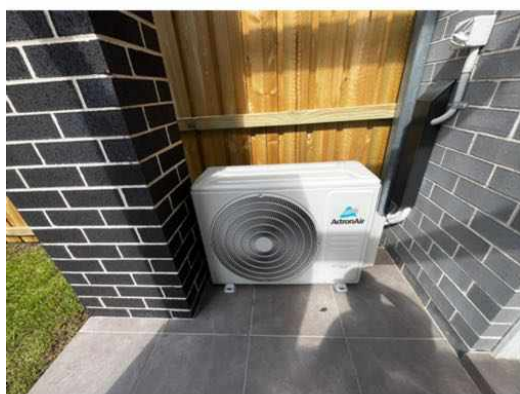
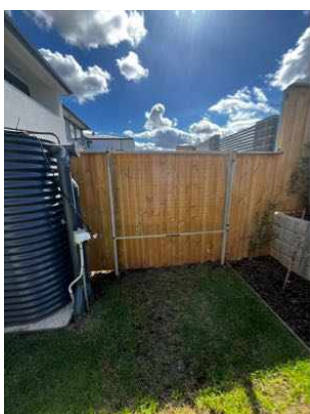
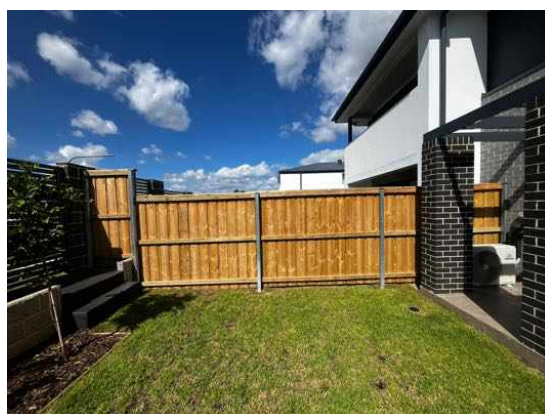
Defects 3.01

Building: Main Building
Location: Yard
Finding: Timber Fencing
Information: Inspection Completed. For your information.

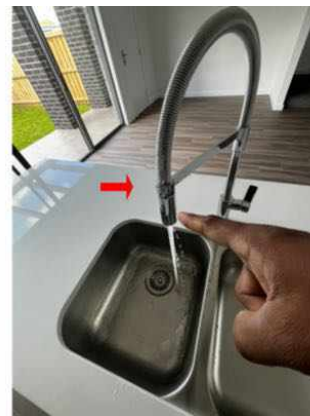
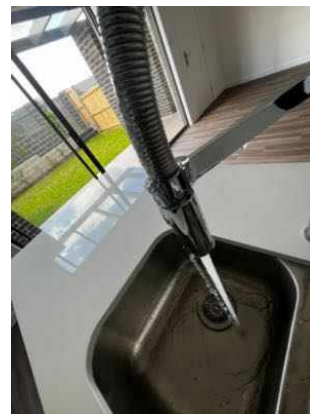
Defects 3.02

Building: Main Building
Location: Kitchen/ Pantry

Finding: Cabinetry Plumbing - Kitchen- Pantry
 Information: Upon Inspection of the Kitchen and the Pantry all cupboards where sinks and basins with drainage plumbing were inspected and no evidence of leaks were present at the time of inspection.

For your information only no remedial works are required at the time of inspection.

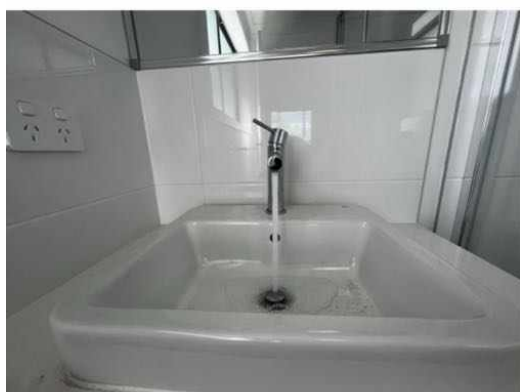
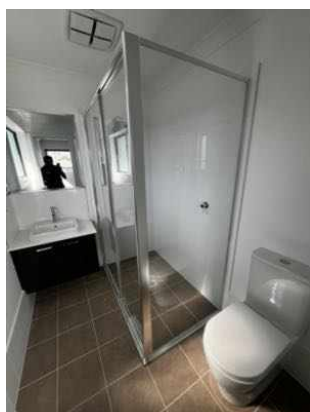
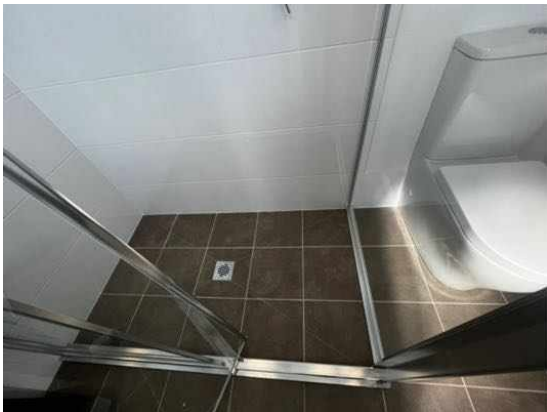
Defects 3.03

Building: Main Building
 Location: Master Ensuite
 Finding: Cabinetry Plumbing / Master Ensuite Inspection/ Moisture Checked
 Information: All cupboards where sinks and basins with drainage plumbing were inspected no evidence of leaks were present at the time of inspection.

Upon Inspection a minor scratch was noticed on the door - it is advised to consult a painter to rectify the same for a good appearance.

Upon Inspection of the area there was no excess moisture reading was found during inspection.

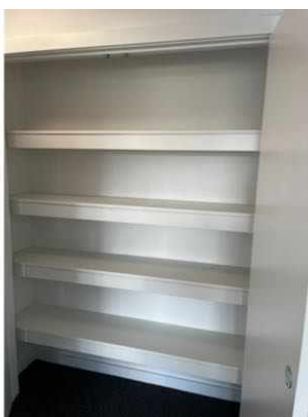
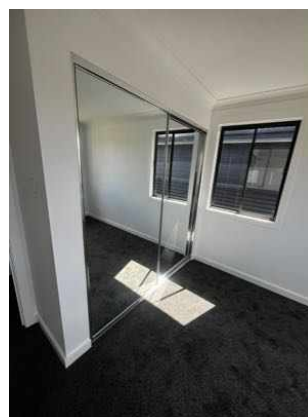
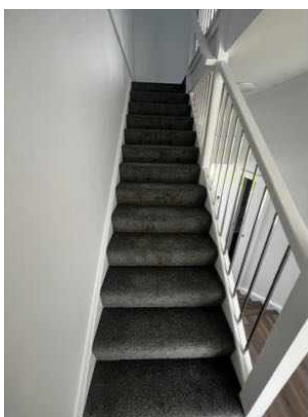
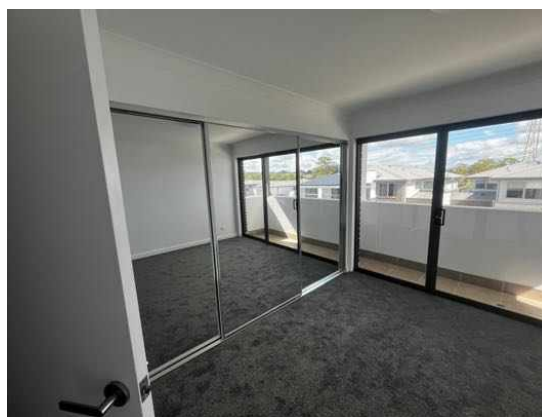
Building: Main Building
 Location: All Areas
 Finding: Additional Photos - Obstructions and Limitations
 Information: These photographs are an indication of the obstructions and limitations which impeded full inspection of the property at the time of inspection. These obstructions can hide an array of defects and should be removed to allow full inspection to be carried out. A re-inspection is recommended once the areas are made accessible.

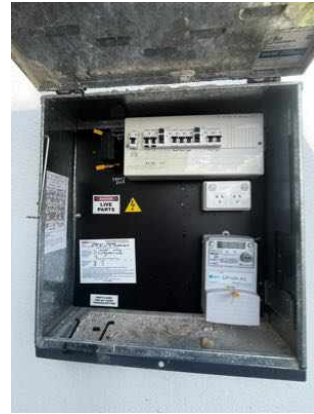
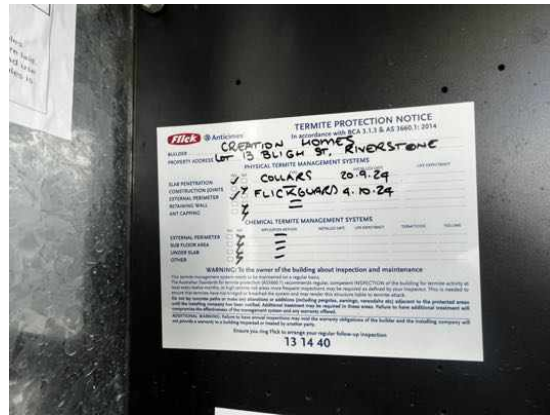
Building: Main Building
 Location: Meter Box
 Finding: Evidence of a chemical treated zone barrier was identified
 Information: During inspection of the property, it was noted that works to install a chemical treated zone barrier had previously been completed. A chemical treated zone barrier is likely to ensure effective protection against termites.

However, we strongly recommend annual inspections of the barrier and surrounding areas as there are several factors that can lead to deterioration of the barrier and decrease its effectiveness.

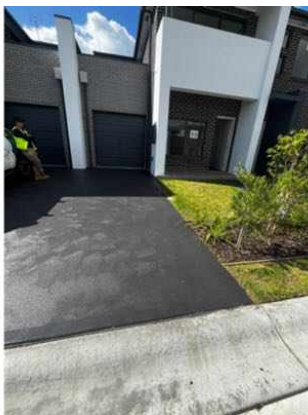
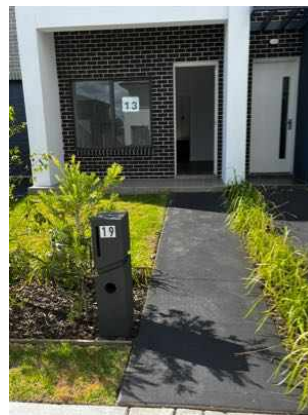
Building: Main Building
 Location: Driveway
 Finding: For information only
 Information: No remedial works are required at the current time.

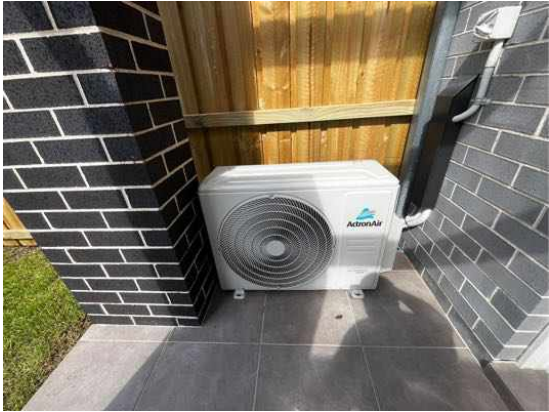
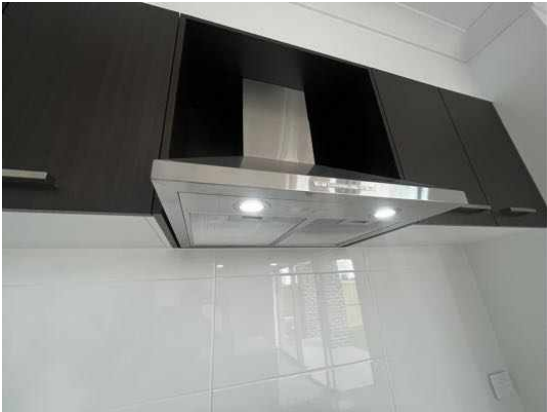
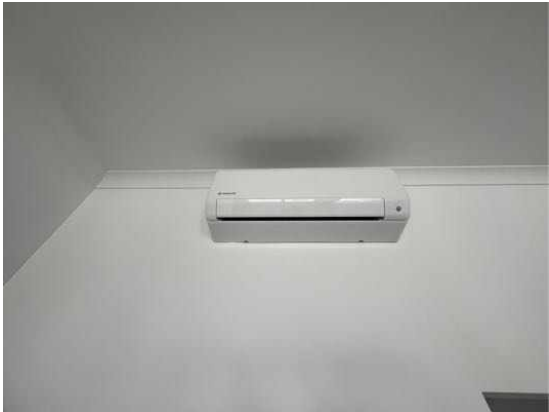
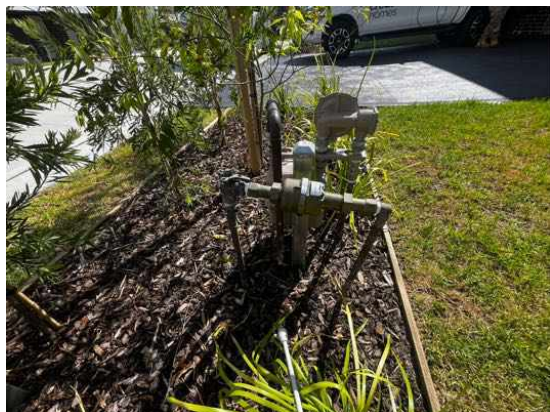
Building: Main Building
 Location: All Areas
 Finding: Plumbing/electrical/gas/aircon/appliances/pool equipment/fire safety etc
 Information: Plumbing and electrical inspections are outside the scope of the building inspection and must be conducted by a Licensed and registered Trades person.

It is highly recommended that the client makes immediate arrangements to have the gas appliances checked by a licensed gas plumber to ensure that the appliances are working safely and efficiently.

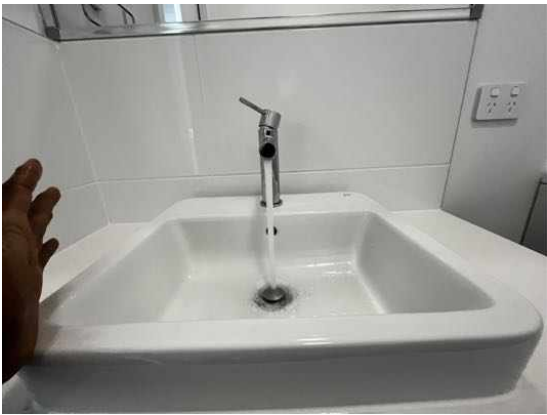
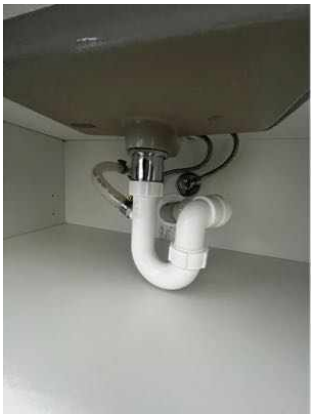
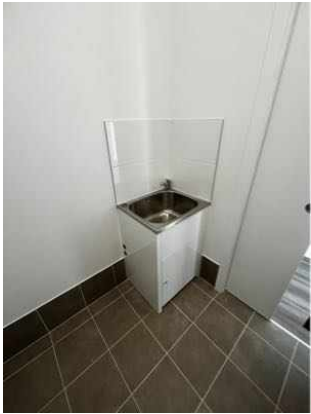
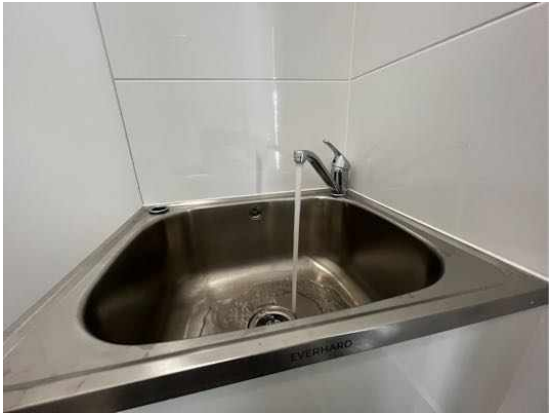
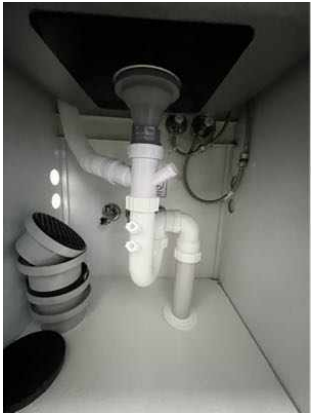
Building: Main Building
 Location: Laundry
 Finding: Cabinetry Plumbing / Laundry/Moisture Checked
 Information: All cupboards where sinks and basins with drainage plumbing were inspected no evidence of leaks were present at the time of inspection.

Upon Inspection of the area there was no excess moisture reading was found during inspection.

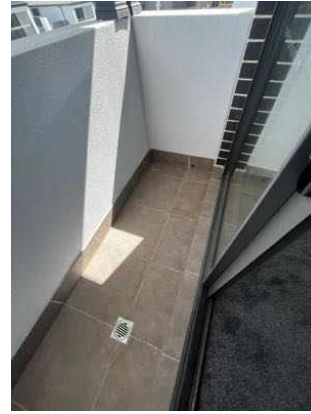
Building: Main Building
Location: Balcony
Finding: Balcony -
Information: The balcony in this area has been inspected .

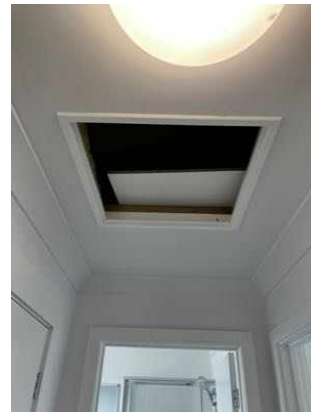
Building: Main Building
 Location: Hallway - Upstairs
 Finding: Obstructions and Limitations - Roof space
 Information: The roof void was inspected up to a safe accessible reachable point inside.

A re-inspection is recommended once the areas are made accessible.

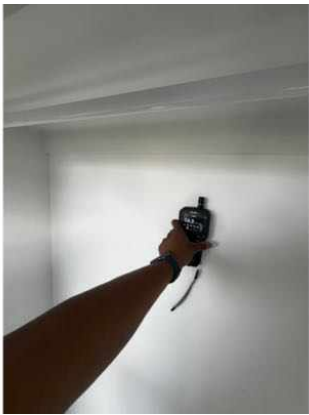
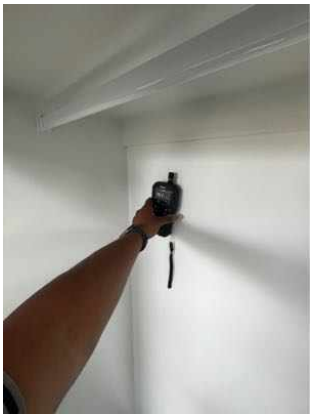
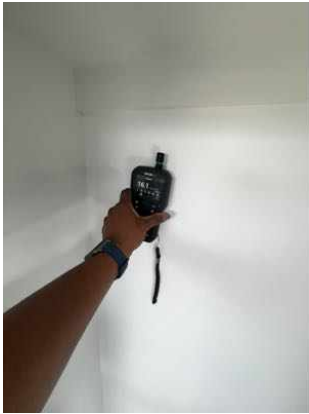
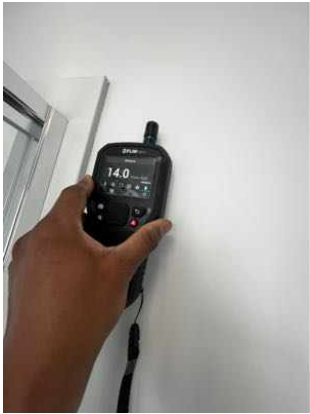
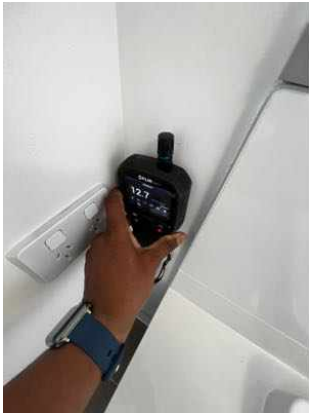
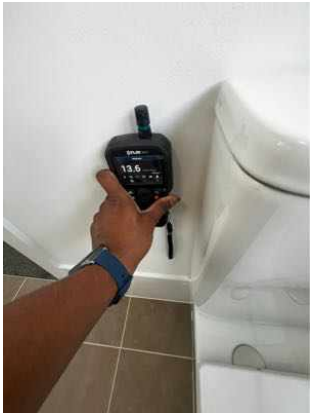
Building: Main Building
Location: All Wet Areas
Finding: Checked for Moisture
Information: Photos taken during inspection around wet areas for checking of moisture and no readings of any high moisture found.

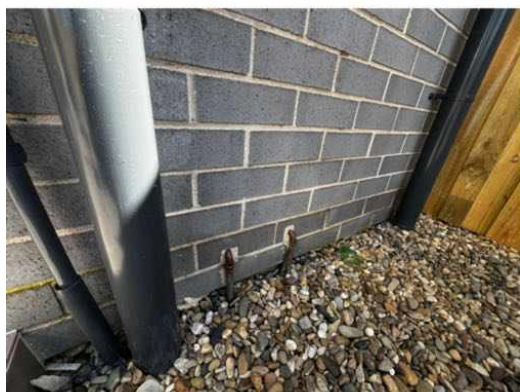
Building:	Main Building
Location:	All External Areas
Finding:	Slab Edge - Exposure
Information:	An inspection zone of at least 75mm in relation to the exposed slab edge, between the bottom brick and the perimeter pavement, is required. This inspection zone should be maintained in order to force termites into the open where they can be detected more readily during regular inspections. The slab edge should not be concealed by anything that may prevent inspection of the area, including render, landscaping, soil, turf, paving, concrete cladding or other structures.

Where the slab edge cannot be properly inspected, it is highly recommended that

termite or timber pest inspections be carried out every 6-12 months to aid protection of the property against infestation.

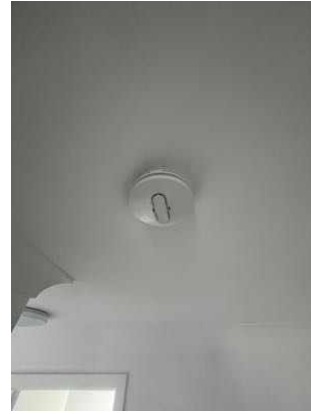
Building:	Main Building
Location:	All Internal Areas
Finding:	Smoke Detectors and Alarms
Information:	Reporting on Smoke Detectors or Alarms, including hard wired smoke detection systems and their legislative requirements, is outside the Scope of this Report.

Please note that this defect is highlighted as a caution only. We suspect, based on our experience in the building industry, that the absence of smoke detectors, or their poor condition, should be addressed as a matter of urgency to improve occupant safety.

Always ensure sufficient working and suitable smoke detectors are installed prior to occupying any building. Additionally, it is advised that all smoke detectors be tested by the homeowner on a monthly basis.

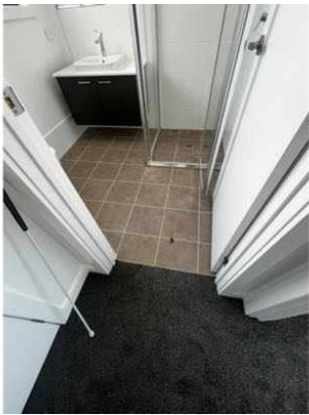
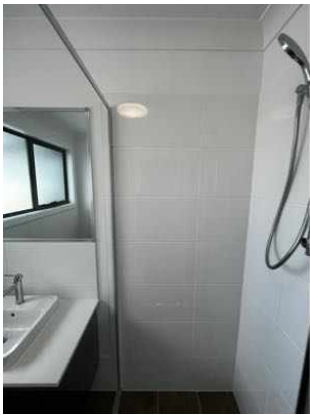
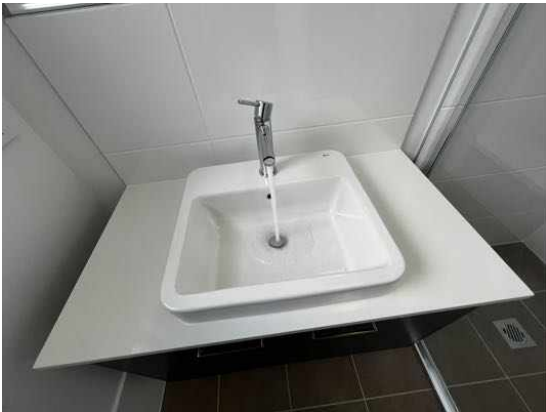
Building: Main Building
 Location: Main Bathroom
 Finding: Cabinetry Plumbing / Main Bathroom Inspection/ Moisture Checked
 Information: All cupboards where sinks and basins with drainage plumbing were inspected no evidence of leaks were present at the time of inspection.

Upon Inspection of the area there was no excess moisture reading was found during inspection.
