Building and Timber Pest Inspection Report

Inspection Date: Wed, 8 Apr 2026

Property Address: 22 Badcoe Ave, Wodonga VIC 3690,
Australia

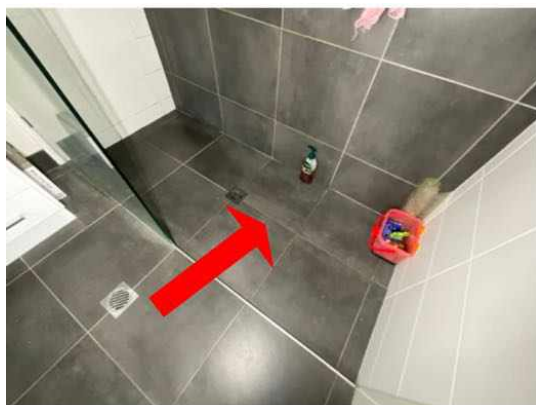
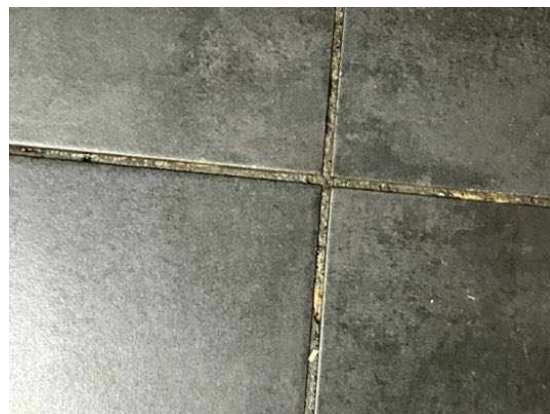
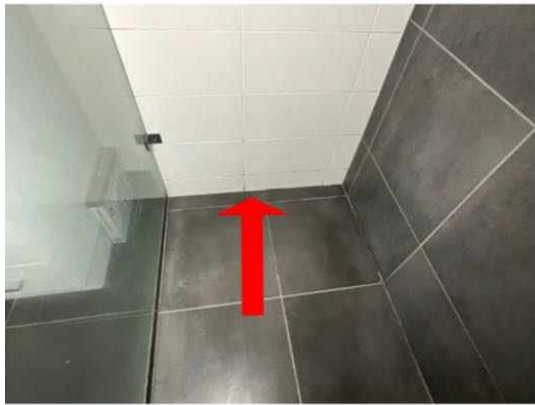
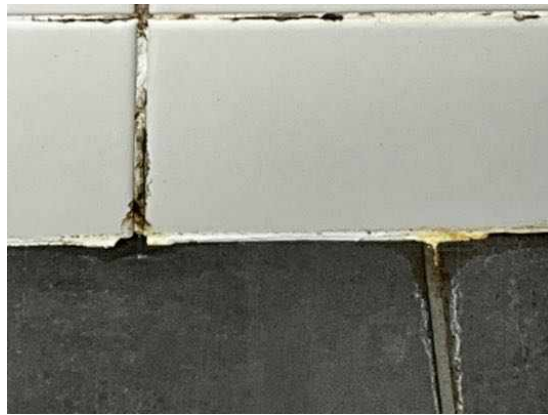
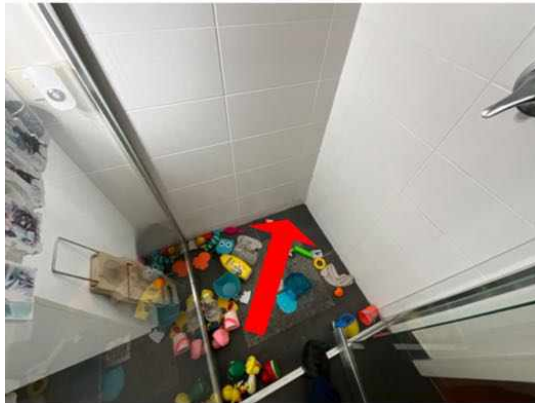
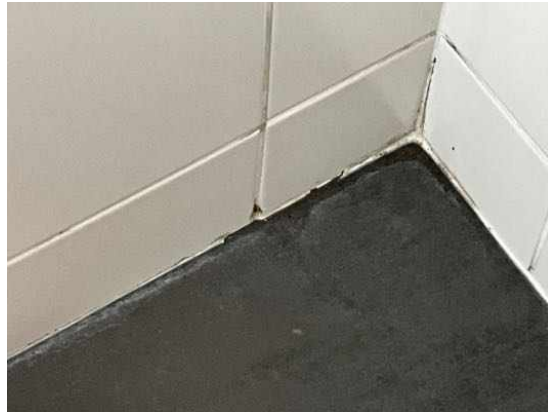
Finding 3.01

Building: Building 1
Location: Ensuite, bathroom
Finding: Inadequate sealant or Grout
Information: This area has a lack of effective Sealant or Grout. This is allowing the ingress of water to the structure inside the wall.

The presence of water encourages Termite attack, Mould and Fungal Decay.

A Tiler or General Handy person must be contacted as soon as possible to effect repairs and prevent further deterioration.

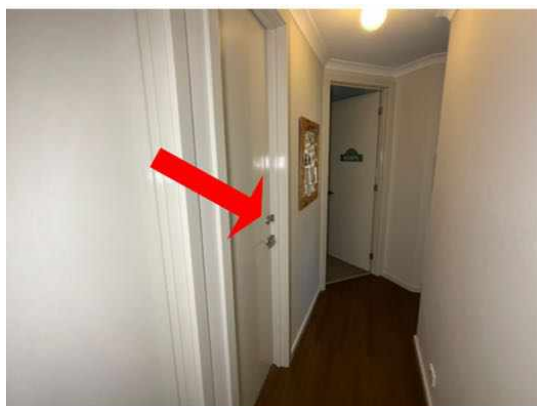
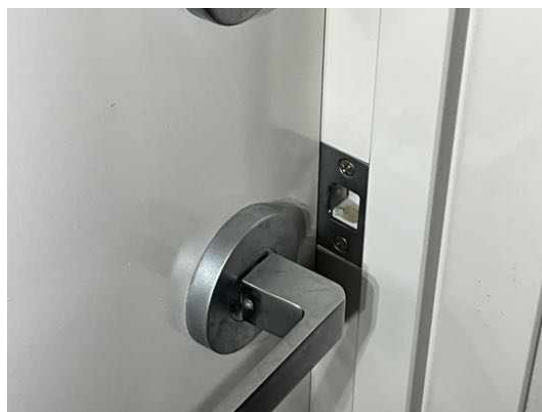
Finding 3.02

Building:	Building 1
Location:	Bathroom
Finding:	Door - Striker plate misaligned
Information:	The striker plate to this door appears to have become misaligned and has consequently resulted in the door's operation being compromised.

This is a common defect and is expected in a property of this age, whether being due to substandard installation or general deterioration of the door hardware.

Readjustment of the striker plate is recommended at client discretion. Works such as these can be completed by a general handyman or qualified carpenter.

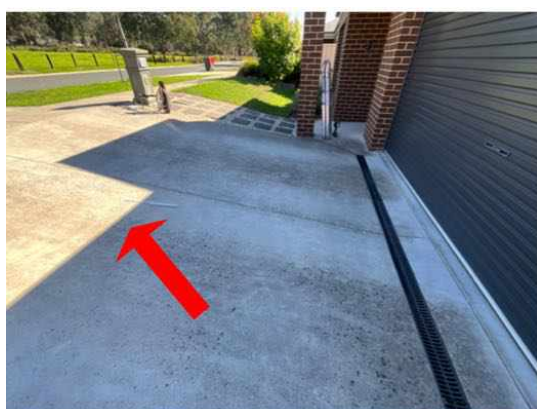
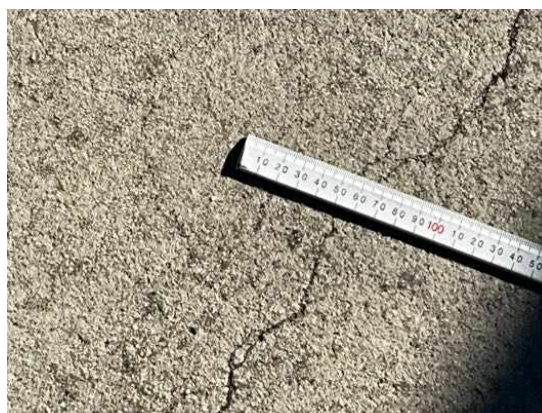
Finding 3.03

Building:	Building 1
Location:	Driveway
Finding:	Cracking - External Concrete Paving Damage Category 1 - Fine (less than 2mm)
Information:	Fine cracks were identified in external concrete paving. Although fine cracks are quite noticeable, they are often only considered to be an appearance defect, and usually do not indicate any structural damage. To be considered a Category 1 or fine crack, the crack is found to be less than 2mm in width.

Generally the cause of a hairline crack in existing concrete paving such as driveways and pathways is indicative of the expansion and contraction of the concrete. Such causes are generally due to environmental factors, such as moisture levels, weather conditions, root systems of nearby trees or the soil types on which they are laid.

Fine cracks may also be due to poor original installation of the concrete. Factors such as poor compaction of the sub surface and/or inadequate reinforcing of the slab may create cracking and other secondary defects.

Monitoring of all cracking should be conducted frequently. Always contact a building inspector should cracks widen, lengthen, or become more numerous.

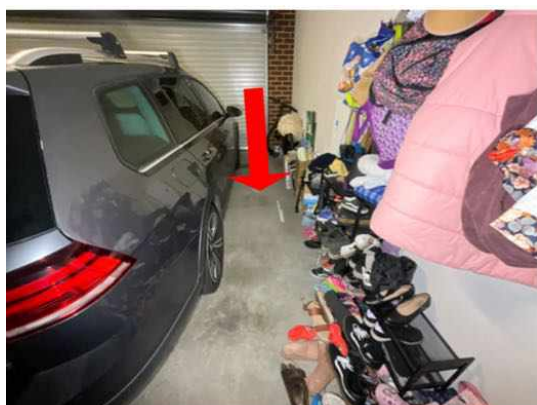
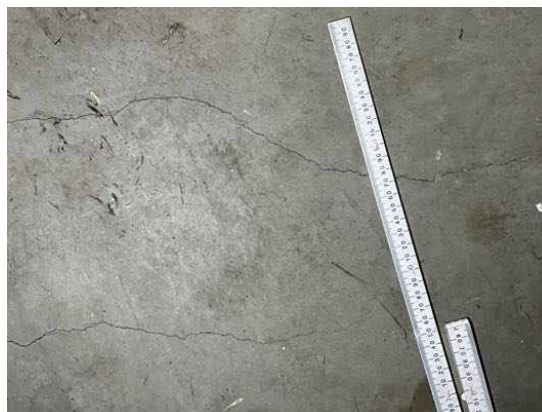
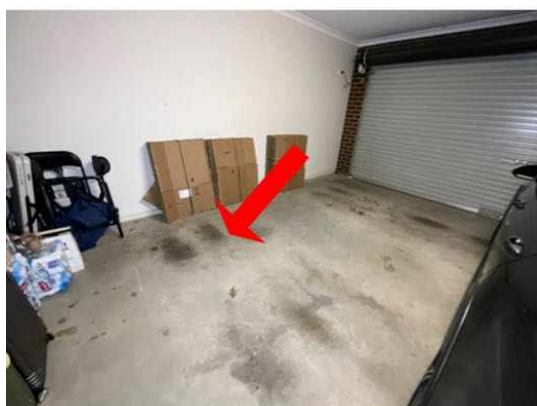
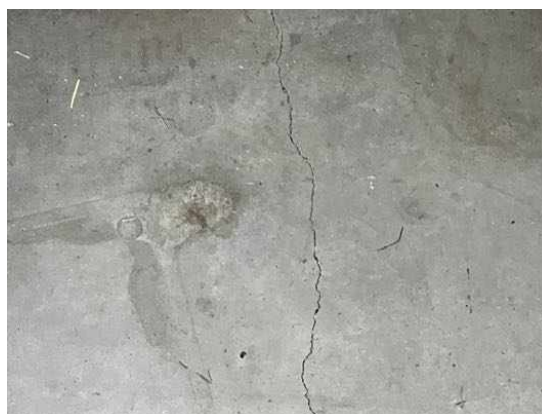
Finding 3.04

Building: Building 1
 Location: Garage
 Finding: Crack in concrete slab - Category 1
 Information: A crack coded as Category 1 was identified in the slab. A Category 1 crack is described as a fine but noticeable crack, with the slab at an otherwise reasonable level.

To be considered Category 1, the approximate width of the crack is less than 1.0mm, or a less than 10mm change in offset when a 3m straight edge is placed over the defect.

Category 1 cracks should be monitored for a period of 12 months. At the end of the monitoring period, identified cracks that are rated greater than Category 2 are considered defects, and require rectification.

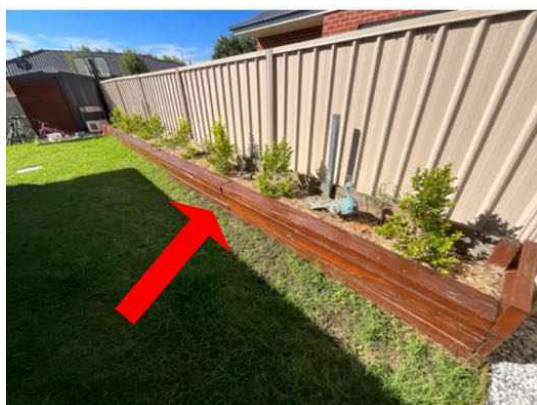
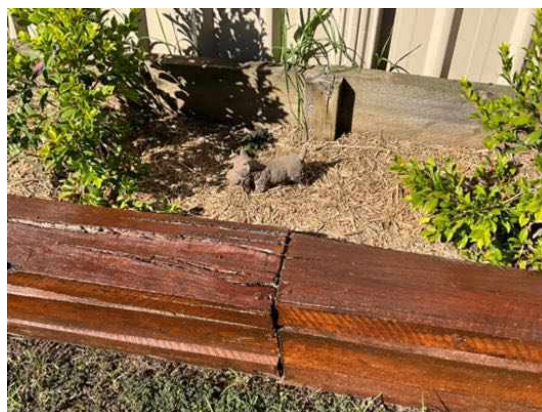
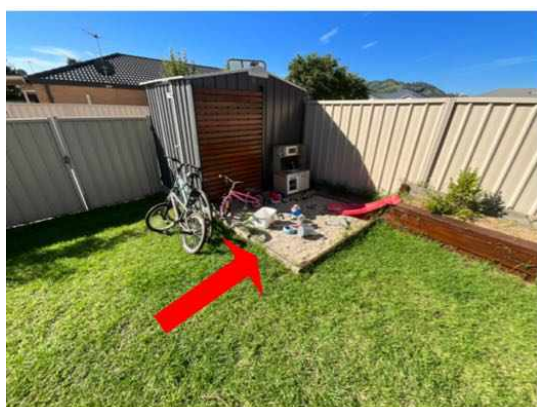
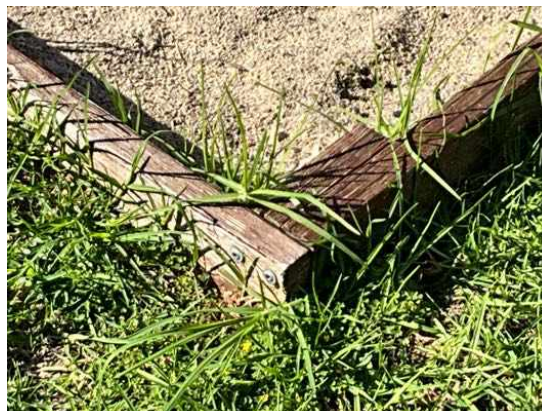
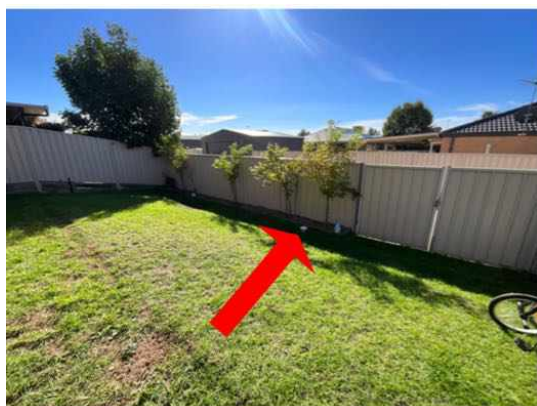
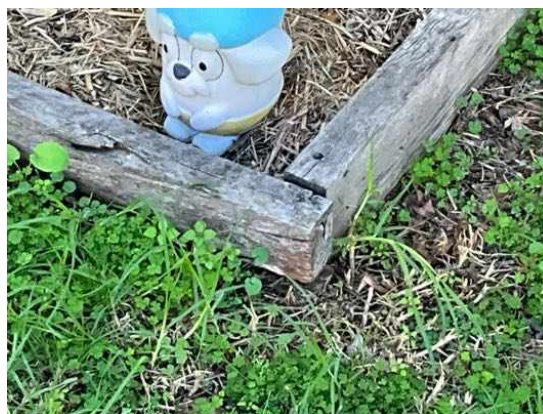
Finding 6.01

Building:	Building 1
Location:	Yard - Back
Finding:	Untreated or non-durable timbers in a hazardous environment
Information:	To reduce the risk of timber pest attack it is essential that timber used in a hazardous environment (e.g. in direct contact with the ground or frequently exposed to damp conditions) is of sufficient durability and/or is adequately preservative treated.

Untreated timbers in direct contact with the ground are likely to develop severe wood rot and/or fungal decay if left unattended creating attraction for subterranean termites to infest the timbers from surrounding areas.

If untreated or non-durable timbers are found to be in a hazardous environment it is highly advised that replacement of these building elements be performed as soon as possible to aid the protection of the property against termite / timber pest attack.

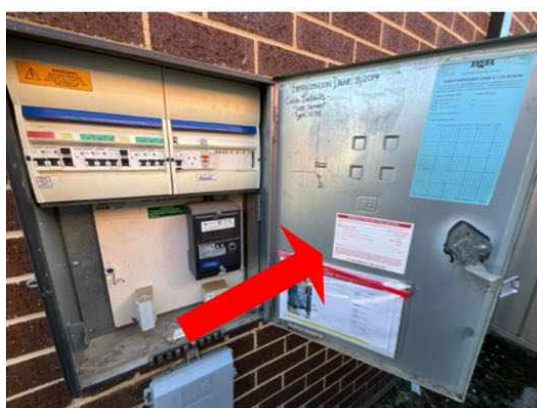
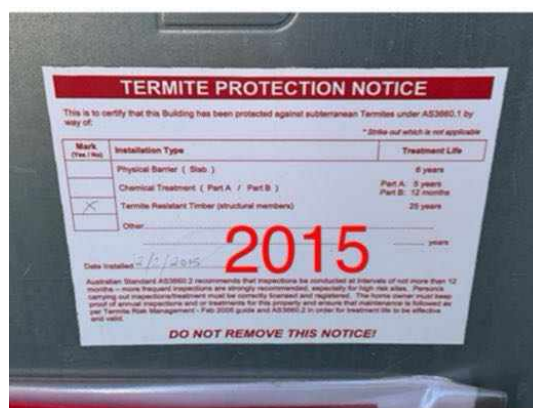
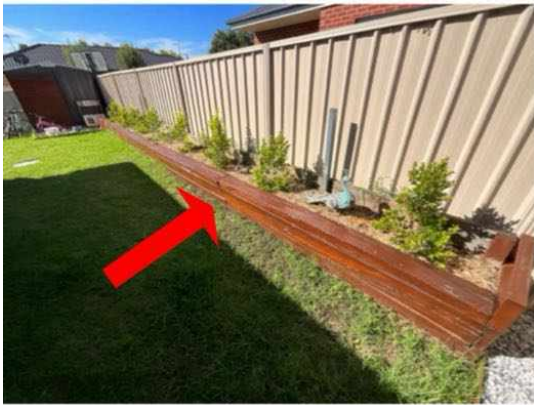
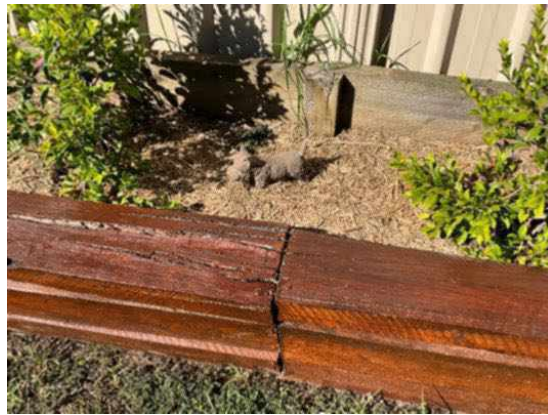
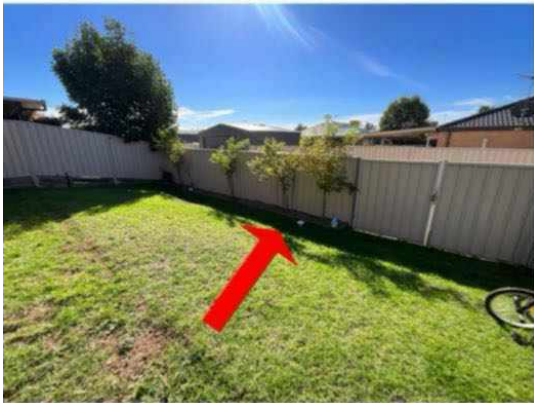
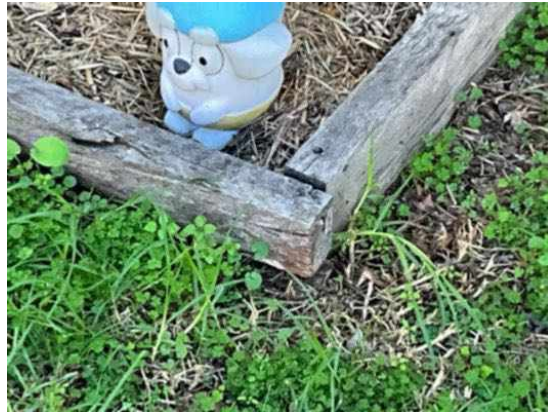
Finding 6.02

Building: Building 1
 Location: All External Areas
 Finding: Termite Management System - no evidence of a chemical installation
 Information: The application of a post-construction chemical termite barrier is highly recommended for all properties, particularly if live termite activity has been found on the site previously. Such barriers are highly effective in preventing termite attack on any timber building elements throughout the property.

A durable notice should be placed in the switchboard unit to indicate current termite barriers. At the time of inspection, it appeared as though no termite management system has been installed, with no evidence to suggest preventative works taking place.

The client may consider gaining further advice from a pest controller as to the costs and procedures involved with this application. It is recommended that obtaining such advice be a short-term priority.

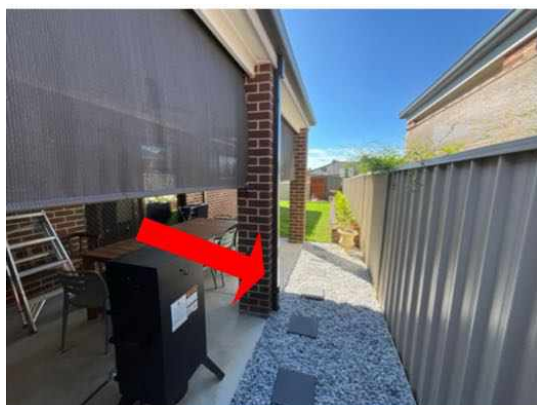
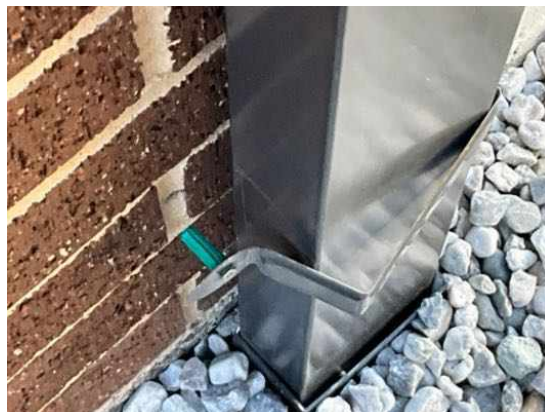
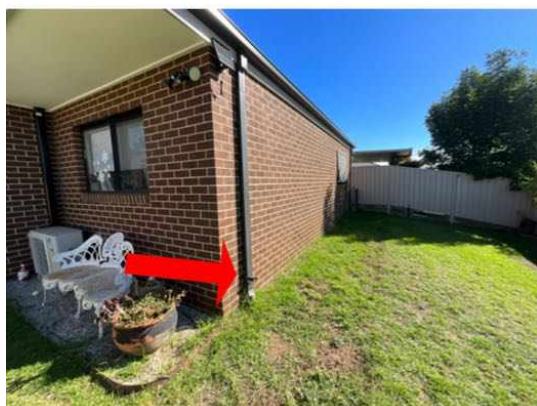
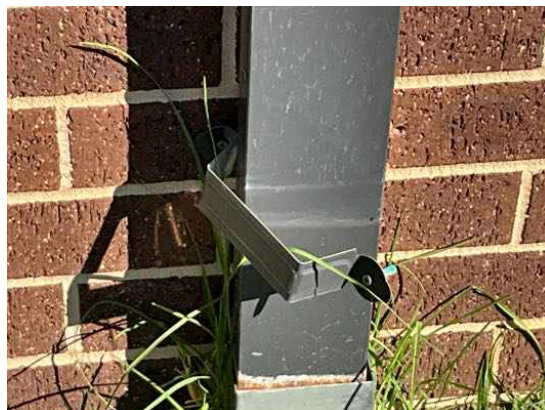
Building: Building 1
 Location: Alfresco, back wall
 Finding: Downpipe clipping
 Information: The downpipe clip has come away from the original fixing. When pressed, it would not return to the original position because of pressure on the fitting.

A plumber or handyman should be contacted as required, to secure the fixture and prevent further deterioration.

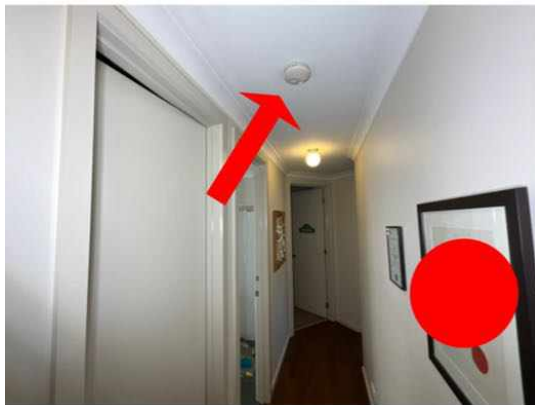
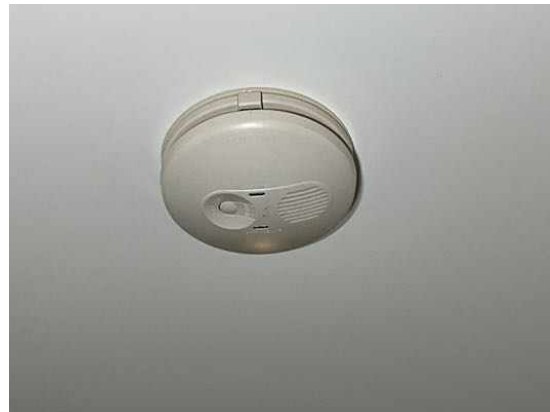
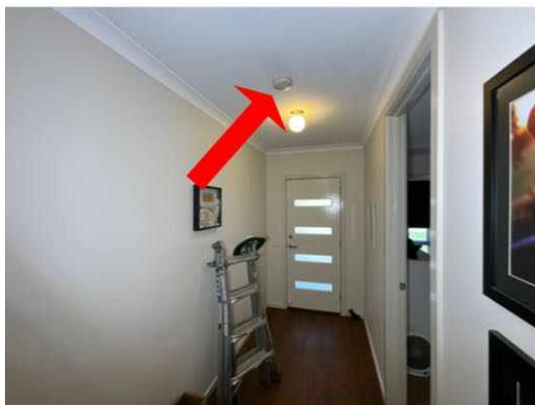
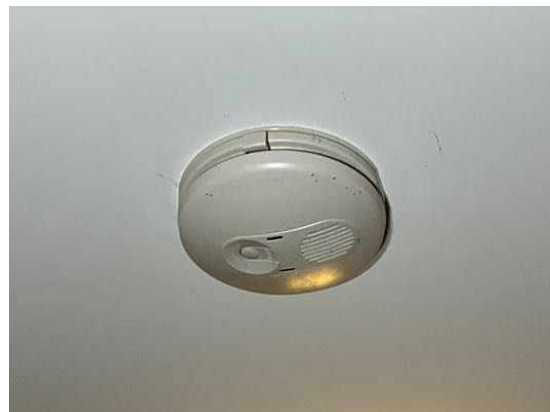
Building: Building 1
 Location: All Internal Areas
 Finding: Smoke Detectors and Alarms
 Information: Reporting on Smoke Detectors or Alarms, including hard wired smoke detection systems and their legislative requirements, is outside the Scope of this Report.

Please note that this defect is highlighted as a caution only. We suspect, based on our experience in the building industry, that the absence of smoke detectors, or their poor condition, should be addressed as a matter of urgency to improve occupant safety.

Further Inspection and/or advisory services is necessary to provide advice on the sufficiency, type and location of smoke detectors, and to test the functionality of all devices. Greater requirements for fire safety and detection exist for commercial buildings.

Always ensure sufficient working and suitable smoke detectors are installed prior to occupying any building. Additionally, it is advised that all smoke detectors be tested by the homeowner on a monthly basis.

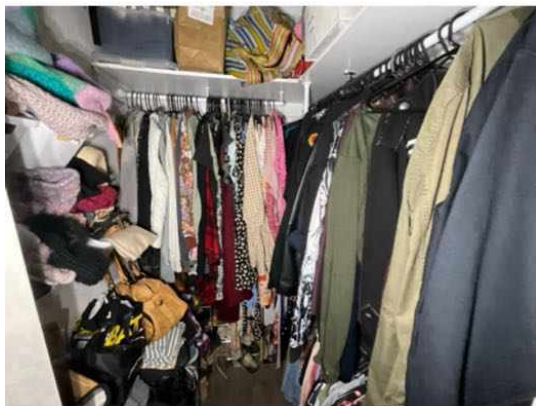
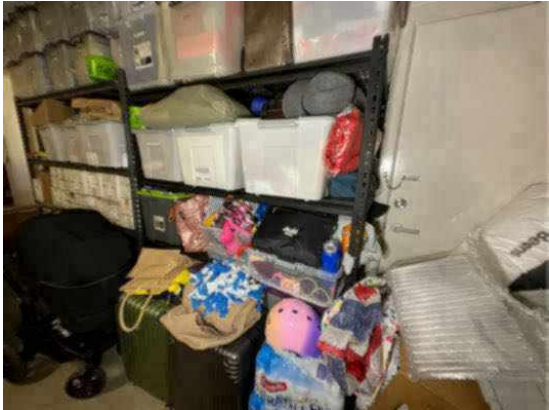
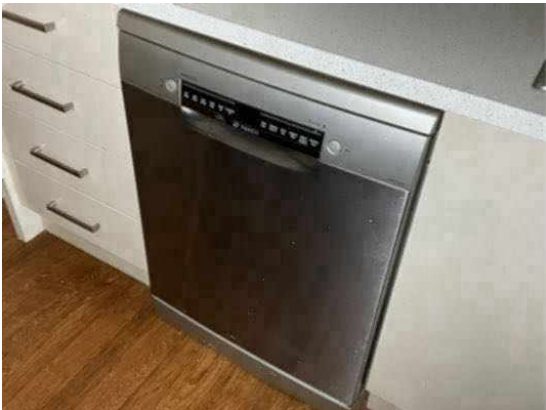
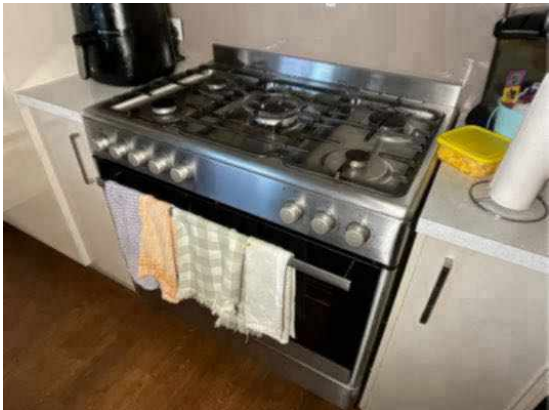
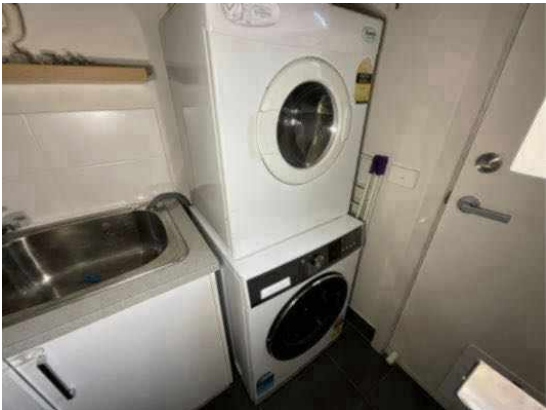
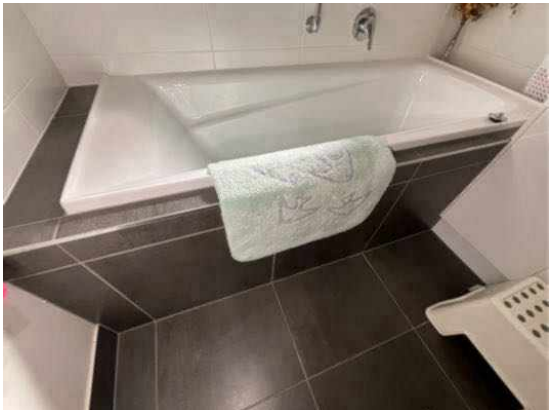
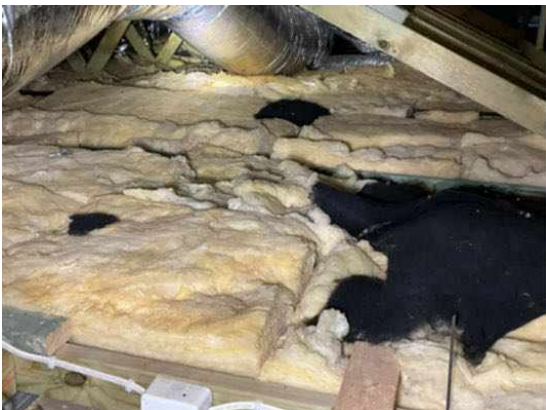
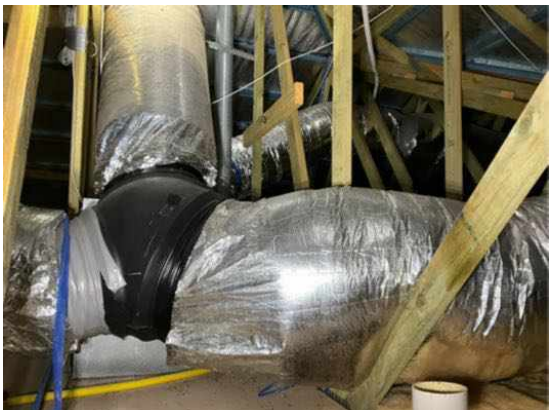
Building:	Building 1
Location:	All Areas
Finding:	Additional Photos - Obstructions and Limitations
Information:	These photographs are an indication of the obstructions and limitations which impeded full inspection of the property at the time of inspection. These obstructions can hide an array of defects and should be removed to allow full inspection to be

carried out. A re-inspection is recommended once the areas are made accessible.
