Building and Timber Pest Inspection Report

Inspection Date: Tue, 27 Jan 2026

Property Address: U3/4 James Ln, Kiama NSW 2533, Australia

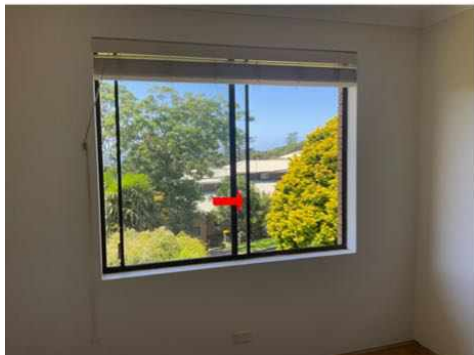
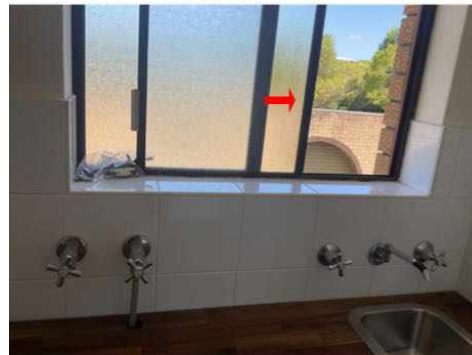
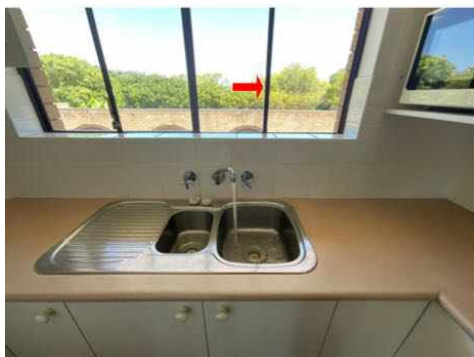
| Finding: | Window opening restrictors missing. |

Window restrictors are required where people who are vulnerable to the risk of falling have access to windows. This means all windows above ground level which do not have another fall prevention safety measure in place, such as a balcony or balustrade should have a restrictor. Some restrictors were found in the unit but not installed.

These need to be added urgently for the safety of all persons.

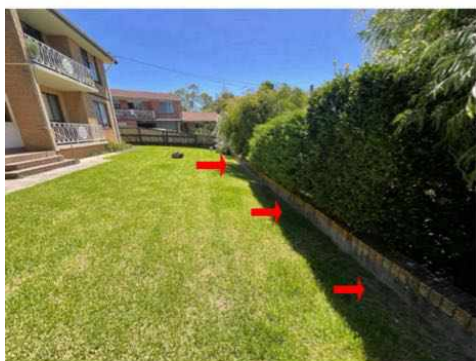
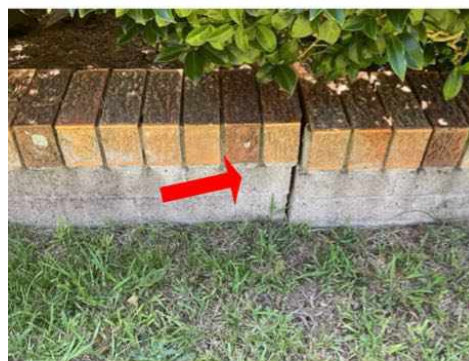
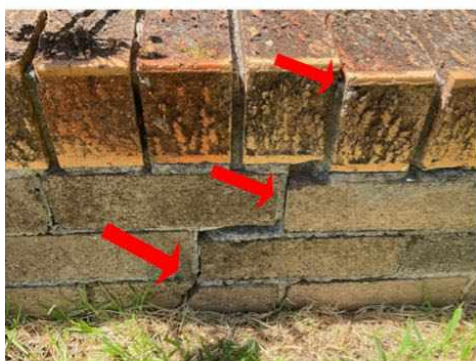
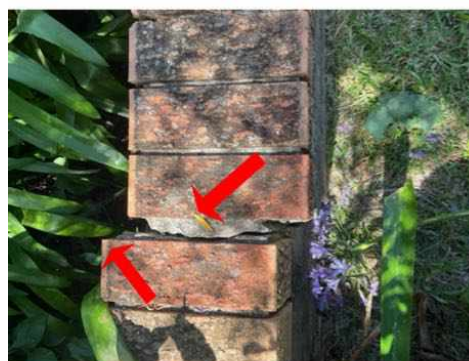
Finding 2.01

| Finding: | Front fence leaning and major step cracking |
| Information: | Evidence of damage was identified to the front fence. Sections of this fence show major step cracking and leaning toward the street. A fencing contractor or bricklayer would be responsible for replacement of this fence as soon a possible to prevent further damage. |

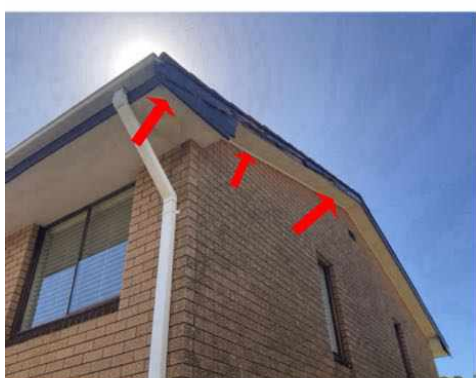
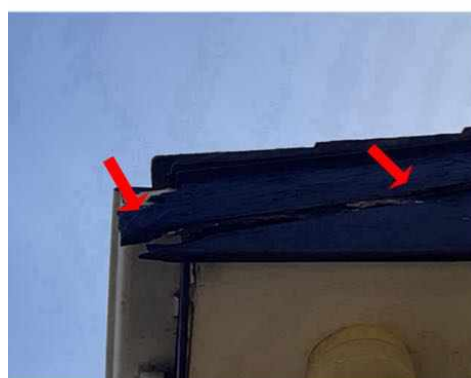
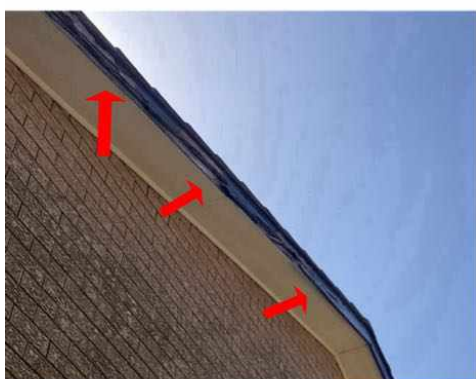
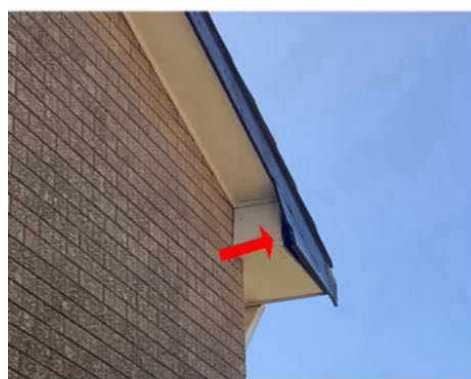
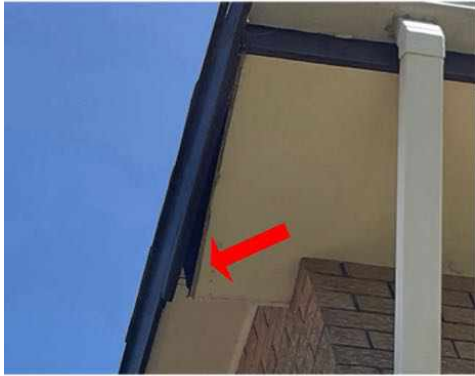
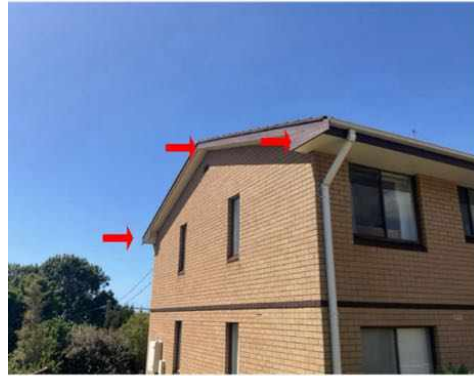
Finding 2.02

| Finding: | Fascias - Wood rotted and loose |
| Information: | Wood rot was found to be affecting fascias and barges, mostly on the left wall of Unit 3. This appears to have been occurring for years and parts are now falling off. |

Wood rot, also known as Fungal Decay, occurs when timbers and other cellulose building materials are exposed to damp conditions on an ongoing basis.

It is likely that this wood rot has developed as a result of faults in the roof plumbing, creating excessive moisture in this areas. Frequent exposure to rain and other weather conditions also make fascias and barges susceptible to accelerated deterioration.

This damaged timber is described as a major defect due to the internal damage that may be caused if rainwater enters the building as a result of this damage.

Early intervention and regular maintenance will prolong the useful life of these building elements. Prior to any works being performed, the cause of the moisture that has created the visible wood rot should be identified and addressed by a roofing contractor.

It is advised that a roof plumber be appointed to inspect all roof plumbing and subsequently identify the cause of the wood rot. Replacement of affected fascias and barges may then be a necessary step in protecting surrounding building elements from such deterioration.

A qualified carpenter or registered builder will then be required to replace these badly affected building materials.

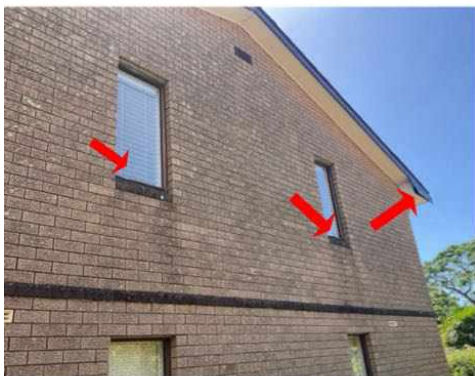
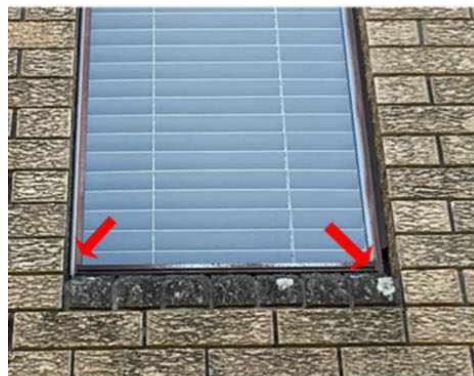
Finding 3.01

| Finding: | Sealant (external) - Missing. |
| Information: | It was noted on inspection that areas of external sealant was missing to small areas of the external windows. |

Flexible sealants should be applied to these affected areas to prevent any subsequent water damage that is likely to occur.

A sealant specialist or skilled handy person should be appointed to complete these works as soon as possible

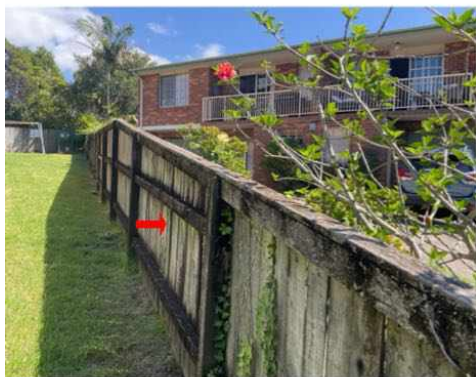
Finding 3.02

Finding: Fence damaged - leaning
 Information: Evidence of damage to this fence was identified at the time of the inspection. The likely cause is not enough concrete used in the post footings.

If left unmanaged this fence may deteriorate further. It is suggest a licensed builder or fencer be engaged for rectification when convenient.

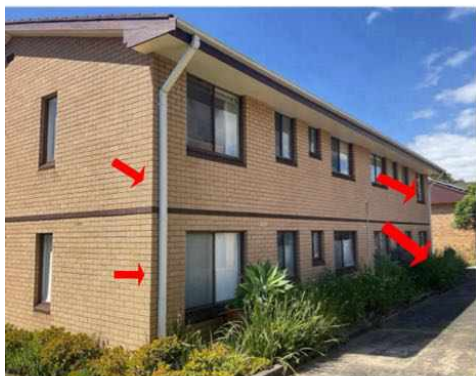
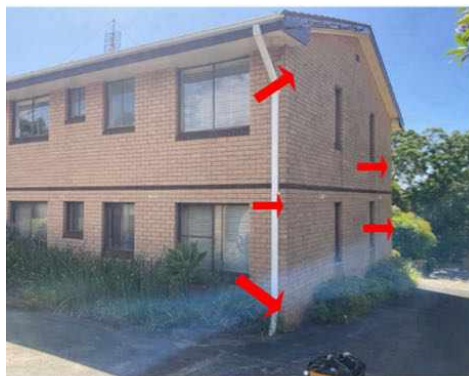
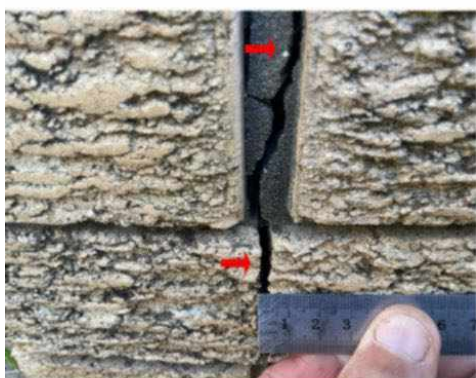
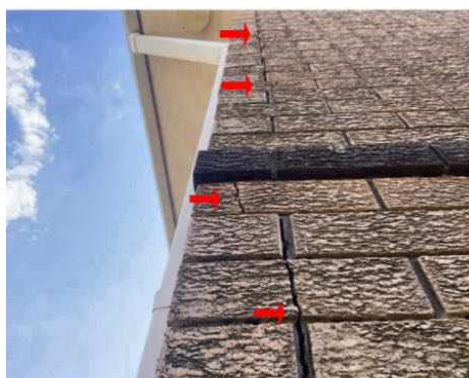
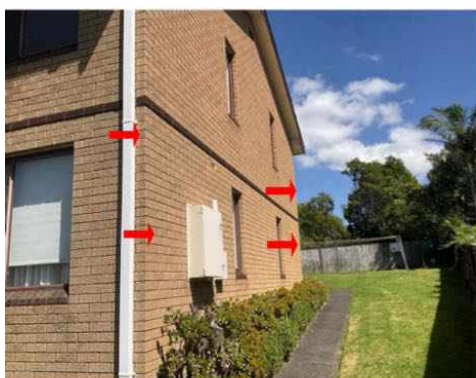
Finding 3.03

Building: Main Building
 Location: All exterior unit wall corners
 Finding: Brickwork - Step cracking (minor up to 3mm)
 Information: Step cracking was identified to the brickwork all 4 corners of the unit block at the time of inspection. Step cracking, which is similar to other forms of cracking, has a variety of possible causes. However, the most common is the subsidence of adjacent footings.

Step cracking is a relatively common defect, and is most likely to occur adjacent to windows, doors and other openings. Mortar failure in the gaps between affected bricks indicates the stresses and tensions affecting the wall.

Where step cracking is extensive or severe, the client is advised to consult a structural engineer. This minor step cracking can be used as a warning sign to address factors causing stress to the wall, which can include the effect of surrounding trees, water leaks, soil erosion, or even the presence of reactive soils in the surrounding area.

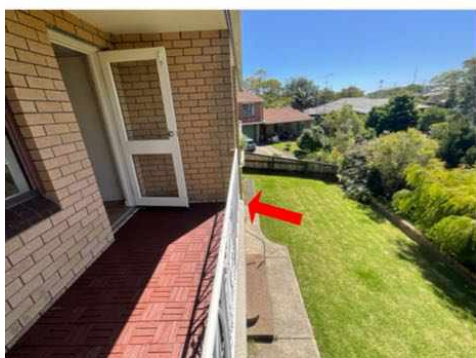
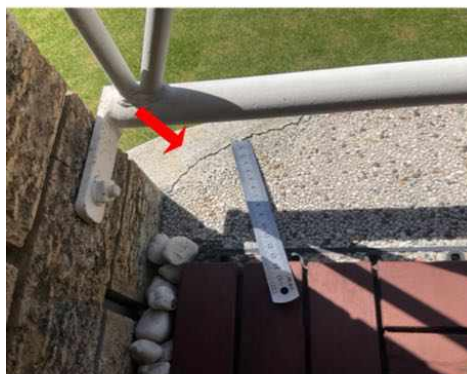
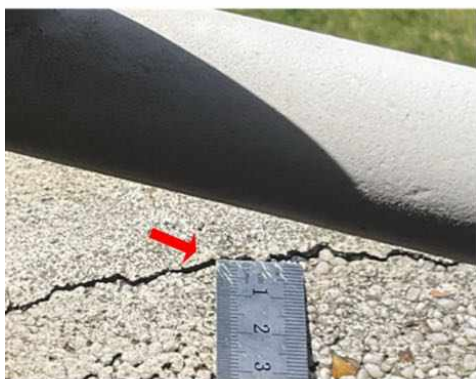
Finding 3.04

| Finding: | Crack in verandah slab - Category 2 |
| Information: | <p>A crack coded as Category 2 was identified in the verandah slab. A Category 2 crack is described as a distinct crack, with the slab being noticeably curved or changed in level.</p> <p>To be considered Category 2, the approximate width of the crack is less than 2.0mm, or a change in offset of less than 15mm when a 3m straight edge is placed over the defect.</p> |

Category 2 cracks to slabs should be monitored for a period of 12 months. At the end of the monitoring period, cracks rated greater than Category 2 are considered defects that require rectification.

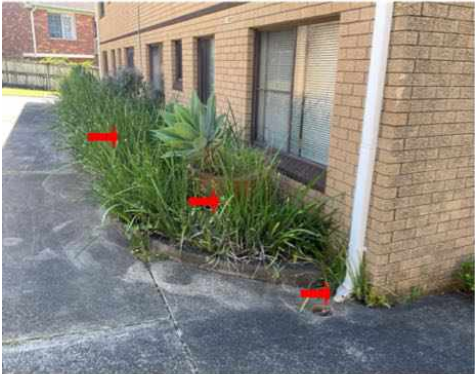
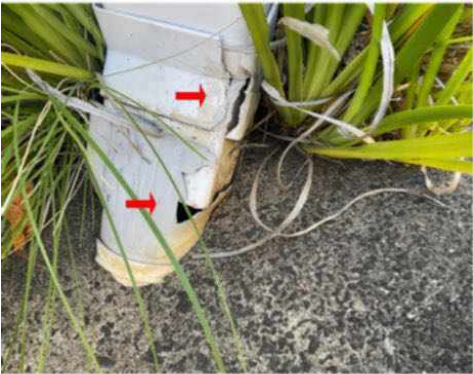
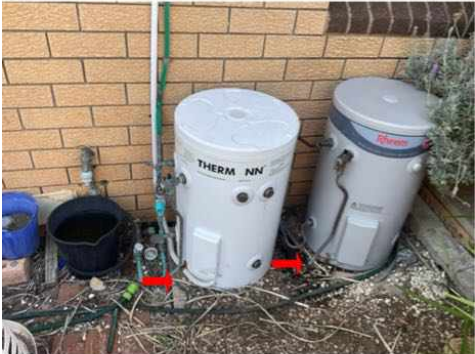
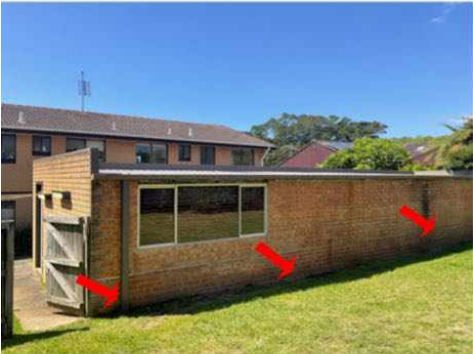
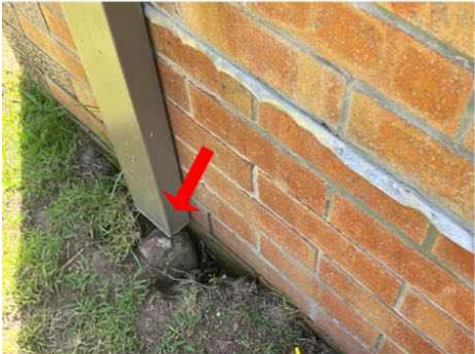
Finding 3.05

| Finding: | Site drainage - Inadequate |
| Information: | The site drainage in these 2 rear wall areas of both buildings was found to be inadequate at the time of inspection, creating potential for subsequent water damage to associated building elements. Both rear walls appear to have no drainage and the rear garage downpipe boot has also cracked. |

Where site drainage is inadequate, installation of an Agricultural (Aggie) Drain may be required. A qualified plumber should be appointed to further inspect the property and perform any remedial works as necessary. Water damage and secondary defects are

likely to occur if left unmanaged.

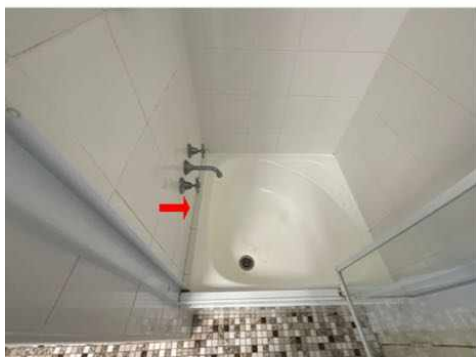
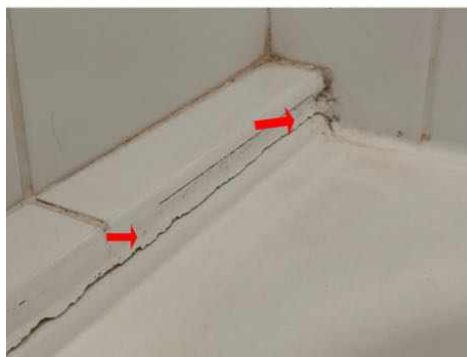
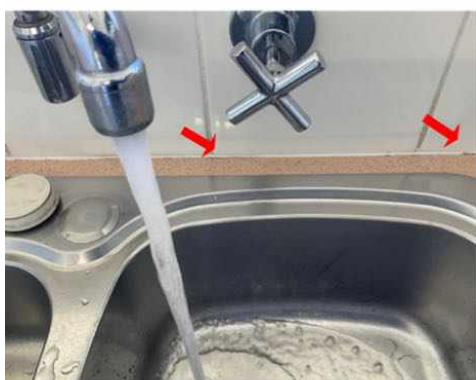
Finding 3.06

Building: Building 1
Location: Pictured shower and kitchen sink areas
Finding: Sealant and grouting - Missing
Information: It was noted on inspection that sealant or grout is missing to these pictured areas of the building.

Flexible and mould resistant materials should be applied to affected areas to prevent any subsequent water damage that is likely to occur.

This needs to be brought to the attention of the builder.

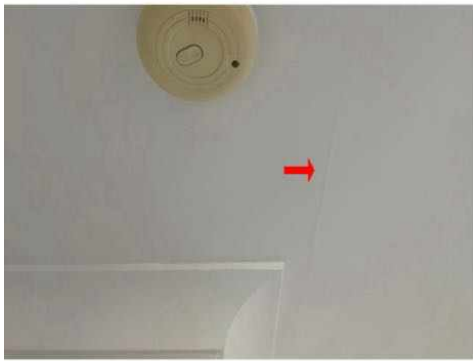
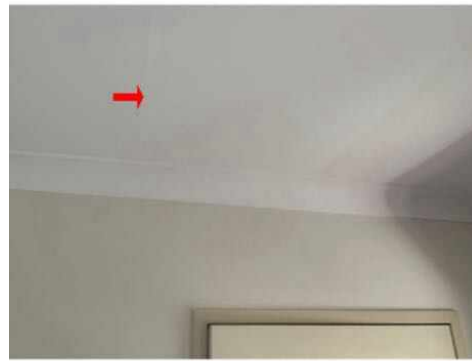
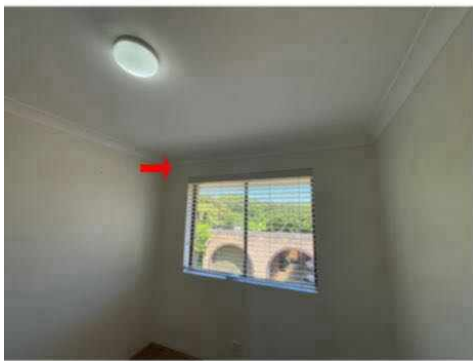
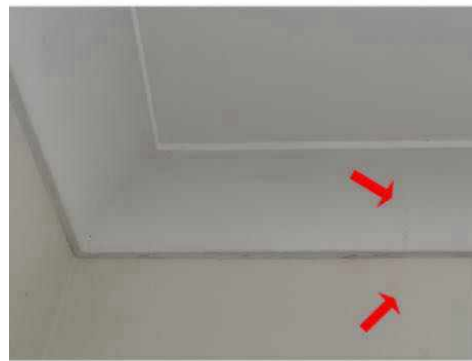
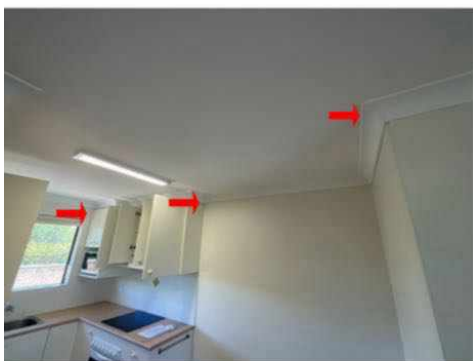
Finding 3.07

| Finding: | Cracking - Damage Category 1 - Fine (up to 1mm) |
| Information: | Although fine cracks are quite noticeable, they are often only considered to be an appearance defect, and usually do not indicate any structural damage. Generally, the cause of a fine crack is indicative of a separation between building materials and finishes (e.g. paint, plaster, etc.) along joints. |

Cracking of this nature can generally be repaired with minor sanding, filling and/or repainting. Such works should be performed by a qualified painter or a general handyman.

Monitoring of all cracking should be conducted frequently. Always contact a building inspector should cracks widen, lengthen, or become more numerous.

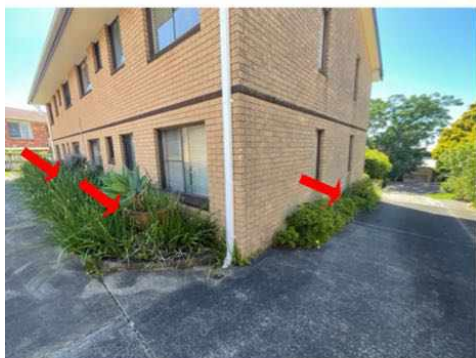
If the slab edge is not properly exposed there is a high risk of termite attack. Sometimes, in order to determine the type of slab, a suitably qualified person such as an architect or builder may be required to consult the construction plans.

Where the slab edge cannot be properly inspected, it is highly recommended that termite or timber pest inspections be carried out every 6-12 months to aid protection of the property against infestation.

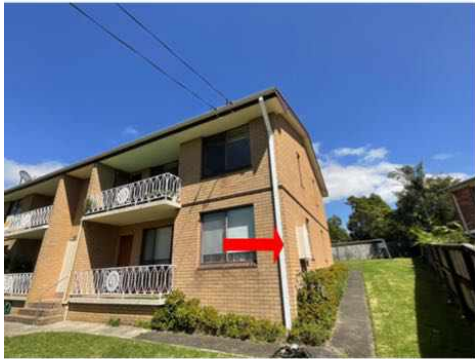
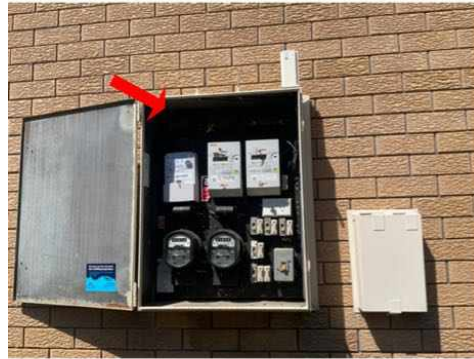
Finding 6.02

Building: Main Building
 Location: Meter Box
 Finding: Termite Management System - no evidence of a chemical installation
 Information: The application of a post-construction chemical termite barrier is highly recommended for all properties, particularly if live termite activity has been found on the site previously. Such barriers are highly effective in preventing termite attack on any timber building elements throughout the property.

A durable notice should be placed in the switchboard unit to indicate current termite barriers. At the time of inspection, no durable notice was found and it appeared as though no termite management system has been installed, with no evidence to suggest preventative works taking place.

The client may consider gaining further advice from a pest controller as to the costs

and procedures involved with this application. It is recommended that obtaining such advice be a short-term priority.
