Building and Timber Pest Inspection Report

Inspection Date: Mon, 2 Mar 2026

Property Address: 8 Cope St, Airport West VIC 3042, Australia

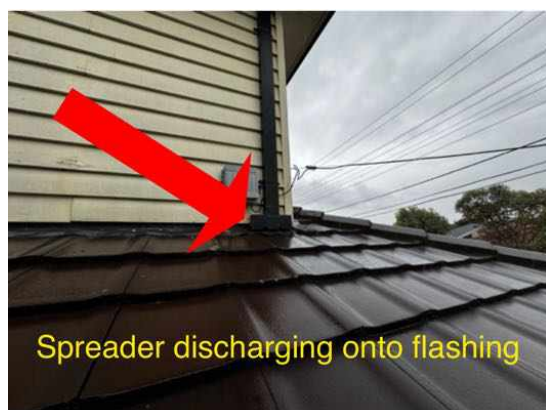
Building: Main Building
 Location: Roof Exterior > Front Left
 Finding: Roof Plumbing – Downpipe Discharging onto Roof Flashing
 Information: A downpipe and spreader located above the living area was observed to be discharging stormwater directly onto a lower roof flashing. Discharging concentrated water flow onto flashing details is considered poor roof plumbing practice and increases the likelihood of water tracking beneath roof coverings.

Flashings are designed to divert incidental water, not to receive direct concentrated discharge from downpipes. Over time, this arrangement may lead to premature deterioration of flashing materials, corrosion, water ponding, and potential water

In accordance with the principles of AS 4349.1–2007, defects that may allow water ingress and cause damage to structural or concealed elements are considered Major Defects, as ongoing exposure can result in timber decay, mould growth, insulation damage and ceiling deterioration.

It is recommended that a licensed roofing plumber be engaged to redesign or redirect the downpipe discharge to an appropriate drainage point that does not rely on flashing as a discharge surface. The affected roof area should be inspected for any signs of existing water damage following rectification.

Rectification recommended in the short term to reduce risk of moisture ingress and associated deterioration.

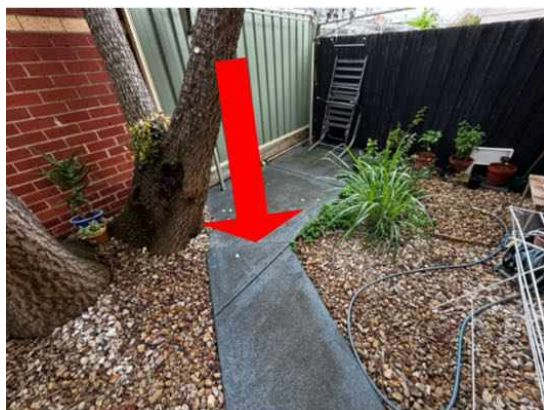
Finding 3.01

Building:	Main Building
Location:	All Areas > All Areas
Finding:	External Defects – Concrete, Brickwork, Roof Drainage, Garage Door, Lintels and Fencing
Information:	The following external defects were observed during the inspection:

Minor cracking was noted to the concrete paving in the rear yard, with cracks measuring less than 5mm in width. The cracking appears consistent with normal shrinkage or minor settlement.

A control joint approximately 30mm in width was observed in the brickwork above the

sliding door opening. The width of the joint appears excessive. An attempt had been made to seal the joint; however, the caulking material used is not suitable for filling a gap of this size and had failed. Excessively wide joints may allow moisture ingress if not properly detailed.

Water pooling was observed within the gutter to the front porch area. This is suspected to be due to insufficient fall towards the downpipe, which may restrict effective stormwater drainage and increase the risk of overflow during heavy rainfall.

Damage to the garage doors was noted, including a small dent and several scratches and scuff marks. The damage appears cosmetic in nature.

Surface rust was observed to the steel lintels above the garage door and window openings. Surface corrosion, if left untreated, may progress and cause expansion of the steel and potential cracking to surrounding brickwork.

The timber fencing to the front of the property was observed to be weathered and slightly leaning forward and out of plumb. Weathering and movement of fencing may result in reduced stability over time.

It is recommended that the rear paving cracks be monitored and sealed if widening occurs. The wide brick control joint should be assessed by a qualified builder or brickwork specialist to determine appropriate rectification, potentially involving installation of a suitable backing rod and flexible sealant designed for large movement joints. The front porch gutter fall should be assessed and adjusted if required to ensure proper drainage. Surface rust to steel lintels should be treated and protected with appropriate coatings. The front fence should be repaired, straightened or replaced as necessary to maintain stability and longevity.

Maintenance and rectification recommended in the short to medium term.

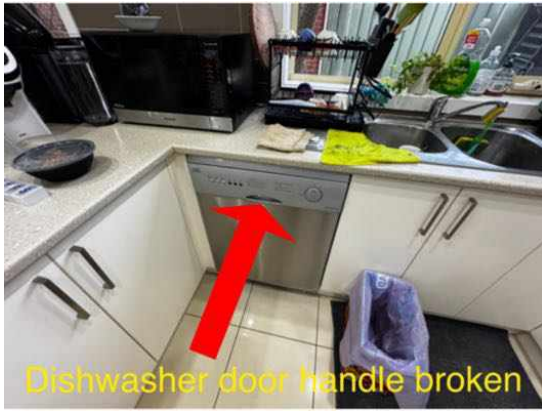
Dishwasher door handle broken

It is recommended that damaged joinery and fixtures be repaired or replaced as required. Plaster cracking and architrave damage should be patched and repainted. Ceiling stains should be monitored, particularly during rainfall events. Cracked concrete and creaking floors should be monitored and addressed if movement or deterioration increases.

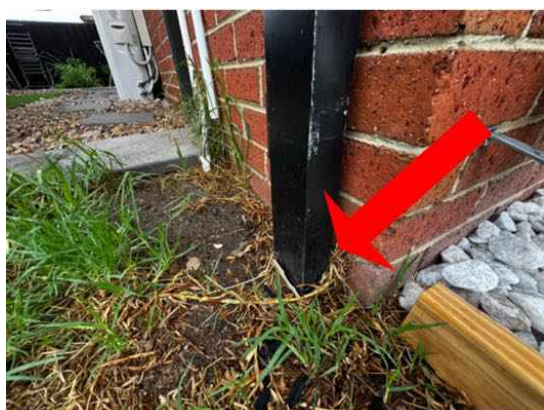
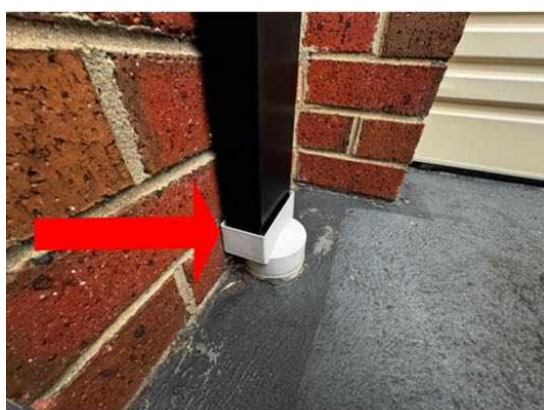
Building:	Main Building
Location:	Walls > All Areas
Finding:	Downpipes hard against brickwork concealing inspection zones (TP)
Information:	At the time of inspection, several downpipes were observed to be installed hard against the external brick walls. This configuration restricts visual access to the wall surface and slab edge behind the downpipes, making it difficult to identify early signs of termite activity.

Effective termite risk management relies on maintaining clear and accessible inspection zones to allow early detection of termite activity. Where services such as downpipes are installed directly against masonry walls, concealed termite entry paths may develop behind these elements without being readily visible, increasing the likelihood of undetected termite ingress.

As a result, the positioning of downpipes hard against the brickwork is considered to increase the risk of concealed termite entry. It is recommended that a licensed termite management or pest control contractor be engaged to assess these locations and provide advice on improving inspection access or implementing supplementary termite management measures to address the increased risk.

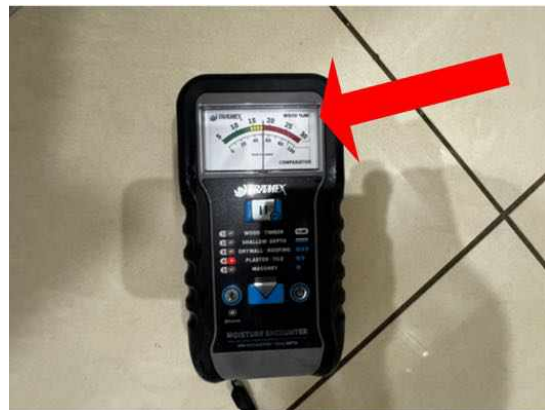
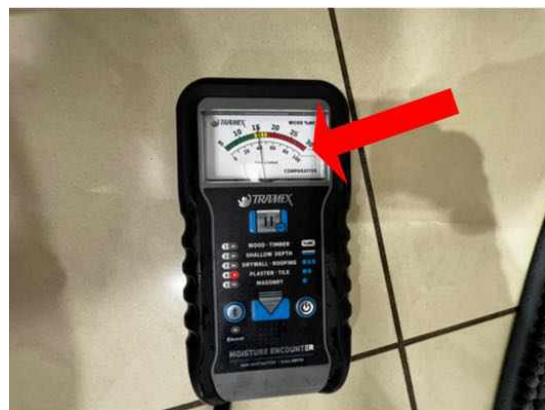
Finding 6.02

Finding: Moderate moisture levels to ground level floor tiles (TP)

Information: At the time of inspection, moderate moisture readings ranging between 40% and 50% were detected using a moisture meter in the kitchen, dining, entry, laundry and the toilet floor tiles on the ground floor. No active water leaks were observed during the inspection. Moisture readings in adjoining rooms were normal. It appears that the moisture is contained to these tiled areas only. No moisture damage was found to any of the skirting boards, door jambs, architraves or joinery suggesting that the moisture levels are stable and not spreading. It is suspected that the moisture may be from conditions such as excessive wet mopping, spills, or historic overflows or leakages from appliances or plumbing fixtures.

In accordance with AS 3660.2, wet areas and plumbing-related moisture issues are recognised as increasing termite risk, as persistent dampness within building elements can create conditions conducive to termite activity and concealed access. Ongoing moisture exposure may also lead to deterioration of surrounding materials, further elevating termite susceptibility.

As a result, the moisture issues identified within these areas are considered to increase the risk of termite activity and material deterioration. It is recommended that these areas are periodically monitored for ongoing moisture issues. Assessment is recommended by a licensed termite management or pest control contractor where elevated termite risk is identified.

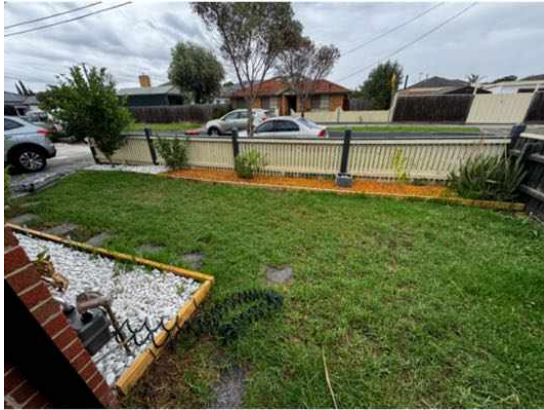
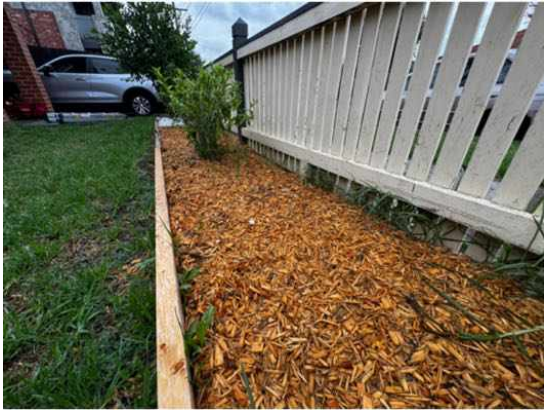
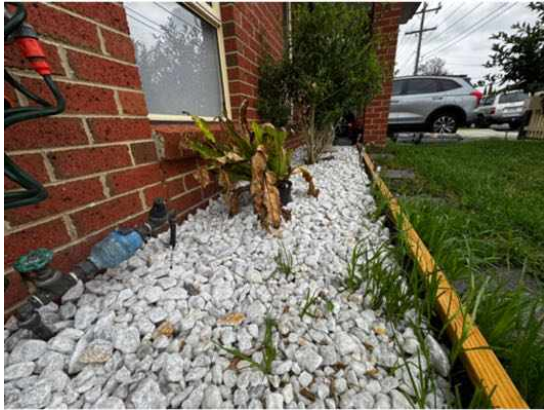
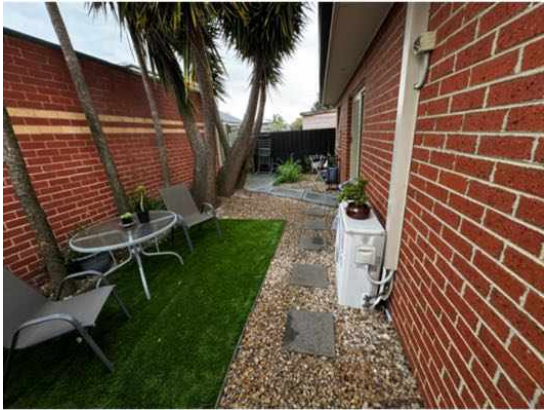
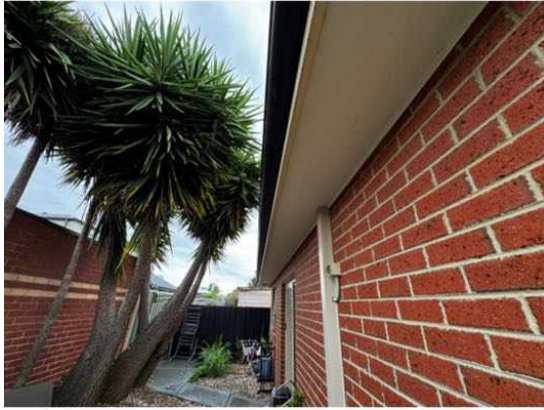
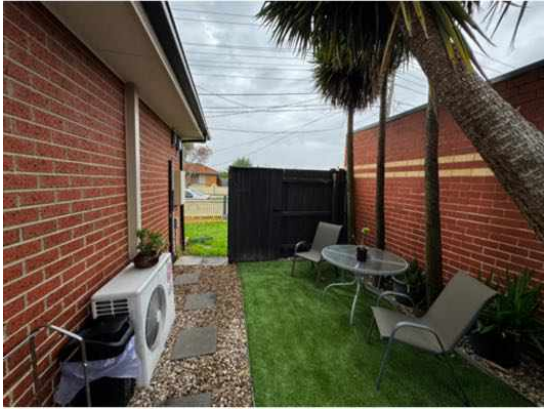
Finding 6.03

Building:	Main Building
Location:	All Areas > All Areas
Finding:	Landscaping & vegetation increasing termite risk (TP)
Information:	At the time of inspection, landscaping, vegetation and mulching was observed around the property, including multiple garden beds, shrubs and plants in close proximity to the dwelling and trees located along the outside boundary of the property.

Environmental conditions that promote moisture retention, provide concealed shelter, or support termite foraging activity are recognised as increasing termite risk to existing buildings. Mature trees, mulched garden beds, irrigation systems can all maintain damp soil conditions and may harbour termite colonies, allowing concealed termite activity to develop and potentially extend toward the building without early detection.

As a result, the extent of vegetation and moisture-retaining landscaping is considered to significantly increase the overall risk of termite activity to the property. It is recommended that a licensed termite management or pest control contractor be engaged to assess the site conditions and provide advice on appropriate risk reduction measures, which may include managing vegetation and mulch, controlling moisture sources, and integrating suitable termite management strategies appropriate for the existing building and site conditions.

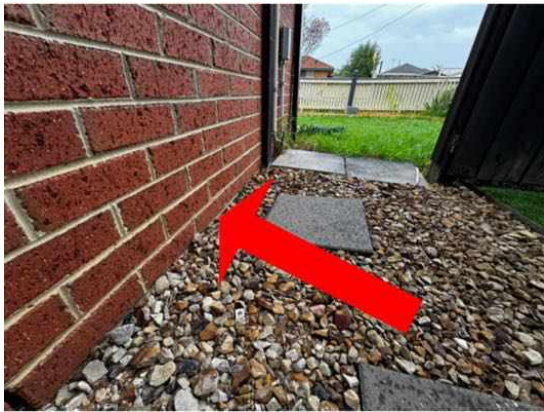
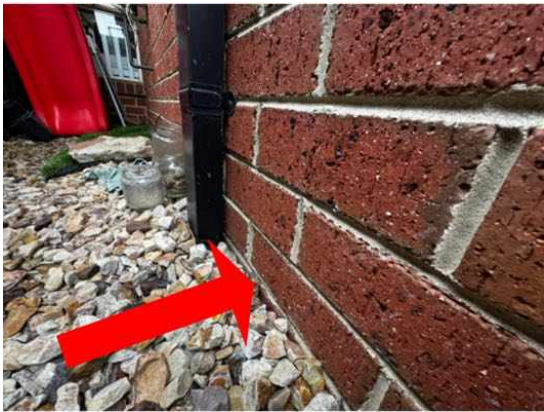
Building:	Main Building
Location:	All Areas > All Areas
Finding:	Slab edge - concealed (TP)
Information:	At the time of inspection, the slab edge to most areas of the building was observed to be concealed behind concrete paving and landscaping. This condition restricts clear visibility of the slab perimeter and limits the ability to visually inspect critical inspection zones intended for the early detection of termite activity.

Where slab edges and inspection zones are concealed, concealed termite entry paths may develop without early warning. In accordance with AS 3660.2, existing buildings are required to maintain conditions that allow for effective inspection and management of termite risk, noting that obstructions such as paving, paths, or landscaping can compromise the effectiveness of termite management measures. Where inspection zones are obstructed, the likelihood of undetected termite activity is increased.

As a result, the current configuration is considered to increase the risk of concealed termite entry to the building. It is recommended that a licensed termite management or pest control contractor be engaged to assess the extent of the concealed slab edges and provide advice on rectification options, which may include modifying paving or landscaping to reinstate suitable inspection access and integrating appropriate termite management measures to suit the existing conditions.

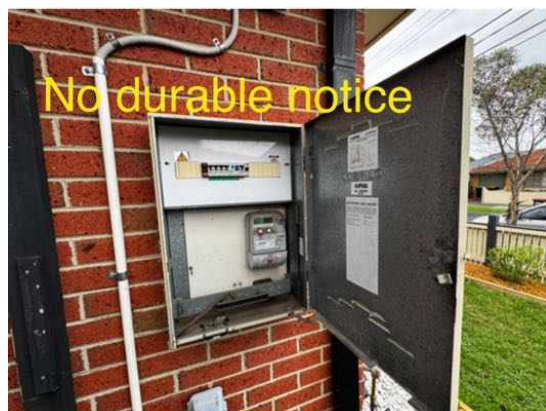
Building:	Main Building
Location:	Meter Box > Front Left
Finding:	Termite management system - no evidence of chemical installation (TP)
Information:	At the time of inspection, there was no visible evidence to suggest that a chemical termite management system has been installed or remains effective. In addition, no durable notice was observed within the electrical switchboard to identify the presence, type, or date of any termite protection measures.

For this reason, the installation of a post-construction chemical termite management system is highly recommended to reduce the risk of termite activity. A durable notice should also be installed within the electrical switchboard to clearly identify the treatment provided and support ongoing inspection and maintenance.

Engagement of a licensed termite management or pest control contractor is recommended as a matter of priority to assess the site conditions, consider local termite risk, and determine the most appropriate treatment method and procedures for this property.

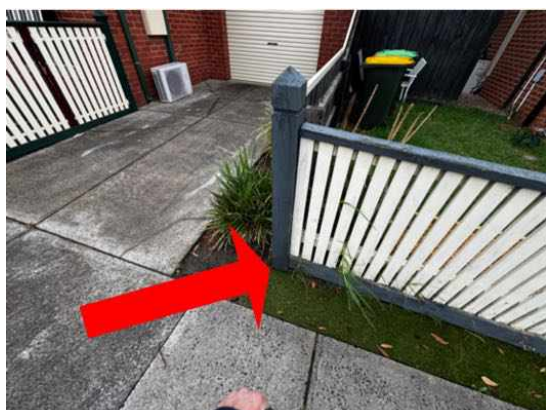
Building: Main Building
 Location: Fence and weatherboard > Front Left, Front Right
 Finding: Timber decay & rot - Conducive conditions (TP)
 Information: At the time of inspection, timber decay was observed to the front and boundary fence posts. The affected area was located to the bottom of the posts with the remaining sections relatively intact. The right hand side boundary fence was heavily decayed and the structure of the fence was in poor condition. Timber decay was also observed to a small section of weatherboard cladding above the living area.

These conditions are suspected to have developed over time due to prolonged moisture exposure and a lack of appropriate timber maintenance, allowing moisture ingress and decay to progress within the timber elements. In accordance with AS 3660.2, deteriorated and moisture-affected timber is recognised as increasing the risk of termite activity, as decayed timber can attract termites and may provide concealed access or harbourage, particularly where defects are obscured by finishes such as paint.

As a result, these condition are considered to present an elevated risk of ongoing deterioration and potential termite susceptibility. It is recommended that an appropriately qualified builder or carpenter be engaged to further assess the extent of timber decay, remove any concealed deteriorated material, and undertake suitable repairs or replacement, with consideration also given to advice from a licensed termite management or pest control contractor where termite risk is identified.
