Building and Timber Pest Inspection Report

Inspection Date: Thu, 5 Mar 2026

Property Address: 53 Newington Blvd, Newington NSW 2127,
Australia

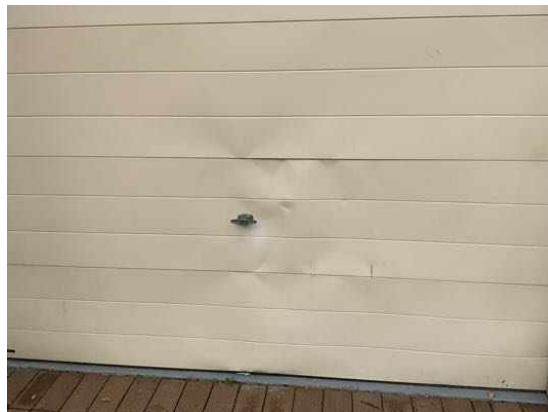
Building: Main Building
Location: Garage
Finding: Minor Dent on Garage Door
Information: A minor dent is visible on the lower section of the garage door. It does not affect how the door works but does impact its appearance.
Risk:
Low. Mainly cosmetic. Could worsen over time if hit again.
Who Can Fix It:

A garage door technician or handyman can repair or replace the panel if needed.

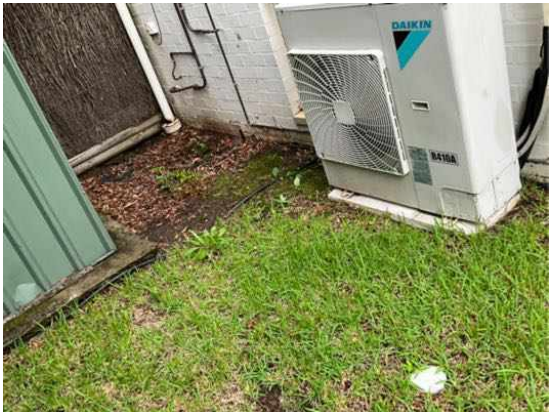
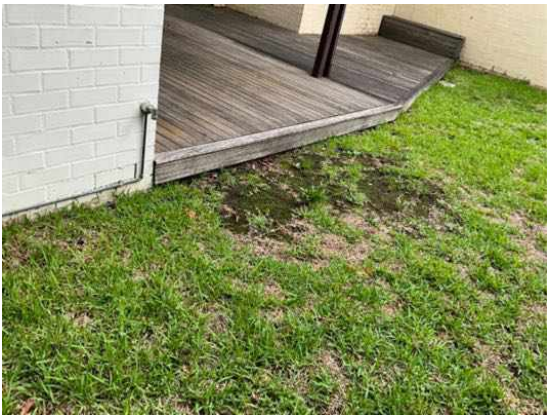
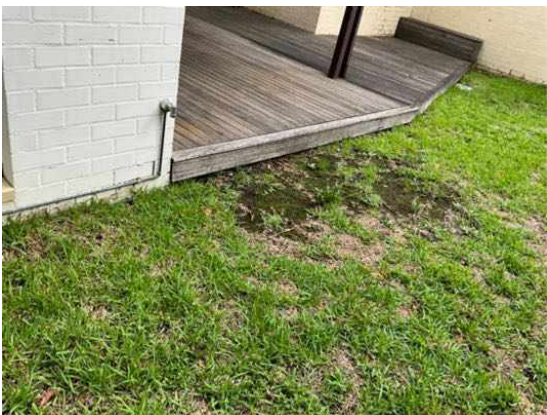
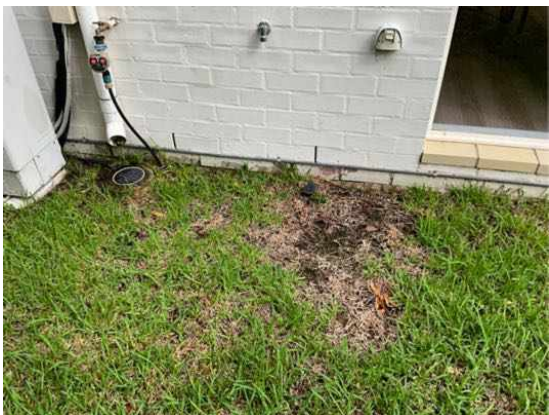
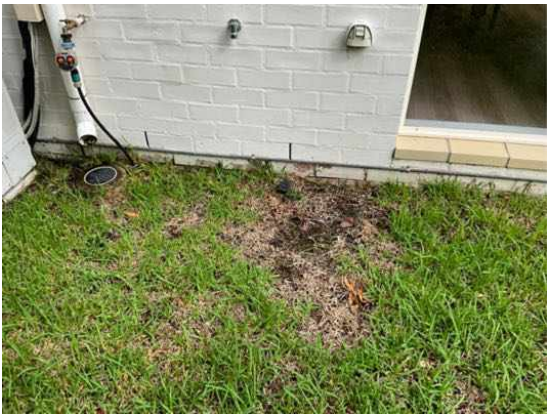
Building: Main Building
 Location: All Areas
 Finding: Perimeter - Insufficient Fall
 Information: The perimeter ground levels were found to have an inadequate slope away from the adjoining building structure, creating potential for water pooling in this area.

and bare ground should fall away from the house by 50mm in the first meter. This standard ensures that excessive moisture does not pool around the base of building structures, which creates potential for water and structural damage, as well as making the area susceptible to termite and timber pest activity.

Where ground levels do not have adequate fall, a licensed paving contractor should be appointed to install or remove and re-level pavement.

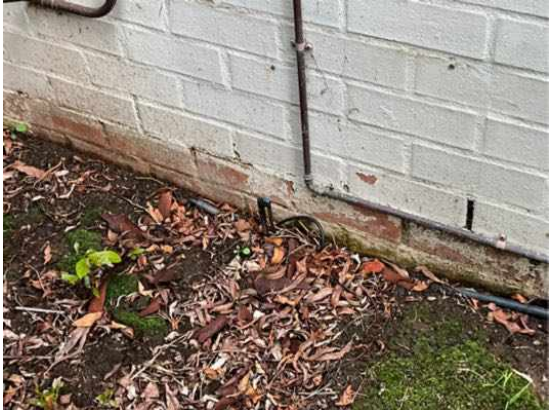
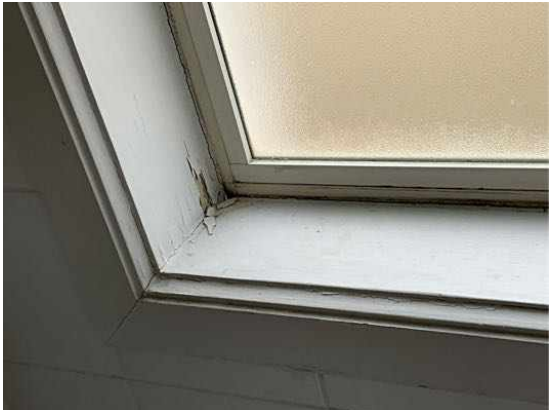
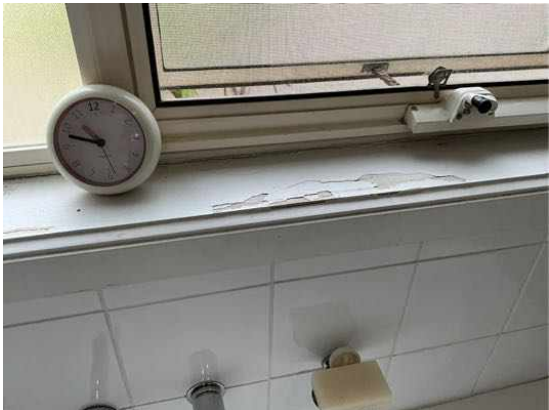
Finding 3.06

Building: Main Building
Location: All Areas
Finding: Flaky Paint
Information: Sections of the paint in this area was found to have deteriorated. Paint deteriorating is generally an indication of excessive moisture in the area that is currently hidden by the painted surface.

The presence of excessive moisture can have major implications on associated building elements if left unattended. While only seemingly minor at this stage, the damage cannot be determined due to the paint, obstructing any further inspection of the damage.

It is highly advised that the affected paint to be cleaned to allow a further, more invasive inspection by a licensed builder/painter. Failure to act on this defect may necessitate major works in the future.

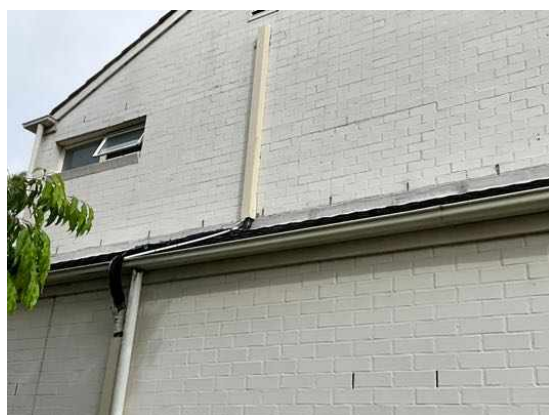
Finding 3.07

Building: Main Building
 Location: Roof Exterior
 Finding: Roof Weathered
 Information: Inspection of the roof revealed widespread weathering to the tiled roof surface. The tiles show loss of surface finish, colour fading, and age-related deterioration typical of older roof coverings. Although no significant cracking was noted, weathering can lead to increased porosity, reduced water-shedding capability, and a higher risk of future cracking or displacement during adverse weather conditions.

A licensed roofer should be engaged to undertake a closer inspection, carry out routine maintenance, and replace any tiles that may be compromised. Ongoing monitoring is recommended due to the age and condition of the roof covering.

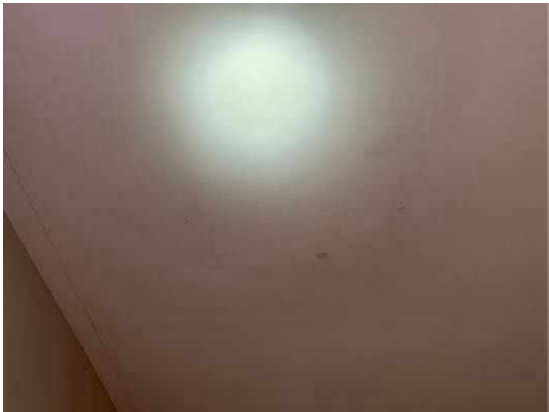
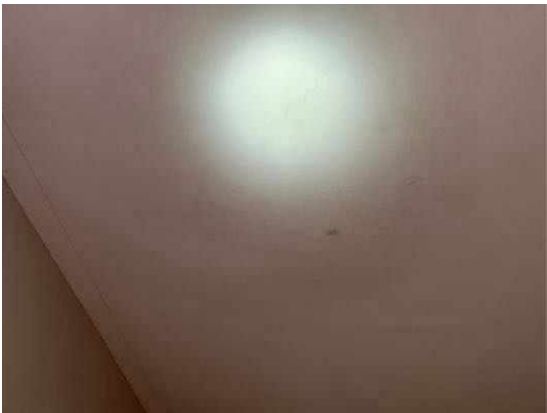
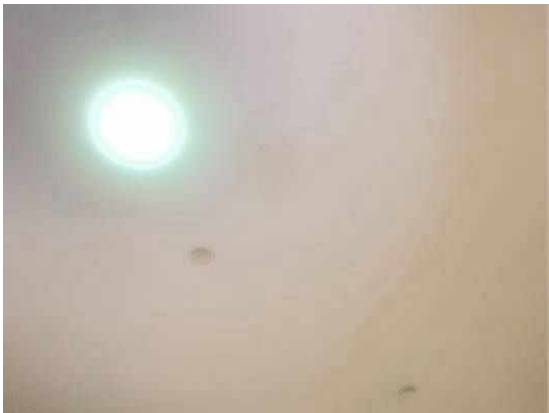
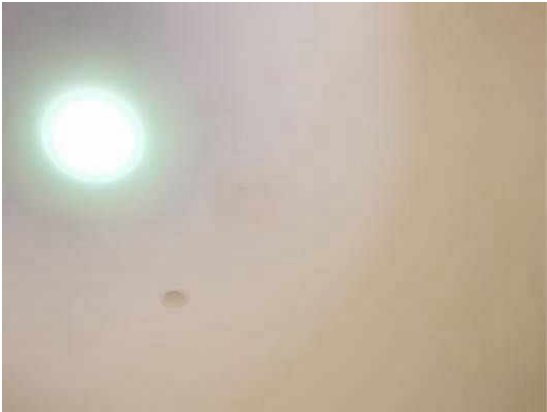
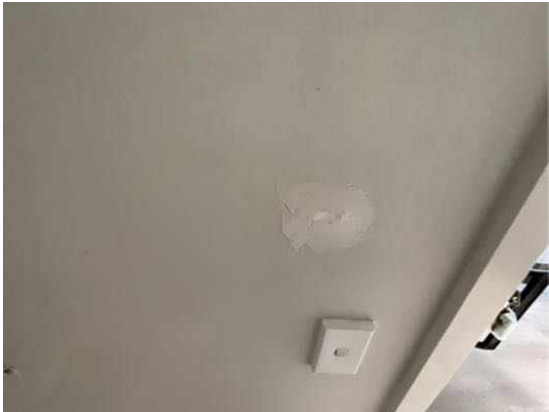
Risk: Poor workmanship poses a range of risks, including compromised structural integrity, potential safety hazards, and a decreased lifespan of the structure. It may also lead to aesthetic and functional issues.

Resolution: A qualified contractor or construction professional should be consulted to assess and address the poor workmanship. They can implement corrective measures to ensure structural soundness, safety, and overall quality of the construction.

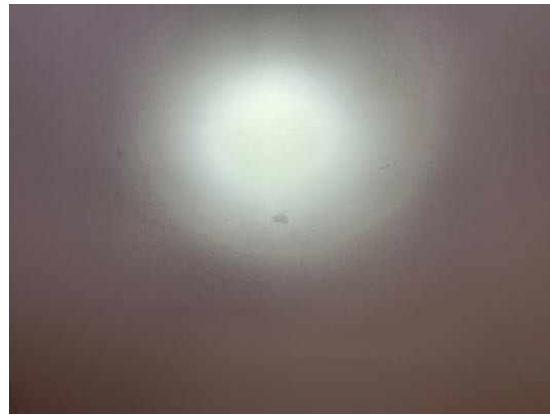
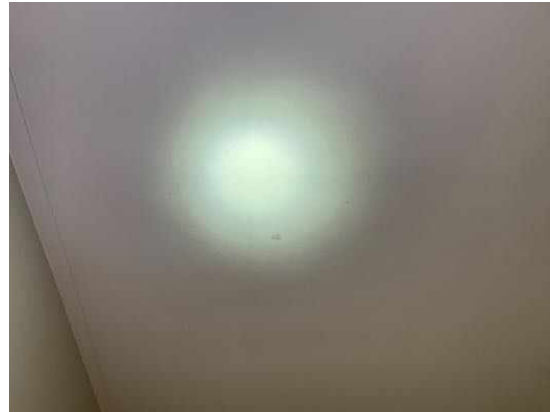
Finding 3.10

Finding: Water staining

Information: Water staining was evident in this area at the time of inspection. Water staining indicates that surfaces have been exposed to excessive moisture over time. The minerals and other elements in the water lead to staining, which may graduate to corrosion and deterioration if left unmanaged.

water staining can be indicative of more serious defects, which may be currently concealed by other building elements.

Where water staining is active, a licensed plumber must be consulted to identify the cause of the staining and to provide advice on any reparation works that may be required. Replacement of any broken or damaged structures is advised.

Conversely, where water staining is old and inactive, affected building materials may be repaired or replaced at client discretion. A qualified carpenter or registered builder may be appointed to perform these works.

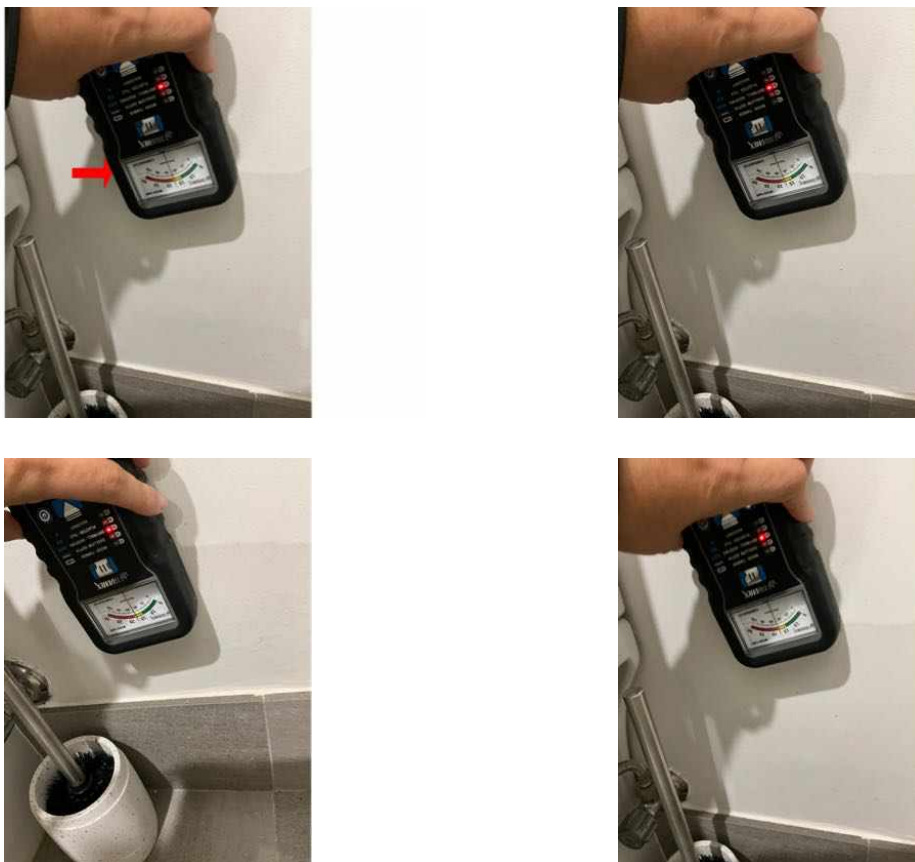
Finding 3.11

Building:	Main Building
Location:	Toilet (WC)
Finding:	Evidence of excessive moisture - Drywall
Information:	Excessive moisture is present at the time of , indicating a potential water leakage issue within the wall.

The prolonged presence of moisture can lead to mold growth, deteriorate the structure, and create an environment conducive to health hazards. Additionally, it may compromise the adhesive holding the tiles, leading to their detachment.

A licensed plumber or a qualified contractor specializing in water damage remediation

should investigate the source of the moisture, fix any leaks, and address the damage. Additionally, replacing affected tiles and ensuring proper waterproofing are crucial to preventing future issues.

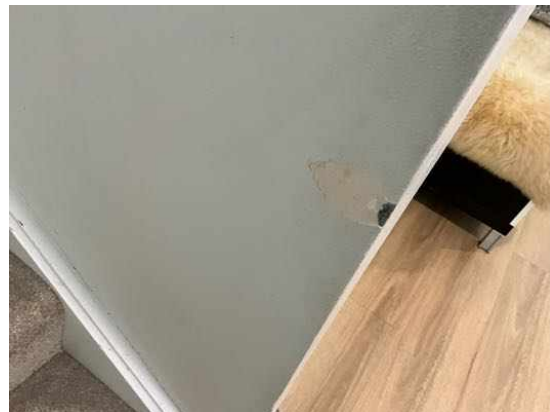
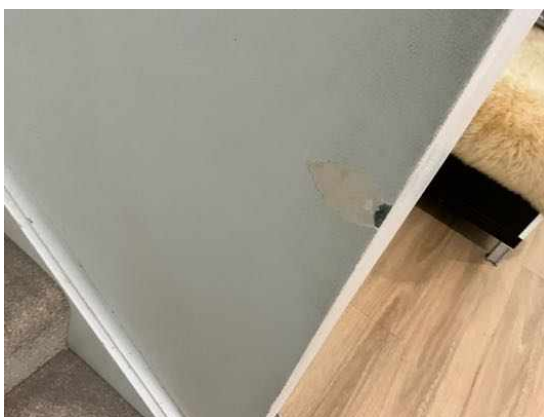
1. Aesthetic Degradation: Scratches mar the appearance of the painted surface, diminishing its visual appeal and potentially lowering property value.
2. Corrosion Vulnerability: Exposed areas of bare metal due to scratched paint are susceptible to corrosion, leading to structural damage and compromised durability.
3. Environmental Hazards: Scratched paint can release hazardous chemicals into the environment, posing risks to both human health and the ecosystem.

A qualified painter should address the issue promptly to repair the scratched paint. Depending on the severity of the scratches, repair options may include sanding, priming, and repainting the affected area to restore the integrity and appearance of the paint surface.

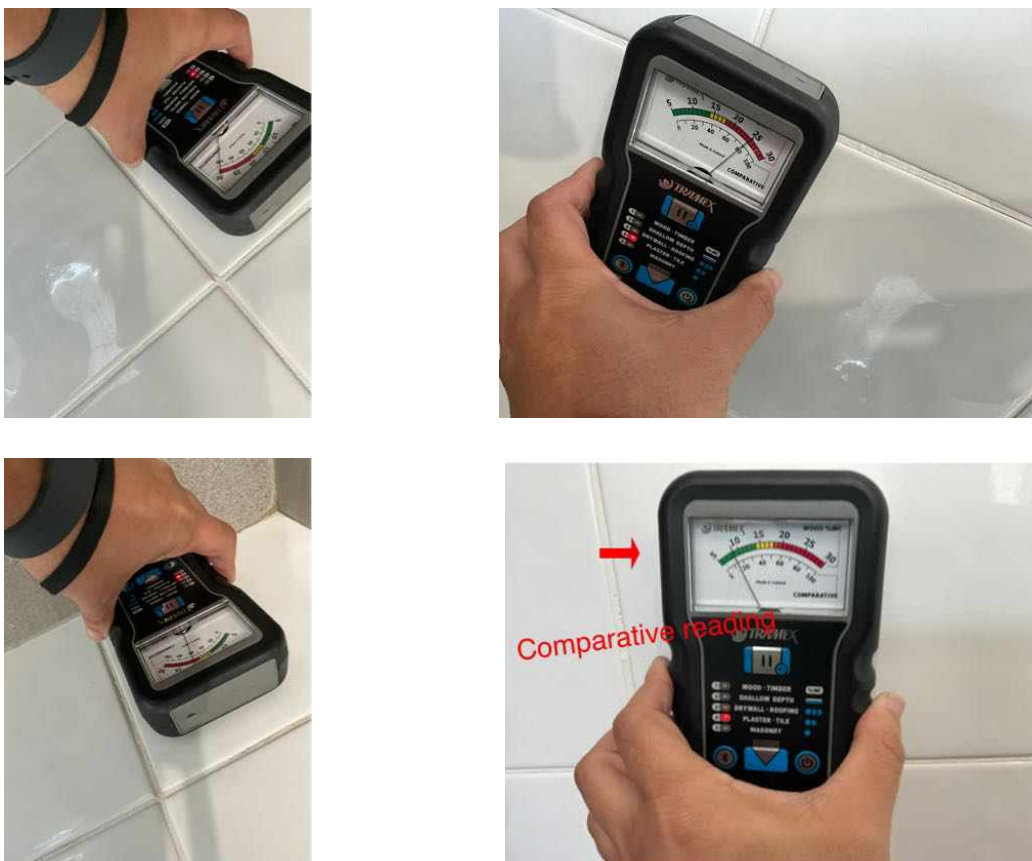
Finding 3.15

Building:	Main Building
Location:	Ensuite
Finding:	Shower - Damp
Information:	Damp is evident to the lower 300mm of wall to the shower alcove. This defect is quite common, and is suspected to have been caused by moisture permeating through the grouting in this area, which shows evidence of deterioration. Leaking pipes within the adjoining wall is also a possible cause.

Damp (or structural damp) refers to the presence of unwanted moisture in the structure of a building, either as the result of intrusion from outside, or condensation from within the structure. In the shower area, internal water leaks or other sources of excessive moisture are generally the cause of damp.

Unmanaged damp in the shower recess is likely to facilitate the formation and development of mould and fungi growth, decaying associated building materials and compromising their structural integrity. It is important to address damp conditions, as the World Health Organisation notes that excess moisture leads - on almost all indoor materials - to growth of microbes such as moulds, fungi and bacteria, which subsequently emit spores and other matter into the indoor air. Exposure to these contaminants is associated with a wide range of respiratory and other health-related problems.

Consultation with a qualified plumber or bathroom specialist is advised immediately to identify the cause of damp and to perform remedial works as required. Where excessive mould growth is present, further inspection by a specialist environmental health inspector should also be considered.

Always ensure that sealant and grout is in good condition to prevent any moisture issues occurring in the future.

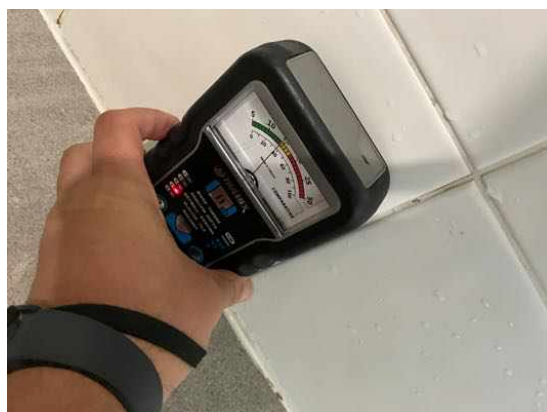
Information: Damp is evident to the lower 300mm of wall to the shower alcove. This defect is quite common, and is suspected to have been caused by moisture permeating through the grouting in this area, which shows evidence of deterioration. Leaking pipes within the adjoining wall is also a possible cause.

Damp (or structural damp) refers to the presence of unwanted moisture in the structure of a building, either as the result of intrusion from outside, or condensation from within the structure. In the shower area, internal water leaks or other sources of excessive moisture are generally the cause of damp.

Unmanaged damp in the shower recess is likely to facilitate the formation and development of mould and fungi growth, decaying associated building materials and compromising their structural integrity. It is important to address damp conditions, as the World Health Organisation notes that excess moisture leads - on almost all indoor materials - to growth of microbes such as moulds, fungi and bacteria, which subsequently emit spores and other matter into the indoor air. Exposure to these contaminants is associated with a wide range of respiratory and other health-related problems.

Consultation with a qualified plumber or bathroom specialist is advised immediately to identify the cause of damp and to perform remedial works as required. Where excessive mould growth is present, further inspection by a specialist environmental health inspector should also be considered.

Always ensure that sealant and grout is in good condition to prevent any moisture issues occurring in the future.

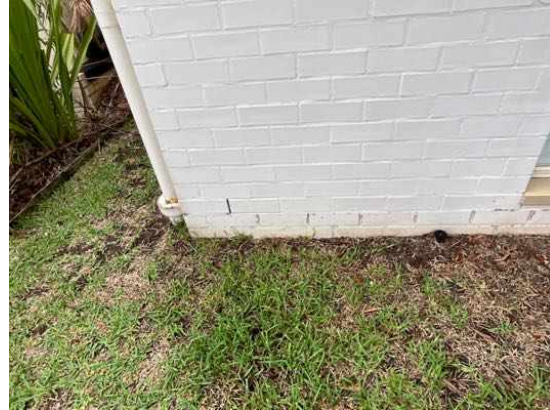
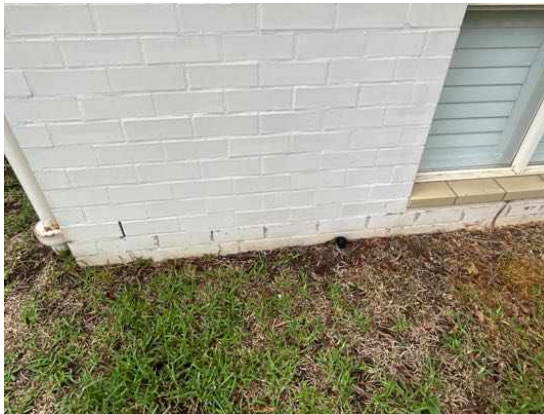
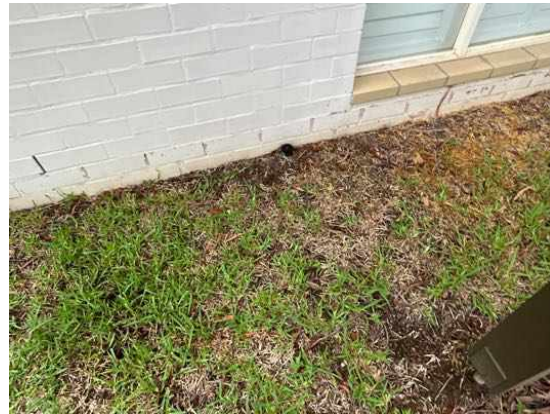
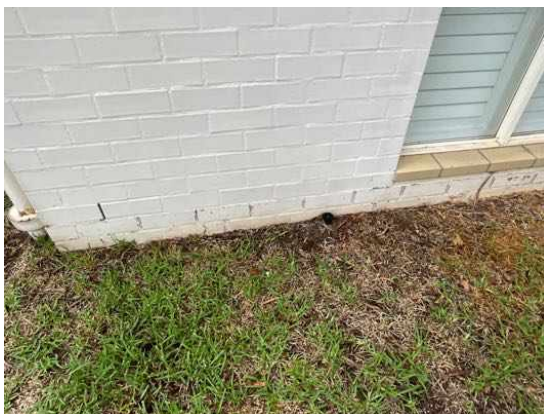
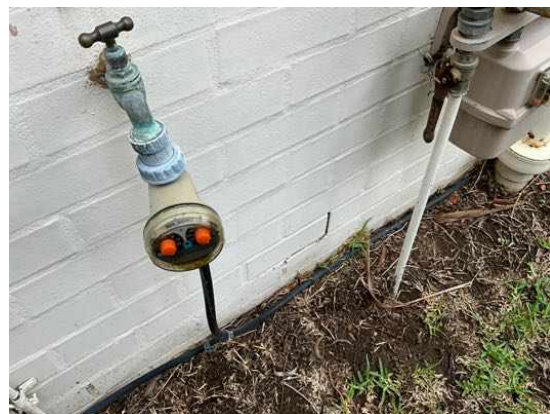
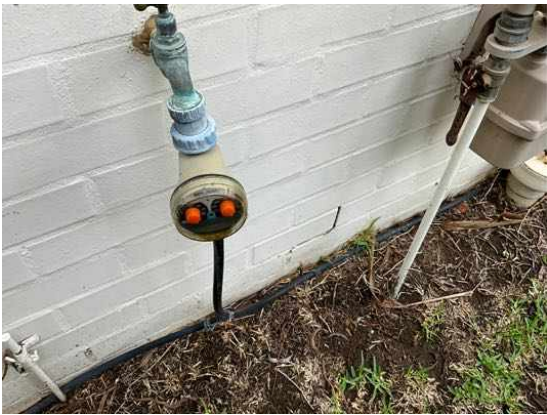
If the slab edge is not properly exposed there is a high risk of termite attack. Sometimes, in order to determine the type of slab, a suitably qualified person such as an architect or builder may be required to consult the construction plans.

Where the slab edge cannot be properly inspected, it is highly recommended that termite or timber pest inspections be carried out every 6-12 months to aid protection of the property against infestation.

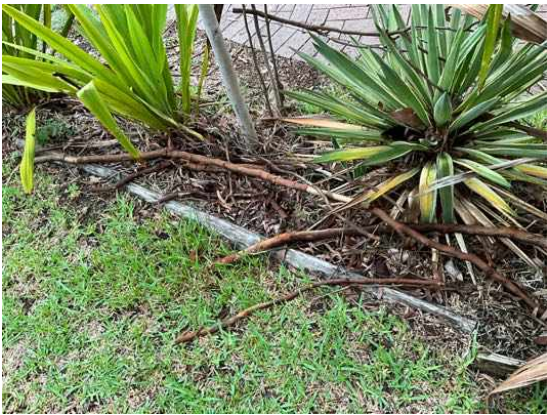
Finding 6.02

Building: Main Building
Location: All Areas
Finding: vegetation around a property can increase the risk of termite infestation
Information: The presence of vegetation around a property can increase the risk of termite infestation, as it provides a conducive environment for them. To address this, consider maintaining a clear space between the vegetation and your home. If you suspect a termite issue, it's advisable to consult with a licensed pest control professional for inspection and treatment.

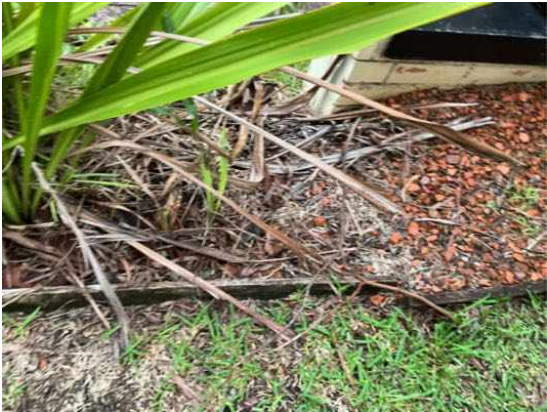
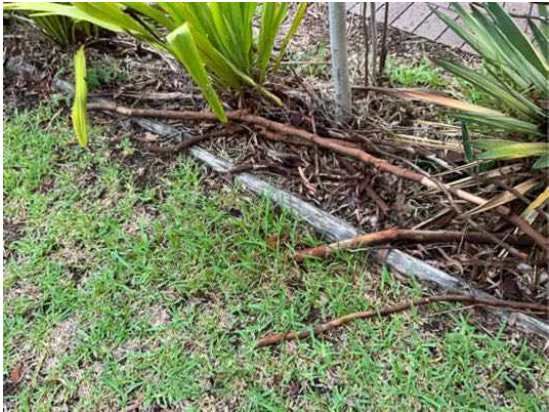
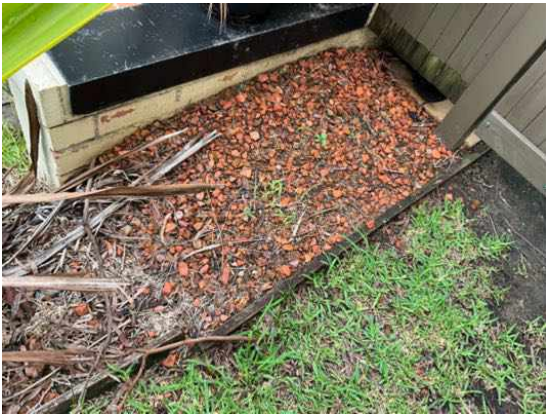
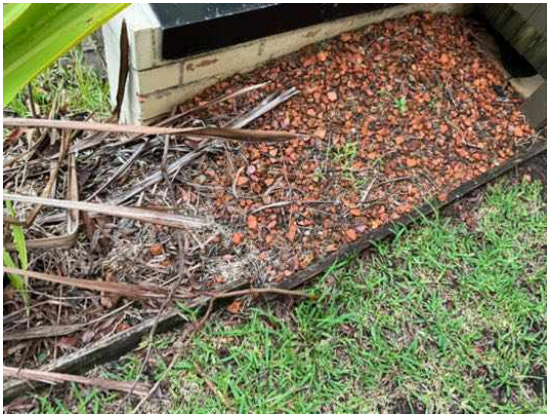
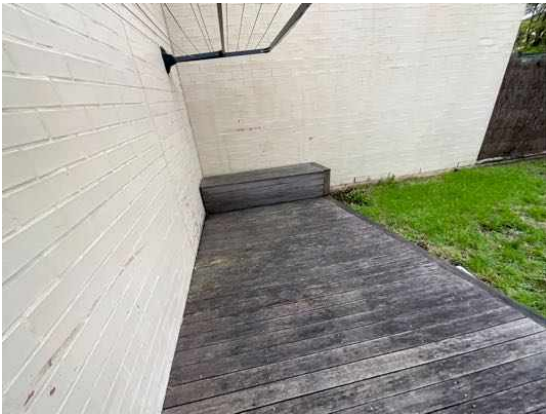
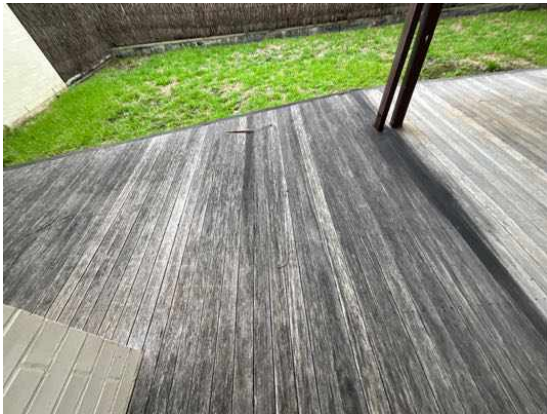
Finding 6.03

Building: Main Building
 Location: All Areas
 Finding: Timber on ground / conducive conditions to termite damage
 Information: Timber on the ground is indeed conducive to termite damage. Termites are known to thrive in moist environments, and wood in contact with soil or moisture is more susceptible to infestation.

To prevent this, it's important to keep timber elevated and away from direct ground contact. Regular inspections and proper termite control measures are also essential to protect your wooden structures from termite damage.

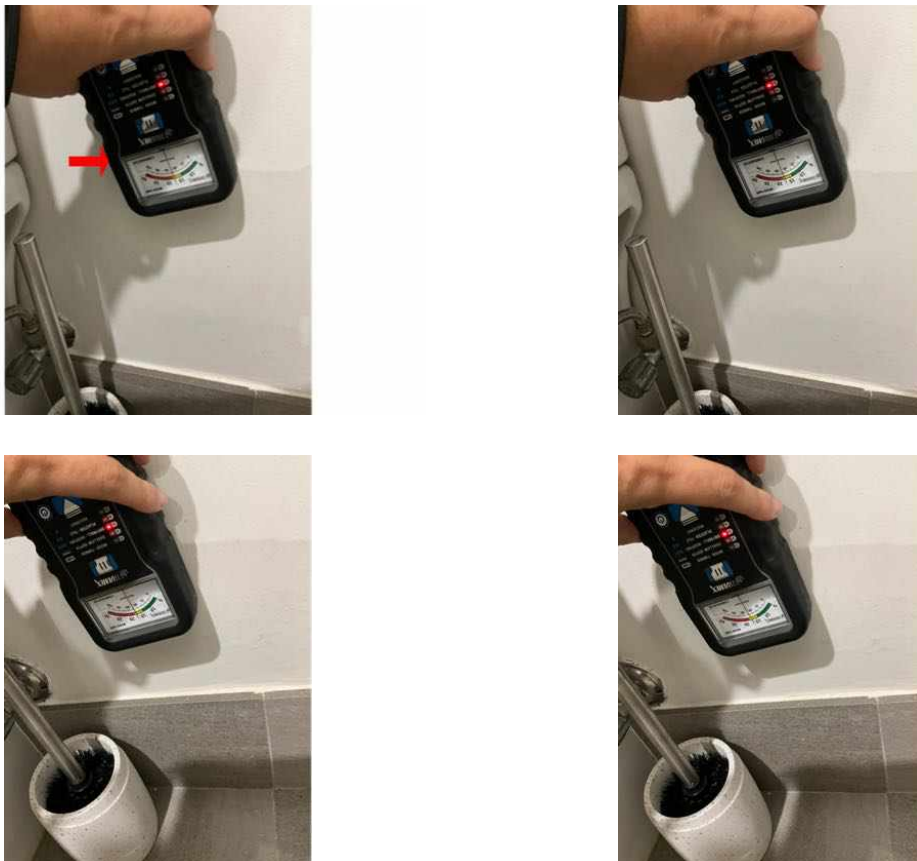
Building: Main Building
 Location: Toilet (WC)
 Finding: Excessive moisture - Conducive to Timber pest
 Information: Excessive moisture can attract termites and produce conditions that promote fungal growth and wood decay.

Excessive moisture is generally caused by deteriorated inadequate or missing roof drainage leaking plumbing pipes or fixtures poorly plumbed HWS overflows or condenser units and poor site drainage.

If mould growth has been found there may be environmental biological or health issues involved. In these cases an appropriately qualified inspector should also be contacted.

Prior to any remedial works being performed a qualified plumber should be appointed to further inspect the property and to identify the cause of the excessive moisture. Works to remove affected building elements may then be necessary and should be performed by an appropriate tradesperson.

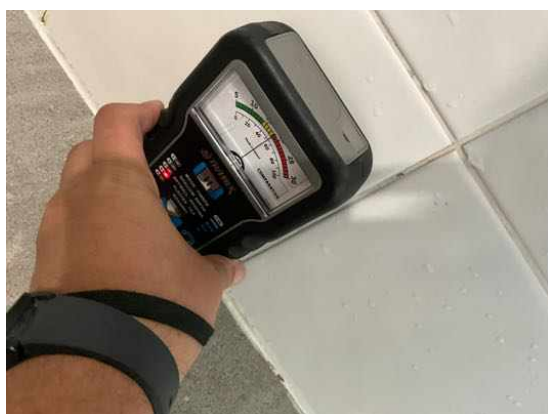
Building:	Main Building
Location:	Bathroom
Finding:	Excessive moisture - Conducive to Timber pest
Information:	Excessive moisture can attract termites and produce conditions that promote fungal growth and wood decay.

Excessive moisture is generally caused by deteriorated inadequate or missing roof drainage leaking plumbing pipes or fixtures poorly plumbed HWS overflows or condenser units and poor site drainage.

If mould growth has been found there may be environmental biological or health issues involved. In these cases an appropriately qualified inspector should also be contacted.

Prior to any remedial works being performed a qualified plumber should be appointed

to further inspect the property and to identify the cause of the excessive moisture. Works to remove affected building elements may then be necessary and should be performed by an appropriate tradesperson.

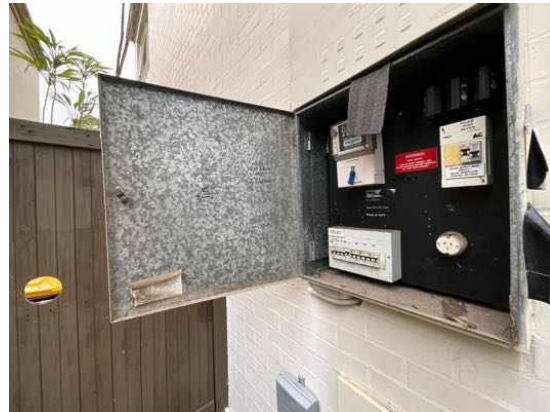
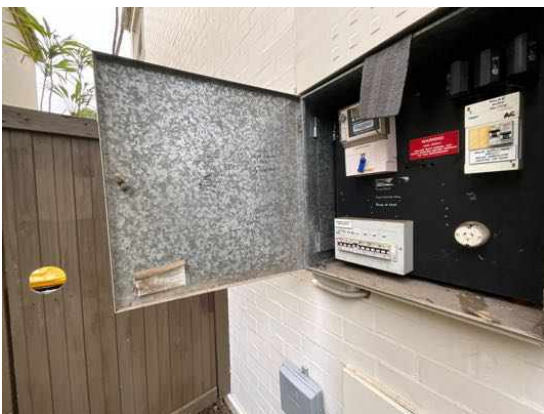
A durable notice placed in the switchboard unit to indicate termite barriers at the time of inspection.

Client must seek further information from the vendor or real estate agent if the conditions of termite management systems were maintained as per the label or seek advise from licensed pest controller.
