# Building and Timber Pest Inspection Report

Inspection Date: Fri, 6 Mar 2026

Property Address: 703/16-20 Smallwood Ave, Homebush NSW  
2140, Australia

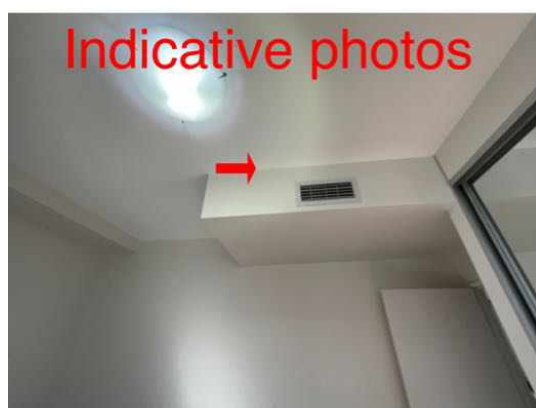
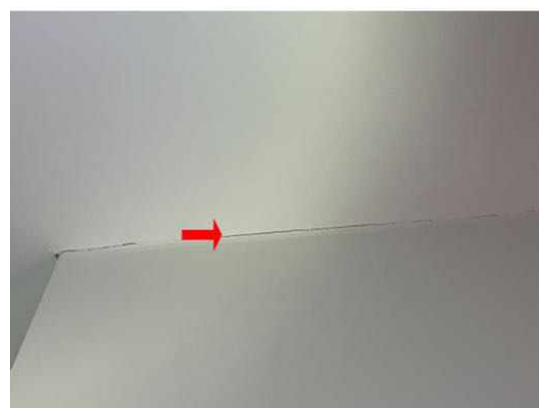
#### Finding 3.01

Building:	Main Building
Location:	Multiple areas
Finding:	Cracking - Damage Category 1 - Fine (up to 1mm)
Information:	Although fine cracks are quite noticeable, they are often only considered to be an appearance defect, and usually do not indicate any structural damage. Generally, the cause of a fine crack is indicative of a separation between building materials and finishes (e.g. paint, plaster, etc.) along joins.

Cracking of this nature can generally be repaired with minor sanding, filling and/or repainting. Such works should be performed by a qualified painter or a general handyman.

Monitoring of all cracking should be conducted frequently. Always contact a building inspector should cracks widen, lengthen, or become more numerous.

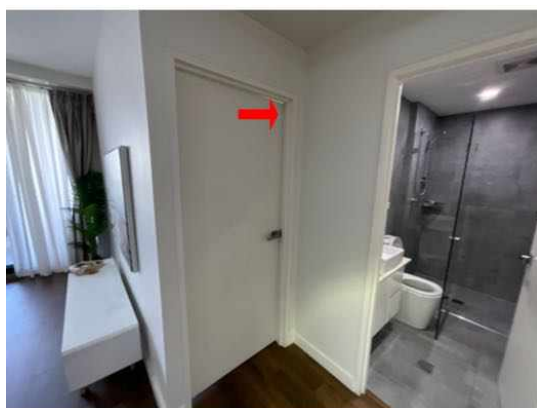
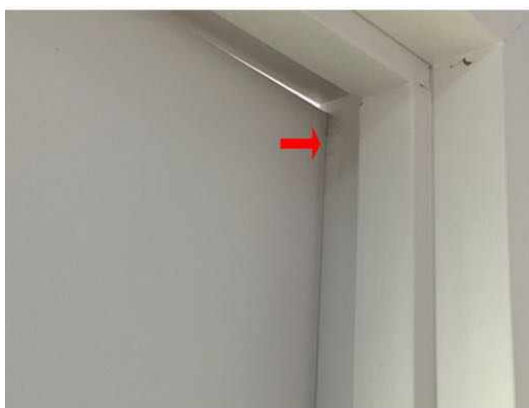
#### Finding 3.02

Building:	Main Building
Location:	Bedroom - Master
Finding:	Door - Binding/jamming

Information: Binding and/or jamming of this door is evident during standard operation. This defect inhibits the functionality of the affected door as well as creating potential for secondary defects to associated building elements, such as damage to the floor covering or adjacent frame.

A door that binds to flooring or to the associated door frame may have several causes, ranging from minor defects, such as poor installation of the door or deteriorated hinges.

A licensed carpenter should be appointed to perform minor rectification works at client discretion.

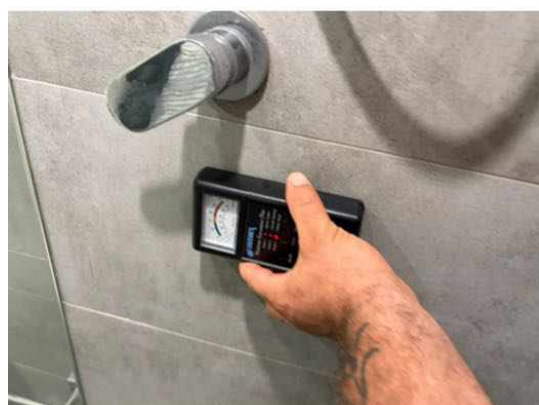
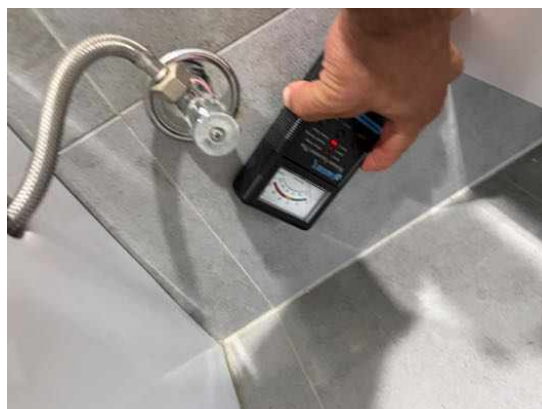
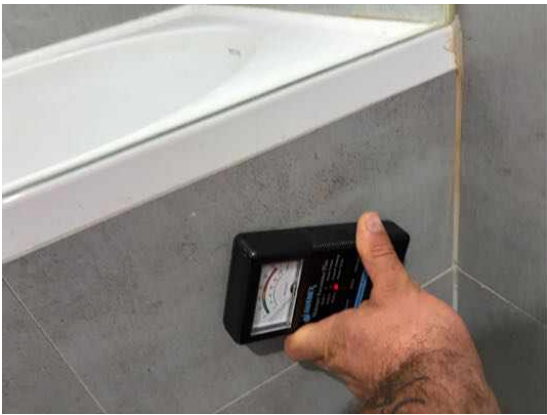
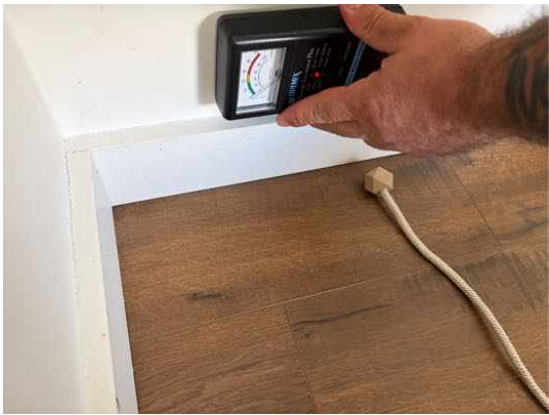
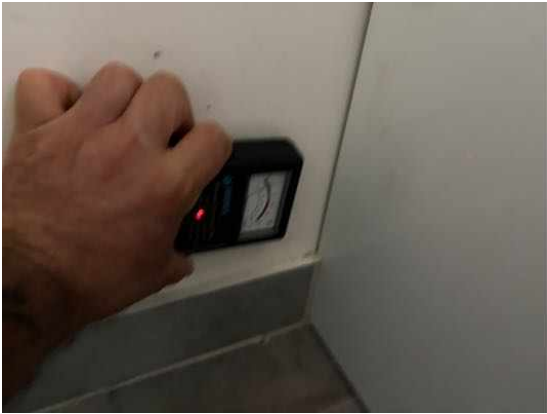
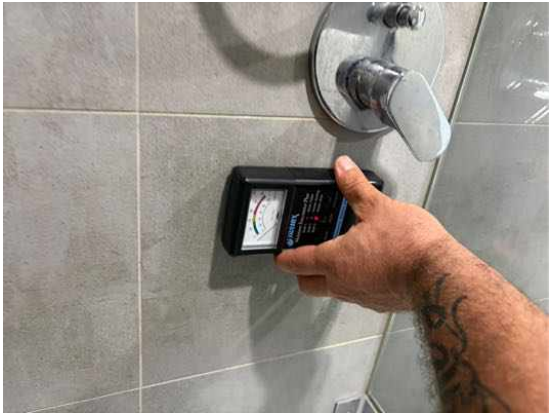
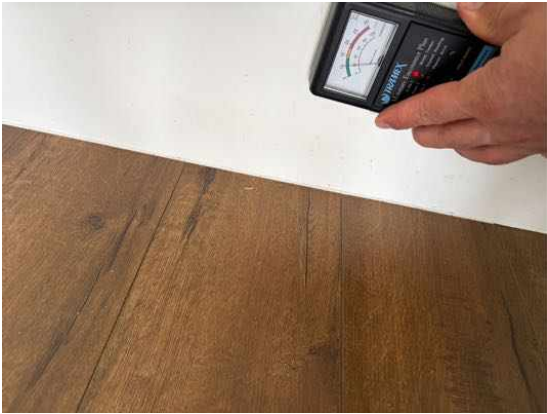
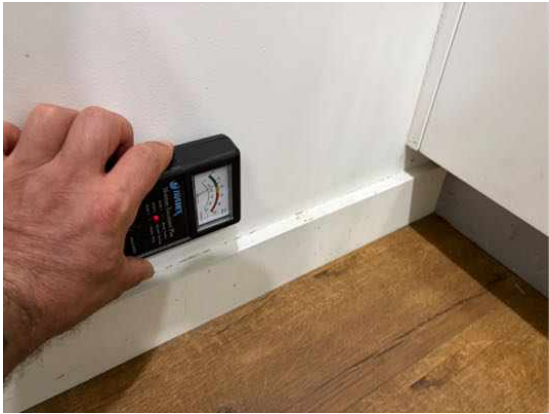
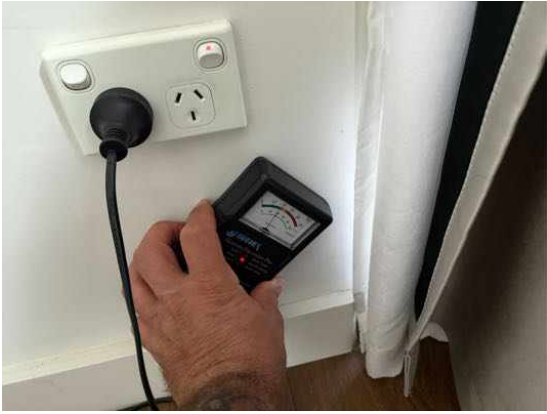
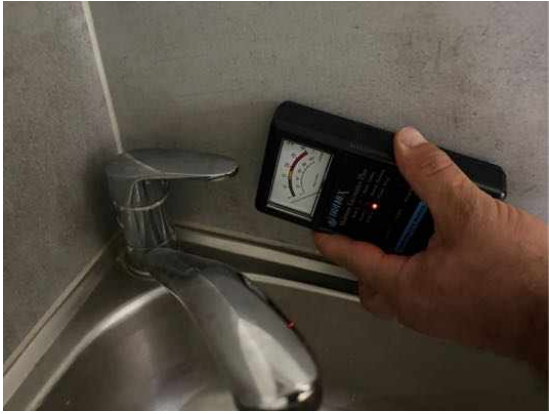
Building: Main Building  
 Location: All Areas  
 Finding: Moisture metre  
 Information: During the inspection the property was checked for moisture using a moisture metre.

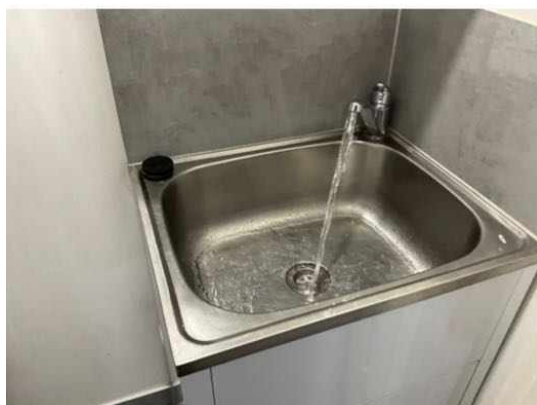
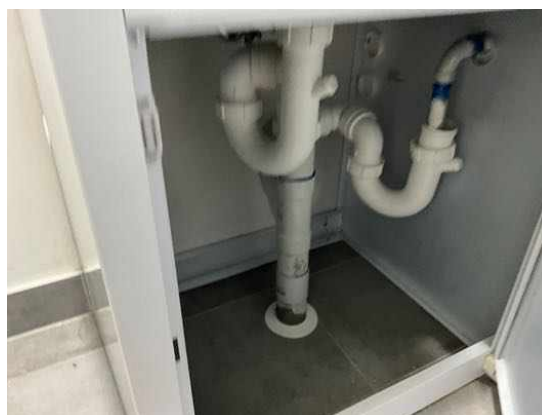
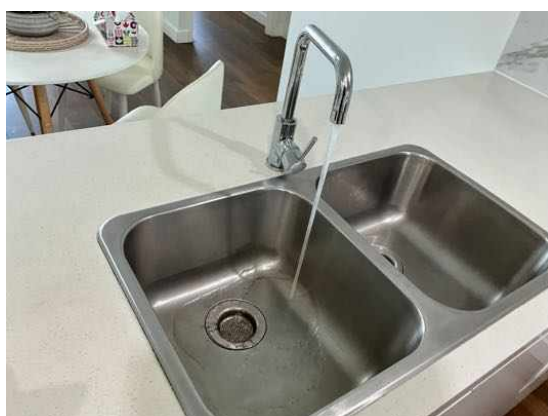
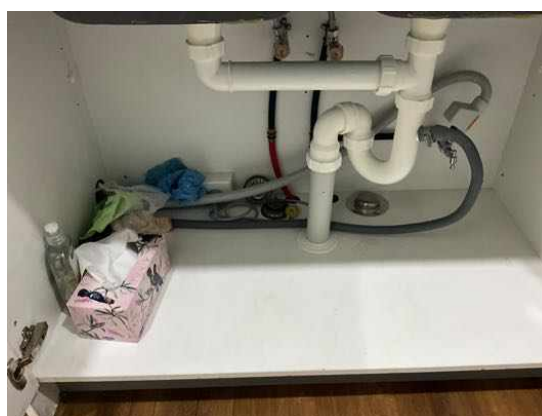
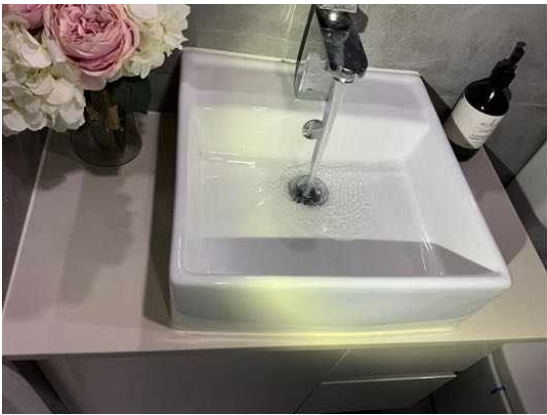
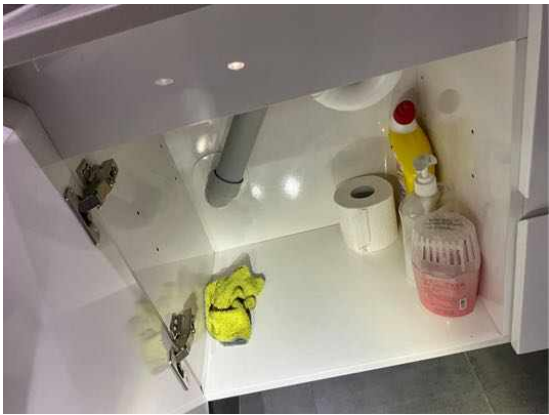
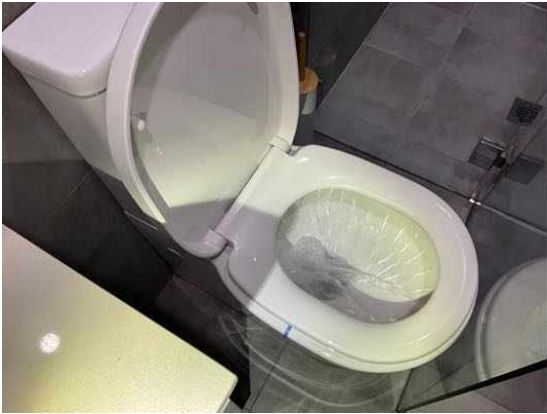
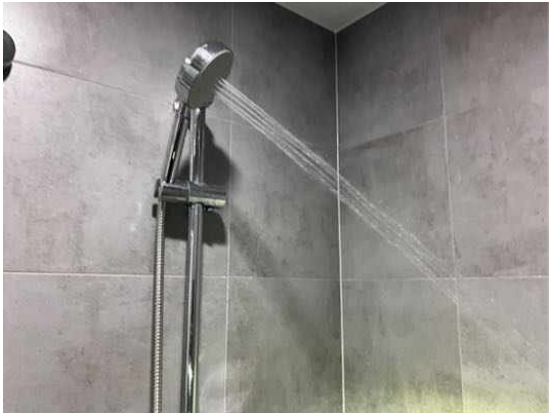
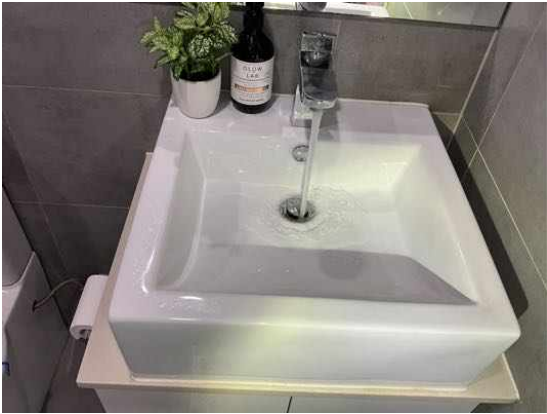
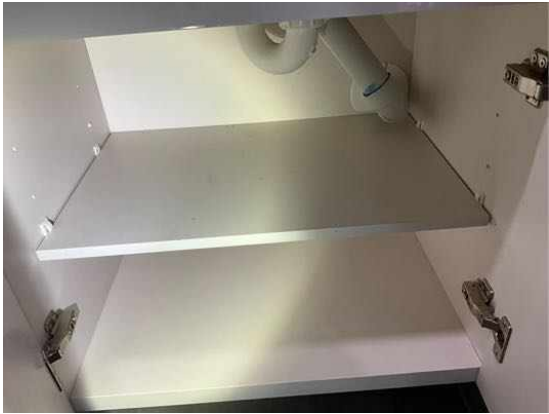
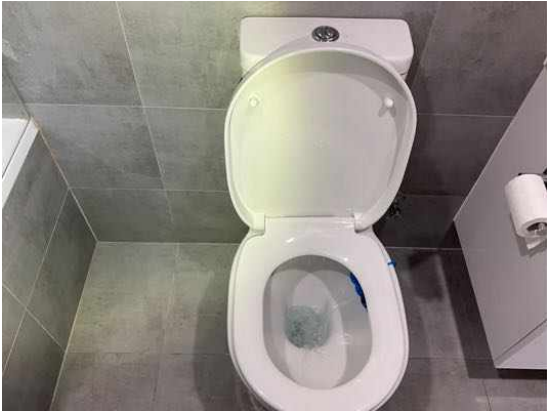
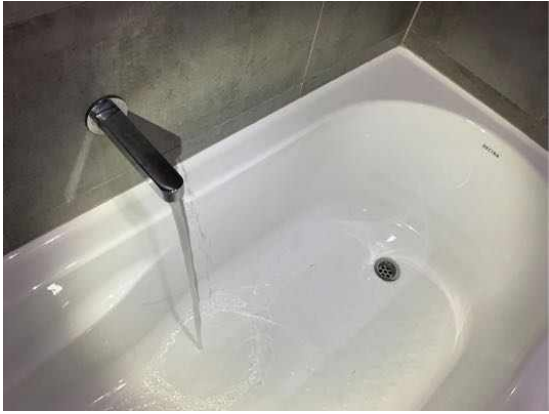
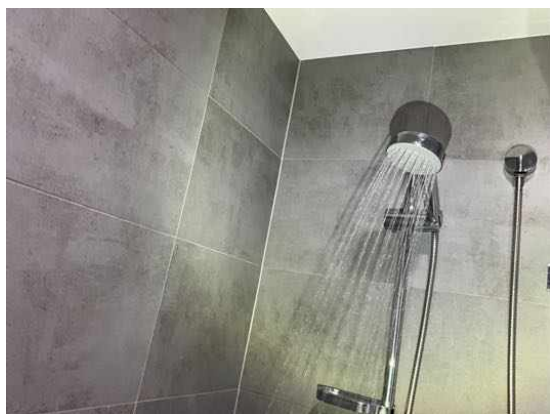
Building: Main Building  
Location: All Wet Areas  
Finding: Waterproofing  
Information:

All taps, mixers and toilets were tested for operation, except for those obstructed. The waterproofing to the shower recess was assessed by checking the walls in and around the shower recess for varying moisture content. There were no significant variations across the tested areas. No sign of recent water damage was evident upon a visual inspection of the surrounding walls, where the visual nature of the inspection was possible.

Consequently, there is no conclusive evidence of any current shower recess leakage other than those which may have already been mentioned earlier in this report. It is reasonable to assume the shower waterproofing is sound. Note that if the shower is not used, or has not been used for some time, moisture readings would not vary significantly and this can lead to erroneous results. It is not possible under the visual inspection criteria (under which a prepurchase inspection is carried out) to categorically determine if there are leaks. If a more accurate assessment is required, a special purpose inspection should be requested. Alternatively, the assumption should be made that the shower may leak.

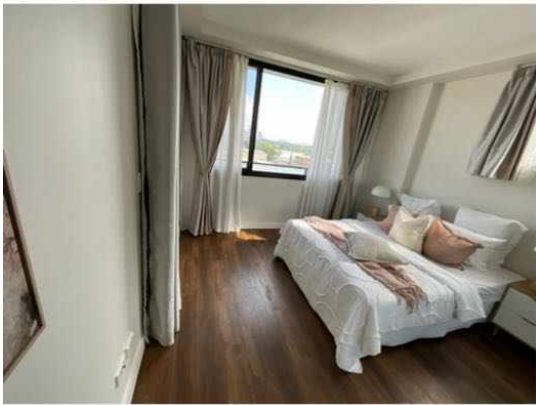
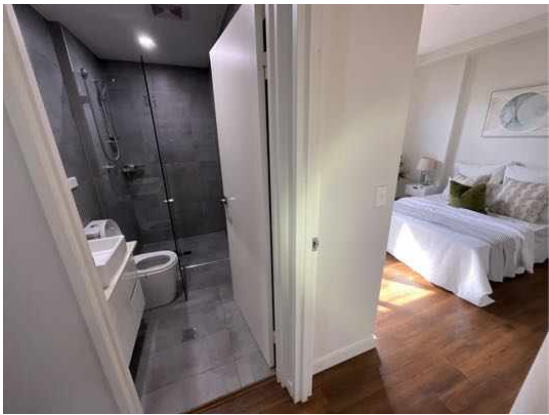
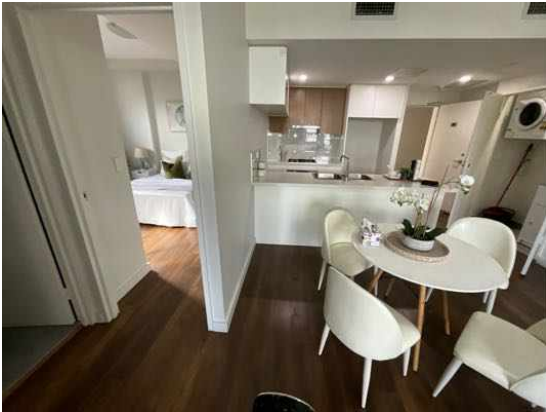
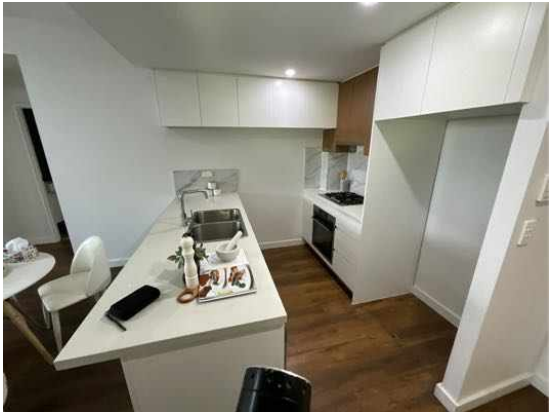
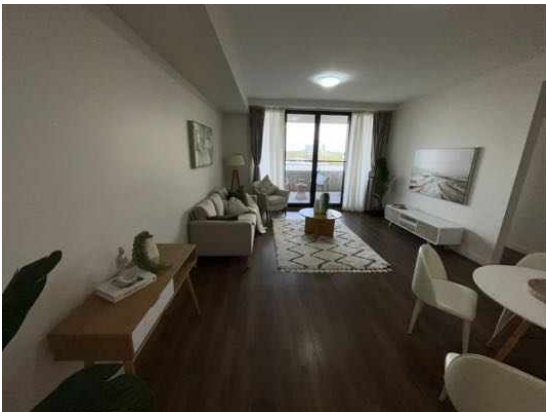
Building: Main Building  
 Location: All Areas  
 Finding: Additional Photos - Obstructions and Limitations  
 Information:

These photographs are an indication of the obstructions and limitations which impeded full inspection of the property at the time of inspection. These obstructions can hide an array of defects and should be removed to allow full inspection to be carried out. A re-inspection is recommended once the areas are made accessible.
