Building and Timber Pest Inspection Report

Inspection Date: Fri, 6 Mar 2026

Property Address: 12 Riverwood Dr, Botanic Ridge VIC 3977,
Australia

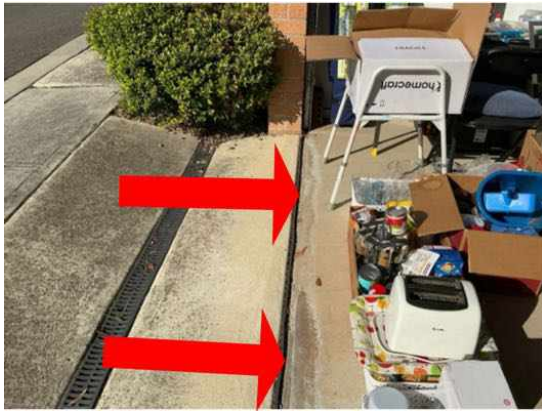
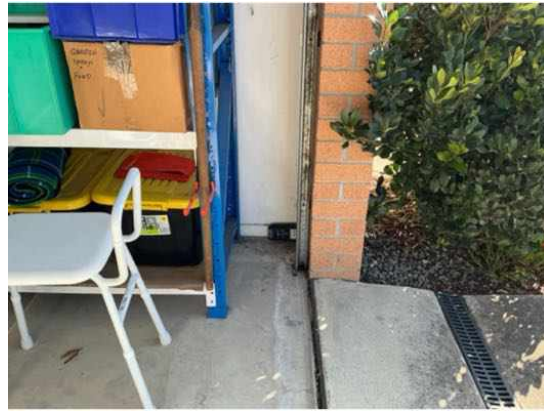
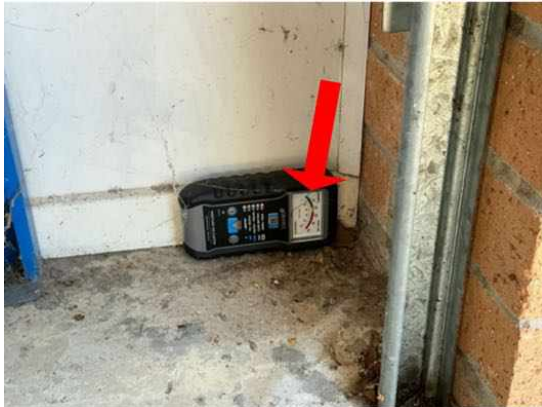
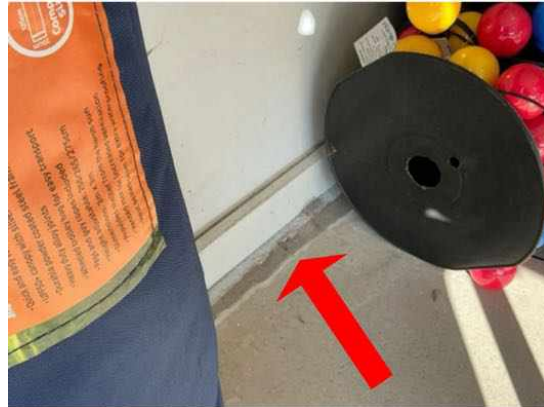
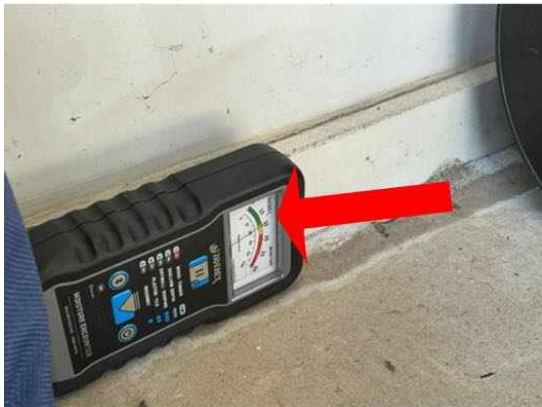
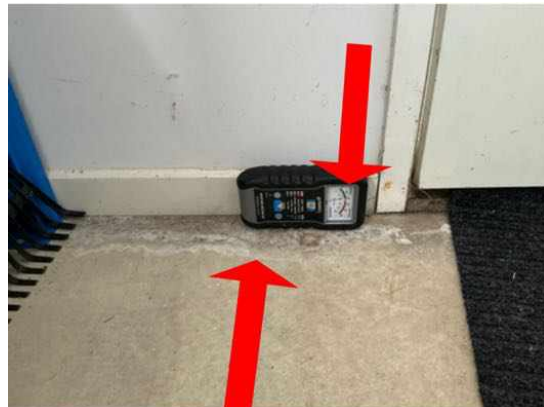
Finding 3.01

Building: Main Building
Location: Garage
Finding: Moisture ingress at garage roller door
Information: During inspection of the garage water staining was observed to parts of the concrete to the roller door area and skirting board areas. Moisture readings were taken using a moisture meter which indicated slightly elevated moisture levels in those areas.

Further investigation was taken by opening the garage roller door and inspecting the external slab at the entry point. It was observed that the external concrete surface is higher than the internal garage floor level. This condition creates an adverse fall toward the garage allowing rainwater to fall toward and potentially enter the garage during rainfall events.

Evidence of moisture staining suggest that water ingress has occurred previously.

This condition represents an improper drainage/fall configuration at the garage entry.

The presence of ongoing or periodic moisture within the garage creates conditions that may be conducive to timber pest activity and building deterioration.

A licensed building contractor should be engaged as soon as possible to assess and rectify the external fall at the garage entrance to reduce the risk of further deterioration.

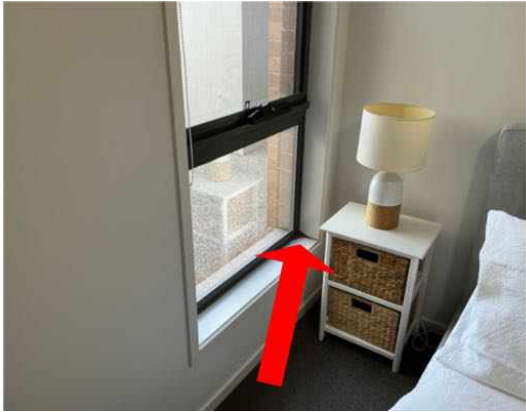
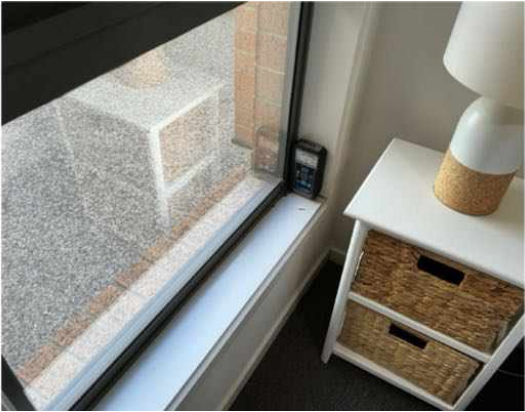
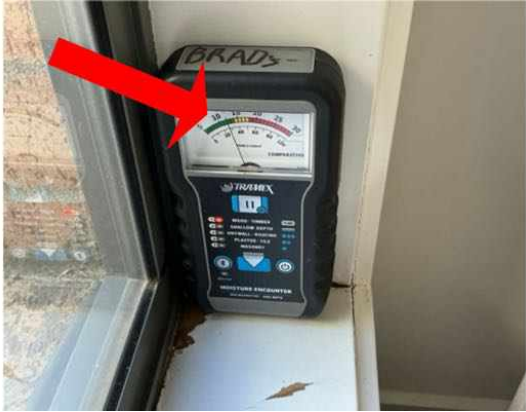
Finding 3.02

Location: Bedroom 3

Finding: Water stains to windows

Information: The front bedroom window shows signs of water stains but tested dry using a moisture meter. It is suspected these stains were caused by some gaps to the window that have been sealed since. Recommend monitoring and if further stains are noticed engage a caulker to seal to reduce the risk of further damage.

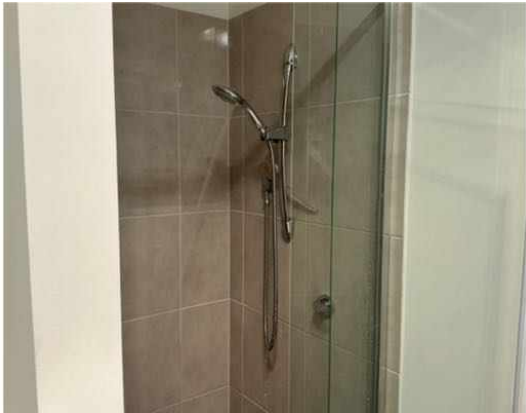
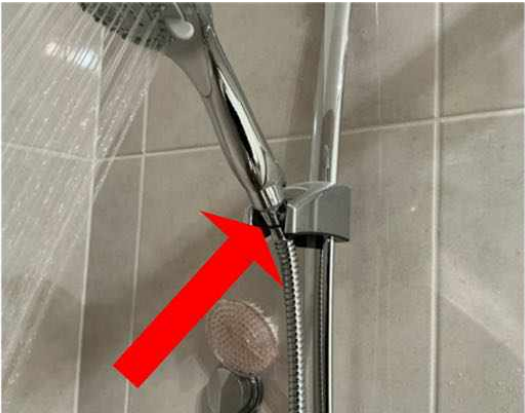
Finding 3.03

Building: Main Building
Location: Ensuite - Master
Finding: Shower head is dripping/leaking
Information: The shower head to the ensuite bathroom is loose and dripping/leaking. This can often happen over time with deterioration or if the shower head is loose and needs tightening. Recommend engaging a plumber to repair/replace the shower head to reduce the risk of further deterioration and water leaks as soon as possible.

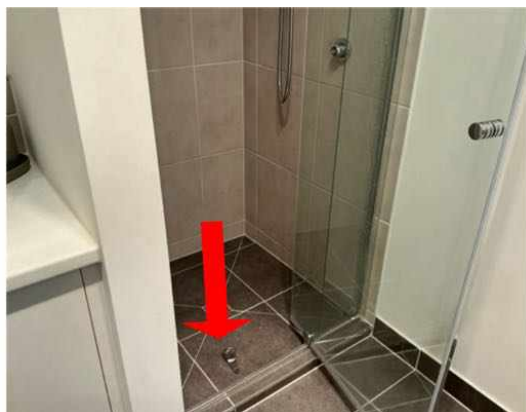
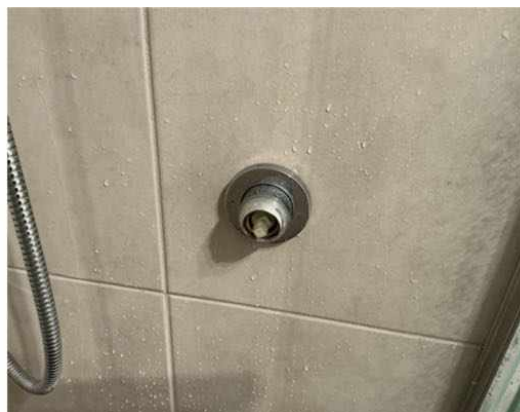
Finding 3.04

Building: Main Building
 Location: Ensuite - Master
 Finding: Bathroom Tap - Loose
 Information: The tap in the ensuite shower has not been installed correctly, or has deteriorated with age, and is consequently loose. This tap being loose creates potential for water leaks and subsequent water damage to the surrounding area.

Where taps or spouts are loose, a qualified plumber should be appointed to re-fix the plumbing fitting.

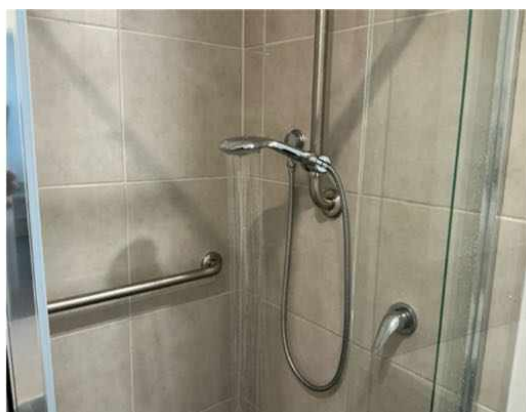
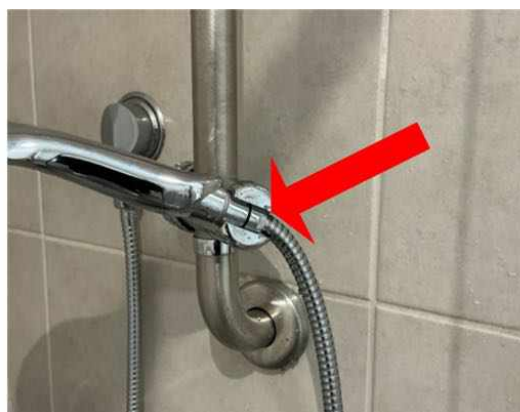
Finding 3.05

Building: Main Building
 Location: Bathroom
 Finding: Shower head is dripping/leaking
 Information: The shower head to the bathroom is loose and dripping/leaking. This can often happen over time with deterioration or if the shower head is loose and needs tightening. Recommend engaging a plumber to repair/replace the shower head to reduce the risk of further deterioration and water leaks as soon as possible.

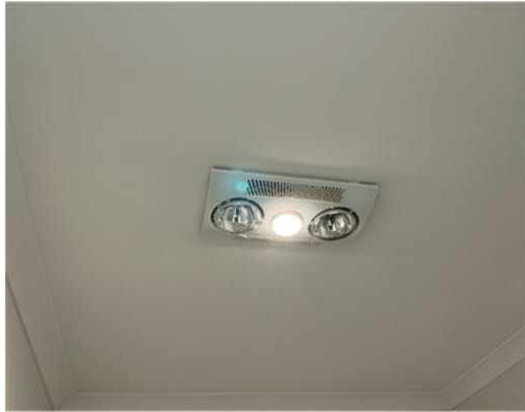
Finding 3.06

Location: Bathroom
 Finding: Heat lamp lights not working
 Information: The heat light lamps to the bathroom were not working during inspection. Recommend engaging an electrician to inspect and repair as necessary to make operational at the owner's discretion.

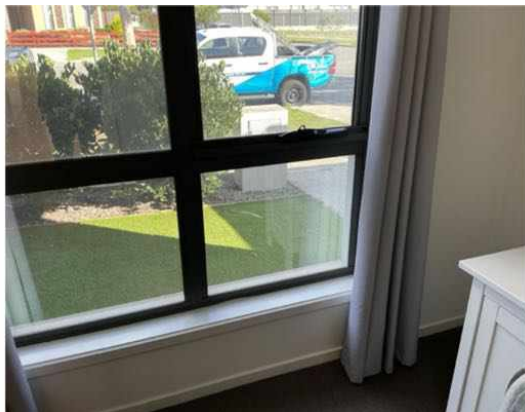
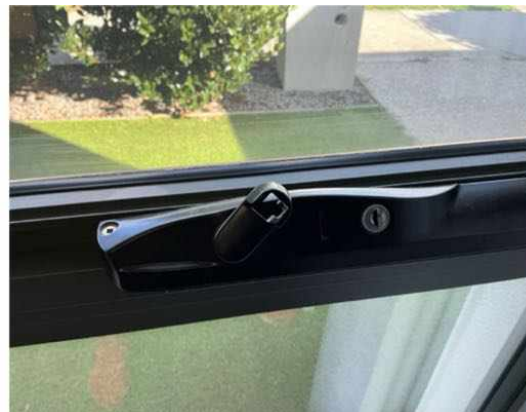
Finding 3.07

Building: Main Building
 Location: Bedroom 2
 Finding: Broken window winder handle
 Information: The window winder handle to bedroom 2 was broken/missing at the time of inspection. Recommend engaging a carpenter to repair/replace to make more operational.

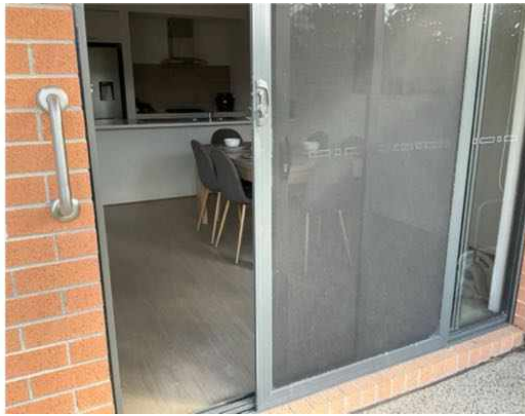
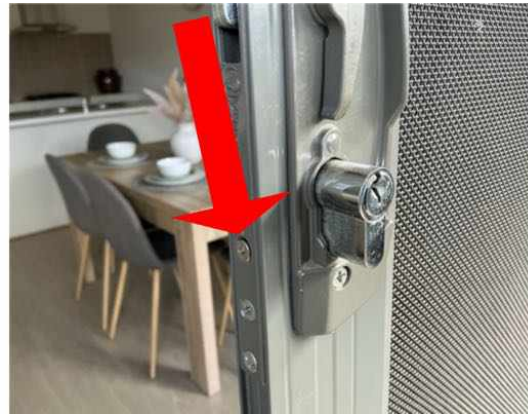
Finding 3.08

Building: Main Building
 Location: Exterior walls - rear
 Finding: Door lock requires tightening
 Information: The patio door lock is loose and requires adjustment to make it operate properly. This can happen overtime with deterioration or lack of maintenance. Recommend engaging

a carpenter to repair/maintain at the owners discretion.

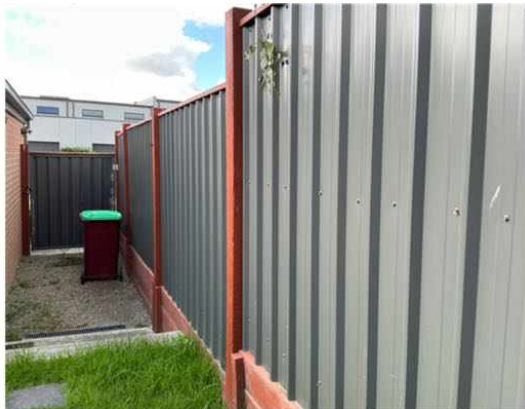
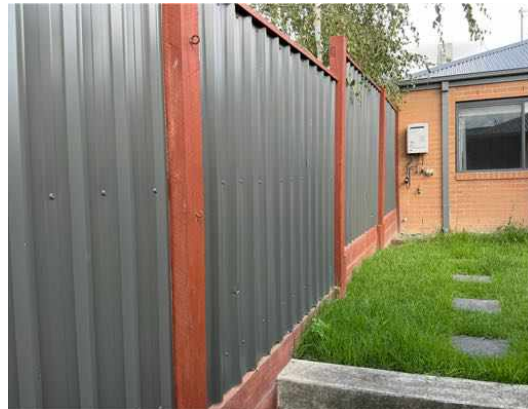
Finding 3.09

Location: Yard - Back

Finding: Fencing - Deteriorated/leaning

Information: It was noted at the time of inspection that sections of the right hand fencing has deteriorated and is leaning. Typically fencing deteriorates due to age and or wear, rot and or rust which is generally expected for a structure of this age, due to prolonged exposure to weather conditions. Sometimes inadequate installation or maintenance can be to blame.

If left unattended, it is likely that further damage will occur. It is suspected that repair of several elements of the fencing may be required however replacement may be a consideration of the client also.

A licensed fencing contractor should be appointed to provide further advice and perform rectification works as necessary.

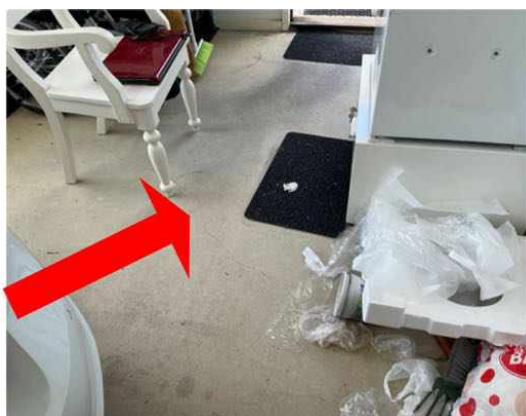
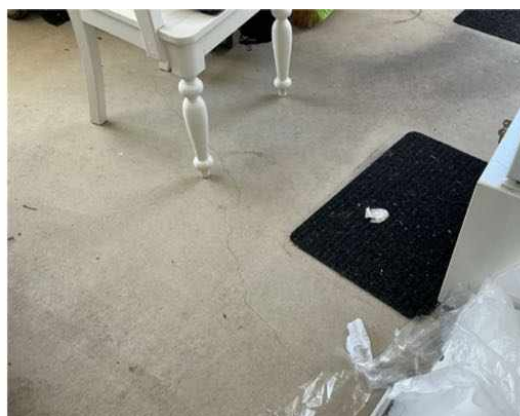
Finding 3.10

Location: Garage

Finding: Garage Cracking - Concrete Paving Damage Category 1 - Fine (less than 2mm)

Information: Fine cracks were identified in the garage concrete paving. Although fine cracks are quite noticeable, they are often only considered to be an appearance defect, and usually do not indicate any structural damage. To be considered a Category 1 or fine crack, the crack is found to be less than 2mm in width.

Generally the cause of a hairline crack in existing concrete paving such as driveways and pathways is indicative of the expansion and contraction of the concrete. Such causes are generally due to environmental factors, such as moisture levels, weather conditions, root systems of nearby trees or the soil types on which they are laid.

Fine cracks may also be due to poor original installation of the concrete. Factors such as poor compaction of the sub surface and/or inadequate reinforcing of the slab may create cracking and other secondary defects.

Monitoring of all cracking should be conducted frequently. Always contact a building inspector should cracks widen, lengthen, or become more numerous.

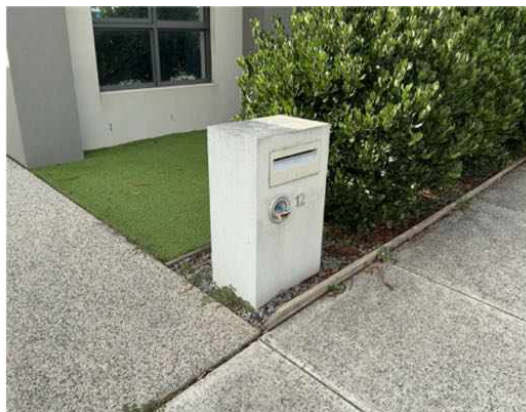
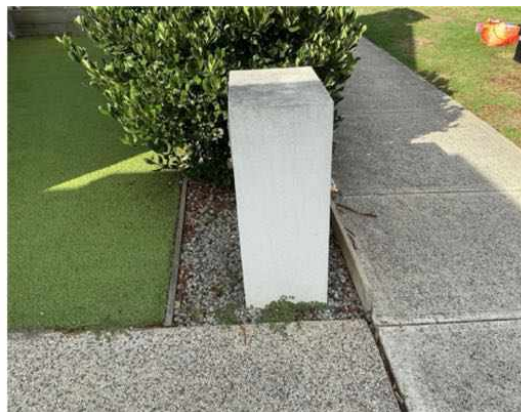
Finding 3.11

Location: Yard - Front

Finding: Letterbox is leaning

Information: It was noticed on inspection that the letterbox is leaning. This can happen overtime if not installed correctly or by tree roots causing movement. Recommend engaging a bricklayer to repair/replace to reduce the risk of future damage at the owners discretion.

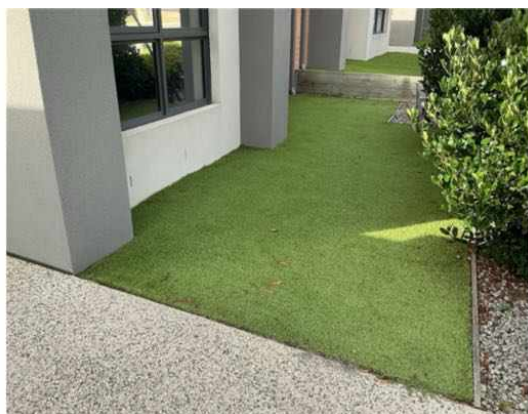
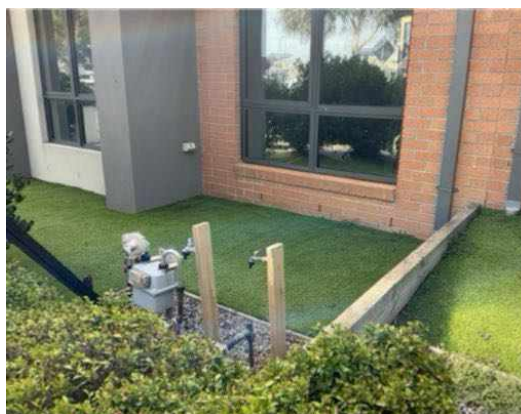
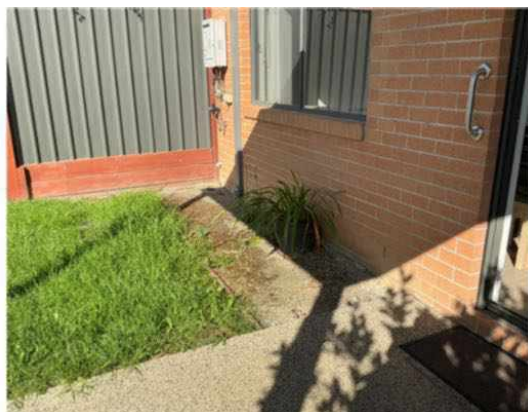
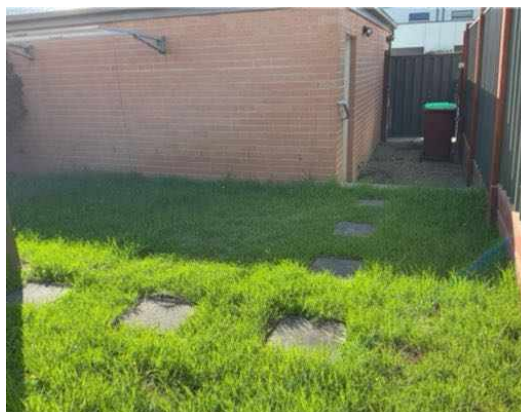
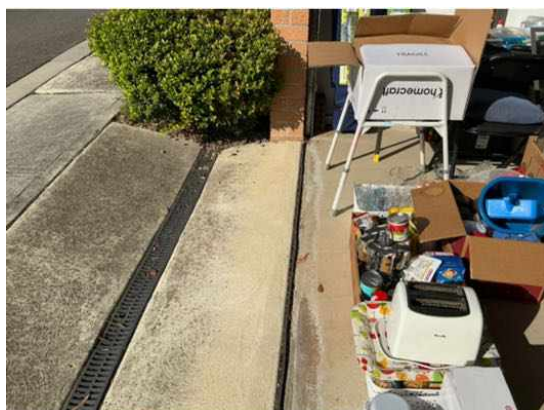
Finding 6.01

Building:	Main Building
Location:	Yards
Finding:	Site drainage - poor/inadequate
Information:	The site drainage to parts of the yards was found to be inadequate at the time of inspection, creating potential for subsequent water damage to associated building elements. Excessive moisture will attract termites.

It is important that water does not lie against the base of walls; surrounding paths and ground levels should be sloped to drain water away from walls. Downpipes should not discharge stormwater onto lower walls or plinths. Stormwater should be carried away by large, regularly cleaned drains. Ground levels may need to be lowered to expose a buried DPC.

Where site drainage is inadequate, installation of an Agricultural (Aggie) Drain may be required. A qualified plumber should be appointed to further inspect the property and perform any remedial works as necessary. Water damage and secondary defects are likely to occur if left unmanaged.

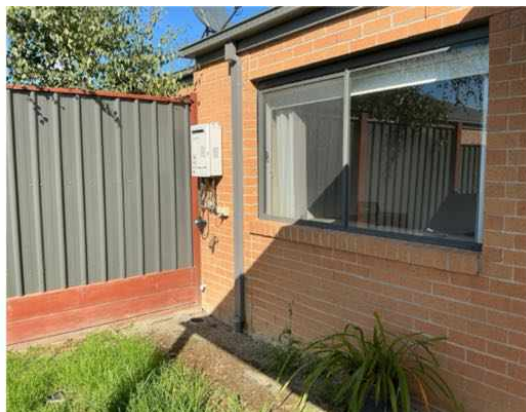
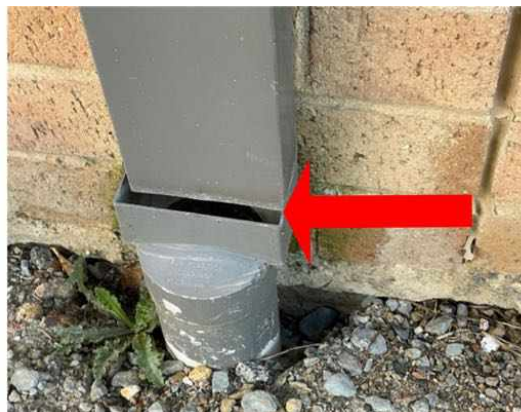
Finding 6.02

Building:	Main Building
Location:	Exterior walls - rear
Finding:	downpipe not properly connected to stormwater
Information:	The rear down pipe is not properly connected to stormwater. This disconnection negatively impacts the functional capacity of the plumbing.

Where plumbing doesn't drain adequately, the area at the base perimeter can become excessively damp, potentially creating an environment that is susceptible to rust and corrosion of surrounding building elements, as well as attracting termites and other pests.

It is highly recommended that a plumber be appointed to further inspect the area and to install adequate drainage equipment immediately where necessary.

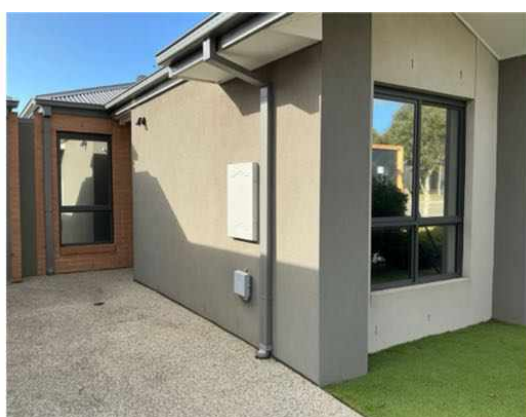
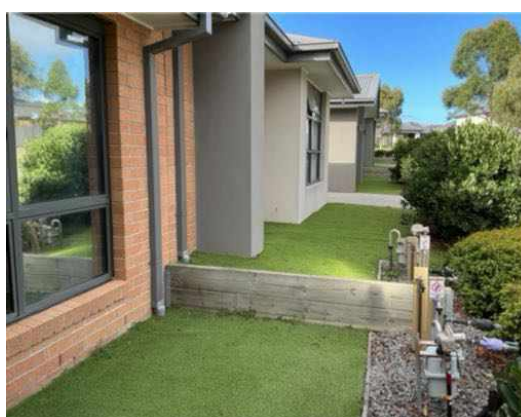
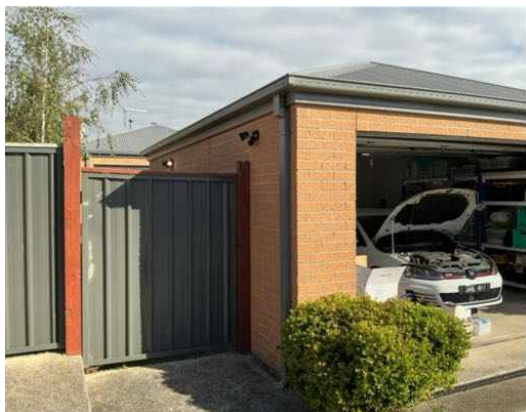
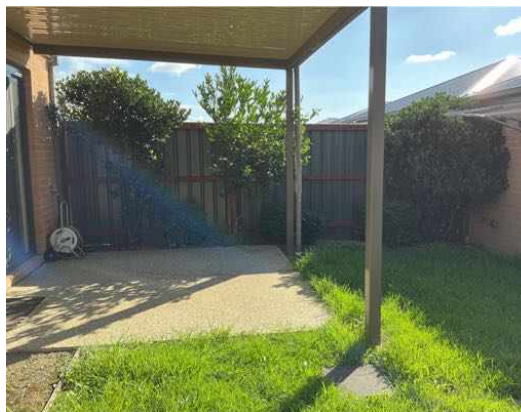
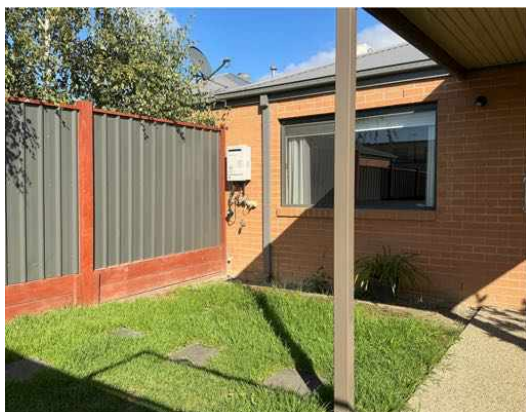
Finding 6.03

Building:	Main Building
Location:	Various parts of the building
Finding:	Bridging attachments to buildings
Information:	Bridging occurs when items against a building provide a concealed entry point for termites into the building or by passing around a termite management system.

Where any part of an attachment to a building is not isolated and is not provided with a clear gap of not less than 25mm from building, bridging occurs. Attachments to buildings such as hot water services, downpipes, verandahs, decks, steps, fences, service conduits and the like provide the opportunity for concealed entry.

Building attachments of this nature need to be frequently inspected for termite activity by a qualified inspector.

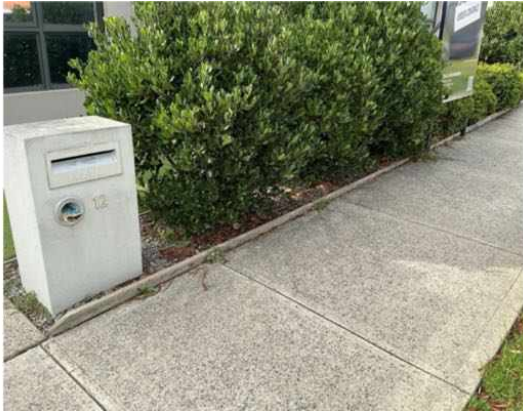
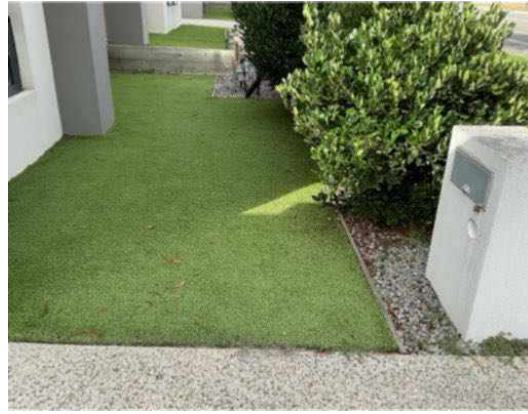
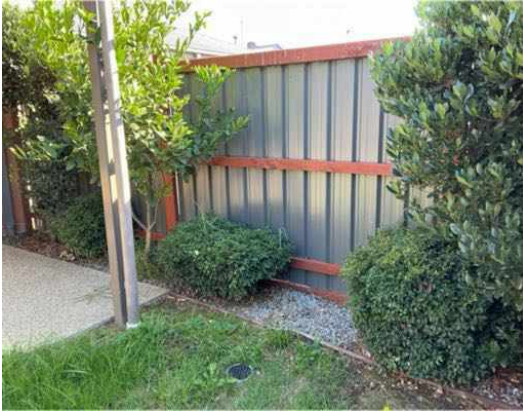
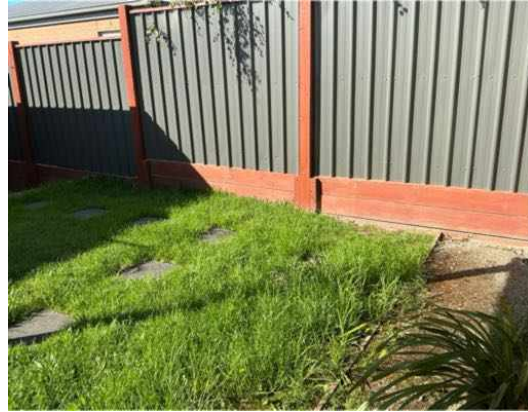
Finding 6.04

Building:	Main Building
Location:	Various parts of the building
Finding:	In ground contact
Information:	Any timbers in direct ground contact provide opportunity for concealed termite entry and are likely to be subject to premature rot and decay as the soil retains moisture or damp conditions against the timbers.

Remove untreated timber that is in direct contact with external grounds. Consider replacement with more durable materials i.e. treated timber or non timber elements. Frequent pest inspections are advised to readily identify any termite activity in these areas.

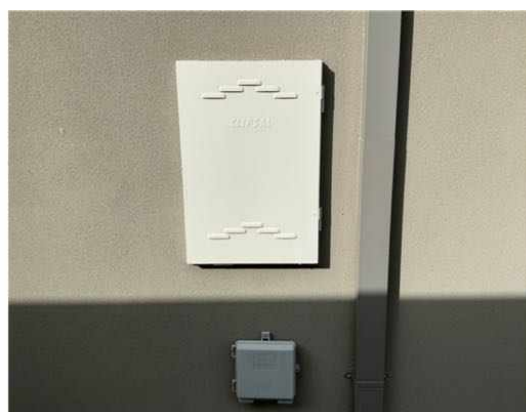
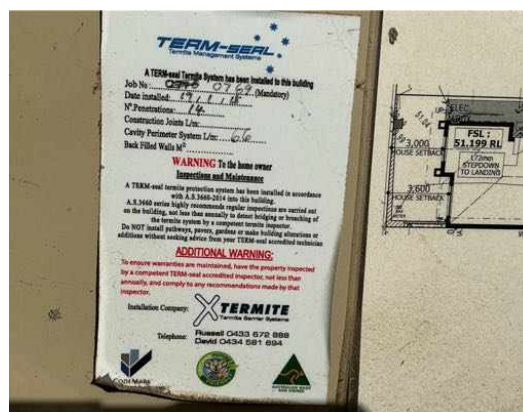
Where a Termite Management System has been identified you should refer to the type of barrier date of installation warranty conditions and any documentation provided by a builder or past owner. Consult the company who installed the barrier to confirm whether the system is still under warranty.

Most chemical termite management systems expire and require replenishment and all physical systems are primarily designed to prevent concealed entry.
