Building and Timber Pest Inspection Report

Inspection Date: Tue, 3 Mar 2026

Property Address: 17 Webb Ave, Seymour VIC 3660, Australia

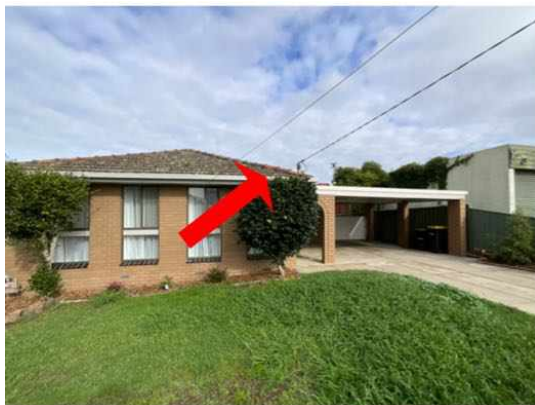
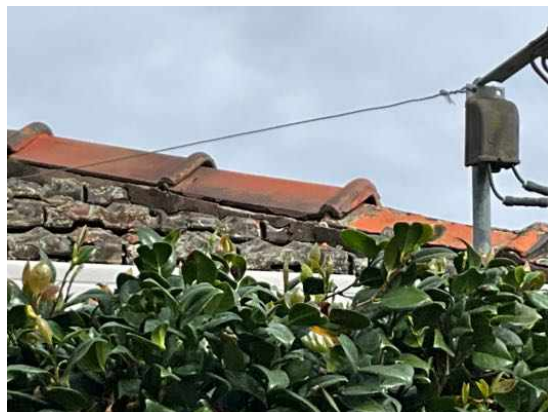
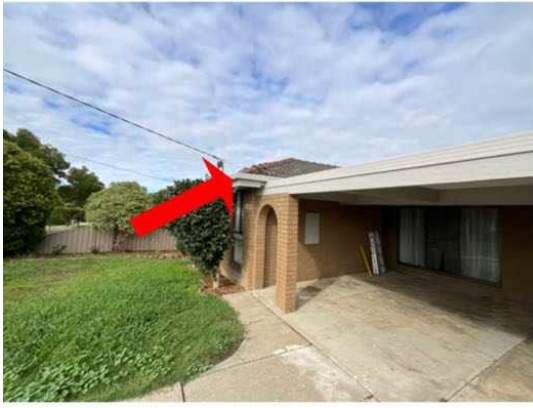
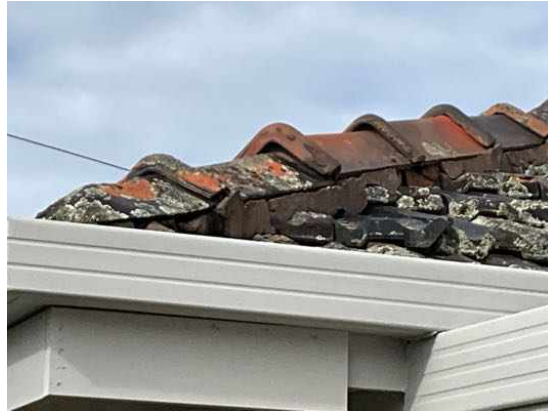
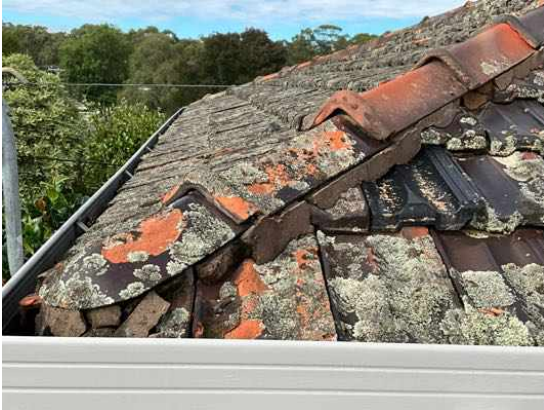
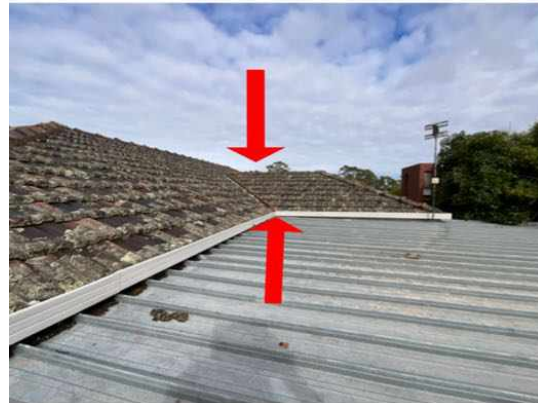
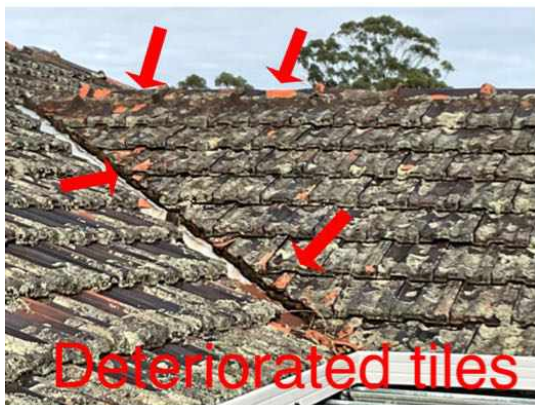
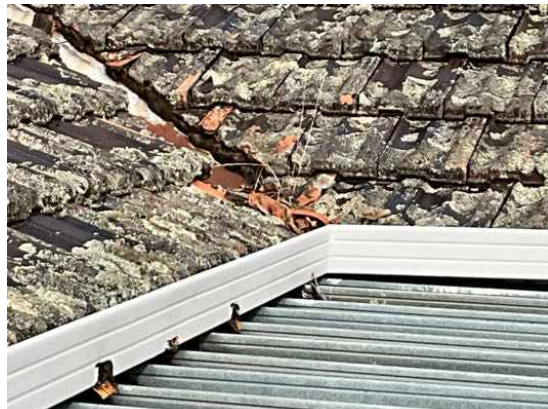
Finding 3.01

Building: Building 1
Location: Roof Exterior
Finding: Roof tiles - Weathered
Information: Upon inspection of the exterior roofing, the majority of roof tiles were considered to be in a fair condition. While weathering of the tiles is consistent with the age of the property, maintenance works are required.

Isolated areas of mortar have come loose in the valleys and minor cracking is also present. Re-pointing and re-sealing the may be considered as an interim solution by the client to help preserve and extend the life span of the tiles.

Where left unmanaged, deteriorating roof tiles are likely to lead to a number of secondary defects, including minor water leaks and weather exposure to internal roofing structures.

Consultation with a roofing contractor is highly advised to gain advice on cost of remedial works that may be required in the short to medium term. Remedial works are likely to increase the longevity of the exterior roofing structure.

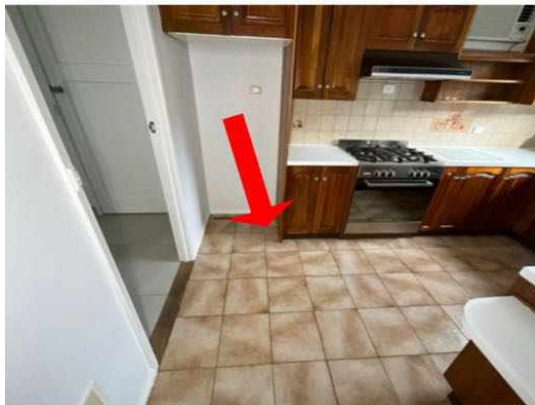
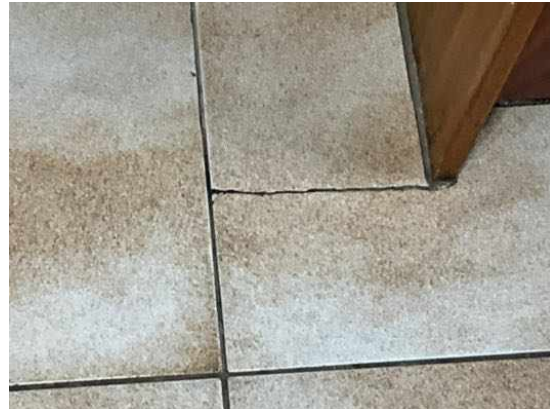
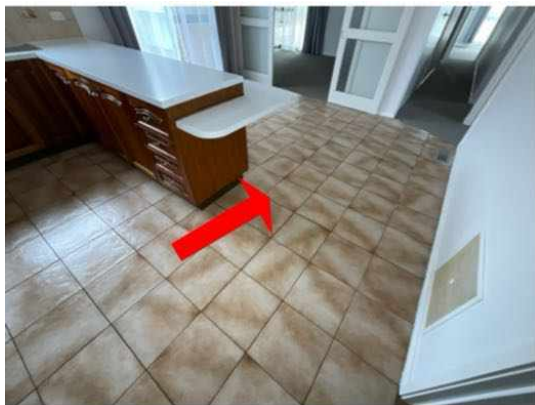
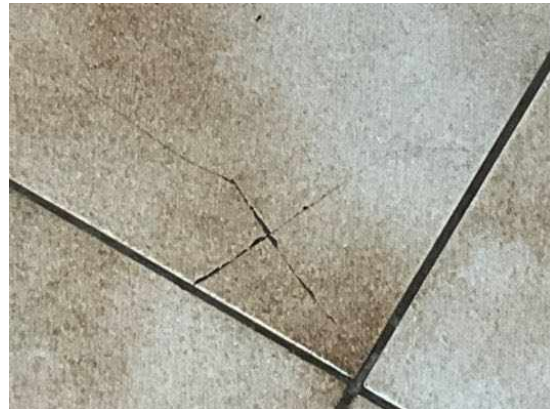
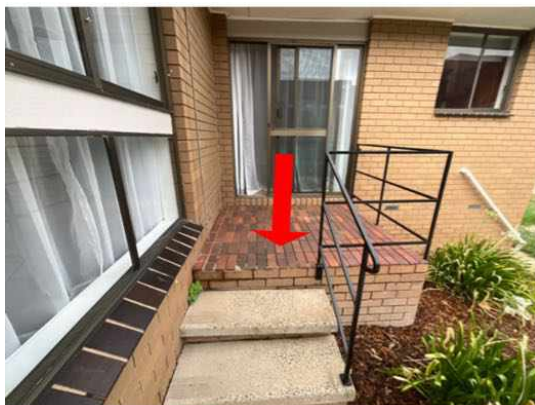
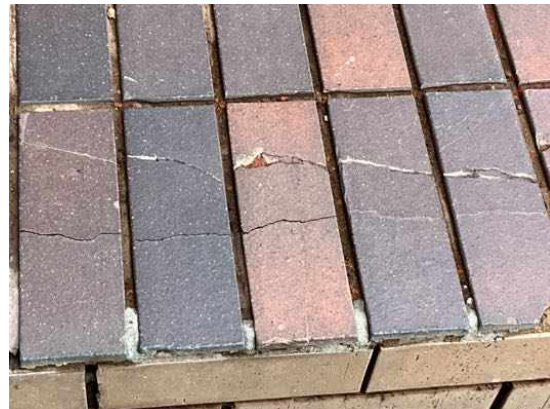
Finding 3.02

Building:	Building 1
Location:	Kitchen, back door
Finding:	Cracked floor tiles
Information:	Cracking in the floor tiles was evident in this area at the time of inspection. It is suspected that this cracking has occurred as a result of minor settlement or impact damage.

Cracked tiles throughout the household detract from the overall appearance of the affected areas however it is unlikely to create or lead to any secondary defects.

While not considered a matter of urgency, replacement of cracked floor tiles is

recommended at the clients discretion. A tiling contractor may be appointed to perform these works. Where cracks become more numerous, contact a licensed building inspector for further investigation.

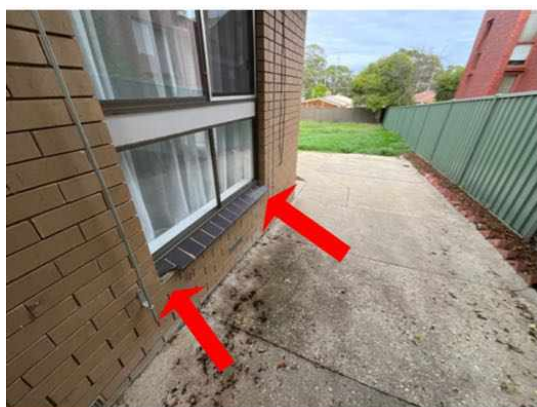
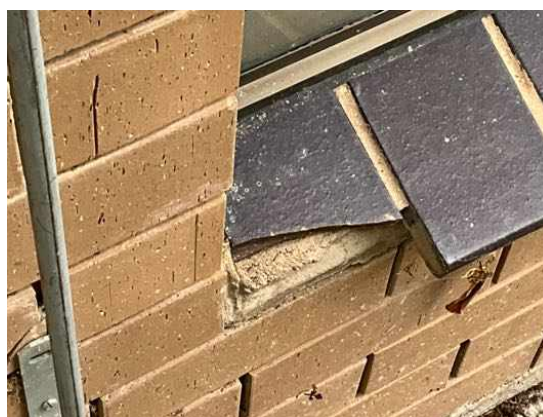
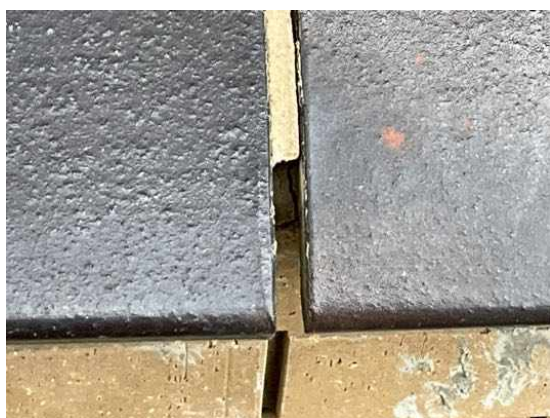
Finding 3.03

Building:	Building 1
Location:	Yard - Side
Finding:	Brickwork - Deteriorated mortar
Information:	Mortar, or 'bedding', is the material which fills joins and intersections between bricks in masonry walls and structures. Sections of mortar in this brickwork were identified as having deteriorated, which is generally expected for a property of this age and

condition.

Mortar may deteriorate as a result of age of building materials, minor movement of bricks, or frequent exposure to weathering. Mortar should be replaced to ensure that bricks remain in their intended location and to prevent gaps, which would allow water or moisture ingress and secondary damage as a result.

Mortar deterioration can be addressed by a bricklayer where areas of deterioration are localised and easily accessible. Alternatively, appointment of a registered builder is advised, to repoint large areas of decaying mortar. Where secondary structural defects have become evident, consultation with a structural engineer may be required.

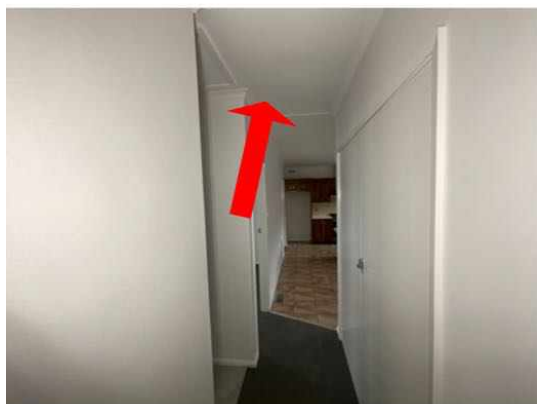
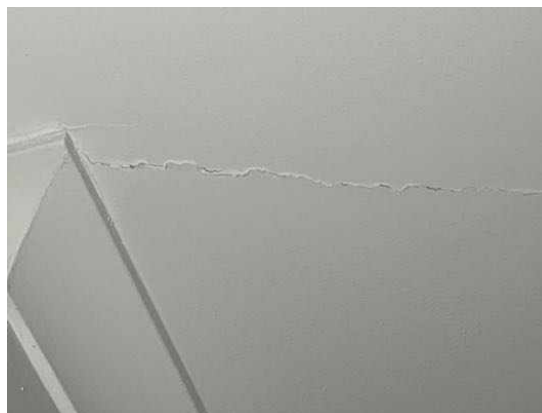
Finding 3.04

Building:	Building 1
Location:	Hall
Finding:	Cracking - Damage Category 1 - Fine (up to 1mm)
Information:	Although fine cracks are quite noticeable, they are often only considered to be an appearance defect, and usually do not indicate any structural damage. Generally, the cause of a fine crack is indicative of a separation between building materials and finishes (e.g. paint, plaster, etc.) along joins.

Cracking of this nature can generally be repaired with minor sanding, filling and/or repainting. Such works should be performed by a qualified painter or a general

handyman.

Monitoring of all cracking should be conducted frequently. Always contact a building inspector should cracks widen, lengthen, or become more numerous.

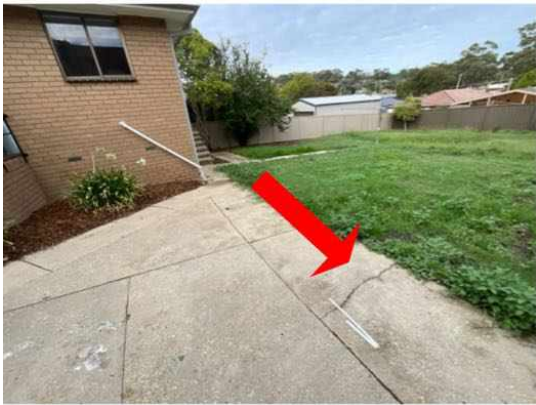
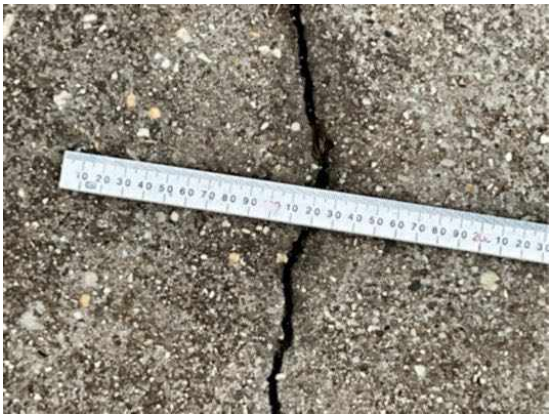
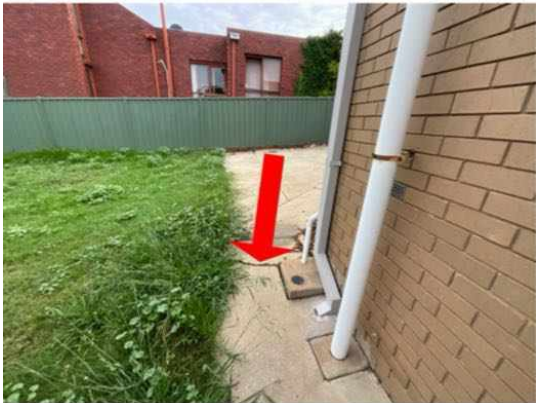
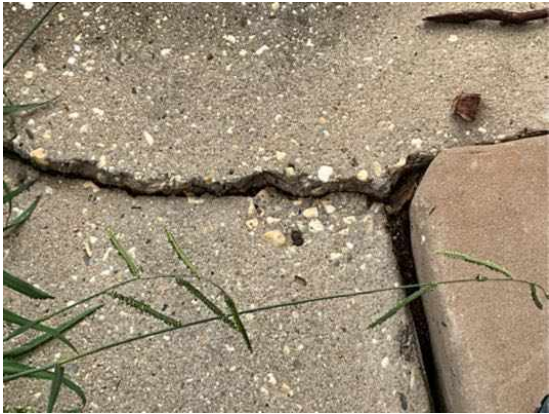
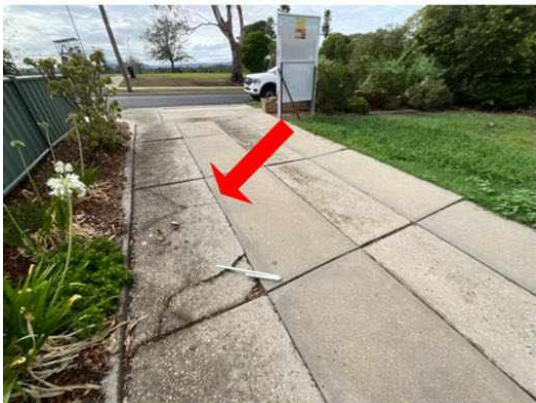
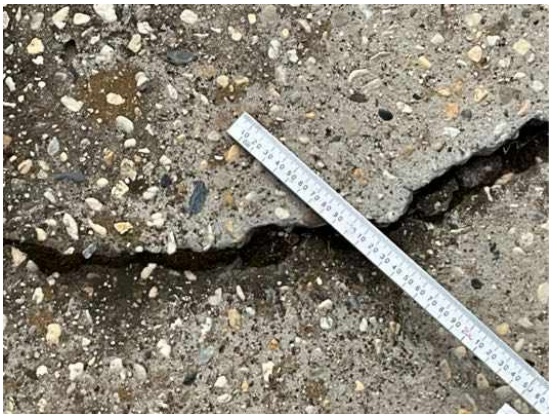
Finding 3.05

Building:	Building 1
Location:	Yard - Back, driveway
Finding:	Cracking - External Concrete Paving Damage Category 4 - Gaps in Slab (4mm - 10mm +)
Information:	Gaps in the slab were identified in external concrete paving. Gaps in the slab are significant and are likely to lead to the development of safety hazards and secondary defects if left unmanaged, such as the creation of a trip hazard.

General age and expected deterioration of the paved areas is a common cause of this type of cracking. However, expansion and contraction of the slab may also have occurred due to environmental factors. Such factors include variable moisture and weather conditions, the presence of trees and their roots having a settling or lifting affect on the soil, or the effect of load bearing, e.g. heavy vehicles over a sustained period of time.

Cracking to this degree may also be due to poor original installation of the concrete. Factors such as poor compaction of the sub surface and/or inadequate reinforcing of the slab may create cracking and other secondary defects. Gaps in the concrete paving may also have a more significant structural cause, such as subsidence of soils.

Where gaps in the concrete paving are adjacent to structural elements of the building, the advice of a Structural Engineer is advisable before undertaking repairs. Significant repair and likely replacement of the concrete paving is probable.

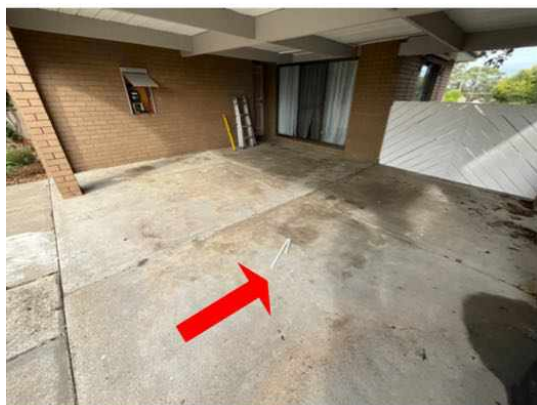
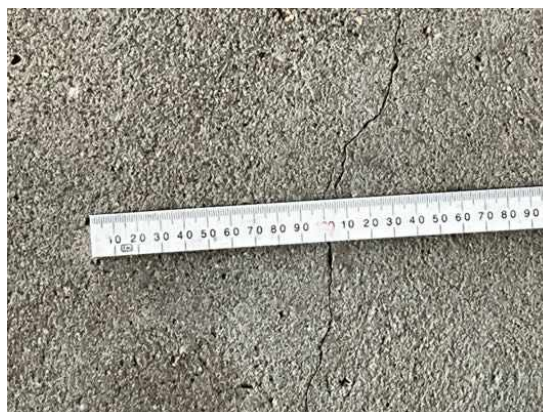
Finding 3.06

Building: Building 1
 Location: Carport
 Finding: Cracking - External Concrete Paving Damage Category 1 - Fine (less than 2mm)
 Information: Fine cracks were identified in external concrete paving. Although fine cracks are quite noticeable, they are often only considered to be an appearance defect, and usually do not indicate any structural damage. To be considered a Category 1 or fine crack, the crack is found to be less than 2mm in width.

Generally the cause of a hairline crack in existing concrete paving such as driveways and pathways is indicative of the expansion and contraction of the concrete. Such causes are generally due to environmental factors, such as moisture levels, weather

conditions, root systems of nearby trees or the soil types on which they are laid.

Fine cracks may also be due to poor original installation of the concrete. Factors such as poor compaction of the sub surface and/or inadequate reinforcing of the slab may create cracking and other secondary defects.

Monitoring of all cracking should be conducted frequently. Always contact a building inspector should cracks widen, lengthen, or become more numerous.

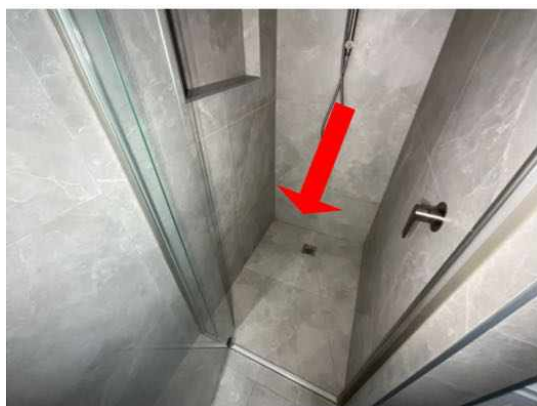
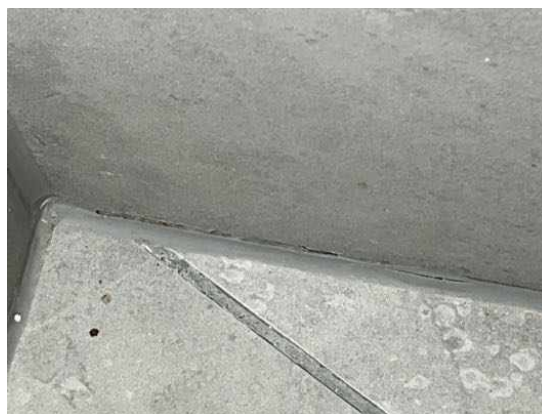
Finding 6.01

Building:	Building 1
Location:	Bathroom
Finding:	Inadequate sealant or Grout
Information:	This area has a lack of effective Sealant or Grout. This is allowing the ingress of water to the structure inside the wall.

The presence of water encourages Termite attack, Mould and Fungal Decay.

A Tiler or General Handy person must be contacted as soon as possible to effect repairs and prevent further deterioration.

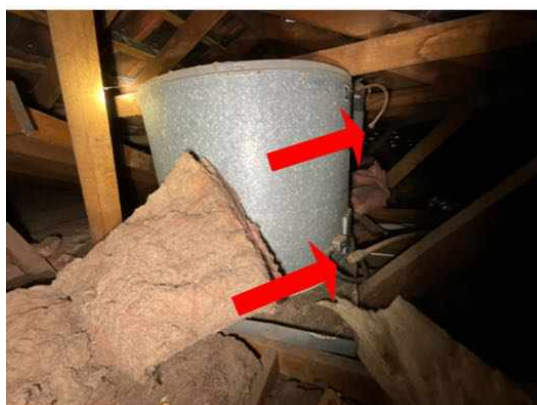
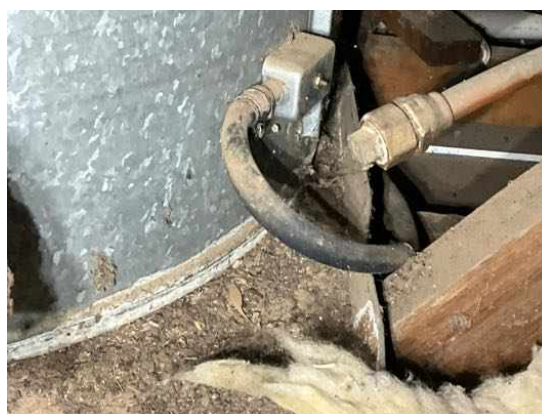
Finding 6.02

Building:	Building 1
Location:	Roof Void
Finding:	Gravity-Fed HWS - Disconnected
Information:	It was noted at the time of inspection that a disconnected gravity-fed hot water system (HWS) remains in this area.

Despite this plumbing structure being unused, it is likely to be storing residual water, and is therefore susceptible to rust and corrosion. If allowed to continue, rust and corrosion is likely to lead to damage to adjoining building elements, and may also make the area susceptible to termite or timber pest activity.

While it is a costly exercise to remove the disused gravity-fed HWS, it is advisable in the short-term future to prevent any further damage to the area. Further consultation with a licensed plumber is required to gain further advice on removal of the structure.

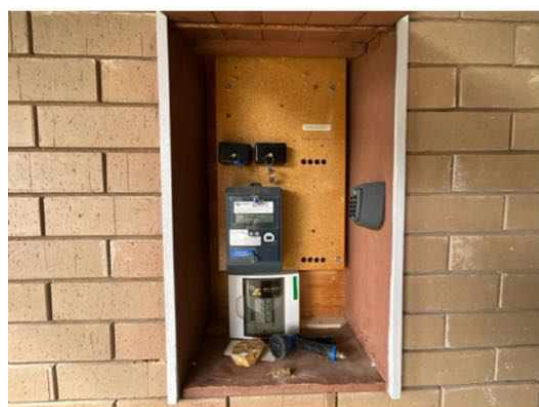
Finding 6.03

Building:	Building 1
Location:	All External Areas
Finding:	Termite Management System - no evidence of a chemical installation
Information:	The application of a post-construction chemical termite barrier is highly recommended

for all properties, particularly if live termite activity has been found on the site previously. Such barriers are highly effective in preventing termite attack on any timber building elements throughout the property.

A durable notice should be placed in the switchboard unit to indicate current termite barriers. At the time of inspection, it appeared as though no termite management system has been installed, with no evidence to suggest preventative works taking place.

The client may consider gaining further advice from a pest controller as to the costs and procedures involved with this application. It is recommended that obtaining such advice be a short-term priority.

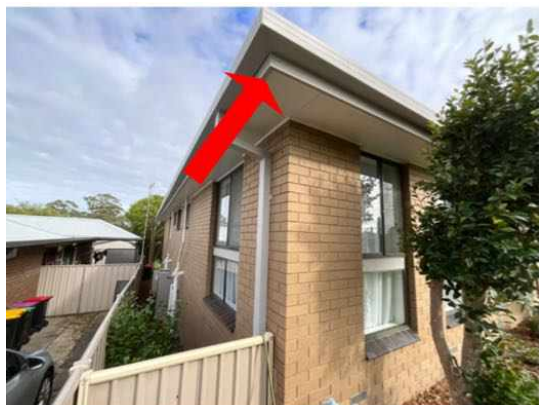
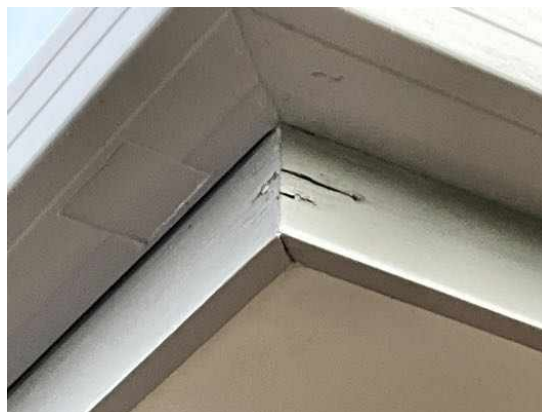
Finding 7.01

Building:	Building 1
Location:	Eaves
Finding:	Fungal decay - present (localised)
Information:	Fungal decay also known as wood decay or wood rot generally refers to the deterioration of timber elements when in contact with excessive levels of moisture for a prolonged period of time.

The development of fungal decay is accelerated by temperatures in the range of 5degreeC to 40degreeC as well as the presence of oxygen. Generally fungal decay develops on timber elements that are in use in an external environment which are exposed to rain penetration.

In this case although the affected timber element is in a decaying state the extent of any visible damage appears to be localised to a specific area and is yet to spread to other parts of the building element or affect adjoining structures. The fungal decay is therefore likely to be of a relatively superficial nature with minimal impact on the structural integrity or tensile strength of the timber element.

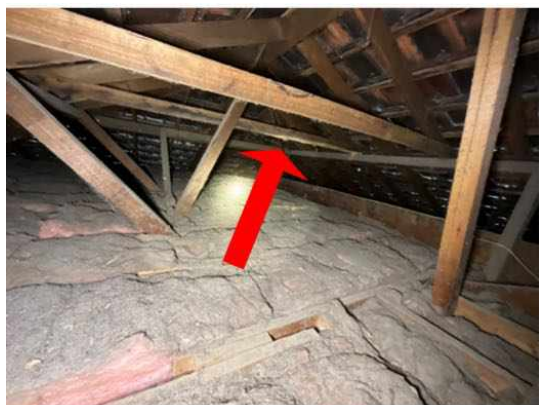
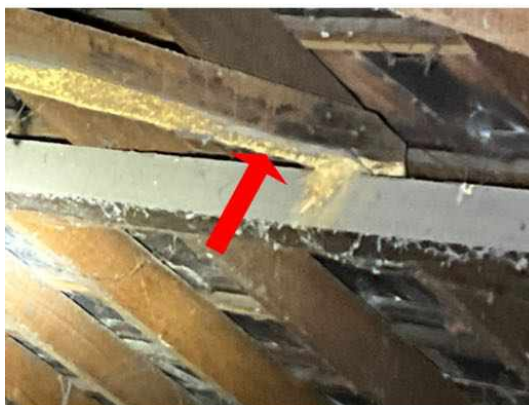
Finding 8.01

Building:	Building 1
Location:	Roof Void
Finding:	Evidence of wood borer activity identified
Information:	Wood borers small beetles that colonise in exposed timber elements are a common timber pest that are regularly mistaken for termites. Although wood borer activity is generally not detrimental to the affected timber they may lead to serious damage and necessitate replacement of certain building elements if left unattended.

The Lyctid borer which generally attacks hardwoods such as subfloor and roofing structures is generally identified by fine dust, surrounding the affected timbers.

The other commonly known borer the Anobium borer is more likely to attack floorboards and may cause severe structural damage to flooring areas.

As no live wood borer activity was identified treatment is not required at this time. Replacement of affected timbers may be considered by the client for superficial reasons.

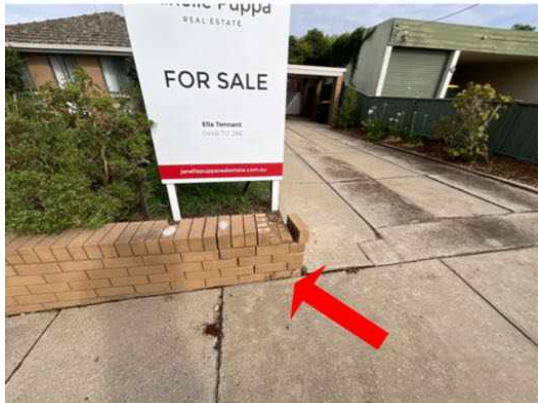
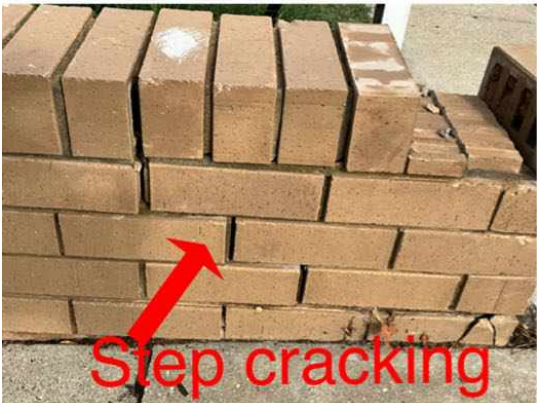
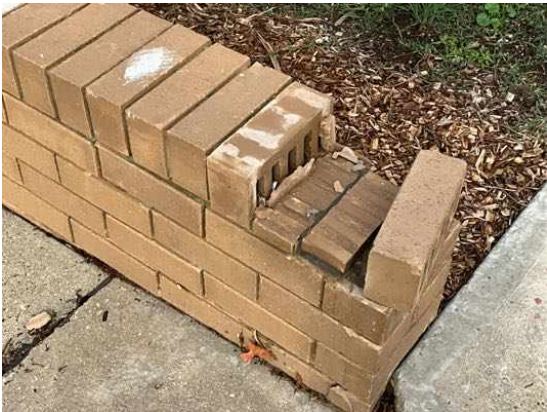
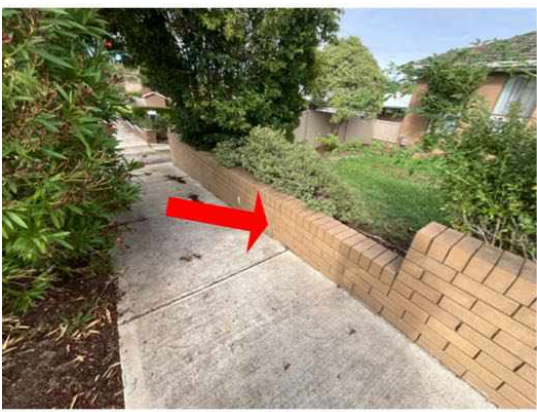
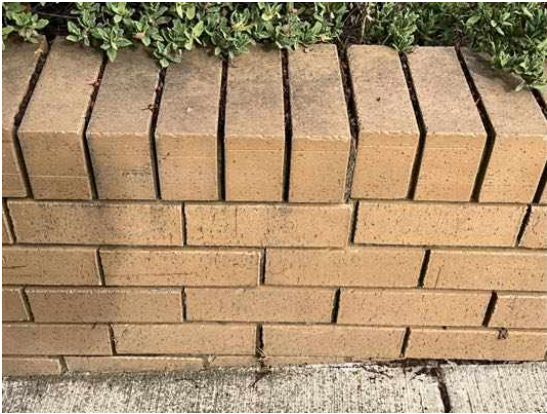
Building: Building 1
Location: Front fence
Finding: Brickwork- Step cracking
Information: Step cracking was identified to the brickwork in this area at the time of inspection. Step cracking, which is similar to other forms of cracking, has a variety of possible causes. However, the most common is the subsidence of adjacent footings.

Step cracking is a relatively common defect, and is most likely to occur adjacent to windows, doors and other openings. Mortar failure in the gaps between affected bricks indicates the stresses and tensions affecting the wall.

Minor step cracking can be used as a warning sign to address factors causing stress to the wall, which can include the effect of surrounding trees, water leaks, soil erosion, or even the presence of reactive soils in the surrounding area.

If cracks increase in size or number contact a Licensed builder immediately to make all needed repairs.

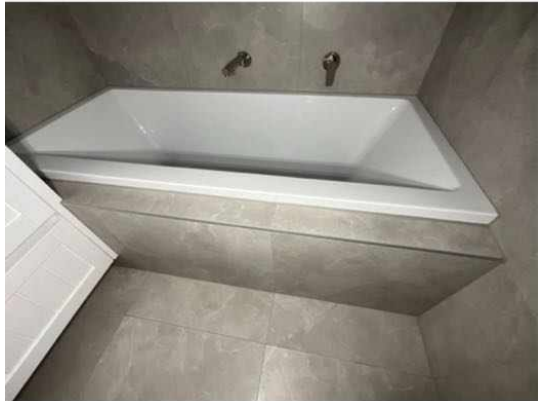
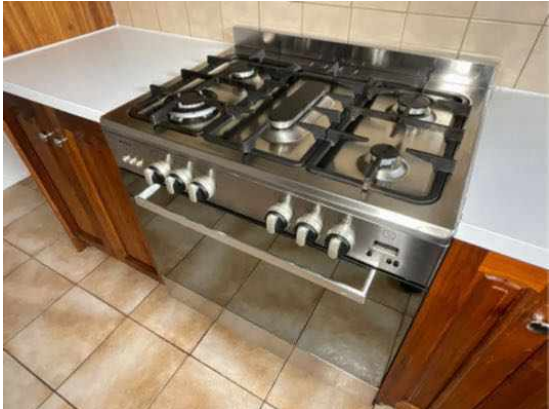
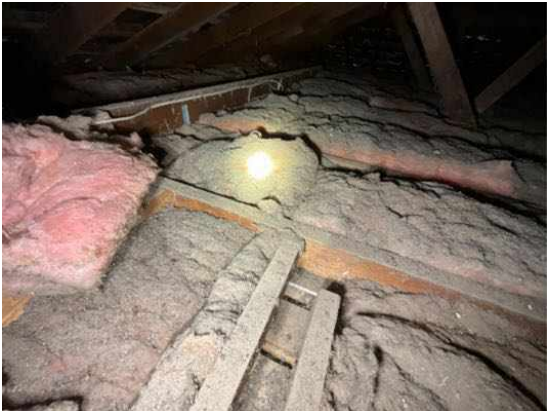
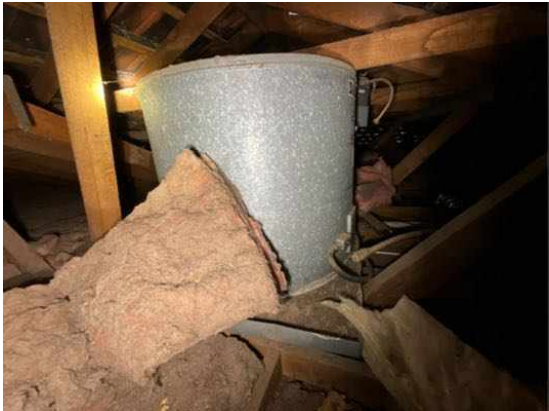
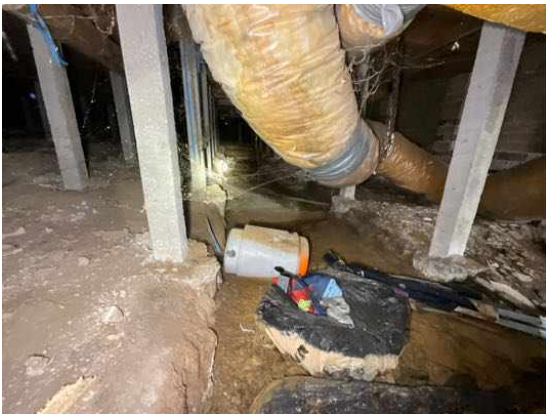
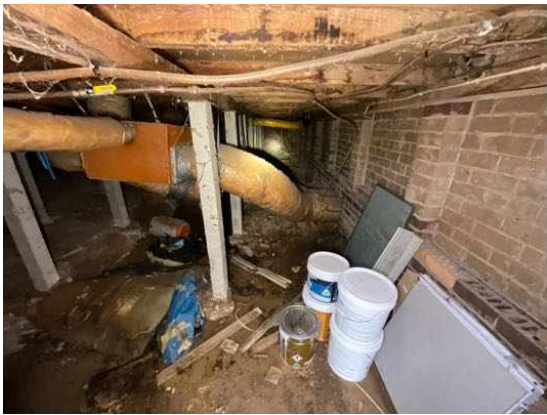
Building: Building 1
Location: All Areas
Finding: Additional Photos - Obstructions and Limitations
Information: These photographs are an indication of the obstructions and limitations which impeded full inspection of the property at the time of inspection. These obstructions can hide an array of defects and should be removed to allow full inspection to be carried out. A re-inspection is recommended once the areas are made accessible.
