Building and Timber Pest Inspection Report

Inspection Date: Mon, 2 Mar 2026

Property Address: 24 Carroll St, North Melbourne VIC 3051,
Australia

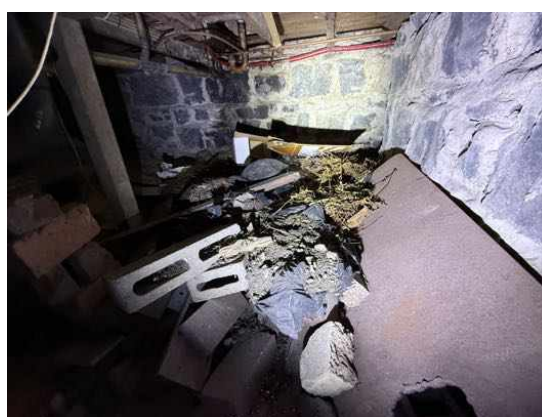
Building:	Main Building
Location:	Bathroom/ subfloor
Finding:	Bathroom Waterproofing Failure & Active Subfloor Leakage
Information:	Significant defects were observed within the bathroom shower enclosure and the associated subfloor area. Internally, visible cracking to multiple shower wall tiles and junctions was noted, along with deteriorated and missing grout to vertical and horizontal joints. These defects compromise the integrity of the tiled surface and allow water ingress behind the wall lining. Gaps at wall junctions and failed sealant indicate the waterproofing system is likely breached.

Subfloor inspection revealed extensive and active moisture ingress beneath the bathroom. Water staining, damp masonry, and wet timbers were observed directly below the shower area. Importantly, moisture was not limited to the waste/drain location; active dripping and dampness appear to be tracking from wall areas, raising

concerns of a leaking supply line and/or concealed plumbing within the wall cavity. Pipework showed signs of prolonged moisture exposure, and surrounding structural timbers are at risk of ongoing saturation.

The extent of moisture present indicates a long-standing leak rather than minor seepage. Continued exposure of subfloor framing to elevated moisture levels may result in timber decay, reduced structural capacity, fungal growth, and increased risk of termite activity due to persistently damp conditions.

Urgent rectification is recommended. A licensed plumber should be engaged immediately to pressure test supply lines, inspect concealed pipework, and identify all active leak sources. Following plumbing repairs, a full bathroom strip-out and replacement of the waterproofing membrane system in accordance with current standards is likely required. Affected subfloor timbers should be assessed for structural integrity and replaced where deterioration is identified. Prompt action is necessary to prevent further structural damage.

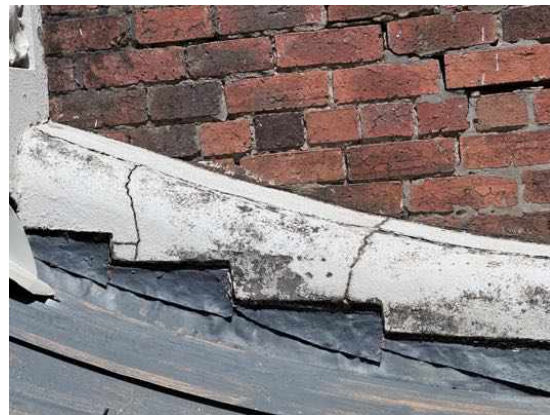
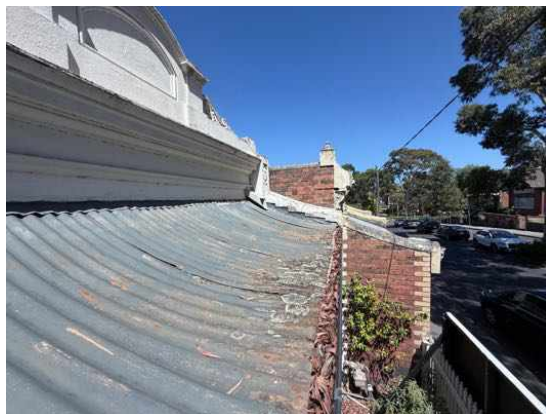
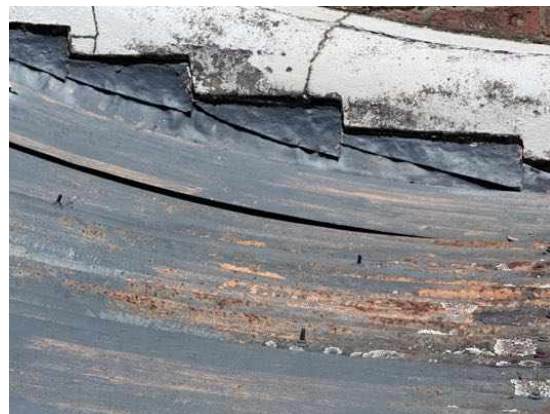
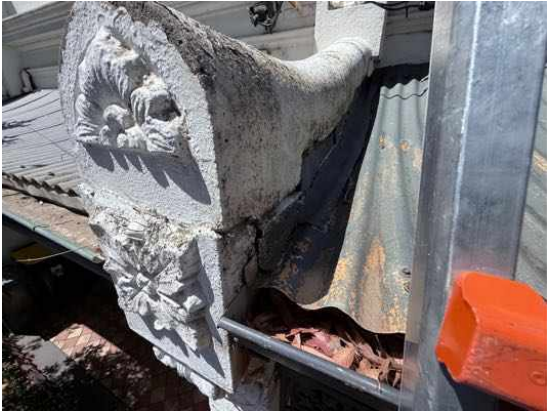
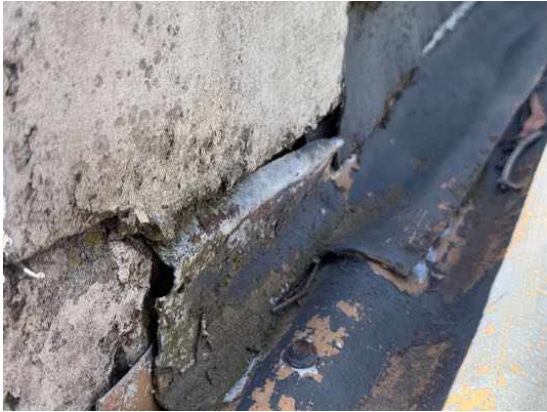
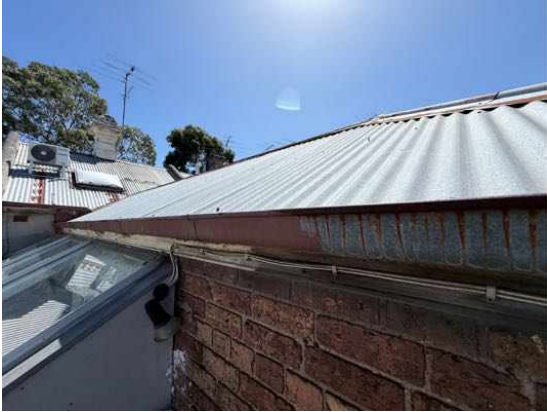
Finding 2.02

Building:	Main Building
Location:	Roof Exterior
Finding:	Roofing, Flashings & Gutters (Advanced Corrosion- moderate to major)
Information:	The metal roof sheeting, associated flashings, ridge/valley cappings and perimeter gutters exhibit widespread surface corrosion and localised advanced rusting at multiple locations. In several areas, protective coatings have deteriorated, with visible oxidation and rust tracking evident along laps, fixings and sheet junctions. The corrosion appears progressive in nature and, if left unaddressed, may result in sections becoming wafer-thin, particularly to flashings and guttering components which are more susceptible to water retention and accelerated decay.

Although no active internal leakage was detected at the time of inspection, the current condition presents an elevated risk of future water ingress. It is also noted that ceilings have been recently painted, which may temporarily obscure historical staining or minor seepage. Given the age and visible deterioration of the metal elements, performance reliability cannot be assured.

Rectification is recommended in the short to medium term. A licensed roofing contractor should undertake a comprehensive assessment to determine the extent of metal thinning, treat or replace affected sections (including flashings and gutters), and ensure all junctions and penetrations are adequately sealed to mitigate the risk of water ingress and consequential internal damage.

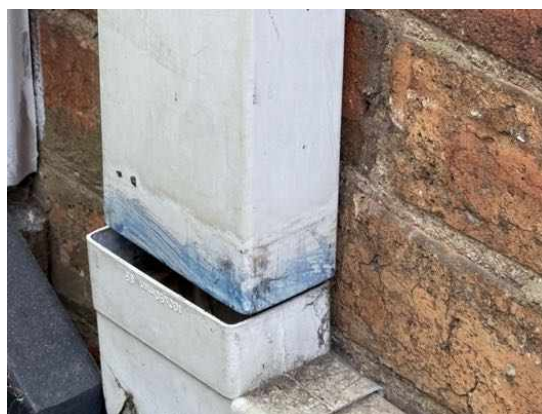
Finding 3.02

Building:	Main Building
Location:	Exterior walls - rear
Finding:	Overflow - Not plumbed for drainage adequately
Information:	The overflow is not plumbed or connected to suitable drainage, which has resulted in the surrounding area becoming excessively damp. These damp conditions can lead to secondary defects such as rot, rust or corrosion of associated building elements, the formation of fungal decay, or even the creation of potential slip hazards. When coupled with poor site drainage, pooling of water may also attract termite activity to this area. It is highly recommended that a qualified plumber be appointed to install adequate drainage to the overflow. These works will ensure that the area remains dry and free of any secondary defects.

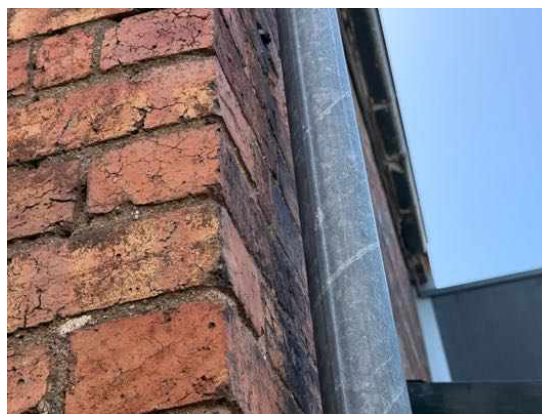
Finding 3.03

Building:	Main Building
Location:	Exterior walls - rear
Finding:	Pipework - Not clipped off
Information:	Plumbing pipes in this area have not been correctly clipped off (secured) to the adjoining structure. Where pipes have not been clipped off, they are more susceptible to impact damage and moisture damage, particularly if they are in direct contact with the ground.

A qualified plumber should be appointed immediately to provide adequate clipping for the plumbing pipes. Failure to do so may necessitate repair works to affected plumbing pipes, which may be a costly exercise.

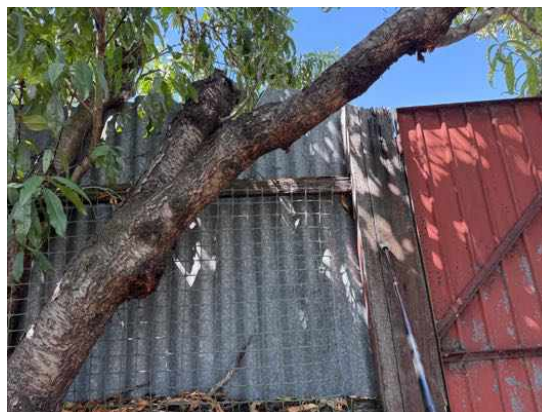
Finding: Fence-Bowed
 Information: Vertical bowing and horizontal bending is caused by lack of resistance to vertical pressures from foundations or horizontal pressures from a range of causes e.g. environmental conditions. If left unmanaged, bowing and bending may eventually lead to fence collapsing. As such, any bowing or bending of fence should be rectified as soon as possible.

Where bowing is less severe, a registered builder, in association with qualified trades, should be appointed to perform remedial works.

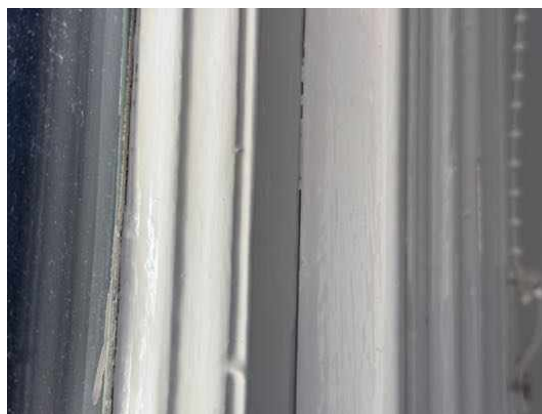
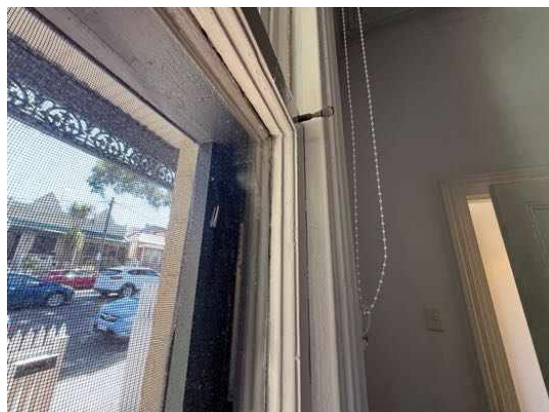
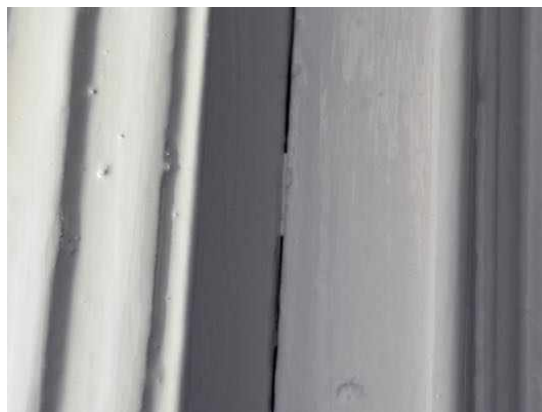
Windows provide ventilation to the adjoining area and should be at a fully operational level to ensure user comfort. Restricted function of the window may also pose as a potential safety hazard if required for emergency egress from the building.

Where windows have been painted shut the seal of the paint needs to be broken. This is generally done by breaking the seal of the paint and then maintaining the sash tracks clearing and lubricating them with silicone. Remedial paint work will likely be required and can be completed along with the rest of the remedial works necessary by a general handyman.

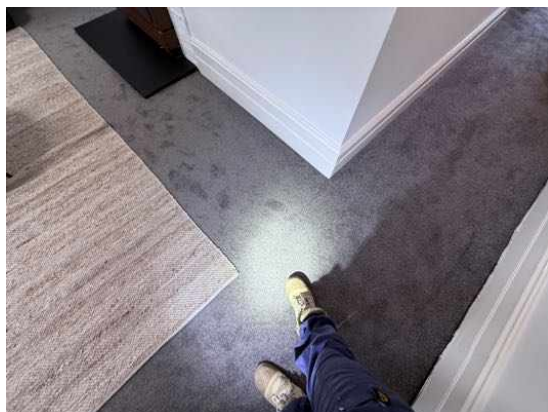
Finding 3.08

Building:	Main Building
Location:	Some Internal Areas
Finding:	Squeaking floors
Information:	The noise that you hear when you step on a floorboard (or floorboards) is usually a result of loose boards. The bounciness and movement in these loose boards causes them to rub together or onto a fixing nail or floor joist which, in turn, creates an unpleasant and annoying noise referred to as creaking or squeaking.

1. Incorrect nails being used to secure the floor to the joist.
2. Nails being fitted inadequately
3. A gap between the top of the floor joist and the underside of the subfloor.
4. An issue with the supporting joists underneath the boards

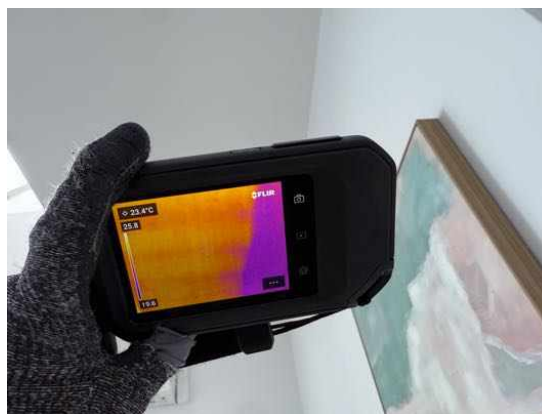
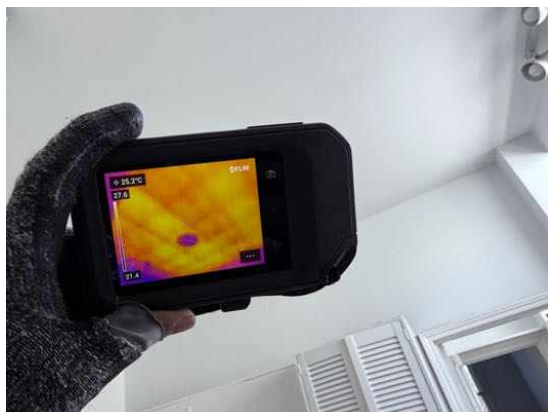
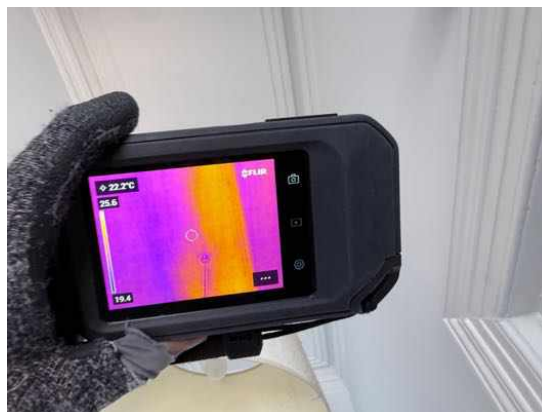
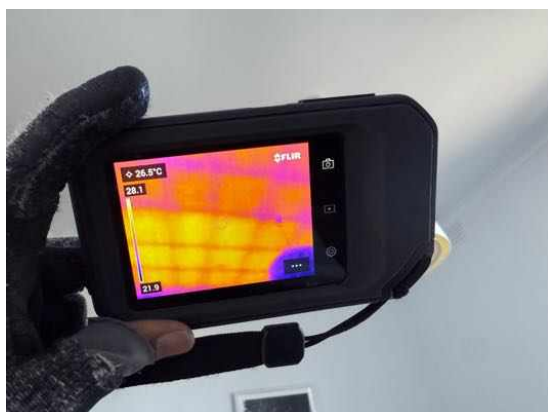
Finding 3.09

Building:	Main Building
Location:	Roof Void
Finding:	Insulation - Missing
Information:	Upon inspection of the roof void it was noted that insulation is not present.

Insufficient insulation will result in a comparatively higher cost to heat and cool a property as there is a lack of Insulation (or uneven coverage of insulation) which works as a barrier to heat transfer. This helps to keep out unwanted heat in summer and preserves warmth inside your home in winter. It can also help soundproof your home from unwanted airborne noise transfer.

Where insulation is absent, the area does not meet current Australian Standards. Installation of adequate insulation is required and should be conducted as soon as possible.

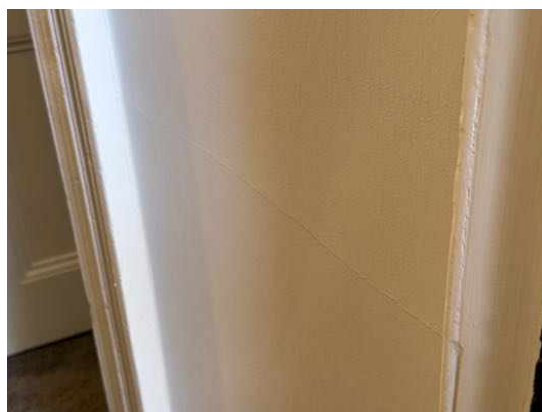
Finding 3.10

Building:	Main Building
Location:	Some Internal Areas
Finding:	Cracking - Damage Category 1 - Fine (up to 1mm)
Information:	Although fine cracks are quite noticeable, they are often only considered to be an appearance defect, and usually do not indicate any structural damage. Generally, the cause of a fine crack is indicative of a separation between building materials and finishes (e.g. paint, plaster, etc.) along joints.

Cracking of this nature can generally be repaired with minor sanding, filling and/or repainting. Such works should be performed by a qualified painter or a general handyman.

Monitoring of all cracking should be conducted frequently. Always contact a building inspector should cracks widen, lengthen, or become more numerous.

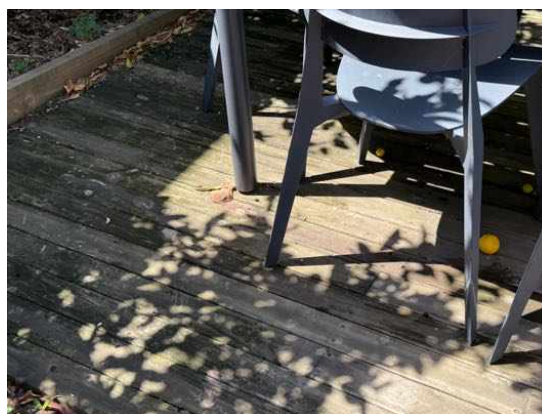
Building:	Main Building
Location:	Yard - Back
Finding:	Timber deck- High conducive condition.
Information:	We are unable to inspect under the timber deck if its in close proximity to the ground.

Where we are unable to inspect timber structures, decks and subfloor areas the risk of undetected termite activity is rated as extremely High.

We strongly recommend the purchaser prioritise a termite treatment by a Licensed Pest Controller to protect and maintain the asset as it is a timber structure.

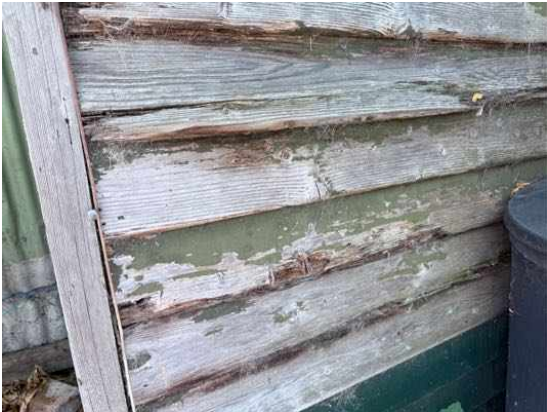
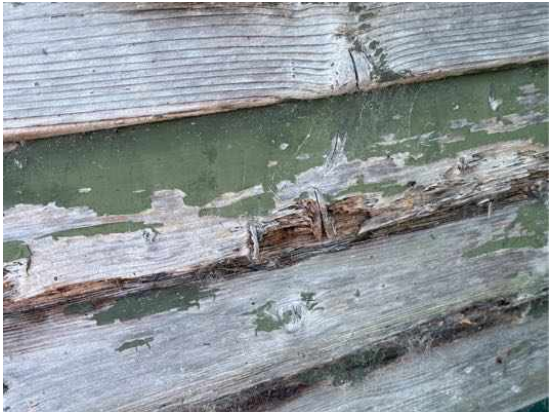
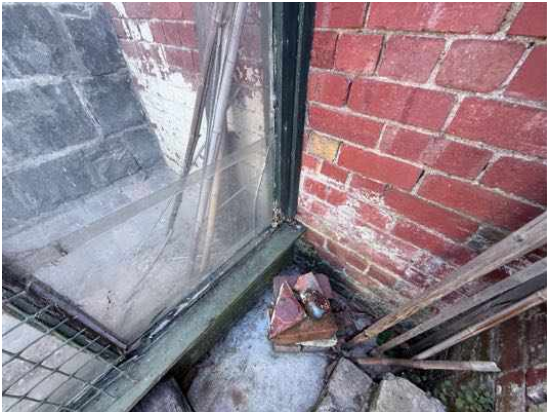
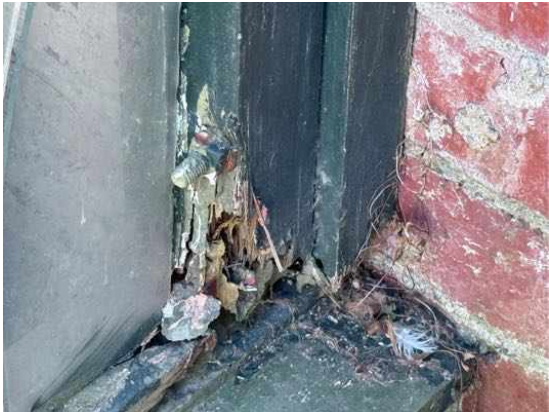
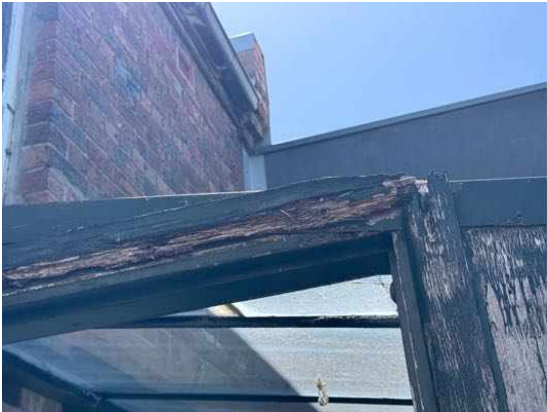
Finding 7.01

Building:	Main Building
Location:	All External Areas
Finding:	Wood rot
Information:	These building elements shows evidence of wood rot. Wood rot, also known as Fungal Decay, occurs when timbers and other cellulose building materials are exposed to damp conditions on an ongoing basis. This could be the result of exposure to weathering over a prolonged period of time, or the attraction of excessive moisture from other abutting building materials. Contributing factors also include poor air ventilation in the area.

Wood rot is often associated with general damp problems and is evidenced by a 'musty' smell or mould and mildew occurring on surfaces. If left unmanaged, damp conditions can lead to further health problems and the decay of timbers will continue. Can also boost termite activity.

the useful life of these building elements. Prior to any works being performed, the cause of the moisture that has created the visible wood rot should be identified and addressed in a suitable manner. Replacement of affected timbers may then be a necessary step in protecting surrounding building elements from such deterioration.

A qualified plumber may be appointed to assess the cause of excessive moisture and to provide advice on any remedial works as required. A qualified carpenter or registered builder may also be required to replace affected building materials.

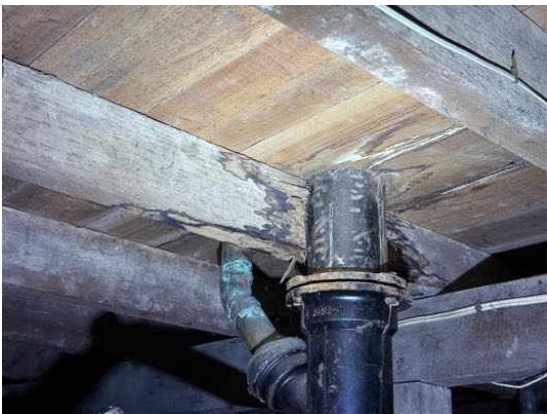
Finding 7.02

Building: Main Building
Location: All Areas
Finding: Timber- early stages of wood rot.
Information: Timbers that are frequently exposed to moisture require adequate protection in order to maintain their condition. Where leaks are not fixed or timbers have not been painted or treated adequately, general deterioration is likely to occur at an accelerated rate.

If left unattended, replacement of these timbers is likely to be necessary in the short-term future. Adequate treatment of these timbers is required as soon as possible by a painting contractor or general handyman.

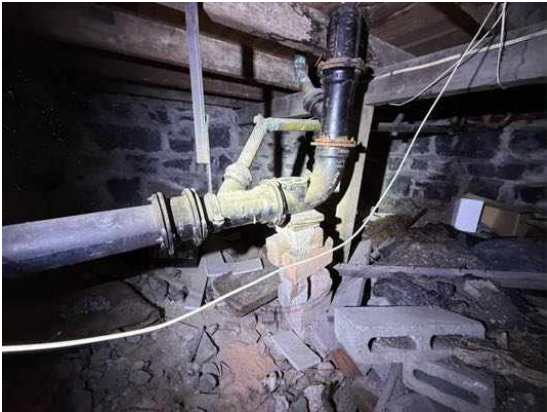
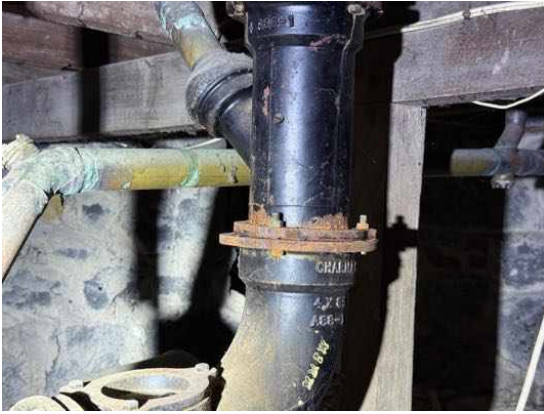
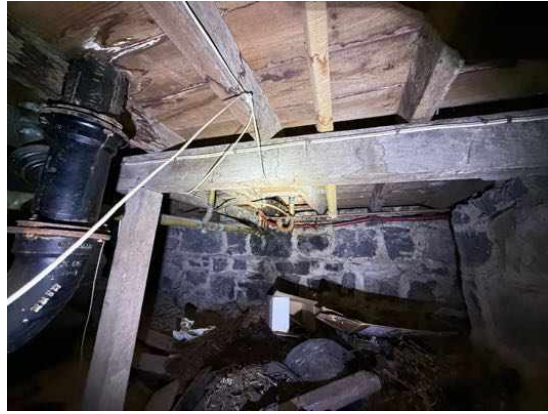
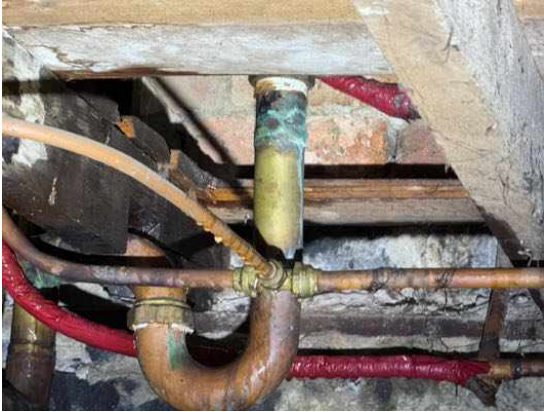
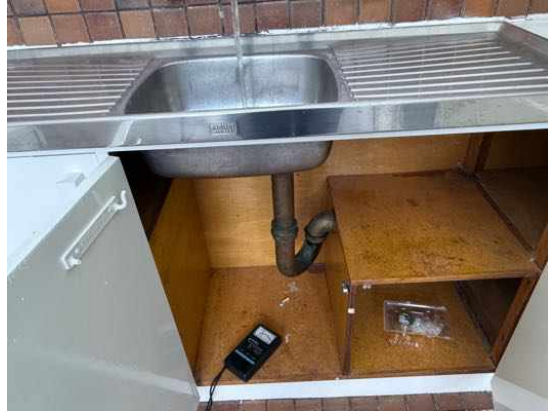
Building: Main Building
Location: All Areas
Finding: Aged Plumbing Infrastructure
Information: The subfloor plumbing observed comprises older cast iron sanitary drainage and copper water supply lines, which appear significantly aged and likely original to the dwelling. Plumbing materials of this age are generally considered to be at or beyond their typical service life expectancy and may be susceptible to internal corrosion, joint deterioration and future failure.

It is recommended that a licensed plumber be engaged to carry out a detailed assessment of the system and provide advice regarding its current condition and whether partial or full replacement should be considered in the medium-term future as part of planned maintenance.
