Building and Timber Pest Inspection Report

Inspection Date: Thu, 12 Mar 2026

Property Address: 159 Nicholson St, Goulburn NSW 2580,
Australia

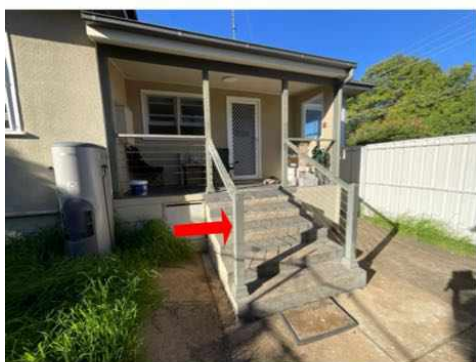
Building:	Building 1
Location:	Verandah - rear
Finding:	Stair railing loose
Information:	The rear balcony railing in this area is loose and requires adjustment to tighten.

If left unmanaged, the fitting may further deteriorate, causing potential for falls.

A carpenter should be appointed to perform these rectification works immediately.

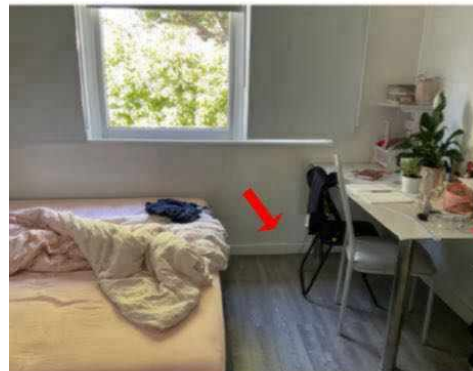
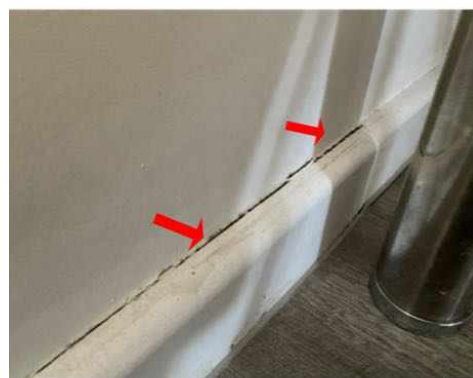
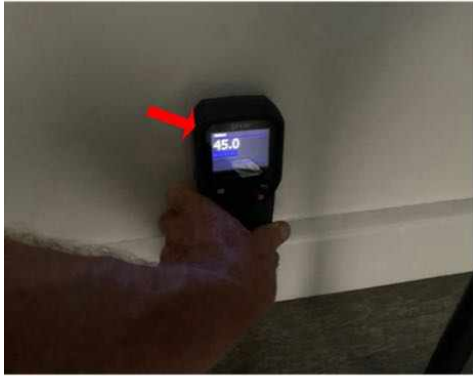
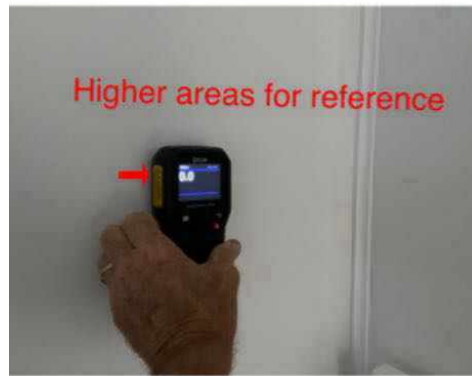
Building: Building 1
 Location: Subfloor, front and right lower wall areas
 Finding: Damp - Rising
 Information: Rising damp was found in the subfloor. It is suspected the very moist subfloor areas has lead to moisture found in the front and right side lower internal house walls.

All moisture was near the skirting with moisture readings of 26.1 to 86.7 recorded. No moisture was found in the mid or upper house walls.

Left unmanaged, rising damp can lead to health problems resulting from mould growth and can have major implications on affected building elements, including wall finishes like paint and plasterwork. Minor mould was found in the front bedroom skirting.

Consultation with a qualified plumber is advised immediately to identify the cause of the damp and perform remedial works as required.

Addition brick vents, mechanical ventilation and external drainage will likely be required to reduce this damp.

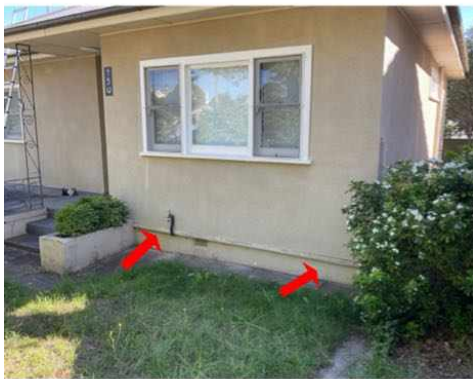
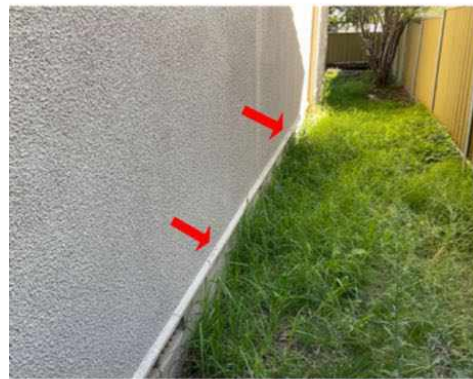
Finding 3.02

Building:	Building 1
Location:	Subfloor
Finding:	Subfloor ventilation - Inadequate
Information:	The subfloor had poor ventilation, with debris blocked many areas and insufficient brick vents. A few external vents were blocked by an air conditioner, tree etc.

A registered builder should be appointed as soon as possible to add more vents to the subfloor walls. Mechanical ventilation would also assist the house to increase ventilation and decrease rising damp and mould.

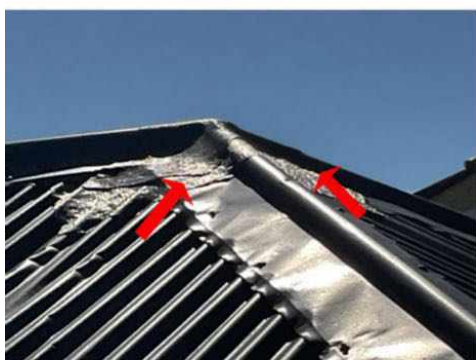
Finding 3.03

Building:	Building 1
Location:	Roof Exterior
Finding:	Roofing areas - Weathered
Information:	Upon inspection of the exterior roofing, the majority of the roof areas were considered to be in a fair condition for its age. Approximately a dozen “patches” has been placed over roof areas and repairs and dented sheets were found. Some roof sheet areas do not appears 100% waterproof where they overlap. A few sheets are slightly lifting on their edges and loose roof nails were evident. While weathering of these pictured areas is consistent with the age of the property, maintenance works are required.

Re-sealing and replacing small areas of gaps, damage or rust the may be considered as an interim solution by the client to help preserve and extend the life span of these roofing areas. Where left unmanaged, deteriorating roofing materials are likely to lead to a number of secondary defects, including minor water leaks and weather exposure to internal roofing structures.

Remedial works are likely to increase the longevity of the exterior roofing structure.

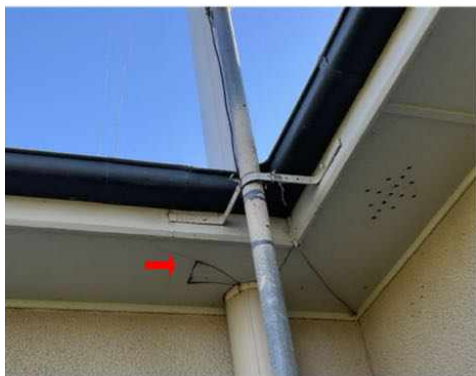
Finding 3.04

Building:	Building 1
Location:	Pictured front left corner
Finding:	Eave - Damaged
Information:	One eave was found to be in a visibly poor condition. The damage may have been sustained as a result of a number of possible causes, including poor roof drainage, leaking roof plumbing or minor impact damage.

The damage to the eave sheeting in this area detracts from the appearance of the structure, as well as potentially compromising the structural integrity of the roofing area.

Where this eave show moderate damage, remedial works may be required by a carpenter.

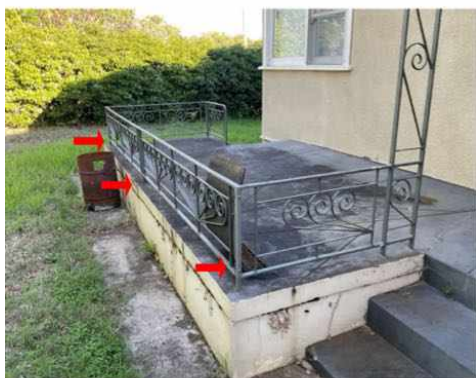
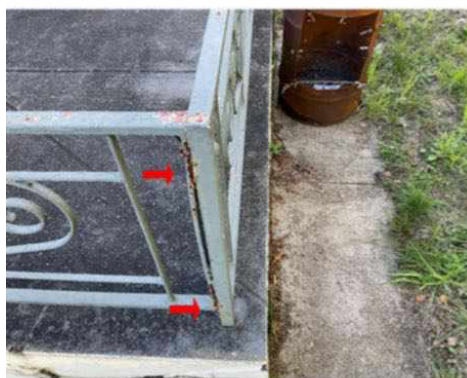
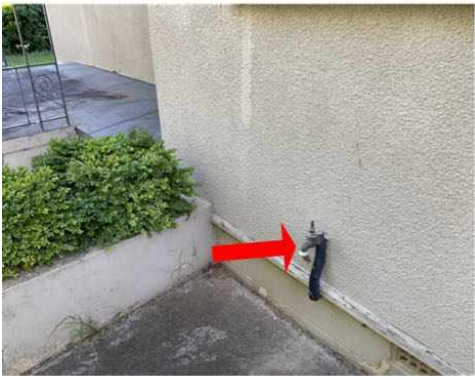
Finding 3.05

Building:	Building 1
Location:	Pictured external areas
Finding:	Building element - Rusted or corroded
Information:	These building elements including gutters, verandah railing, garage roof, front tap pipe etc shows evidence of rusting and corrosion, which is likely to have developed as a result of excessive exposure to moisture and or inadequate coatings. The pipe to the front tap is severely rusted in the front right subfloor.

As surface rust provides no protection to the underlying iron, the deteriorating condition is likely to worsen if not addressed in the short-term future.

Rusting and corrosion should be managed by ideally removing or limiting the affected surface from exposure to moisture. A registered builder and plumber may be appointed to replace any building elements that have been severely affected by rust or water damage in the next 2 years.

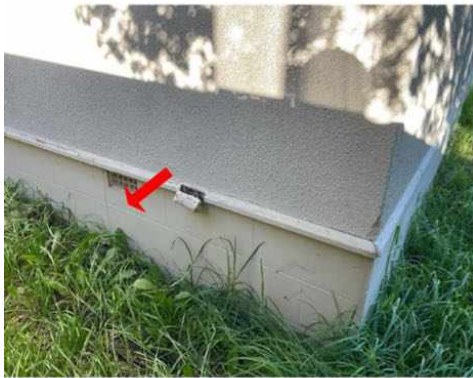
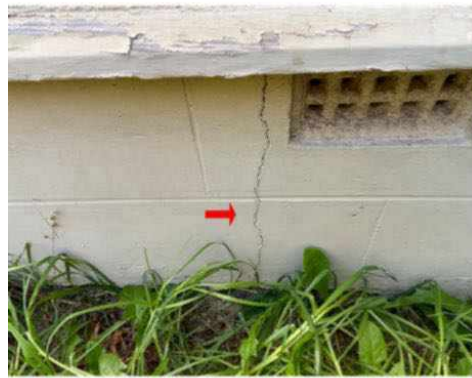
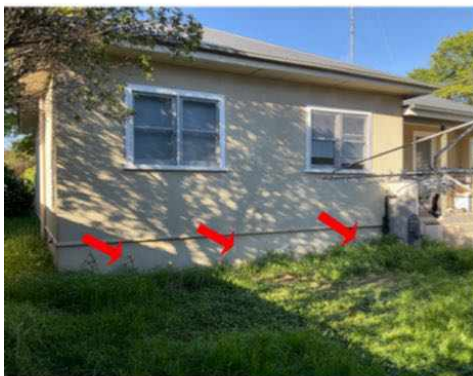
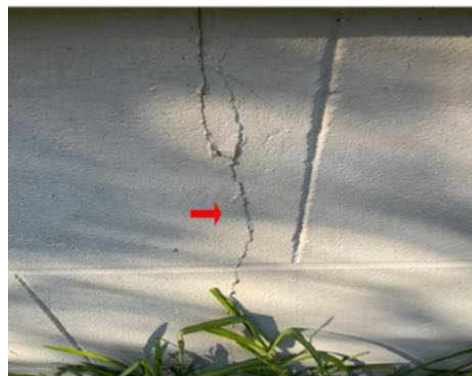
Finding 3.06

Building:	Building 1
Location:	Exterior walls
Finding:	Step cracking to brickwork (minor under 5mm- most 1mm)
Information:	Step cracking was identified to the brickwork in many areas at the time of inspection. Step cracking, which is similar to other forms of cracking, has a variety of possible causes. However, the most common is the subsidence of adjacent footings.

Step cracking is a relatively common defect, and is most likely to occur adjacent to windows, doors and other openings. Mortar failure in the gaps between affected bricks indicates the stresses and tensions affecting the wall.

Where step cracking is extensive or severe, the client is advised to consult a structural engineer. This minor step cracking can be used as a warning sign to address factors causing stress to the wall, which can include the effect of surrounding trees, water leaks, soil erosion, or even the presence of reactive soils in the surrounding area.

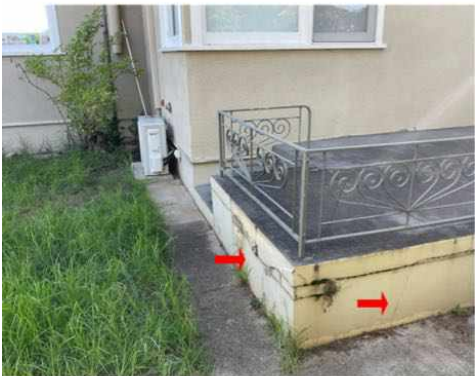
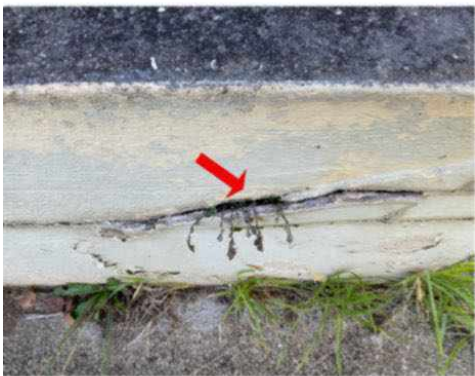
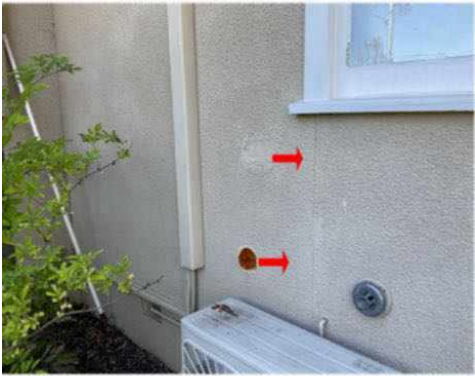
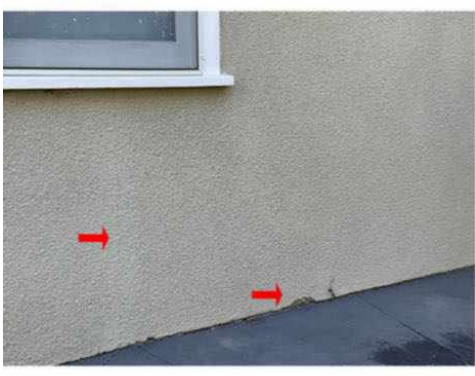
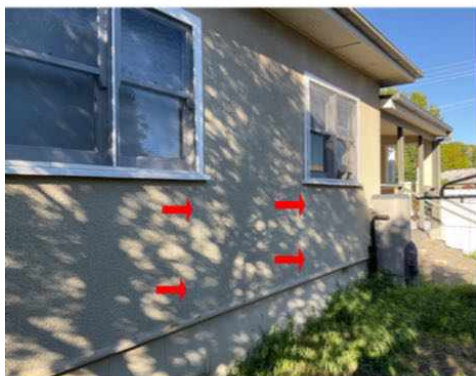
Finding 3.07

Building: Building 1
 Location: Pictured external areas
 Finding: Render (external) cracking.
 Information: It has been observed that cracking to some external rendered surfaces. The degree of damage is described as noticeable cracks which are repairable. Cracking of this size are generally less than 5mm in width.

Always contact your building inspector should cracks widen, lengthen, or become more numerous.

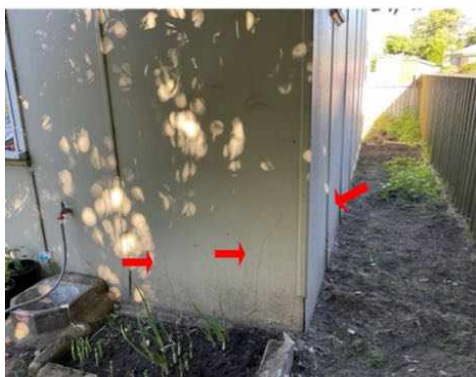
Finding 3.08

Building:	Building 2
Location:	Shed
Finding:	Cladding damaged
Information:	Evidence of damage was identified to some shed walls where the cladding has minor damage. A carpenter would be the trade responsible for rectification of this wall area.

These may be asbestos.

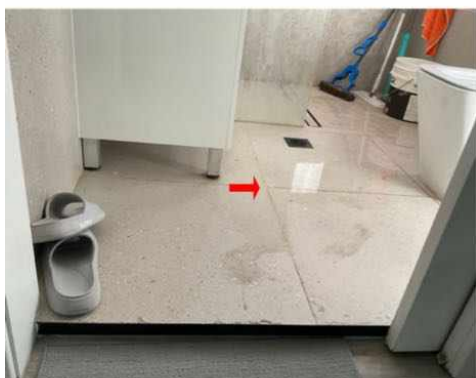
Finding 3.09

Building:	Building 1
Location:	Bathroom
Finding:	Bathroom tiling - Insufficient fall
Information:	There is an insufficient fall in the bathroom tiling, which means that the angle of the tiling is inadequate for water to drain away. This is resulting in pooling of water in the area, creating the potential for slips and falls and water damage to nearby areas. This is likely to lead to further defects if not repaired. Adjustment by a tiling contractor is required as soon as possible to prevent any further damage to the area.

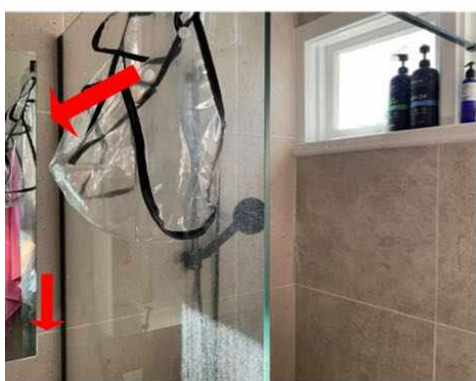
Finding 3.10

Building:	Building 1
Location:	Bathroom
Finding:	Shower screen - Leaking
Information:	Leaking was evident to the upper shower screening at the time of inspection. It is suspected that the leaking has occurred as a result missing sealant. Leaking from the shower , where left unattended, is likely to lead to water damage to adjoining flooring and walls. Such damage can lead to water damage and necessitate extensive remedial works being required. Active water leaks may also create an environment that is susceptible to the formation and development of mould.

Appointment of a sealant expert is required to repair or replace this missing sealant. Such works should be performed as soon as possible to ensure that no further damage occurs.

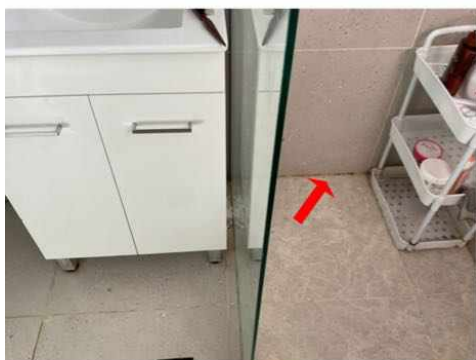
Finding 3.11

Building:	Building 1
Location:	Bathroom
Finding:	Sealant and grouting - Missing or damaged
Information:	It was noted on inspection that sealant or grout is degraded to these pictured wet areas.

Different materials and floor areas move at different rates, generally causing cracking to grout or sealant at this point. A flexible sealant is required to allow for expected expansion and contraction, while keeping the joint water tight and protective of all associated building materials.

Flexible and mould resistant materials should be applied to affected areas to prevent any subsequent water damage that is likely to occur. Regular maintenance and replacement of damage or missing or damaged sealant and grout is highly recommended to the wet areas, as this is a regular wear and tear defect. Sealant and grouting in areas that come into regular contact with water should be maintained for the long term care of your property.

A sealant specialist or tiling contractor should be appointed to complete these works as soon as possible

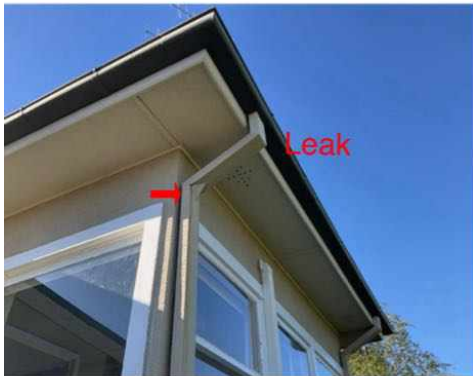
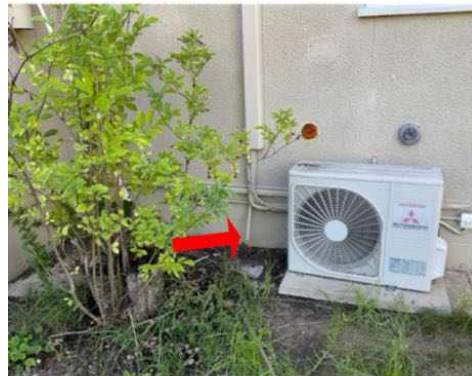
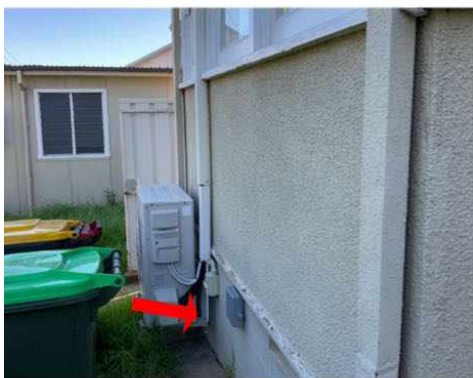
Finding 3.12

Building:	Building 1
Location:	Walls
Finding:	Site drainage - Inadequate
Information:	The site drainage in this area was found to be inadequate at the time of inspection, creating potential for subsequent water damage to associated building elements.

The air conditioner overflow run against the house walls. One downpipe has a small leak evidenced by staining.

Where site drainage is inadequate, installation of an Agricultural (Aggie) Drain may be required. A qualified plumber should be appointed to further inspect the property and perform any remedial works as necessary. Secondary defects are likely to occur if left

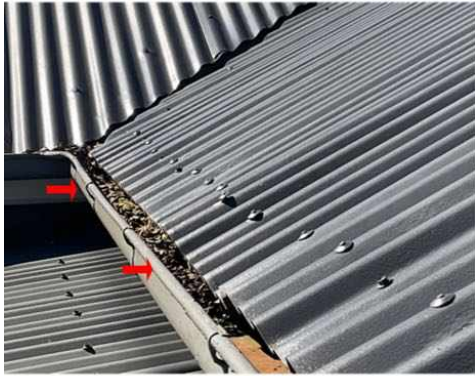
Finding 3.13

Building:	Building 1
Location:	Roof exterior
Finding:	Gutters - Full and blocked
Information:	The guttering on around the roof was found to be blocked at the time of the inspection. Roof plumbing structures, such as guttering and downpipes, should be free of all debris to prevent blockages. Blockages of the guttering and downpipes will lead to pooling and accumulated water overflows, which is likely to subsequently flood eaves and exterior walls.

Blocked gutters are likely to lead to high levels of moisture in the affected areas which can cause rust and decay of the gutters and downpipes and wood rot to adjoining timber areas. Blockages in gutters should therefore be removed immediately to ensure dry conditions are maintained.

It is highly advised that gutters be cleaned by the homeowner or a general handyman as a matter of urgency.

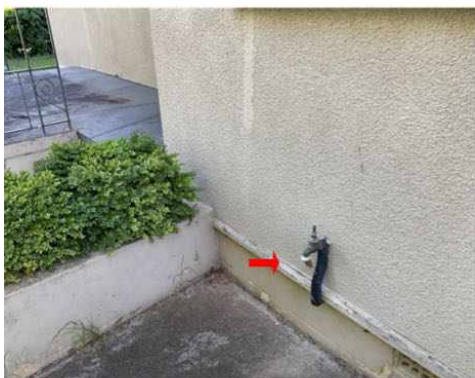
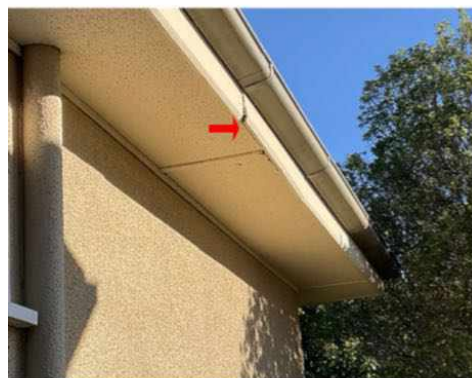
Finding 3.14

Building: Building 1
 Location: Pictured external areas
 Finding: Building elements - Damaged
 Information: Evidence of minor missing or damaged areas was identified at the time of the inspection. These include -

1. The tap is missing a handle. This tap pipe is severely corroded in the subfloor and it is thought it is disconnected.
2. Some fascia is loose requiring refixing.
3. The laundry tub only has cold water connected.
4. The shower rail is loose.

A carpenter would be the trade responsible for rectification of these areas when convenient.

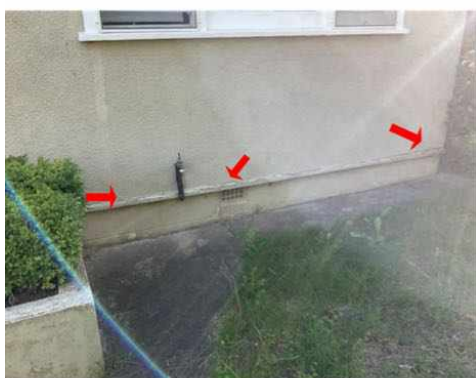
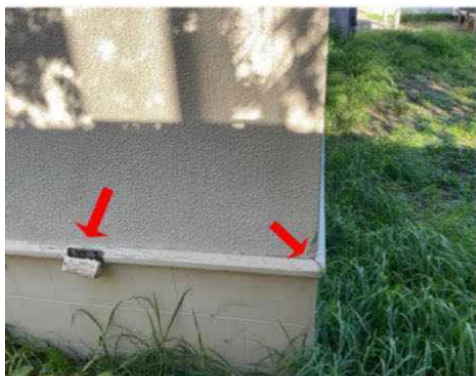
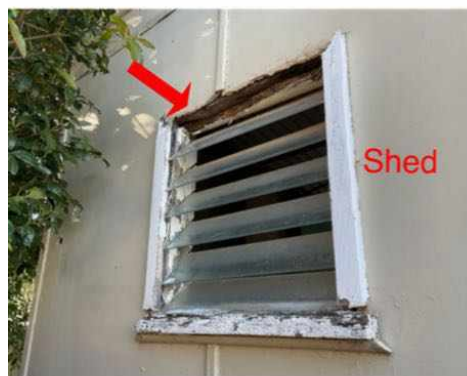
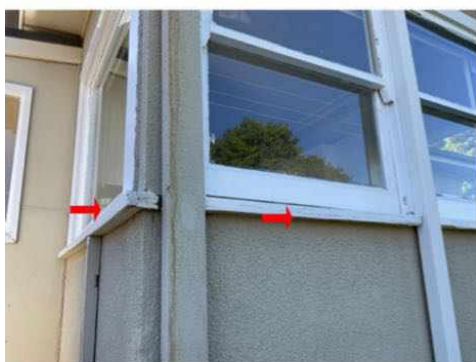
Building:	Building 1
Location:	Pictured areas if both buildings
Finding:	Wood rot
Information:	The building shows evidence of wood rot. Wood rot, also known as Fungal Decay, occurs when timbers and other cellulose building materials are exposed to damp conditions on an ongoing basis. This could be the result of exposure to weathering over a prolonged period of time, or the attraction of excessive moisture from other abutting building materials.

Early intervention and regular maintenance, particularly of exterior timbers, will prolong the useful life of these building elements. Prior to any works being performed, the cause of the moisture that has created the visible wood rot should be identified and addressed in a suitable manner. Replacement of affected timbers may then be a necessary step in protecting surrounding building elements from such deterioration.

A qualified carpenter or registered builder may also be required to replace affected building materials.

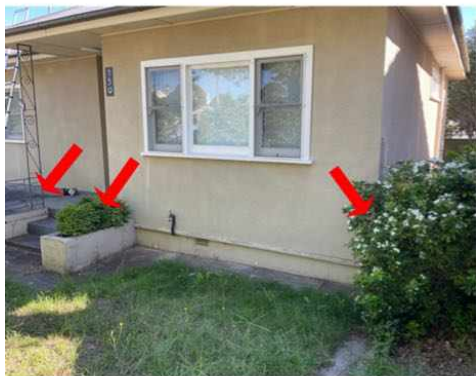
Building:	Building 1
Location:	Yard - front
Finding:	Bridging - Vegetation and decking
Information:	Where vegetation and decking obstructs inspection of building elements, also known as bridging as it provides a bridging point for the access of termites, full inspection can not be achieved. Consequently moisture or dampness may be present and the areas becomes conducive to termite activity. Plants and decks against or very close to buildings provide cover, shade and can provide an environment that is attractive to termite infestation.

The removal of any such stored building or plant materials that may be conducive to

termite activity should be carried out as soon as possible and arrange re inspection to minimize the risk of termite attack.

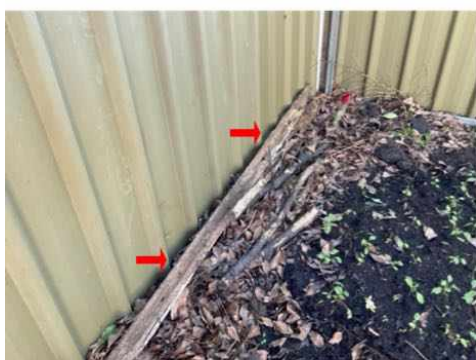
Finding 6.03

Building:	Building 1
Location:	Yard & subfloor
Finding:	Timber in contact with the ground
Information:	Numerous timbers in direct ground contact provide opportunity for concealed termite entry and are subject to premature rot and decay as the soil retains moisture or damp conditions against the timbers.

Removal of all waste timber that is in direct contact with ground is highly advised. This timber is promoting mould and wood rot and is very attractive to termites.

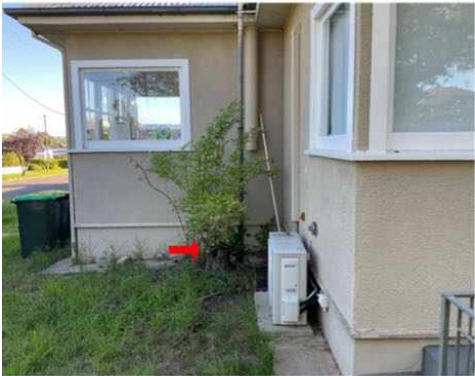
Finding 6.04

Building: Building 1
Location: Pictured yard area
Finding: Tree stumps - left in ground
Information: Tree stumps left in ground provide opportunity for termite attack as they are likely to be subject to rot and decay providing an attractive food source. Treatment and/or Removal of the stump is highly recommended. A pest controller and tree removalist should be engaged to perform such works.

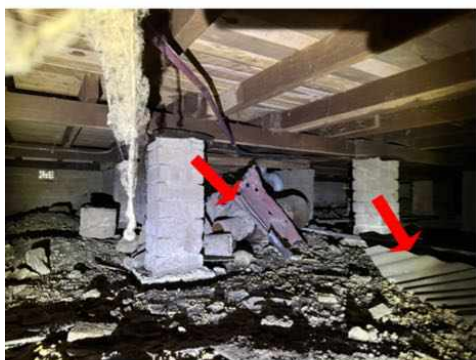
Finding 6.05

Building: Building 1
Location: Subfloor
Finding: Subfloor - Debris
Information:

An array of debris was found in the subfloor area at the time of inspection. Debris in this area restricts subfloor ventilation and creates potential for concealed pest entry. Stored timbers and other materials may also make the area susceptible to termite activity and wood rot.

Debris in the subfloor should be removed as soon as possible. Depending on the location and amount of debris and stored items, the homeowner may elect to undertake this task. Alternatively there are a large number of rubbish removal subcontractors that could undertake these works.

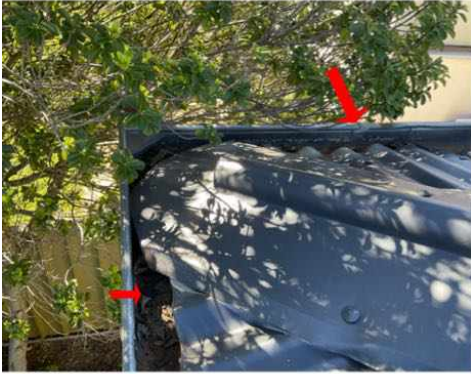
Finding 6.06

Building:	Building 1
Location:	Roof exterior
Finding:	Gutters - Full and blocked
Information:	The guttering on around the roof was found to be blocked at the time of the inspection. Roof plumbing structures, such as guttering and downpipes, should be free of all debris to prevent blockages. Blockages of the guttering and downpipes will lead to pooling and accumulated water overflows, which is likely to subsequently flood eaves and exterior walls.

It is highly advised that gutters be cleaned by the homeowner or a general handyperson as a matter of urgency.

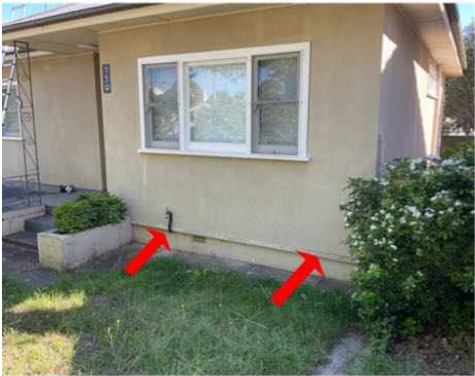
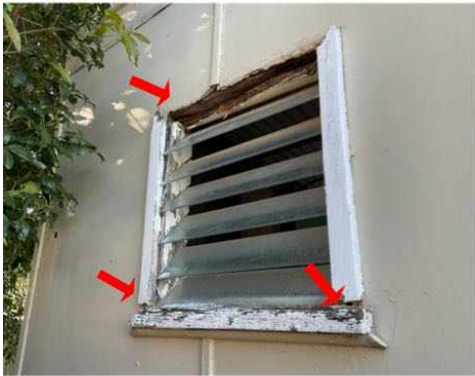
In this case, the affected timber element is in a decaying state and will need replacement by a carpenter or licensed builder.

Note - See ALL wood rot photos, all these show fungal decay.

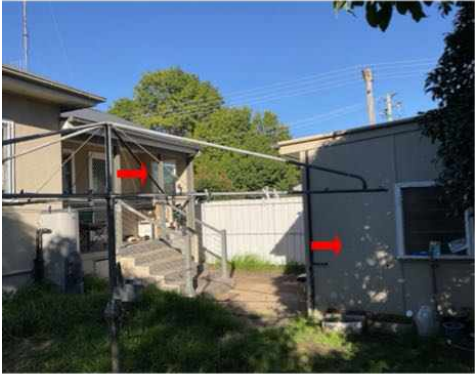
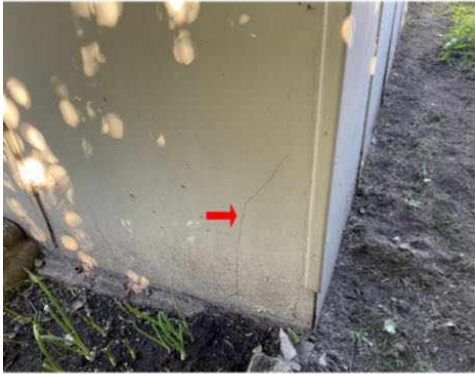
Building: Building 1
 Location: Shed, subfloor, eaves
 Finding: Asbestos - Suspected ACM Identified on Site
 Information: Reporting on Asbestos is outside the Scope of this Report. This suspected defect is highlighted as a caution only. We suspect, based on our experience in the building industry, that there is a higher risk of the identified building element containing asbestos.

In the interim, the client is advised to act with caution, especially when considering any damage to building materials general wear and tear renovations extensions demolition and general maintenance activities due to the suspected presence of Asbestos.
