Building and Timber Pest Inspection Report

Inspection Date: Fri, 6 Mar 2026

Property Address: 7 Kimberley Ave, Narara NSW 2250,
Australia

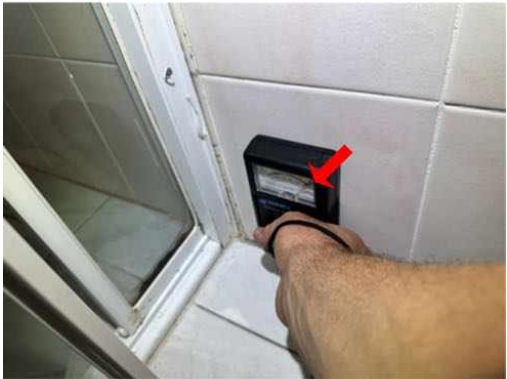
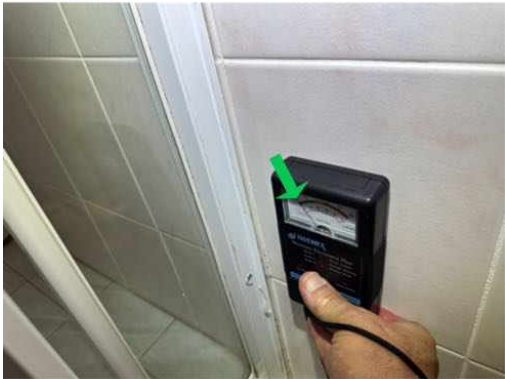
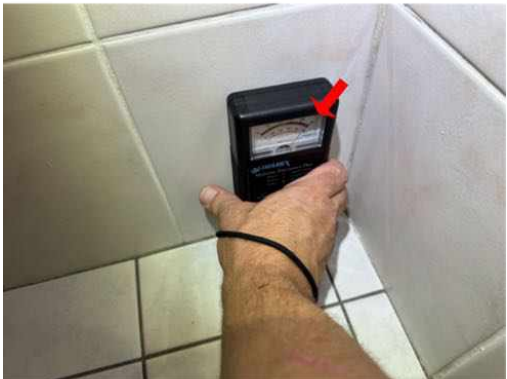
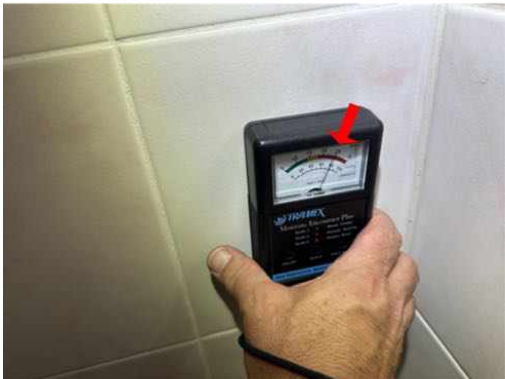
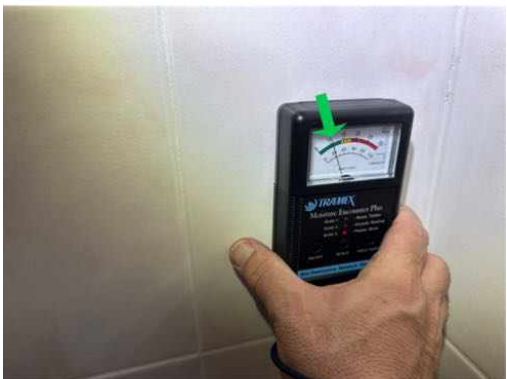
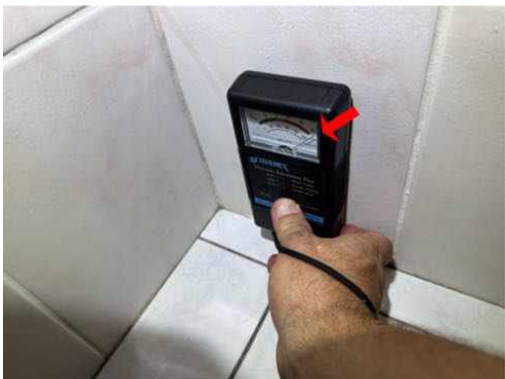
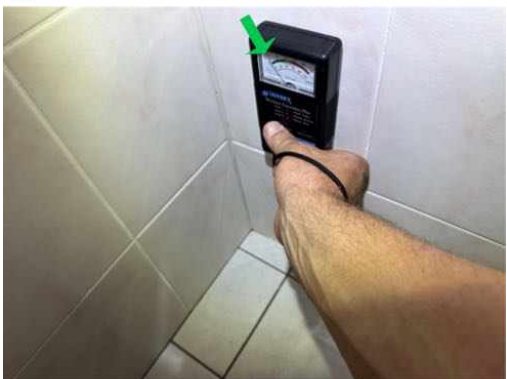
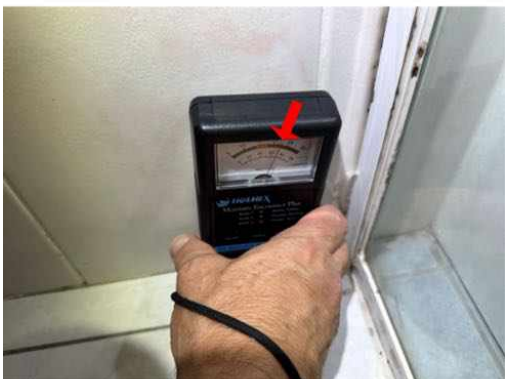
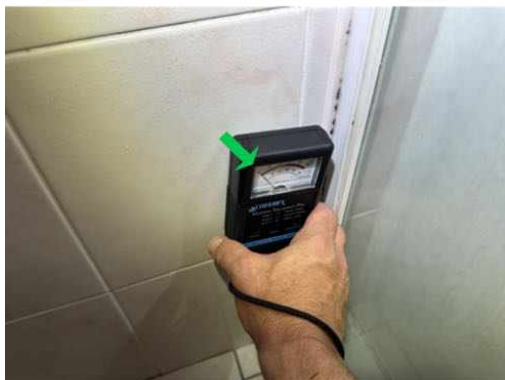
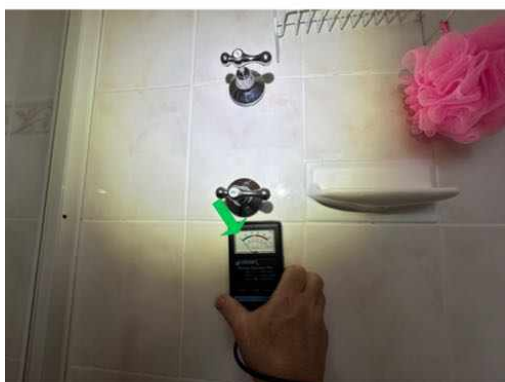
Building: Main Building
Location: Bathroom > Centre Left
Finding: Moisture meter: used in Shower area.
Information: A moisture meter was used during the inspection and isolated spots of excessive moisture was detected to accessible walls inside the property at the time of inspection.

It was noted on inspection that sealant or grout is in fair condition to most of the tiled shower alcove, with some areas requiring maintenance.

Different materials and floor areas move at different rates, generally causing cracking to grout or sealant at this point. A flexible sealant is required to allow for expected expansion and contraction, while keeping the joint water tight and protective of all associated building materials.

A moisture meter was used on all accessible walls during the inspection and excessive moisture was detected to bathroom shower walls on the lower tiled areas. All areas with high moisture should be investigated by way of an invasive inspection by either a plumber and/or pest controller. High moisture levels also increase the likelihood of termite attack and may also be conducive to borer activity, wood decay, mould and deterioration of the building elements.

Flexible and mould resistant materials should be applied to affected areas to prevent any subsequent water damage that is likely to occur. Regular maintenance and replacement of damage or missing or damaged sealant and grout is highly recommended to the wet areas, as this is a regular wear and tear defect. Sealant and grouting in areas that come into regular contact with water should be maintained for the long term care of your property.

Monitoring the area is advised and if any visual signs of excessive moisture appear (peeling paint, mould) then consultation with a qualified plumber or bathroom specialist would be advised to identify the cause of damp and to perform remedial works as required.

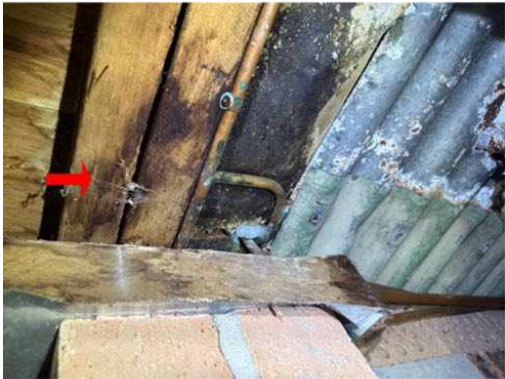
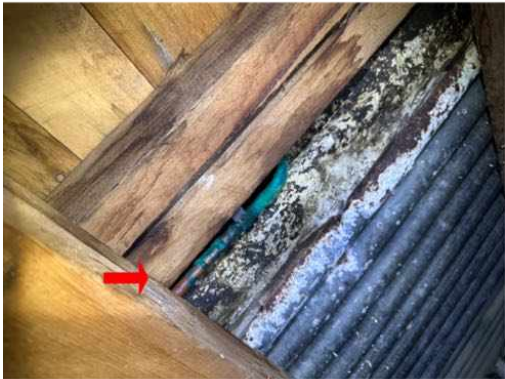
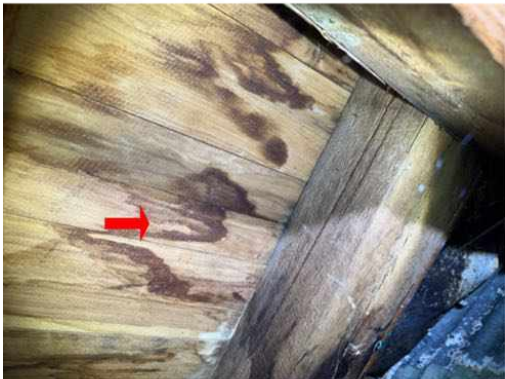
Finding 2.02

Building:	Main Building
Location:	Subfloor-Bathroom > Centre Left
Finding:	Water staining
Information:	Water staining was evident in this area at the time of inspection. Water staining indicates that surfaces have been exposed to excessive moisture over time. The minerals and other elements in the water lead to staining, which may graduate to corrosion and deterioration if left unmanaged.

While mostly an appearance defect, water staining can be indicative of more serious defects, which may be currently concealed by other building elements.

Where water staining is active, a licensed plumber or waterproofing contractor must be consulted to identify the cause of the staining and to provide advice on any reparation works that may be required. Replacement of any broken or damaged structures is advised.

Conversely, where water staining is old and inactive, affected building materials may be repaired or replaced at client discretion. A qualified carpenter or registered builder may be appointed to perform these works.

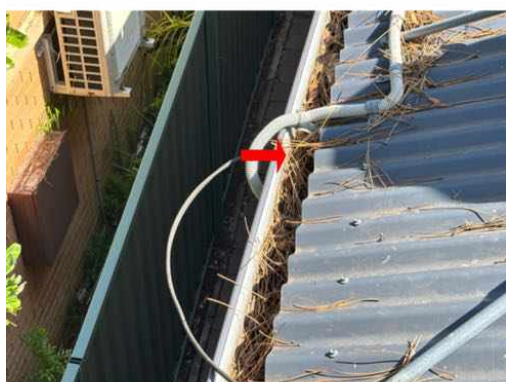
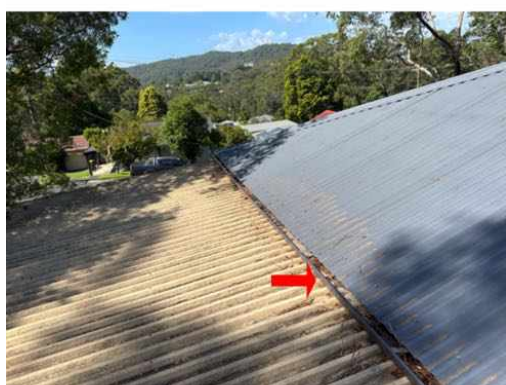
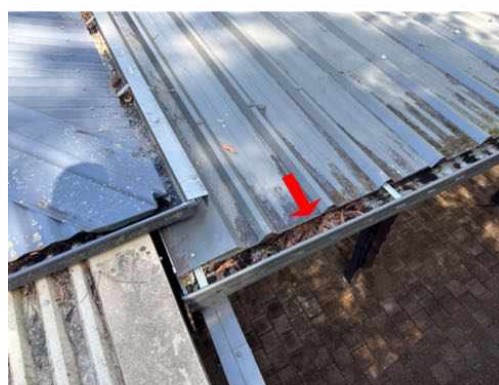
Finding 3.01

Blocked gutters are likely to lead to high levels of moisture in the affected areas. Such moisture will not only cause rust and decay of the associated building materials, but can also provide conditions that are conducive to termite and timber pest activity. Blockages in gutters should therefore be removed immediately to ensure dry conditions are maintained.

Consult a Licensed Plumber for further specific advice on remedial works that may be required. In the interim, it is highly advised that blocked gutters be removed by the homeowner or a general handyperson as a matter of urgency.

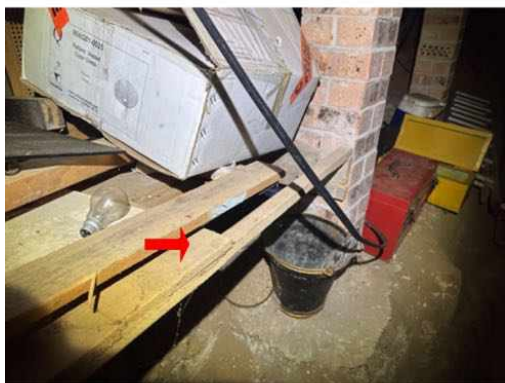
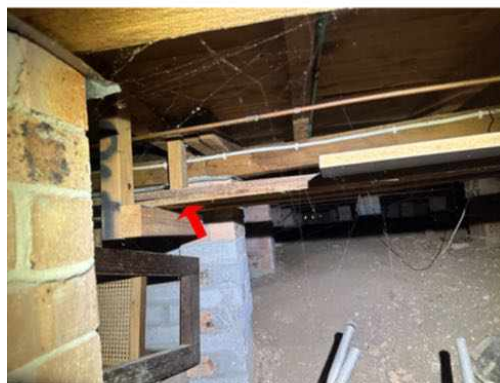
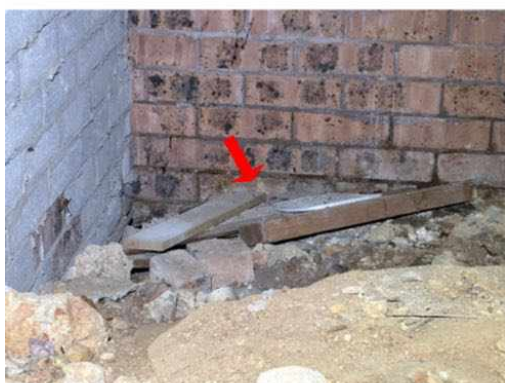
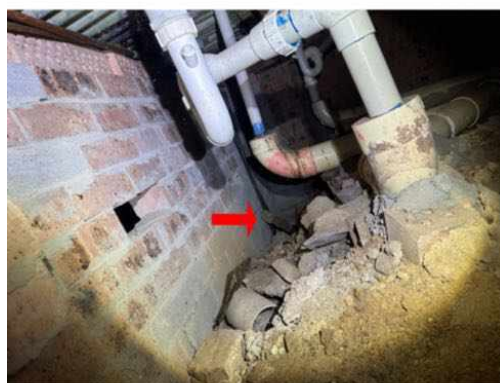
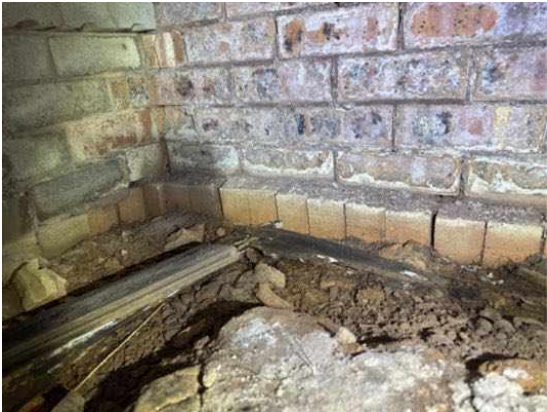
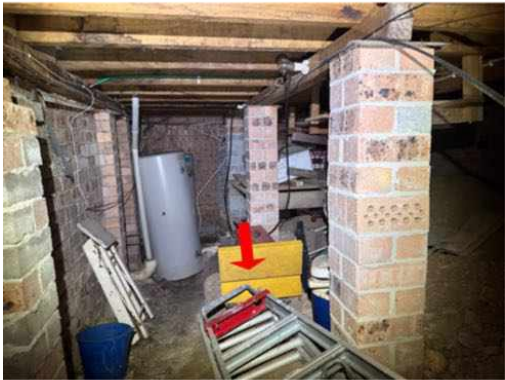
Building:	Main Building
Location:	Subfloor > All Areas
Finding:	Subfloor - Debris
Information:	An array of debris was found in the subfloor area at the time of inspection. Debris in this area restricts subfloor ventilation and creates potential for concealed pest entry. Stored timbers and other materials may also make the area susceptible to termite activity and wood rot.

A clear and empty subfloor will be better ventilated and easier to maintain in a dry condition. The removal of any timber debris is vital in minimising the risk of termite or wood borer activity.

Debris in the subfloor should be removed as soon as possible. Depending on the location and amount of debris and stored items, the homeowner may elect to undertake this task. Alternatively there are a large number of rubbish removal subcontractors that could undertake these works.

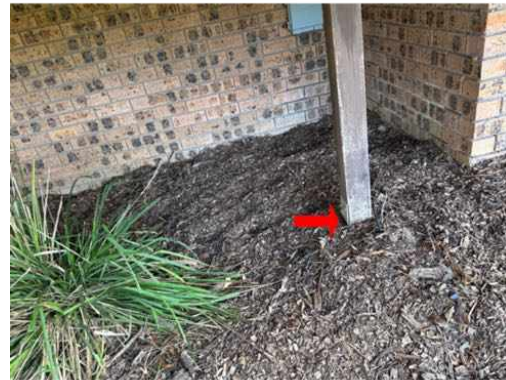
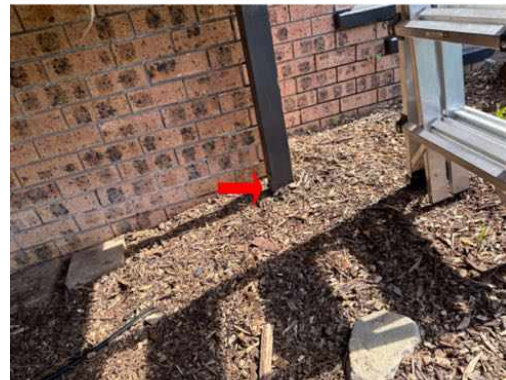
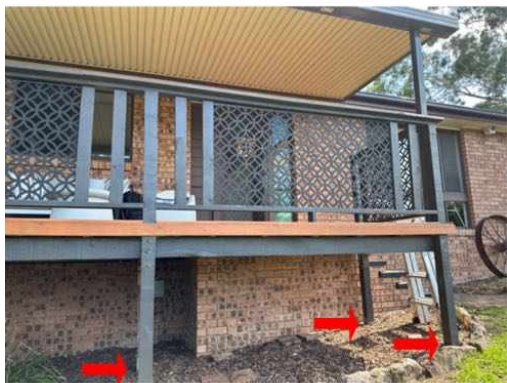
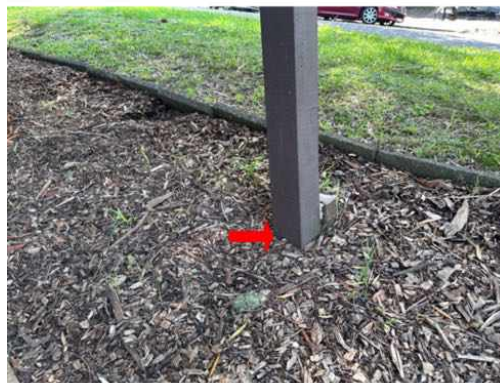
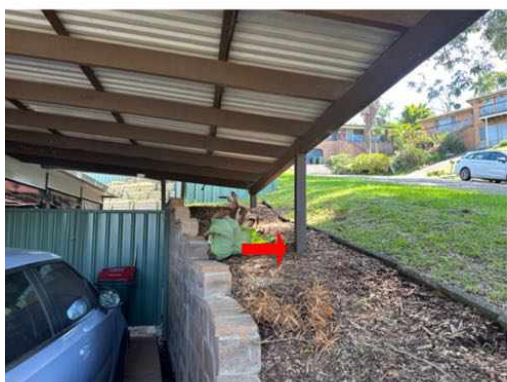
Building: Main Building
Location: All Areas > All Areas
Finding: Building materials in direct ground contact - conducive to termites
Information: Where timber elements are in direct contact with the ground and consequently moisture or dampness they become conducive to termite activity. Whether timber is used as a building element part of a fencing structure or stored as an unused item they can provide an environment that is attractive to termite infestation.

When met with excessive moisture timber begins to decay and develop wood rot. Any timbers that are in direct contact with external grounds especially if left untreated or non-durable also provide ingress for subterranean termites into that particular element.

The removal of any such materials that may be conducive to termite activity should be removed as soon as possible to minimise the risk of termite attack.

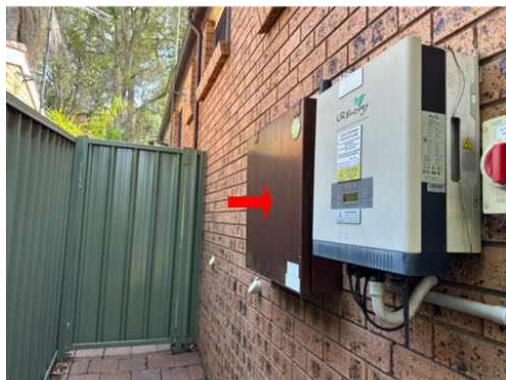
Finding 6.02

Building:	Main Building
Location:	Electrical circuit box > Front Left
Finding:	Termite Management System - no evidence of a chemical installation
Information:	The application of a post-construction chemical termite barrier is highly recommended for all properties, particularly if live termite activity has been found on the site previously. Such barriers are highly effective in preventing termite attack on any timber building elements throughout the property.

A durable notice should be placed in the switchboard unit to indicate current termite barriers. At the time of inspection, it appeared as though no termite management system has been installed, with no evidence to suggest preventative works taking place.

The client may consider gaining further advice from a pest controller as to the costs and procedures involved with this application. It is recommended that obtaining such advice be a short-term priority.

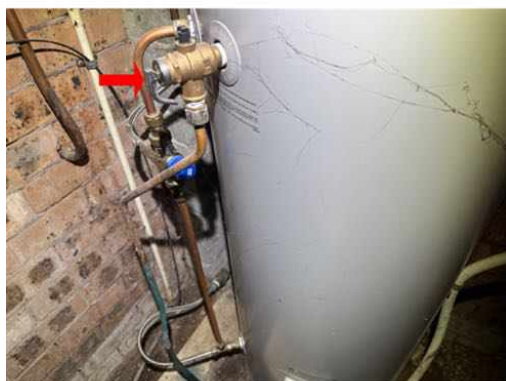
Finding 6.03

Building:	Main Building
Location:	Subfloor > Front Left
Finding:	HWS Overflow - Not Connected
Information:	The Hot Water System (HWS) overflow was found to be disconnected from storm water drainage and is creating excessive moisture in the surrounding area.

These damp conditions can lead to secondary defects such as rot, rust or corrosion of associated building elements, the formation of fungal decay, or even the creation of potential slip hazards. When coupled with poor site drainage, pooling of water may also attract termite activity to this area.

It is highly recommended that a licensed plumber be appointed to connect the HWS overflow in order to prevent such an environment from being created. These minor works should be carried out as soon as possible.

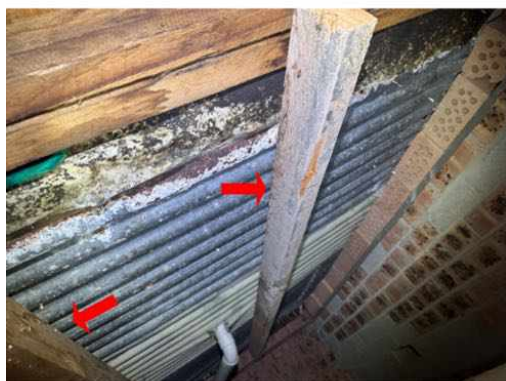
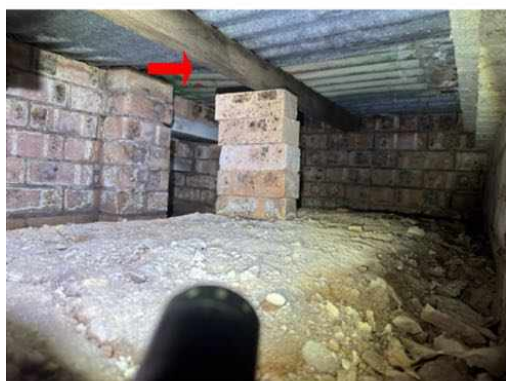
Finding 6.04

Building:	Main Building
Location:	Subfloor-Balcony/Bathroom > Centre Left
Finding:	Formwork timber: Left in situ
Information:	Formwork timber appears to have been left on site and in situ after concrete

construction. Formwork timber is used to support and shape the concrete while pouring during the construction process. Leaving formwork timbers in the subfloor space or around the exterior of the property increases the risk of termite activity being present. As they are likely to come into contact with weather conditions or excessive moisture wood rot is likely to develop on timbers that are not treated. It is highly recommended that any formwork timbers be immediately removed from areas in which they may attract any termite/timber pest attack. Minimisation of risk/prevention of termite attack is far more adequate than dealing with the presence of termite activity.

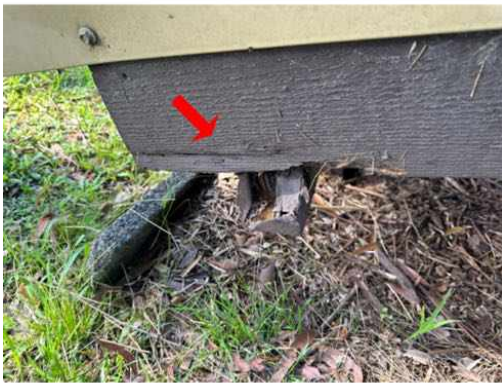
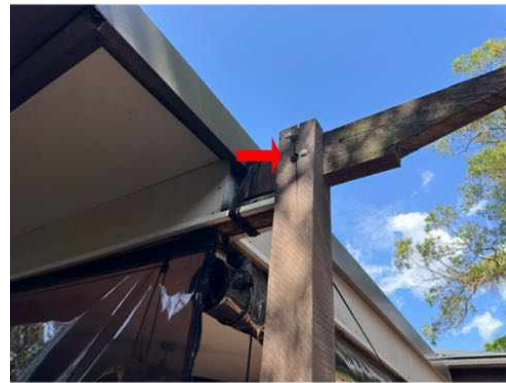
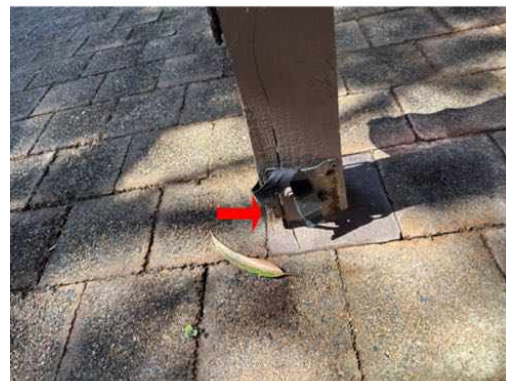
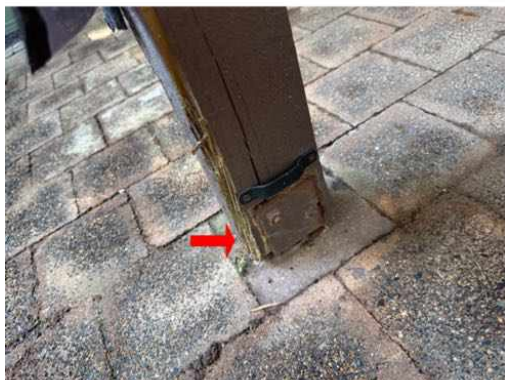
Finding 7.01

Building:	Main Building
Location:	Carport > Centre Right
Finding:	Wood rot
Information:	This building element shows evidence of wood rot. Wood rot, also known as Fungal Decay, occurs when timbers and other cellulose building materials are exposed to damp conditions on an ongoing basis. This could be the result of exposure to weathering over a prolonged period of time, or the attraction of excessive moisture from other abutting building materials. Contributing factors also include poor air

Wood rot is often associated with general damp problems and is evidenced by a 'musty' smell or mould and mildew occurring on surfaces. If left unmanaged, damp conditions can lead to further health problems and the decay of timbers will continue.

Wood rot or fungal decay was found in the in isolated areas of the front deck and carport rafters at the time of inspection. Wood rot is conducive to termite activity, all susceptible timbers (where applicable) should be removed and where applicable replaced with non-susceptible timber as soon as possible.

Early intervention and regular maintenance, particularly of exterior timbers, will prolong the useful life of these building elements. Prior to any works being performed, the cause of the moisture that has created the visible wood rot should be identified and addressed in a suitable manner. Replacement of affected timbers may then be a necessary step in protecting surrounding building elements from such deterioration.

A qualified plumber may be appointed to assess the cause of excessive moisture and to provide advice on any remedial works as required. A qualified carpenter or registered builder may also be required to replace affected building materials.

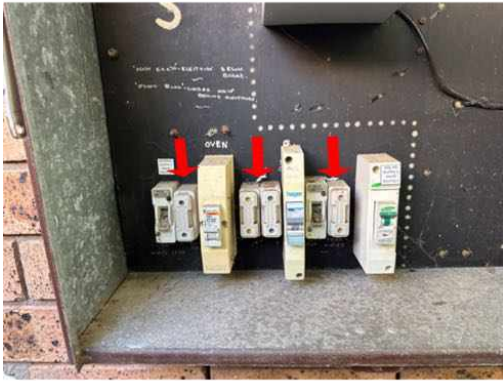
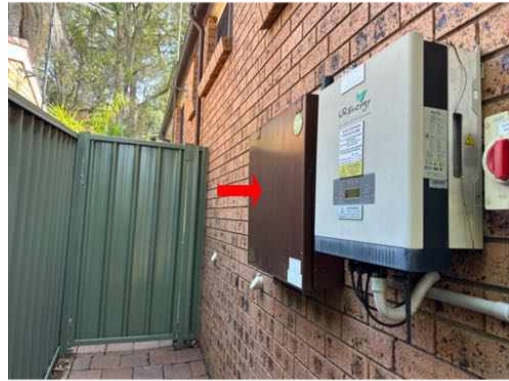
Building: Main Building
Location: Electrical Switchboard > Front Left
Finding: Electrical switchboard - Old ceramic fuses
Information: The electrical switchboard while appearing to have adequate safety switches installed has old ceramic fuses in place.

While this on its own on is not considered a defect it is noted for the clients consideration that a switchboard upgrade may be required in the short to mid term to improve the functionality of the electrical system. A licensed electrician could be appointed to provide quotation for the works at the client's discretion which may in turn expose other required works to bring the system up to a compliant state.

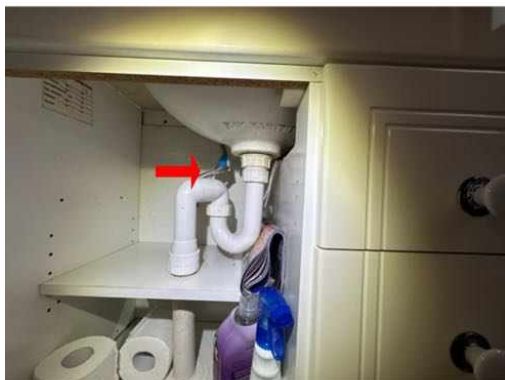
Building: Main Building
 Location: All Areas > All Areas
 Finding: Pipe: Flexible Braided pipes.
 Information: Braided Stainless Steel Flexi connector hose are popular in modern home fit outs because they can be bent into shape. They started to be installed in the early two thousands and their use is now extremely widespread in contemporary construction and renovations.

Flexible braided hoses accounted for more than one in five water damage claims lodged by Australian households according to research released by general insurer IAG.

It is recommended that the Flexi pipes to be replaced at the owners discretion to avoid an “escape water incident” which may lead to water damage to other building elements in the home.

This work can be undertaken by a licensed plumber, general handy person at the owners discretion.

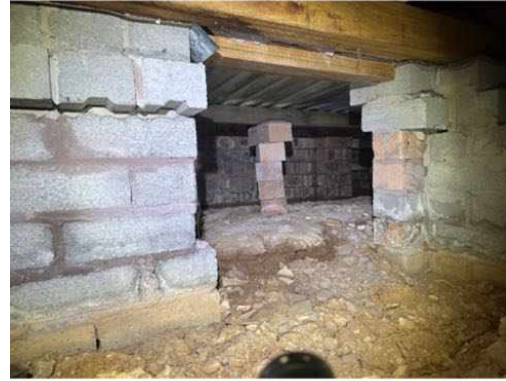
Building: Main Building
Location: Subfloor > Rear
Finding: Sub Floor restricted Access.
Information: At the time of inspection the sub floor area had restricted access due to minimal crawl space between floor and ground levels, and a continuous footing wall with impassable breaks at intervals.
