# Building and Timber Pest Inspection Report

Inspection Date: Wed, 8 Apr 2026

Property Address: 12 Frederick St, Vincentia NSW 2540,  
Australia

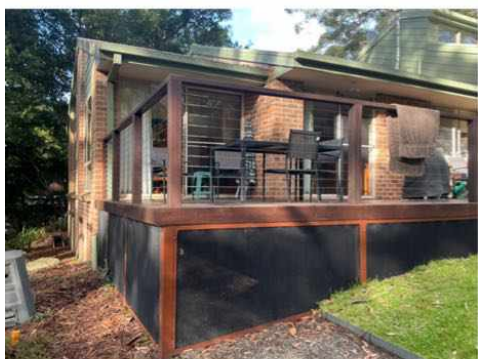
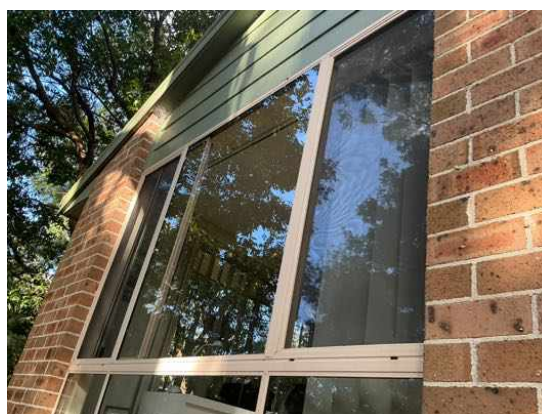
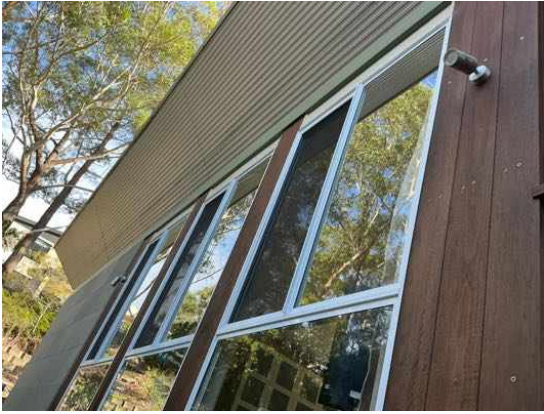
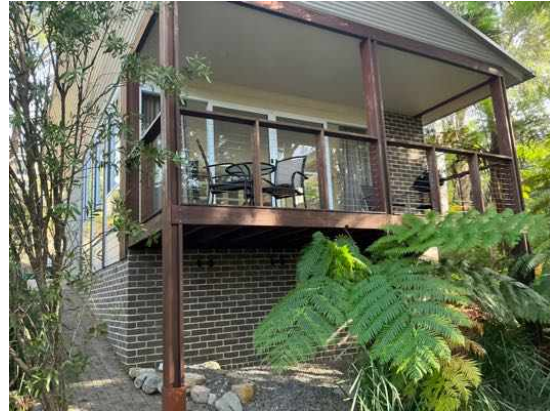
All windows higher than 2000mm from the external ground/floor level must NOT be able to open wider than 125mm. It is highly recommended that permanent locks be fitted at 125mm open ASAP.

Although this report does not include structural compliance it appears that the main house structure has steel mesh flyscreens and air vents suggesting that this is a high fire rated area. The studio does not have the steel mesh flyscreens. Further investigation is recommended.

These items should be repaired by the relevant tradesman as soon as possible.

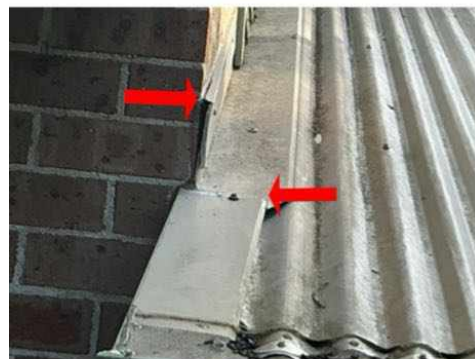
### Finding 2.01

| Finding: | Flashing Inadequate |
| Information: | At the time of inspection the flashing in this area appeared to be inadequate. |

Flashings are an integral element of the building's external waterproofing systems. Flashings divert water away from the structures' openings to prevent any water ingress. If these flashings are inadequate or compromised in any way it will allow water penetration through the exterior cladding skin.

Water ingress will lead to secondary defects such as water staining and internal damage progressing to structural damage if left unmanaged. Damp environments are also conditions suitable for termite activity. It is advisable to get this defect rectified as soon as possible.

Consult a licensed Builder for further instructions.

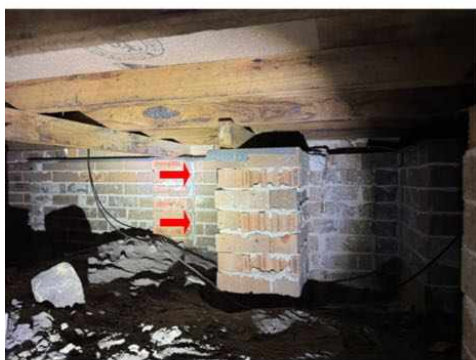
| Information: | Termite activity was found to have affected this area of the subfloor. It is advised that the area be visually inspected frequently to ensure that the condition of affected building materials does not reoccur. |

Please note that although no evidence of live termite activity was found in the roof void or subfloor, because of obstructions and access restrictions the extent of any activity, in the wall cavity and roof space areas is unknown.

It is strongly recommended that the licensed Timber Pest Controller who conducted the last treatment is consulted for further information regarding a termite management system. DNA Pest Control (02) 4421 2009 installed their product on 15/5/21, however it is unknown if this treatment is still active.

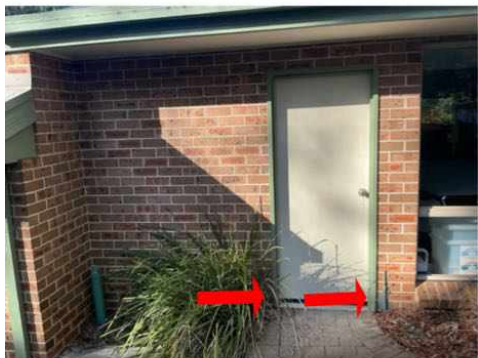
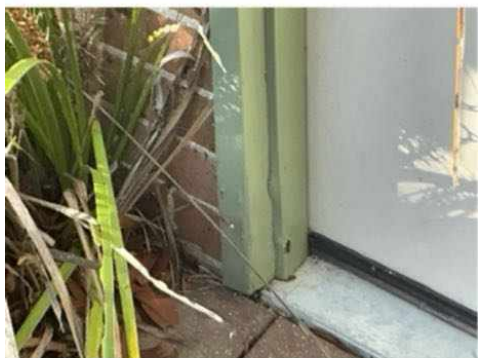
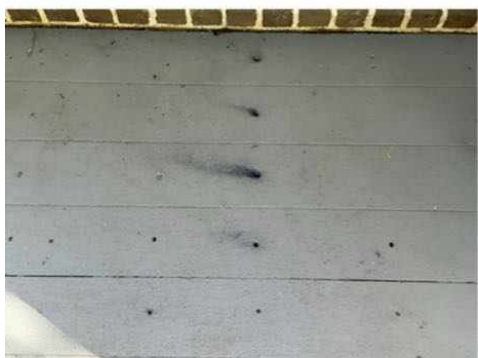
### Finding 3.01

| Finding: | Building element - Rusted or corroded |
| Information: | This building element shows evidence of rusting and corrosion, which is likely to have developed as a result of excessive exposure to moisture and or inadequate coatings. Rusted items include; |

- the garage door jam requires repairs.
- some exterior screws require replacement.

As surface rust provides no protection to the underlying iron, the deteriorating condition is likely to worsen if not addressed in the short-term future. Where possible,

Rusting and corrosion should be managed by ideally removing or limiting the affected surface from exposure to moisture. A registered builder may be appointed to replace any building elements that have been severely affected by rust or water damage.

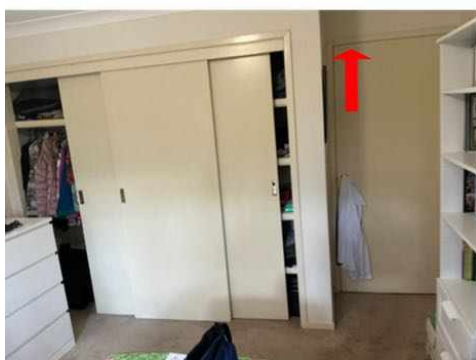
### Finding 3.02

This defect inhibits the functionality of the affected door as well as creating potential for secondary defects to associated building elements, such as damage to the floor covering. A door that binds to flooring or to the associated door frame may have several causes, ranging from minor defects, such as poor installation of the door or deteriorated hardware.

For minor causes, a qualified carpenter or general handyperson should be appointed to perform minor rectification works at client discretion.

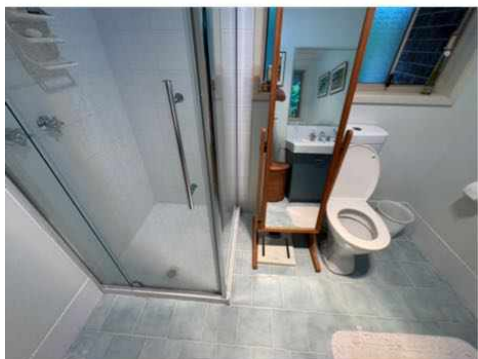
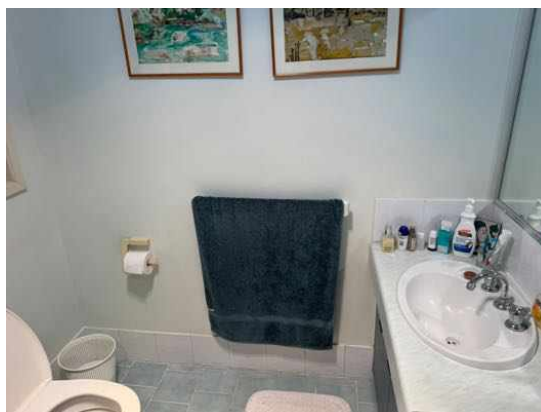
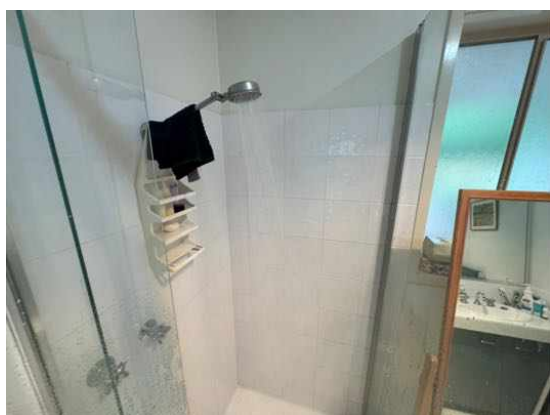
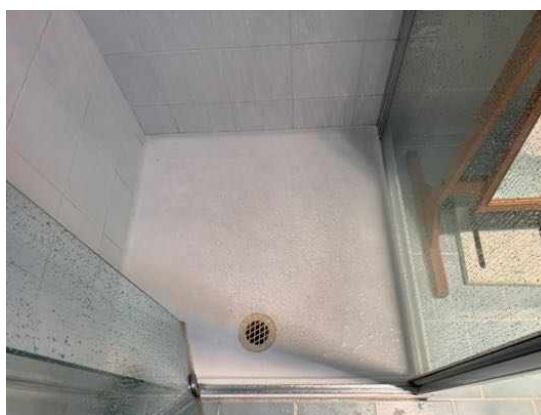
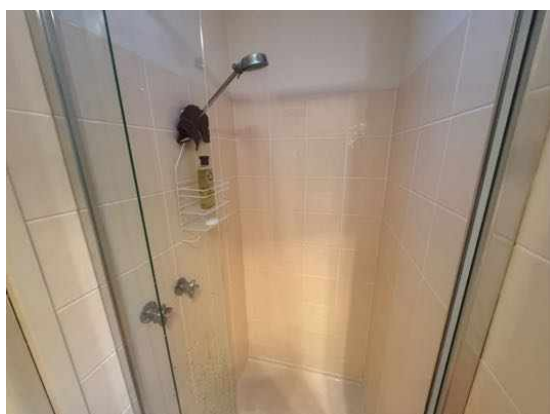
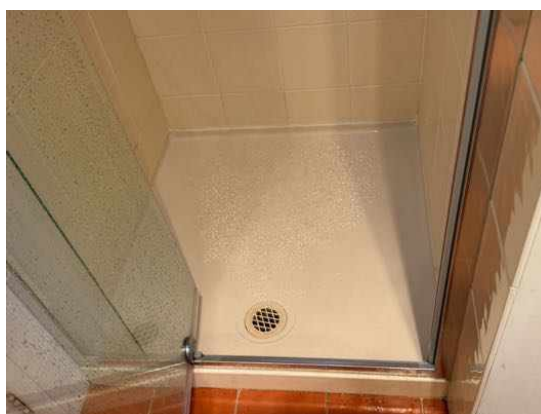
### Finding 3.03

Building: Main Building  
 Location: All Areas  
 Finding: Sealant and grouting - Missing or damaged  
 Information: It was noted on inspection that sealant or grout is degraded to the tiled shower alcove and or other areas of the bathroom.

Different materials and floor areas move at different rates, generally causing cracking to grout or sealant at this point. A flexible sealant is required to allow for expected expansion and contraction, while keeping the joint water tight and protective of all associated building materials.

There appears to be excessive mould to the sealant and grout which will likely require scraping out and replacement.

Flexible and mould resistant materials should be applied to affected areas to prevent any subsequent water damage that is likely to occur. Regular maintenance and replacement of damage or missing or damaged sealant and grout is highly recommended to the wet areas, as this is a regular wear and tear defect. Sealant and grouting in areas that come into regular contact with water should be maintained for the long term care of your property.

A sealant specialist or tiling contractor should be appointed to complete these works as soon as possible

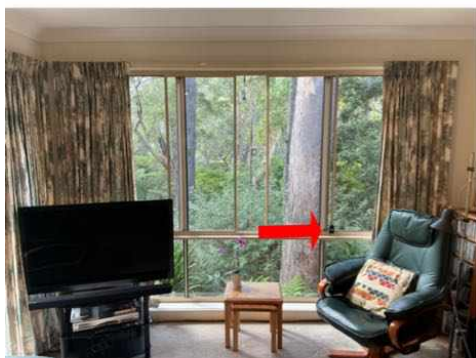
### Finding 3.04

| Finding: | Building element - Damaged |
| Information: | Breakage occurs generally when the building materials have either aged and decayed, or as a result of damage (accidental or deliberate). This includes; <ul style="list-style-type: none"> <li>- The lounge room sliding window latch is loose requiring repairs.</li> </ul> |

Repair and/or replacement of broken elements is advised to ensure that additional secondary defects do not arise as a consequence. Such works are necessary, as all building elements play a key role in the operation and function of the overall structure and its performance.

A relevant tradesperson should be appointed to provide a quote to repair or replace the affected building element prior to purchase.

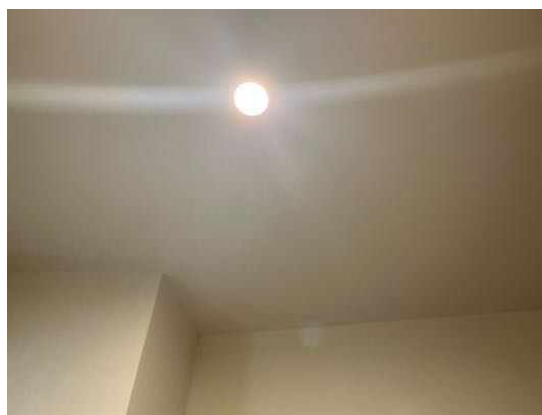
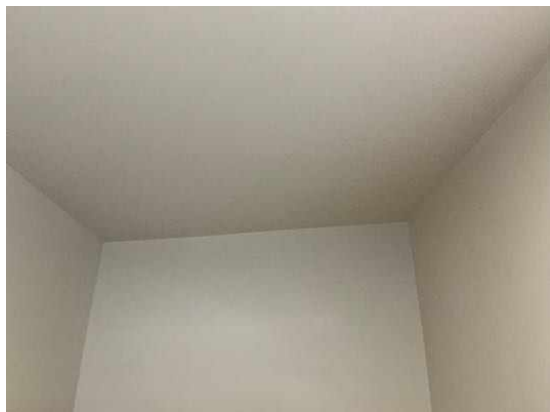
### Finding 3.05

| Finding: | Exhaust fan - Missing |
| Information: | An exhaust fan has not been installed in this area. Missing exhaust fans may lead to the development of more significant defects such as moisture damage to surrounding building materials from inadequate ventilation. Inadequate ventilation in internal areas creates an environment that is conducive to the formation and development of mould and other respiratory hazards. It is highly advised that a licensed electrician be appointed to retrospectively install an exhaust fan. Failure to perform works to aid the ventilation of the area may lead to the development of these secondary defects. |

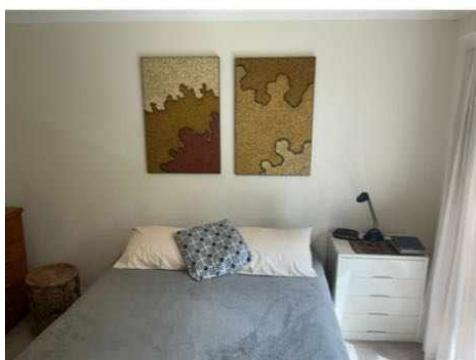
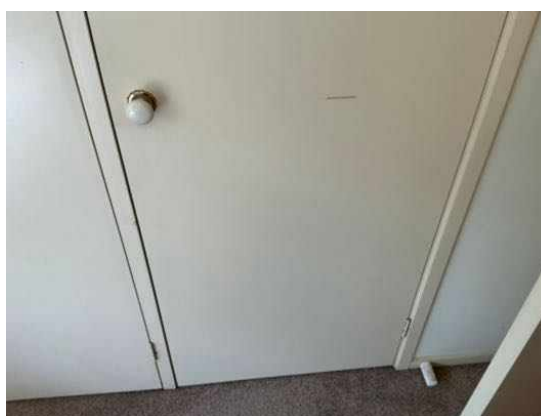
### Finding 3.06

| Information: | Superficial scuff marks were noted to the internal surfaces in this area at the time of inspection. |

Marked and scuffed surfaces, while detracting from the overall appearance of the affected building element, do not indicate any operational or structural damage. This degree of surface damage is consistent with general wear and tear. Marked surfaces may be left at client discretion, if no repair/replacement is necessarily required. Marked surfaces are unlikely to result in the development of secondary damage. However, the client may wish to seek quotations for the cost to refurbish or replace the affected surface.

A general handyman or cleaning contractor may be appointed to rectify marked or scuffed surfaces at the client's discretion.

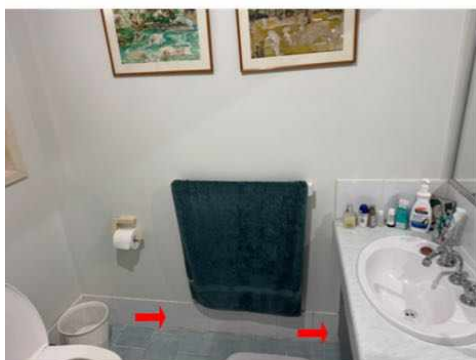
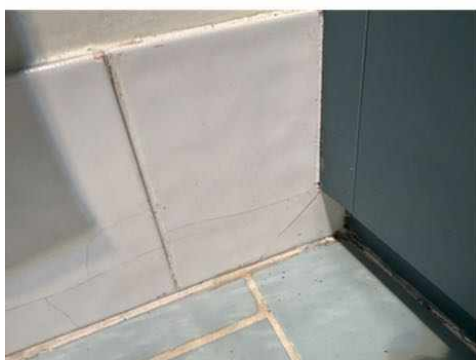
### Finding 3.07

| Finding: | Tiles - Cracked or damaged |
| Information: | Cracking was evident to the tiling in this area at the time of inspection. While the cracking appears to be minor, this area is frequently exposed to water, allowing potential for water penetration into adjoining sections of walls or flooring. |

If left unmanaged, water penetration to these areas may lead to subsequent water damage, which is likely necessitate repair work to affected building elements.

A tiling contractor should be appointed to ensure that no further water damage occurs. The re-application of silicone and grouting throughout remaining tile work is also advised, to further protect the area against water penetration.

Where water penetration has led to water damage, appointment of a relevant tradesperson may be required to repair damaged building elements.

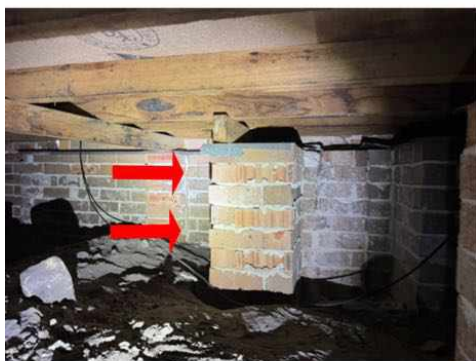
| Information: | Termite activity was found to have affected this area of the subfloor. It is advised that the area be visually inspected frequently to ensure that the condition of affected building materials does not reoccur. |

Please note that although no evidence of live termite activity was found in the roof void or subfloor, because of obstructions and access restrictions the extent of any activity, in the wall cavity and roof space areas is unknown.

It is strongly recommended that the licensed Timber Pest Controller who conducted the last treatment is consulted for further information regarding a termite management system. DNA Pest Control (02) 4421 2009 installed their product on 15/5/21, however it is unknown if this treatment is still active.

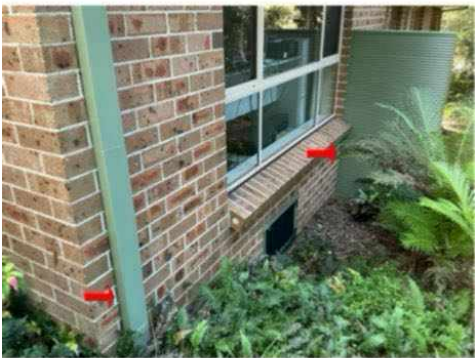
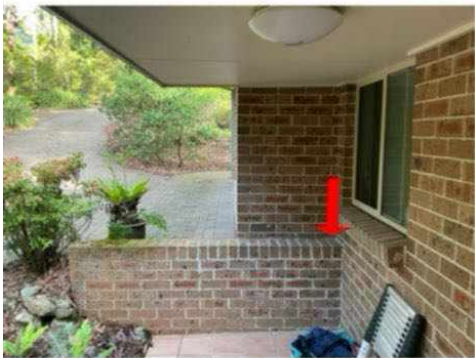
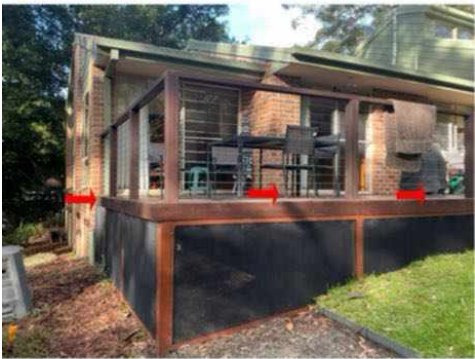
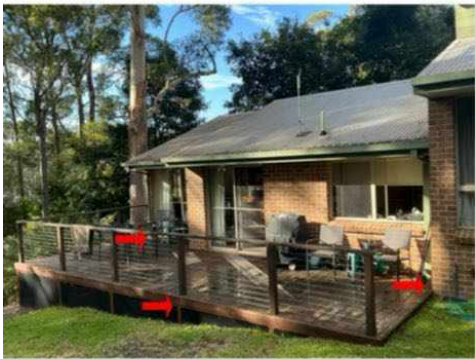
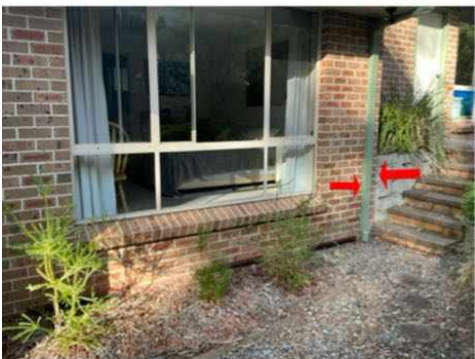
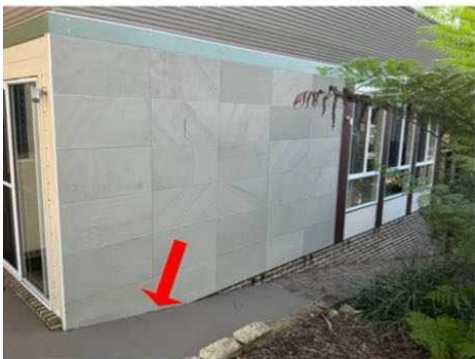
### Finding 6.01

Where bridging of the termite management system has occurred full inspection is prevented and termites may enter a property in a concealed or undetectable manner.

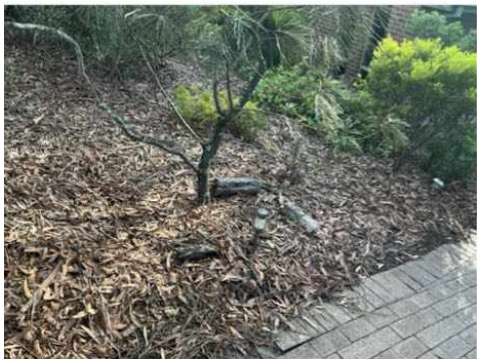
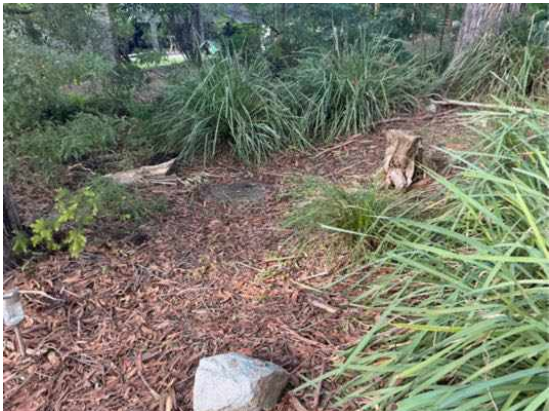
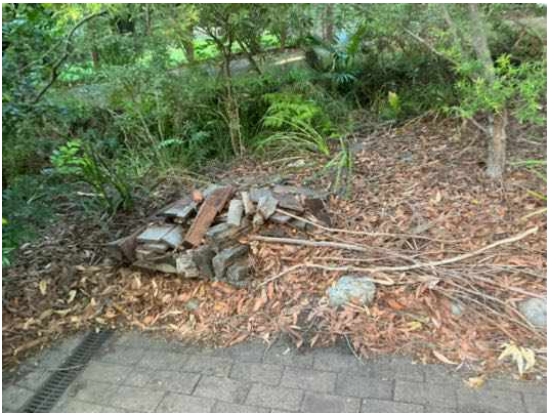
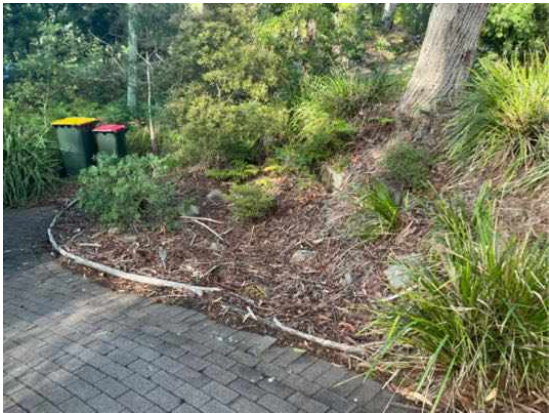
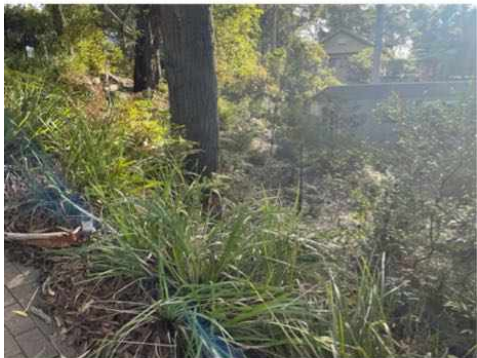
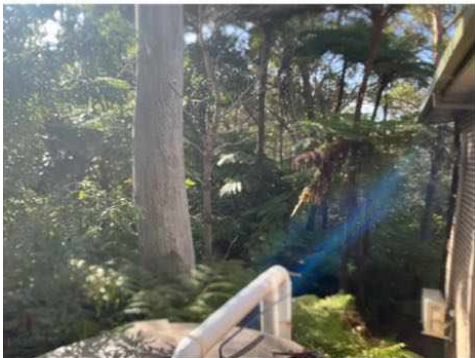
Finding 6.02

Building: Main Building  
Location: All Areas  
Finding: In ground contact  
Information: Any timbers in direct ground contact provide opportunity for concealed termite entry and are likely to be subject to premature rot and decay as the soil retains moisture or damp conditions against the timbers.

Remove untreated timber that is in direct contact with external grounds. Consider replacement with more durable materials i.e. treated timber or non timber elements. Frequent pest inspections are advised to readily identify any termite activity in these areas.

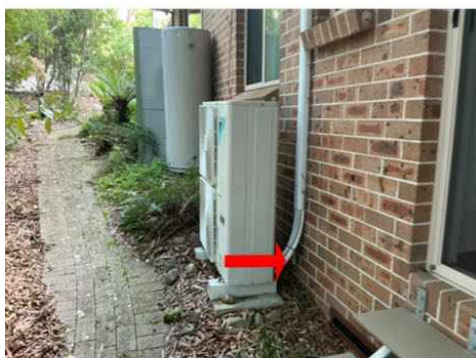
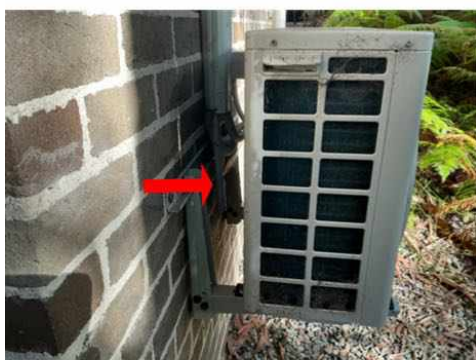
### Finding 6.03

| Finding: | Air-conditioning unit - Condensation Pipe Leak |
| Information: | Leaking from an external air-conditioning unit condensation pipe is a normal function of the unit, however this should be plumbed into the house drainage or directed away from the house structure. |

Heavy leaking from the air-conditioning unit is likely to produce damp conditions in the surrounding area conditions which are conducive to termite attack. If left unattended, such leaking can develop into water pooling below the unit, creating potential for subsequent water damage to associated building elements.

A refrigeration mechanic or licensed plumber should be appointed to assess the condition of the unit and to perform any remedial works as necessary. While discharge from an air-conditioning unit can generally be managed through basic plumbing work, such appointments are deemed necessary to identify any major issues.

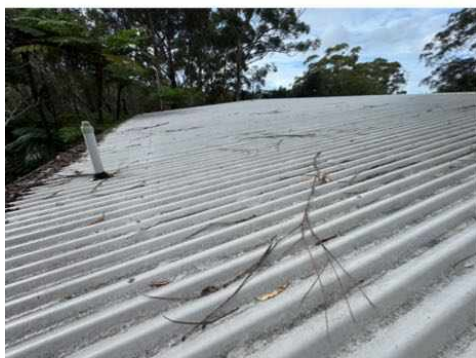
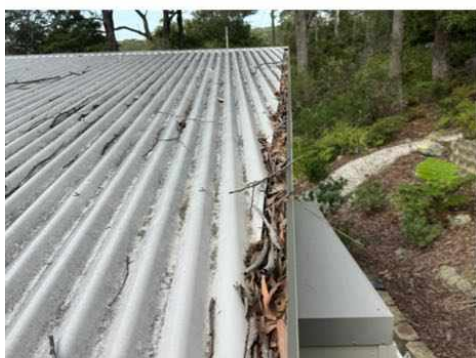
### Finding 6.04

Blocked gutters are likely to lead to high levels of moisture in the affected areas. Such moisture will not only cause rust and decay of the associated building materials, but can also provide conditions that are conducive to termite and timber pest activity. Blockages in gutters should therefore be removed immediately to ensure dry conditions are maintained.

Consult a Licensed Plumber for further specific advice on remedial works that may be required. In the interim, it is highly advised that blocked gutters be removed by the homeowner or a general handyperson as a matter of urgency.

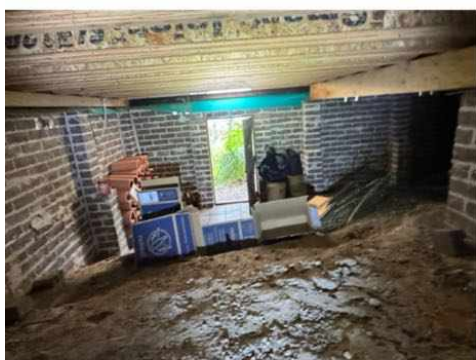
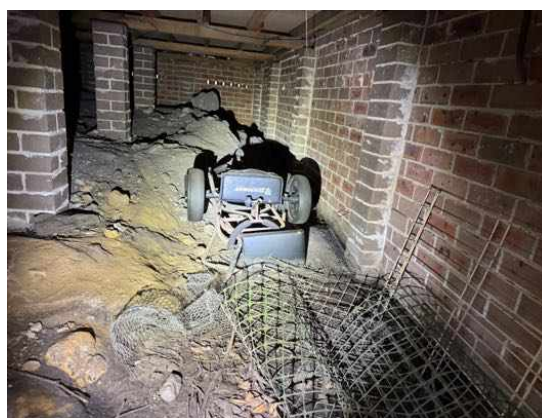
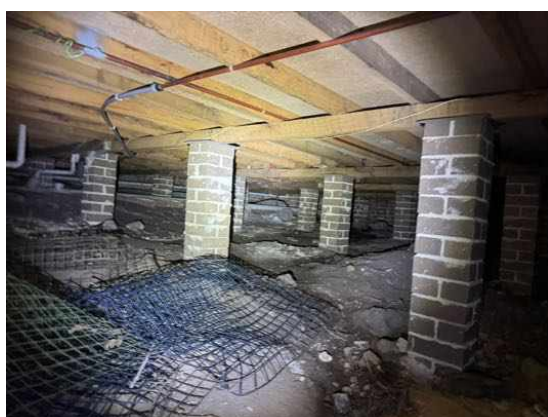
### Finding 6.05

Building: Main Building  
 Location: Subfloor  
 Finding: Subfloor - Debris

**Information:** An array of debris was found in the subfloor area at the time of inspection. Debris in this area restricts subfloor ventilation and creates potential for concealed pest entry. Stored timbers and other materials may also make the area susceptible to termite activity and wood rot.

A clear and empty subfloor will be better ventilated and easier to maintain in a dry condition. The removal of any timber debris is vital in minimising the risk of termite or wood borer activity.

Debris in the subfloor should be removed as soon as possible. Depending on the location and amount of debris and stored items, the homeowner may elect to undertake this task. Alternatively there are a large number of rubbish removal subcontractors that could undertake these works.

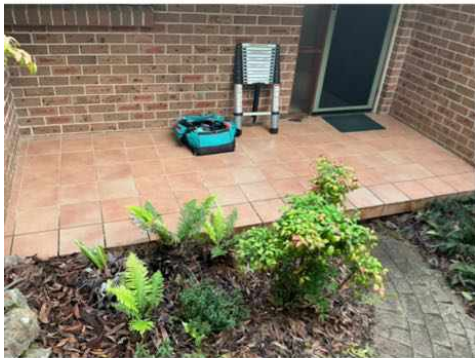
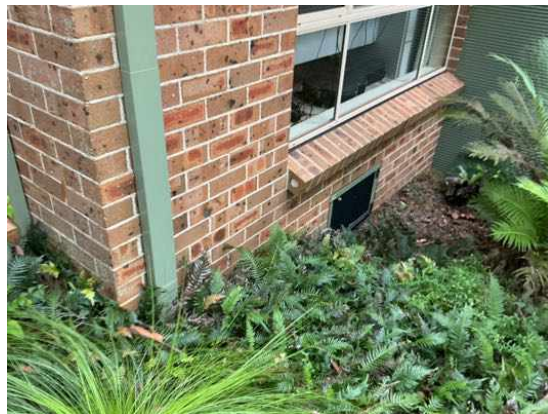
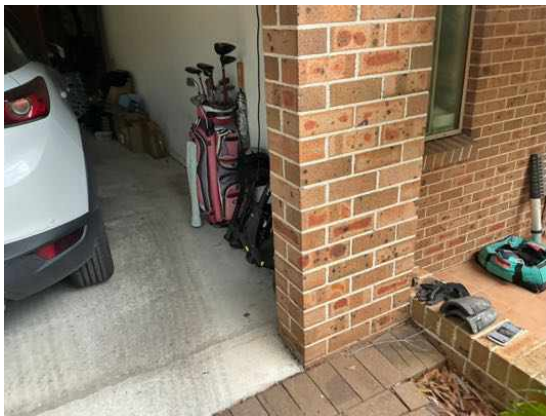
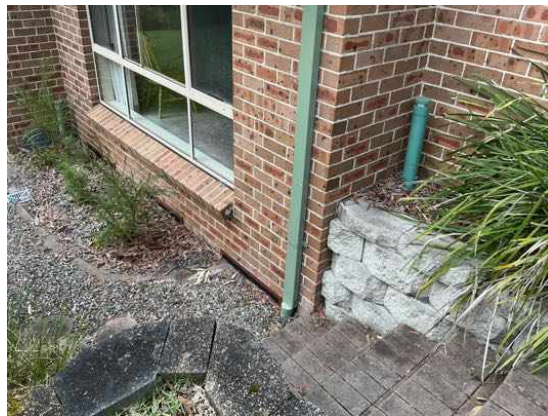
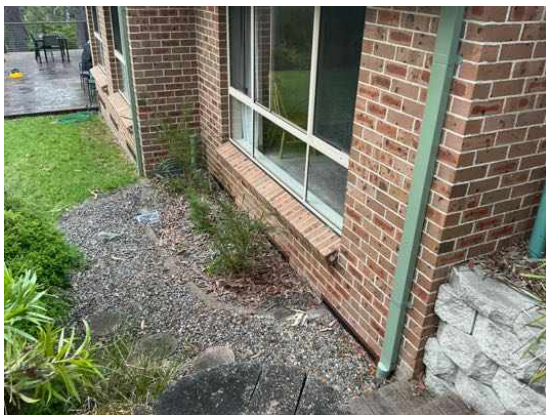
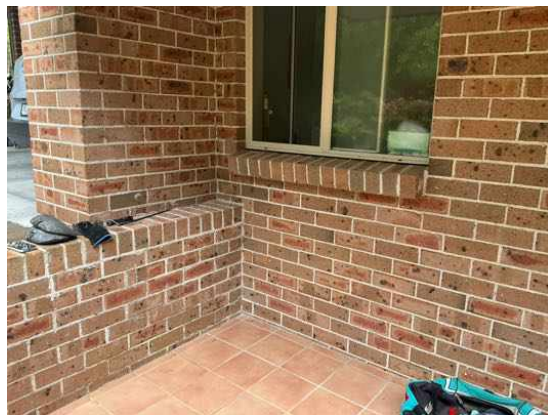
### Finding 6.06

**Building:** Main Building  
**Location:** Subfloor  
**Finding:** Subfloor - Lack of ventilation  
**Information:** It was noted at the time of inspection that the subfloor area lacks adequate ventilation. Ventilation can be restricted by a variety of minor defects, including obstructions in the subfloor space, a lack of vents or a low clearance.

A well ventilated subfloor aids in maintaining dry conditions, preventing secondary damage such as wood rot and pest activity, as well as preventing the development of mould and mildew (which can lead to respiratory safety hazards for occupants).

The initial step in improving ventilation is to ensure that the subfloor area is free of any debris or stored items. Where ventilation is still inadequate, it is advised to ensure that all vents are clear of blockages, and additional vents may be installed.

The client may also consider mechanical ventilation (powered fans) to improve subfloor airflow. Remedial works should be conducted as a matter of urgency to protect against the development of potentially harmful subfloor conditions.

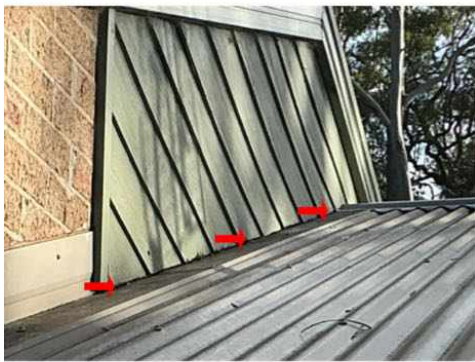
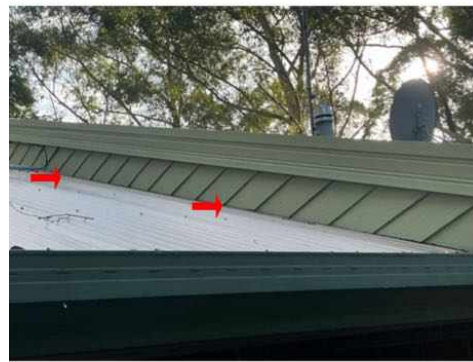
### Finding 7.01

| Finding: | Fungal decay - present (localised) |
| Information: | Fungal decay also known as wood decay generally refers to the deterioration of timber elements when in contact with excessive levels of moisture for a prolonged period of time. Generally fungal decay develops on timber elements that are in use in an external environment which are exposed to rain penetration. |

In this case although the affected timber element is in a decaying state the extent of any visible damage appears to be localised to a specific area. The fungal decay is therefore likely to be of a relatively superficial nature with minimal impact on the structural integrity or tensile strength of the timber element.

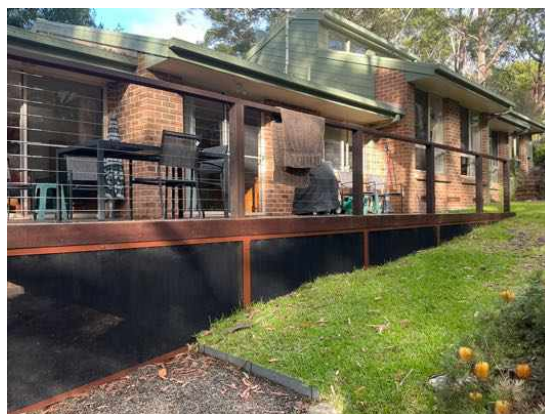
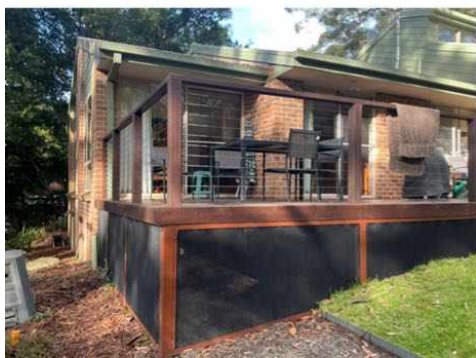
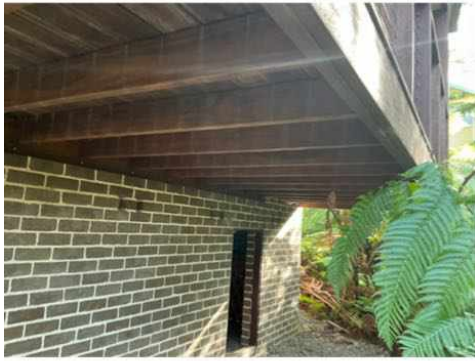
External timber structures and fixings are also constantly exposed to weather elements and can deteriorate in an accelerated manner, ongoing assessments are required.

It is highly recommended that a Structural Engineer further assess the external timber balcony or deck to inform the client of its load capacity. Regular maintenance inspections by competent practitioners is needed.

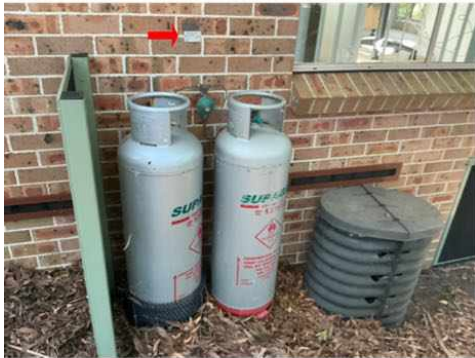
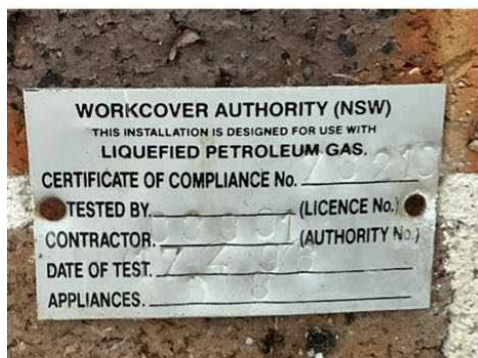
Building: Main Building  
 Location: Exterior walls  
 Finding: Gas Bottle Regulator - Non-compliant  
 Information: In the opinion of the inspector, the gas bottle regulator is non compliant. However, in relation to gas and related gas plumbing, you should always consult a licensed plumber/gas fitter for further advice. The main house gas bottle regulator compliance plate reads 7/4/96. Gas bottles should be positioned on a solid, level platform.

The studio gas bottle compliance plate reads 19 -5-14.

Where installation is out dated, the client should contact the responsible trade (gas plumber) to undertake further inspections.
