# Building and Timber Pest Inspection Report

Inspection Date: Thu, 12 Feb 2026

Property Address: 11 Fleet Avenue, Jordan Springs NSW 2747

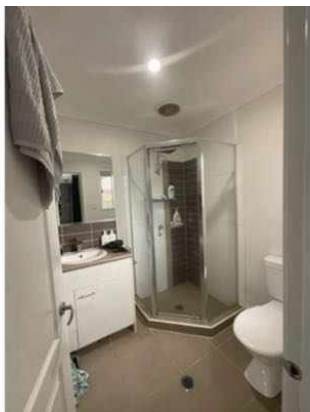
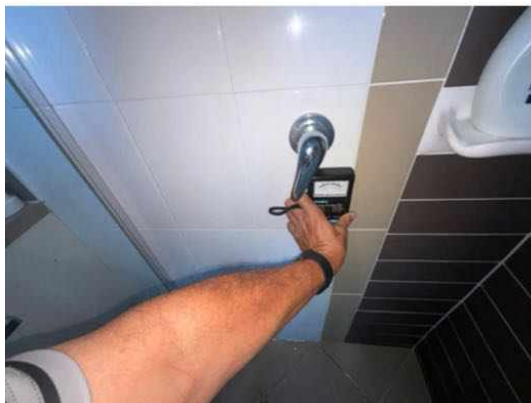
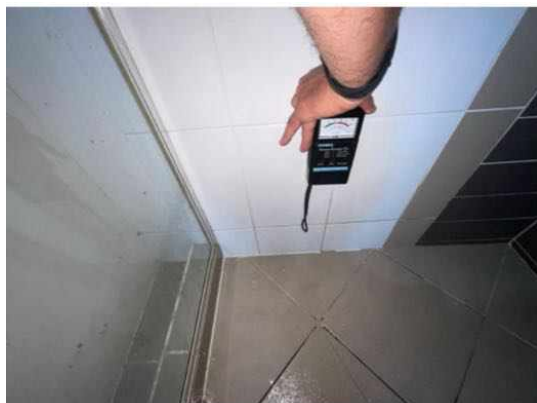
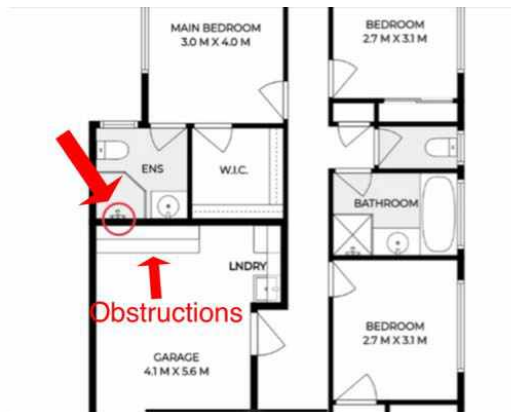
Building:	Main Building
Location:	Ensuite
Finding:	Shower - Damp
Information:	Moisture Defect – Damp to Shower Alcove Wall

Damp was evident to the wall of the shower alcove at the time of inspection. This condition is suspected to be caused by either leaking pipes or fittings within the adjoining wall, or missing or deteriorated sealant around the tap penetrations.

A qualified plumber or bathroom renovation specialist should be engaged to identify the source of the damp and undertake necessary remedial works. This may include resealing, plumbing repairs, or further invasive investigation.

Ongoing maintenance of grout and sealant is essential to prevent future moisture issues.

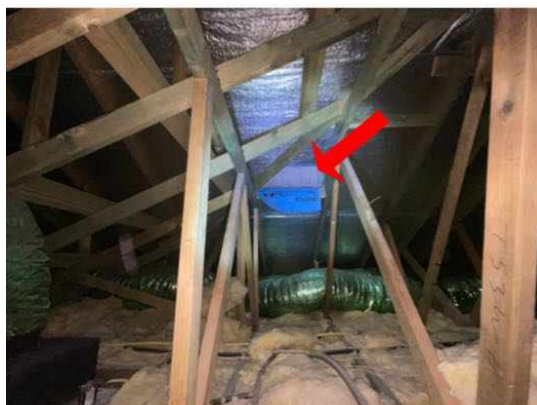
### Finding 3.02

Building: Main Building  
 Location: Roof Void  
 Finding: Sarking was found to be damaged in this area.  
 Information: Damaged Roof Sarking

Where sarking is damaged, its ability to insulate and prevent moisture ingress is compromised. This may reduce the property's energy efficiency and increase the risk of moisture penetration, particularly from condensation or leaking roof tiles.

Any holes or damaged sections of sarking should be repaired or replaced to restore full functionality. These works should be completed by a roofing contractor or other suitably qualified tradesperson.

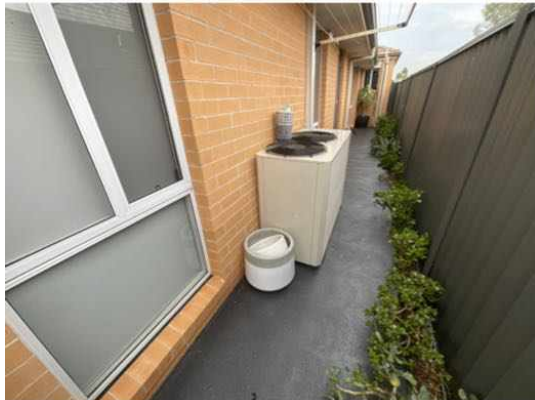
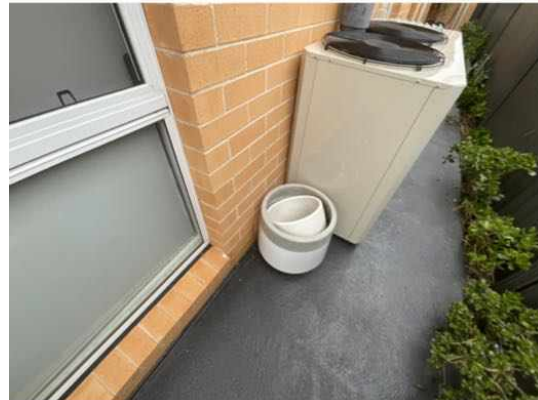
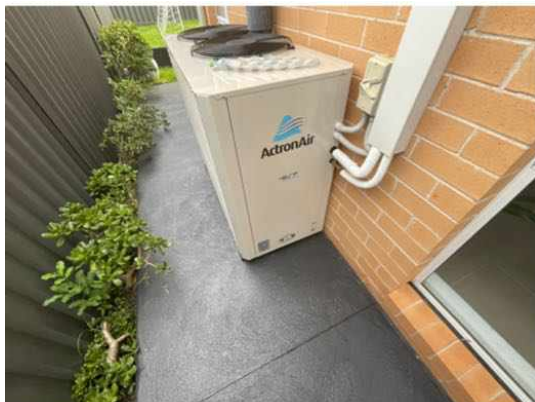
Defect Type: Restricted Access / Concealed Entry Risk

An air conditioning unit is positioned in close proximity to the external wall, obstructing visual access to the wall surface and/or weep holes in this location.

- Obstructions such as this limit the ability to detect evidence of termite activity or conditions conducive to infestation.

- It is recommended that the A/C unit or associated obstruction be moved to allow a clear inspection of the wall and weep holes.
- A re-inspection should be carried out once access is available.
- It is also recommended that external walls remain clear of obstructions for ongoing periodical termite inspections, in accordance with best practice.

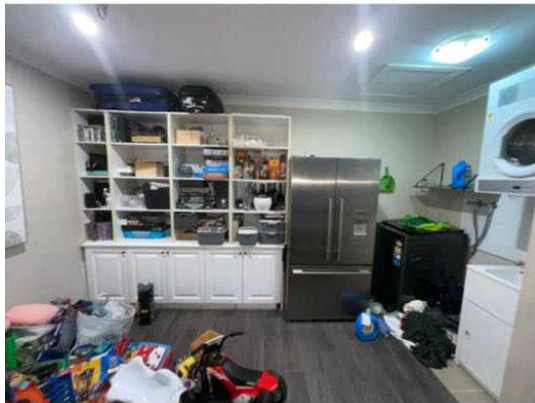
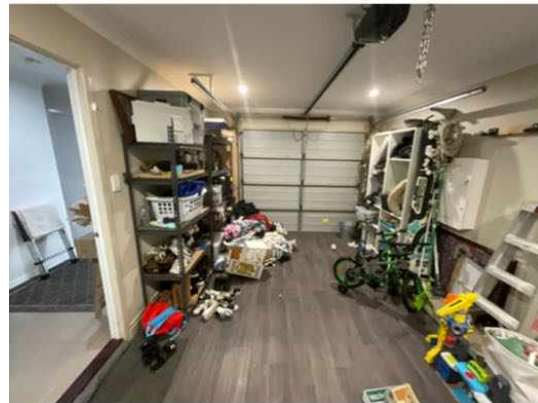
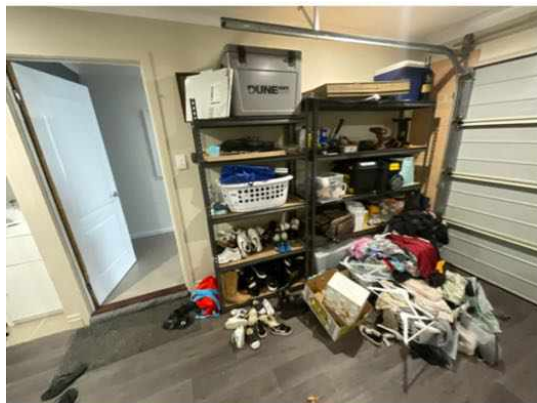
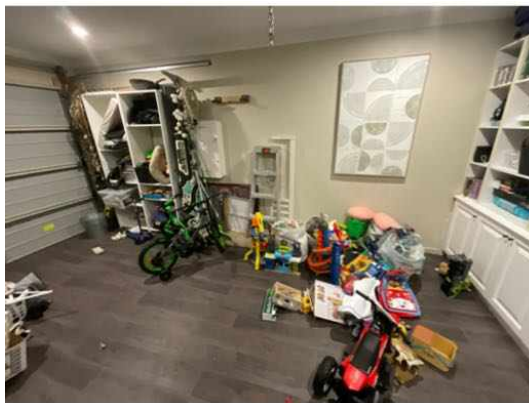
These obstructions—including stored items, fixed furniture, floor coverings, or limited access areas—may conceal defects or conditions not visible during the inspection. It is important to note that significant issues such as moisture damage, termite activity, or structural faults can exist behind or beneath obstructed areas.

It is strongly advised that all obstructions be removed and a re-inspection be carried out to ensure a thorough assessment of the previously inaccessible areas. This will allow for a more accurate evaluation of the property's condition and the identification of any concealed defects.

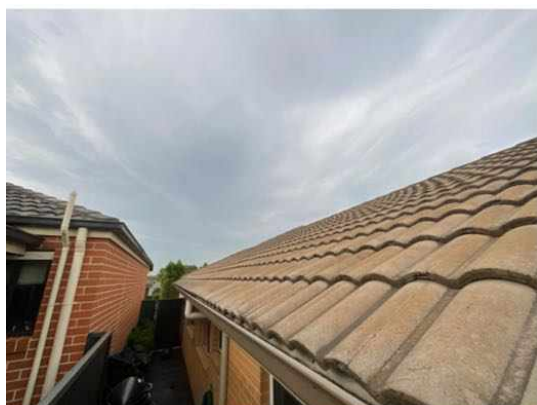
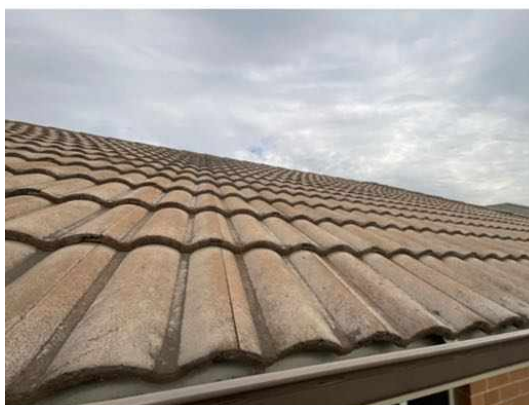
Building: Main Building  
Location: Roof Exterior  
Finding: Roof Tiles – External Inspection.  
Information: Condition Overview:

Upon inspection of the exterior roofing, the majority of roof tiles were found to be in good condition. The mortar to the capping tiles appeared sound, with no significant signs of deterioration. General weathering of the roof tiles is consistent with the age and type of the property and does not raise immediate concern.

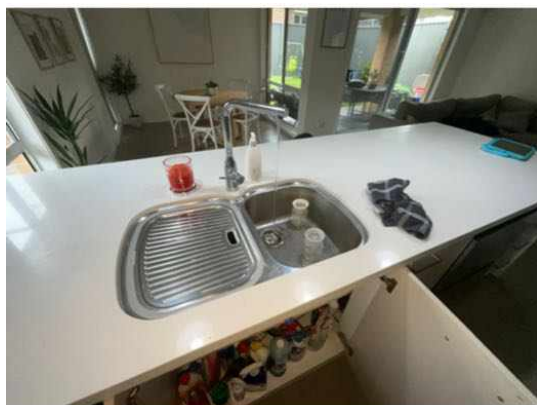
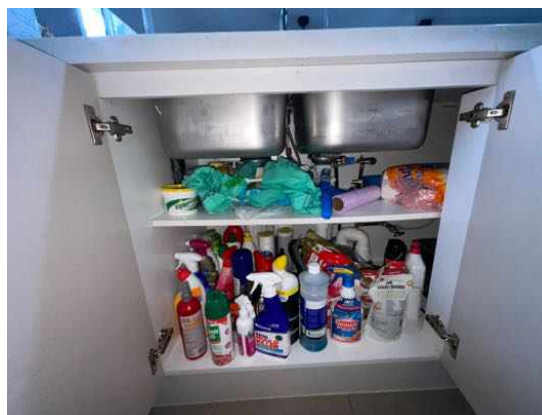
Building: Main Building  
 Location: Kitchen  
 Finding: Kitchen Sink – Overall Condition & Recommendations.  
 Information: Observations:

- Further monitoring and testing are recommended once the tap(s) are in constant use, to identify any drainage issues or signs of slow leaks not evident during the limited inspection.
- It is recommended that the stored items beneath the sink be removed to allow for a full re-inspection of the plumbing and cabinetry, ensuring no concealed defects are

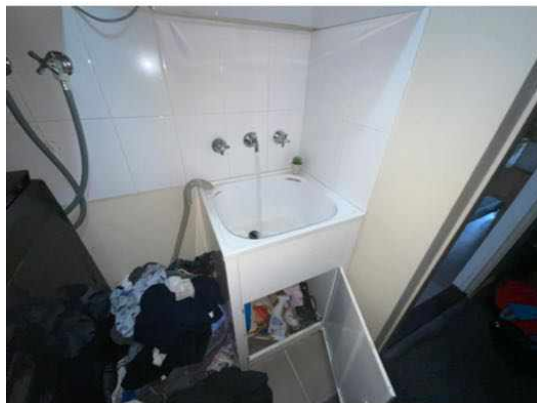
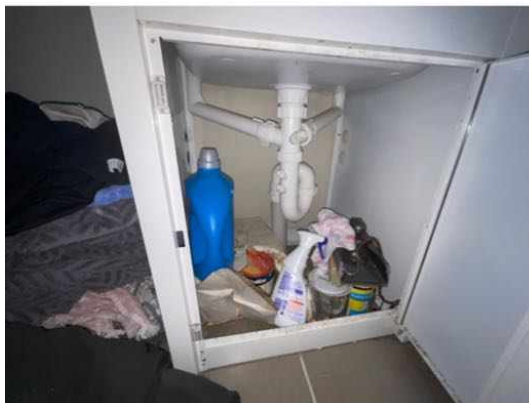
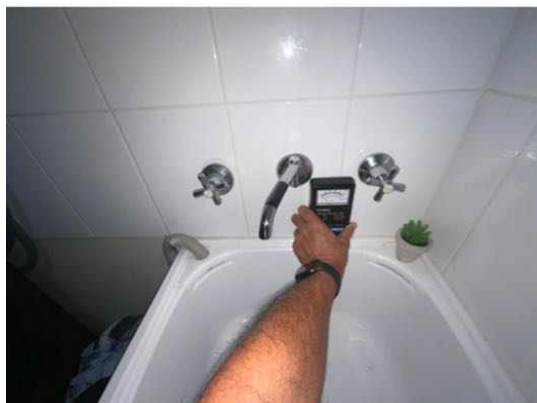
Building: Main Building  
 Location: Laundry  
 Finding: Laundry - Taps/Plumbing/Drainage.  
 Information: Observation: Laundry Tub – Taps, Plumbing, and Cabinetry

- Further monitoring or testing is recommended once the taps are placed into regular use, to ensure no leaks develop over time and that the drainage system continues to perform adequately.
- Flexible and mould-resistant sealant should be applied to junctions between the basin and the wall to prevent water ingress that may lead to damage.
- Regular maintenance and prompt replacement of missing or deteriorated sealant is highly recommended, as this is a common wear-and-tear issue.
- Sealant and grouting in wet areas should be maintained as part of the long-term care and upkeep of the property.
- Where required, a sealant specialist or qualified tiling contractor should be appointed to carry out remedial sealing works.
