Building and Timber Pest Inspection Report

Inspection Date: Fri, 20 Mar 2026

Property Address: 11 Samantha Terrace, Wodonga VIC 3690,
Australia

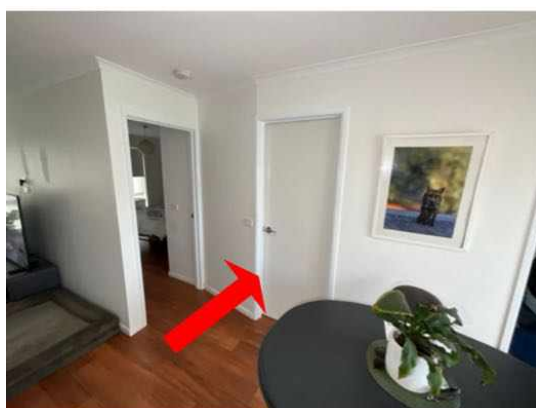
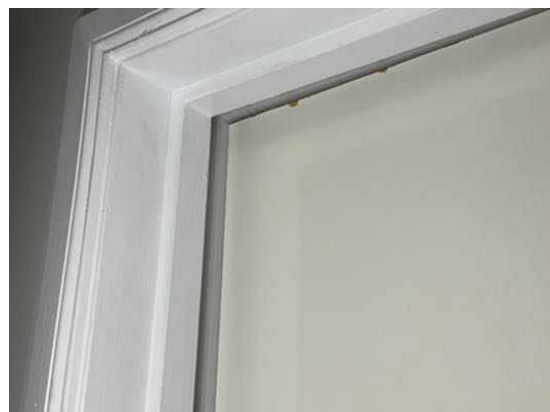
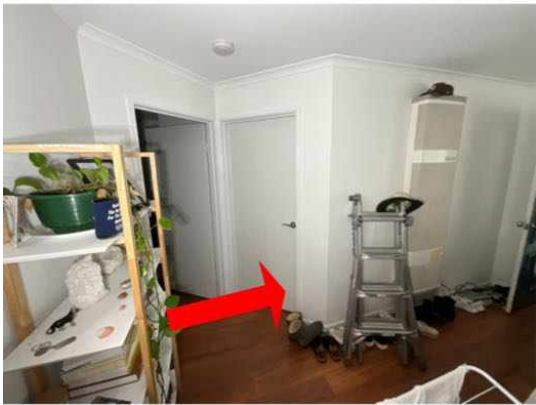
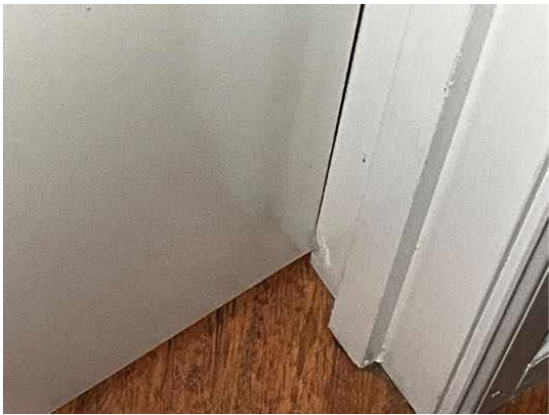
Finding 3.01

Building: Building 1
Location: Bathroom, bed 2
Finding: Door- Binding/jamming
Information: Binding and/or jamming of this door is evident during standard operation. This defect inhibits the functionality of the affected door as well as creating potential for secondary defects to associated building elements, such as damage to the floor covering.

A door that binds to flooring or to the associated door frame may have several causes, ranging from minor defects, such as poor installation of the door or deteriorated hinges, through to major structural issues, such as damage to subfloor structures.

A qualified carpenter or general handyperson should be appointed to perform minor rectification works at client discretion.

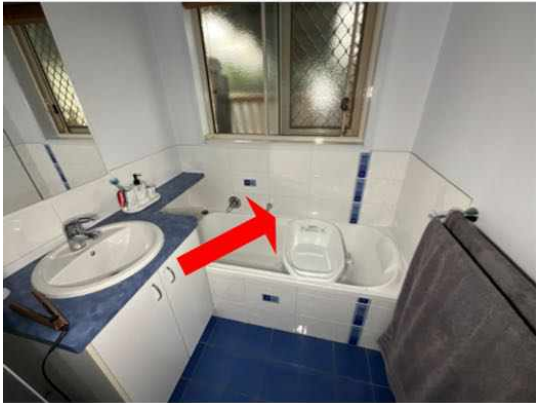
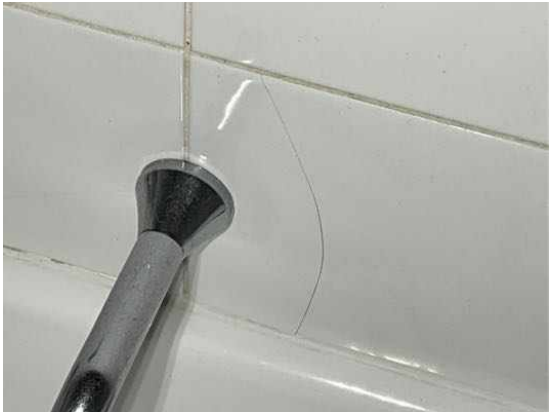
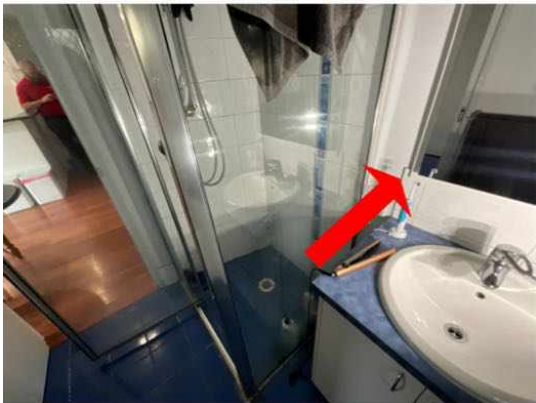
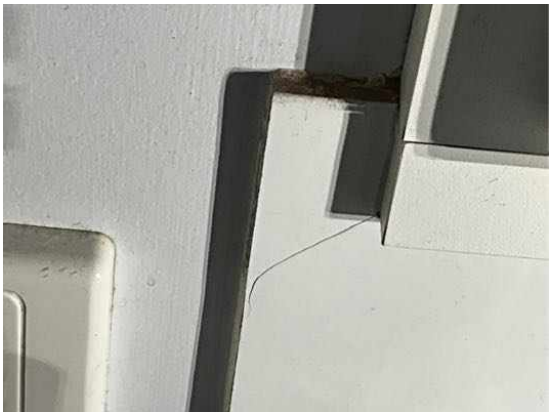
Finding 3.02

Building: Building 1
 Location: Bathroom
 Finding: Wall Tiles- Cracked
 Information: Cracked tiles within the household detract from the overall appearance of the affected areas, as well as creating potential for water penetration to adjoining building elements. If left unmanaged, water damage may occur as a result of constant water penetration over a prolonged period of time.

While not considered a matter of urgency, replacement of tiles is advised as a solution. A Tiling Contractor may be appointed to perform these works at client discretion.

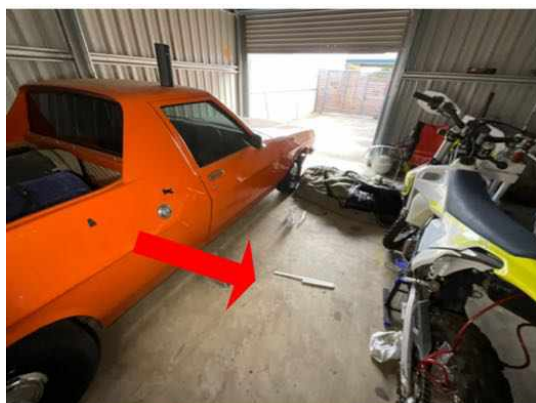
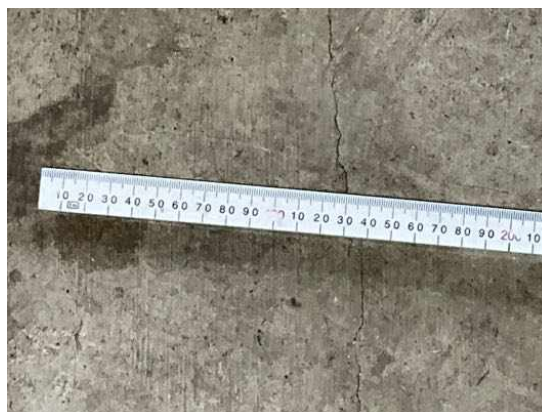
Finding 3.03

Building:	Building 1
Location:	Garage
Finding:	Crack in concrete slab - Category 1
Information:	A crack coded as Category 1 was identified in the slab. A Category 1 crack is described as a fine but noticeable crack, with the slab at an otherwise reasonable level.

To be considered Category 1, the approximate width of the crack is less than 1.0mm, or a less than 10mm change in offset when a 3m straight edge is placed over the defect.

Category 1 cracks should be monitored for a period of 12 months. At the end of the monitoring period, identified cracks that are rated greater than Category 2 are considered defects, and require rectification.

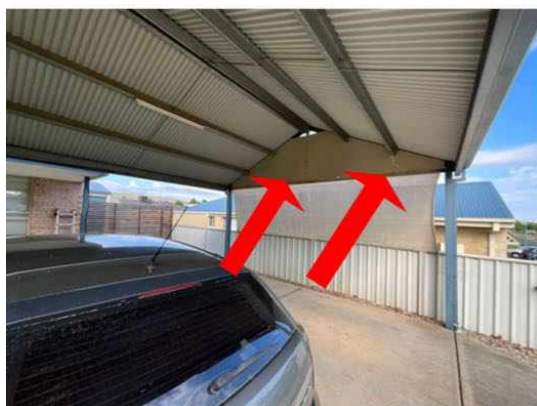
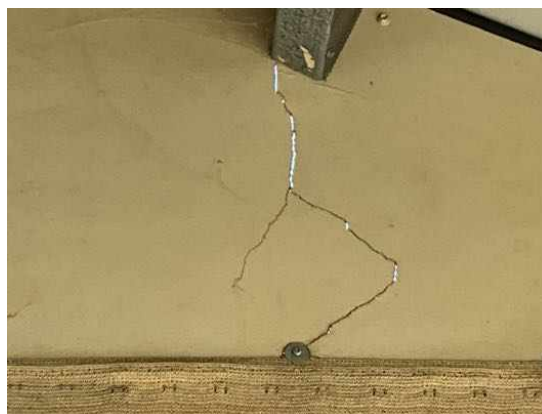
Finding 3.04

Building:	Building 1
Location:	Carport
Finding:	Cladding- deteriorated
Information:	The external cladding shows signs of damage in several areas. Although not serious at this point, monitoring should be undertaken at intervals to ensure no further damage occurs.

A cladding specialist or handyman could be contacted as needed to patch any damage to prevent further deterioration.

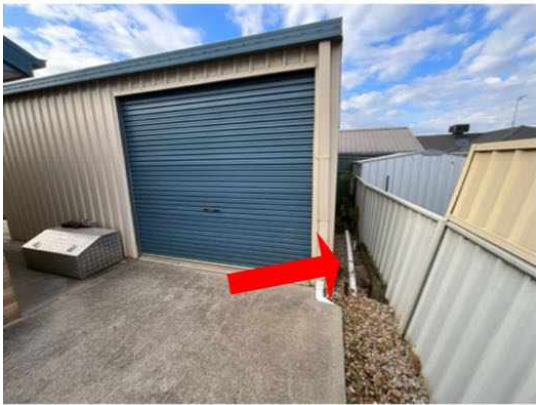
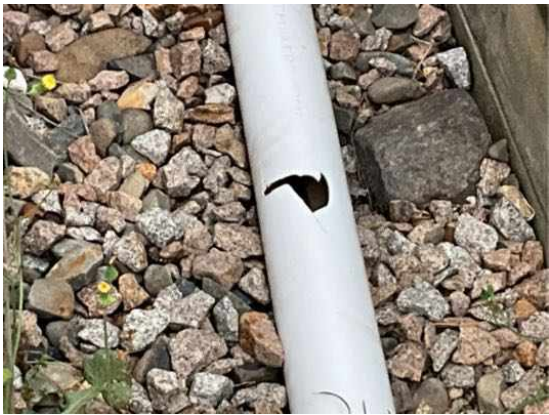
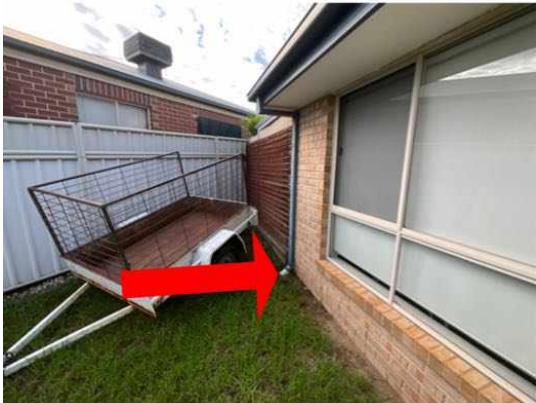
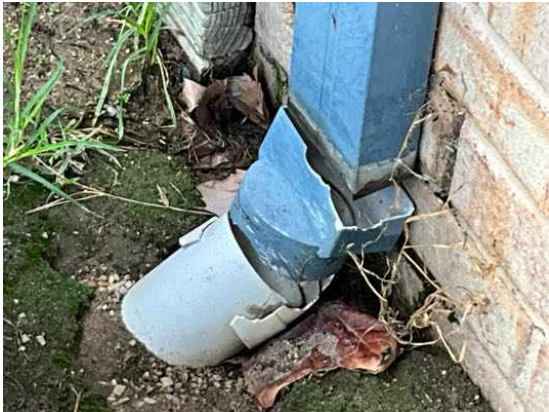
Finding 6.01

Building:	Building 1
Location:	Garage, front wall
Finding:	Downpipe/ Stormwater pipe Damaged
Information:	The Stormwater element was found to be damaged at the time of inspection.

Downpipes ensure excess water is directed away from the structure to prevent damage. This damage includes Fungal timber decay, Termite attack and sinking of the stumps that support the floor. All of this type of damage may lead to costly repairs.

A Plumber should be contacted to make repairs as soon as possible to prevent deterioration of the Structure.

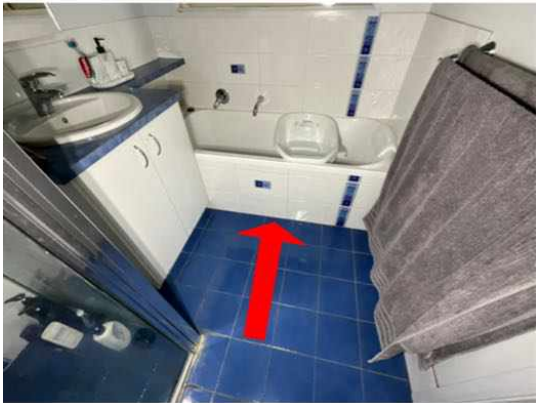
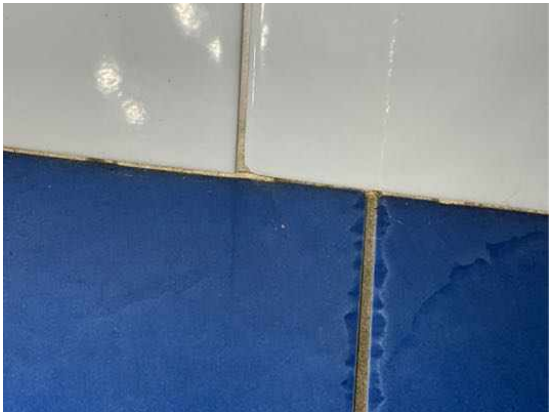
Finding 6.02

Building: Building 1
Location: Bathroom
Finding: Inadequate sealant or Grout
Information: This area has a lack of effective Sealant or Grout. This is allowing the ingress of water to the structure inside the wall.

The presence of water encourages Termite attack, Mould and Fungal Decay.

A Tiler or General Handy person must be contacted as soon as possible to effect repairs and prevent further deterioration.

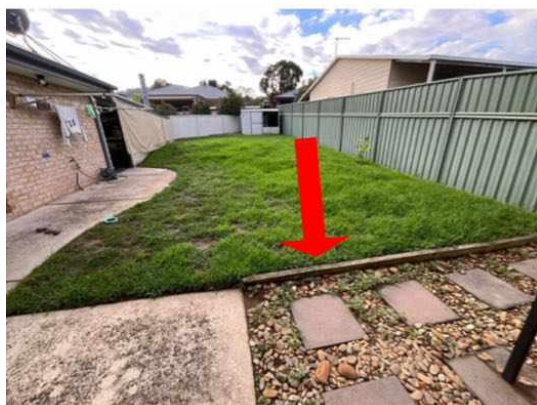
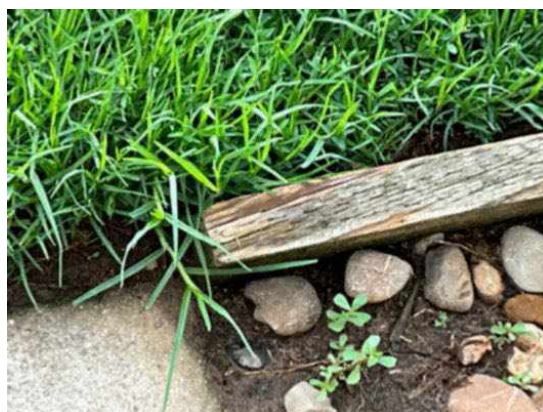
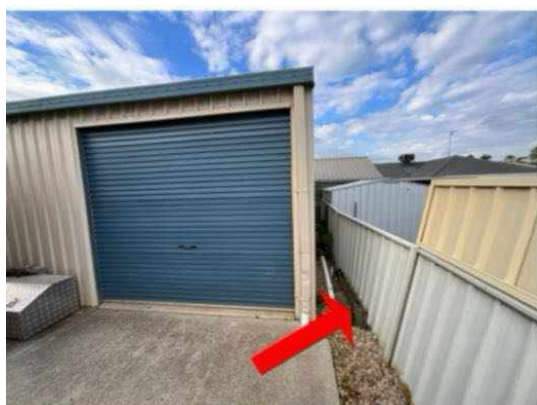
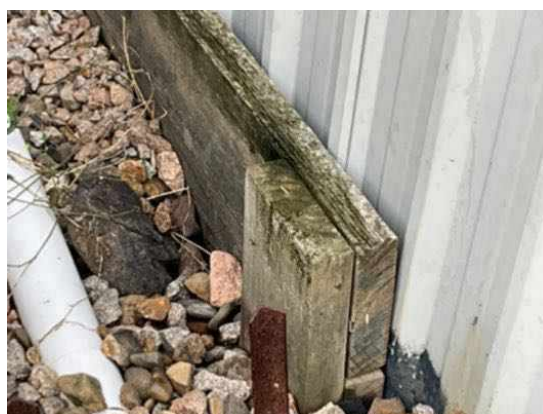
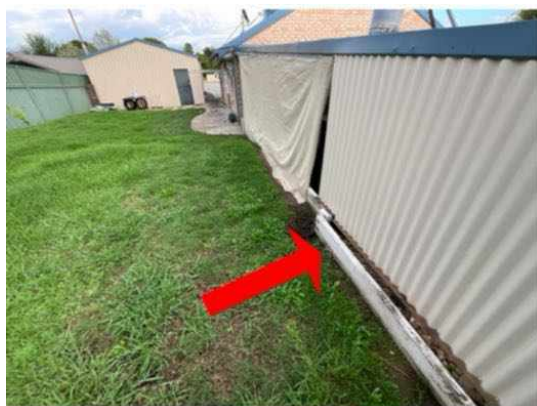
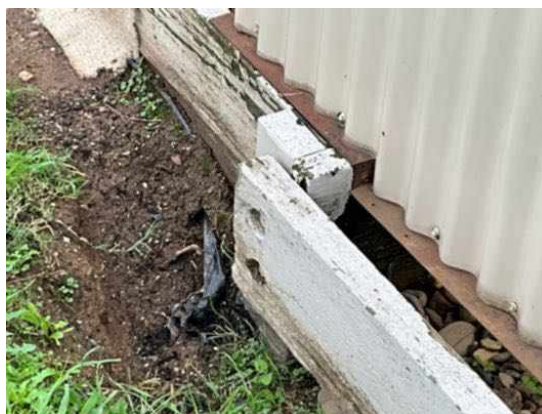
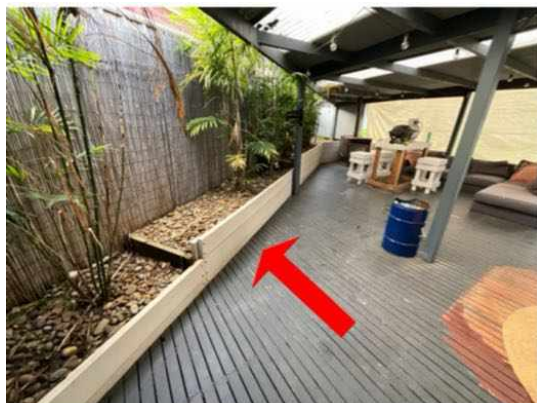
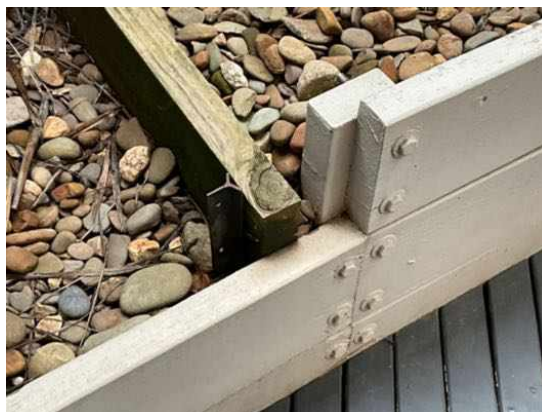
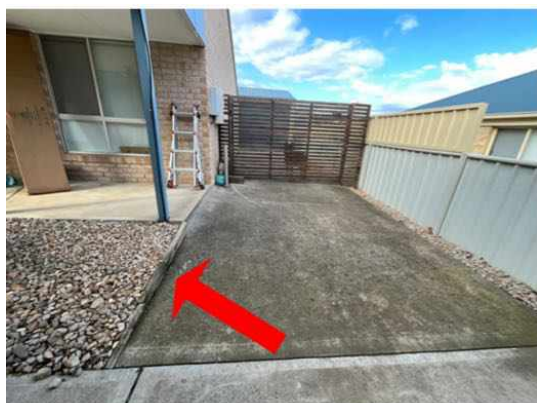
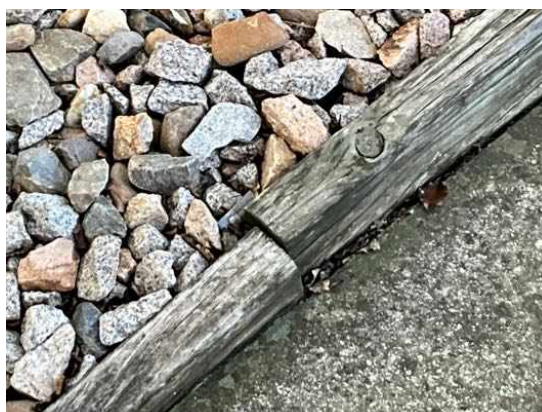
Finding 6.03

Building:	Building 1
Location:	Yard - Back, front, alfresco
Finding:	Untreated or non-durable timbers in a hazardous environment
Information:	To reduce the risk of timber pest attack it is essential that timber used in a hazardous environment (e.g. in direct contact with the ground or frequently exposed to damp conditions) is of sufficient durability and/or is adequately preservative treated.

Untreated timbers in direct contact with the ground are likely to develop severe wood rot and/or fungal decay if left unattended creating attraction for subterranean termites to infest the timbers from surrounding areas.

If untreated or non-durable timbers are found to be in a hazardous environment it is highly advised that replacement of these building elements be performed as soon as possible to aid the protection of the property against termite / timber pest attack.

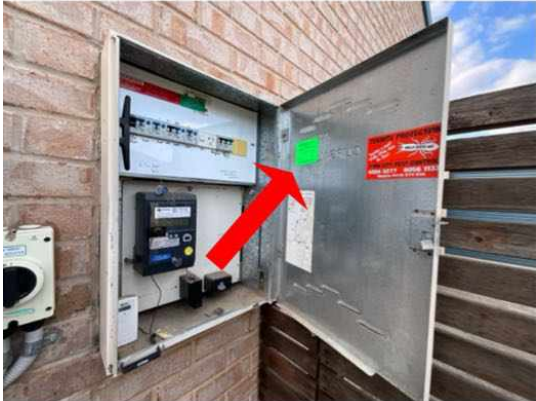
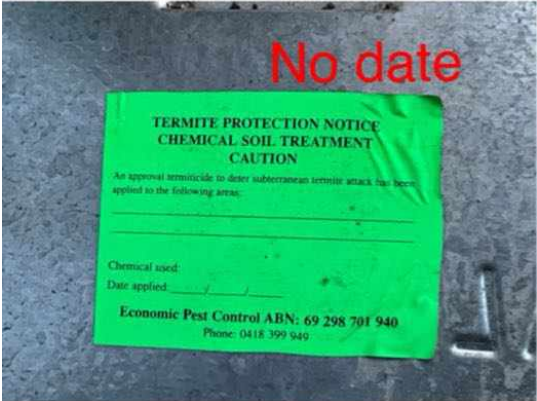
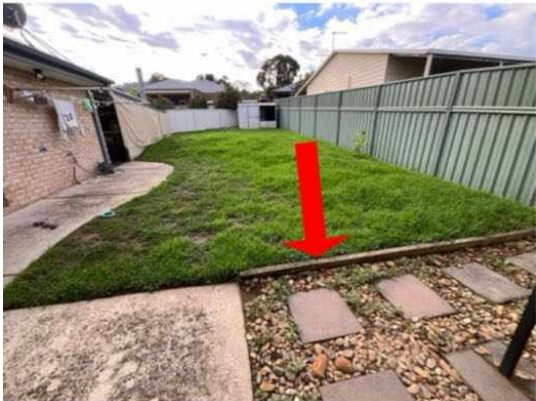
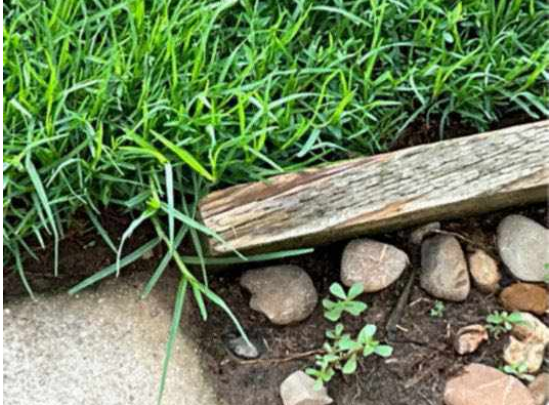
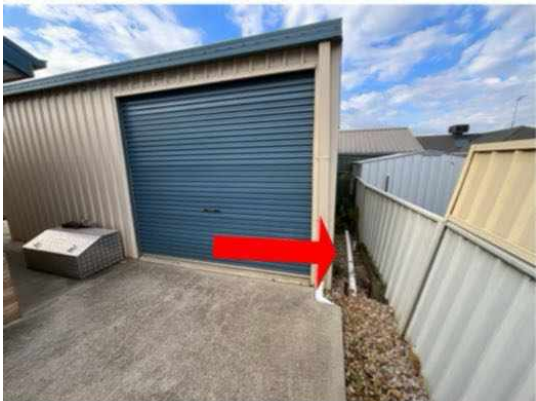
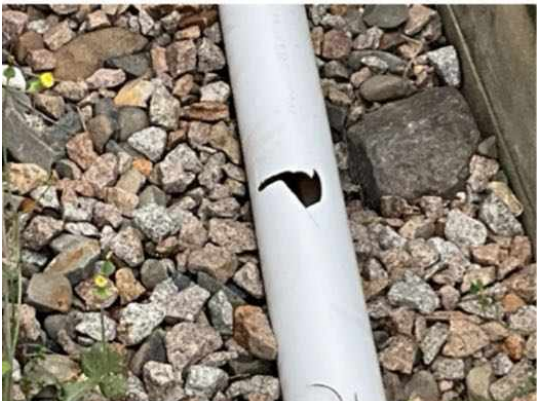
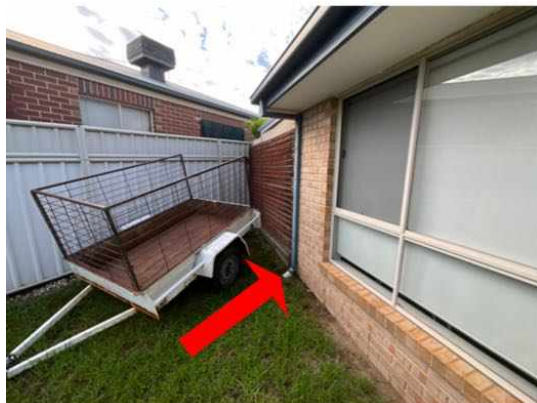
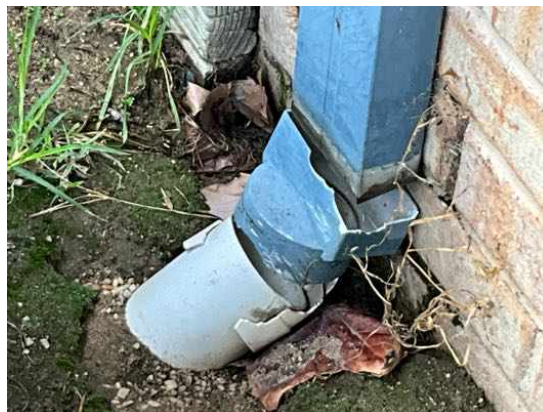
Finding 6.04

Building: Building 1
 Location: All External Areas
 Finding: Termite Management System - no evidence of a chemical installation
 Information: The application of a post-construction chemical termite barrier is highly recommended for all properties, particularly if live termite activity has been found on the site previously. Such barriers are highly effective in preventing termite attack on any timber building elements throughout the property.

A durable notice should be placed in the switchboard unit to indicate current termite barriers. At the time of inspection, it appeared as though no termite management system has been installed, with no evidence to suggest preventative works taking

place.

The client may consider gaining further advice from a pest controller as to the costs and procedures involved with this application. It is recommended that obtaining such advice be a short-term priority.

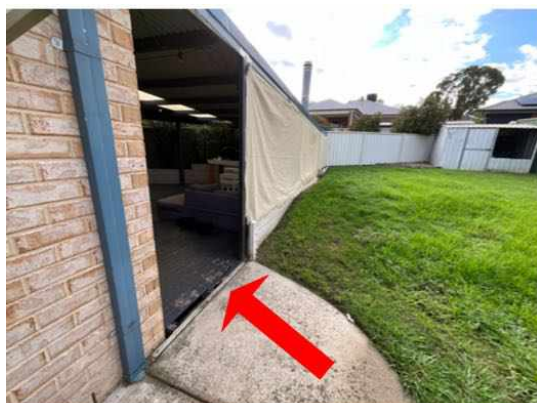
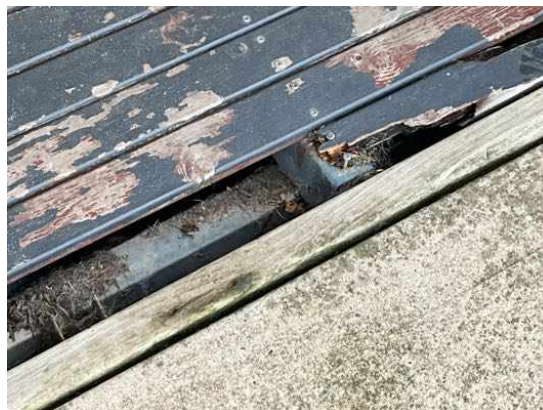
Finding 7.01

Building:	Building 1
Location:	Alfresco
Finding:	Fungal decay - present (localised)
Information:	Fungal decay also known as wood decay or wood rot generally refers to the deterioration of timber elements when in contact with excessive levels of moisture for a prolonged period of time.

The development of fungal decay is accelerated by temperatures in the range of 5degreeC to 40degreeC as well as the presence of oxygen. Generally fungal decay develops on timber elements that are in use in an external environment which are exposed to rain penetration.

In this case although the affected timber element is in a decaying state the extent of any visible damage appears to be localised to a specific area and is yet to spread to other parts of the building element or affect adjoining structures. The fungal decay is therefore likely to be of a relatively superficial nature with minimal impact on the structural integrity or tensile strength of the timber element.

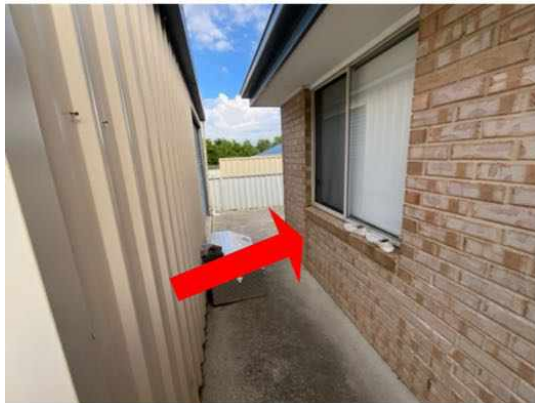
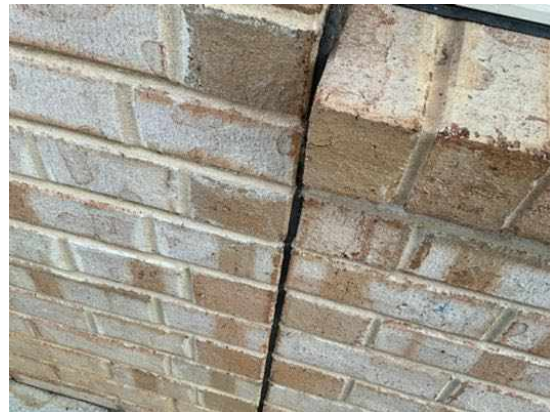
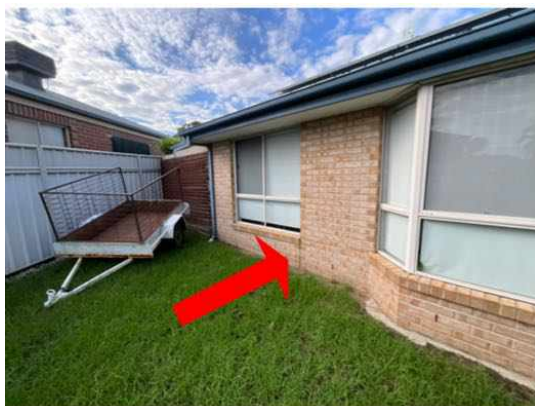
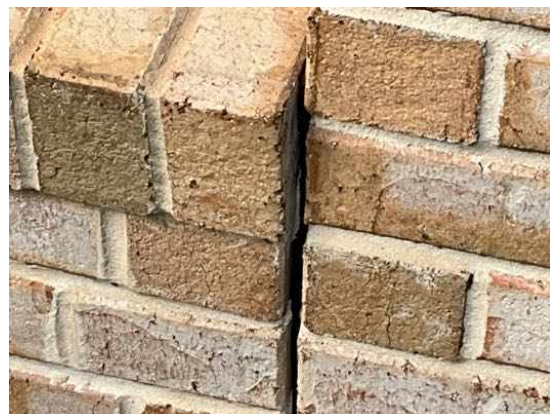
Building: Building 1
Location: Expansion joints
Finding: Inadequate sealant/caulking
Information: This area has a lack of effective Sealant or Grout. This may be allowing the ingress of water to the structure.

The presence of water encourages Termite attack, Mould and Fungal Decay.

A Caulker or General Handy person must be contacted soon to effect repairs and prevent possible deterioration.

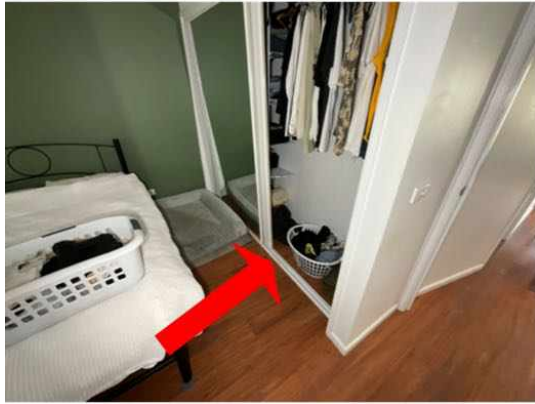
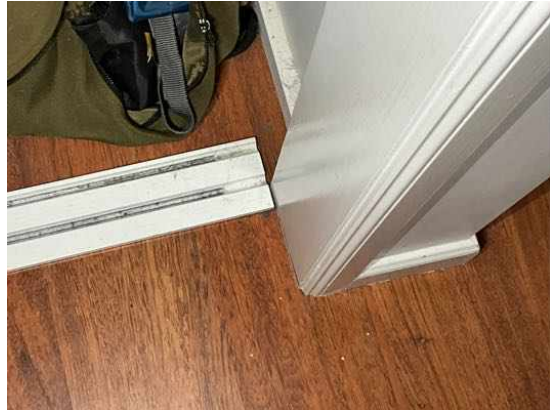
Building: Building 1
Location: Bedroom - Master
Finding: Wardrobe rail
Information: The rail/ track that guides the doors is not fixed to the floor. This allows in acceptable

movement of the doors.

A handyman or cabinet maker should secure the track and prevent further deterioration.

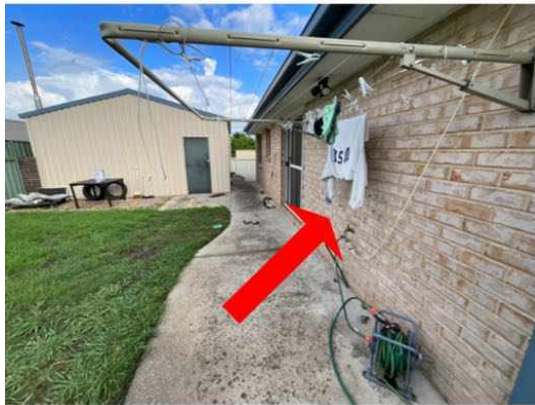
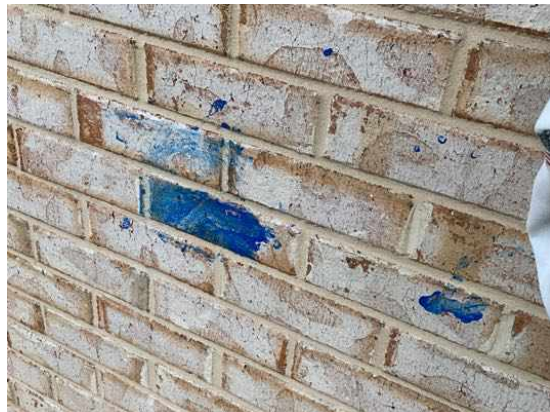
Building: Building 1
 Location: Back wall
 Finding: Paint residue
 Information: Several areas show a kind of overspray of paint. This is a cosmetic defect in this case.

No action is required except at the discretion of the client.

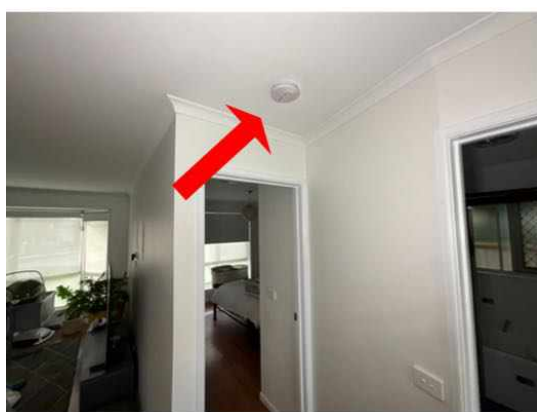
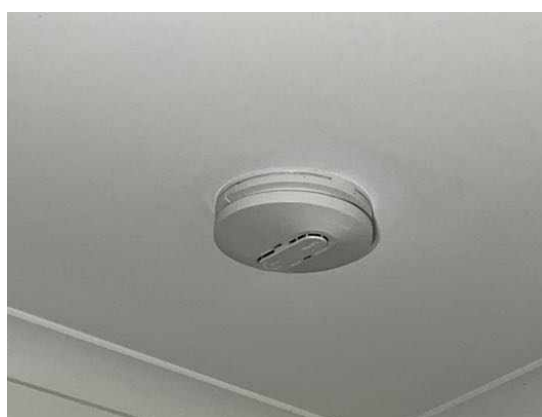
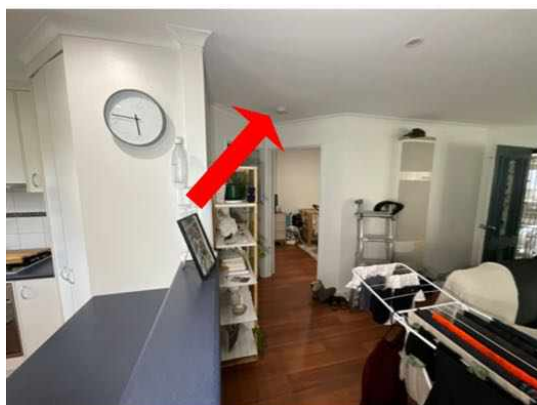
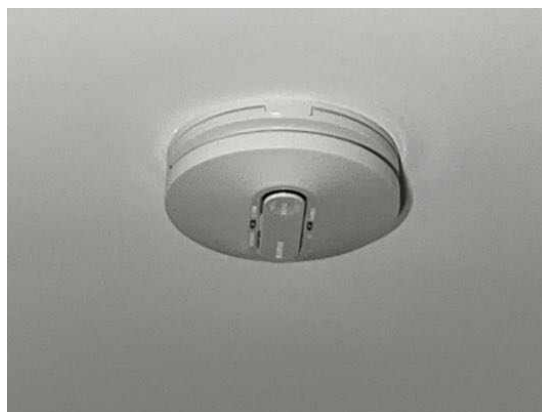
Building: Building 1
 Location: All Internal Areas
 Finding: Smoke Detectors and Alarms
 Information: Reporting on Smoke Detectors or Alarms, including hard wired smoke detection systems and their legislative requirements, is outside the Scope of this Report.

Please note that this defect is highlighted as a caution only. We suspect, based on our

experience in the building industry, that the absence of smoke detectors, or their poor condition, should be addressed as a matter of urgency to improve occupant safety.

Further Inspection and/or advisory services is necessary to provide advice on the sufficiency, type and location of smoke detectors, and to test the functionality of all devices. Greater requirements for fire safety and detection exist for commercial buildings.

Always ensure sufficient working and suitable smoke detectors are installed prior to occupying any building. Additionally, it is advised that all smoke detectors be tested by the homeowner on a monthly basis.

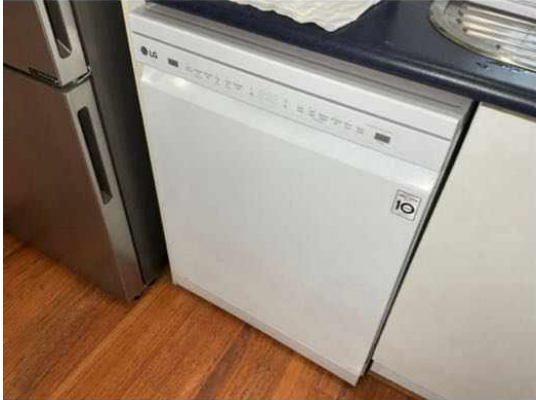
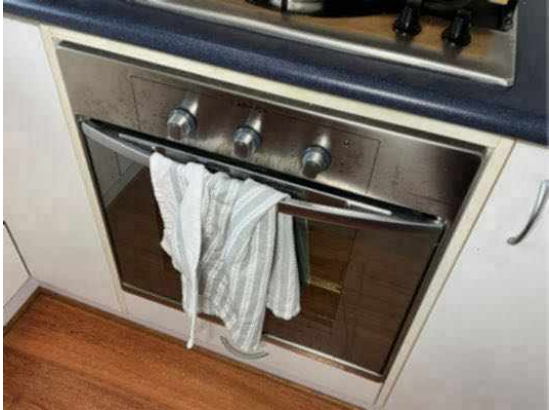
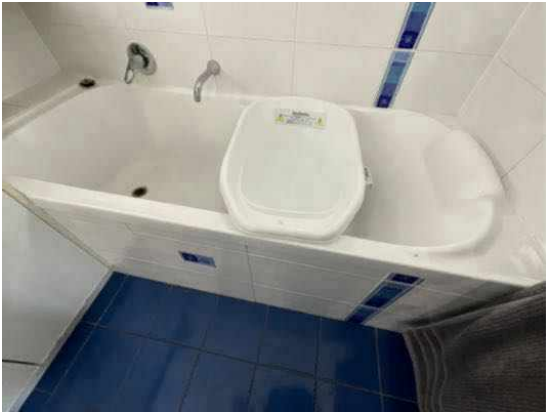
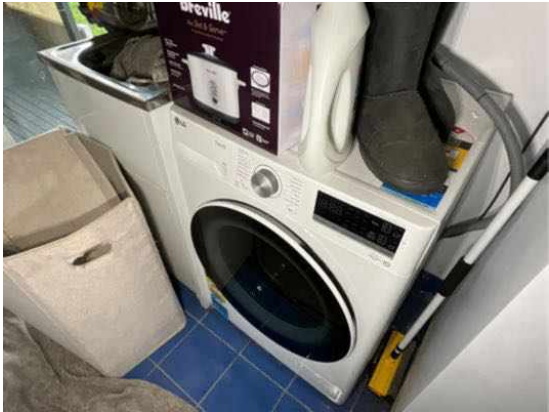
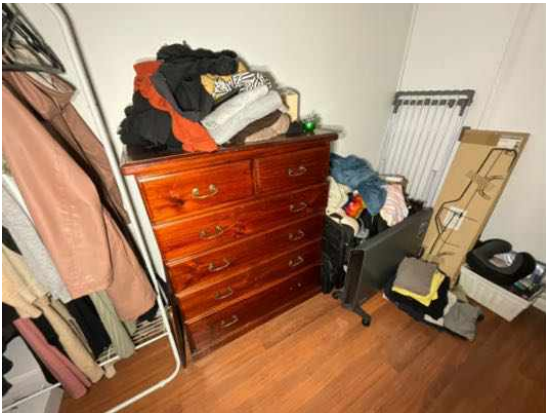
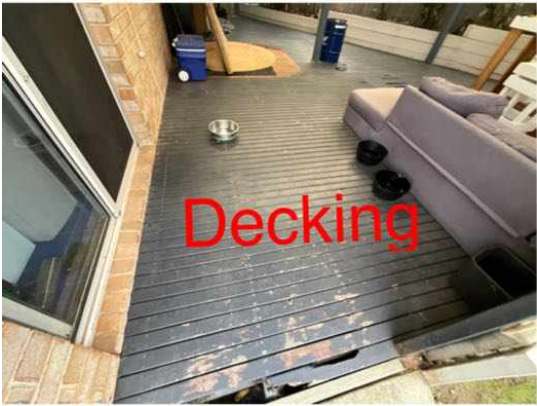
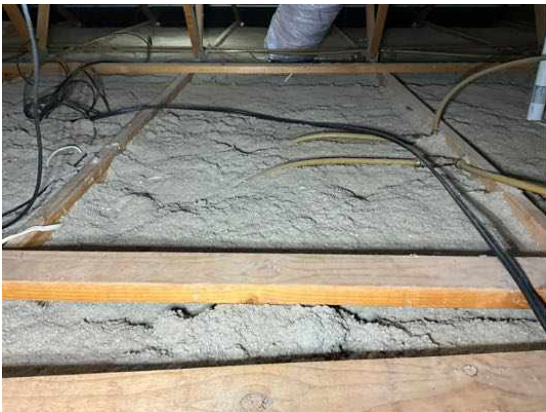
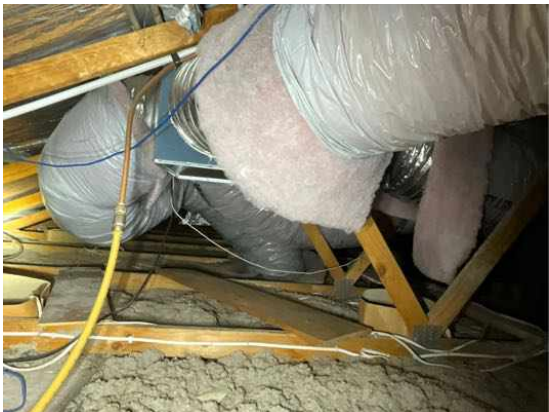
Building:	Building 1
Location:	All Areas
Finding:	Additional Photos - Obstructions and Limitations
Information:	These photographs are an indication of the obstructions and limitations which impeded full inspection of the property at the time of inspection. These obstructions can hide an array of defects and should be removed to allow full inspection to be carried out. A re-inspection is recommended once the areas are made accessible.
