Building and Timber Pest Inspection Report

Inspection Date: Tue, 10 Mar 2026

Property Address: 3 Ash St, Golden Square VIC 3555,
Australia

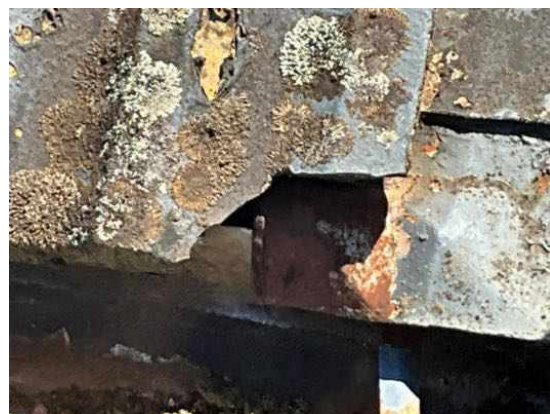
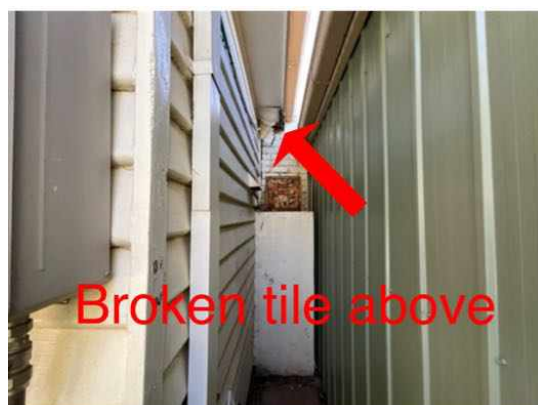
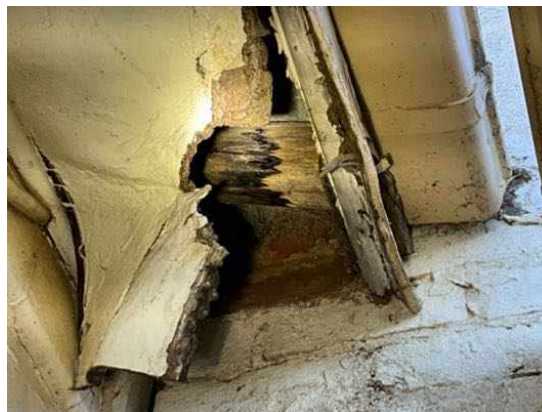
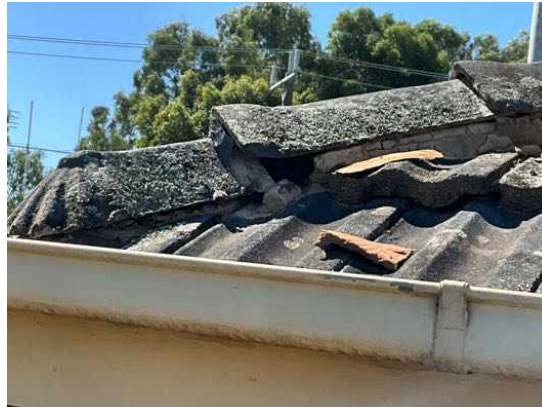
Finding 3.01

Building: Building 1
Location: Roof Exterior
Finding: Roof tiles - Broken
Information: Upon inspection of the exterior roof covering, broken roofing tiles were identified. Broken and friable roof tiles are generally the result of ageing and weathering of what is essentially a porous material.

If left to further deteriorate, broken and brittle roof tiles are likely to lead to water penetration via the roof into the ceiling space, causing secondary damage to ceiling linings, insulation and roof structures. Broken roof tiles are also likely to detract from the effectiveness of the roof drainage system, creating potential for secondary damage to the exterior roof covering and roof plumbing.

Replacement of broken tiles is required and should be performed by a roofing contractor as soon as possible.

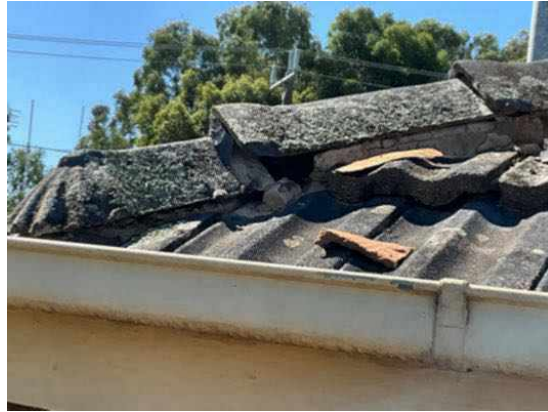
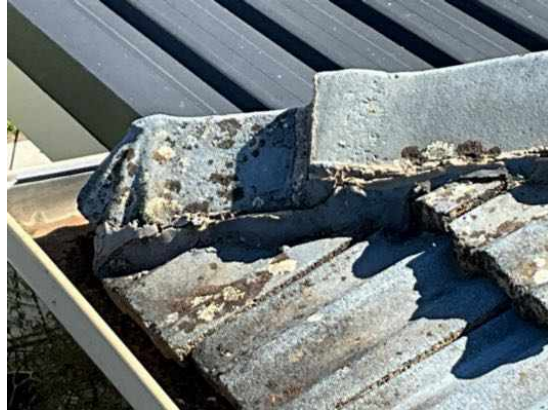
Finding 3.02

Building:	Building 1
Location:	Roof Exterior
Finding:	Mortar - Deterioration
Information:	Mortar, or 'bedding', is the material which fills joints and intersections between tiles and other building elements on the exterior roof covering, such as gable ends, hip capping and valleys. Upon inspection of the exterior roof, it was noted that sections of the mortar show varying levels of deterioration.

Mortar generally deteriorates as a result of frequent exposure to weather conditions over a prolonged period of time. Mortar that is deteriorating may allow water ingress into the roof void, putting associated building elements and roofing structures at risk of water damage. Deteriorated mortar also detracts from the functionality of roof tiles and other roofing elements, potentially decreasing weather tightness and roof drainage.

Mortar deterioration can be attended to by a handyperson where areas of deterioration are localised and easily accessible. Otherwise, consultation with a roofing contractor is advised where greater works are required.

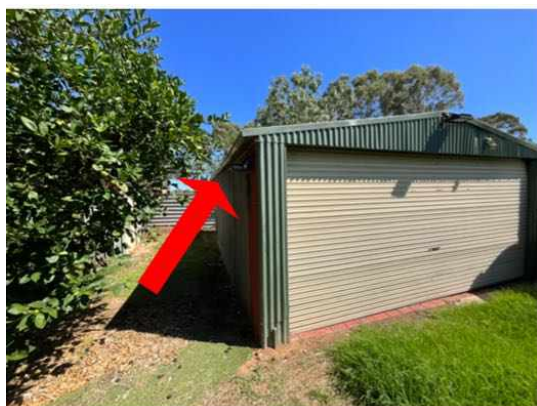
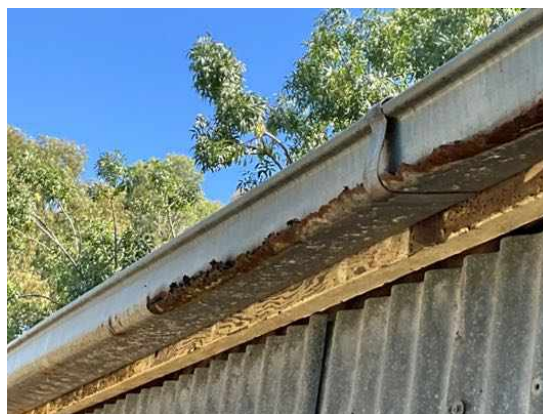
Finding 3.03

Building:	Building 1
Location:	Shed
Finding:	Gutters- Deteriorated
Information:	The guttering and some downpipes have deteriorated.

Although not a major problem now, they will deteriorate further if left for an extended period.

Sagging can be seen in the gutter.

A Licensed Plumber should be engaged as soon as possible to advise on any repairs or maintenance that may be required.

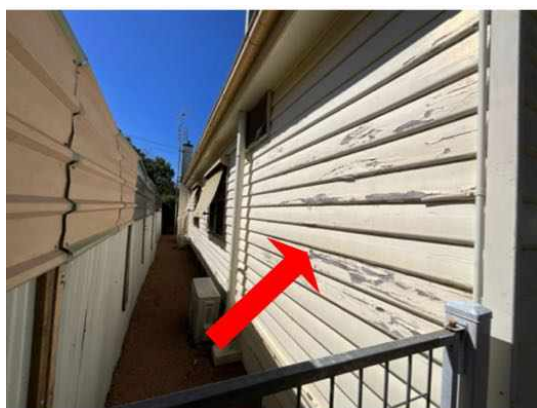
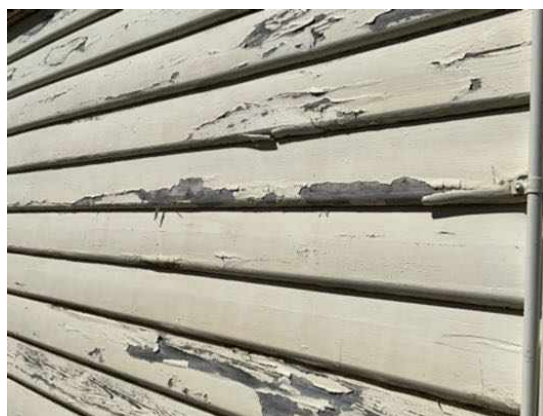
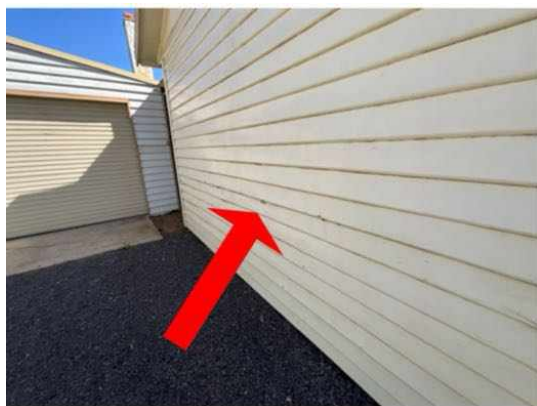
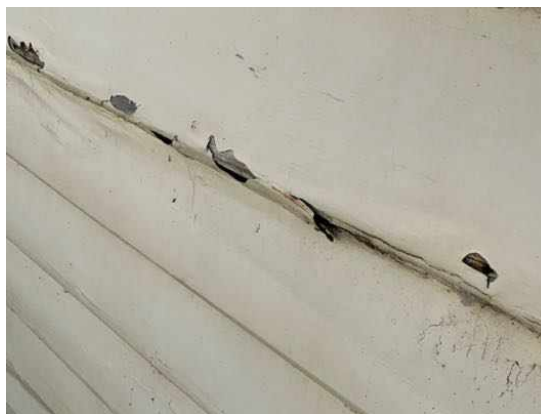
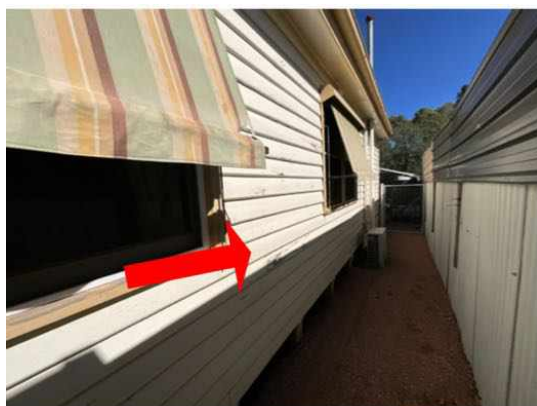
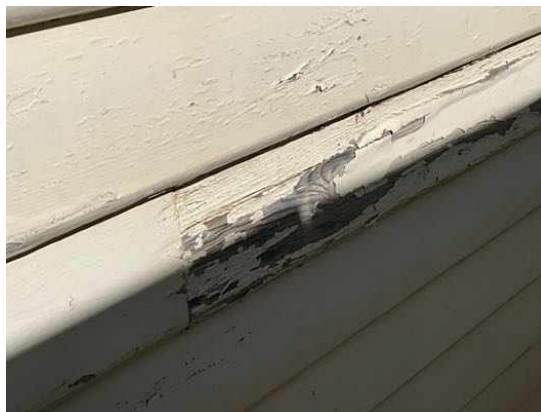
Finding 3.04

Building: Building 1
Location: External timber
Finding: External painting deteriorated
Information: Much of the external paintwork including but not limited to windows, fascias, guttering, veranda and other external fitments have been neglected and require attention to prepare and re-paint.

Whilst incomplete or missing paint finish is generally an appearance defect, it can also lead to the development of secondary building defects over time. Incomplete areas of paint finish expose the area to moisture, potentially accelerating the deterioration of underlying building materials.

Degraded paint finishes should be sanded back, filled, leveled and painted, as applicable. Where inadequate or missing paint protection has led to the deterioration of the associated building element, repair and/or replacement of this building element may be required.

A painting contractor should be appointed as soon as possible to perform necessary works to aid the appearance of the affected area and to ensure the area is protected against further deterioration. Alternatively, the homeowner following manufacturer instructions may perform these works.

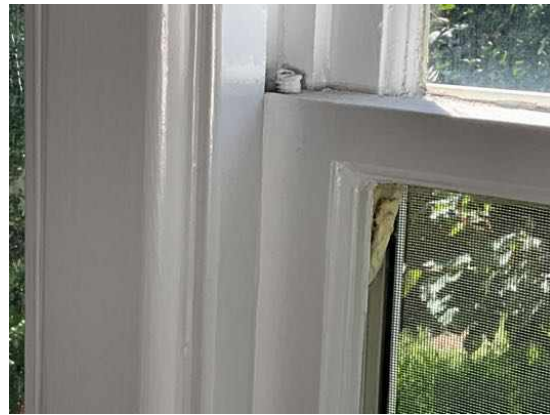
Finding 3.05

Building:	Building 1
Location:	Bedroom 1
Finding:	Windows - Sash painted shut
Information:	Where window sashes have been painted shut, it is generally indicative of poor, rushed workmanship. The window is difficult if not impossible to open and close until remedial works have been undertaken.

Windows provide ventilation to the adjoining area and should be at a fully operational level to ensure user comfort. Restricted function of the window may also pose as a potential safety hazard if required for emergency egress from the building.

Where windows have been painted shut the seal of the paint needs to be broken. This is generally done by breaking the seal of the paint and then maintaining the sash tracks clearing and lubricating them with silicone. Remedial paint work will likely be required and can be completed along with the rest of the remedial works necessary by a general handyman.

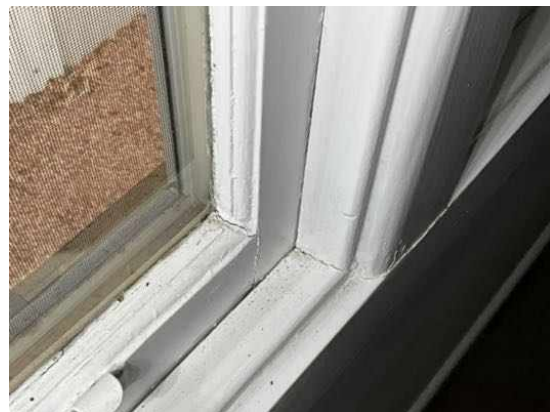
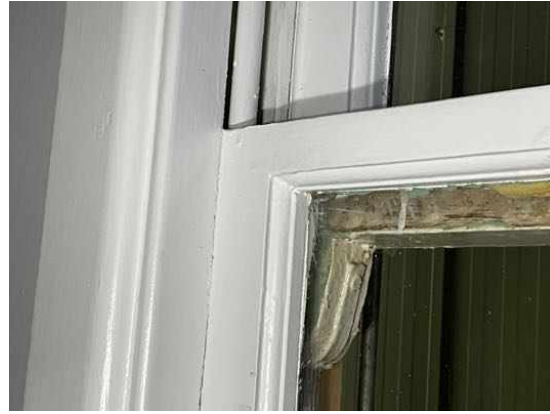
Finding 3.06

Information: Several windows throughout the property were jammed and difficult to operate at the time of the inspection. Windows provide ventilation to the adjoining area and should be at a fully operational level to ensure user comfort. Restricted function of the window may also pose as a potential safety hazard if required for emergency egress from the building.

Generally, factors such as general age of the building element and a lack of maintenance are the usual causes for this type of defect.

Replacement of window hardware or frame may be required, as well as minor repairs and cleaning. A registered builder or general handy person will be required to repair the affected windows.

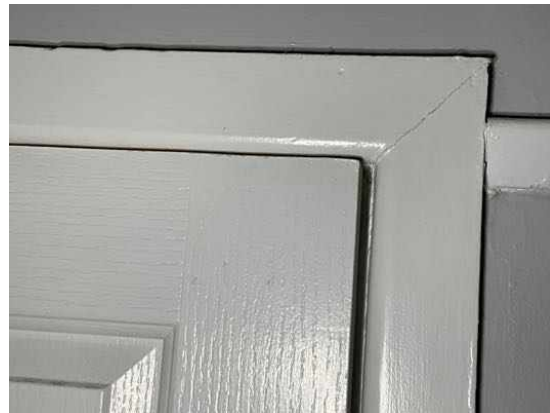
Finding 3.07

Building: Building 1
 Location: Kitchen
 Finding: Door- Binding/jamming
 Information: Binding and/or jamming of this door is evident during standard operation. This defect inhibits the functionality of the affected door as well as creating potential for secondary defects to associated building elements, such as damage to the floor covering.

A qualified carpenter or general handyperson should be appointed to perform minor rectification works at client discretion.

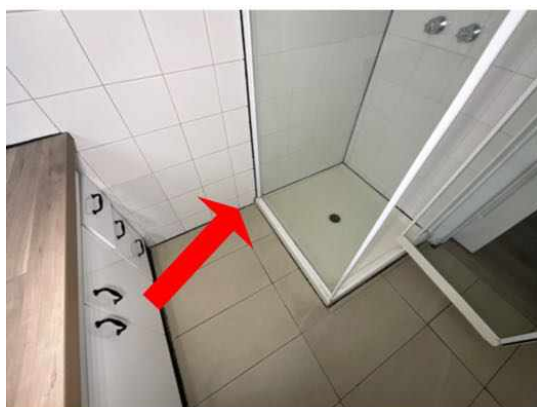
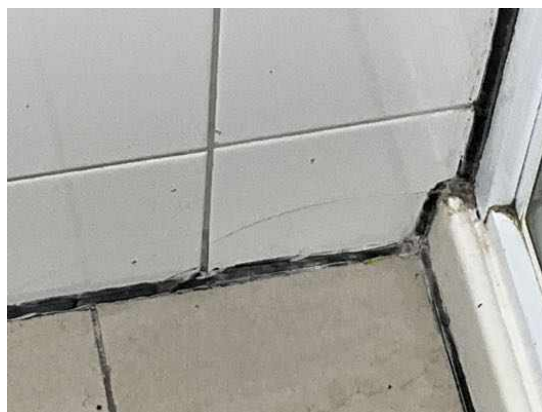
Finding 3.08

Building: Building 1
 Location: Bathroom
 Finding: Wall Tiles- Cracked
 Information: Cracked tiles within the household detract from the overall appearance of the affected areas, as well as creating potential for water penetration to adjoining building elements. If left unmanaged, water damage may occur as a result of constant water penetration over a prolonged period of time.

While not considered a matter of urgency, replacement of tiles is advised as a solution.

A Tiling Contractor may be appointed to perform these works at client discretion.

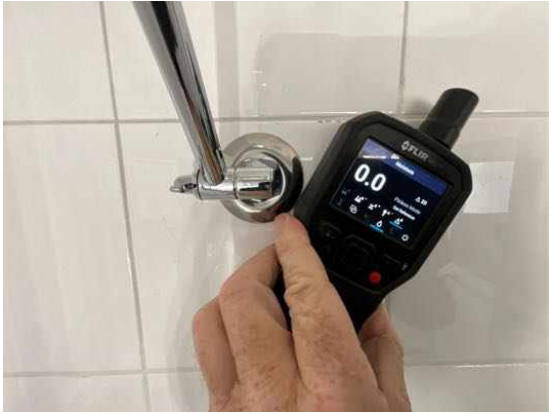
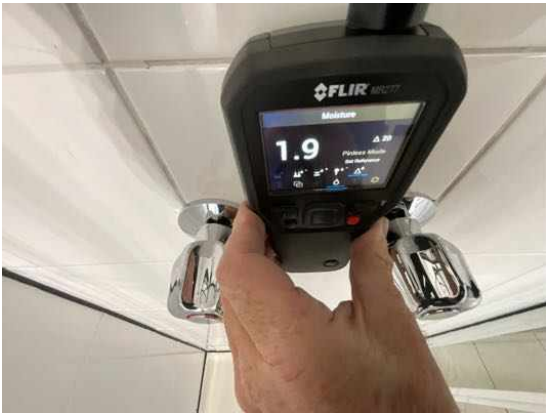
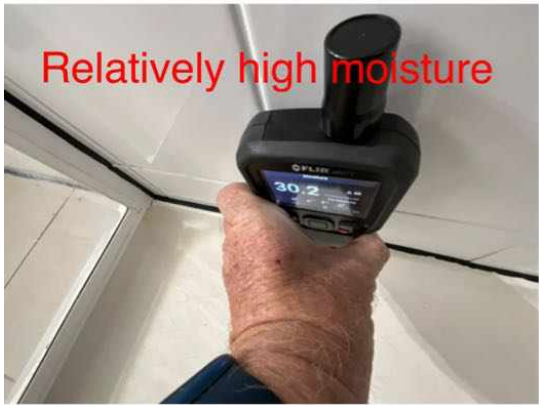
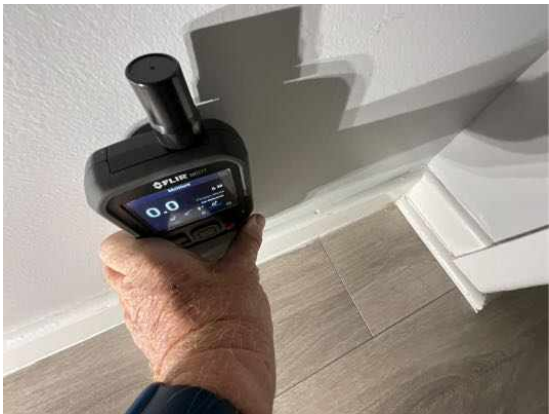
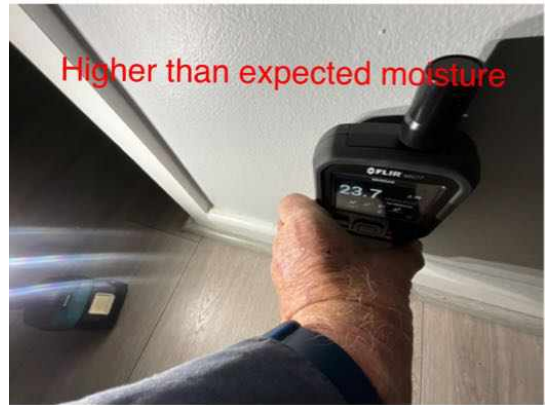
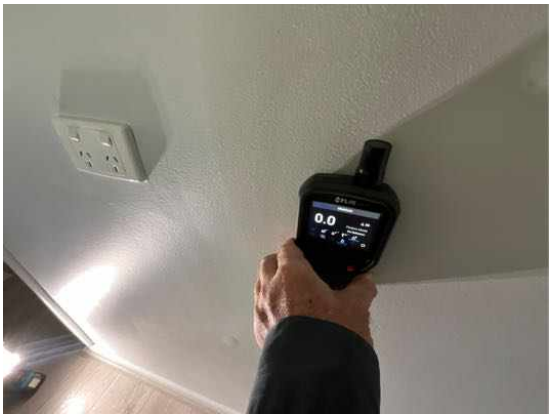
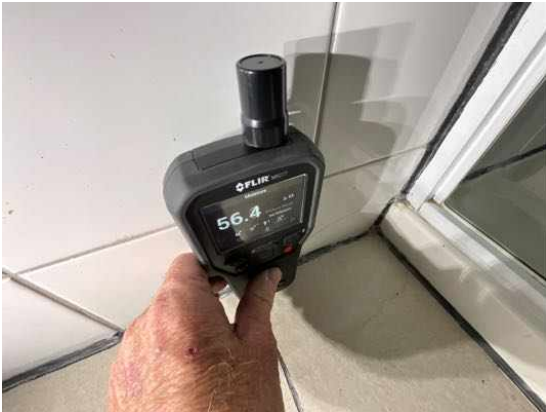
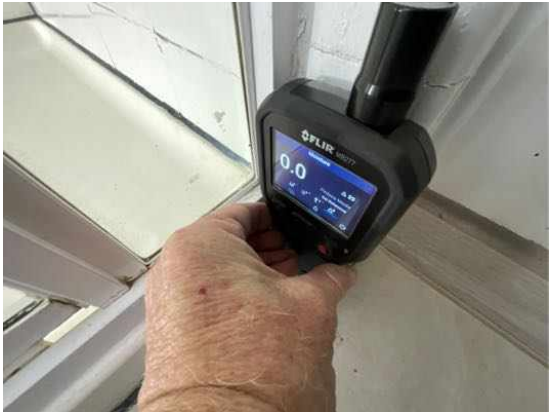
Building:	Building 1
Location:	Bathroom
Finding:	Shower Damp- Significant
Information:	Damp is evident to the lower wall to the Shower Alcove. This is suspected to have been caused by moisture permeating through the grouting in this area.

Relatively High levels of moisture were observed on the outside of the shower walls in the opposite wall.

Damp (or structural damp) refers to the presence of unwanted moisture in the structure of the building, either as a result of intrusion from outside, or condensation from within the structure. In the Shower area, internal water leaks or other sources of excessive moisture are generally the cause of damp.

Consultation with a qualified Plumber or Bathroom Specialist is advised immediately to identify the cause of damp and to perform remedial works as required.

Always ensure that sealant and grout is in good condition to prevent any moisture issues occurring in the future.

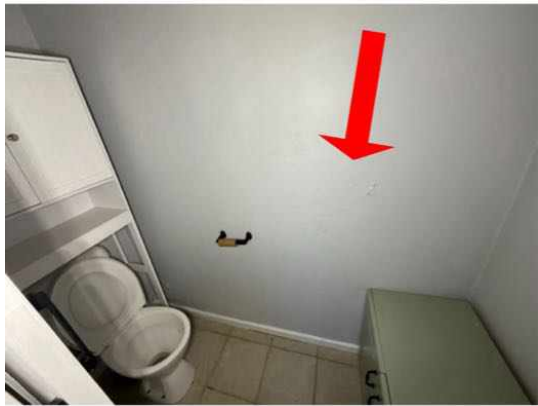
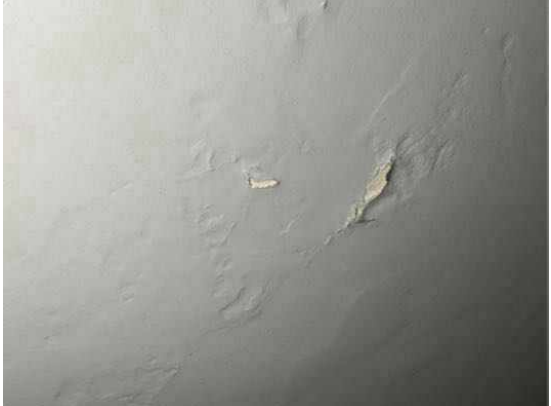
Finding 6.02

Building: Building 1
 Location: Toilet (WC)
 Finding: Evidence of excessive moisture- present at the time of inspection.
 Information: Excessive moisture can attract termites and produce conditions that promote termite attack fungal growth and wood decay. Excess damp in this area may create further deterioration.

Appropriate trades should be contacted soon to restore the area and prevent further deterioration.

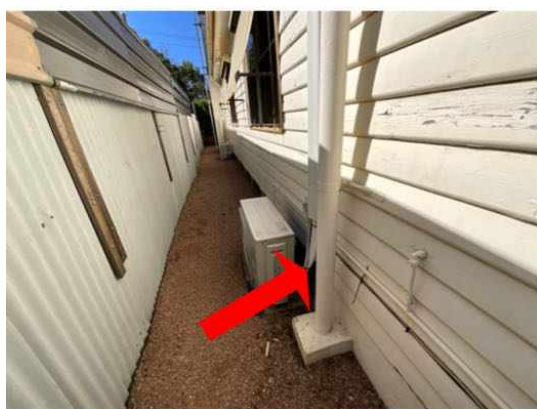
Finding 6.03

Building:	Building 1
Location:	Yard - Side
Finding:	Air conditioner - Disconnected overflow
Information:	The Air Conditioner (A/C) overflow was found to be disconnected from storm water drainage and is creating excessive moisture in the surrounding area.

Such leaking creates an environment which is conducive to an array of defects, including water damage to associated building elements and the attraction of termite or timber pest infestation.

It is highly recommended that a licensed plumber be appointed to connect the A/C overflow in order to prevent such an environment from being created. These minor works should be carried out as soon as possible.

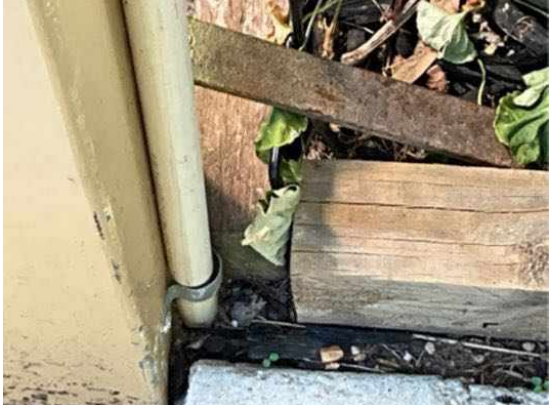
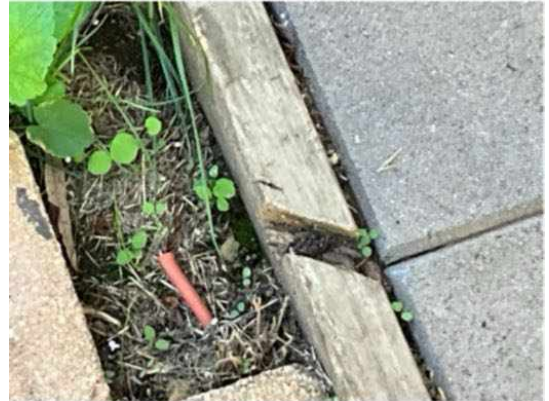
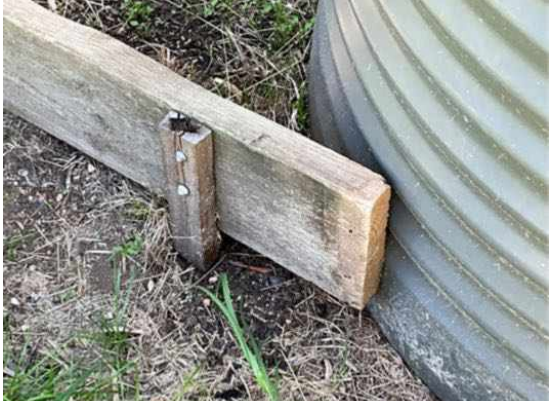
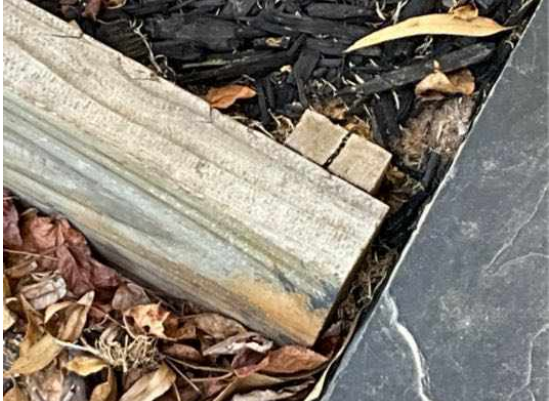
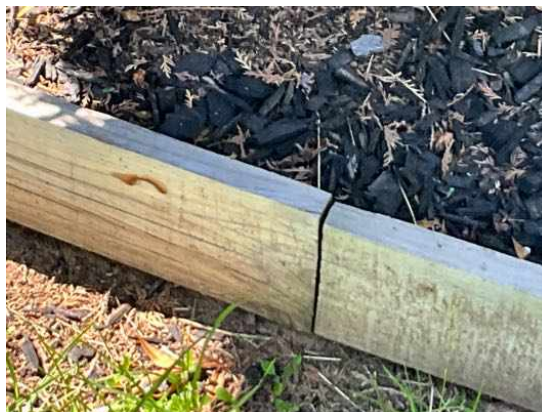
Finding 6.04

Building:	Building 1
Location:	Yard - Back, front
Finding:	Untreated or non-durable timbers in a hazardous environment
Information:	To reduce the risk of timber pest attack it is essential that timber used in a hazardous environment (e.g. in direct contact with the ground or frequently exposed to damp conditions) is of sufficient durability and/or is adequately preservative treated.

Untreated timbers in direct contact with the ground are likely to develop severe wood rot and/or fungal decay if left unattended creating attraction for subterranean termites to infest the timbers from surrounding areas.

If untreated or non-durable timbers are found to be in a hazardous environment it is highly advised that replacement of these building elements be performed as soon as possible to aid the protection of the property against termite / timber pest attack.

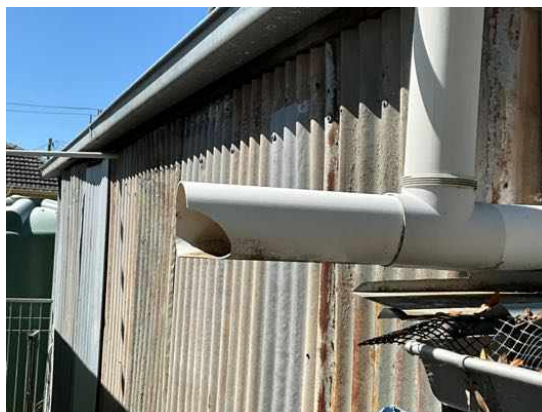
Finding 6.05

Building:	Building 1
Location:	Shed
Finding:	Stormwater drain - Not connected
Information:	The roof plumbing is not adequately connected to stormwater drainage on the site. This disconnection negatively impacts the functional capacity of the roof plumbing.

Where roof plumbing doesn't drain adequately, the area at the base perimeter can become excessively damp, potentially creating an environment that is susceptible to rust and corrosion of surrounding building elements, as well as attracting termites and other pests.

It is highly recommended that a plumber be appointed to further inspect the area and to install adequate drainage equipment where necessary.

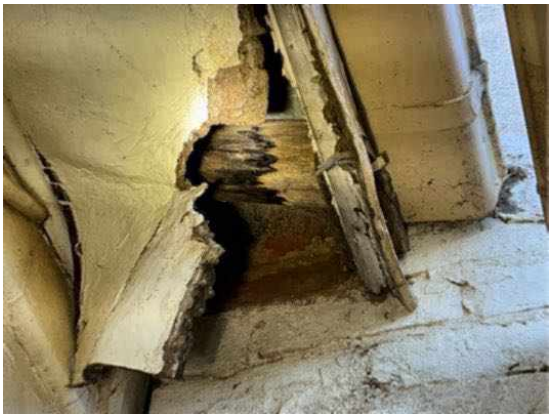
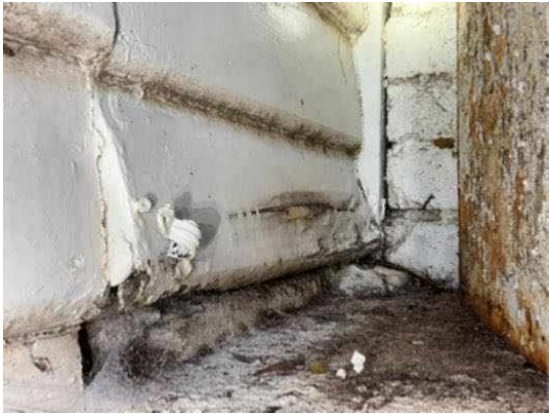
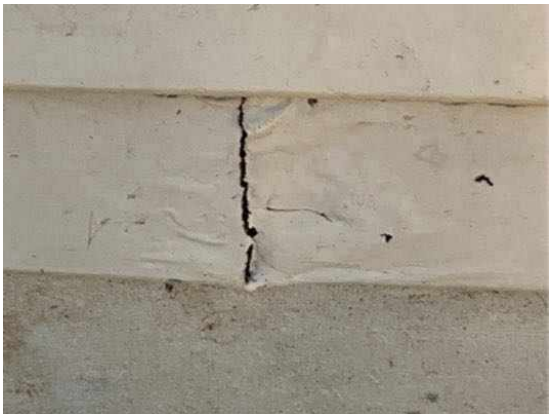
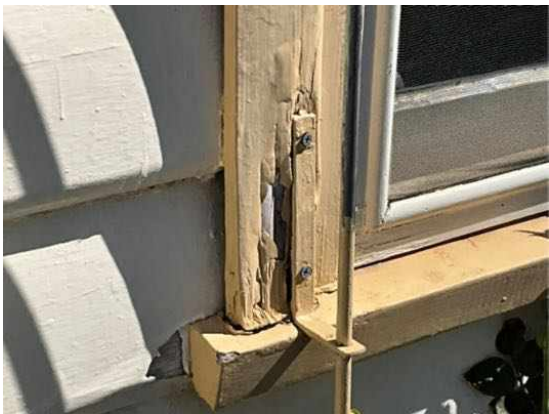
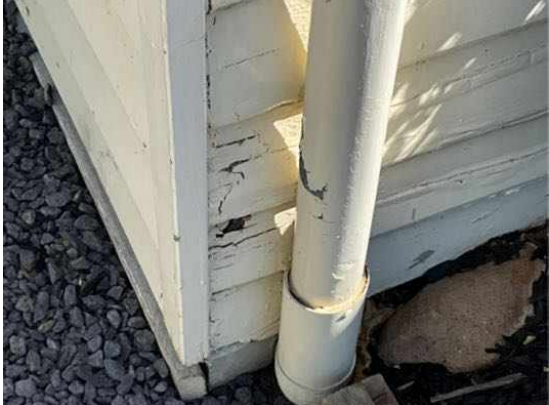
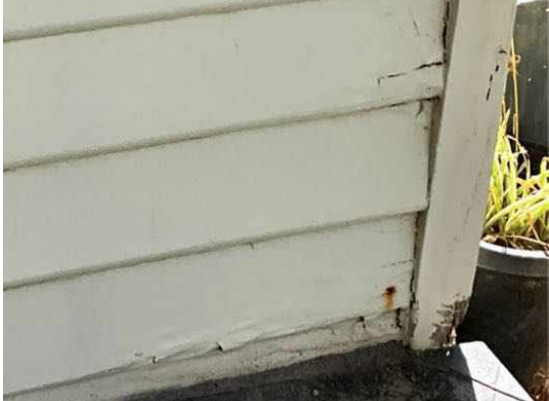
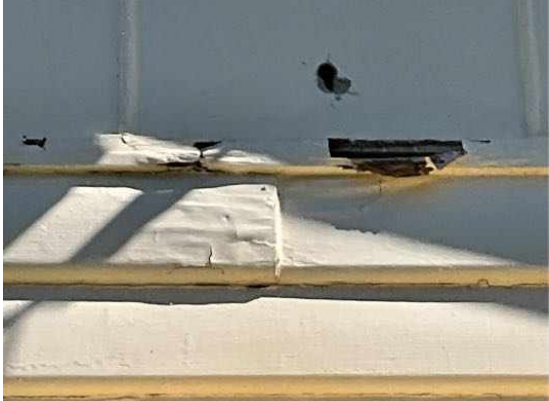
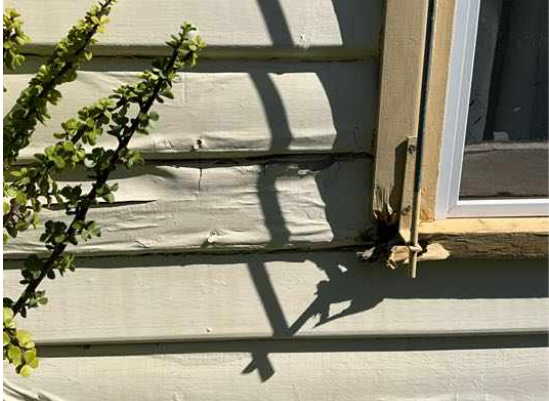
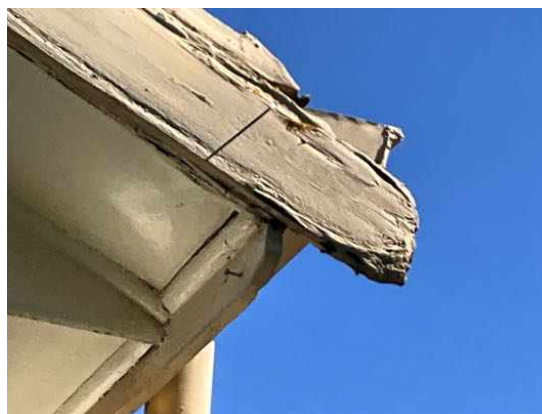
Finding 7.01

Building:	Building 1
Location:	Eaves, back and front walls
Finding:	Fungal decay - present (localised)
Information:	Fungal decay also known as wood decay or wood rot generally refers to the deterioration of timber elements when in contact with excessive levels of moisture for a prolonged period of time.

The development of fungal decay is accelerated by temperatures in the range of 5degreeC to 40degreeC as well as the presence of oxygen. Generally fungal decay develops on timber elements that are in use in an external environment which are exposed to rain penetration.

In this case although the affected timber element is in a decaying state the extent of any visible damage appears to be localised to a specific area and is yet to spread to other parts of the building element or affect adjoining structures. The fungal decay is therefore likely to be of a relatively superficial nature with minimal impact on the structural integrity or tensile strength of the timber element.

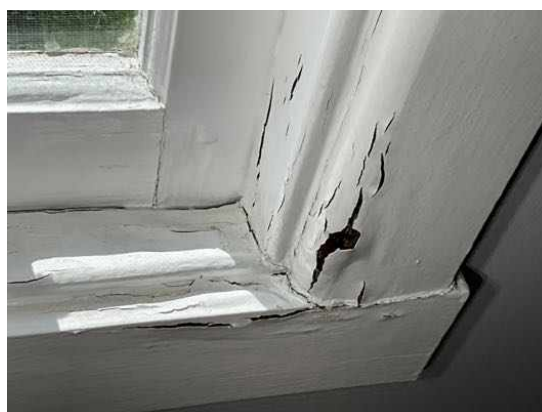
Finding 7.02

Building:	Building 1
Location:	Bedroom 1
Finding:	Fungal decay - present (localised)
Information:	Fungal decay also known as wood decay or wood rot generally refers to the deterioration of timber elements when in contact with excessive levels of moisture for a prolonged period of time.

The development of fungal decay is accelerated by temperatures in the range of 5degreeC to 40degreeC as well as the presence of oxygen. Generally fungal decay develops on timber elements that are in use in an external environment which are exposed to rain penetration.

In this case although the affected timber element is in a decaying state the extent of any visible damage appears to be localised to a specific area and is yet to spread to other parts of the building element or affect adjoining structures. The fungal decay is therefore likely to be of a relatively superficial nature with minimal impact on the structural integrity or tensile strength of the timber element.

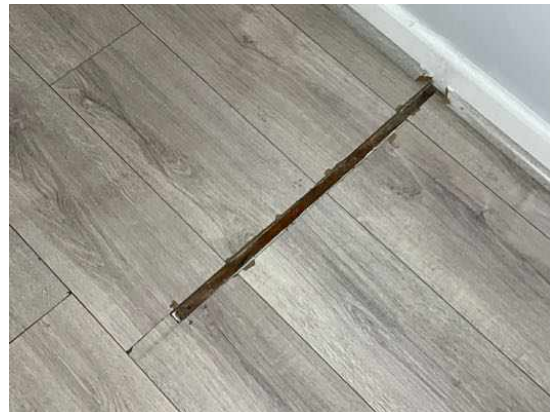
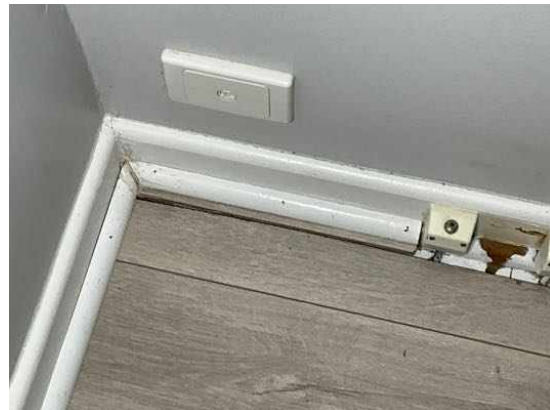
Building: Building 1
 Location: Floating floor
 Finding: Timber flooring- deterioration
 Information: The flooring in this area shows signs of deterioration. Some slight movement and separation of the Boards is evident.

A Flooring specialist should be contacted soon to restore the area and prevent further deterioration.

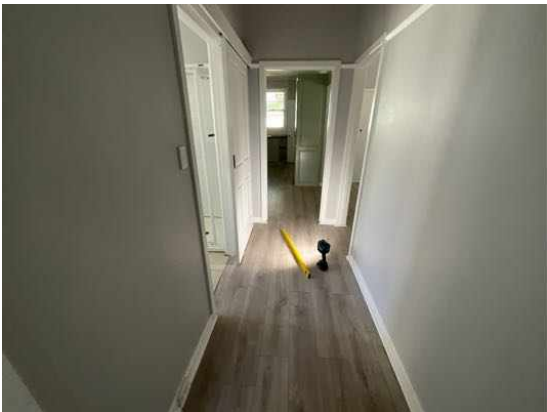
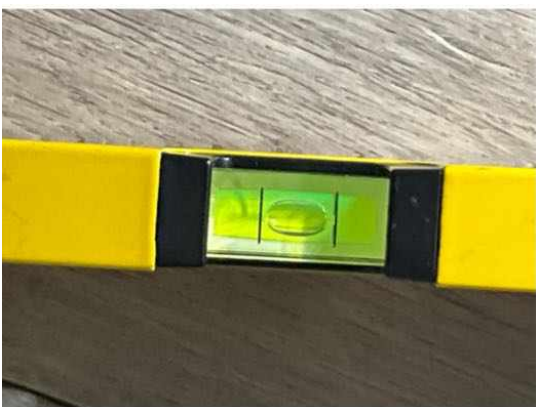
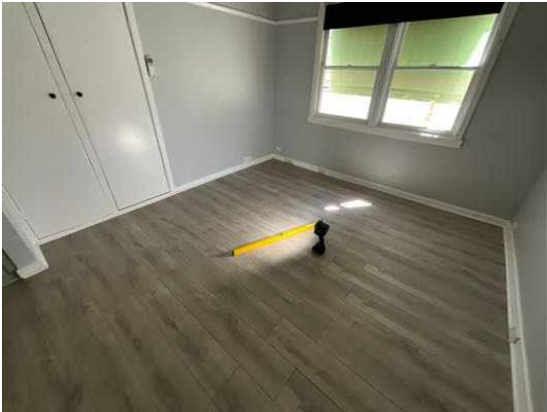
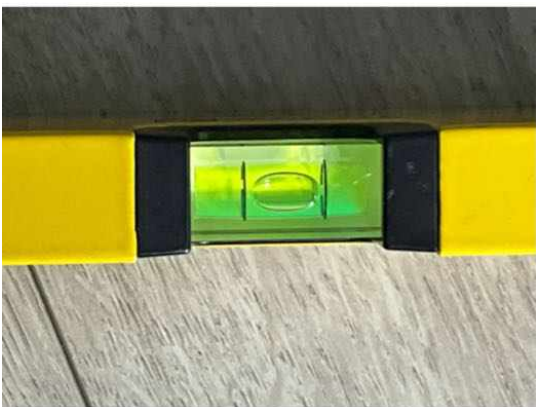
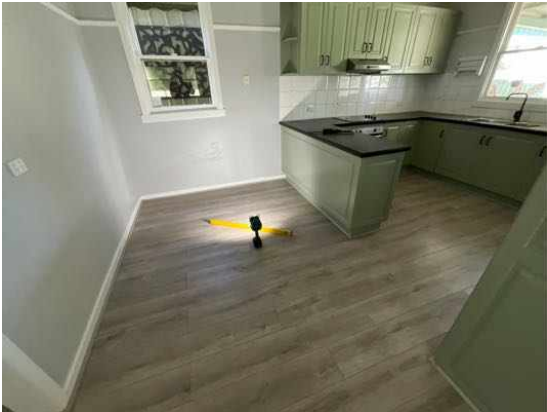
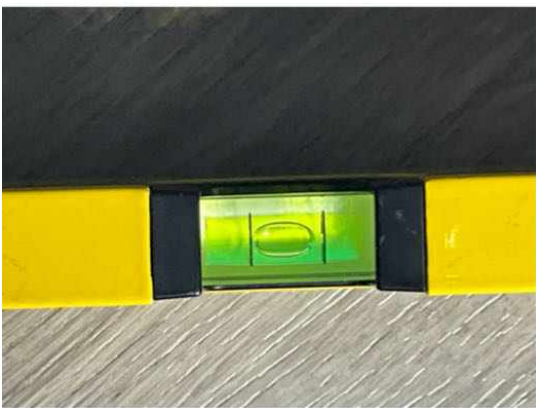
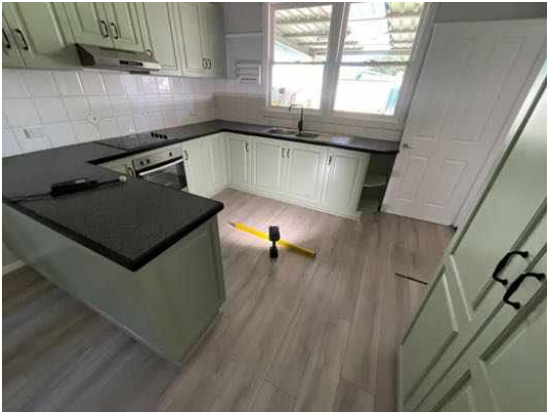
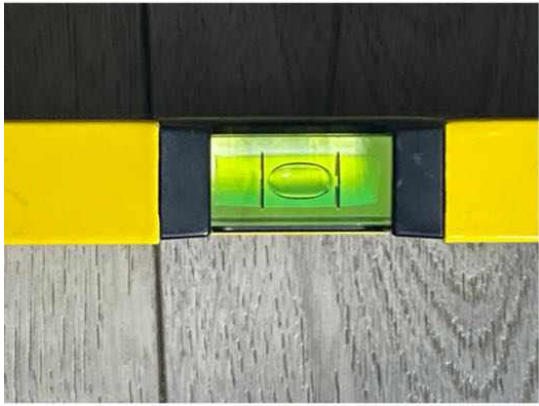
Building: Building 1
 Location: All Internal Areas
 Finding: Flooring- generally level
 Information: The internal flooring in this area is generally level and even. Where slightly uneven flooring is present it is likely to indicate minor defects such as expected movement of the foundations of the property.

No immediate action is needed.

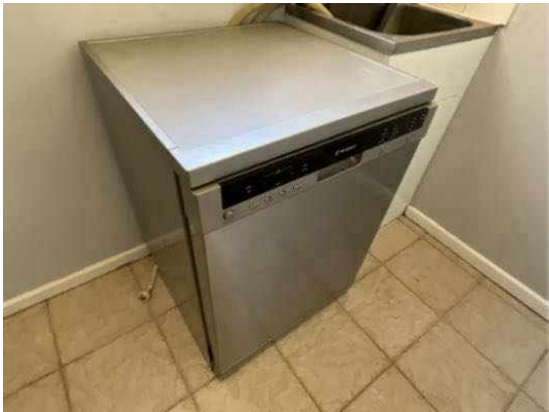
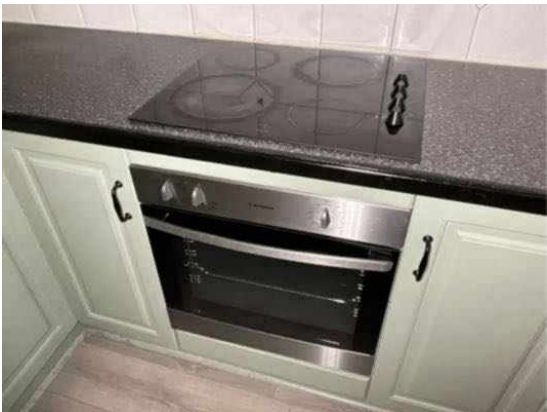
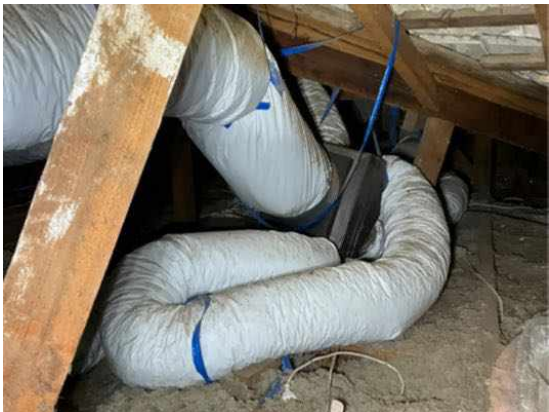
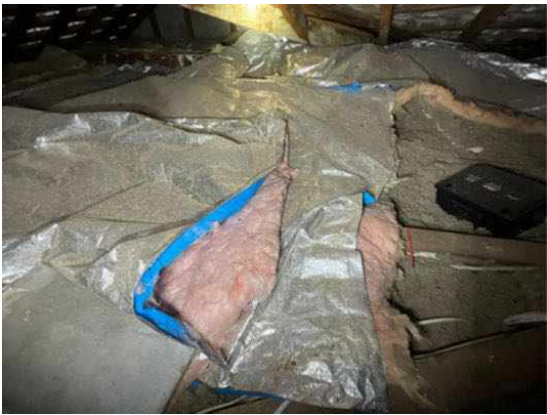
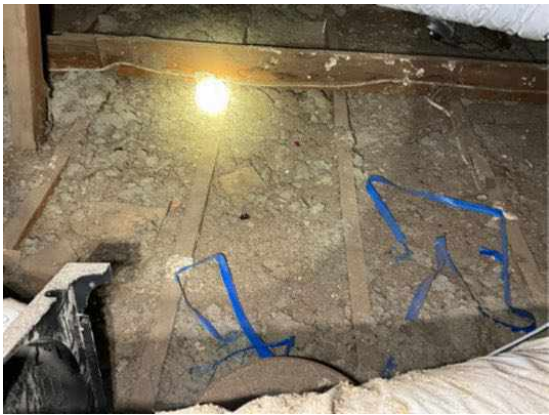
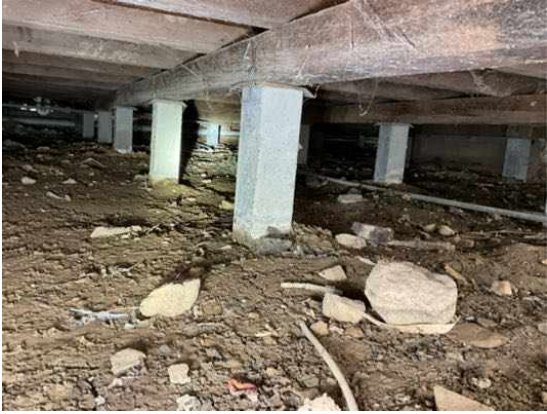
Building: Building 1
Location: All Areas
Finding: Additional Photos - Obstructions and Limitations
Information: These photographs are an indication of the obstructions and limitations which impeded full inspection of the property at the time of inspection. These obstructions can hide an array of defects and should be removed to allow full inspection to be carried out. A re-inspection is recommended once the areas are made accessible.
