Building Inspection Report

Inspection Date: Thu, 12 Mar 2026

Property Address: 16 Crawford Grove, Andrews Farm SA
5114, Australia

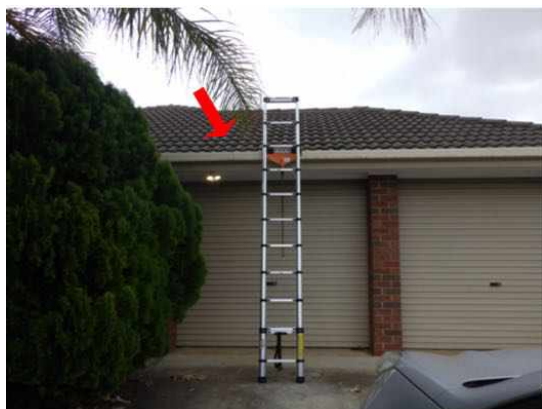
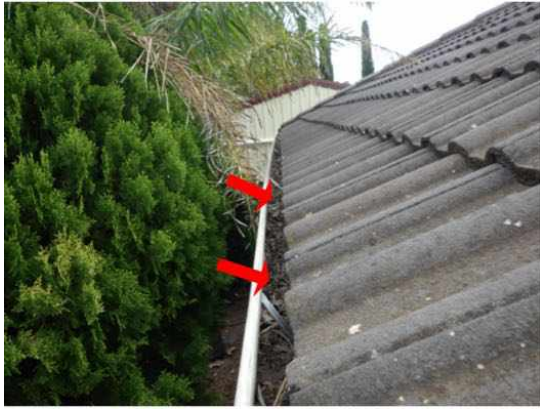
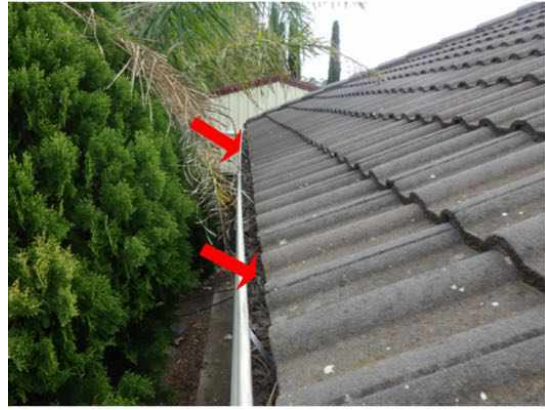
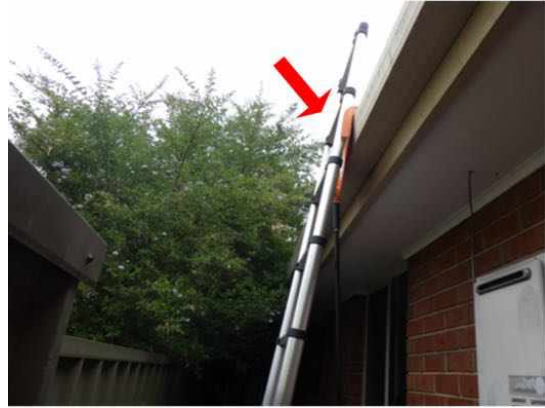
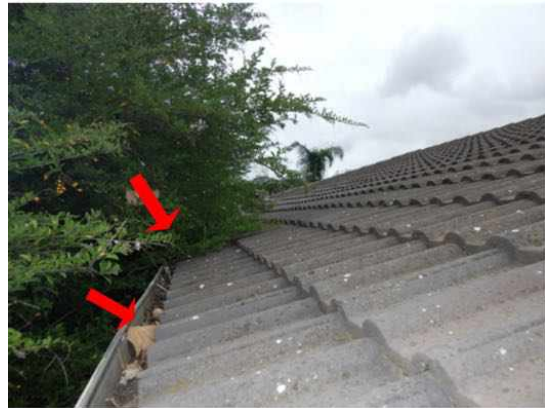
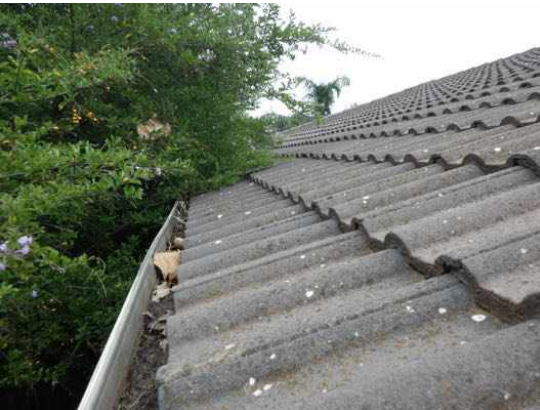
Defects 2.01

Blocked gutters are likely to lead to high levels of moisture in the affected areas. Such moisture will not only cause rust and decay of the associated building materials, but can also provide conditions that are conducive to termite and timber pest activity. Blockages in gutters should therefore be removed immediately to ensure dry conditions are maintained.

Consult a Licensed Plumber for further specific advice on remedial works that may be required. In the interim, it is highly advised that blocked gutters be removed by the homeowner or a general handyperson as a matter of urgency.

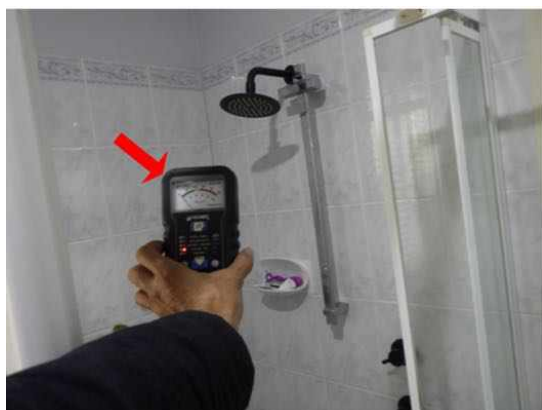
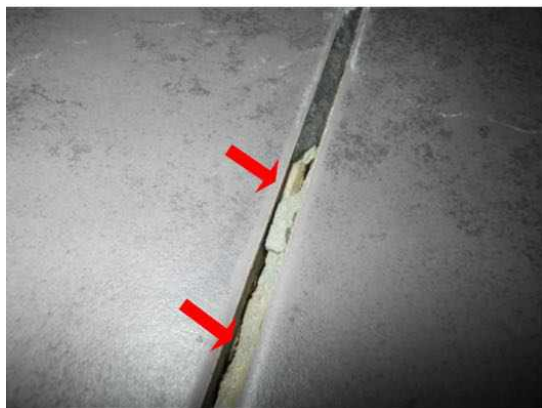
Defects 2.02

Building: Building 1
Location: Bathroom
Finding: Shower Alcove - Damp & Grout Deteriorated
Information: Damp is evident to the lower 400mm approximately of wall to the shower alcove. This defect is quite common, and is suspected to have been caused by moisture permeating through the grouting in this area, which shows evidence of deterioration. Leaking pipes within the adjoining wall is also a possible cause.

Damp (or structural damp) refers to the presence of unwanted moisture in the structure of a building, either as the result of intrusion from outside, or condensation from within the structure. In the shower area, internal water leaks or other sources of excessive moisture are generally the cause of damp.

Unmanaged damp in the shower recess is likely to facilitate the formation and development of mould and fungi growth, decaying associated building materials and compromising their structural integrity. Exposure to these contaminants is associated with a wide range of respiratory and other health-related problems.

Consultation with a qualified plumber or bathroom specialist is advised immediately to identify the cause of damp and to perform remedial works as required. Where excessive mould growth is present, further inspection by a specialist environmental health inspector should also be considered.

Always ensure that sealant and grout is in good condition to prevent any moisture issues occurring in the future.

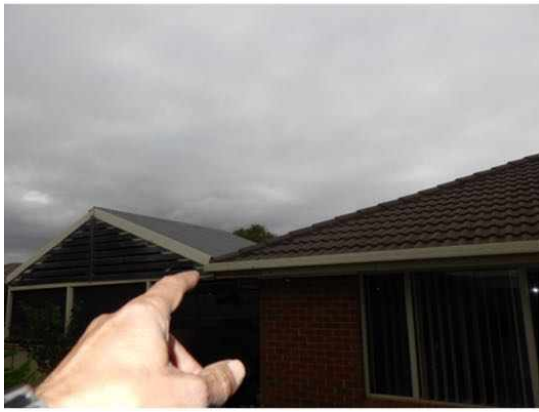
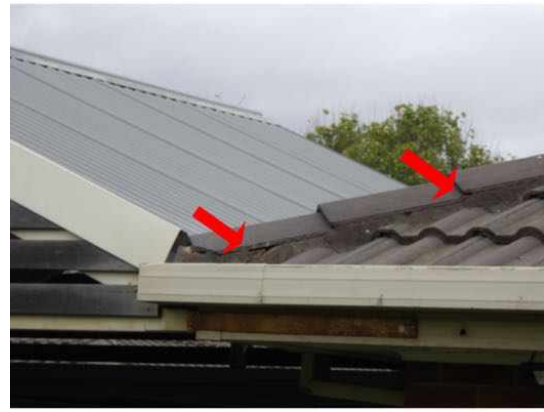
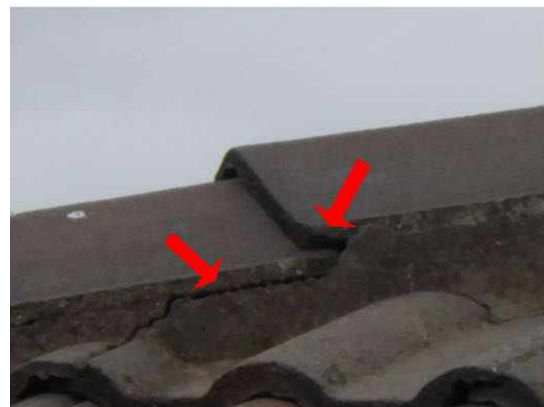
Defects 3.01

Building:	Building 1
Location:	All External Areas
Finding:	Mortar - Deterioration
Information:	At the time of inspection it was noticed evidence of mortar deterioration to few roof tiles around the property.

Mortar, or 'bedding', is the material which fills joins and intersections between tiles and other building elements on the exterior roof covering, such as gable ends, hip capping and valleys. Upon inspection of the exterior roof, it was noted that sections of the mortar show varying levels of deterioration.

Mortar generally deteriorates as a result of frequent exposure to weather conditions over a prolonged period of time. Mortar that is deteriorating may allow water ingress into the roof void, putting associated building elements and roofing structures at risk of water damage. Deteriorated mortar also detracts from the functionality of roof tiles and other roofing elements, potentially decreasing weather tightness and roof drainage.

Mortar deterioration can be attended to by a handyperson where areas of deterioration are localised and easily accessible. Otherwise, consultation with a roofing contractor is advised where greater works are required.

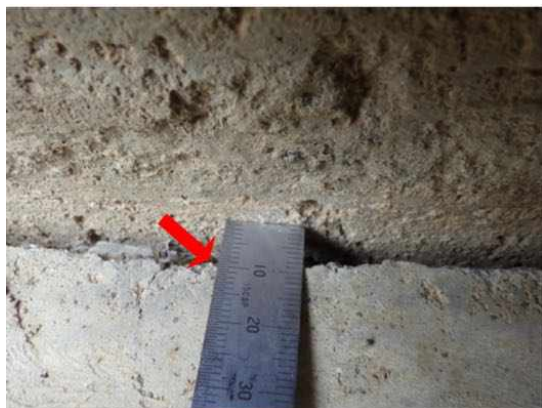
Defects 3.02

Building:	Building 1
Location:	All External Areas
Finding:	Gaps in perimeter pavement
Information:	Gaps in the external concrete paving were identified at the time of inspection. Gaps in the slab are significant and are likely to lead to the development of secondary defects if left unmanaged, such as the creation of a trip hazard and water entry points.

A licensed Plumber should be appointed immediately to ensure that the stormwater pipework is intact and adequate, and all gaps to concrete, driveways and paths should be sealed by a licensed builder or a general handy person to keep moisture from entering.

A licensed concretor may be required to replace pavements that are beyond repair.

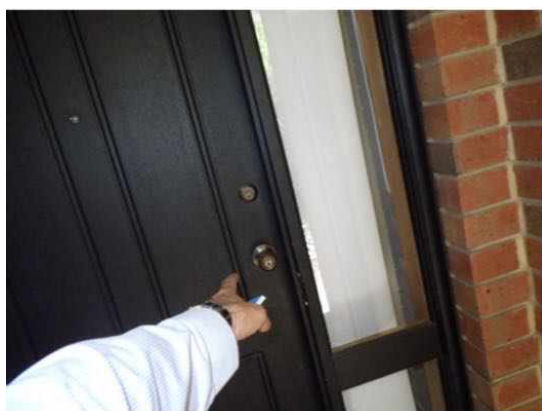
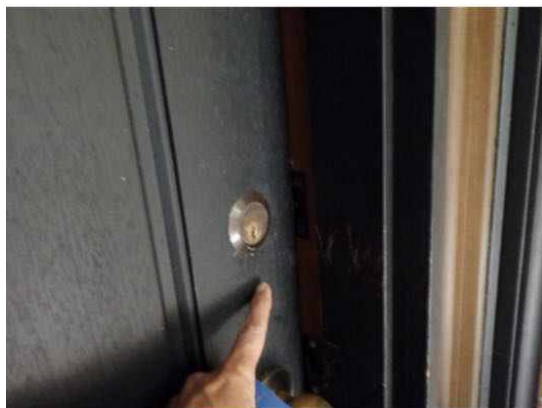
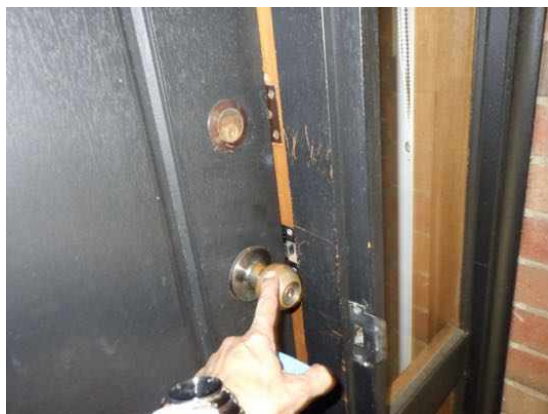
Defects 3.03

Building:	Building 1
Location:	All External Areas
Finding:	Entry Door - Binding/jamming
Information:	Binding and/or jamming of this entry door is evident during standard operation. This defect inhibits the functionality of the affected door as well as creating potential for secondary defects to associated building elements, such as damage to the floor covering.

A door that binds to flooring or to the associated door frame may have several causes, ranging from minor defects, such as poor installation of the door or deteriorated hinges, through to major structural issues, such as damage to subfloor structures.

Where door binding/jamming appears to indicate major structural issues, a registered builder specialising in re-stumping should be appointed to provide an estimate on the cost of rectification.

For minor causes, a qualified carpenter or general handyperson should be appointed to perform minor rectification works at client discretion.

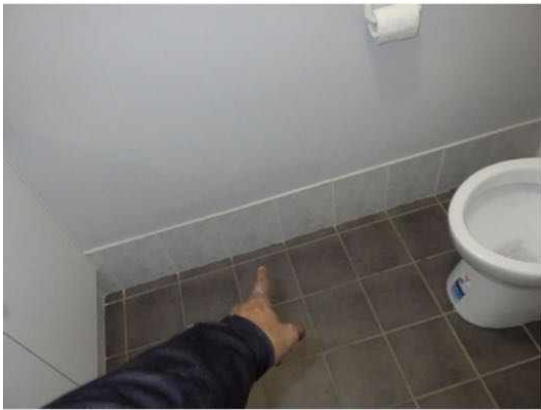
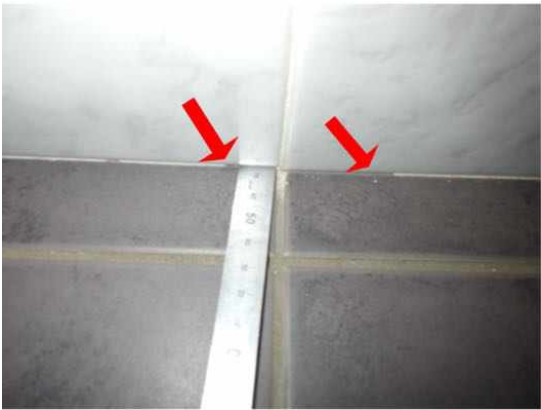
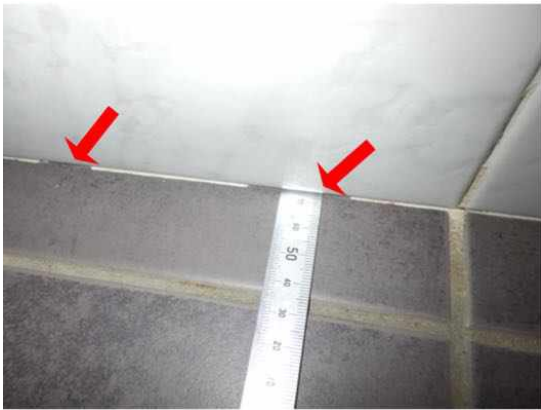
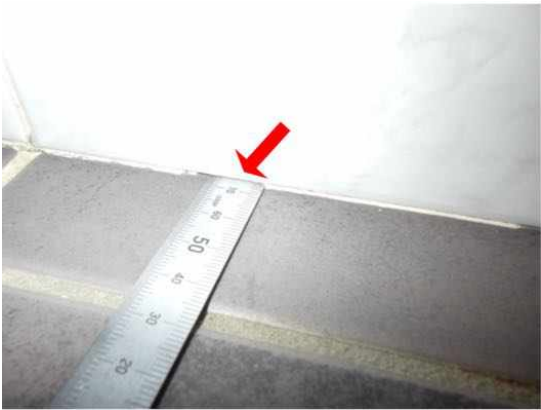
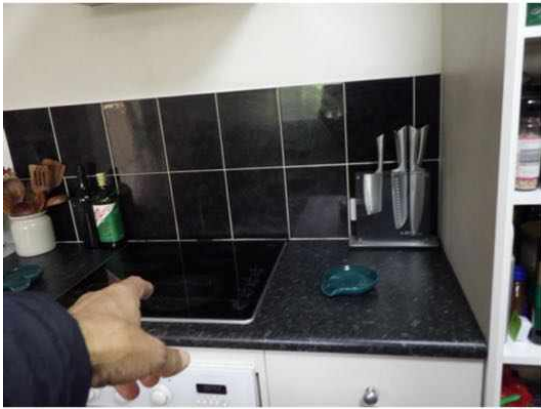
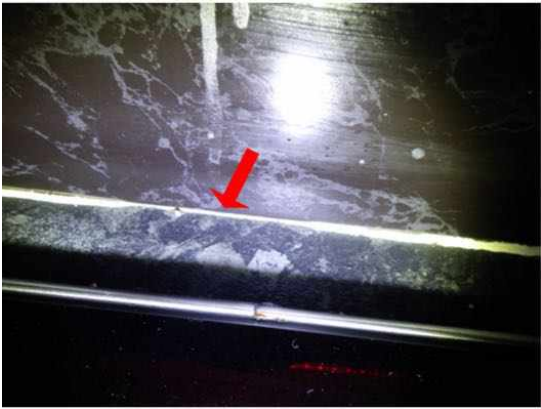
Defects 3.05

Building: Building 1
Location: All Internal Areas
Finding: Grout - Missing/ Deteriorated
Information: Grout is missing / deteriorated in this bathroom , toilet & kitchen area. Grout is used to protect gaps and crevices in building materials to ensure that they are water-tight and prevent water penetration to the associated structures.

Where grout is missing, a tiling contractor should be appointed immediately to apply grout and re-apply any silicone where necessary. Failure to do so is likely to lead to water damage to the surrounding area.

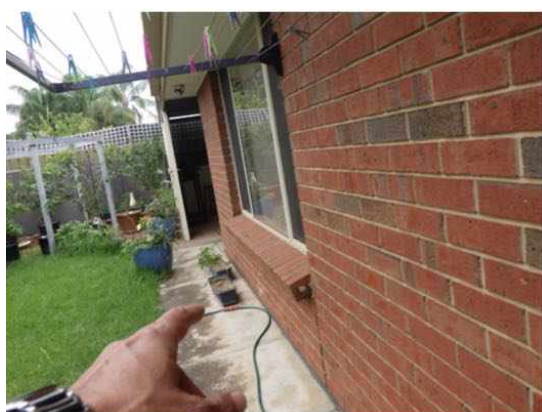
Defects 3.06

Building:	Building 1
Location:	All External Areas
Finding:	Bridging - Vegetation
Information:	Where vegetation obstructs inspection of building elements, also known as bridging as it provides a bridging point for the access of termites, full inspection can not be achieved. Consequently moisture or dampness may be present and the areas becomes conducive to termite activity. Plants against or very close to buildings provide cover, shade and can provide an environment that is attractive to termite infestation.

The removal and replanting of species that do not provide "cover" or cutting back of existing vegetation will assist greatly in preventing Bridging from occurring.

The removal of any such materials that may be conducive to termite activity should be carried out as soon as possible and arrange re inspection to minimize the risk of termite attack.

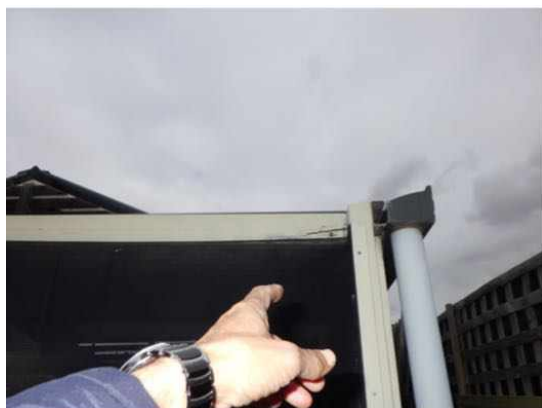
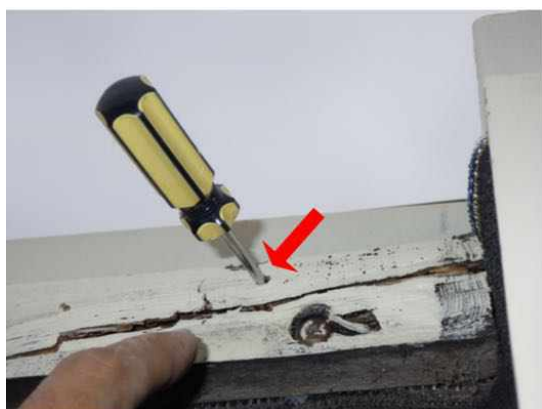
Defects 3.07

Finding: Wood rot
Information: This building element shows evidence of wood rot. Wood rot, also known as Fungal Decay, occurs when timbers and other cellulose building materials are exposed to damp conditions on an ongoing basis. This could be the result of exposure to weathering over a prolonged period of time, or the attraction of excessive moisture from other abutting building materials. Contributing factors also include poor air ventilation in the area.

Wood rot is often associated with general damp problems and is evidenced by a 'musty' smell or mould and mildew occurring on surfaces. If left unmanaged, damp conditions can lead to further health problems and the decay of timbers will continue.

Early intervention and regular maintenance, particularly of exterior timbers, will prolong the useful life of these building elements. Prior to any works being performed, the cause of the moisture that has created the visible wood rot should be identified and addressed in a suitable manner. Replacement of affected timbers may then be a necessary step in protecting surrounding building elements from such deterioration.

A qualified plumber may be appointed to assess the cause of excessive moisture and to provide advice on any remedial works as required. A qualified carpenter or registered builder may also be required to replace affected building materials.

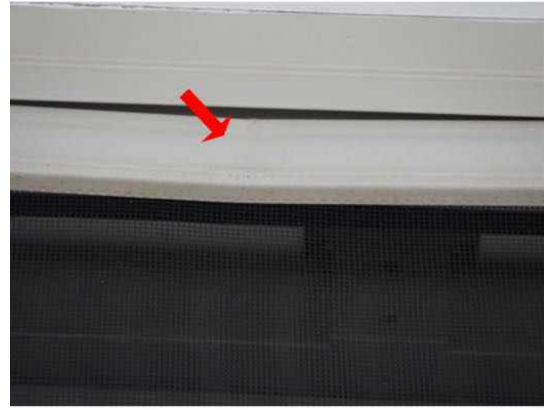
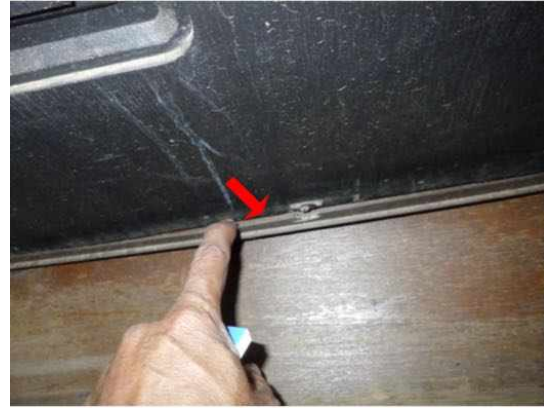
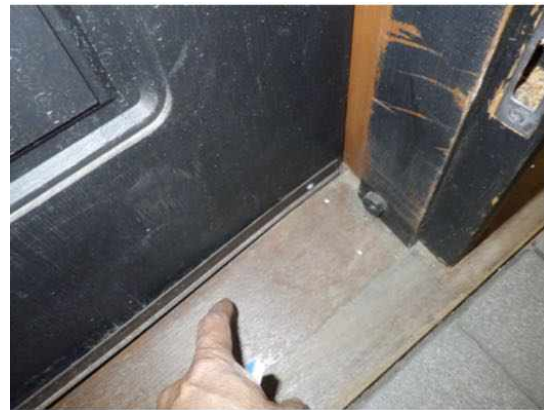
Defects 3.08

Building: Building 1
Location: All External Areas
Finding: Building element - Damaged/ Loose from its original fixing
Information: At the time of inspection it was noticed that few building elements were damaged / loose from its original fixing around the property .

Breakage occurs generally when the building materials have either aged and decayed, or as a result of damage (accidental or deliberate).

Repair and/or replacement of broken elements is advised to ensure that additional secondary defects do not arise as a consequence. Such works are necessary, as all building elements play a key role in the operation and function of the overall structure and its performance.

A relevant tradesperson should be appointed to repair or replace the affected building element prior to any subsequent damage being caused.

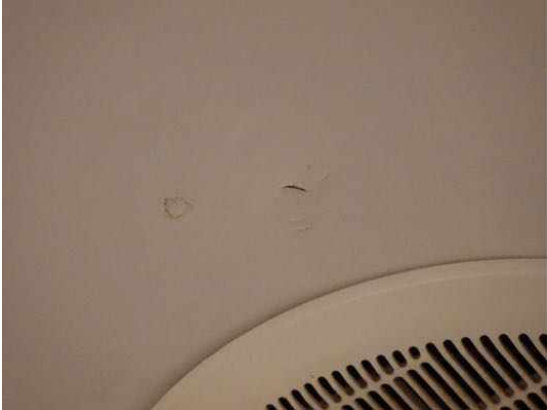
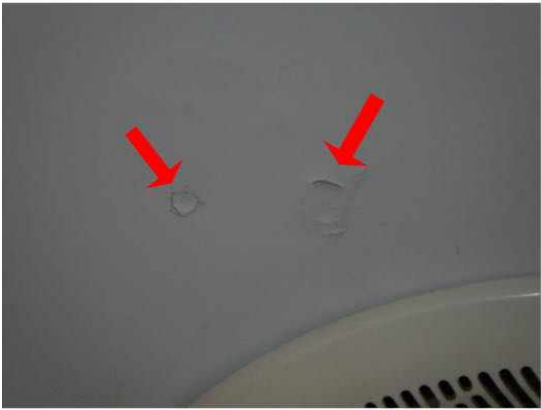
Defects 3.11

Scuffed surfaces, while detracting from the overall appearance of the affected building element, do not indicate any operational or structural damage. This degree of surface damage is consistent with general wear and tear and minor impact damage, normally accumulated over a number of years.

Marked surfaces may be left as is at the discretion of the client; no repairs or replacement are necessarily required, as this is an appearance defect. However, the client may wish to seek quotations for the cost to refurbish or replace the identified building element.

A general handyman or plasterer may be appointed to rectify marked surfaces if considered necessary by the client.

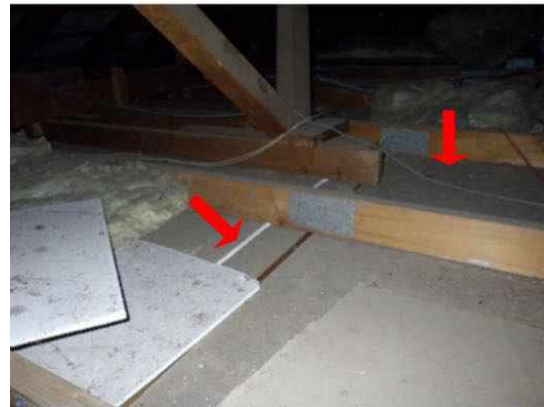
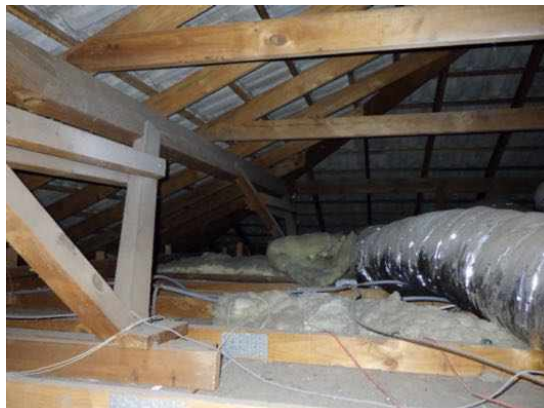
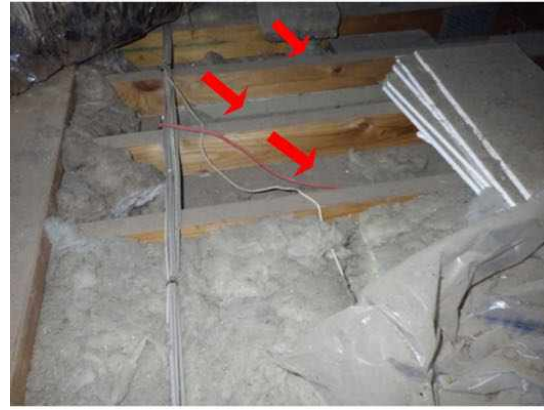
Defects 3.13

Building: Building 1
Location: All Internal Areas
Finding: Insulation - Missing
Information: Upon inspection of the roof void it was noted that insulation is not present in few sections in this roof space area.

Insufficient insulation will result in a comparatively higher cost to heat and cool a property as there is a lack of Insulation (or uneven coverage of insulation) which works as a barrier to heat transfer. This helps to keep out unwanted heat in summer and preserves warmth inside your home in winter. It can also help soundproof your home from unwanted airborne noise transfer.

Where insulation is absent, the area does not meet current Australian Standards. Installation of adequate insulation is required and should be conducted as soon as possible.

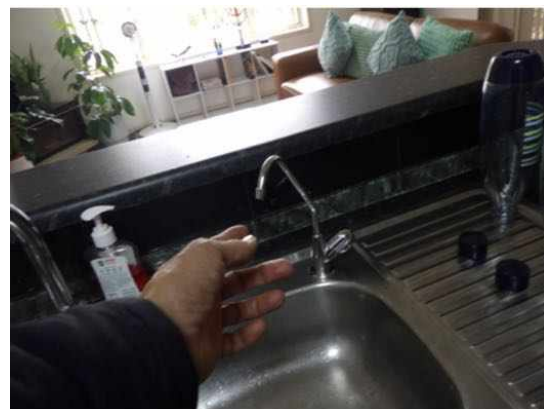
Defects 3.15

Non-operational items should be addressed to ensure that the full function of the building structure is available. Where some building elements are not operating as intended, it is possible that secondary building defects could arise due to their non-operation.

Repair and/or replacement of the faulty building element is recommended. It is highly recommended that the relevant tradesperson be engaged to perform any necessary works.

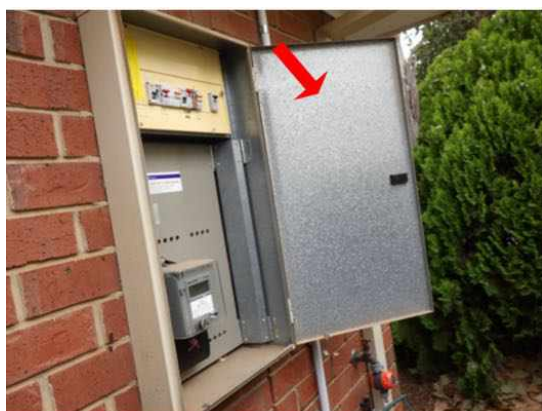
Building: Building 1
 Location: All External Areas >
 Finding: Termite Management System - No evidence of a chemical installation
 Information: The application of a post-construction chemical termite barrier is highly recommended for all properties, particularly if live termite activity has been found on the site previously. Such barriers are highly effective in preventing termite attack on any timber building elements throughout the property.

A durable notice should be placed in the switchboard unit to indicate current termite barriers. At the time of inspection, it appeared as though no termite management system has been installed, with no evidence to suggest preventative works taking place.

The client may consider gaining further advice from a pest controller as to the costs and procedures involved with this application. It is recommended that obtaining such advice be a short-term priority.
