Building and Timber Pest Inspection Report

Inspection Date: Wed, 14 Jan 2026

Property Address: 11 Eyre Pl, Caloundra West QLD 4551,
Australia

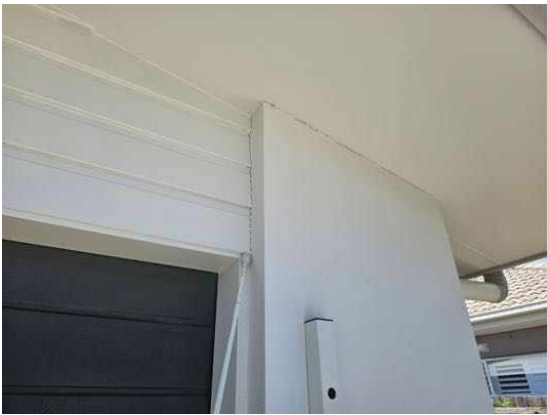
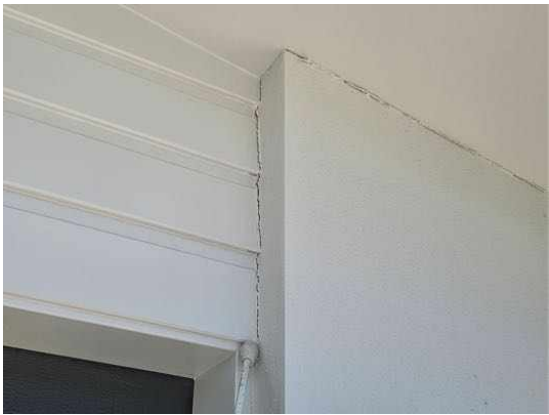
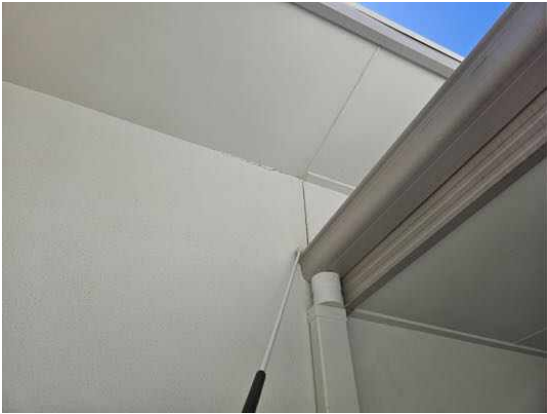
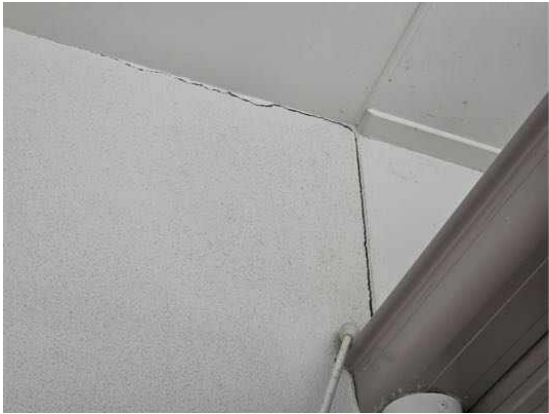
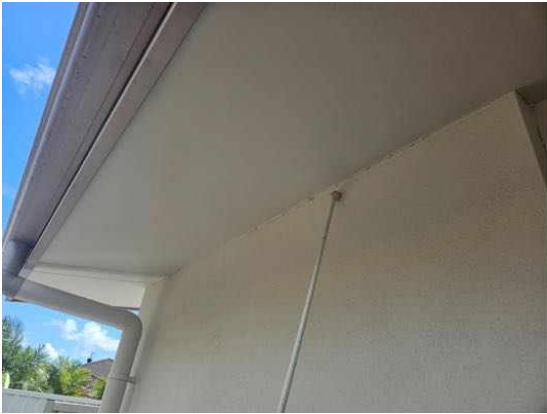
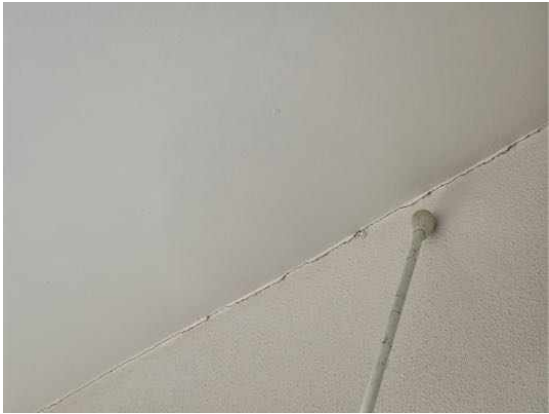
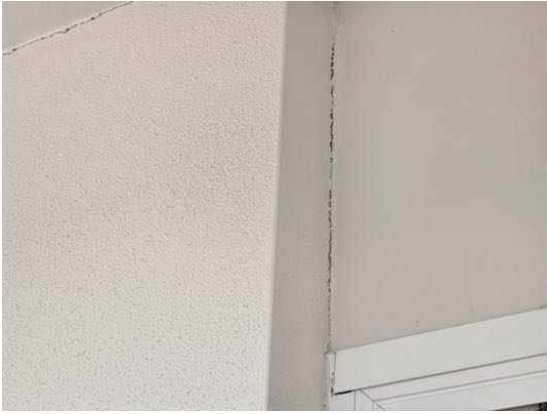
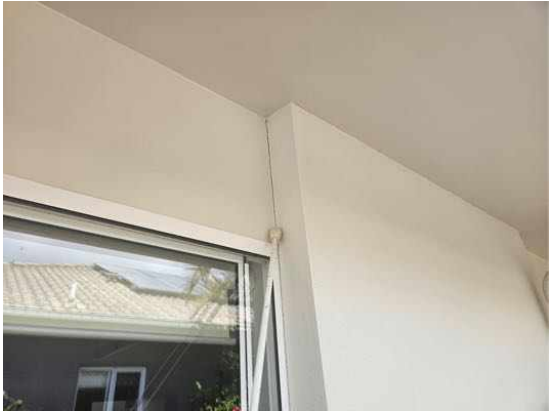
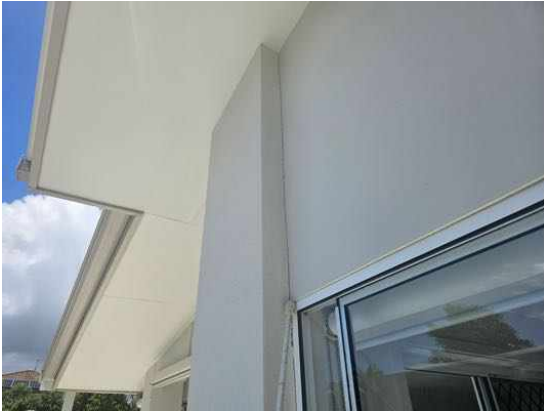
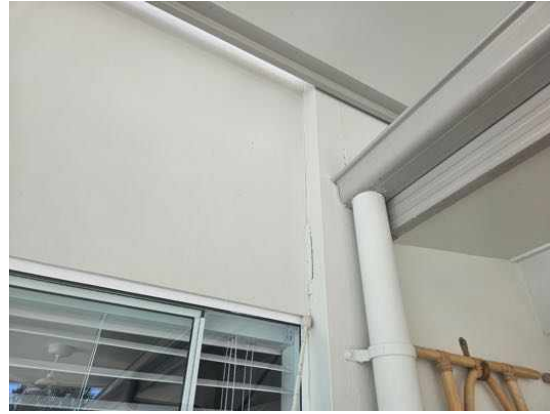
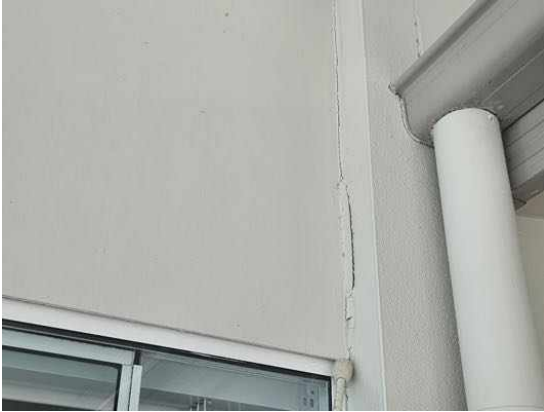
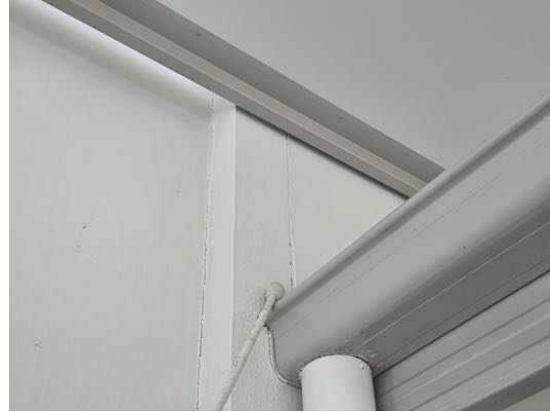
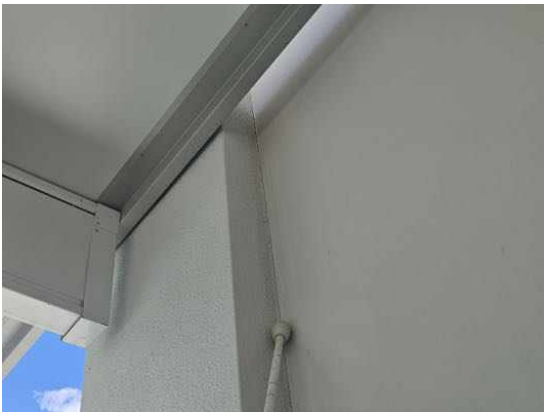
Building:	Main Building
Location:	All External Areas
Finding:	Minor movement cracking - external
Information:	Multiple areas of minor to moderate movement cracking to external wall cladding and ceiling linings in the areas shown in the photos, was observed at the time of the inspection. Internal cracking was not able to be assessed due to recent painting work completed throughout the inside of the home.

Cracking of this nature is expected in this type of building and it appears to be associated with movement of building elements of different types at the positions where they join; however, some locations appear to be somewhat larger and these should be monitored for a period of time. Should there be further greater movement, always contact a structural engineer or a licensed builder.

The fine but visible cracks can be patched and painted over by an experienced painter or handyman at the clients discretion.

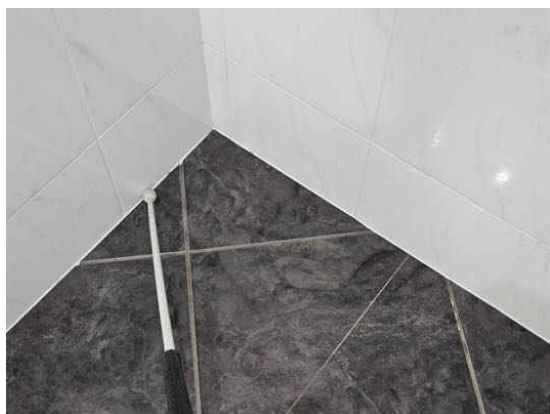
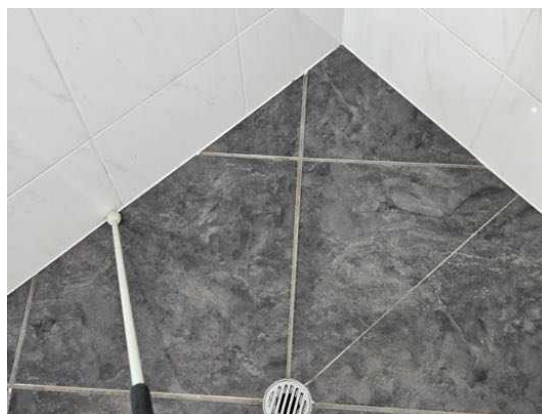
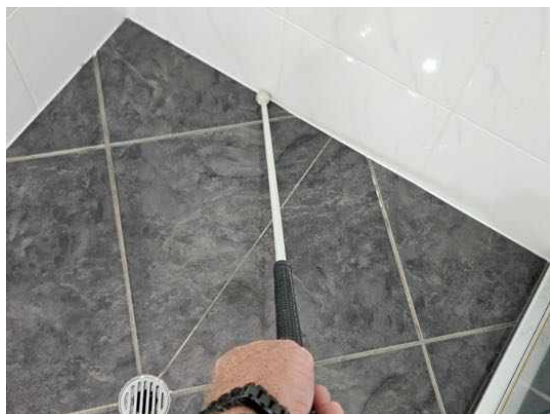
Building:	Main Building
Location:	Ensuite - Master
Finding:	Elevated moisture present - ensuite shower
Information:	Elevated moisture was noted in the lower tiled wall surfaces of the ensuite shower.

The levels varied at differing points throughout the recess. This could possibly be due to deteriorated grout and silicone sealants and / or plumbing fittings and fixtures. The grouts and sealants can break down over time and become porous, allowing moisture to enter the wall sheet surface behind the tiles. Some scouring of the grout and deteriorated silicone sealant at the base were noted.

Moisture was not detected the in the walls on the reverse side of the shower.

Elevated moisture can attract timber pests and vermin, and produce conditions that promote timber pest attack, fungal growth and wood decay.

It is recommended that the moisture levels in these areas be monitored over time and the grout and silicone could be renewed to possibly eliminate any further moisture penetration.

A licensed tiler and / or sealant specialist could be engaged to renew these elements.

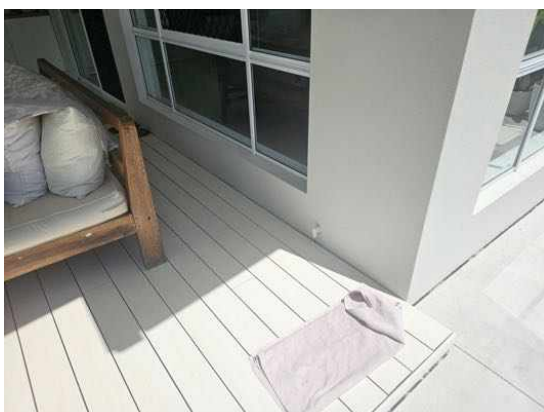
Where bridging has occurred full inspection is prevented and termites may enter a property in a concealed or undetectable manner.

It is recommend that the client consult with a licensed timber pest controller to ascertain the type and installation of the system to ensure coverage.

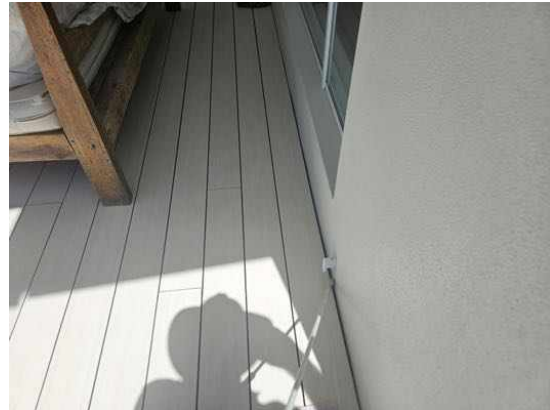
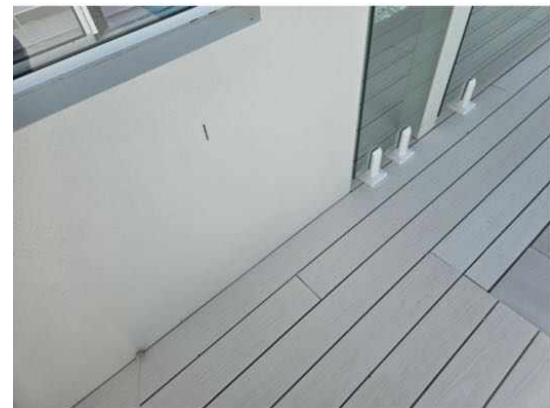
Finding 6.03

Building:	Main Building
Location:	Rear patio
Finding:	Deck against house - inspection zone
Information:	The deck as inspected on the day, is built against the house perimeter and above the weep holes. An inspection zone between decking and the house exterior is required to maintain visual inspection area, gap of greater than 25mm between structures and the slab edge of the home is required.

Where the slab edge cannot be properly inspected, there is a high risk of termite attack. It is usually recommended that termite or timber pest inspections be carried out every 6-12 months to aid protection of the property against infestation.

If the deck or structure is close to the ground and cannot be inspected visually from under the structure, a barrier system may be required to mitigate any risk created by the reduction of inspection ability.

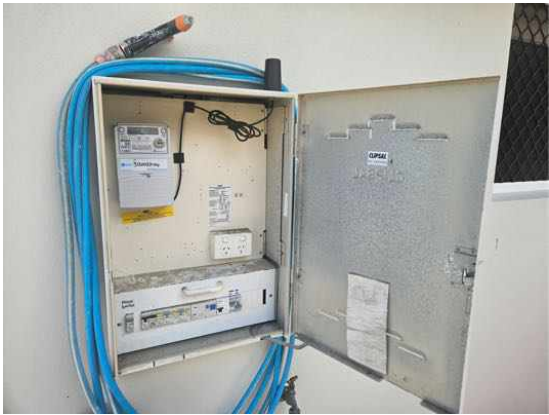
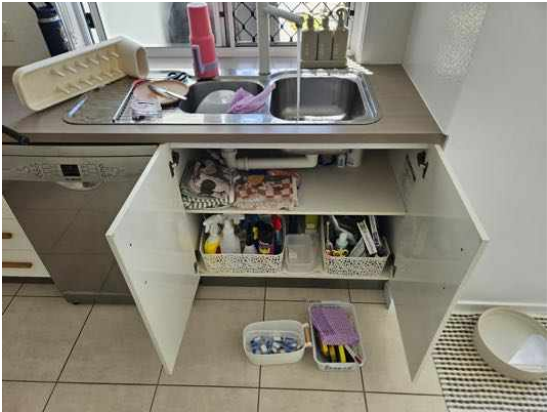
Building: Main Building
 Location: Meter box, kitchen cupboard
 Finding: Durable pest inspection notice - not assessable
 Information: On the day of inspection it was noted that the durable timber pest inspection / treatment notice was missing, not visible or out of date. These notices / stickers are to verify the timber pest inspection dates, the inspector, the currency and type of timber pest system / barrier in place or being used in and around the property.

Annual, or more regular, inspections are crucial in maintaining and managing the properties timber pest risk profile. By not having regular inspections of the property raises the properties risk of undetected defects and damage. Without regular inspection at intervals of not greater than annually the buildings risk profile will categorised as high. Properties with trees within 50m and with gardens close to the building are at greater risk and will have a high risk profile.

It is recommend that a licensed timber pest controller be contacted to assess the properties needs and provide costings for an annual inspection programme.
