Building and Timber Pest Inspection Report

Inspection Date: Mon, 02 Mar 2026

Property Address: 44 Folkard St, North Ryde NSW 2113,
Australia

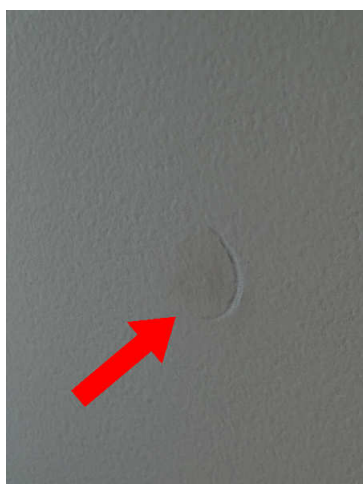
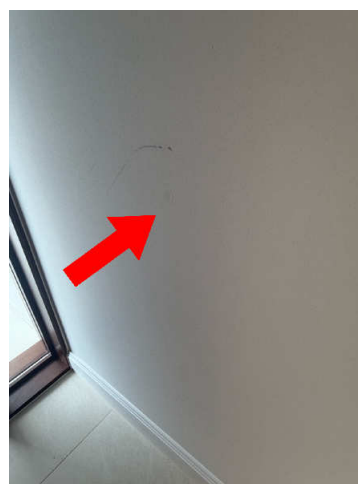
Finding 3.01

Location: Entry

Finding: Minor Surface Indentation – Wall Finish

Information: A minor surface indentation/dent was observed to the painted wall finish. The affected area appears cosmetic in nature, with no visible cracking or structural impact noted at the time of inspection.

Patch, sand and repaint as required to restore the wall finish if desired.
