Building and Timber Pest Inspection Report

Inspection Date: Mon, 9 Feb 2026

Property Address: 13 Hartford Ave, Glen Alpine NSW 2560,
Australia

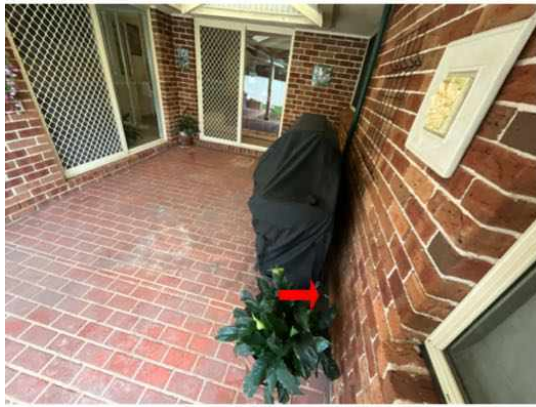
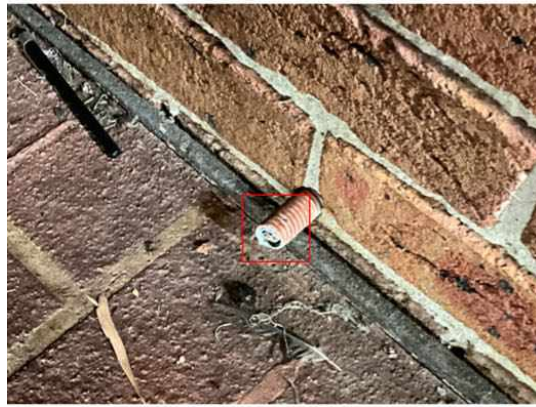
Building: Main Building
Location: Alfresco
Finding: Electrical wiring - Exposed/Messy
Information: Instances of exposed wiring, messy wiring, not in junction boxes or unprotected with electrical tape was identified in this area at the time of inspection.

We highly recommend that a licensed electrician be engaged to check this area and make safe all exposed wiring before any further inspections or works are carried out.

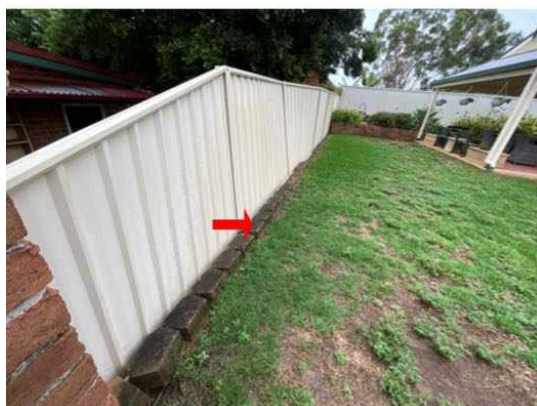
Building:	Main Building
Location:	Retaining Walls
Finding:	Retaining wall — Defective
Information:	The retaining wall in this area was found to be defective at the time of inspection. Generally, defective retaining walls are caused by poor original design or material use. However, deteriorated retaining walls may also be a result of substandard construction, poor site drainage or unmanaged stormwater flows.

AS4349.1-2007 requires all retaining walls in excess of 700mm to be inspected by a licensed and practicing structural engineer.

The structural engineer may draft a scope of works for a licensed trade to carry out rectifications.

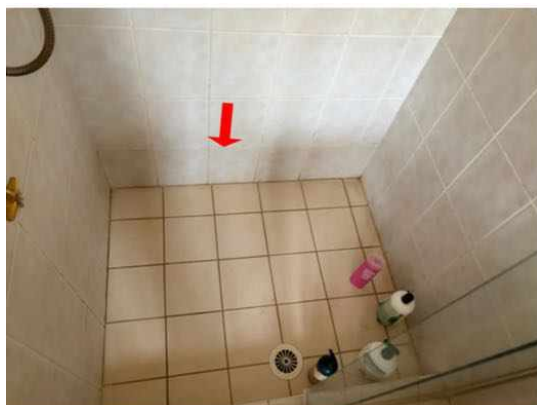
Finding 3.01

Building:	Main Building
Location:	Ensuite
Finding:	Shower damp - Sealant and grout
Information:	Damp is evident to the lower 400mm of wall to the shower alcove. This defect is quite common, and is suspected to have been caused by moisture permeating or leaching through the grouting and sealant in this area, which shows evidence of deterioration. Leaking pipes within the wall is also a possible cause however this seems unlikely in this instance as there is no moisture build up around the taps or transferring to the other side of the wall. There appears to be no sealant around the tap spindles which may be a small contributing factor.

Unmanaged damp in the shower recess is likely to facilitate the formation and development of mould and fungi growth, decaying associated building materials and compromising their structural integrity of associated elements. It is important to address damp conditions, as the World Health Organisation notes that excess moisture leads - on almost all indoor materials - to growth of microbes such as moulds, fungi and bacteria, which subsequently emit spores and other matter into the indoor air. Exposure to these contaminants is associated with a wide range of respiratory and other health-related problems. Damp conditions also create a conducive environment for termite infestation.

Consultation with a bathroom sealant specialist is advised immediately to identify the cause of damp and to perform remedial works as required.

Always ensure that sealant and grout is in good condition to prevent any moisture issues occurring in the future.

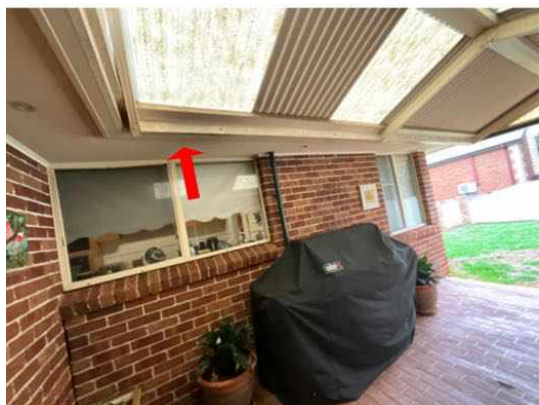
Finding 3.02

Building:	Main Building
Location:	Alfresco
Finding:	Eaves - Water staining
Information:	Water staining to eaves linings in this area was evident at the time of inspection. Water staining indicates that surfaces have been exposed to excessive moisture over time. The minerals and other elements in the water lead to staining, which may graduate to corrosion and deterioration if left unmanaged. While mostly an appearance defect, water staining can be indicative of more serious defects, which may be currently concealed by the lining. A possible cause could be overflow of stormwater from the gutters due to gutters being blocked.

The client is advised to ensure the gutters are free of any obstruction at all times. Where water staining is active, a licensed roof plumber must be consulted to identify the cause of the staining and to provide advice on any reparation works that may be

required. Replacement of any damaged structures is advised.

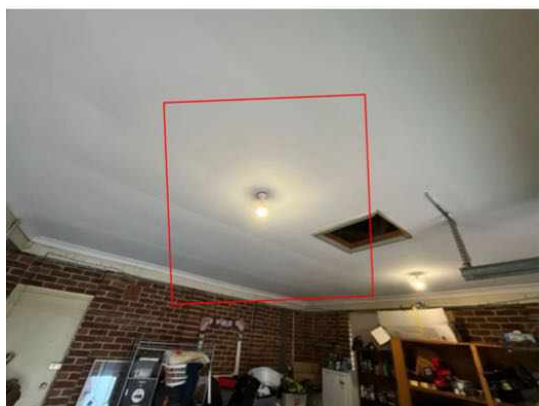
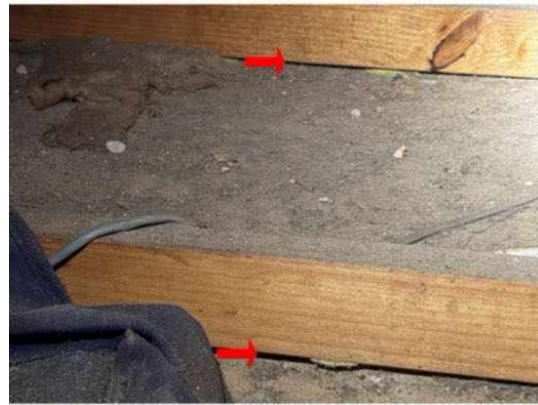
Finding 3.03

Information: Sections of the ceiling were found to be sagging at the time of inspection. Sagging to the fixed ceiling structure generally indicates that the building materials have swollen, due to contact with water, or that fixings (e.g. nails or glue) have become loose and require reattachment.

Where minor sagging is evident, comparatively minor works, such as re-gluing of ceiling sheets, may be required. Such works may be performed by relevant tradespeople, such as plasterers and painters. Where excessive moisture has caused the roofing structure to swell and sag, the source of the water leak should primarily be identified prior to any remedial works being performed.

The appropriate action should be taken by the client as soon as possible to ensure that any potential further damage is limited.

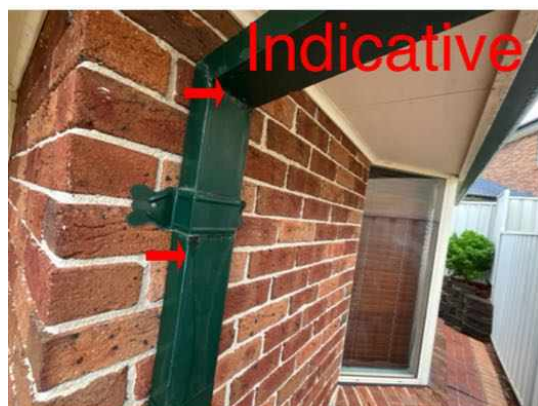
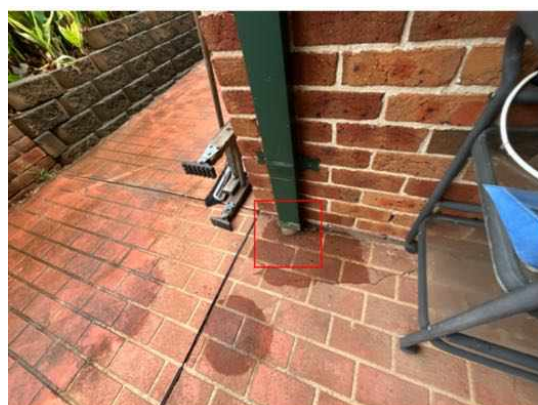
Finding 3.04

Building: Main Building
 Location: Multiple areas of roof plumbing
 Finding: Water leak - External
 Information: Water leaks were found to be present to exterior plumbing work. Leaks are generally caused by deterioration of the plumbing elements over time, due to exposure to weather conditions, but may have also been caused by minor impact damage.

Such leaking creates damp conditions in the affected area, causing potential for water pooling and subsequent water damage if left unattended. These conditions may also attract termite attack, particularly if the area is subject to minimal levels of sun throughout daylight hours.

It is highly advised that a licensed plumber be appointed to rectify any water leaks that may be present. Areas of repair and replacement of plumbing fittings and fixtures may be required and, as such, a quotation should be sought.

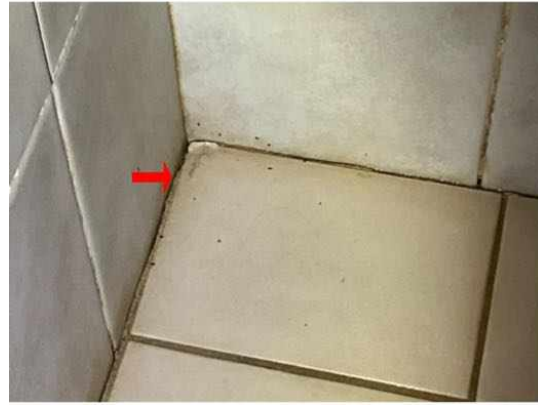
Building:	Main Building
Location:	All Wet Areas
Finding:	Sealant and grouting - Missing or damaged
Information:

It was noted on inspection that sealant or grout is degraded to this area.

Different materials and floor areas move at different rates, generally causing cracking to grout or sealant at this point. A flexible sealant is required to allow for expected expansion and contraction, while keeping the joint water tight and protective of all associated building materials.

Flexible and mould resistant materials should be applied to affected areas to prevent any subsequent water damage that is likely to occur. Regular maintenance and replacement of damage or missing or damaged sealant and grout is highly recommended to the wet areas, as this is a regular wear and tear defect. Sealant and grouting in areas that come into regular contact with water should be maintained for the long term care of your property.

A sealant specialist should be appointed to complete these works as soon as possible.

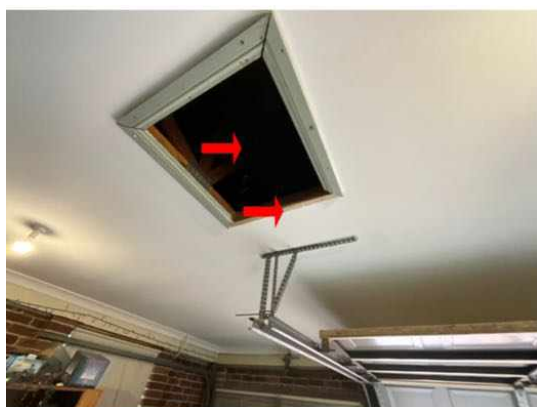
Building:	Main Building
Location:	Garage
Finding:	Building element - Missing
Information:	The manhole cover and trim were found to be missing at the time of inspection. Although some building elements may seem irrelevant or unnecessary, all building elements play a key role in the operation and function of the overall structure and its performance.

Replacement of any missing building element should be conducted as soon as possible to ensure that no damage or functional issues occur to associated building materials.

The appropriate tradesperson should be appointed as soon as possible to replace the missing building element.

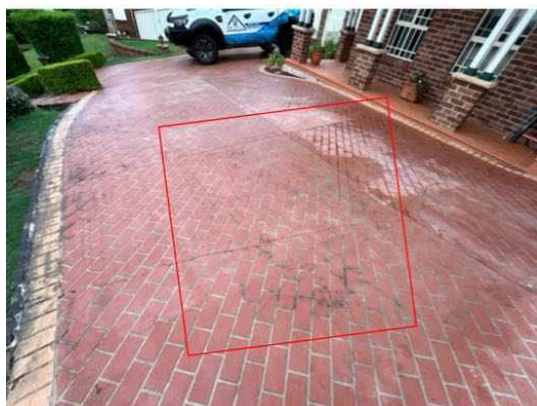
Finding 3.09

Building:	Main Building
Location:	Multiple areas
Finding:	Cracking - External Concrete Paving Damage Category 1 - Fine (less than 2mm)
Information:	Fine cracks were identified in external concrete paving. Although fine cracks are quite

noticeable, they are often only considered to be an appearance defect, and usually do not indicate any structural damage. To be considered a Category 1 or fine crack, the crack is found to be less than 2mm in width.

Generally the cause of a hairline crack in existing concrete paving such as driveways and pathways is indicative of the expansion and contraction of the concrete. Such causes are generally due to environmental factors, such as moisture levels, weather conditions, root systems of nearby trees or the soil types on which they are laid.

Fine cracks may also be due to poor original installation of the concrete. Factors such as poor compaction of the sub surface and/or inadequate reinforcing of the slab may create cracking and other secondary defects.

Monitoring of all cracking should be conducted frequently. Always contact a building inspector should cracks widen, lengthen, or become more numerous.

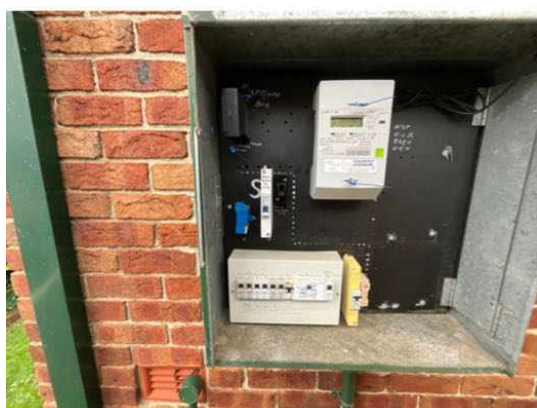
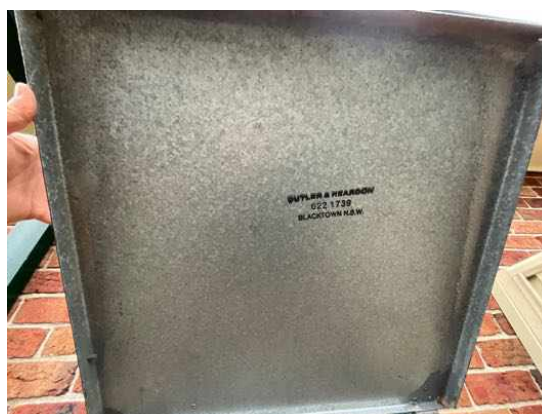
Building:	Main Building
Location:	Meterbox
Finding:	Termite Management System - no evidence of installation
Information:	The application of a post-construction chemical termite barrier is highly recommended for all properties, particularly if live termite activity has been found on the site previously. Such barriers are highly effective in preventing termite attack on any timber building elements throughout the property.

A durable notice should be placed in the switchboard unit to indicate current termite barriers. At the time of inspection, it appeared as though no termite management system has been installed, with no evidence to suggest preventative works taking place.

The client may consider gaining further advice from a pest controller as to the costs and procedures involved with this application. It is recommended that obtaining such advice be a short-term priority.

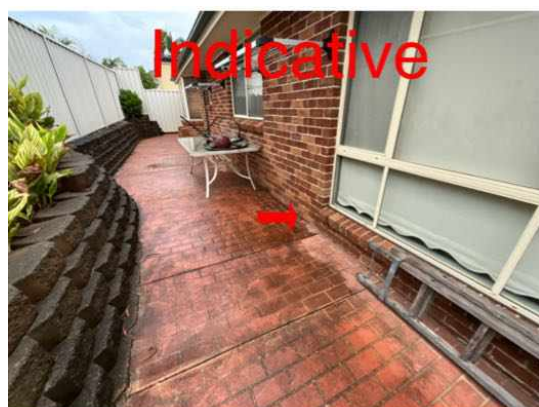
Finding 6.02

Building:	Main Building
Location:	Perimeter
Finding:	Slab Edge - Exposure
Information:	Slab Edge Exposure: Where external concrete slab edges are not exposed there is a high risk of concealed termite entry. In some buildings built since July 1995 the edge of the slab forms part of the termite shield system. In these buildings an inspection zone of at least 75mm should be maintained to permit detection of termite entry. The concrete edge should not be concealed by render, tiles, cladding, flashings, adjoining structures, paving, soil, turf or landscaping etc. Where this is the case you should arrange to have the slab edge exposed for inspection. Concealed termite entry may already be taking place but could not be detected at the time of the inspection. This

may have resulted in concealed timber damage. Does the slab edge inspection zone fully comply?

Not able to comment. A very high proportion of termite attacks are over the edge of both Infill and other concrete slabs types. Covering the edge of a concrete slab makes concealed termite entry easy. Infill slab type construction has an even higher risk of concealed termite ingress as the slab edge is concealed due to the construction design and cannot be exposed. The type of slab may only be determined by assessment of the construction plans by a qualified person e.g. Builder, Architect. Construction Plans may be obtainable by your local Council or Builder. Termite activity and or damage may be present in concealed timbers of the building. We strongly recommend frequent regular inspections in accordance with AS 3660.2. Where the slab edge is not fully exposed or the slab is an infill slab or the slab type cannot be determined then we strongly recommend inspections every 3 to 6 months in accordance with AS 3660.2 or AS 4349.3.

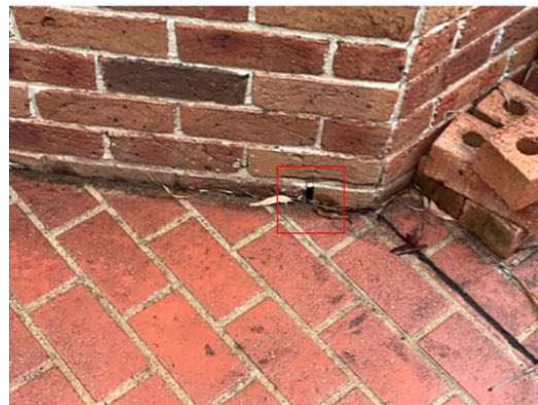
Weep holes in the exterior brickwork of the property are designed to allow condensation that may build up between the brickwork and subsequent timber framework to drain from within the wall hence preventing any deterioration of the timber building elements.

Additionally build-up of moisture is likely to occur if weep holes are covered further attracting termite activity to these areas.

It is highly recommended that weep holes are left exposed in all areas throughout the external property. Therefore if any termite activity leading into weep holes becomes easily detectable during frequent pest inspections.

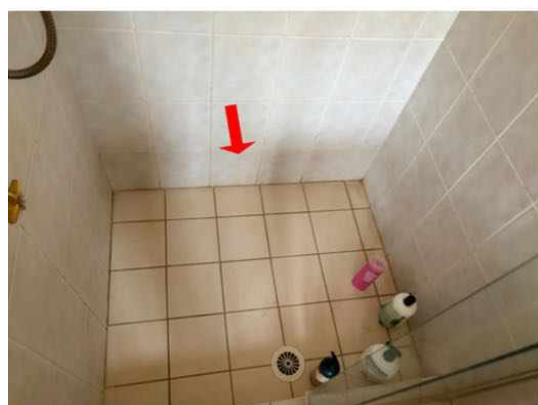
Information: Damp is evident to the lower 400mm of wall to the shower alcove. This defect is quite common, and is suspected to have been caused by moisture permeating or leaching through the grouting and sealant in this area, which shows evidence of deterioration. Leaking pipes within the wall is also a possible cause however this seems unlikely in this instance as there is no moisture build up around the taps or transferring to the other side of the wall. There appears to be no sealant around the tap spindles which may be a small contributing factor.

Damp (or structural damp) refers to the presence of unwanted moisture in the structure of a building, either as the result of intrusion from outside, or condensation from within the structure. In the shower area, internal water leaks, degraded materials or other sources of excessive moisture are generally the cause of damp.

Consultation with a bathroom sealant specialist is advised immediately to identify the cause of damp and to perform remedial works as required.

Always ensure that sealant and grout is in good condition to prevent any moisture issues occurring in the future.

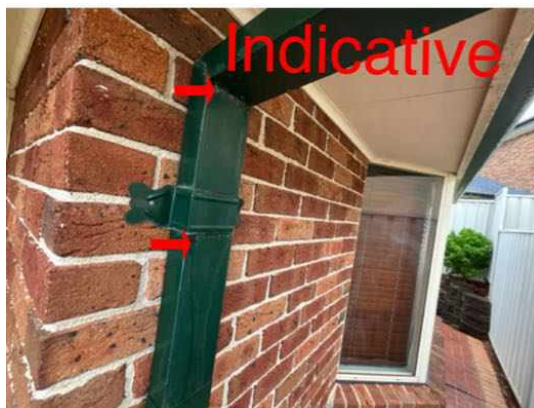
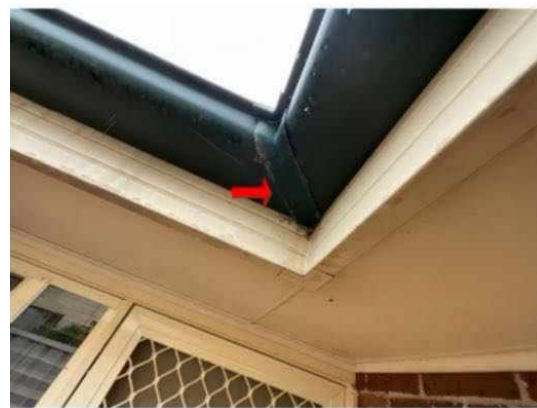
Finding 6.08

Such leaking creates damp conditions in the affected area, causing potential for water pooling and subsequent water damage if left unattended. These conditions may also attract termite attack, particularly if the area is subject to minimal levels of sun throughout daylight hours.

It is highly advised that a licensed plumber be appointed to rectify any water leaks that may be present. Areas of repair and replacement of plumbing fittings and fixtures may be required and, as such, a quotation should be sought.

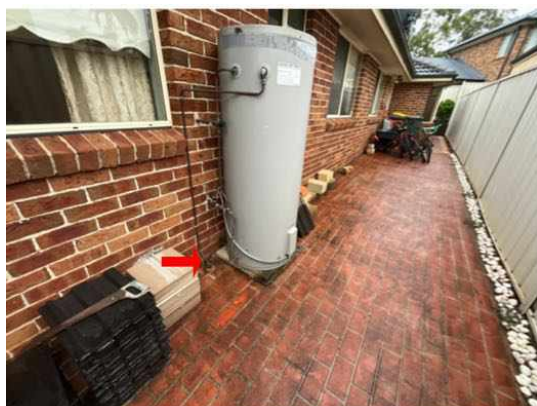
Finding 6.09

Building: Main Building
 Location: Yard - Side
 Finding: Overflow - Not plumbed for drainage
 Information: The overflow is not plumbed or connected to suitable drainage, which can result in the surrounding area becoming excessively damp.

of associated building elements, the formation of fungal decay, or even the creation of potential slip hazards. When coupled with poor site drainage, pooling of water may also attract termite activity to this area.

It is highly recommended that a licensed plumber be appointed to install adequate drainage to the overflow. These works will ensure that the area remains dry and free of any secondary defects.

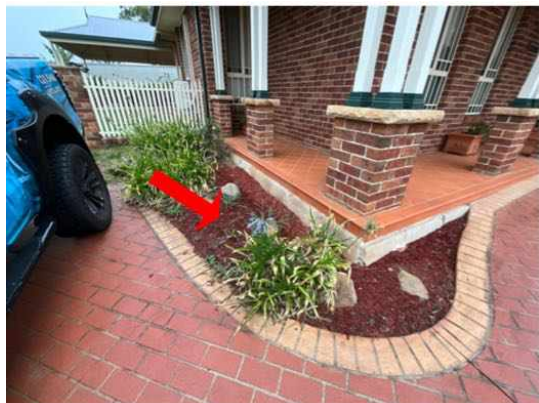
Finding 6.10

Building:	Main Building
Location:	Garden beds
Finding:	Garden Beds
Information:	Garden beds were found to be evident in the garden area. These garden beds can include untreated timber, and with a combination of moisture from watering hosing can make conditions conducive to termite activity and termite ingress.

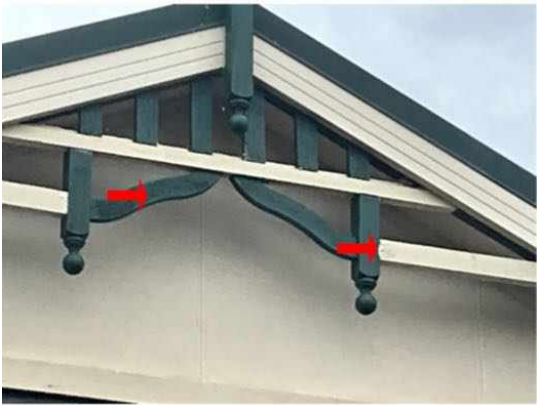
Finding 7.01

Early intervention and regular maintenance, particularly of exterior timbers, will prolong the useful life of these building elements. Prior to any works being performed, the cause of the moisture that has created the visible wood rot should be identified and addressed in a suitable manner. Replacement of affected timbers may then be a necessary step in protecting surrounding building elements from such deterioration.

A licensed plumber may be appointed to assess the cause of excessive moisture and to provide advice on any remedial works as required. A licensed carpenter may also be required to replace affected building materials.

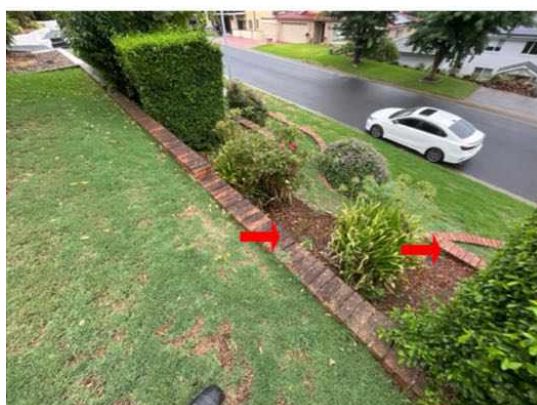
Building: Main Building
 Location: Retaining walls
 Finding: Retaining walls
 Information: At the time of inspection the retaining walls were checked and no defects were observed other than those which May have been mentioned earlier in this report.

AS4349.1-2007 requires all retaining walls in excess of 700mm to be inspected by a licensed and practicing structural engineer.
