# Building and Timber Pest Inspection Report

Inspection Date: Wed, 8 Apr 2026

Property Address: 76 Spitfire Dr, Raby NSW 2566, Australia

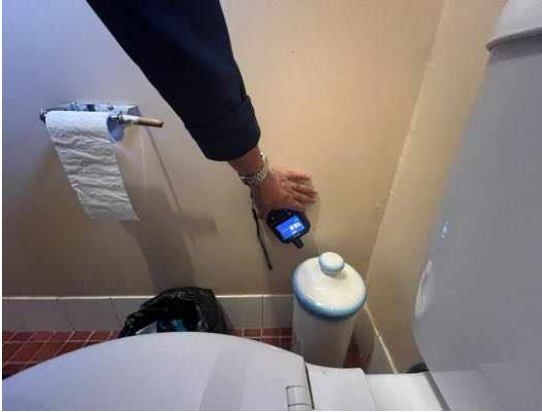
Building: Main Building  
Location: Bathroom  
Finding: Elevated Moisture Bathroom & Back of shower  
Information: Elevated moisture levels were detected to tiled surfaces in bathroom/shower areas. The back of shower area also showed elevated moisture but no visible deterioration was evident at the time of inspection.

This may be due to porous or missing grout, cracked tiles or recent use, however the possibility of waterproofing membrane failure or plumbing leaks cannot be excluded. Persistent moisture ingress can lead to concealed damage, including timber rot and mould growth. Further investigation by a licensed plumber and/or waterproofing contractor is recommended as soon as possible. Rectification may involve waterproofing repairs and potential refurbishment depending on findings.

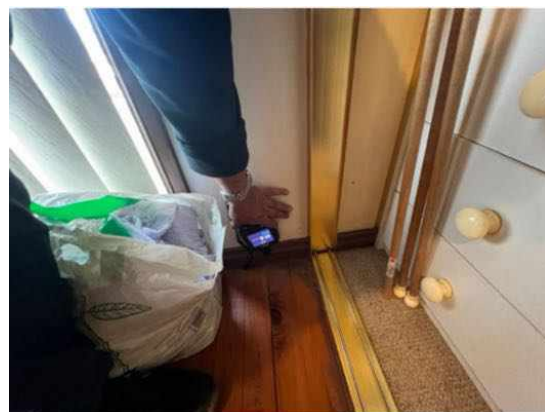
### Finding 3.05

Building:	Main Building
Location:	All Internal Areas - Front wall
Finding:	Elevated Moisture – Further Investigation Recommended
Information:	Elevated moisture readings were detected with no visible surface issues, although no significant structural damage was evident at the time of inspection, dampness can contribute to deterioration if left unaddressed. A further investigation by a licensed plumber or waterproofing specialist is recommended to confirm the source and ensure no concealed issues are developing.

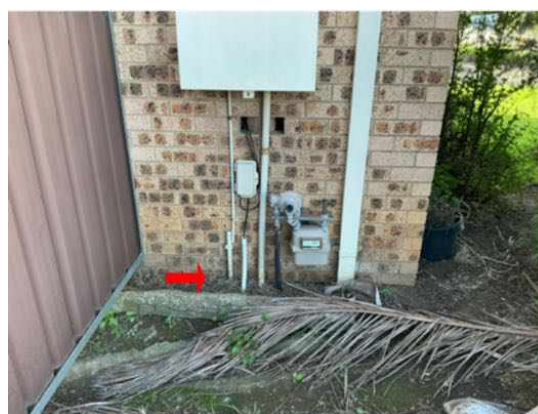
### Finding 3.06

Building:	Main Building
Location:	All External Areas
Finding:	Site drainage - Inadequate
Information:	The site drainage in this area was found to be inadequate at the time of inspection, creating potential for subsequent water damage to associated building elements.

It is important that water does not lie against the base of walls; surrounding paths and ground levels should be sloped to drain water away from walls. Downpipes should not discharge stormwater onto lower walls or plinths. Stormwater should be carried away by large, regularly cleaned drains. Ground levels may need to be lowered to expose a buried DPC.

Where site drainage is inadequate, installation of an Agricultural (Aggie) Drain may be required. A qualified plumber should be appointed to further inspect the property and perform any remedial works as necessary. Water damage and secondary defects are likely to occur if left unmanaged.

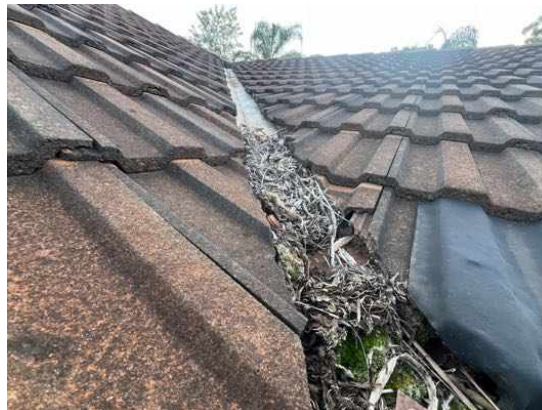
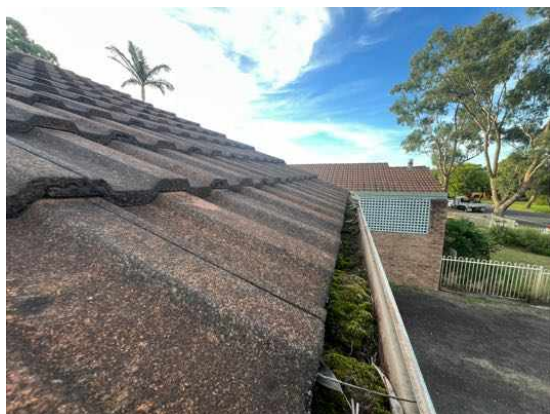
### Finding 3.07

Building:	Main Building
Location:	All External Areas
Finding:	Gutters - Blocked
Information:	Roof plumbing structures, such as guttering and downpipes, should be free of all debris to prevent blockages. Blockages of the guttering and downpipes will lead to pooling and accumulated water overflows, which is likely to subsequently flood eaves and exterior walls.

Blocked gutters are likely to lead to high levels of moisture in the affected areas. Such moisture will not only cause rust and decay of the associated building materials, but can also provide conditions that are conducive to termite and timber pest activity. Blockages in gutters should therefore be removed immediately to ensure dry

Consult a Licensed Plumber for further specific advice on remedial works that may be required. In the interim, it is highly advised that blocked gutters be removed by the homeowner or a general handyperson as a matter of urgency.

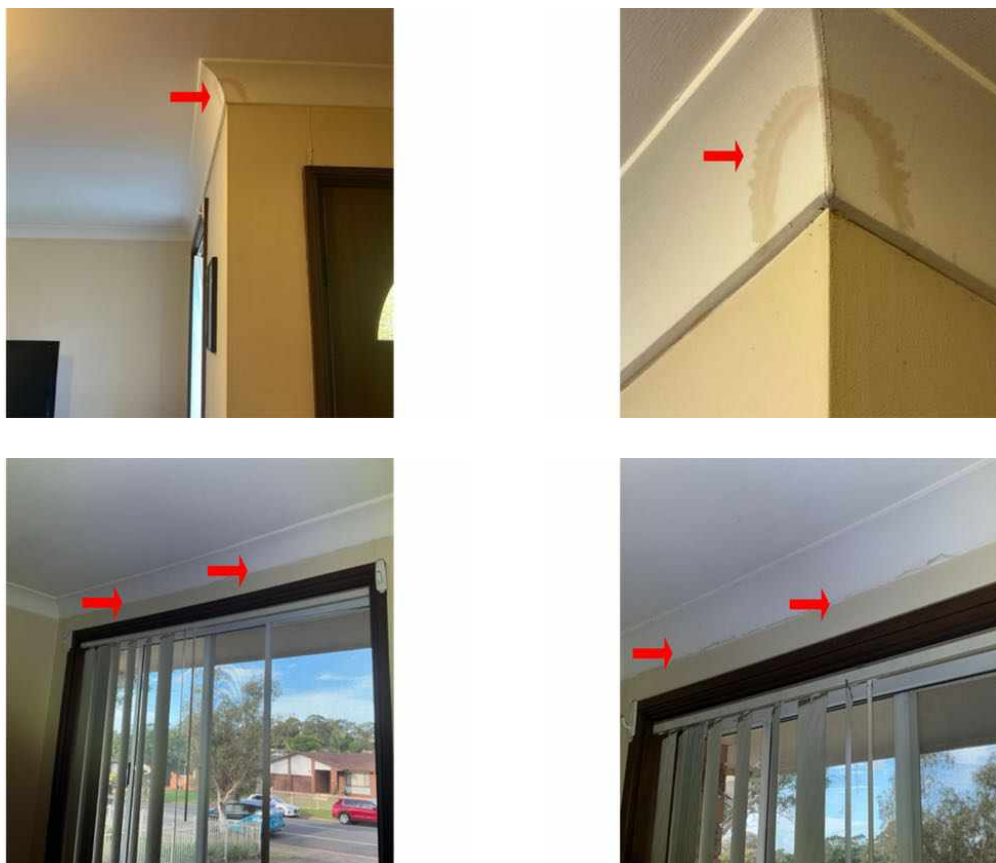
Building:	Main Building
Location:	All Internal Areas - Lounge
Finding:	Water staining
Information:	Water staining was evident in this area at the time of inspection. Water staining indicates that surfaces have been exposed to excessive moisture over time. The minerals and other elements in the water lead to staining, which may graduate to corrosion and deterioration if left unmanaged.

While mostly an appearance defect, water staining can be indicative of more serious defects, which may be currently concealed by other building elements.

Where water staining is active, a licensed plumber must be consulted to identify the cause of the staining and to provide advice on any reparation works that may be required. Replacement of any broken or damaged structures is advised.

Conversely, where water staining is old and inactive, affected building materials may be repaired or replaced at client discretion. A qualified carpenter or registered builder may be appointed to perform these works.

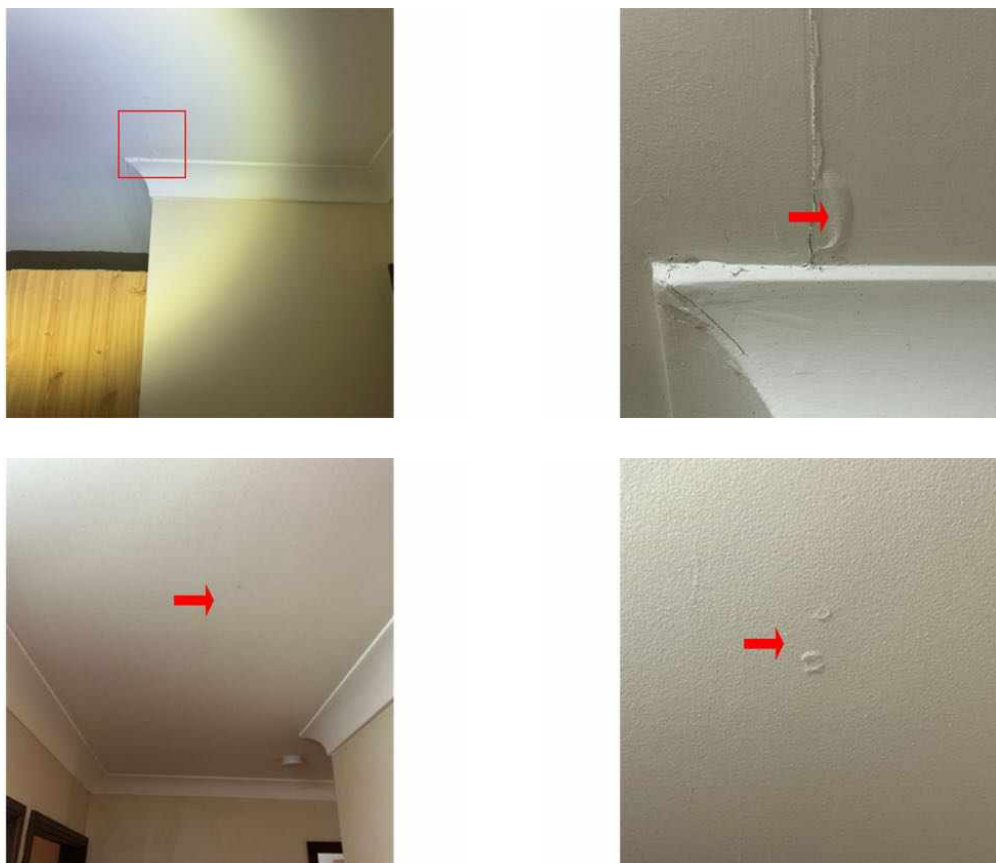
### Finding 3.10

Building:	Main Building
Location:	Kitchen, hallway
Finding:	Painted surface - Bubbling
Information:	Sections of paint in this area was found to have bubbled and deteriorated. Paint bubbling is generally an indication of excessive moisture in the area, that is currently hidden by the painted surface.

The presence of excessive moisture can have major implications on associated building elements if left unattended. While only seemingly minor at this stage, the damage cannot be determined due to the paint obstructing any further inspection of the damage.

It is highly advised that the affected paint be cleaned to allow a further, more invasive inspection by a licensed plumber. Failure to act on this defect may necessitate major works in the future.

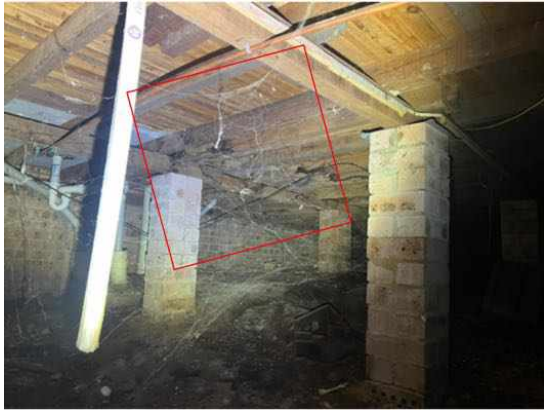
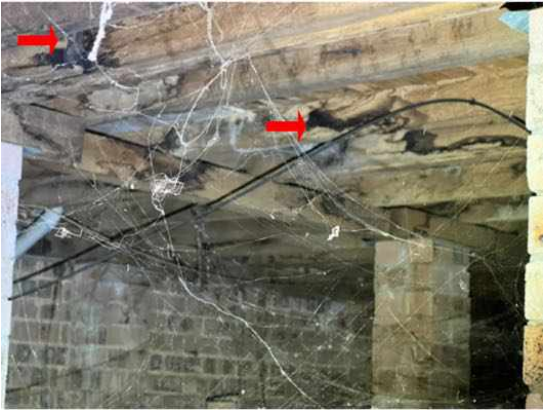
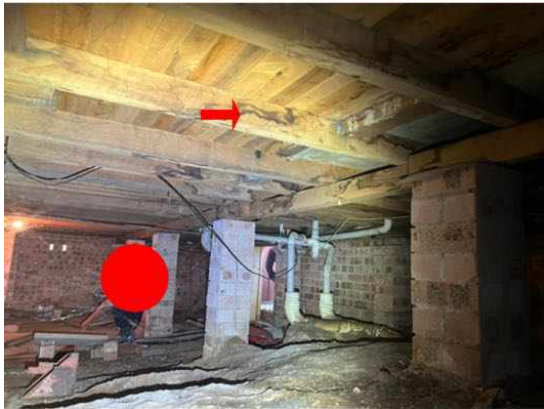
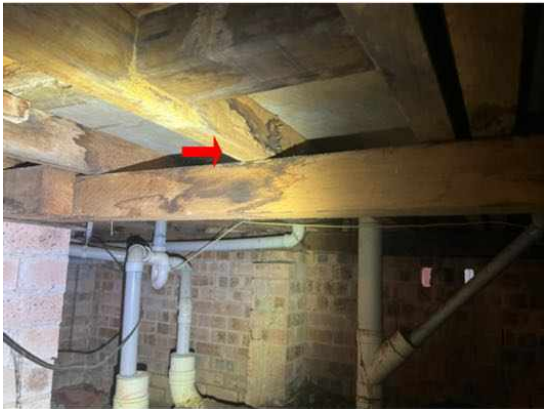
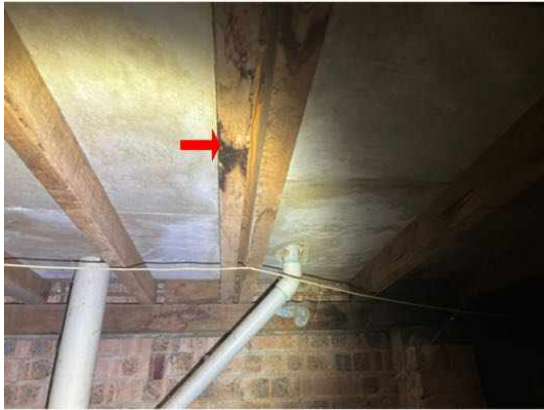
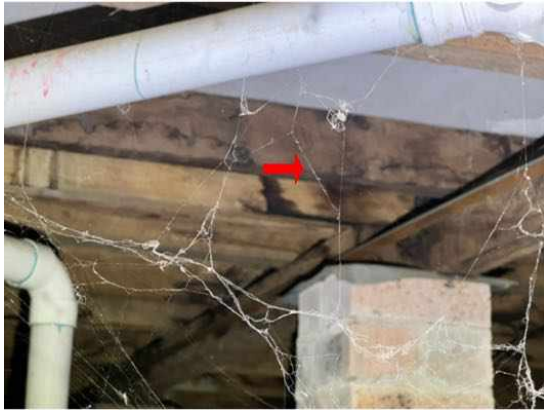
Finding: Aged Timber and moisture staining – Subfloor

Information: Minor Decay and elevated moisture was noted to some areas, consistent with age-related shrinkage and general weathering. The affected areas also exhibited localised surface darkening and moisture stains which may indicate past moisture exposure. No evidence of structural compromise was observed at the time of inspection. These conditions appear typical for a dwelling of this age and construction, but ongoing monitoring is recommended. A licensed builder or licensed carpenter should be consulted if there is further deterioration or leaks. It is also recommended for a licensed timber pest technician to perform invasive inspection for concealed timber pest activity.

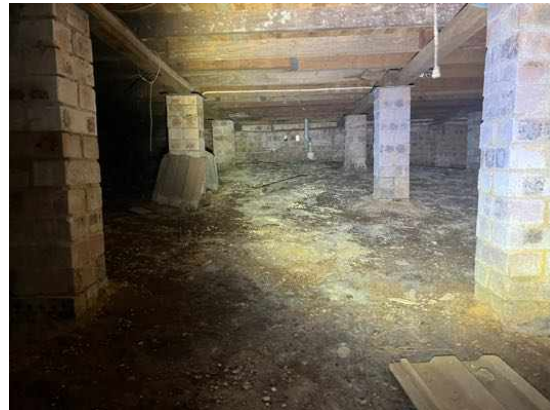
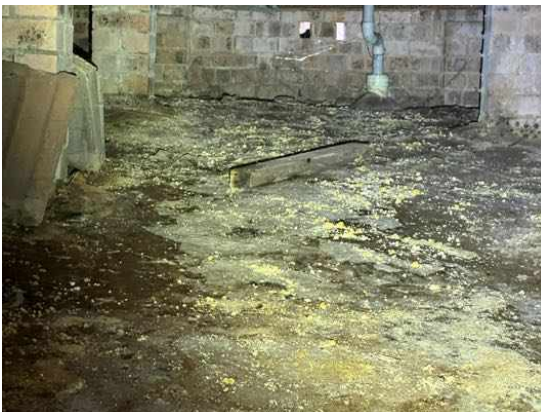
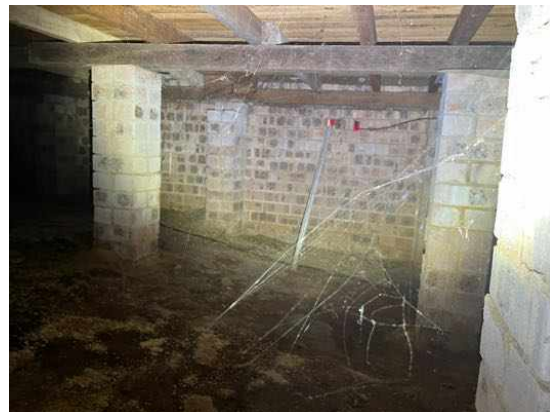
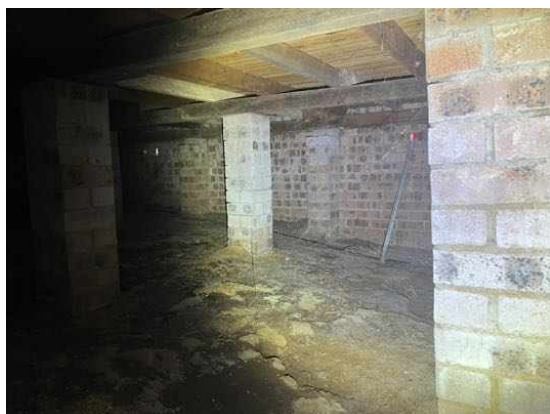
Finding 3.26

Building:	Main Building
Location:	Subfloor
Finding:	Subfloor ventilation - Inadequate
Information:	Adequate subfloor ventilation aids in preventing excessive moisture wood rot and termite activity by ensuring a dry subfloor environment.

Subfloor ventilation can be improved in most cases by addressing the causes such as exposing subfloor vents installing additional new vents installing mechanical (forced airflow) ventilation and removing debris from the subfloor.

A registered builder should be appointed as soon as possible to perform these works as necessary.

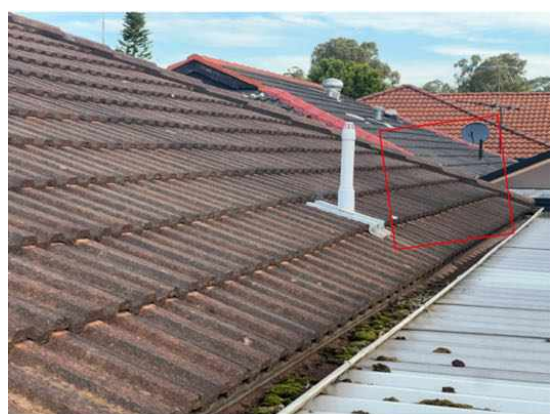
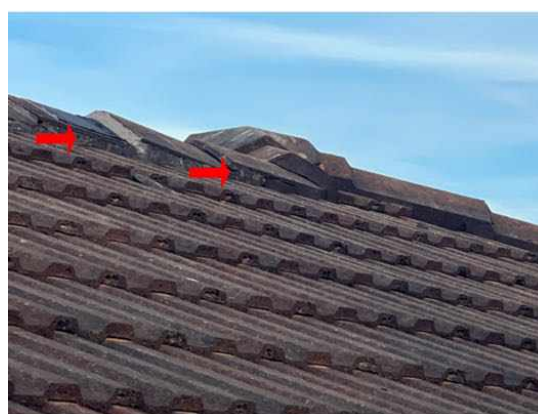
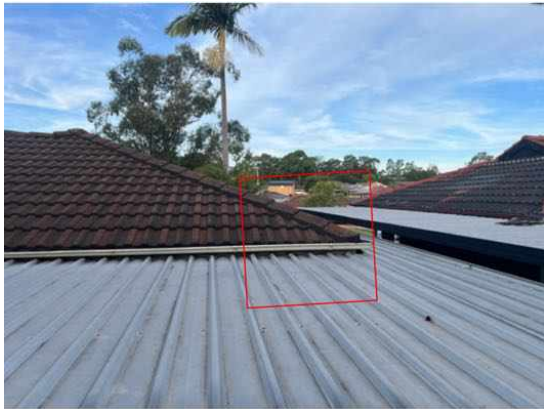
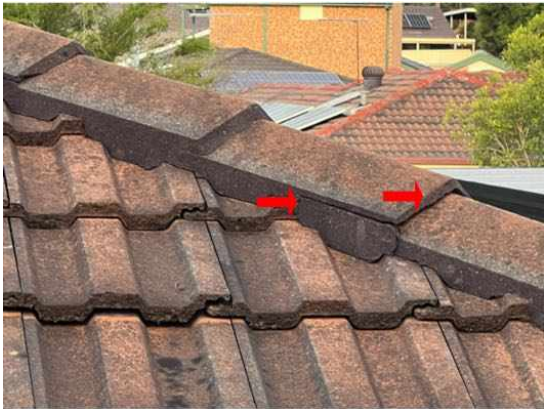
### Finding 3.27

Building:	Main Building
Location:	Roof Exterior
Finding:	Mortar - Deterioration
Information:	Mortar, or 'bedding', is the material which fills joins and intersections between tiles and other building elements on the exterior roof covering, such as gable ends, hip capping and valleys. Upon inspection of the exterior roof, it was noted that sections of the mortar show varying levels of deterioration.

Mortar generally deteriorates as a result of frequent exposure to weather conditions over a prolonged period of time. Mortar that is deteriorating may allow water ingress into the roof void, putting associated building elements and roofing structures at risk of water damage. Deteriorated mortar also detracts from the functionality of roof tiles and other roofing elements, potentially decreasing weather tightness and roof drainage.

Mortar deterioration can be attended to by a handyperson where areas of deterioration are localised and easily accessible. Otherwise, consultation with a roofing contractor is advised where greater works are required.

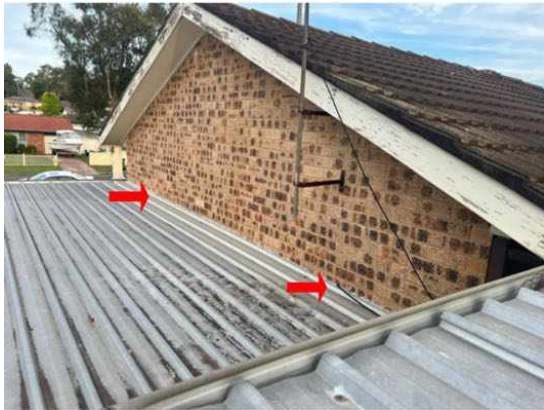
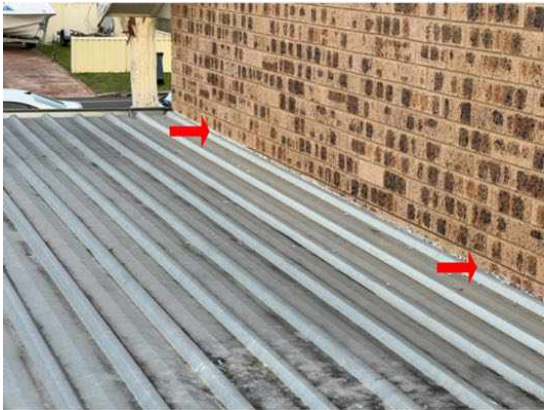
**Finding 3.28**

Building: Main Building  
Location: Roof Exterior  
Finding: Flashing defective -poor installation  
Information: The metal flashing at the wall junction appears inadequately installed, with visible gaps add or lifting and reliance on surface sealant rather than a properly chased and continuous detail. The junction does not appear fully weather-tight, increasing the risk of moisture ingress into the wall cavity or roof structure over time. Defective flashing installation can lead to concealed deterioration if not addressed. Recommend assessment and rectification by a qualified roofing contractor to ensure compliant and effective weatherproofing.

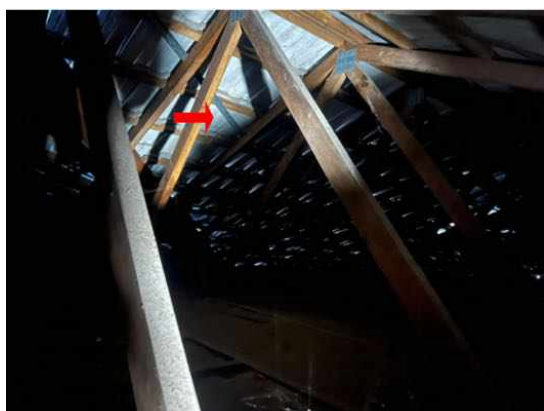
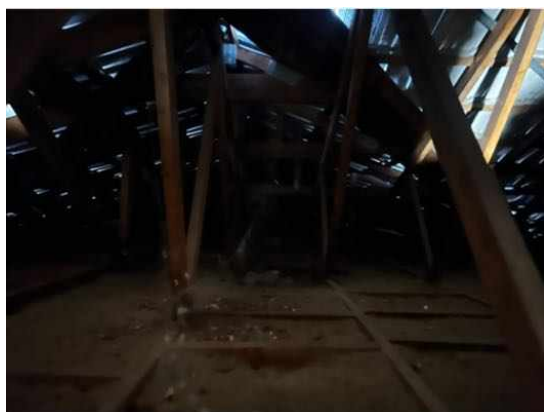
### Finding 3.29

Building:	Main Building
Location:	Roof Void
Finding:	Roof Void – No Sarking & Light Ingress
Information:	Light ingress is visible through multiple roof tile laps, which is typical of older tile roofs without sarking and may allow minor wind-driven moisture or dust into the space, though no active leaks were observed.

Consider retrofitting sarking or roof wrap in the future to improve thermal and moisture performance.

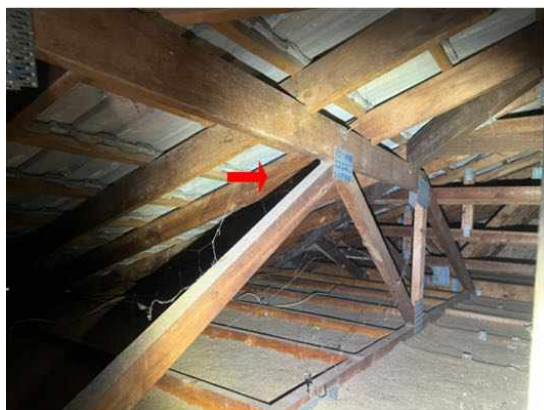
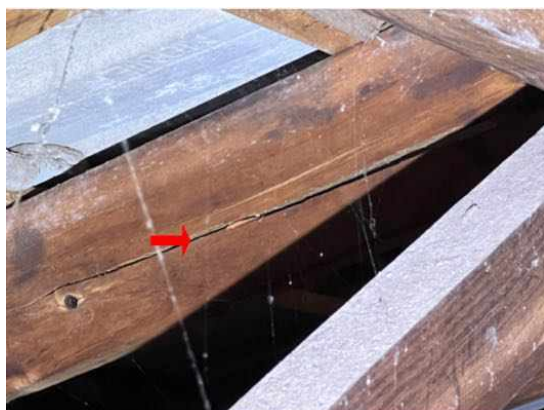
### Finding 3.30

Building:	Main Building
Location:	Roof Void
Finding:	Roof Void Observation – Timber Splitting in Roof Framing
Information:	longitudinal splits were observed in roof framing member within the roof void. No signs of distortion, bowing, deflection, moisture ingress, or fungal decay were evident at the time of inspection. Current structural integrity does not appear compromised. However, A licensed carpenter should be consulted to access further.

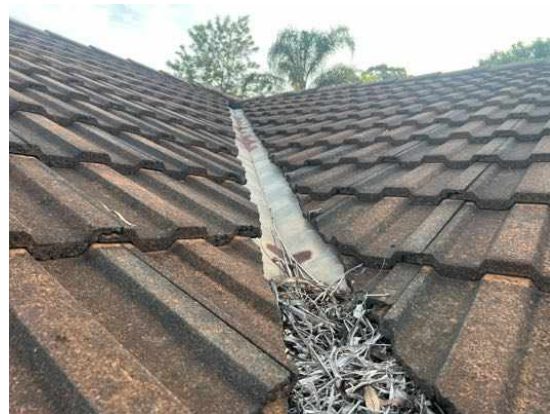
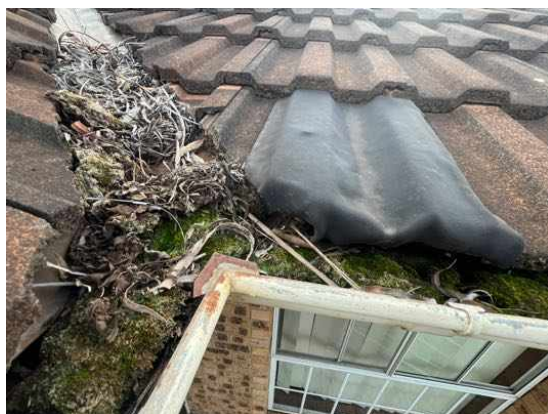
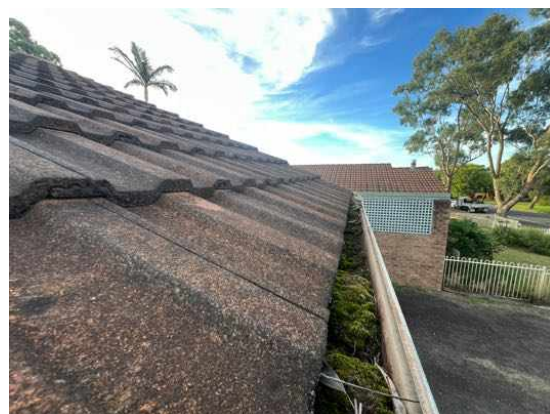
Blocked gutters are likely to lead to high levels of moisture in the affected areas. Such moisture will not only cause rust and decay of the associated building materials, but can also provide conditions that are conducive to termite and timber pest activity. Blockages in gutters should therefore be removed immediately to ensure dry conditions are maintained.

Consult a Licensed Plumber for further specific advice on remedial works that may be required. In the interim, it is highly advised that blocked gutters be removed by the homeowner or a general handyperson as a matter of urgency.

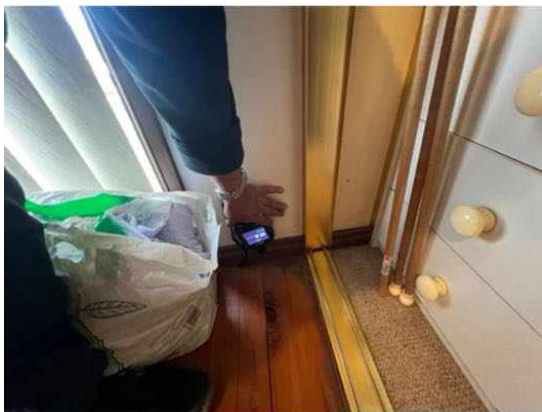
### Finding 6.06

Building:	Main Building
Location:	Subfloor, Front lower wall
Finding:	Elevated moisture - identified
Information:	Elevated moisture can attract termites and produce conditions that promote fungal growth and wood decay.

If mould growth has been found there may be environmental biological or health issues involved. In these cases an appropriately qualified inspector should also be contacted.

Prior to any remedial works being performed a qualified plumber should be appointed to further inspect the property and to identify the cause of the excessive moisture. Works to remove affected building elements may then be necessary and should be performed by an appropriate tradesperson.
