Building and Timber Pest Inspection Report

Inspection Date: Thu, 5 Feb 2026

Property Address: 19 Langley Ave, Renwick NSW 2575,
Australia

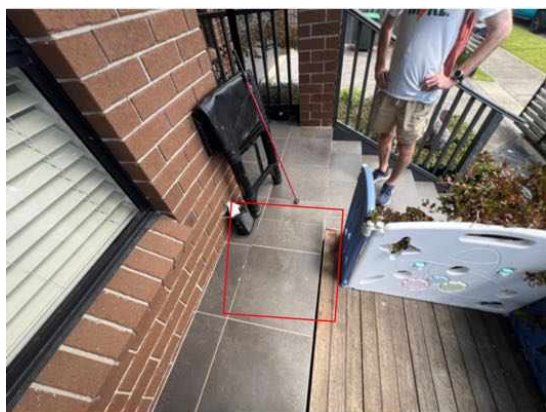
Building:	Main Building
Location:	Verandah
Finding:	Tiles - Drummy or Popped (grout degraded)
Information:	It was noted on inspection that grout is degraded to the tiled area and noticeable popped tiles.

Drummy or Popped tiles indicate that the bond between the tiles and the substrate has weakened, likely due to moisture exposure or improper installation. This can lead to tiles detaching completely over time, which may cause safety hazards. Gaps in the grout further compromise the waterproofing of the surface, allowing moisture to penetrate behind the tiles. This can cause water damage, mold growth, and deterioration of the underlying structure. The drummy effect and loose tiles also affect the visual quality and longevity of the tiled surface.

Engage a qualified tiler to carefully remove and replace the drummy or popped tiles.

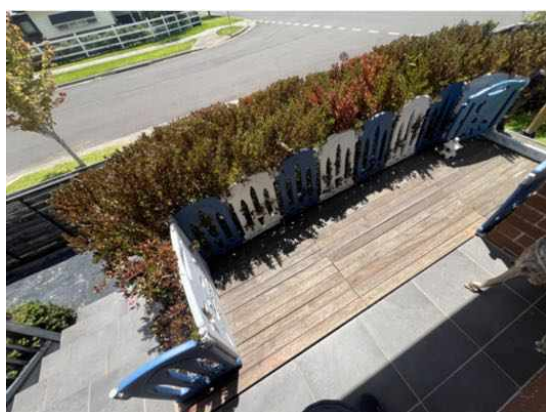
Finding 1.03

Building:	Main Building
Location:	Verandah - deck
Finding:	Balustrade - Suspected Non-Compliance
Information:	The balustrade was measured and found to be less than the present building regulation requirement of 1000mm high. Additionally the gaps between the balustrade cladding were found to be greater than the present building regulation requirement of 125mm.

This defect creates a potential safety hazard and should be rectified as soon as possible to ensure the safety of the area and to meet present building standards and regulations.

A registered builder should be contacted to discuss possible rectification solutions.

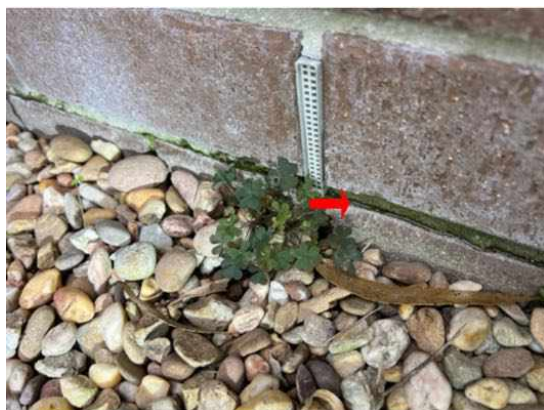
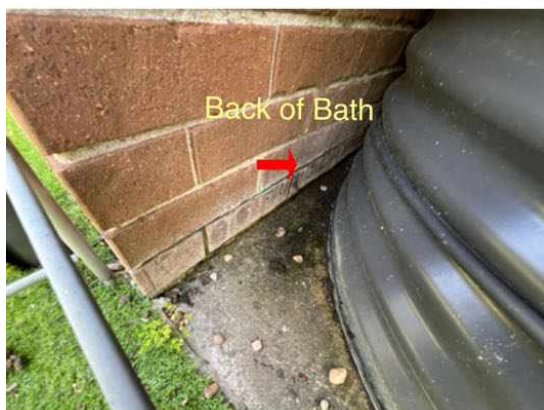
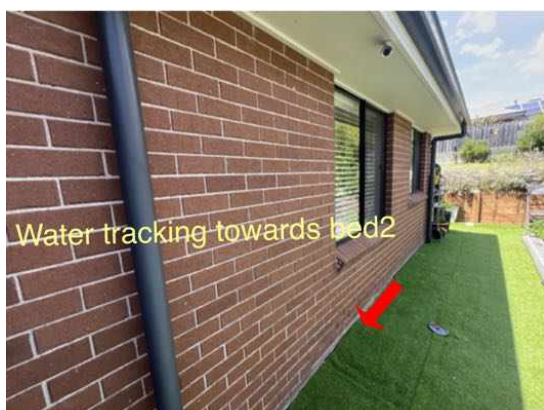
Finding 2.01

Finding: Bath - Water Leak

Information: The bath was operated during the inspection and water was subsequently observed discharging externally from weep holes and mortar joints at damp-proof course level behind the bathroom. The water was noted to track behind the bath and adjoining areas, extending toward the laundry and along the wall line toward the rear of the garage/Bedroom 2.

Once the bath tap was turned off, the external water discharge ceased. This confirms the condition is not consistent with a concealed pipe or waste failure and is instead indicative of a water leak associated with the bath tap fittings or related connection points during use.

An unmanaged water leak of this nature may result in concealed moisture exposure to surrounding building elements and may create conditions that are conducive to timber pest activity if left unattended.

It is recommended that a licensed plumber assess the bath tap fittings and associated connections to identify and rectify the source of the water leak. As no visible internal damage was identified at the time of inspection, a registered builder should undertake invasive investigation where necessary to determine whether any concealed moisture-related deterioration is present.

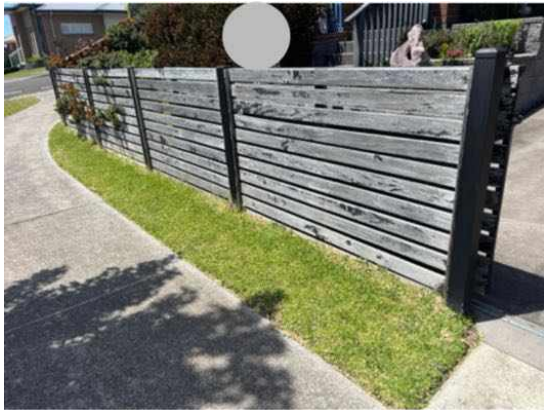
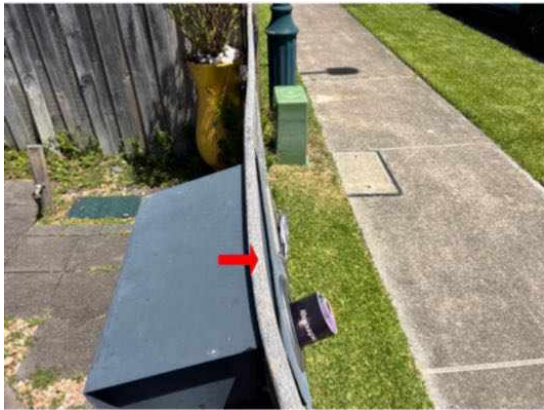
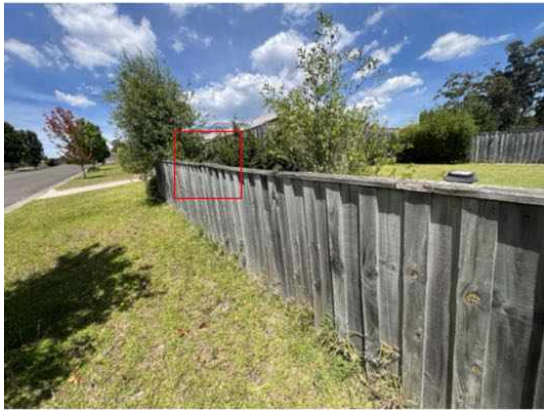
Finding 3.01

Building:	Yard
Location:	Fencing
Finding:	Fencing - Deteriorated
Information:	It was noted at the time of inspection that sections of the fencing throughout the property have deteriorated. Typically fencing deteriorates due to age and or wear, rot and or rust which is generally expected for a structure of this age, due to prolonged exposure to weather conditions. Sometimes inadequate installation or maintenance

If left unattended, it is likely that further damage will occur. It is suspected that repair of several elements of the fencing may be required however replacement may be a consideration of the client also.

A licensed fencing contractor should be appointed to provide further advice and perform rectification works as necessary.

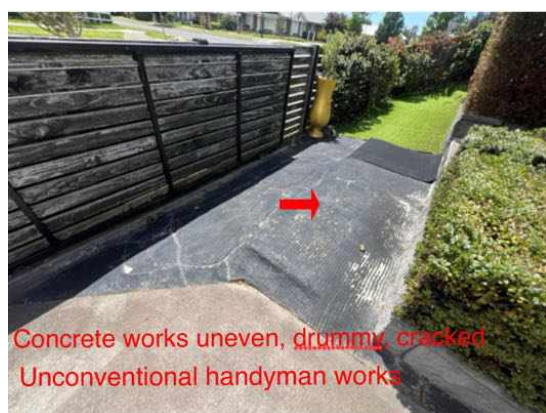
Finding 3.02

Building: Yard
Location: Yard - Front

Finding: Unconventional handyman work
 Information: This handyman work appears to have been completed to a substandard level and does not comply with regular building practices. Where handyman work is not completed satisfactorily, accelerated deterioration of the associated building elements is likely to occur and secondary defects to surrounding structures may develop.

It is highly recommended that the substandard work be rectified by professional services. Works to improve this area are likely to increase the safety and the operation of the associated building elements.

The client should exercise care when coming into the immediate vicinity of the substandard works. Rectification works are advised as soon as possible by the appropriate trades.

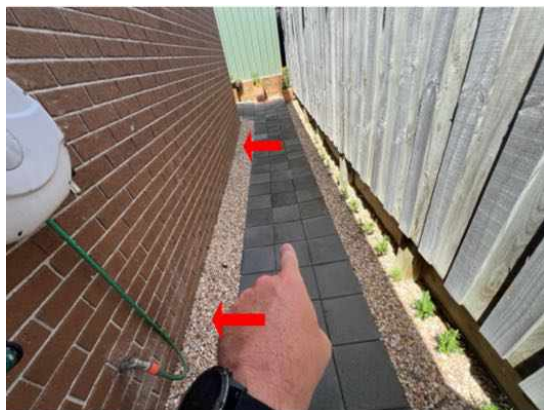
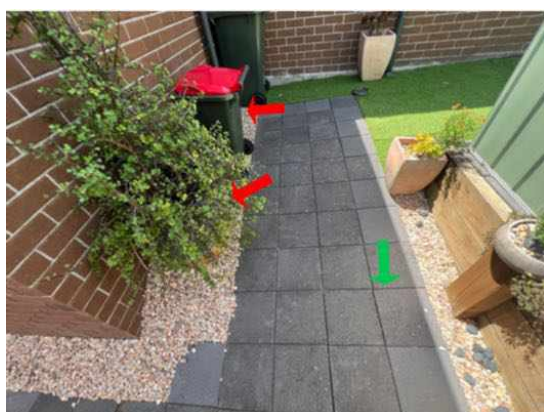
Building:	Yard
Location:	Yard - Back, Side
Finding:	Site drainage - Inadequate
Information:	The site drainage in this area was found to be inadequate at the time of inspection, creating potential for subsequent water damage to associated building elements.

It is important that water does not lie against the base of walls; surrounding paths and ground levels should be sloped to drain water away from walls. Downpipes should not disgorge stormwater onto lower walls or plinths. Stormwater should be carried away by large, regularly cleaned drains. Ground levels may need to be lowered to expose a buried DPC.

Where site drainage is inadequate, installation of an Agricultural (Aggie) Drain may be required. A qualified plumber should be appointed to further inspect the property and perform any remedial works as necessary. Water damage and secondary defects are likely to occur if left unmanaged.

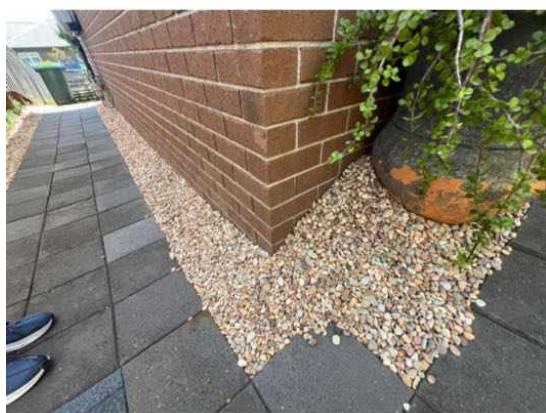
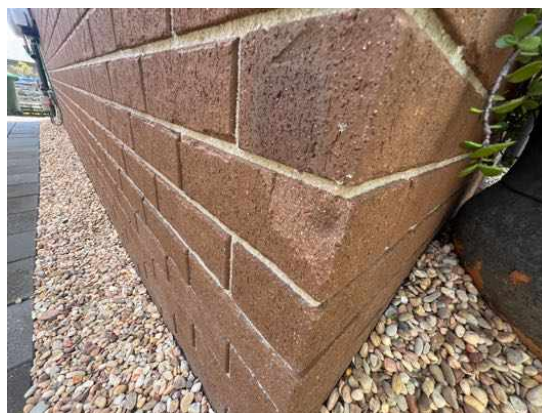
Building:	Main Building
Location:	Exterior walls - right side (garage)
Finding:	Brickwork - Damaged
Information:	Breakage occurs generally when the building materials have either aged and decayed, or as a result of damage (accidental or deliberate).

Repair and/or replacement of broken elements is advised to ensure that additional secondary defects do not arise as a consequence. Such works are necessary, as all building elements play a key role in the operation and function of the overall structure and its performance.

A bricklayer should be appointed to repair or replace the affected building element prior to any subsequent damage being caused.

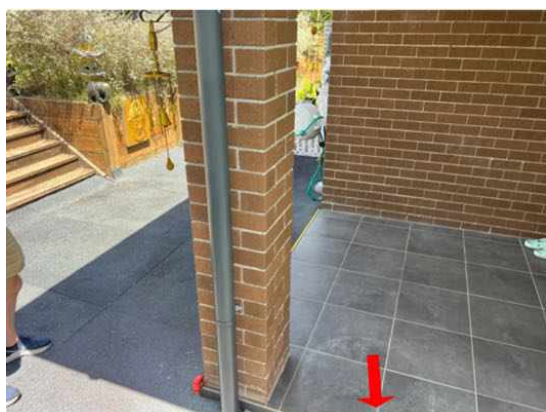
Finding: Tiles - Cracked or damaged

Information: Cracking was evident to the tiling in this area at the time of inspection. While the cracking appears to be minor, this area is frequently exposed to water, allowing potential for water penetration into adjoining sections of walls or flooring.

If left unmanaged, water penetration to these areas may lead to subsequent water damage, which is likely necessitate repair work to affected building elements.

A tiling contractor should be appointed to ensure that no further water damage occurs. The re-application of silicone and grouting throughout remaining tile work is also advised, to further protect the area against water penetration.

Where water penetration has led to water damage, appointment of a relevant tradesperson may be required to repair damaged building elements.

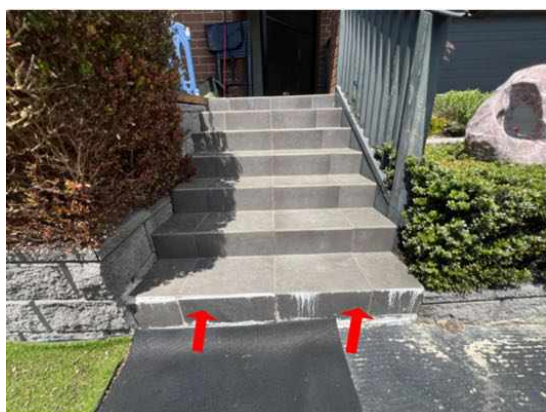
Poorly executed tiling can compromise the functionality and appearance of the area, potentially leading to issues such as loose tiles, water ingress, or accelerated deterioration over time.

It is highly recommended that a floor and wall tiler be appointed to complete these works and ensuring a safe and durable finish that enhances the longevity of the

associated building elements.

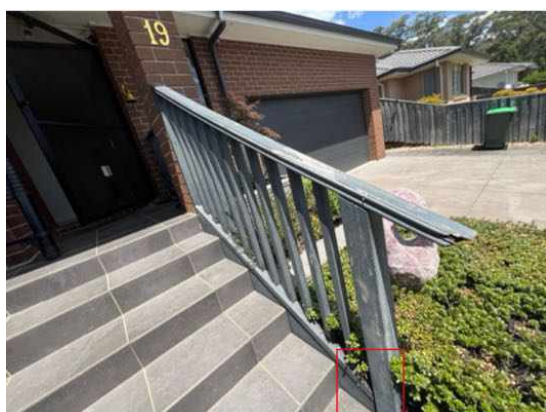
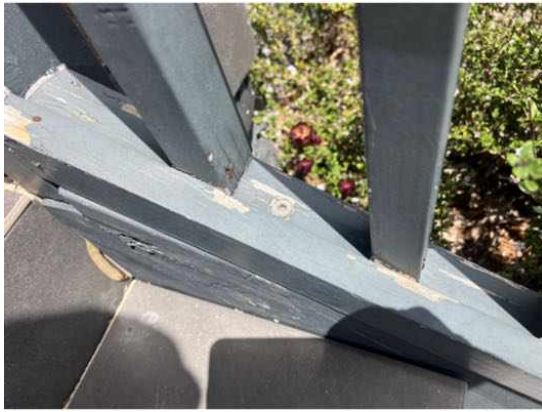
Finding 3.12

Building:	Main Building
Location:	Verandah
Finding:	Balustrade - Rusted Fixings
Information:	Corrosion was observed to fixings associated with the balustrade. Rusted fixings can reduce the effectiveness of connections over time and may contribute to loosening or instability of the balustrade if deterioration progresses.

Ongoing exposure to weather and moisture is a common contributing factor to this condition. Continued corrosion may lead to further deterioration of both fixings and adjoining timber elements.

It is recommended that a registered builder or qualified carpenter assess the balustrade fixings and determine whether repair or replacement is required to maintain adequate performance.

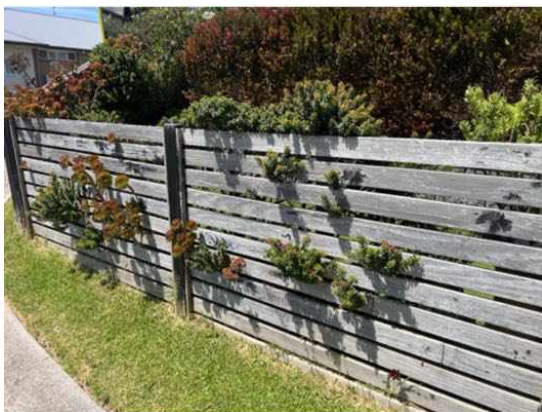
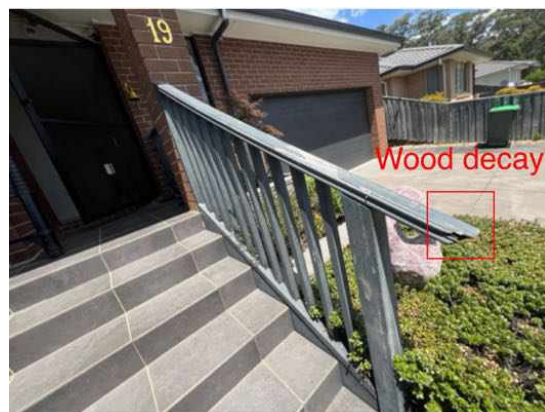
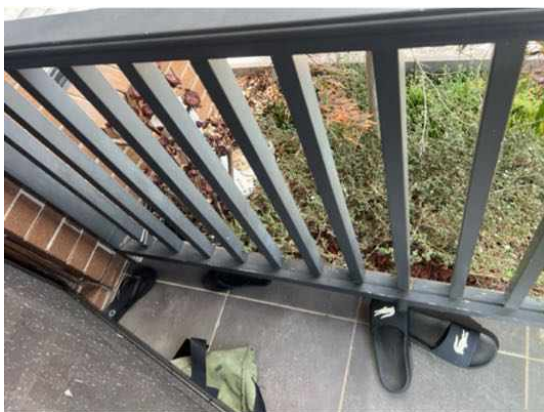
Finding 3.13

Building:	Main Building
Location:	Verandah
Finding:	Timber - exposed to weather
Information:	External timbers that are frequently exposed to harsh weather conditions require adequate protection in order to maintain their condition. Where timbers have not been painted or treated adequately, general deterioration is likely to occur at an accelerated rate.

If left unattended, replacement of these timbers is likely to be necessary in the short-term future. Adequate treatment of these timbers is required as soon as possible by a painting contractor or general handyman.

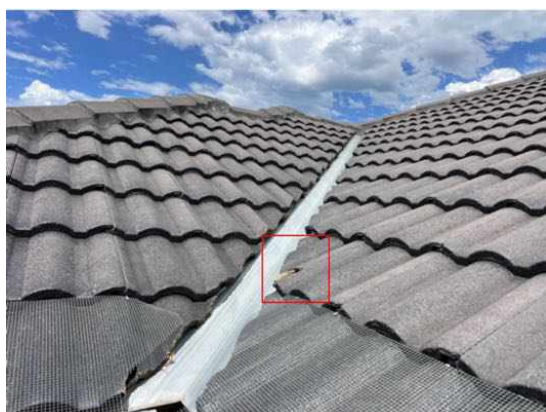
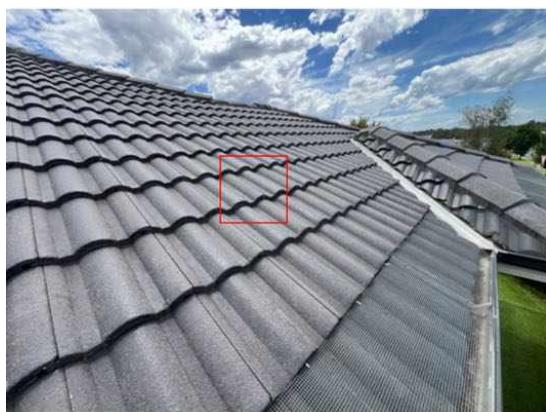
Building:	Main Building
Location:	Roof Exterior
Finding:	Roof tiles - Broken

Information: Upon inspection of the exterior roof covering, broken roofing tiles were identified. Broken and friable roof tiles are generally the result of ageing and weathering of what is essentially a porous material.

If left to further deteriorate, broken and brittle roof tiles are likely to lead to water penetration via the roof into the ceiling space, causing secondary damage to ceiling linings, insulation and roof structures. Broken roof tiles are also likely to detract from the effectiveness of the roof drainage system, creating potential for secondary damage to the exterior roof covering and roof plumbing.

Replacement of broken tiles is required and should be performed by a roofing contractor as soon as possible.

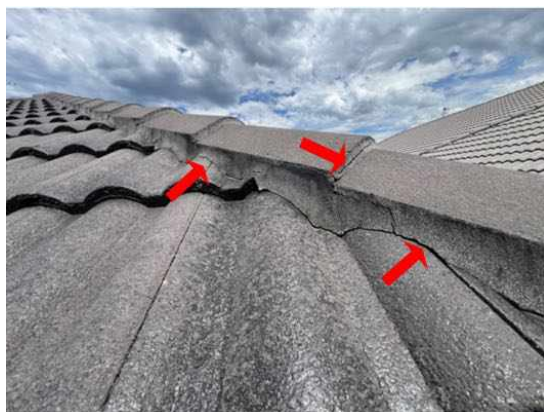
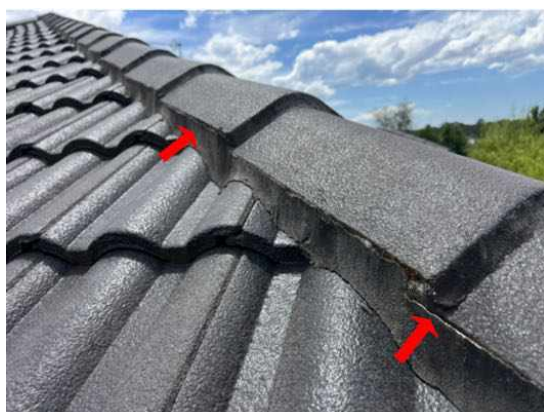
Finding 3.16

Building: Main Building
 Location: Roof Exterior
 Finding: Roof Mortar - Deterioration
 Information: Mortar, or 'bedding, is the material which fills joints and intersections between tiles and other building elements on the exterior roof covering, such as gable ends, hip capping and valleys.

Upon inspection of the exterior roof, it was noted that sections of the mortar show

varying levels of deterioration.

Mortar deterioration can be attended to by a licensed roofing contractor

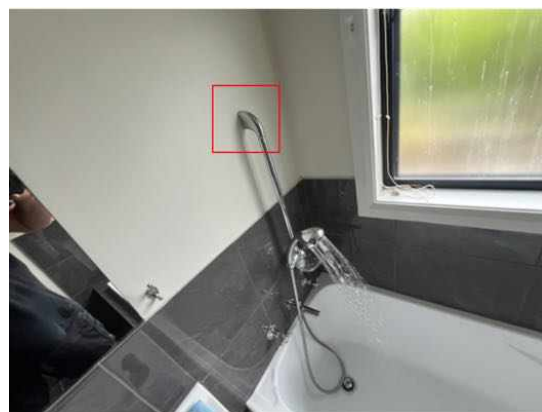
Finding 3.22

Building:	Main Building
Location:	Ensuite, Bathroom
Finding:	Fitting or fixture - Loose
Information:	The fitting in this area is loose and requires adjustment to tighten.

A relevant tradesperson should be appointed to perform these rectification works at discretion of the client.

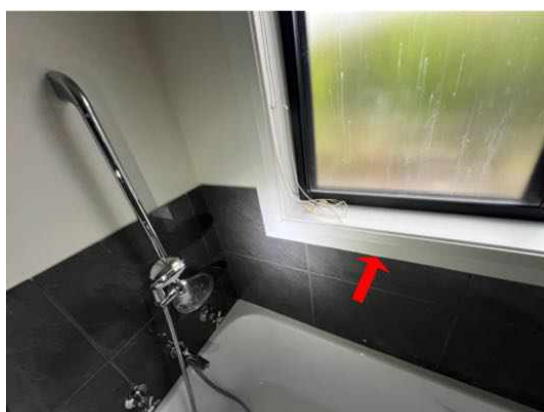
Finding 3.23

Building:	Main Building
Location:	Ensuite, Bathroom
Finding:	Paint - Flaking
Information:	Flaking paint was identified at the time of inspection. This defect is commonly caused by moisture ingress, poor surface preparation, or the natural ageing and deterioration of paint over time.

It is recommended that a qualified painter be engaged to prepare and repaint the affected area to ensure proper adhesion and a durable finish. Investigation into potential underlying causes, such as moisture issues, should also be considered to prevent recurrence.

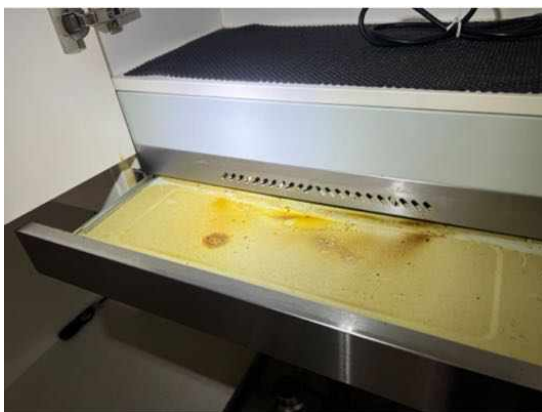
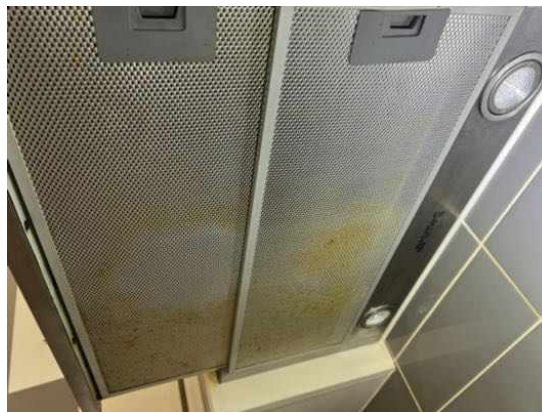
Finding 3.27

Building:	Main Building
Location:	Kitchen
Finding:	Surface - Requires cleaning
Information:	Regular cleaning and maintenance improves the longevity of all building elements. A build up of dirt and debris can reduce the useful life of building materials and may result in earlier replacement of items being required.

Remedial cleaning is recommended in order to improve the appearance of this area as well as to counteract the development of bacteria. Such works can be performed by a cleaning contractor and should be completed at the discretion of the client.

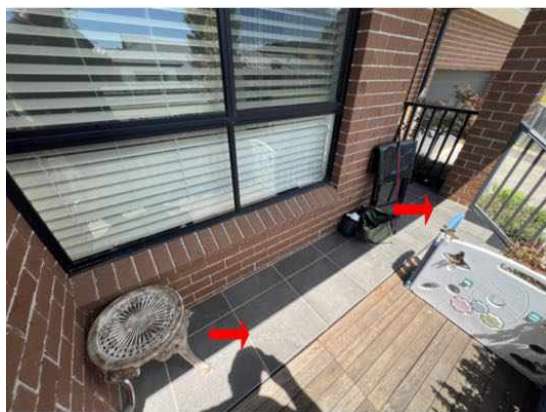
Finding 6.04

Building:	Main Building
Location:	External - Garage
Finding:	Bridging of termite barrier
Information:	Bridging of termite barriers occurs when termites bridge (usually by building a mud tunnel) a termite barrier or inspection zone or where termites have a passage allowing them to bridge the barrier.

The client should consider obtaining further advice from a timber pest technician regarding treatments required in this area. It is recommended that obtaining such advice be a short-term priority.
