Building and Timber Pest Inspection Report

Inspection Date: Mon, 12 Jan 2026

Property Address: 5 Skye Ct, Kellyville NSW 2155, Australia

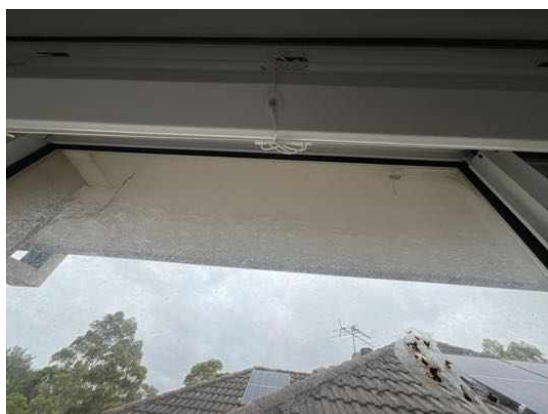
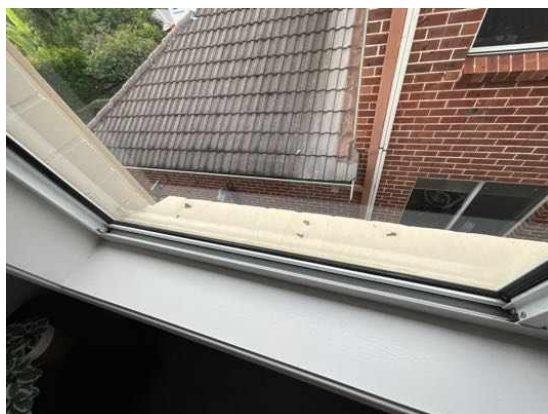
Finding 1.02

Building:	Main Building
Location:	All Areas
Finding:	Window child lock missing
Information:	The window in question lacks a child lock mechanism, which poses a potential safety risk to young occupants in the premises. As per Australian Standards windows accessible to children should be equipped with appropriate child safety locks to prevent accidental opening, reducing the risk of falls and ensuring compliance with safety regulations.

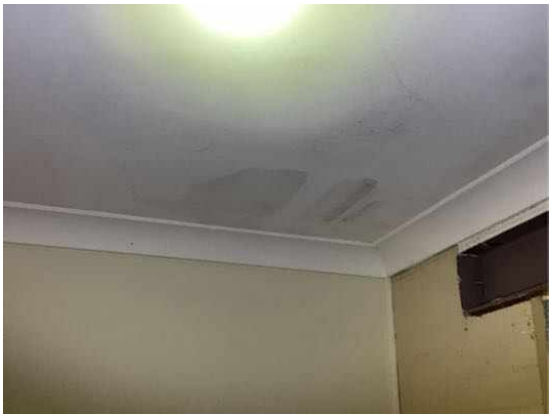
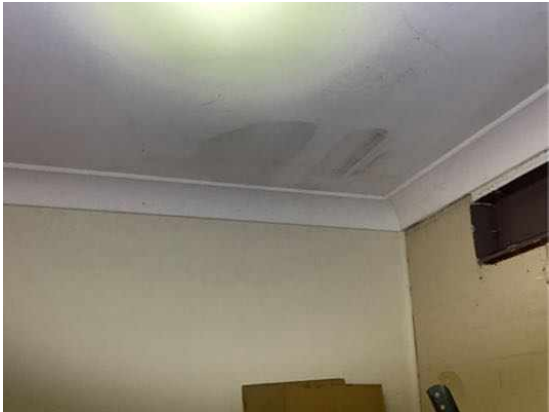
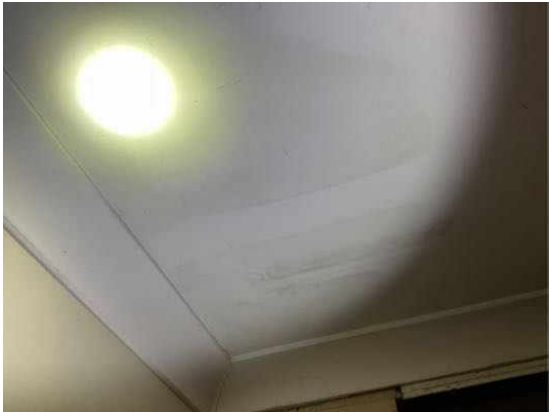
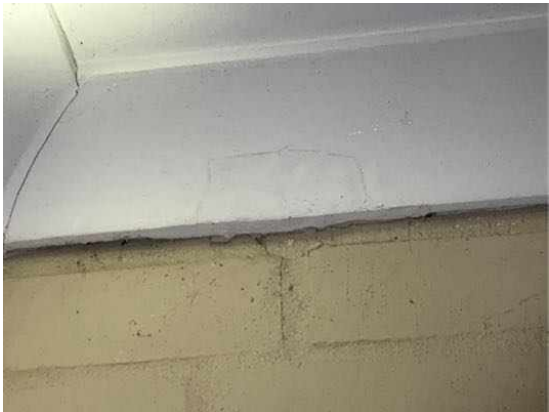
Finding 2.01

Finding: Roof Leaks

Information: The roof has developed leaks, allowing water to penetrate the building envelope. These leaks may be due to damaged or missing shingles/tiles, deteriorated flashing, clogged gutters, or other roof system failures.

A licensed roofing contractor or qualified roofer should be contacted to inspect and repair the roof leaks. They will:

- Identify the source of the leaks and assess the extent of the damage.
- Repair or replace damaged shingles, tiles, flashing, or other roofing materials.
- Ensure proper sealing around roof penetrations, such as vents, chimneys, and skylights.
- Clean and maintain gutters and downspouts to ensure proper drainage.
- Provide recommendations for any additional necessary repairs or preventive measures to avoid future leaks.

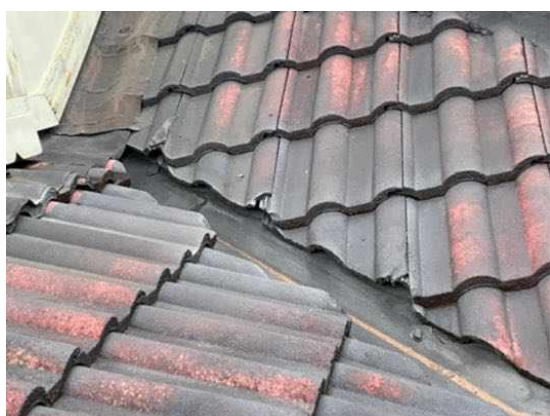
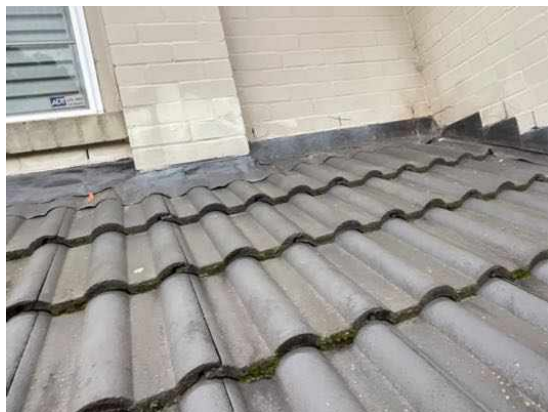
Building:	Main Building
Location:	All Areas
Finding:	Roof Weathered
Information:	Upon inspection of the exterior roofing, the majority of roof was not in a fair condition. While weathering of the roof is consistent with the age of the property, maintenance works are required.

Isolated areas of mortar have come loose in the valleys and minor cracking is also present. Re-pointing and re-sealing the may be considered as an interim solution by the client to help preserve and extend the life span of the tiles.

Where left unmanaged, deteriorating roof are likely to lead to a number of secondary defects, including minor water leaks and weather exposure to internal roofing structures.

Consultation with a roofing contractor is highly advised to gain advice on cost of remedial works that may be required in the short to medium term. Remedial works are likely to increase the longevity of the exterior roofing structure.

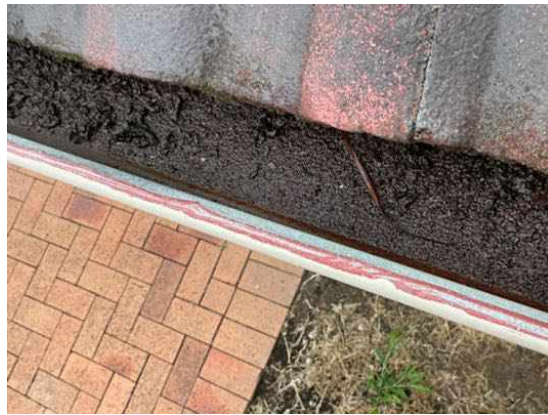
Finding 3.02

Building:	Main Building
Location:	All Areas
Finding:	Blocked gutters - organic debris
Information:	The roof gutter system was observed to be blocked with organic debris and moss growth, as evident in the provided images.

- Water ingress into the eaves or walls,
- Timber rot or deterioration of fascia and soffits,
- Accelerated moss and algae growth, promoting further blockages,
- Potential foundation issues if water pools near the base of the structure.

A licensed roofing contractor or qualified gutter cleaning service should be engaged to remove the debris and inspect the system for any further issues.

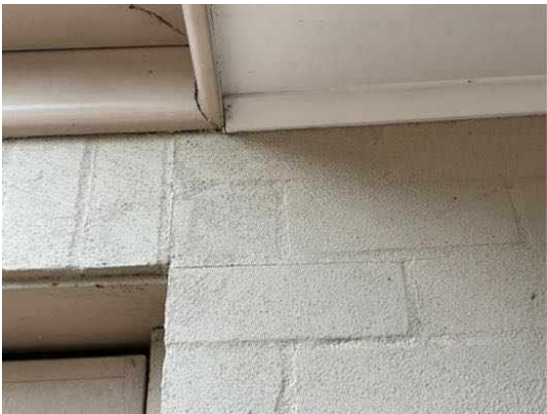
Finding: Brickwork - Cracking [Fine]

Information: Although fine cracks are quite noticeable, they are often only considered to be an appearance defect and usually do not indicate any structural damage. Generally, the cause of a fine crack is indicative of a separation between brickwork and mortar throughout the structure, but single bricks may also show cracks of this nature.

Cracking of this nature can generally be repaired with minor filling and should be conducted by a qualified bricklayer.

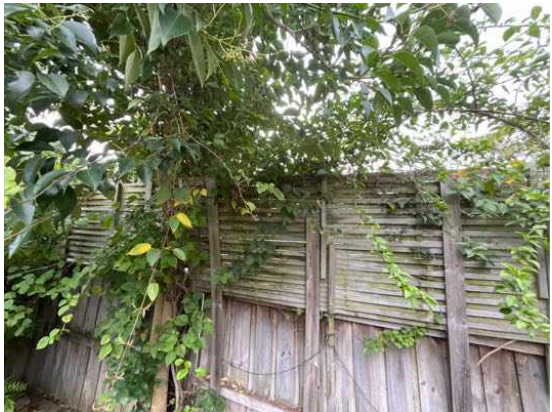
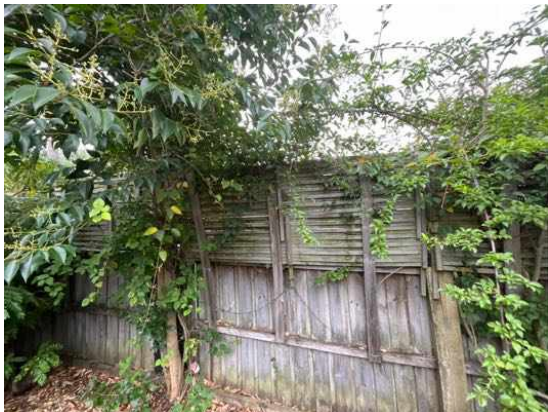
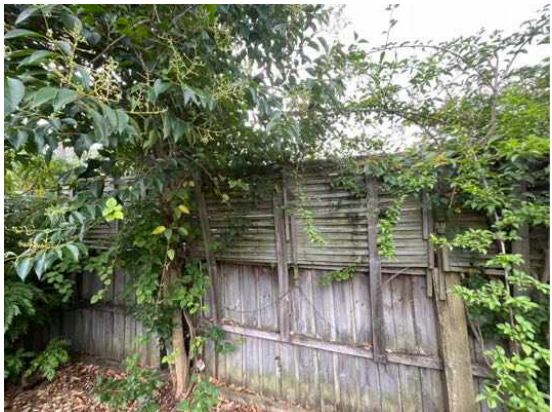
The leaning fence poses a risk of collapse, potential property damage, and a security breach, diminishing its effectiveness as a barrier.

A skilled fencing contractor or handyman is needed to assess and rectify the leaning fence. Timely repair is crucial to restore the fence's stability and prevent further damage or safety hazards.

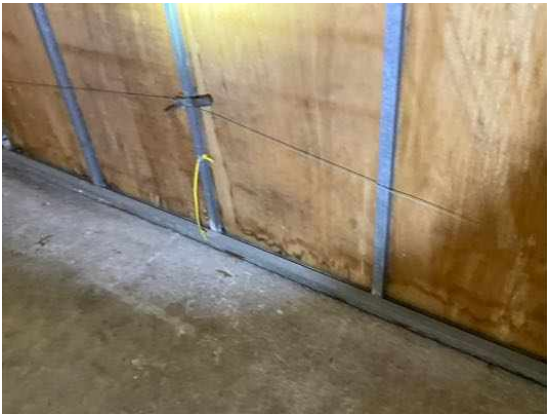
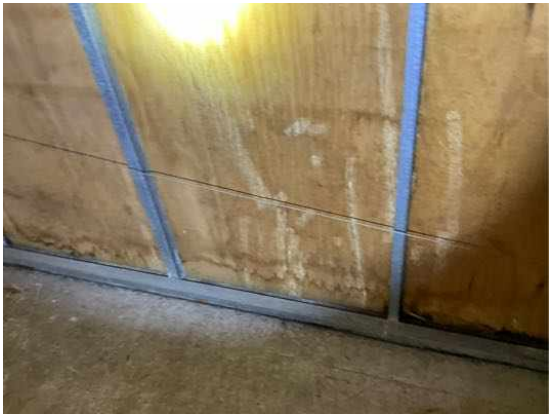
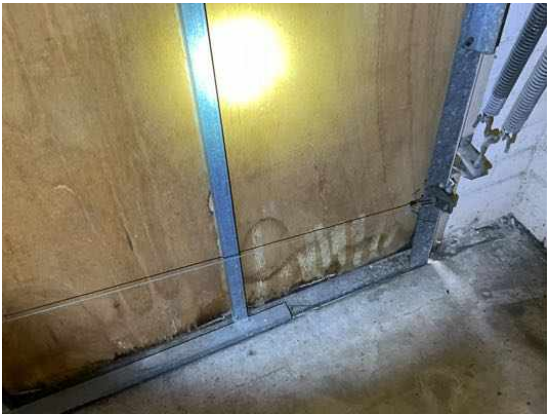
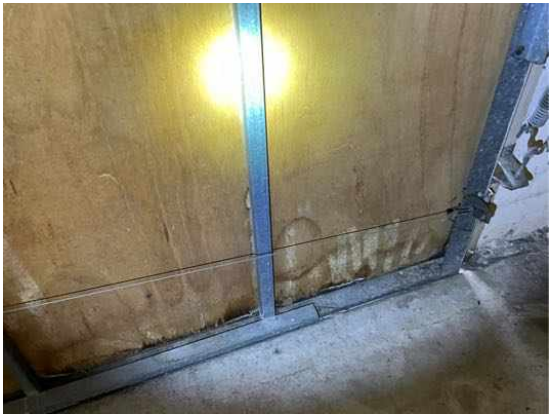
Building: Main Building
Location: Garage
Finding: Water staining
Information: Water staining was evident in this area at the time of inspection. Water staining indicates that surfaces have been exposed to excessive moisture over time. The minerals and other elements in the water lead to staining, which may graduate to corrosion and deterioration if left unmanaged.

While mostly an appearance defect, water staining can be indicative of more serious defects, which may be currently concealed by other building elements.

Where water staining is active, a licensed plumber must be consulted to identify the cause of the staining and to provide advice on any reparation works that may be required. Replacement of any broken or damaged structures is advised.

Conversely, where water staining is old and inactive, affected building materials may be repaired or replaced at client discretion. A qualified carpenter or registered builder may be appointed to perform these works.

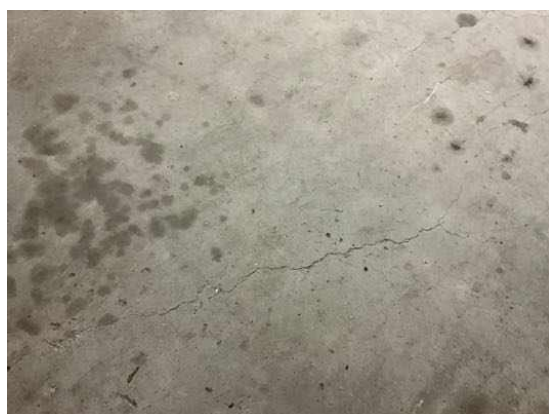
Finding 3.11

Building: Main Building
Location: Garage

Finding: Crack in concrete slab - Category 0
 Information: A crack coded as Category 0 was identified in the slab. A Category 0 crack is described as a hairline crack, representing insignificant movement of slab from level.

The approximate width of the crack to be considered Category 0 is 0.3mm, or change in offset of less than 8mm when a 3m straight edge is placed over the defect.

No rectification is required at this time. However, all cracking should be monitored over a 12 month period to identify any further damage in the area.

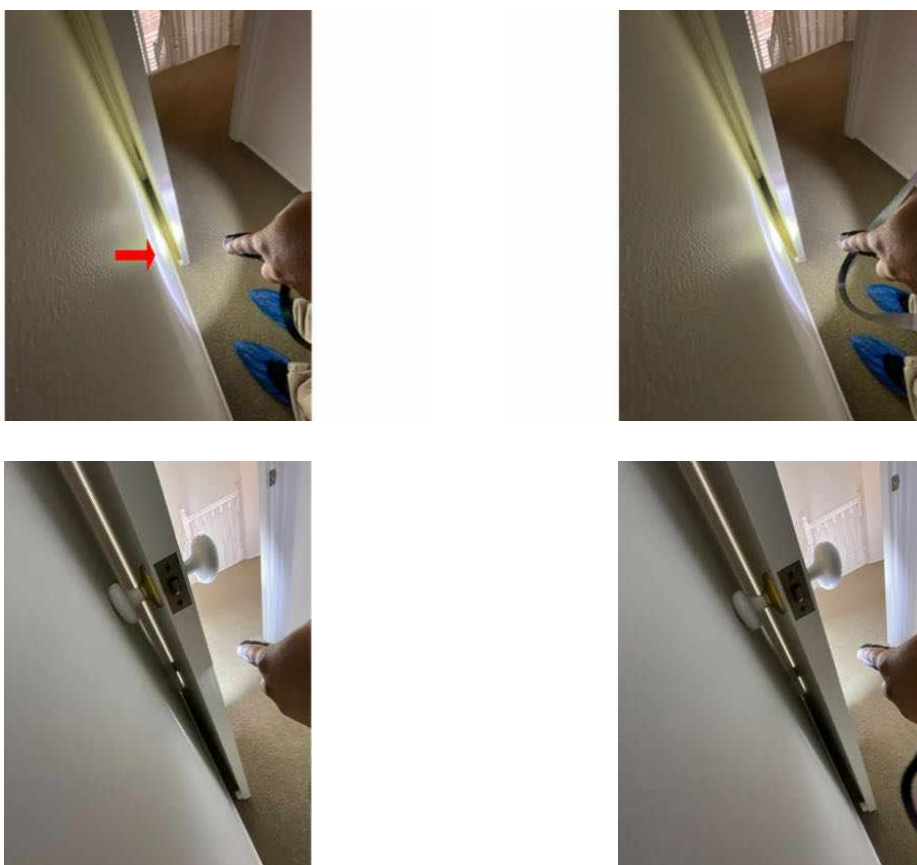
Finding 3.12

Building: Main Building
 Location: Bedroom
 Finding: Missing Door Stopper
 Information: The door lacks a stopper, which is essential to prevent the door from swinging too far and potentially damaging the wall or the door handle. The absence of a door stopper increases the likelihood of impact damage to both the door and surrounding surfaces over time.

- Damage Risk: Moderate risk of damage to the door handle, wall, or door itself from repeated impacts when the door is opened forcefully or by a gust of wind.

- **Wear and Tear Risk:** Increased wear on door hardware and hinges due to the potential for abrupt stops without a dedicated stopper.

- **Engage a Handyperson or Carpenter:** A handyperson or carpenter should install a suitable door stopper to prevent excessive door movement. This could be a floor-mounted or wall-mounted stopper depending on the space and door design.

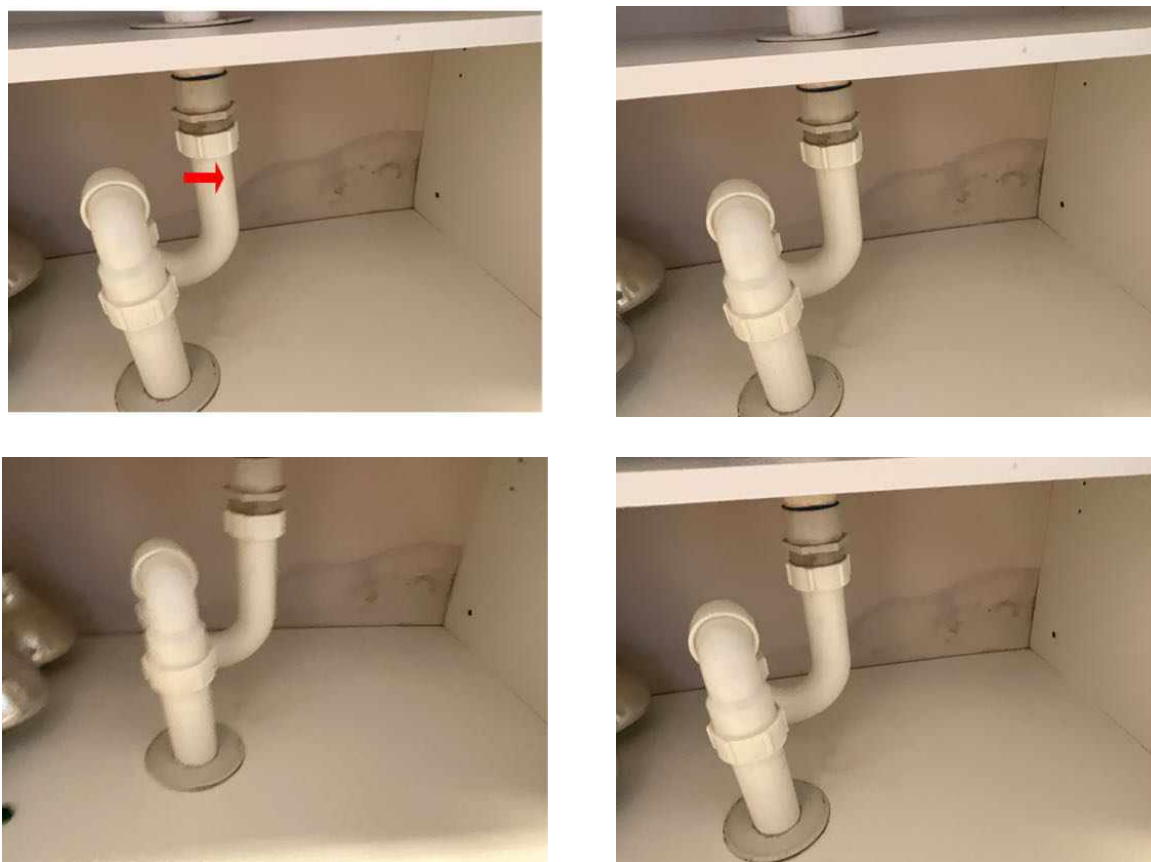
Finding 3.13

Building:	Main Building
Location:	Ensuite
Finding:	Water Stains in Vanity
Information:	“Water stains observed in the vanity area, compromising its appearance and potentially causing damage.”

Continued water exposure may lead to material damage, mold growth, and diminished aesthetic appeal.

A licensed plumber or maintenance professional should assess and fix any leaks

contributing to the water stains, while a cleaning or restoration service may be needed to address the visible stains and prevent further damage.

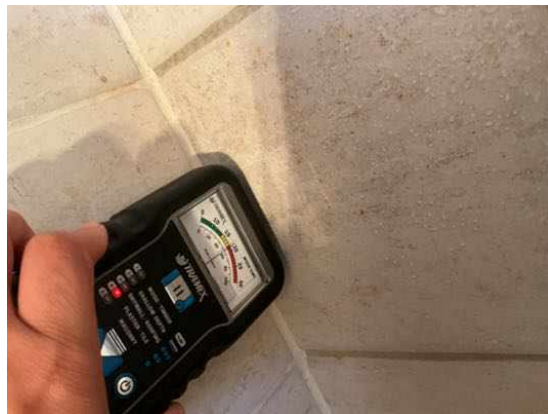
Finding 3.14

Building:	Main Building
Location:	Ensuite
Finding:	Shower - Damp
Information:	Damp is evident to the lower 300mm of wall to the shower alcove. This defect is quite common, and is suspected to have been caused by moisture permeating through the grouting in this area, which shows evidence of deterioration. Leaking pipes within the adjoining wall is also a possible cause.

Consultation with a qualified plumber or bathroom specialist is advised immediately to identify the cause of damp and to perform remedial works as required. Where excessive mould growth is present, further inspection by a specialist environmental health inspector should also be considered.

Always ensure that sealant and grout is in good condition to prevent any moisture issues occurring in the future.

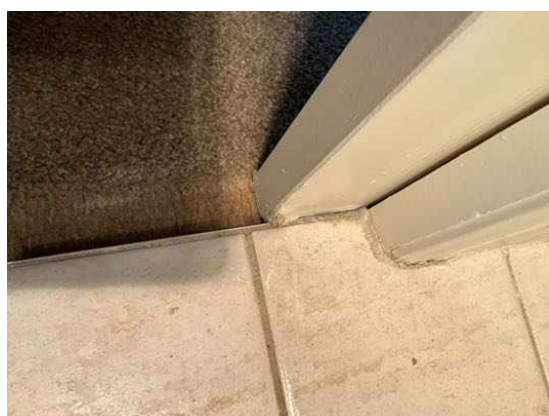
Finding 3.15

Building:	Main Building
Location:	Ensuite
Finding:	Water damage
Information:	The door in the shower area has sustained water damage, resulting in swelling and discoloration of the wood, as well as potential structural issues. This damage compromises both the aesthetic and functional aspects of the vanity."

1. **Carpenter or Woodworker:** They can assess and repair the damage to the vanity, potentially replacing any irreparable parts.
2. **Plumber:** If the water damage is due to plumbing issues, a plumber can fix leaks and ensure there are no further water-related problems.
3. **General Contractor:** If the damage is extensive and affects the surrounding area, a general contractor can coordinate the repair work, including both the vanity and any related structural or cosmetic repairs.

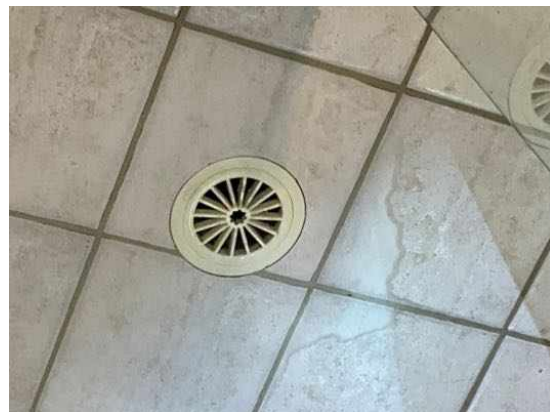
Finding 3.16

Building:	Main Building
Location:	Ensuite
Finding:	Shower base - Water pooling
Information:	Evidence of water pooling around the floor waste in the shower recess was noticed at the time of inspection. It is suspected that this excessive moisture is attributed to insufficient fall in the shower floor tiles.

This pooling is minor overall but is still considered unsatisfactory, as standard tiling practices would not permit this situation to occur. Pooling water around floor wastes can create a slip hazard in extreme cases and create conditions that are conducive to mould growth over time. Where left unmanaged, the degradation of sealant and grouting is also likely to occur, possibly necessitating further repair works.

Remedial works may involve some sections of tiling and flooring repair and replacement. A tiling contractor or bathroom specialist should be appointed to provide further advice on reparation options and to perform works as necessary.

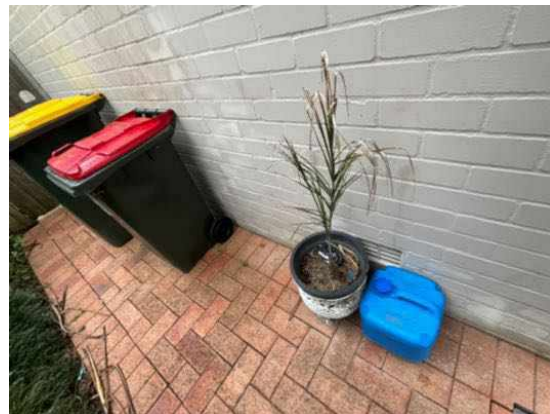
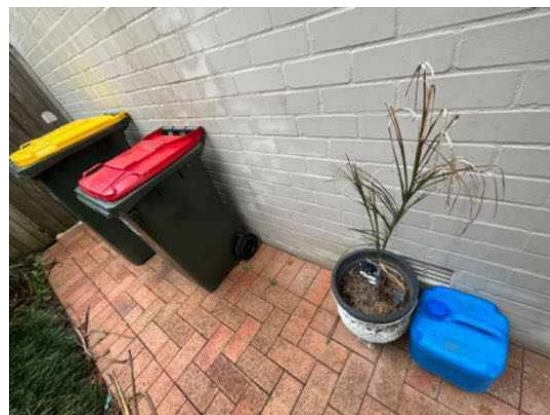
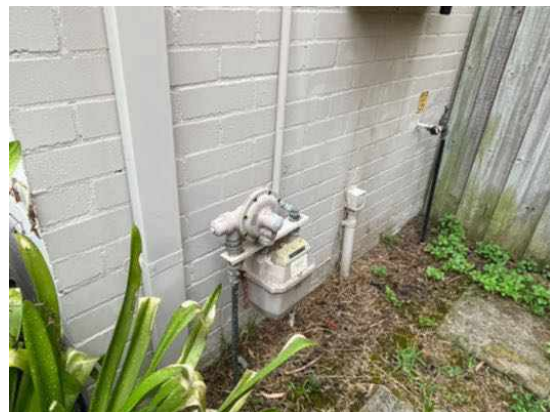
Finding 3.17

If the slab edge is not properly exposed there is a high risk of termite attack. Sometimes, in order to determine the type of slab, a suitably qualified person such as an architect or builder may be required to consult the construction plans.

Where the slab edge cannot be properly inspected, it is highly recommended that termite or timber pest inspections be carried out every 6-12 months to aid protection of the property against infestation.

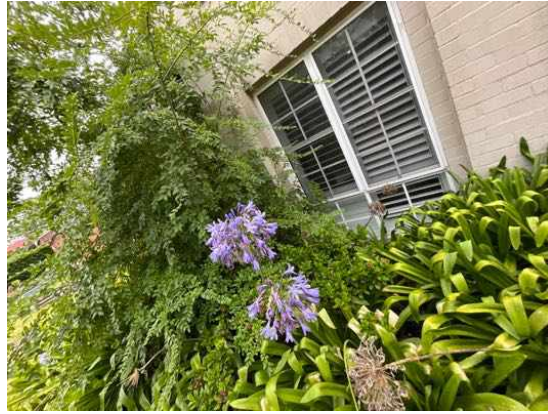
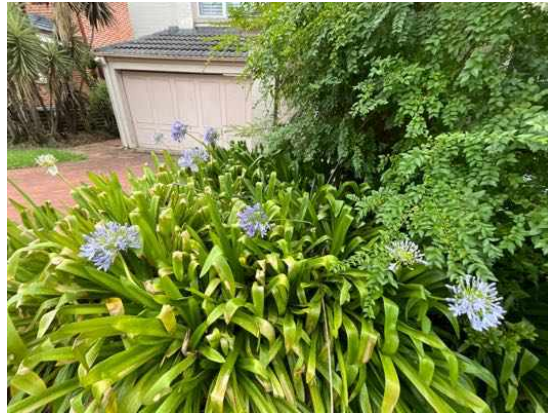
Information: The presence of dense vegetation around a property can increase the risk of termite infestation, as it provides a conducive environment for them. To address this, consider maintaining a clear space between the vegetation and your home. If you suspect a termite issue, it's advisable to consult with a licensed pest control professional for inspection and treatment.

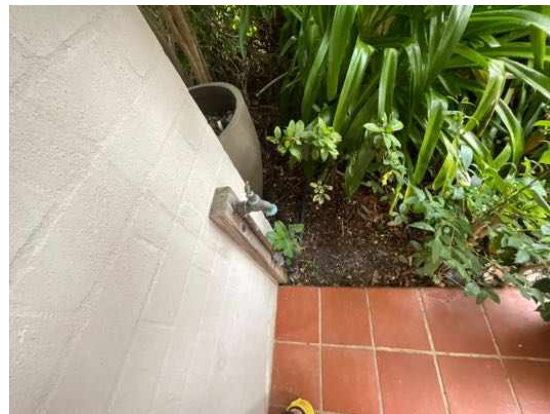
Finding 6.05

Building:	Main Building
Location:	All Areas
Finding:	No Drain under tap
Information:	There is no drain installed under the tap, leading to water accumulation and creating conducive conditions for timber pests. This defect needs immediate attention to prevent potential damage and pest infestation.

3. Repair and Prevention: Inspecting and repairing any existing water damage and implementing measures to prevent future water accumulation and pest infestations.

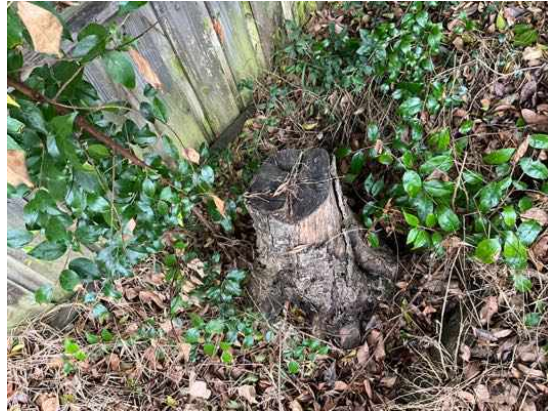
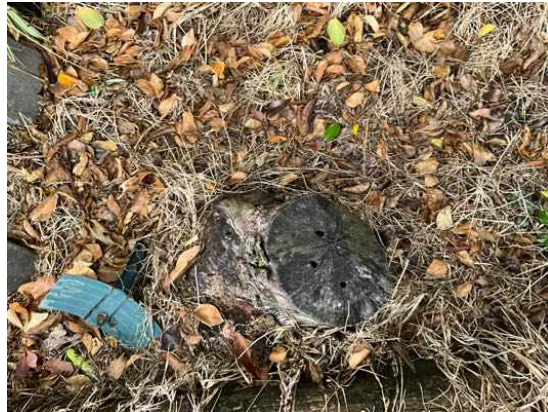
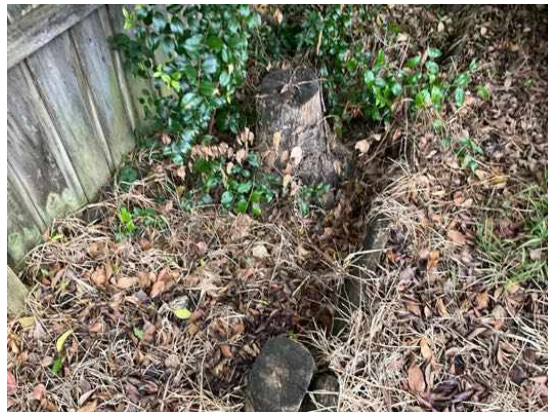
Finding 6.06

Building:	Main Building
Location:	All Areas
Finding:	Cut and Exposed tree Stumps
Information:	The tree stump, which has been cut and exposed, poses a potential risk of termite infestation due to its increased vulnerability to termite attacks.

Please contact Licenced pest controller for further advice. Pictures attached for your reference.

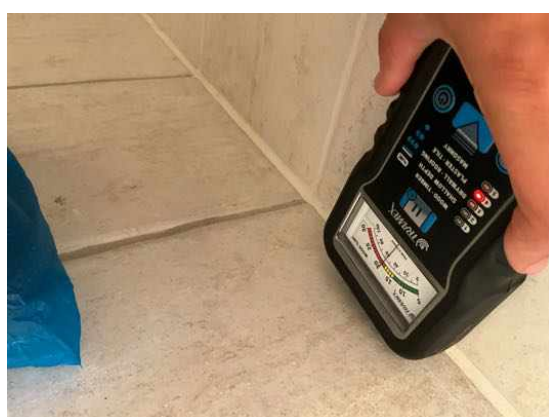
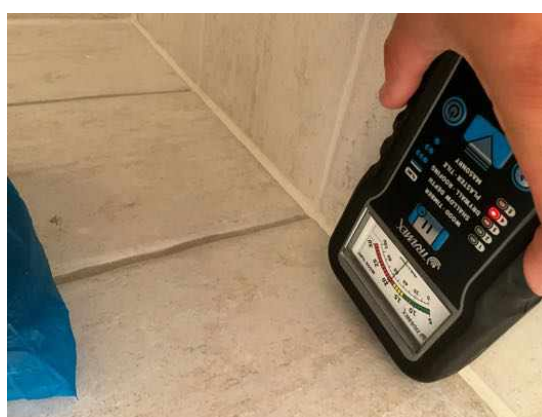
Finding 6.07

Building:	Main Building
Location:	Ensuite
Finding:	Excessive moisture - Conducive to Timber pest
Information:	Excessive moisture can attract termites and produce conditions that promote fungal growth and wood decay.

Prior to any remedial works being performed a qualified plumber should be appointed to further inspect the property and to identify the cause of the excessive moisture. Works to remove affected building elements may then be necessary and should be performed by an appropriate tradesperson.

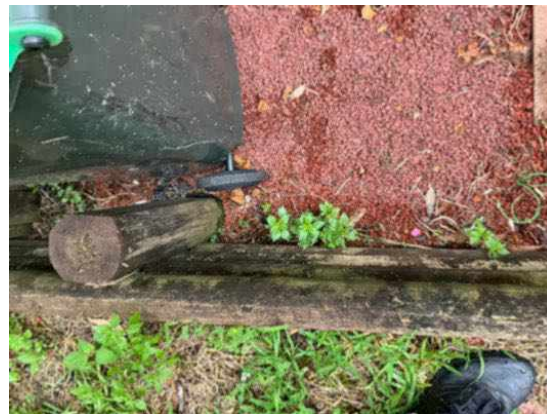
Finding 7.01

Early intervention and regular maintenance, particularly of exterior timbers, will prolong the useful life of these building elements. Prior to any works being performed, the cause of the moisture that has created the visible wood rot should be identified and addressed in a suitable manner. Replacement of affected timbers may then be a necessary step in protecting surrounding building elements from such deterioration.

A qualified plumber may be appointed to assess the cause of excessive moisture and to provide advice on any remedial works as required. A qualified carpenter or registered builder may also be required to replace affected building materials.
