Building and Timber Pest Inspection Report

Inspection Date: Fri, 27 Feb 2026

Property Address: 32 Hedley St, Riverwood NSW 2210,
Australia

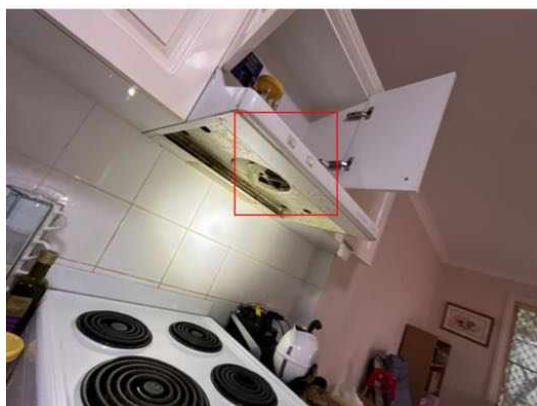
The National Construction Codes 2022 (NCC) Volume Two, Clause 10.7.4

- Requires that exhaust from a kitchen, bathroom, laundry, or toilet must be discharged to outdoor air or to a space with adequate natural ventilation (like an open verandah).
- Discharging into a roof space, ceiling void, or wall cavity is not permitted unless that space itself is ventilated to the outside.
- If the kitchen has a recirculating rangehood with a charcoal filter (that cleans the air and blows it back into the room), this is allowed under the NCC.

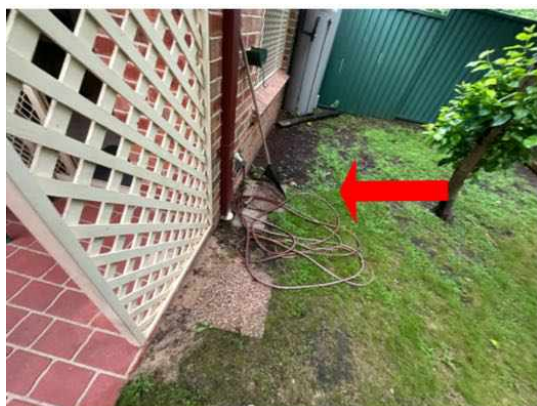
Building:	Main Building
Location:	Backyard
Finding:	Site drainage— Inadequate
Information:	The site drainage in this area was found to be inadequate at the time of inspection, creating potential for subsequent water damage to associated building elements. This is additionally conducive to termite activity.

It is important that water does not lie against the base of walls; surrounding paths and ground levels should be sloped to drain water away from walls. Downpipes should not discharge stormwater onto lower walls or plinths. Stormwater should be carried away by large, regularly cleaned drains. Ground levels may need to be lowered to expose a buried DPC.

Where site drainage is inadequate, installation of an Agricultural (Aggie) Drain may be required. A licensed plumber should be appointed to further inspect the property and perform any remedial works as necessary. Water damage and secondary defects are likely to occur if left unmanaged.

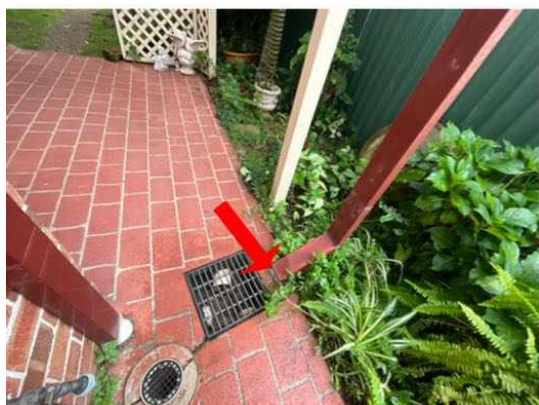
Building: Main Building
 Location: Multiple areas of roof plumbing
 Finding: Water leak - External
 Information: Water leaks were found to be present to exterior plumbing work. Leaks are generally caused by deterioration of the plumbing elements over time, due to exposure to weather conditions, but may have also been caused by minor impact damage.

Such leaking creates damp conditions in the affected area, causing potential for water pooling and subsequent water damage if left unattended. These conditions may also attract termite attack, particularly if the area is subject to minimal levels of sun throughout daylight hours.

It is highly advised that a licensed plumber be appointed to rectify any water leaks that may be present. Areas of repair and replacement of plumbing fittings and fixtures may be required and, as such, a quotation should be sought.

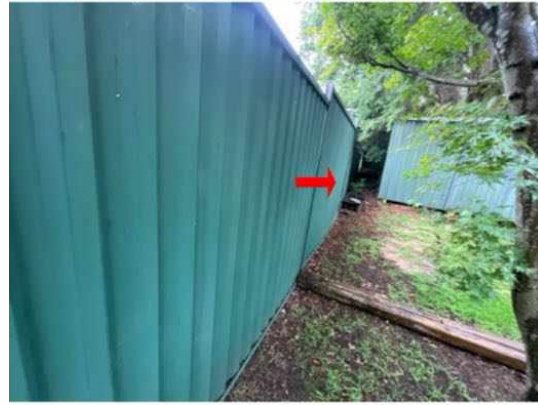
Finding: Fencing - Deteriorated

Information: It was noted at the time of inspection that sections of the fencing in this area has deteriorated. Typically fencing deteriorates due to age and or wear, rot and or rust which is generally expected for a structure of this age, due to prolonged exposure to weather conditions. Sometimes inadequate installation or maintenance can be to blame.

If left unattended, it is likely that further damage will occur. It is suspected that repair of several elements of the fencing may be required however replacement may be a consideration of the client also.

A licensed fencing contractor should be appointed to provide further advice and perform rectification works as necessary.

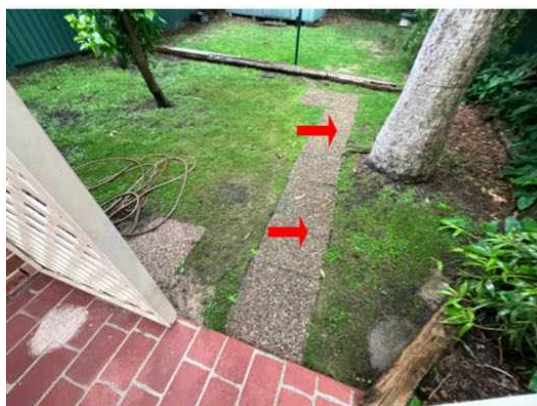
Building: Main Building
 Location: Backyard
 Finding: Paving — Uneven
 Information:

Sections of the external paved area are uneven, which may develop into a trip hazard. It appears as though the area has been subject to rough installation, or that paving sections have lifted due to movements in the foundation.

Left unmanaged, the May develop into a safety hazard due to trip and fall.

Re-paving of the area is required to remedy this situation. Further consultation with a specialist concreter is advised.

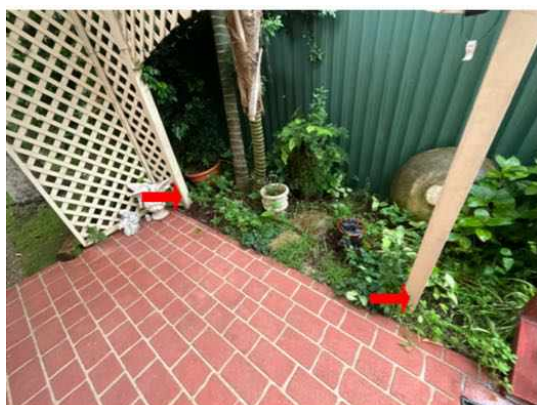
Building:	Main Building
Location:	Yard
Finding:	Untreated or non-durable timbers in a hazardous environment
Information:	To reduce the risk of timber pest attack it is essential that timber used in a hazardous environment (e.g. in direct contact with the ground or frequently exposed to damp conditions) is of sufficient durability and/or is adequately preservative treated.

Untreated timbers in direct contact with the ground are likely to develop severe wood rot and/or fungal decay if left unattended creating attraction for subterranean termites to infest the timbers from surrounding areas.

If untreated or non-durable timbers are found to be in a hazardous environment it is highly advised that replacement of these building elements be performed as soon as possible to aid the protection of the property against termite / timber pest attack.

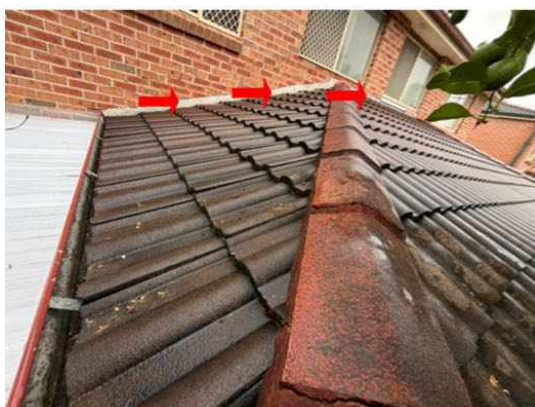
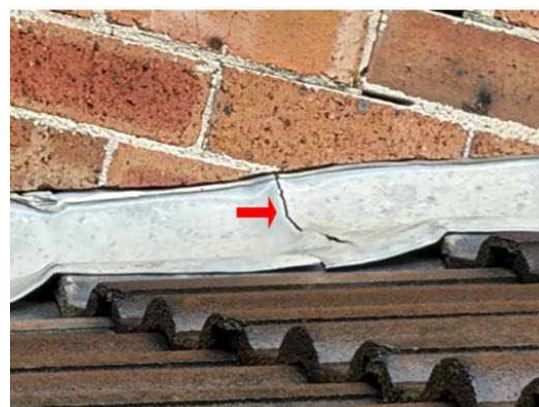
Building:	Main Building
Location:	Flashing
Finding:	Roof plumbing - Flashing cracked
Information:	Water leaks generally occur when a particular area of the property is not weather or water tight. Cracks were evident to the roof flashing in this area at the time of inspection.

Regardless of the location, if left unmanaged, even minor leaks can lead to serious damage of associated building elements, potentially resulting in the need for replacement of building materials. Damage to ceilings, wood rot, mould and other hazards, such as electrical hazards, may also arise if left unmanaged.

Further inspection and repair by a roof specialist or a licensed roof plumber is advised to adequately rectify the potential leak.

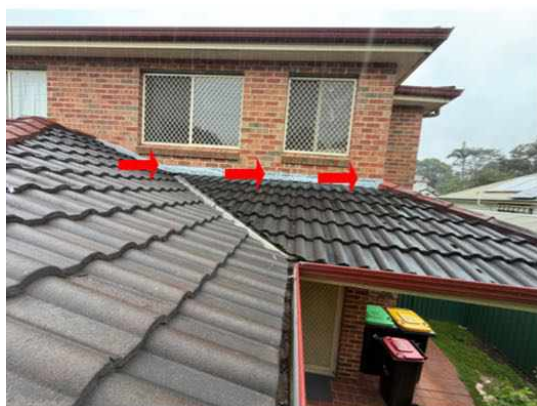
Building: Main Building
 Location: Roof Exterior
 Finding: Roof tiles - Weathered
 Information:

Upon inspection of the exterior roofing, the majority of roof tiles were considered to be in a fair condition. While weathering of the tiles is consistent with the age of the property, maintenance works are required.

Isolated areas of mortar have come loose and minor cracking is also present. Re-pointing and re-sealing the may be considered as an interim solution by the client to help preserve and extend the life span of the tiles.

Where left unmanaged, deteriorating roof tiles are likely to lead to a number of secondary defects, including minor water leaks and weather exposure to internal roofing structures.

Consultation with a licensed roofing contractor is highly advised to gain advice on cost of remedial works that may be required in the short to medium term. Remedial works are likely to increase the longevity of the exterior roofing structure.

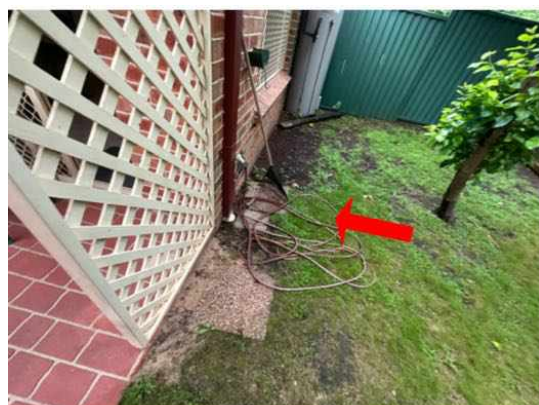
Building:	Main Building
Location:	Multiple areas of roof plumbing
Finding:	Water leak - External
Information:	Water leaks were found to be present to exterior plumbing work. Leaks are generally caused by deterioration of the plumbing elements over time, due to exposure to weather conditions, but may have also been caused by minor impact damage.

be required and, as such, a quotation should be sought.

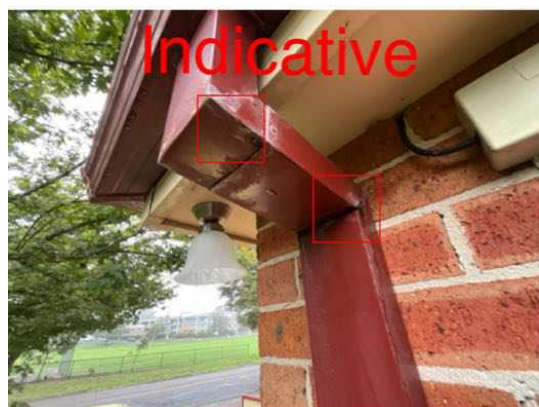
Building:	Main Building
Location:	Meterbox
Finding:	Termite Management System - no evidence of installation
Information:	The application of a post-construction chemical termite barrier is highly recommended for all properties, particularly if live termite activity has been found on the site previously. Such barriers are highly effective in preventing termite attack on any timber building elements throughout the property.

The client is highly recommended to retain a strata copy in relation to any active termite management systems, warranties and other details.

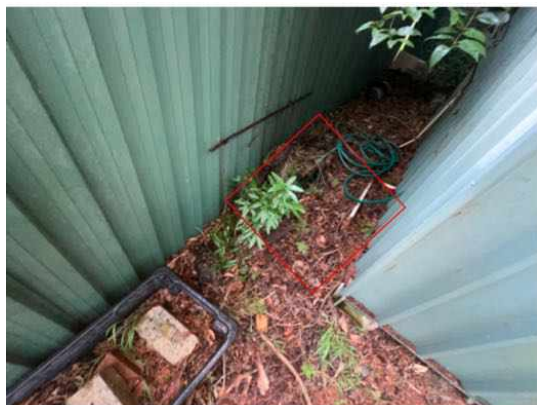
Building:	Main Building
Location:	
Finding:	Surrounding bushland - Conducive
Information:	Home and or building is situated in a high risk area for termite activity, due to close proximity to surrounding bushland.

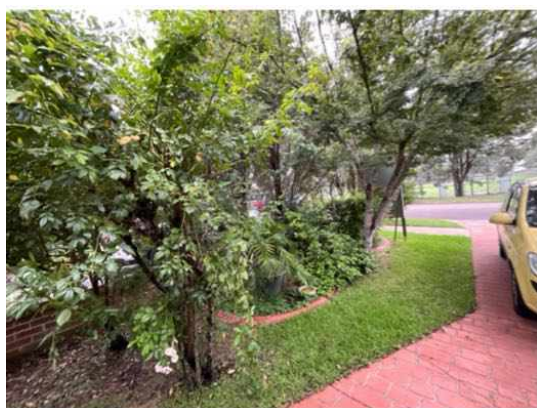
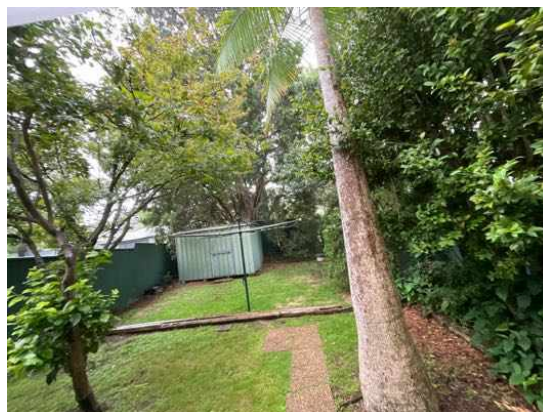
Building:	Main Building
Location:	Vegetation
Finding:	Vegetation - Abutting property
Information:	Vegetation against external wall may have an invasive root system. If there are weak points in the brick work or concrete slab, it is possible for the roots to gain entry into these areas. Once the roots have gained entry, it is possible for termites to gain concealed entry via these roots. It is recommended to remove the vegetation and root system where possible.

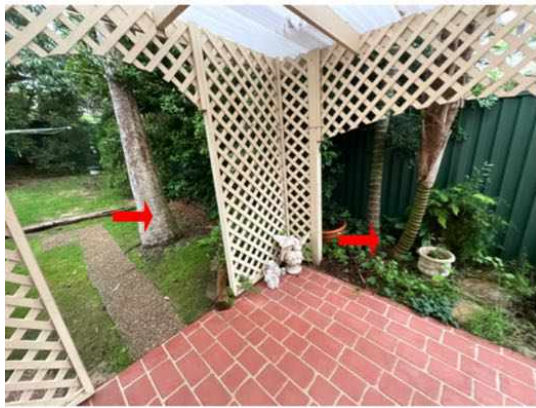
Building:	Main Building
Location:	Garden beds
Finding:	Garden Beds
Information:	Garden beds were found to be evident in the garden area. These garden beds can include untreated timber, and with a combination of moisture from watering hosing can make conditions conducive to termite activity and termite ingress.
