Building and Timber Pest Inspection Report

Inspection Date: Mon, 15 Dec 2025

Property Address: 16 Darley St, Marrickville NSW 2204,
Australia

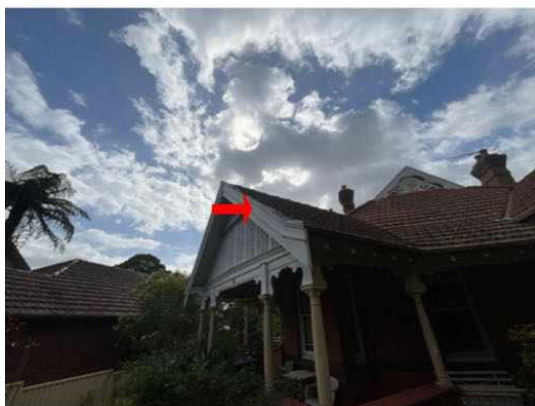
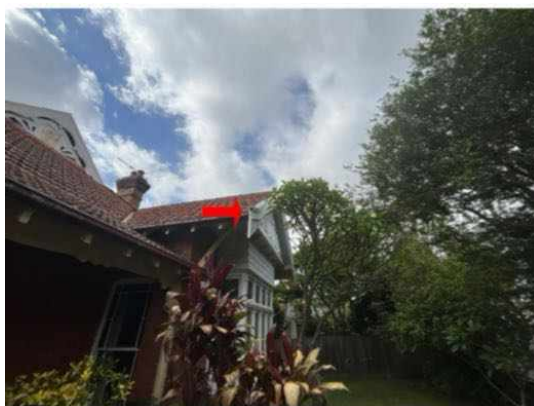
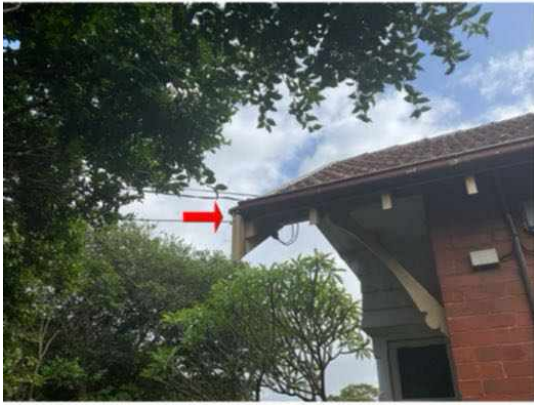
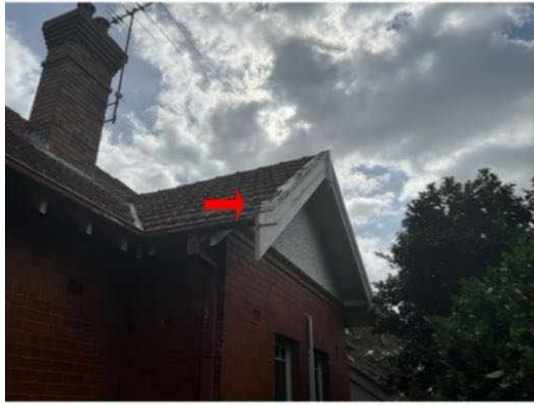
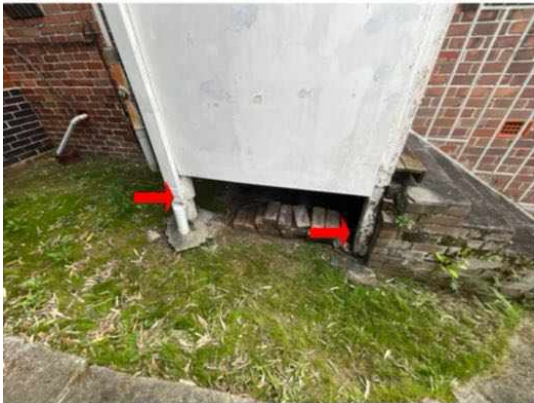
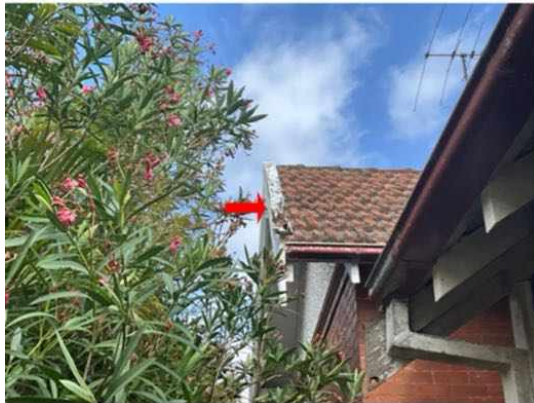
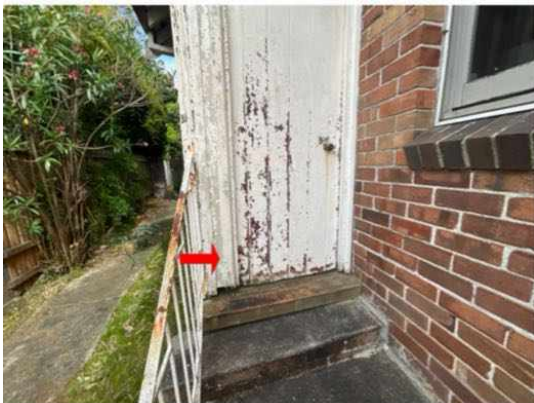
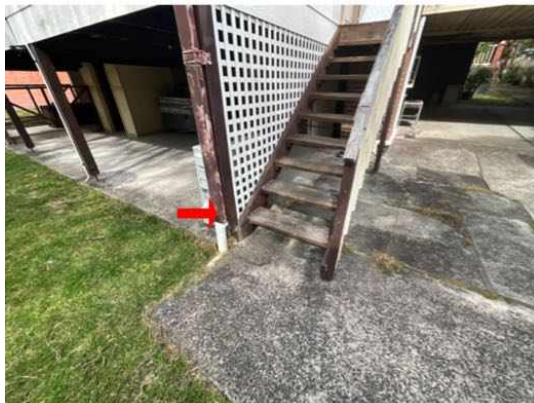
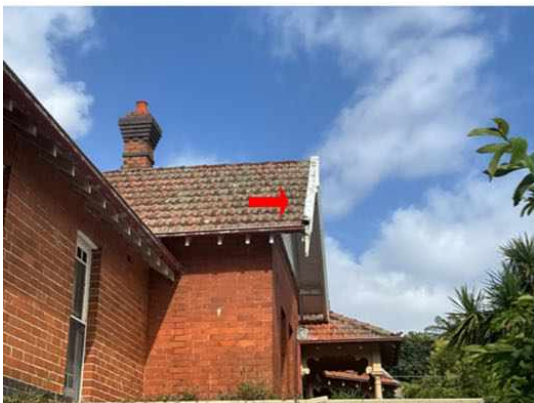
Building:	Main Building
Location:	External Areas
Finding:	Wood rot
Information:	This building element shows evidence of wood rot. Wood rot, also known as Fungal Decay, occurs when timbers and other cellulose building materials are exposed to damp conditions on an ongoing basis. This could be the result of exposure to weathering over a prolonged period of time, or the attraction of excessive moisture from other abutting building materials.

Early intervention and regular maintenance, particularly of exterior timbers, will prolong the useful life of these building elements. Prior to any works being performed, the cause of the moisture that has created the visible wood rot should be identified and addressed in a suitable manner. Replacement of affected timbers may then be a necessary step in protecting surrounding building elements from such deterioration.

A qualified carpenter or registered builder may also be required to replace affected building materials.

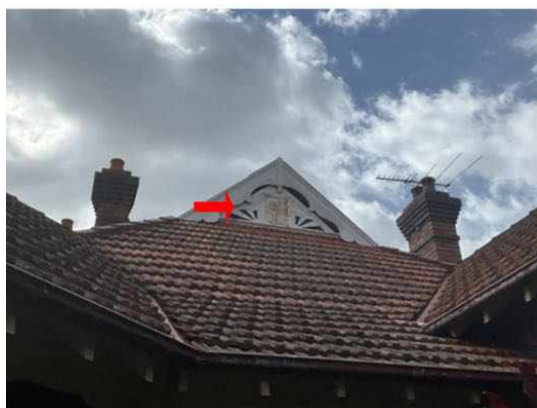
Finding 3.02

Building:	Main Building
Location:	Roof Exterior
Finding:	Building element - Rusted or corroded
Information:	This building element shows evidence of rusting and corrosion, which is likely to have developed as a result of excessive exposure to moisture and or inadequate coatings.

As surface rust provides no protection to the underlying iron, the deteriorating condition is likely to worsen if not addressed in the short-term future.

Where possible, the use of galvanized (treated) metals or aluminium coated metals aid in rust prevention, as does regular general maintenance. Rust formation can be controlled with coatings, such as paint, that isolate the iron from the environment.

Rusting and corrosion should be managed by ideally removing or limiting the affected surface from exposure to moisture.

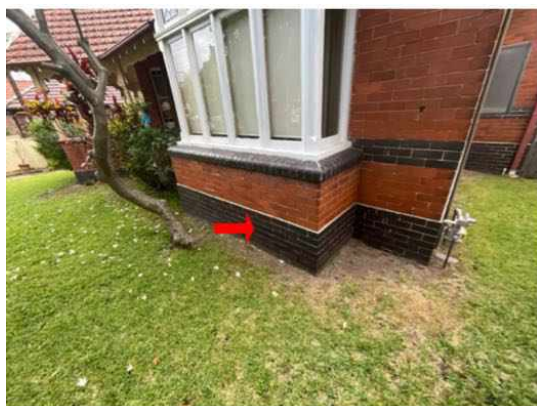
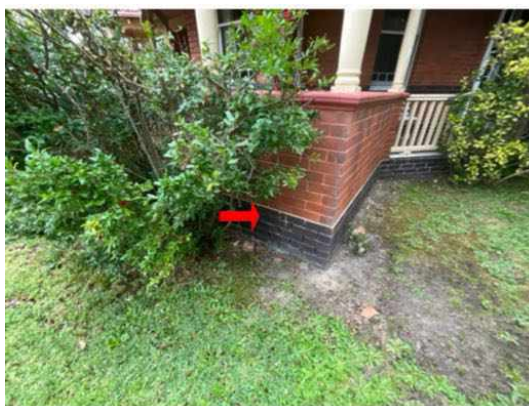
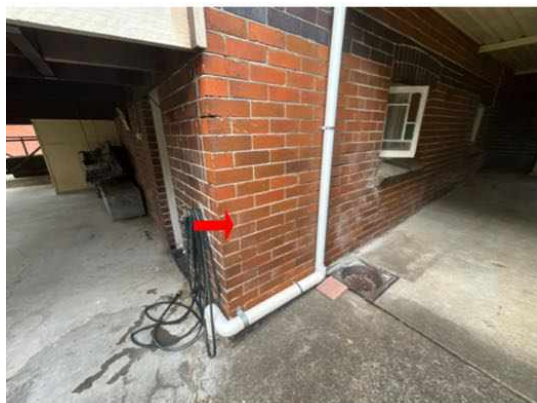
Finding 3.03

Building:	Main Building
Location:	Exterior walls
Finding:	Brickwork - Deteriorated mortar
Information:	Mortar, or 'bedding', is the material which fills joins and intersections between bricks in masonry walls and structures. Sections of mortar in this brickwork were identified as having deteriorated.

Mortar deterioration can be addressed by a bricklayer.

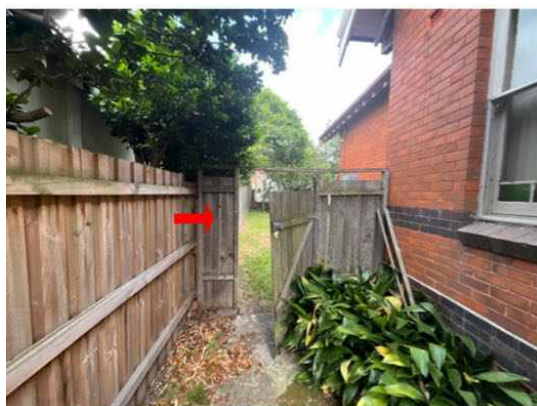
Finding 3.04

Building: Yard
 Location: Fencing
 Finding: Fencing - Deteriorated
 Information:

It was noted at the time of inspection that sections of the fencing throughout the property have deteriorated. Typically fencing deteriorates due to age and or wear, rot and or rust which is generally expected for a structure of this age, due to prolonged exposure to weather conditions. Sometimes inadequate installation or maintenance can be to blame.

If left unattended, it is likely that further damage will occur. It is suspected that repair of several elements of the fencing may be required however replacement may be a consideration of the client also.

A licensed fencing contractor should be appointed to provide further advice and perform rectification works as necessary.

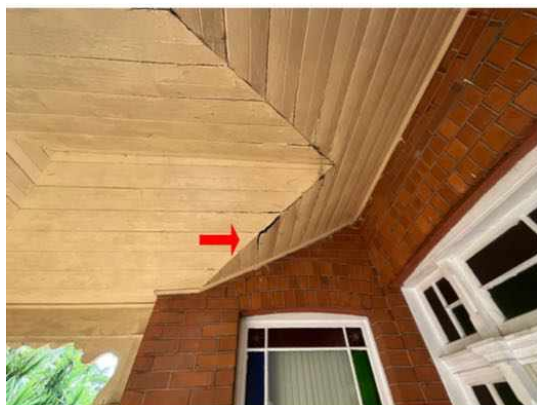
Finding 3.05

Building:	Main Building
Location:	Front Porch
Finding:	Nails - Popping
Information:	Popped nails were identified at the time of inspection. Nails and screws are held by the friction between them and the surface that they are applied to. Over time, the nails and screws can back out, which is often a result of general ageing and deterioration of the building structure.

Re-fastening of popped nails will help to maintain the stability of these, and associated, building elements. Such minor works will also help to improve the appearance of the affected area and secure the linings. These works should be performed by a qualified carpenter at client discretion.

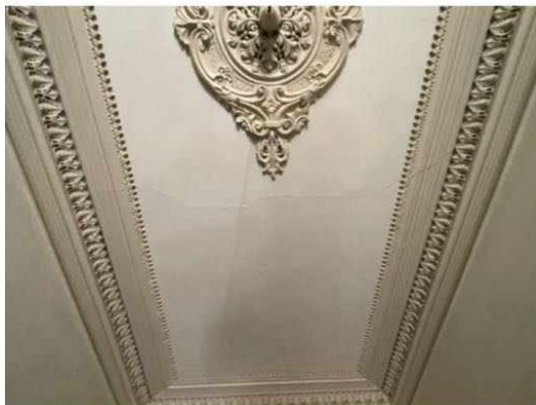
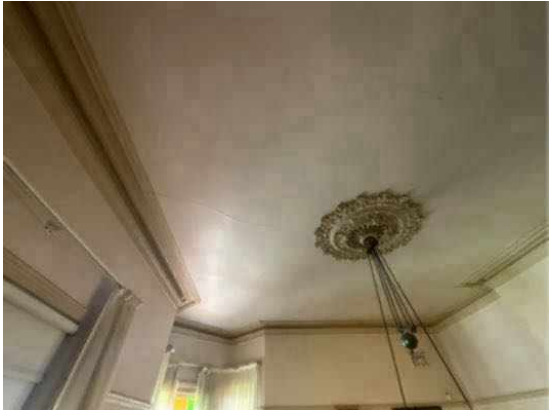
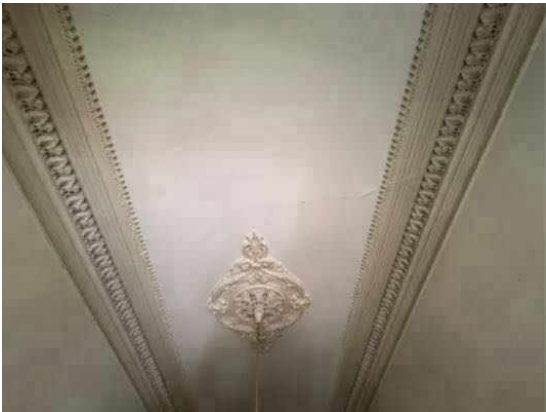
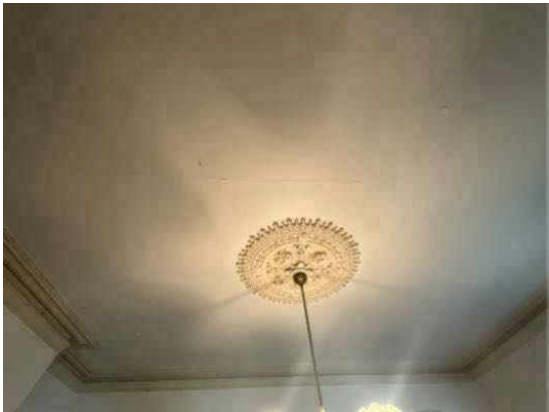
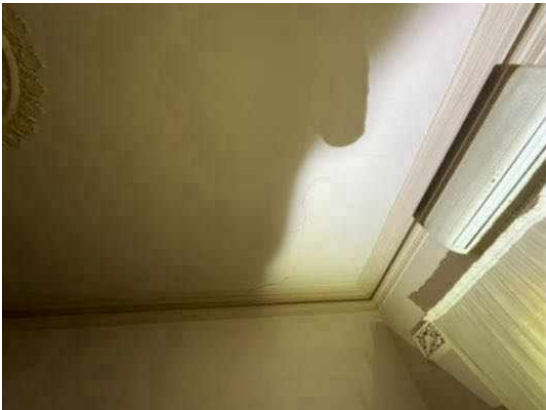
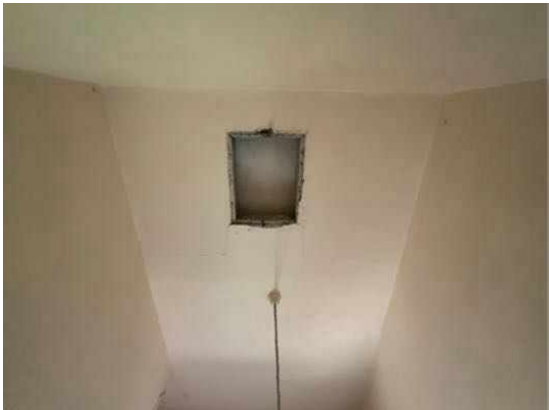
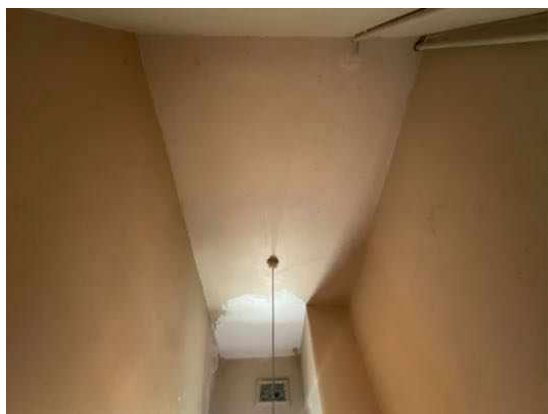
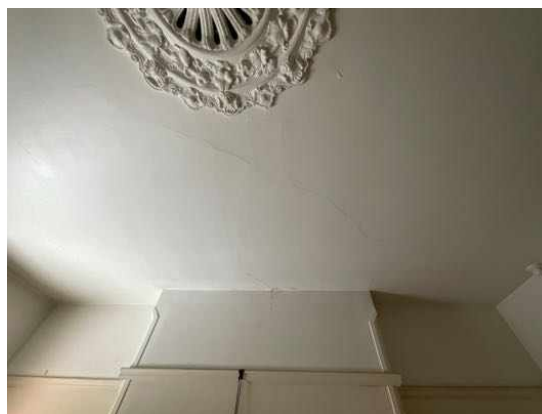
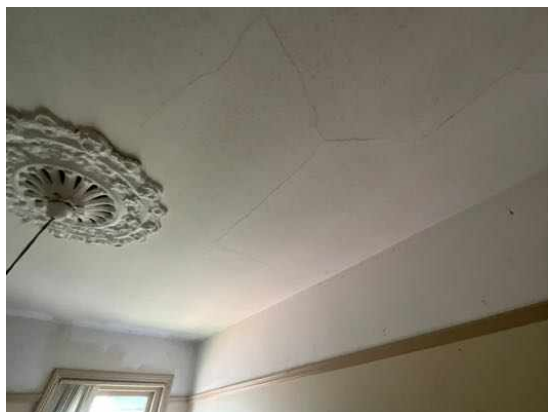
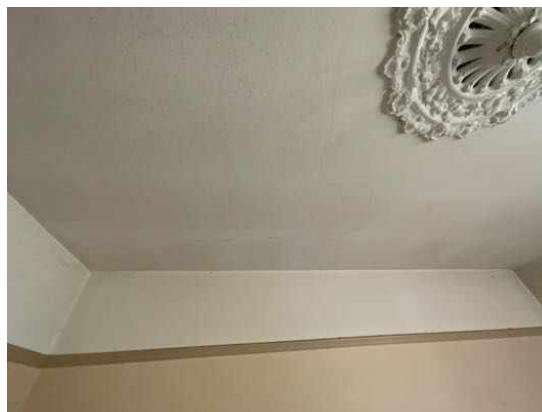
Finding 3.06

Building:	Main Building
Location:	Internal Areas
Finding:	Cracking - Damage Category 1 - Fine (up to 1mm)
Information:	Although fine cracks are quite noticeable, they are often only considered to be an appearance defect, and usually do not indicate any structural damage. Generally, the cause of a fine crack is indicative of a separation between building materials and

Cracking of this nature can generally be repaired with minor sanding, filling and/or repainting. Such works should be performed by a qualified painter or a general handyman.

Monitoring of all cracking should be conducted frequently. Always contact a building inspector should cracks widen, lengthen, or become more numerous.

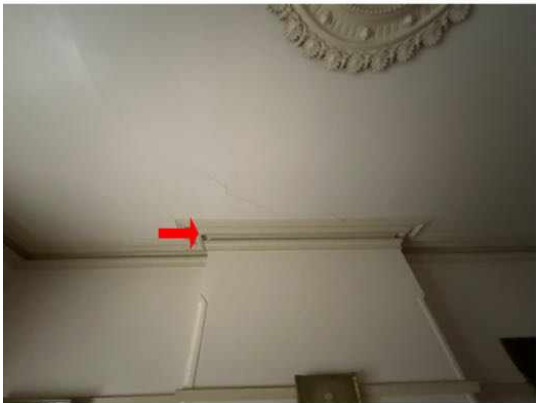
Finding 3.07

Building:	Main Building
Location:	Formal Lounge Room
Finding:	Ceiling - Water stained
Information:	Water staining to ceiling linings in this area was evident at the time of inspection. Water staining indicates that surfaces have been exposed to excessive moisture over time. The minerals and other elements in the water lead to staining, which may graduate to corrosion and deterioration if left unmanaged.

Although there was no moisture detected in the ceiling I would recommend monitoring and acting on one of the following.

Where water staining is active, a licensed plumber must be consulted to identify the cause of the staining and to provide advice on any reparation works that may be required. Replacement of any damaged structures is advised.

Conversely, where water staining is old and inactive, affected building materials may be repaired or replaced at client discretion.

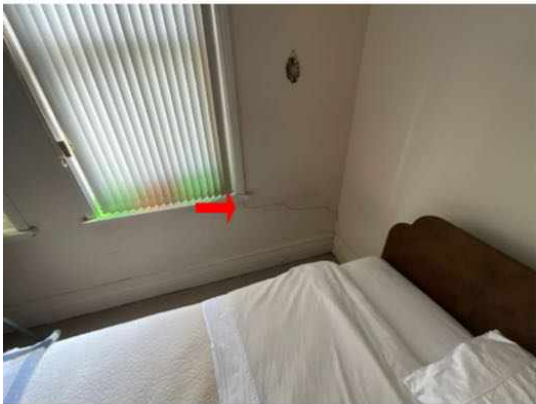
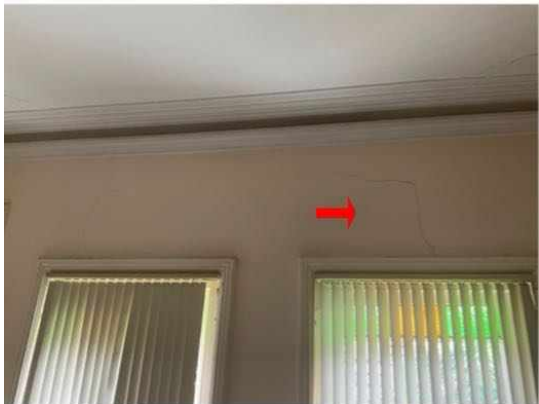
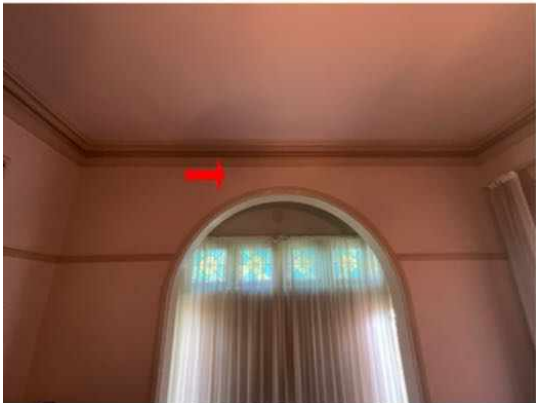
Finding 3.08

Building: Main Building
Location: Internal Areas
Finding: Cracking - Damage Category 2 - Noticeable (up to 5mm)
Information: Noticeable cracks are a common occurrence as a result of many primary defects. Such causes may include age, general wear and tear, expected building movement, general expansion/contraction of building materials in different weather conditions, and/or minor failings in the installation or application of building materials. I recommend monitoring and if further cracking is evident appoint a bricklayer to see what works are required.

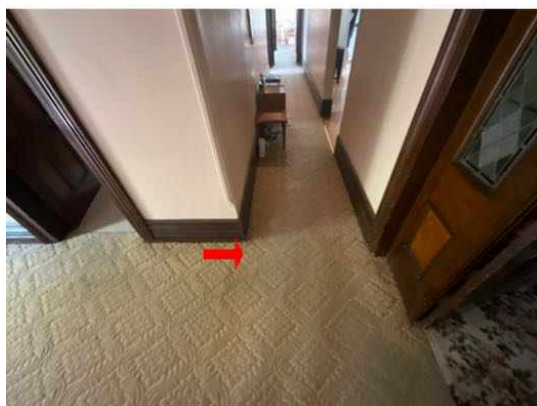
Finding 3.09

Building:	Main Building
Location:	Hallway
Finding:	Floors - bouncy
Information:	The internal flooring in this area was identified as being bouncy at the time of inspection. A bouncy floor surface generally presents as a discernible change in level as they are walked across, in noisy or creaking flooring, or in consequent movement of surrounding furniture and fixtures.

Bouncy floors generally indicate that the floorboards or the subfloor structures are coming loose from the joists that they are installed on. Bouncy flooring may also be the result of gaps between flooring and joist structures, which require packing.

The client is advised to seek quotations for required repairs from a Registered Builder.

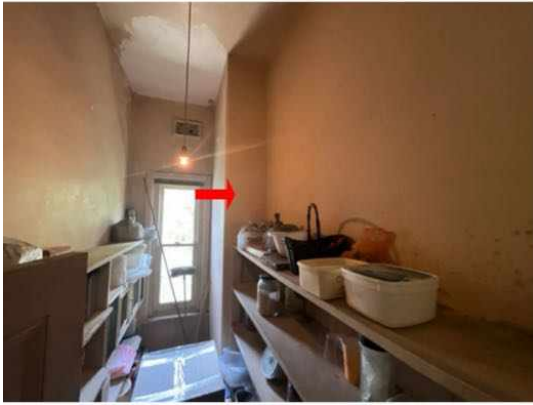
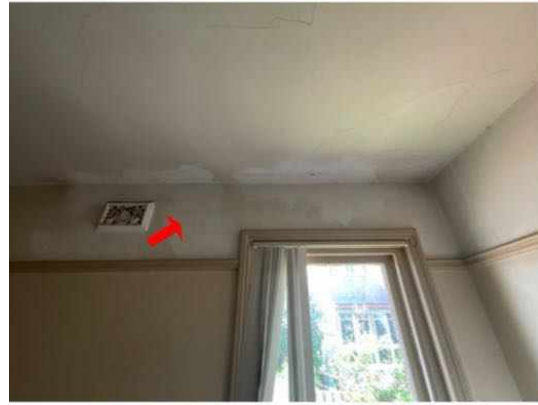
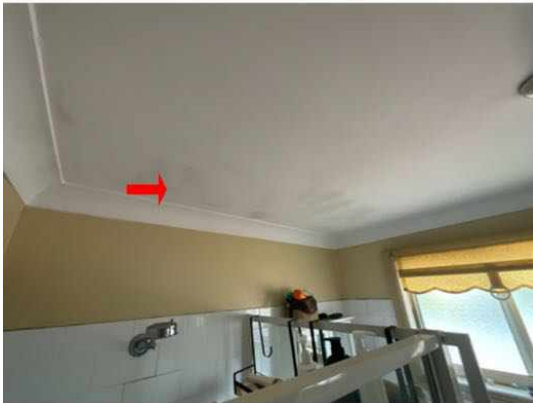
Finding 3.10

Building:	Main Building
Location:	Pantry - Walk In, Bedroom & Bathroom
Finding:	Mould - Present
Information:	Generally, the client is advised to ensure that the general environment is free of moisture and humidity to aid in the prevention of mould formation and development.

Any mould found during the inspection should be cleaned by a cleaning contractor or the homeowner as applicable.

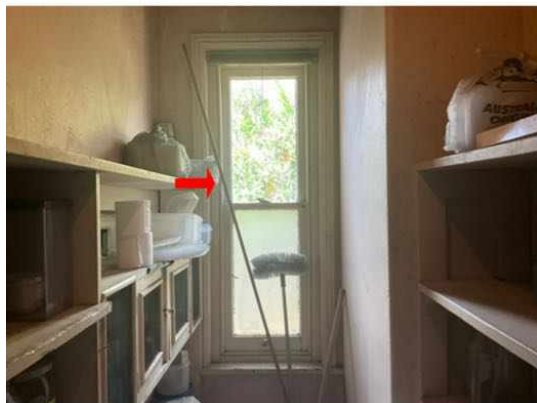
Finding 3.11

Building:	Main Building
Location:	Window
Finding:	Windows - Sash cords missing
Information:	Sashes are the moveable panes of windows that primarily slide vertically over each other to expose one half of the window area. Each sash is provided with springs balances and/or compression weather-stripping, which act to hold the window in place in one position.

To facilitate this operation the weight of the glazed panel is usually balanced by steel weights or counterbalances. The sash weight is connected by a cord or chain that runs over a pulley at the top of the frame. These cords are prone to degradation over time and replacement is required.

Repairing or replacing sash cords involves some work and is often best completed by an experienced carpenter or specialist window restorer. It is advised that such works be completed to improve the operational state of the affected window.

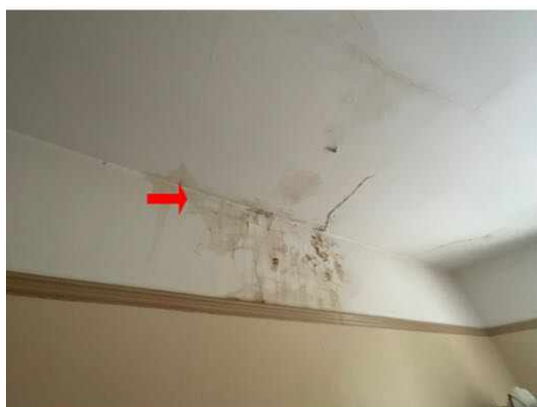
Finding 3.12

Building:	Main Building
Location:	Bedroom 3
Finding:	Ceiling - Water stained
Information:	Water staining to ceiling linings in this area was evident at the time of inspection. Water staining indicates that surfaces have been exposed to excessive moisture over time. The minerals and other elements in the water lead to staining, which may graduate to corrosion and deterioration if left unmanaged.

Although there was no moisture detected in the ceiling I would recommend monitoring and acting on one of the following.

Where water staining is active, a licensed plumber must be consulted to identify the cause of the staining and to provide advice on any reparation works that may be required. Replacement of any damaged structures is advised.

Conversely, where water staining is old and inactive, affected building materials may be repaired or replaced at client discretion.

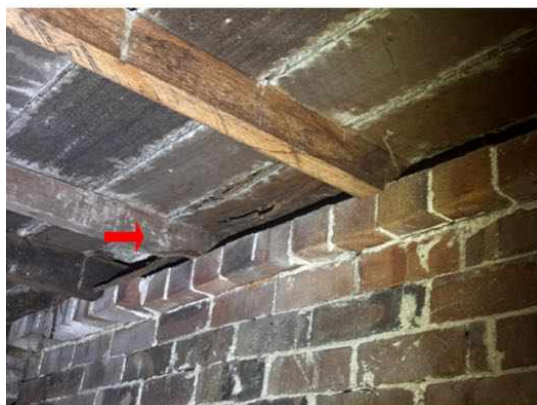
Building: Main Building
 Location: Subfloor
 Finding: Termite - damage identified
 Information: Despite no live termite or timbered pest activity being indicated, termite damage was found to have affected this area.

A building contractor should be appointed to provide a further invasive inspection and

to see what necessary works are required.

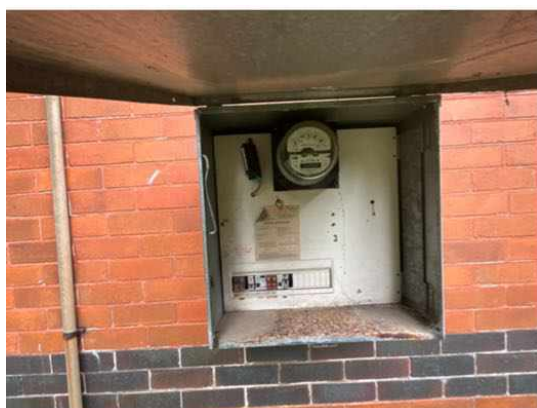
Finding 6.01

Building:	Main Building
Location:	All Areas
Finding:	Termite Management System - no evidence of a chemical installation
Information:	The application of a post-construction chemical termite barrier is highly recommended for all properties, particularly if live termite activity has been found on the site previously. Such barriers are highly effective in preventing termite attack on any timber building elements throughout the property.

A durable notice should be placed in the switchboard unit to indicate current termite barriers. At the time of inspection, it appeared as though no termite management system has been installed, with no evidence to suggest preventative works taking place.

The client may consider gaining further advice from a pest controller as to the costs and procedures involved with this application. It is recommended that obtaining such advice be a short-term priority.

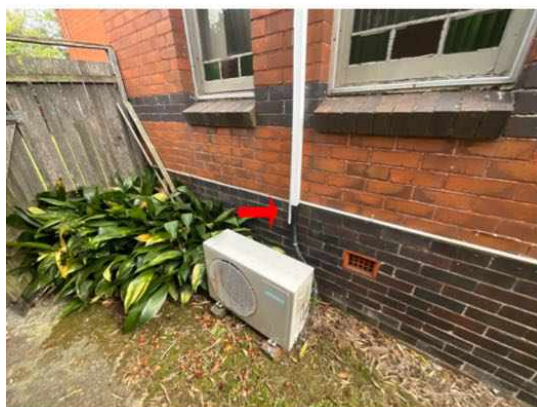
Finding 6.02

Building:	Main Building
Location:	Exterior walls
Finding:	Air conditioner - Disconnected overflow
Information:	The Air Conditioner (A/C) overflow was found to be disconnected from storm water drainage and is creating excessive moisture in the surrounding area.

Such leaking creates an environment which is conducive to an array of defects, including water damage to associated building elements and the attraction of termite or timber pest infestation.

It is highly recommended that a licensed plumber be appointed to connect the A/C overflow in order to prevent such an environment from being created. These minor works should be carried out as soon as possible.

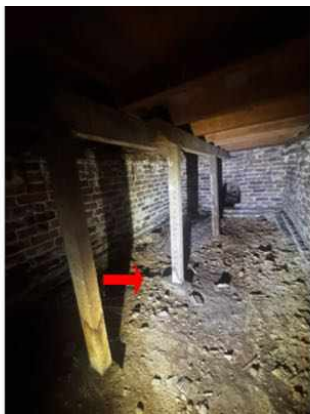
Finding 6.03

Building:	Main Building
Location:	Subfloor
Finding:	In ground contact
Information:	Any timbers in direct ground contact provide opportunity for concealed termite entry and are likely to be subject to premature rot and decay as the soil retains moisture or damp conditions against the timbers.

Remove untreated timber that is in direct contact with external grounds. Consider replacement with more durable materials i.e. treated timber or non timber elements. Frequent pest inspections are advised to readily identify any termite activity in these areas.

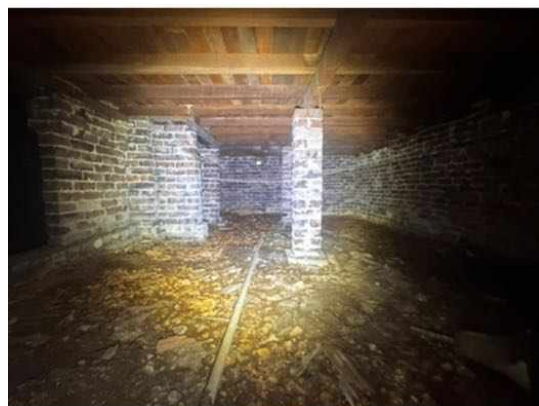
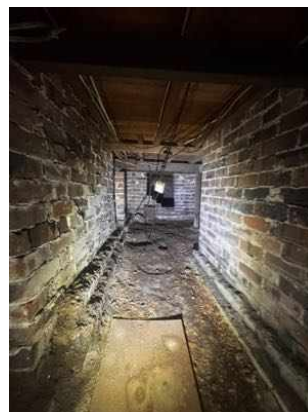
Finding 6.04

Building:	Main Building
Location:	Subfloor
Finding:	Subfloor - Lack of ventilation
Information:	It was noted at the time of inspection that the subfloor area lacks adequate ventilation. Ventilation can be restricted by a variety of minor defects, including obstructions in the subfloor space, a lack of vents or a low clearance.

A well ventilated subfloor aids in maintaining dry conditions, preventing secondary damage such as wood rot and pest activity, as well as preventing the development of mould and mildew (which can lead to respiratory safety hazards for occupants).

The client may also consider mechanical ventilation (powered fans) to improve subfloor airflow.

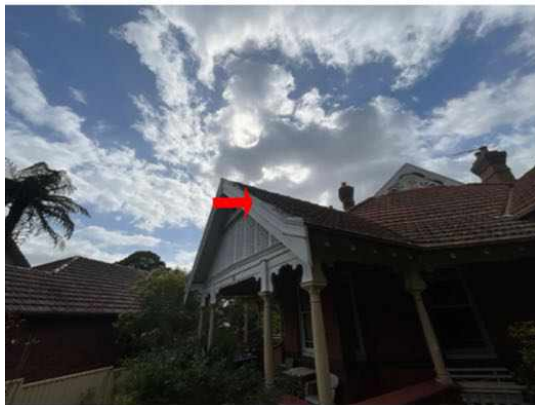
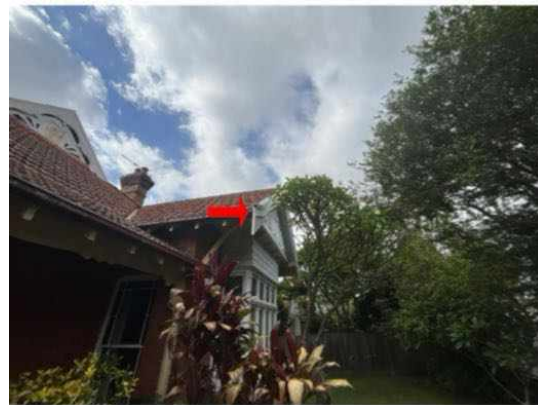
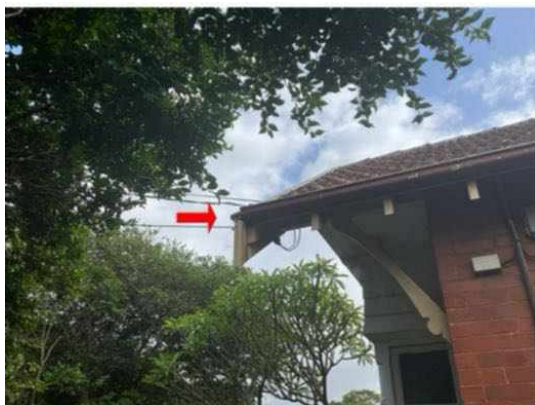
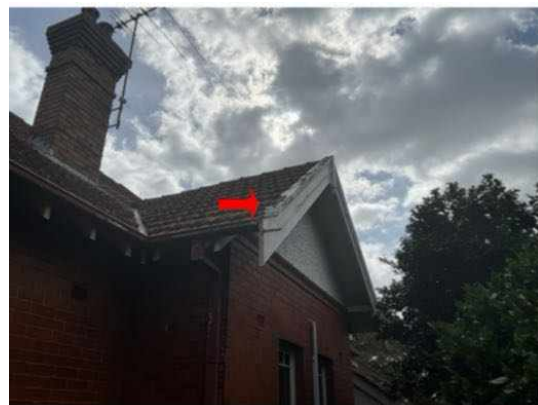
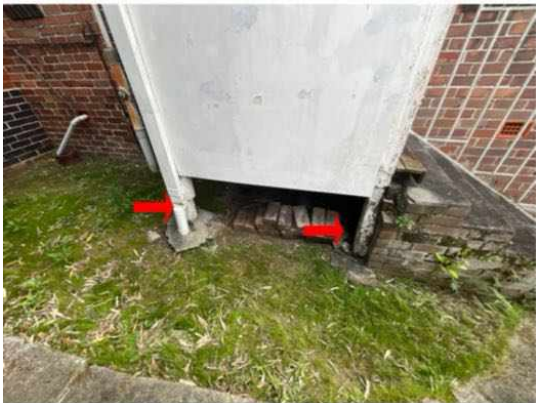
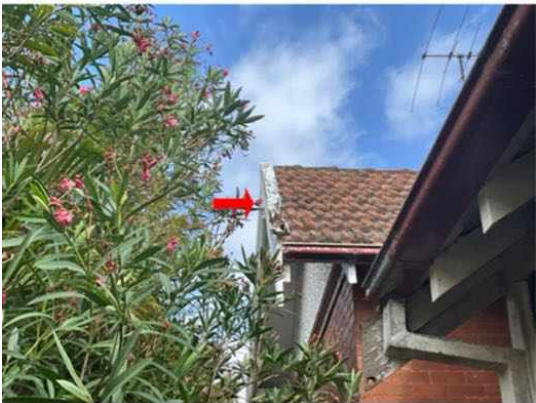
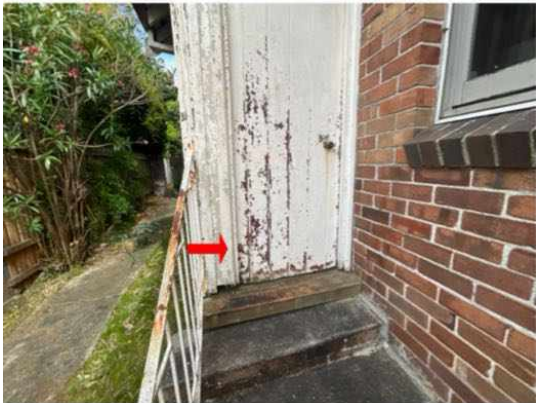
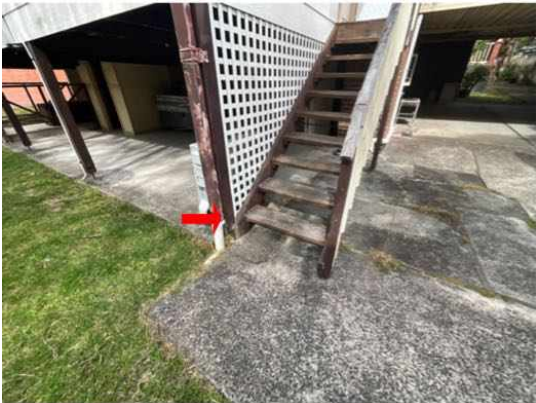
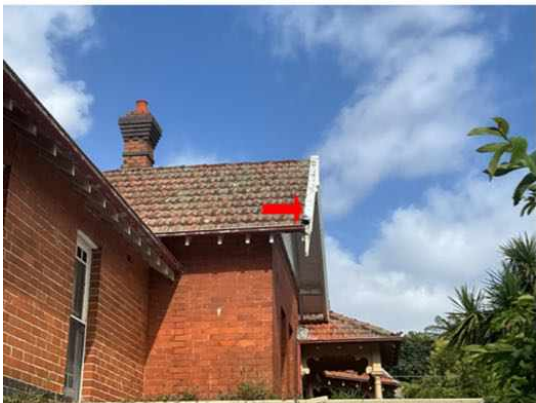
Finding 7.01

Finding: Fungal decay - present (localised)

Information: Fungal decay also known as wood decay or wood rot generally refers to the deterioration of timber elements when in contact with excessive levels of moisture for a prolonged period of time.

The development of fungal decay is accelerated by temperatures in the range of 5degreeC to 40degreeC as well as the presence of oxygen. Generally fungal decay develops on timber elements that are in use in an external environment which are exposed to rain penetration.

In this case although the affected timber element is in a decaying state the extent of any visible damage appears to be localised to a specific area and is yet to spread to other parts of the building element or affect adjoining structures. The fungal decay is therefore likely to be of a relatively superficial nature with minimal impact on the structural integrity or tensile strength of the timber element.
