Building and Timber Pest Inspection Report

Inspection Date: Thu, 19 Mar 2026

Property Address: 15/8 Myall St, Cabramatta NSW 2166,
Australia

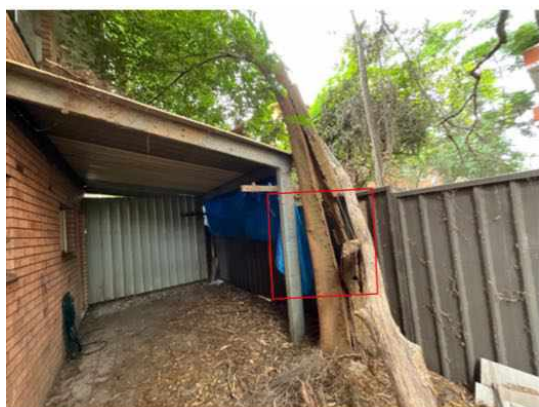
Building:	Main Building
Location:	Courtyard
Finding:	Failed Tree Impacting Structure
Information:	A tree adjacent to the structure has failed, with the trunk visibly split and leaning against the building. The failed tree is exerting load onto the roof structure and nearby elements, including the metal cladding and support post. This presents a risk of further structural damage, including deformation of the roof framing and potential collapse under additional load (e.g. wind).

The tree appears to be decayed/termite damaged, indicating long-term deterioration that has not been addressed. Its proximity to the structure has allowed direct impact and loading onto the building.

This is a risk of structural damage to roof and supports and a safety hazard due to possible further movement or collapse. Engage a qualified arborist to safely remove the failed tree and assess surrounding vegetation. A licensed builder should then inspect the affected structure and carry out any necessary repairs to restore structural integrity.

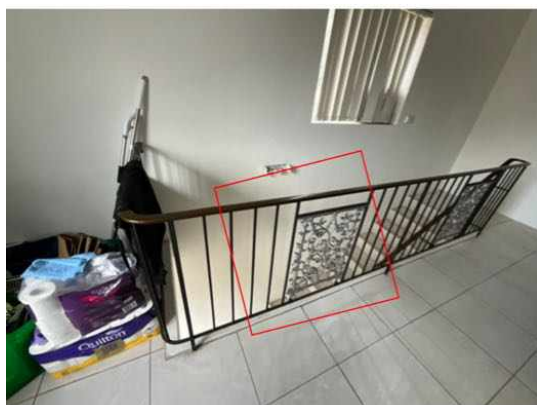
Finding 1.02

Building:	Main Building
Location:	Staircase
Finding:	Balustrade - Suspected Non-Compliance
Information:	The balustrade was measured and found to be less than the present building regulation requirement of 1000mm high.

This defect creates a potential safety hazard and should be rectified as soon as possible to ensure the safety of the area and to meet present building standards and regulations.

A licensed builder should be contacted to discuss possible rectification solutions.

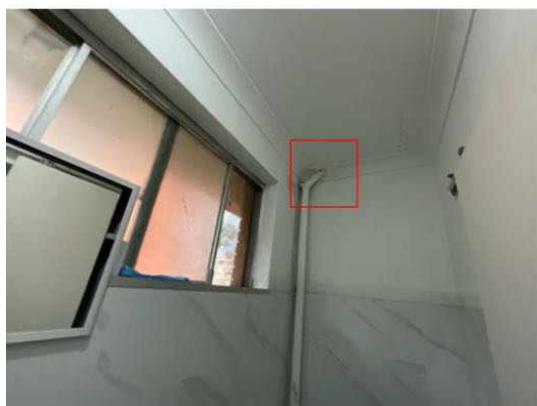
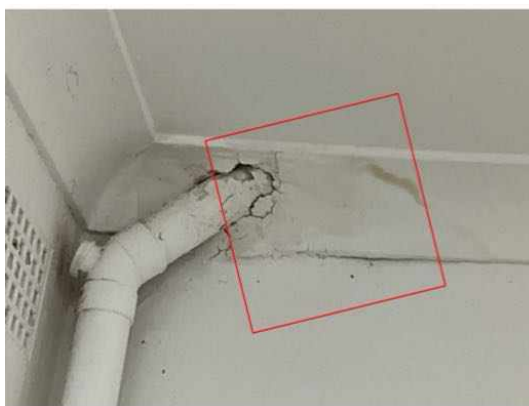
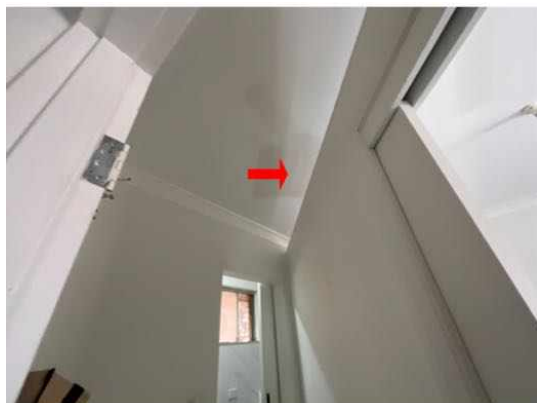
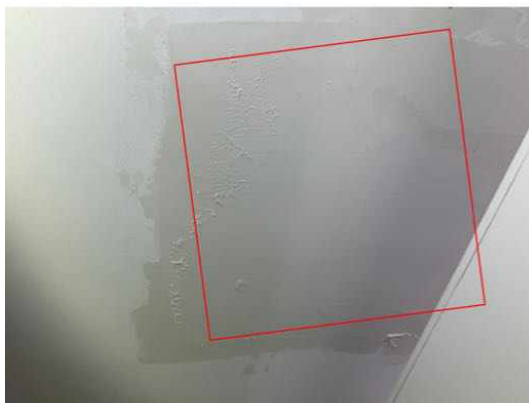
Finding 2.01

Building:	Main Building
Location:	Multiple areas
Finding:	Ceiling - Water damaged
Information:	Water damage to the ceiling lining is generally an indication of excessive moisture being present in the roof void, usually via a leak to the roof covering.

Where water damage is evident to the ceiling, the primary requirement is to identify and rectify the source of the leak. A roof restoration specialist should be appointed as soon as possible to identify the leak and perform rectification works as necessary, ensuring the water damage is restricted.

Once the leak is repaired, consultation with relevant tradespeople, including plasterers and painters, is advised. Rectification works may include replacement of ceiling lining or minor repainting, depending on the extent of the damage.

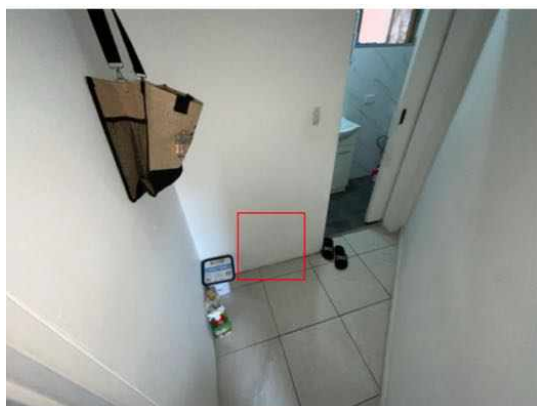
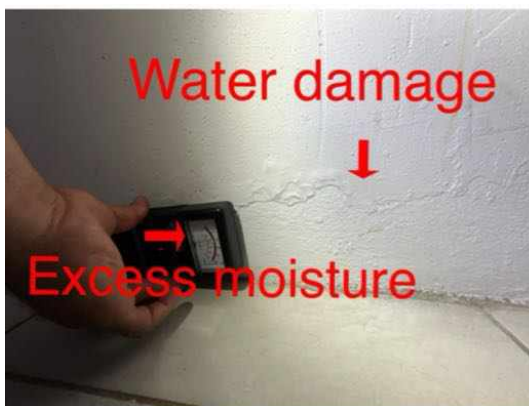
Finding 2.02

Building:	Main Building
Location:	Bathroom
Finding:	Water leak - Internal
Information:	A water leak was found in this area at the time of inspection. Internal water leaks can be detrimental to surrounding building elements; their potential causes include damage to plumbing fittings and fixtures, through to water damage and deterioration of associated building elements.

Rust, corrosion, decay and water damage are potential outcomes where a minor water leak is left unattended. More serious defects may also result, such as electrical hazards, or water damage to structural building elements.

In extreme cases, structural damage may develop due to a prolonged water leak. It is highly advised that internal water leaks be addressed by a licensed plumber as a matter of relative urgency.

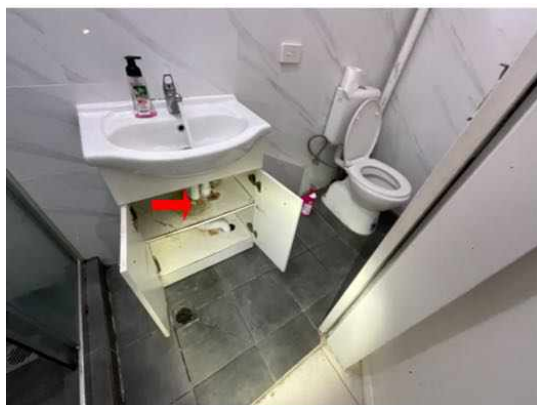
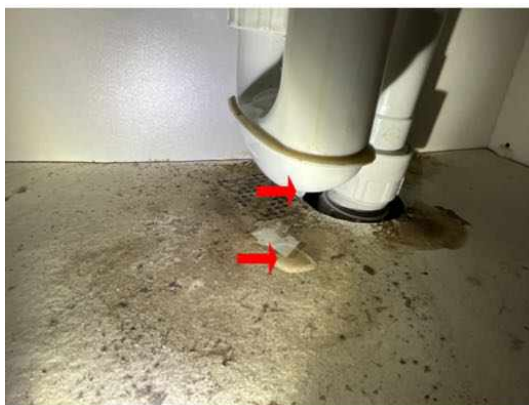
Finding 3.01

Building: Main Building
 Location: Bathroom
 Finding: Water leak - Active
 Information: Generally, water leaks occur when a particular area of the property is not weather or water tight. As the surrounding area was found to be damp at the time of inspection, the leak is considered ongoing and hence requires urgent action.

Regardless of the location, even minor leaks that are left unmanaged can lead to serious damage of associated building elements and result in the need for replacement of building materials. Mould and other hazards such as electrical hazards may also arise if the leak is left to develop.

It is highly advised that the cause of the leak be identified and resolved immediately by a licensed plumber to prevent any further damage. Depending on the extent of the damage previously sustained, repair and/or replacement of any affected building materials may be required.

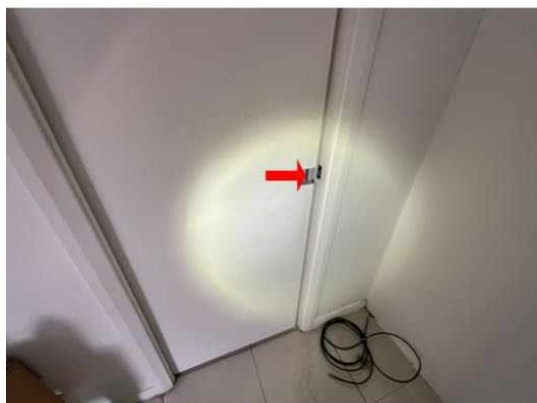
Finding 3.02

Building:	Main Building
Location:	Bedroom
Finding:	Building element - Damaged
Information:	Door handle was found to have been damaged and missing at the time of inspection. Breakage occurs generally when the building materials have either aged and decayed, or as a result of damage (accidental or deliberate).

Repair and/or replacement of broken elements is advised to ensure that additional secondary defects do not arise as a consequence. Such works are necessary, as all building elements play a key role in the operation and function of the overall structure and its performance.

A relevant tradesperson should be appointed to repair or replace the affected building element prior to any subsequent damage being caused.

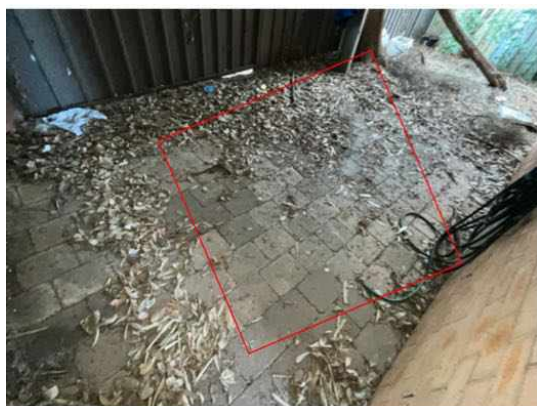
Finding 3.03

Building:	Main Building
Location:	
Finding:	Paving — Uneven
Information:	Sections of the external paved area are uneven, which may develop into a trip hazard. It appears as though the area has been subject to rough installation, or that paving sections have lifted due to movements in the foundation.

Left unmanaged, the May develop into a safety hazard due to trip and fall.

Re-paving of the area is required to remedy this situation. Further consultation with a specialist concreter is advised.

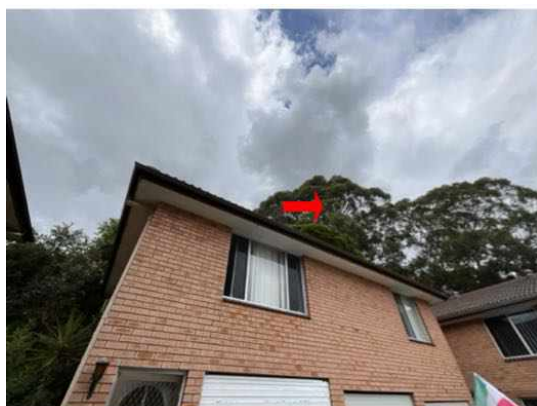
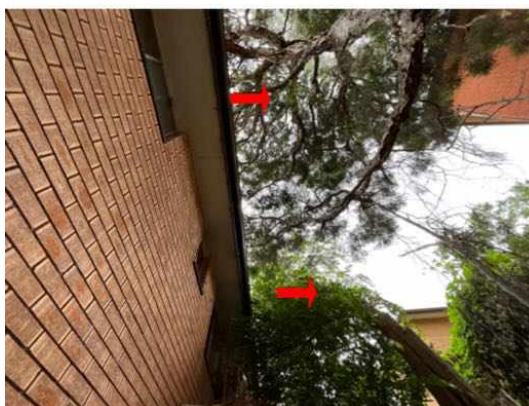
Finding 3.04

Building:	Main Building
Location:	Roof Exterior
Finding:	Trees - Overhanging and filling gutters
Information:	Overhanging trees often result in excessive amounts of leaf debris accumulating in gutters.

Gutters are a critical part of the building's management of storm water and rain. It is therefore important that they be kept clear to prevent secondary damage to associated building elements, including exterior and interior walls, ceiling linings and any adjoining building elements. Where gutters are blocked, pooling of rainwater is likely to occur, fast-tracking rust and corrosion of the roof plumbing elements.

It is highly advised that all overhanging tree branches be removed as soon as possible to prevent any further damage. Repair and/or replacement of sections of damaged guttering may also be required where the extent of the damage necessitates.

Such works should be performed by the homeowner; however, appointment of a landscape contractor or an arborist may be required. Consultation with a licensed roof plumber is required where guttering has been damaged.

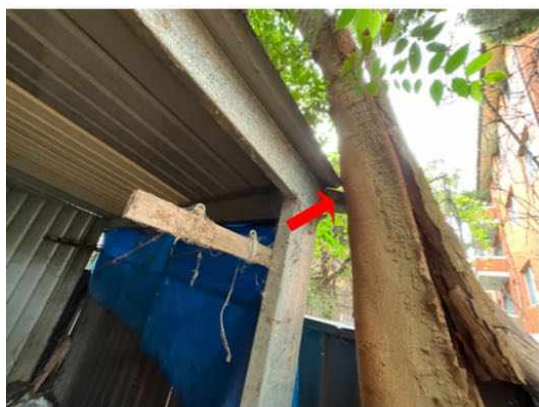
Finding 3.05

Building:	Main Building
Location:	Courtyard
Finding:	Roof plumbing - Missing
Information:	Some sections of the roof are not adequately drained via gutters and downpipes. Gutters and downpipes that are not installed adequately are likely to result in excessively damp conditions against the exterior surfaces and around the base perimeter of the building.

Excessive moisture creates an environment which accelerates the deterioration of building elements in the area, as well as being conducive to termite and pest infestation. Such an environment is likely to necessitate repair and/or replacement of building elements, which are prone to sustaining wood rot, rust or corrosion.

A roofing plumber should be appointed as soon as possible to install relevant roof plumbing materials. Depending on the extent of the damage, repair and/or replacement of damaged building elements may be required.

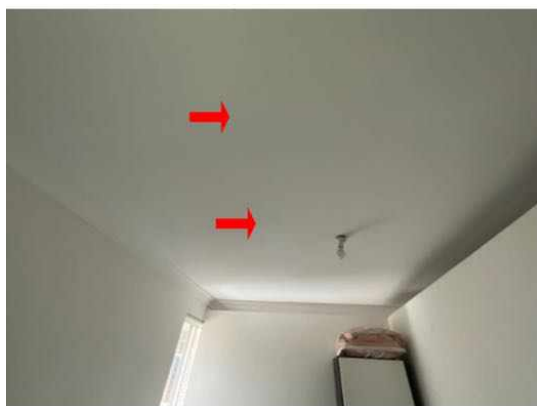
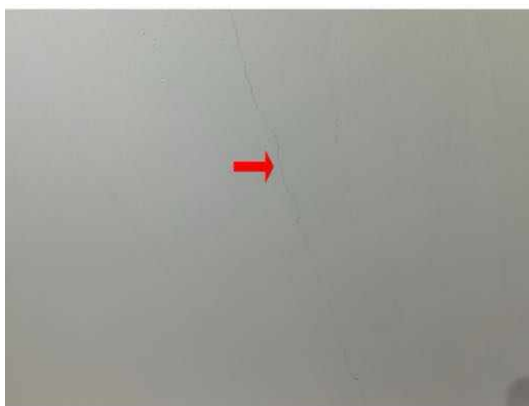
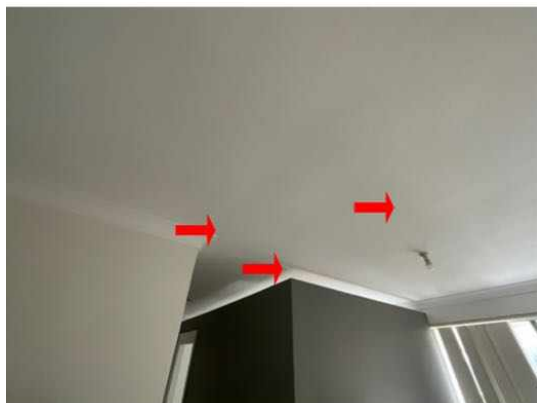
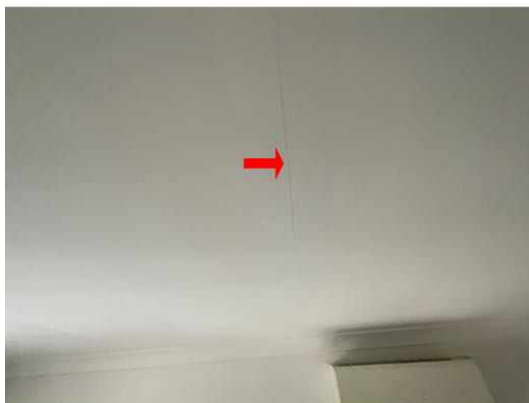
Finding 3.06

Building:	Main Building
Location:	Multiple areas
Finding:	Cracking - Damage Category 1 - Fine (up to 1mm)
Information:	Although fine cracks are quite noticeable, they are often only considered to be an appearance defect, and usually do not indicate any structural damage. Generally, the cause of a fine crack is indicative of a separation between building materials and finishes (e.g. paint, plaster, etc.) along joins.

Cracking of this nature can generally be repaired with minor sanding, filling and/or repainting. Such works should be performed by a qualified painter or a general handyman.

Monitoring of all cracking should be conducted frequently. Always contact a building inspector should cracks widen, lengthen, or become more numerous.

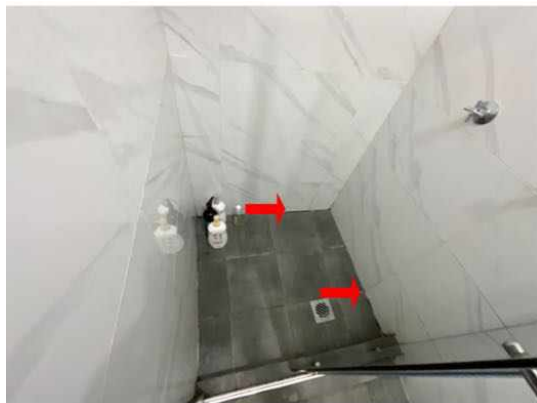
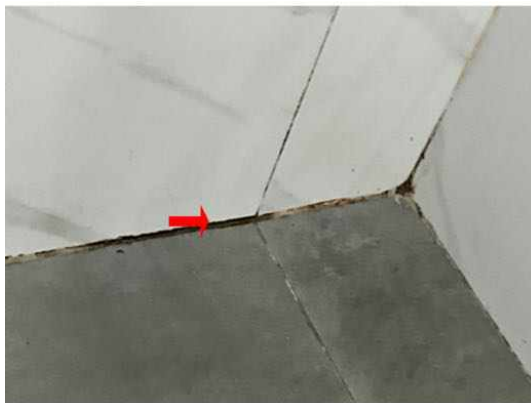
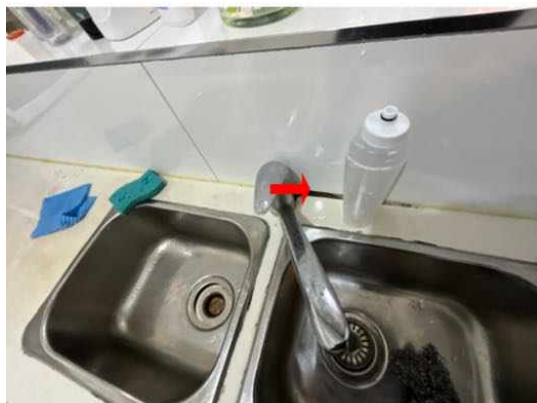
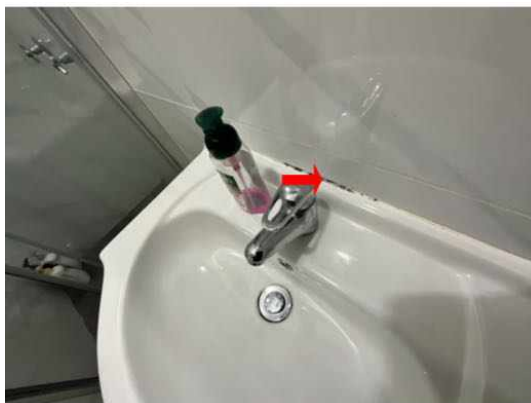
Finding 3.07

Building:	Main Building
Location:	All Wet Areas
Finding:	Sealant and grouting - Missing or damaged
Information:

It was noted on inspection that sealant or grout is degraded to this area.

Different materials and floor areas move at different rates, generally causing cracking to grout or sealant at this point. A flexible sealant is required to allow for expected expansion and contraction, while keeping the joint water tight and protective of all associated building materials.

Flexible and mould resistant materials should be applied to affected areas to prevent any subsequent water damage that is likely to occur. Regular maintenance and replacement of damage or missing or damaged sealant and grout is highly recommended to the wet areas, as this is a regular wear and tear defect. Sealant and grouting in areas that come into regular contact with water should be maintained for the long term care of your property.

A sealant specialist should be appointed to complete these works as soon as possible.

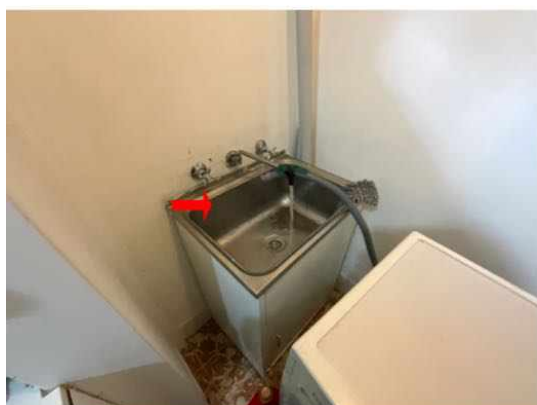
Finding 3.08

Building: Main Building
 Location: Laundry
 Finding: Fitting or fixture - Loose sink
 Information:

The laundry sink in this area is loose and can be moved with minimal force applied by hand. The sink should be fixed firmly to the wall and/or floor.

If left unmanaged, the sink may move and cause damage to pipes, fitting and finishes.

A licensed plumber should be appointed to perform these rectification works.

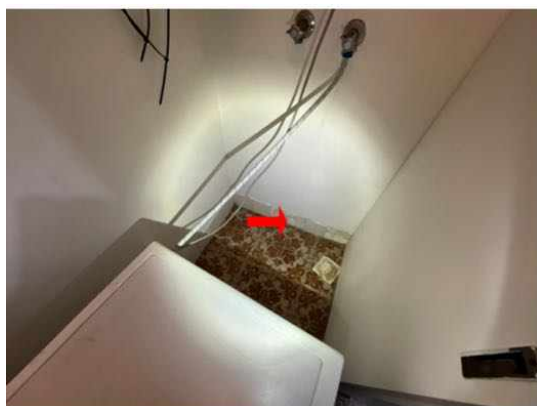
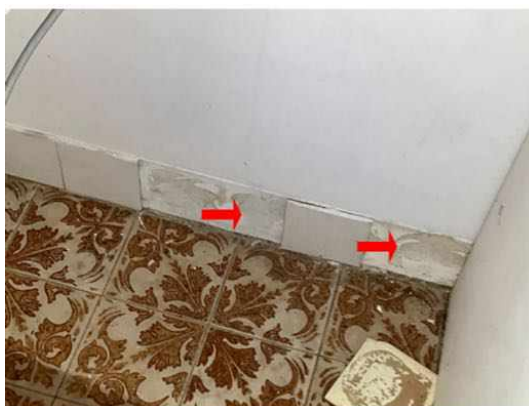
Finding 3.09

Building:	Main Building
Location:	Laundry
Finding:	Skirting tiles - Missing
Information:	Skirting tiles were missing in this area at the time of inspection. Complete tiled skirting is important in preventing water ingress into the adjoining walls and flooring, protecting the areas against potential water damage. The incomplete skirting also detracts from the overall appearance of the area.

If left unmanaged, water ingress into adjoining areas may have major implications, and may potentially necessitate works to other building elements in the long-term future.

It is highly recommended that a tiling contractor be appointed to complete these minor works as soon as possible to prevent such damage from occurring.

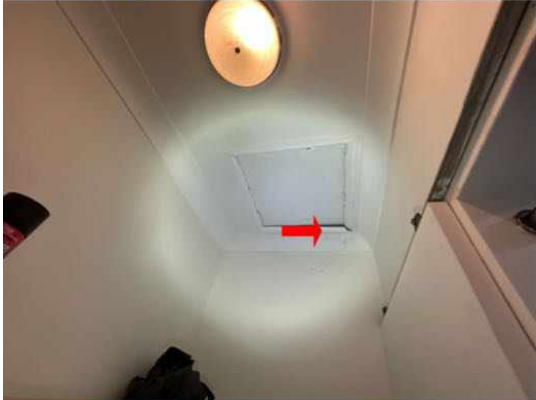
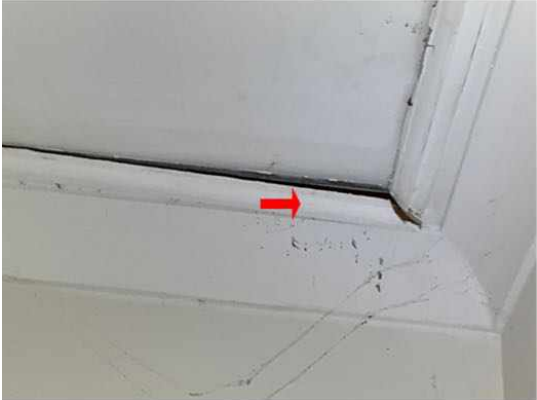
Finding 3.10

Building:	Main Building
Location:	Laundry
Finding:	Beads - Damaged
Information:	Beading acts (like cornice or skirtings) to cover the intersection or joins of building materials. It was noted at the time of inspection that beading in this area has deteriorated. This deterioration is suspected to have been caused by general ageing and frequent exposure to weather, which is expected in a building of this age and condition.

Beading is important in weatherproofing the surrounding building elements and preventing pest ingress. Furthermore, beading works to protect the joins of building materials, which are more susceptible to deterioration and decay.

Repair or replacement of the beading is advised to ensure the protection and longevity of any associated building elements. Such works may be performed by a general handyperson or qualified carpenter.

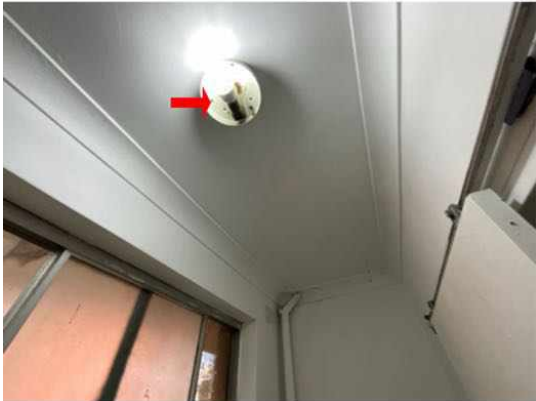
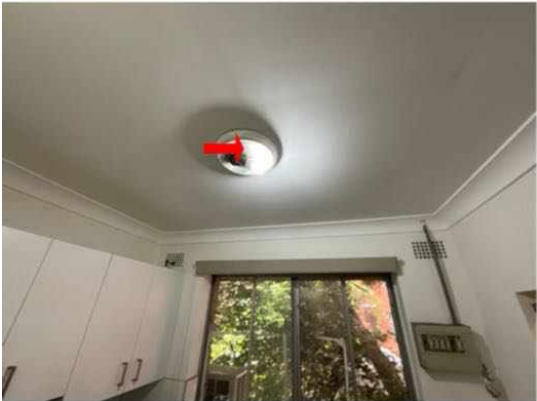
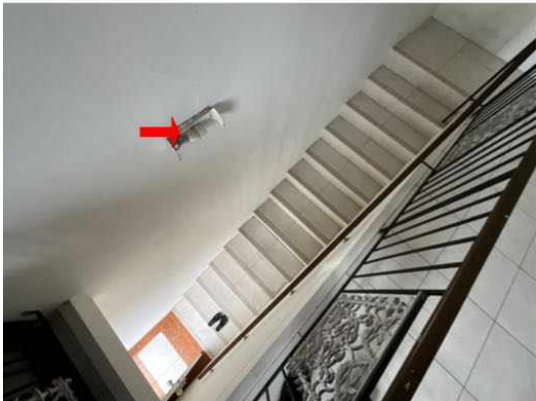
Finding 3.11

Building: Main Building
Location: Multiple areas
Finding: Light cover - Missing (Cosmetic)
Information: The light cover in this area was found to be missing at the time of inspection. Breakage occurs generally when the building materials have aged and decayed, but may also be indicative of impact damage to the building element (accidental or deliberate). This is mainly a cosmetic defect which can be replaced by the home owner.

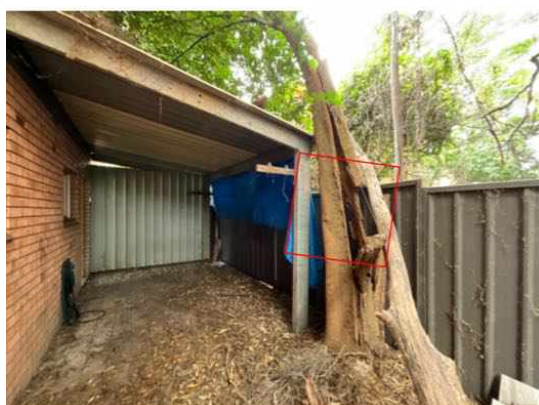
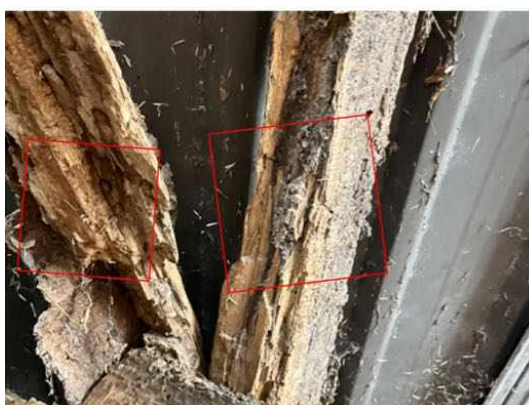
Building:	Main Building
Location:	Courtyard
Finding:	Evidence of termite damage
Information:	Despite no live termite or timber pest activity being indicated, previous termite damage was found to have affected this area or otherwise termite workings were identified at the time of inspection. This damage is considered to be inactive.

It is advised that the area be visually inspected frequently to ensure that the condition of affected building materials does not worsen.

A licensed pest controller should be appointed to provide a treatment plan.

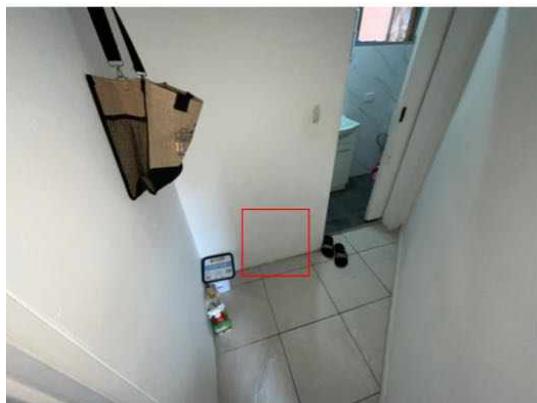
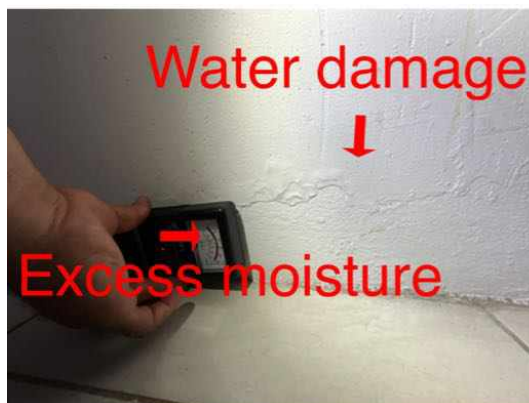
Finding 6.01

Building:	Main Building
Location:	Bathroom
Finding:	Water leak - Internal
Information:	A water leak was found in this area at the time of inspection. Internal water leaks can be detrimental to surrounding building elements; their potential causes include damage to plumbing fittings and fixtures, through to water damage and deterioration of associated building elements.

Rust, corrosion, decay and water damage are potential outcomes where a minor

water leak is left unattended. More serious defects may also result, such as electrical hazards, or water damage to structural building elements.

In extreme cases, structural damage may develop due to a prolonged water leak. It is highly advised that internal water leaks be addressed by a licensed plumber as a matter of relative urgency.

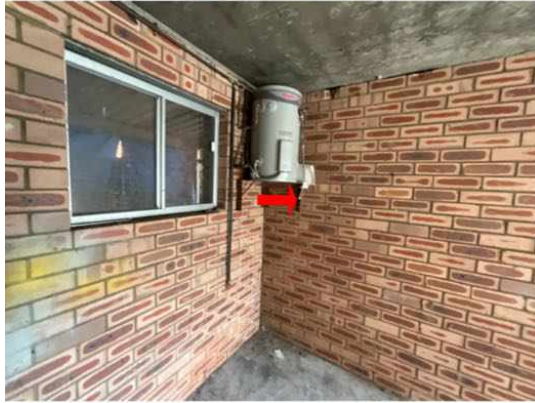
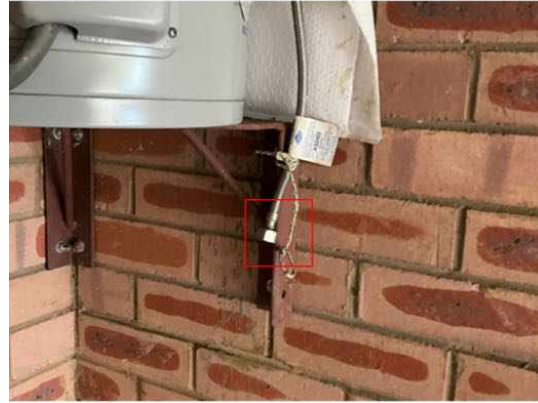
These damp conditions can lead to secondary defects such as rot, rust or corrosion

of associated building elements, the formation of fungal decay, or even the creation of potential slip hazards. When coupled with poor site drainage, pooling of water may also attract termite activity to this area.

It is highly recommended that a licensed plumber be appointed to install adequate drainage to the overflow. These works will ensure that the area remains dry and free of any secondary defects.
