Building Inspection Report

Inspection Date: Fri, 20 Mar 2026

Property Address: 5A Collins Ave, Edwardstown SA 5039,
Australia

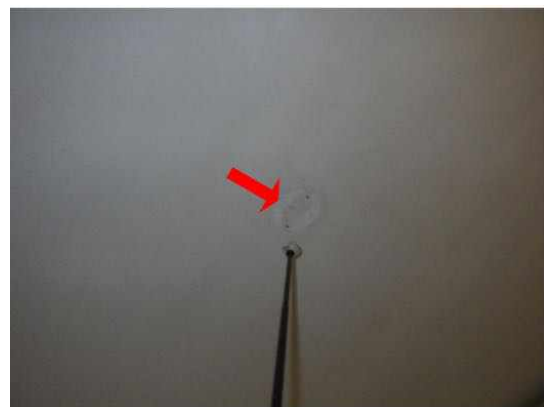
Defects 1.01

Building:	Building 1
Location:	All Internal Areas
Finding:	Smoke Detectors and Alarms - Missing
Information:	At the time of inspection it was noticed that Smoke Detectors and Alarms - Missing in this area and creating a potential safety hazards for the persons coming in contact in this area.

Please note that this defect is highlighted as a caution only. We suspect, based on our experience in the building industry, that the absence of smoke detectors, or their poor condition, should be addressed as a matter of urgency to improve occupant safety.

Always ensure sufficient working and suitable smoke detectors are installed prior to occupying any building. Additionally, it is advised that all smoke detectors be tested by the homeowner on a monthly basis.

Please refer to AS3786 and state based legislation, which may also apply.

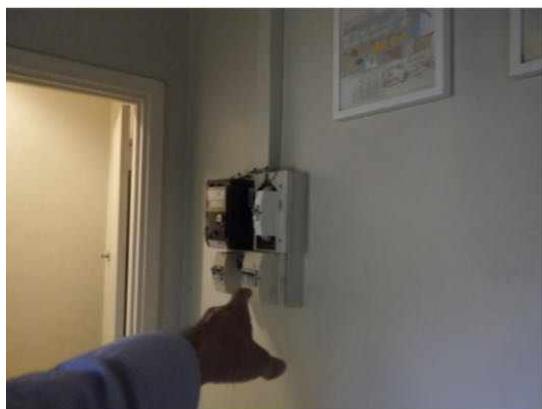
Defects 1.02

Finding: Laundry Area – Electrical Meter Box - Cover was missing / Exposed / Not adequately protected

Information: At the time of inspection it was noticed that the electrical meter is installed internally within the laundry area of the property. It was also observed that the electrical meter box cover was missing / exposed / not adequately protected at the time of inspection, creating a potential safety hazard for persons coming into contact with this area.

Exposed electrical components present a significant safety risk and should be treated as an urgent defect. Although some building elements may appear minor, all building components contribute to the safe operation and overall performance of the structure.

It is strongly advised that a suitably qualified licensed electrician be appointed as soon as possible to assess the installation and provide an appropriate compliant cover / enclosure to the electrical meter box to minimise safety risks and ensure safe operation.

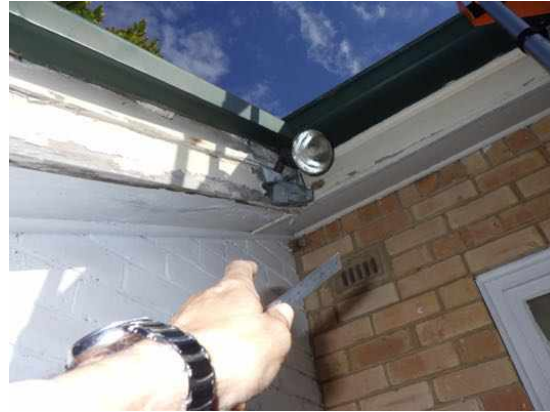
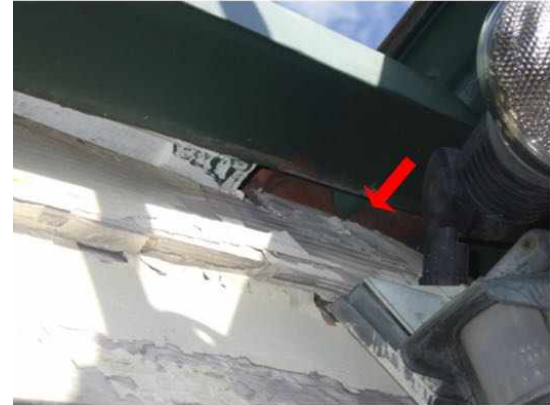
Defects 2.01

Finding: Roof plumbing - Flashing inadequate

Information: At the time of inspection it was noticed that some sections of the roof are missing or have inadequate roof flashings. Apart from that at the time of inspection it was also noticed that roof sheet was loose from its original fixing.

Flashings that are not installed adequately or are missing are likely to result in water penetration to the interior of the property, as well as creating excessively damp

conditions against the exterior surfaces and around the base perimeter of the building.

Premature ageing and secondary building defects are imminent where roof plumbing is missing or inadequately installed. Additionally, water pooling also creates an environment that is susceptible to termite and pest infestation.

A roofing plumber should be appointed as soon as possible to install relevant roof plumbing materials, ensuring that no further damage is sustained.

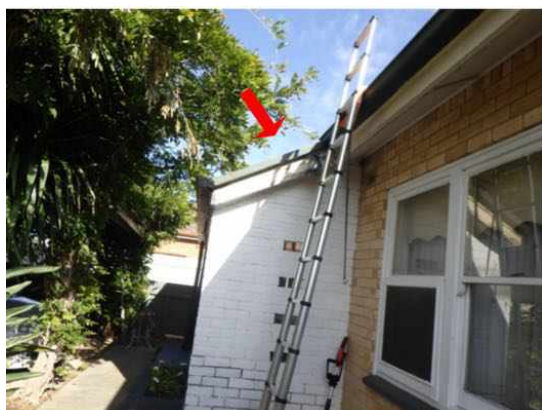
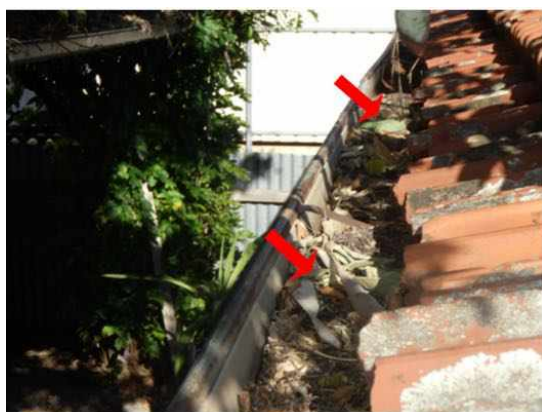
Defects 2.02

Building:	Building 1
Location:	All External Areas
Finding:	Gutters - Blocked
Information:	At the time of inspection it was noticed that gutters were blocked in few sections around the property. Gutters have to be cleaned in regular intervals.

Blocked gutters are likely to lead to high levels of moisture in the affected areas. Such moisture will not only cause rust and decay of the associated building materials, but can also provide conditions that are conducive to termite and timber pest activity. Blockages in gutters should therefore be removed immediately to ensure dry conditions are maintained.

Consult a Licensed Plumber for further specific advice on remedial works that may be required. In the interim, it is highly advised that blocked gutters be removed by the homeowner or a general handyperson as a matter of urgency.

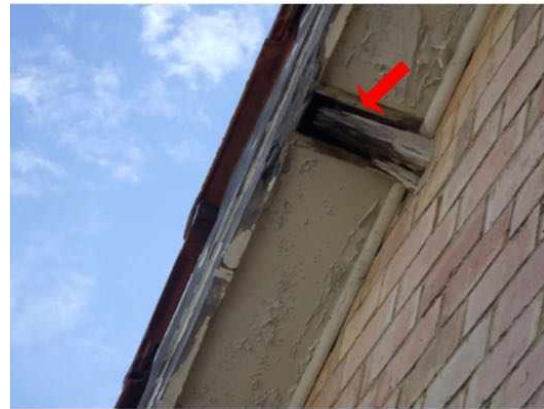
Defects 2.03

Building:	Building 1
Location:	All External Areas
Finding:	Wood rot
Information:	This building element shows evidence of wood rot. Wood rot, also known as Fungal Decay, occurs when timbers and other cellulose building materials are exposed to damp conditions on an ongoing basis. This could be the result of exposure to weathering over a prolonged period of time, or the attraction of excessive moisture from other abutting building materials. Contributing factors also include poor air

Wood rot is often associated with general damp problems and is evidenced by a 'musty' smell or mould and mildew occurring on surfaces. If left unmanaged, damp conditions can lead to further health problems and the decay of timbers will continue.

Early intervention and regular maintenance, particularly of exterior timbers, will prolong the useful life of these building elements. Prior to any works being performed, the cause of the moisture that has created the visible wood rot should be identified and addressed in a suitable manner. Replacement of affected timbers may then be a necessary step in protecting surrounding building elements from such deterioration.

A qualified plumber may be appointed to assess the cause of excessive moisture and to provide advice on any remedial works as required. A qualified carpenter or registered builder may also be required to replace affected building materials.

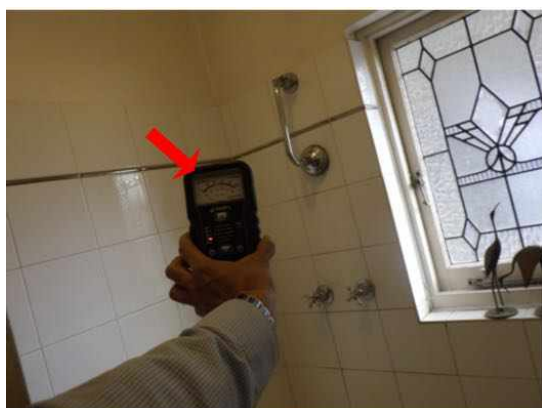
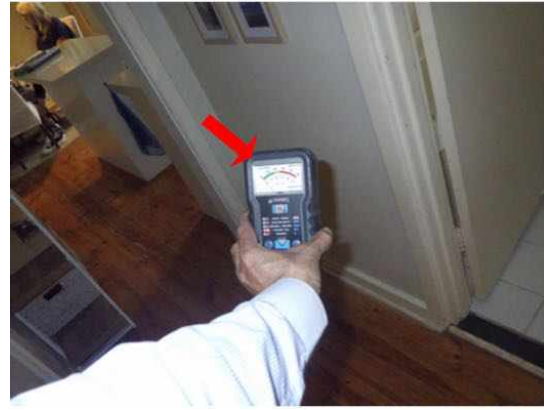
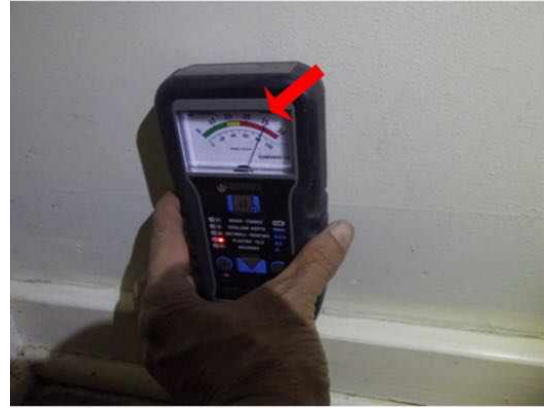
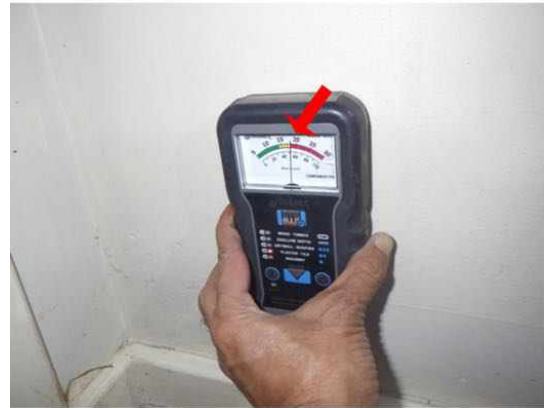
Defects 2.05

Building: Building 1
Location: Bathroom
Finding: Shower Alcove - Damp & Moisture is transferring to other side of the walls
Information: Damp is evident to the lower 500mm approximately of wall to the shower alcove. This defect is quite common, and is suspected to have been caused by moisture permeating through the grouting in this area, which shows evidence of deterioration. Leaking pipes within the adjoining wall is also a possible cause.

Apart from that at the time of inspection it was also noticed that moisture is transferring to other side of the external & internal walls.

Damp (or structural damp) refers to the presence of unwanted moisture in the structure of a building, either as the result of intrusion from outside, or condensation from within the structure. In the shower area, internal water leaks or other sources of excessive moisture are generally the cause of damp.

Unmanaged damp in the shower recess is likely to facilitate the formation and development of mould and fungi growth, decaying associated building materials and compromising their structural integrity. Exposure to these contaminants is associated with a wide range of respiratory and other health-related problems.

Consultation with a qualified plumber or bathroom specialist is advised immediately to identify the cause of damp and to perform remedial works as required. Where excessive mould growth is present, further inspection by a specialist environmental health inspector should also be considered.

Always ensure that sealant and grout is in good condition to prevent any moisture issues occurring in the future.

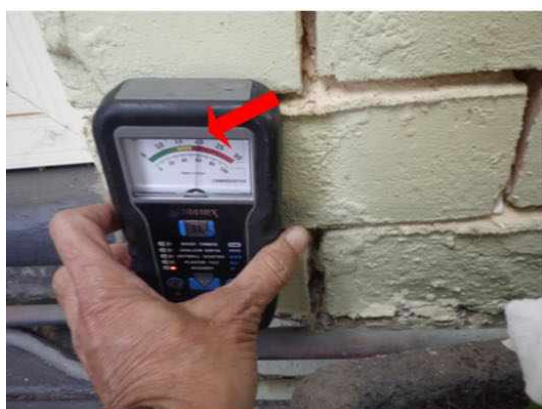
Defects 2.06

Building:	Building 1
Location:	All External Areas
Finding:	External walls - Damp at lower base
Information:	At the time of inspection it was noticed that high moisture readings were noted in the few sections of rear external wall around the property.

Damp (or structural damp) refers to the presence of unwanted moisture in the structure of a building, either as the result of intrusion from outside, or condensation from within the structure. Generally, structural damp is caused by rain penetration, rising damp, and leaks from plumbing pipes.

Unmanaged damp facilitates the formation and development of mould, fungi growth and wood rot, decaying associated building materials and compromising their structural integrity. Damage to finishes is also likely to occur, including lifting, bubbling, peeling and staining of paint, plaster and wallpaper.

The first step in addressing damp is to diagnose the cause. The identified cause should be addressed first prior to repairing the appearance and other defects which have resulted from the rising damp. If the original cause is not resolved, further cases of damp are likely to ensue, resulting in secondary defects.

Consultation with a qualified plumber is advised immediately to identify the cause of damp and perform remedial works as required. Where excessive mould growth is present, further inspection by a specialist environmental health inspector should also be considered.

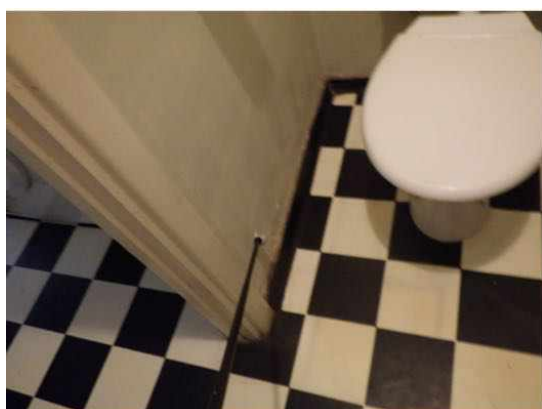
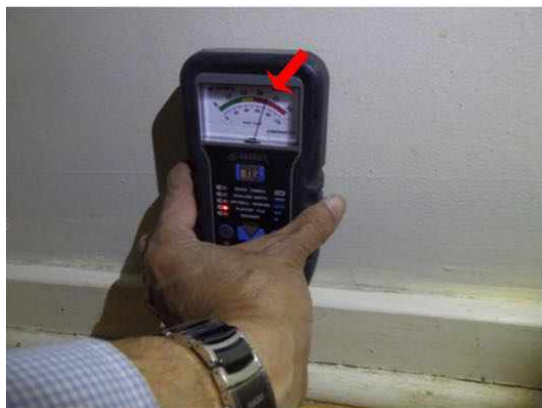
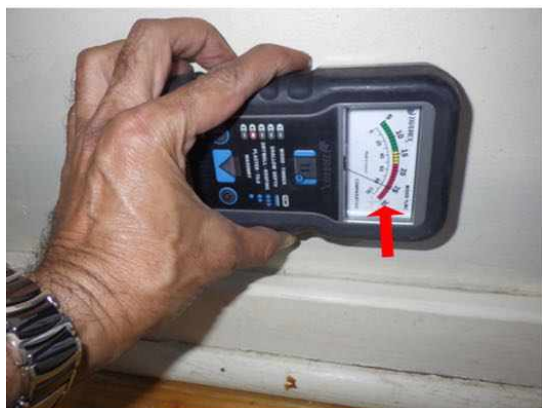
Defects 2.07

Building:	Building 1
Location:	All External Areas
Finding:	Internal walls - Damp adjacent to bathroom, laundry and toilet walls at lower base
Information:	At the time of inspection it was noticed that high moisture readings were noted in few sections of internal walls adjacent to bathroom , laundry and toilet walls at lower base.

Damp (or structural damp) refers to the presence of unwanted moisture in the structure of a building, either as the result of intrusion from outside, or condensation from within the structure. Generally, structural damp is caused by rain penetration, rising damp, and leaks from plumbing pipes.

Unmanaged damp facilitates the formation and development of mould, fungi growth and wood rot, decaying associated building materials and compromising their structural integrity. Damage to finishes is also likely to occur, including lifting, bubbling, peeling and staining of paint, plaster and wallpaper.

The first step in addressing damp is to diagnose the cause. The identified cause should be addressed first prior to repairing the appearance and other defects which have resulted from the rising damp. If the original cause is not resolved, further cases of damp are likely to ensue, resulting in secondary defects.

Consultation with a qualified plumber is advised immediately to identify the cause of damp and perform remedial works as required. Where excessive mould growth is present, further inspection by a specialist environmental health inspector should also be considered.

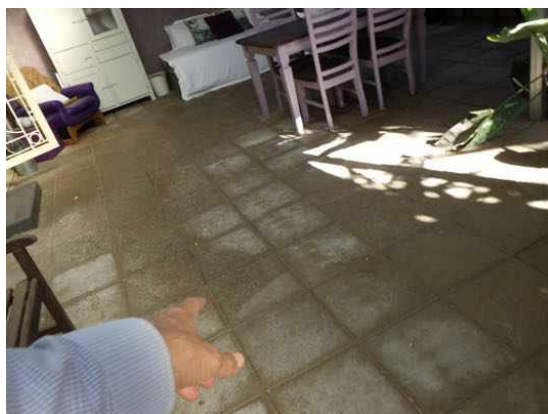
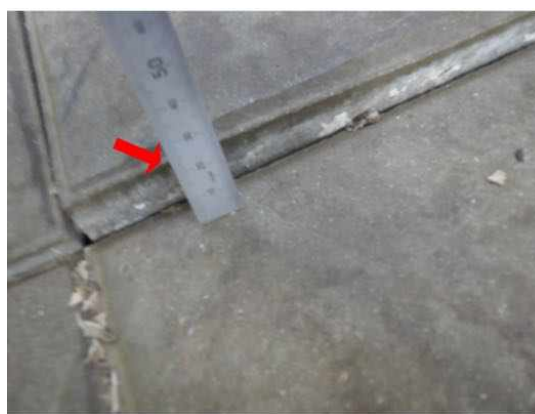
Defects 3.01

Building:	Building 1
Location:	All External Areas
Finding:	Paving - Uneven
Information:	Sections of the external paved area are uneven, creating a potential trip hazard. It appears as though the area has been subject to rough installation, or that paving sections have lifted due to movements in the foundation of the property.

Where paving creates a trip hazard, personal injury may ensue if due caution is not taken by all persons within this area.

Re-paving of the area is required as soon as possible to remedy this situation. Further consultation with a specialist concreter is advised.

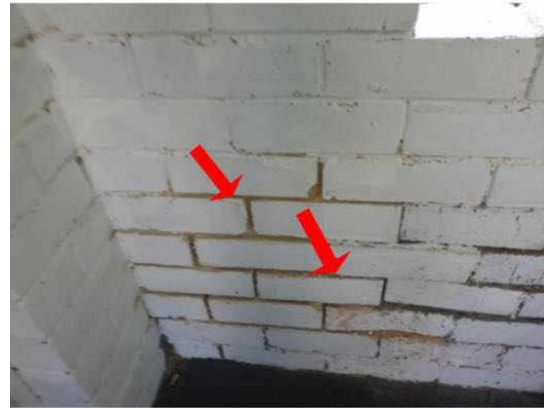
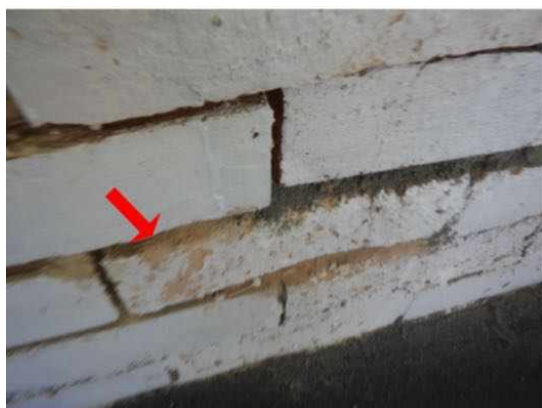
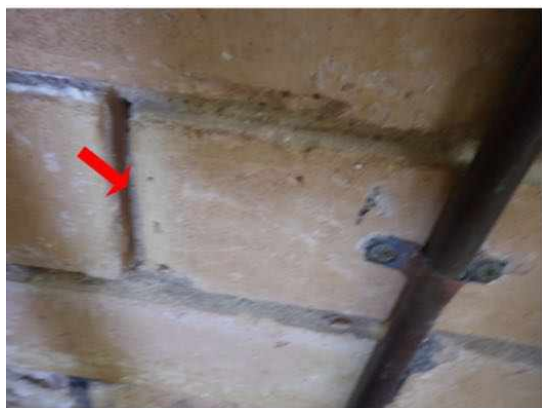
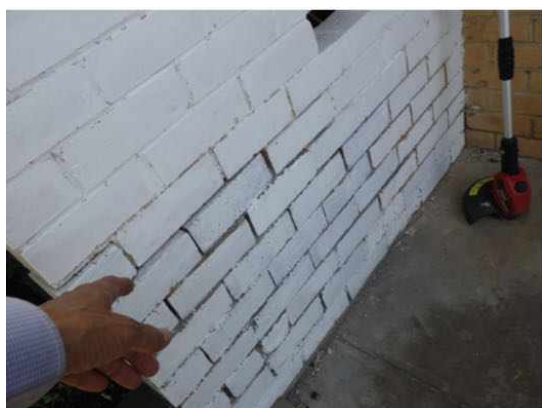
Defects 3.03

Building:	Building 1
Location:	All External Areas
Finding:	Brickwork - Deteriorated mortar

Information: At the time of inspection it was noticed evidence of mortar deterioration to few sections of bricks around the property.

Mortar, or 'bedding', is the material which fills joins and intersections between bricks in masonry walls and structures. Sections of mortar in this brickwork were identified as having deteriorated, which is generally expected for a property of this age and condition.

Mortar may deteriorate as a result of age of building materials, minor movement of bricks, or frequent exposure to weathering. Mortar should be replaced to ensure that bricks remain in their intended location and to prevent gaps, which would allow water or moisture ingress and secondary damage as a result.

Mortar deterioration can be addressed by a bricklayer where areas of deterioration are localised and easily accessible. Alternatively, appointment of a registered builder is advised, to repoint large areas of decaying mortar. Where secondary structural defects have become evident, consultation with a structural engineer may be required.

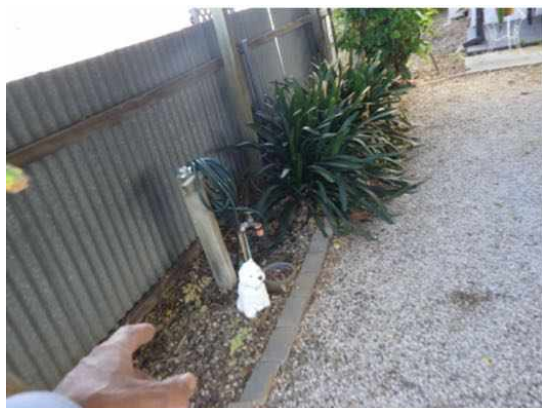
Defects 3.04

Building:	Building 1
Location:	All External Areas
Finding:	Fencing - Deteriorated
Information:	It was noted at the time of inspection that sections of the fencing throughout the property have deteriorated. Typically fencing deteriorates due to age and or wear, rot and or rust which is generally expected for a structure of this age, due to prolonged exposure to weather conditions. Sometimes inadequate installation or maintenance can be to blame.

If left unattended, it is likely that further damage will occur. It is suspected that repair of several elements of the fencing may be required however replacement may be a

consideration of the client also.

A licensed fencing contractor should be appointed to provide further advice and perform rectification works as necessary.

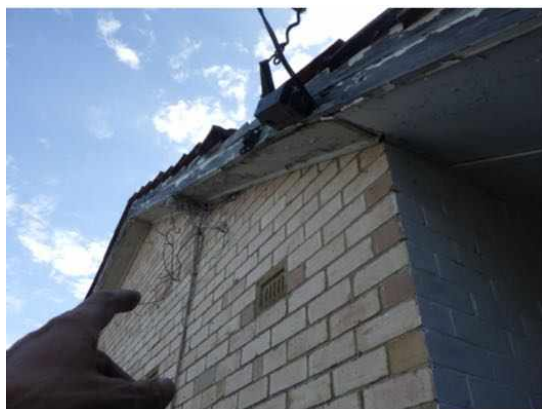
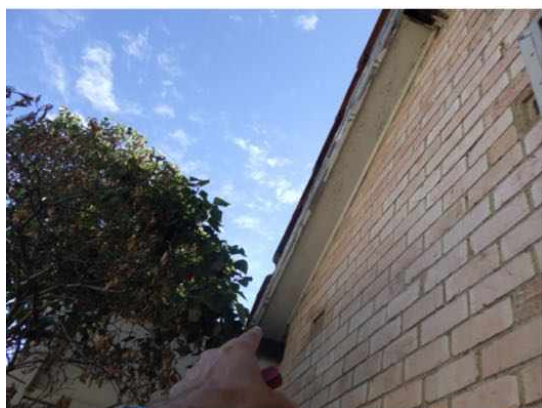
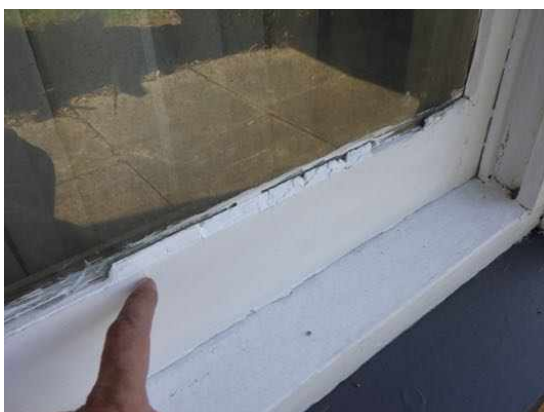
Defects 3.05

Building:	Building 1
Location:	All External Areas
Finding:	External painting deteriorated
Information:	Much of the external paintwork including but not limited to windows, fascias, guttering, veranda and other external fitments have been neglected and require attention to prepare and re-paint.

Whilst incomplete or missing paint finish is generally an appearance defect, it can also lead to the development of secondary building defects over time. Incomplete areas of paint finish expose the area to moisture, potentially accelerating the deterioration of underlying building materials.

Degraded paint finishes should be sanded back, filled, leveled and painted, as applicable. Where inadequate or missing paint protection has led to the deterioration of the associated building element, repair and/or replacement of this building element may be required.

A painting contractor should be appointed as soon as possible to perform necessary works to aid the appearance of the affected area and to ensure the area is protected against further deterioration. Alternatively, the homeowner following manufacturer instructions may perform these works.

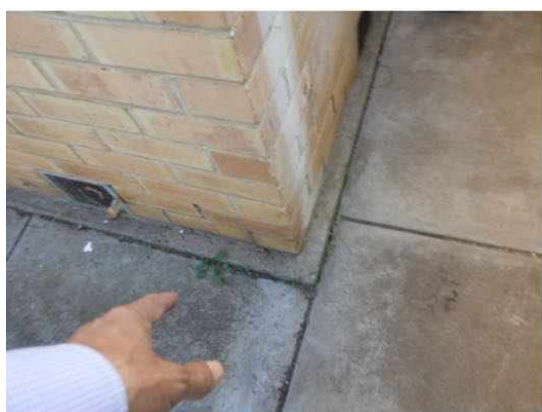
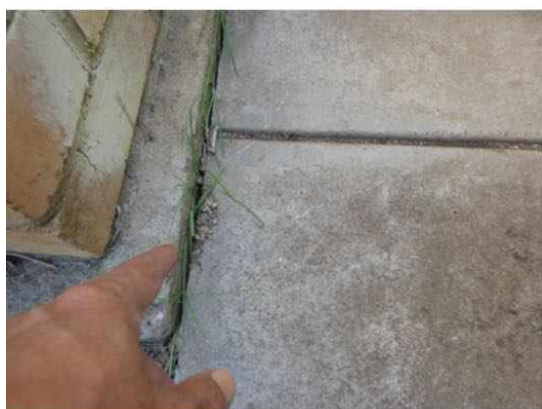
Defects 3.06

Building:	Building 1
Location:	All External Areas
Finding:	Bridging - Vegetation
Information:	Where vegetation obstructs inspection of building elements, also known as bridging as it provides a bridging point for the access of termites, full inspection can not be

achieved. Consequently moisture or dampness may be present and the areas becomes conducive to termite activity. Plants against or very close to buildings provide cover, shade and can provide an environment that is attractive to termite infestation.

The removal and replanting of species that do not provide "cover" or cutting back of existing vegetation will assist greatly in preventing Bridging from occurring.

The removal of any such materials that may be conducive to termite activity should be carried out as soon as possible and arrange re inspection to minimize the risk of termite attack.

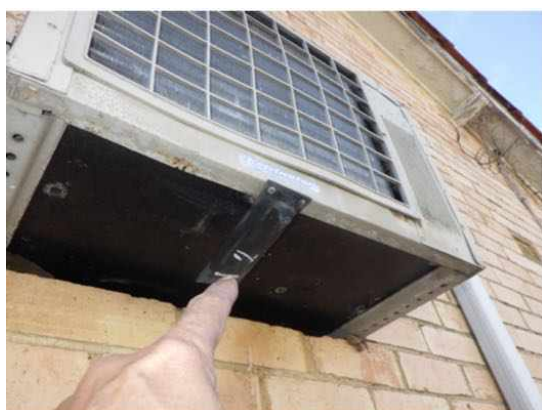
Defects 3.07

Building:	Building 1
Location:	All External Areas
Finding:	Air conditioner - Disconnected overflow
Information:	The Air Conditioner (A/C) overflow was found to be disconnected from storm water drainage and is creating excessive moisture in the surrounding area.

Such leaking creates an environment which is conducive to an array of defects, including water damage to associated building elements and the attraction of termite or timber pest infestation.

It is highly recommended that a licensed plumber be appointed to connect the A/C overflow in order to prevent such an environment from being created. These minor works should be carried out as soon as possible.

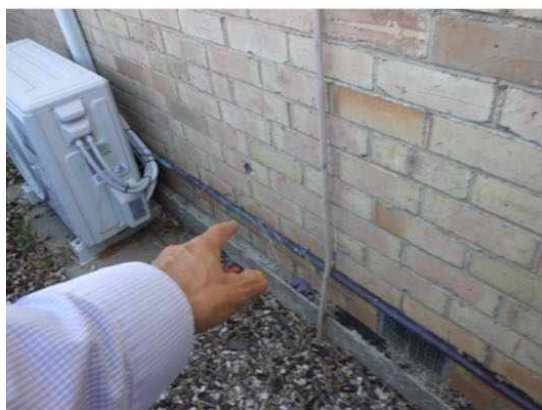
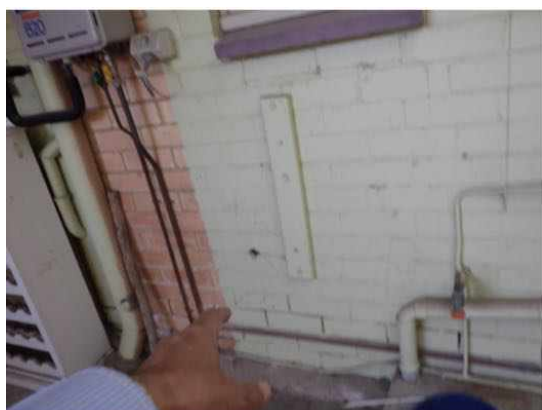
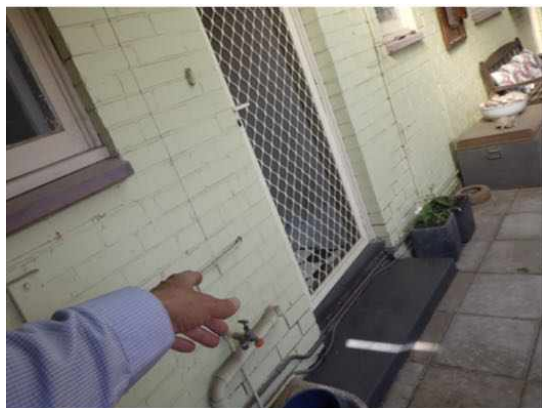
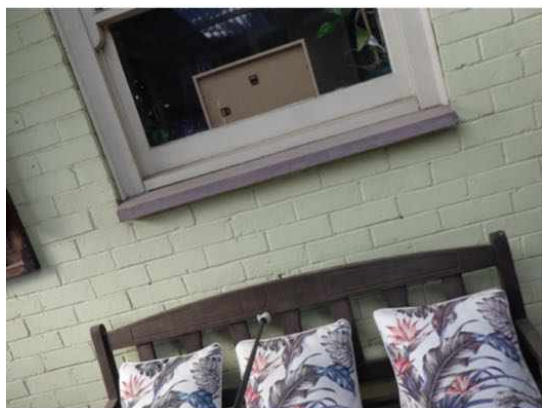
Defects 3.09

Gaps and holes around pipework makes the area susceptible to insect and vermin ingress, as well as allowing water penetration to the cavity wall. As such, associated building elements are likely to deteriorate at an accelerated rate, and major implications are expected if holes around the pipework are left unmanaged.

All excessive holes, gaps or cracks should be adequately filled by a suitable sealant or trimmings as soon as possible to prevent any further damage. Such works may be conducted by a general handyperson or licensed plumber.

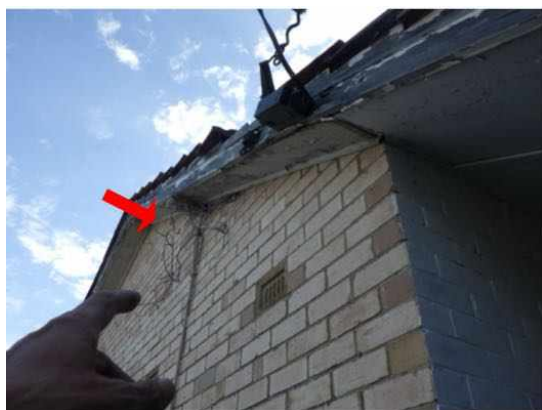
Defects 3.10

Building:	Building 1
Location:	All External Areas
Finding:	External Wall – Front Area – Creeper Vegetation
Information:	At the time of inspection it was noticed that creeper vegetation was hanging over the external wall - eaves (LHS) in the front area of the property. It was also observed that sections of the creeper vegetation were dry at the time of inspection.

Creeper vegetation in contact with external wall surfaces can retain moisture, restrict visual inspection, and may contribute to deterioration of associated building materials over time. Dry vegetation may also require maintenance to reduce unnecessary loading and improve presentation of the area.

It is advised that appropriate maintenance be carried out as required, including trimming or removal of vegetation where necessary, to allow ongoing monitoring of the wall surface and associated building elements.

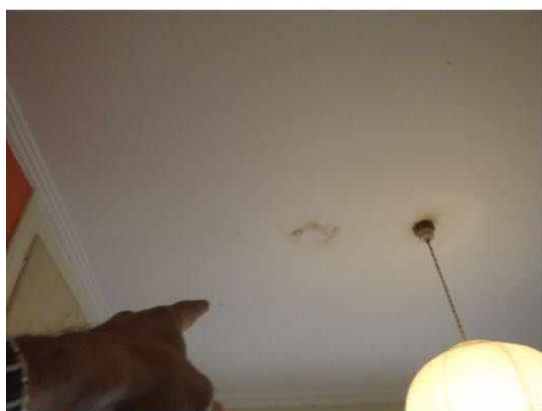
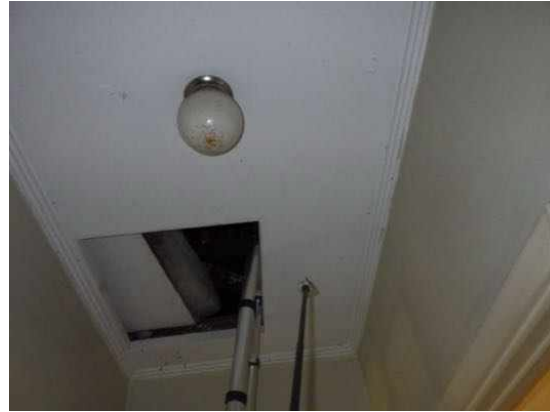
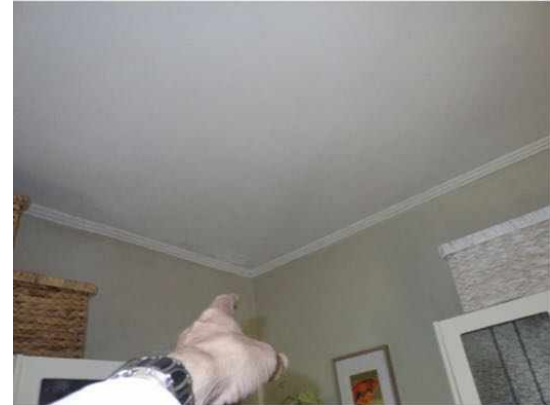
Defects 3.14

Building:	Building 1
Location:	All Internal Areas
Finding:	Ceiling - Water stained
Information:	Water staining to ceiling linings in this area was evident at the time of inspection. Water staining indicates that surfaces have been exposed to excessive moisture over time. The minerals and other elements in the water lead to staining, which may graduate to corrosion and deterioration if left unmanaged.

Conversely, where water staining is old and inactive, affected building materials may be repaired or replaced at client discretion.

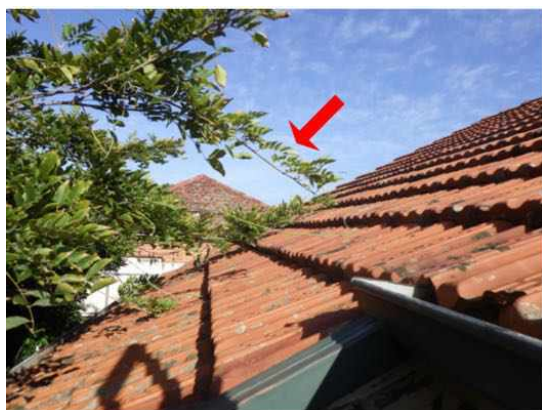
Noted Item

Building: Building 1
Location: All External Areas
Finding: Trees - Overhanging and filling gutters
Information: Overhanging trees often result in excessive amounts of leaf debris accumulating in gutters.
